23 March 2012

Ms Jenny Easton  
Tasman District Council  
Private Bag 4  
**RICHMOND 7050**

### **GROUNDWATER MONITORING AT FORMER FCC SITE, MAPUA – FEBRUARY 2012 SAMPLING UPDATE**

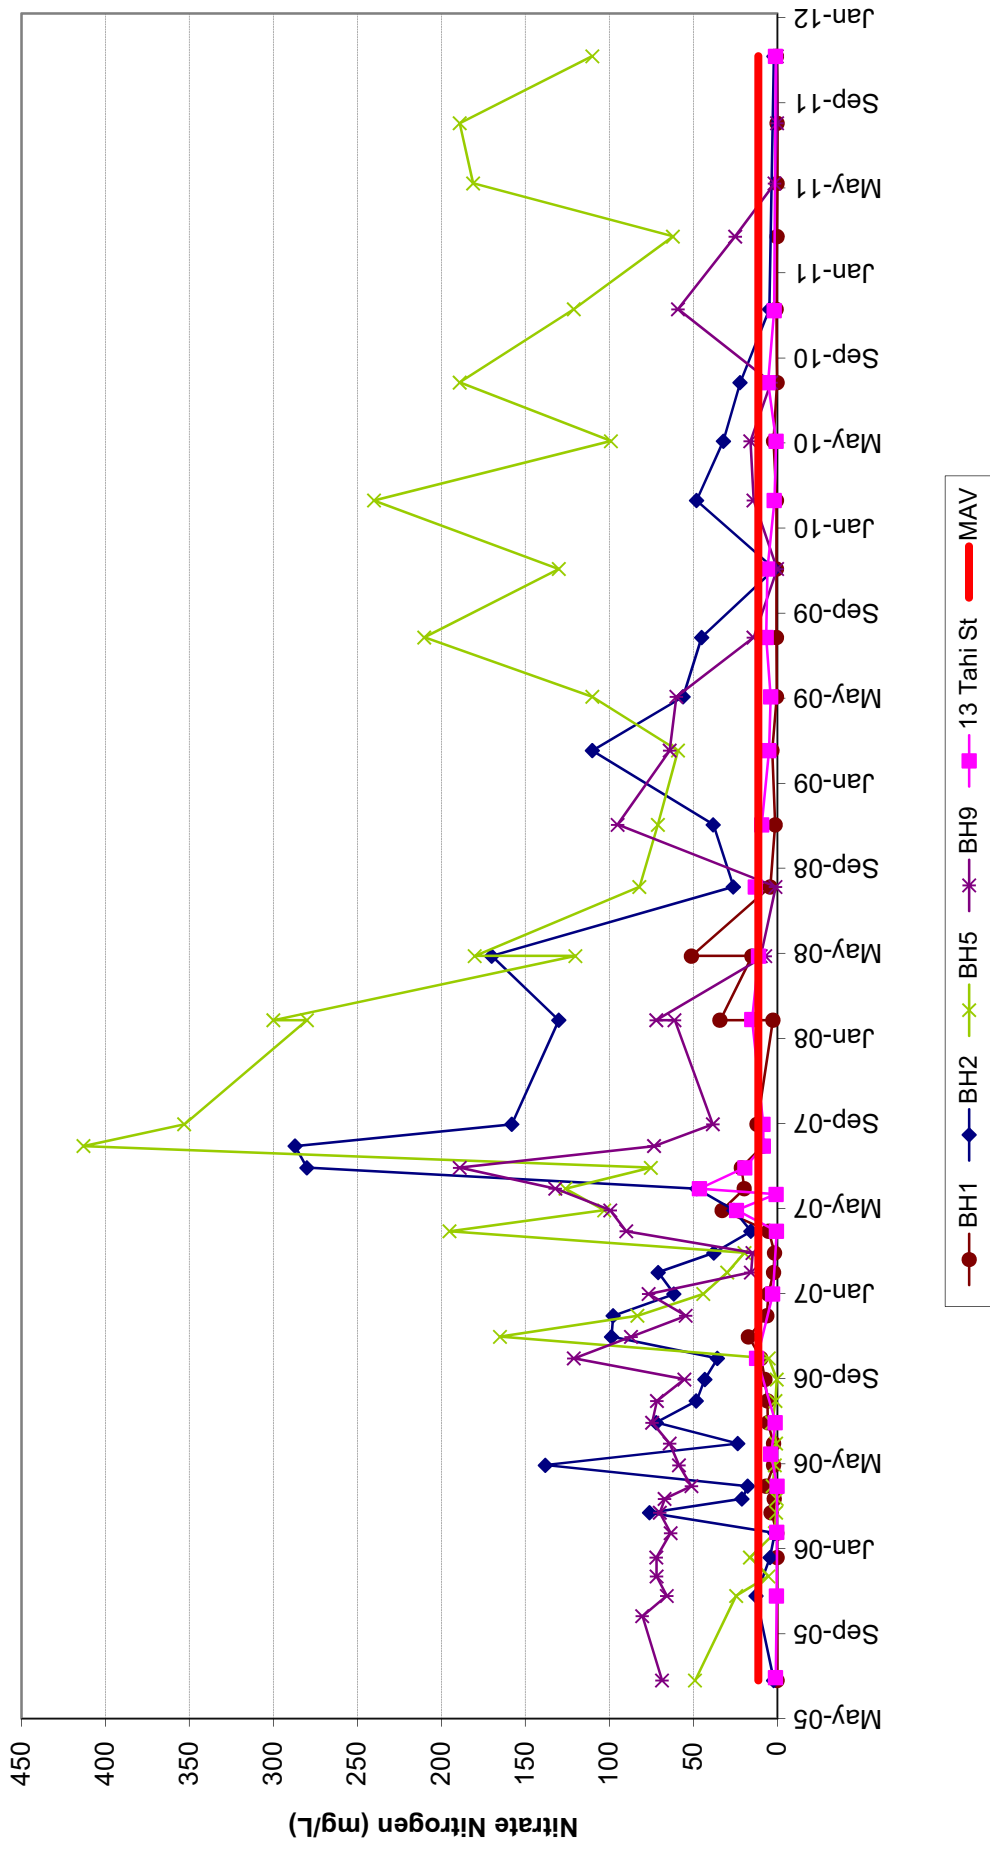
Figure 2. Nitrate-N  
MAV DWSNZ 11.3 mg/L

- ∴ Figure 2 shows nitrate-nitrogen concentrations. Three boreholes have historically shown elevated concentrations: BH2, BH5 and BH9. Since late 2007, concentrations have decreased substantially, which coincides with the cessation of the MCD reactor in mid-2007. Despite this general decline, BH5 continues to show significantly elevated concentrations. During the last year, only BH5 and BH9 have had measured nitrate-N concentrations above the Maximum Acceptable Value in the Drinking Water Standards for New Zealand 2005 (Revised 2008), which is 11.3 mg/L. BH9 has one exceedance of the MAV in February 2011 (25 mg/L), with the remaining concentrations between 0.004 and 1.49 mg/L. BH5 recorded concentrations between 62 and 189 mg/L. Figure 2a shows the boreholes that have typically displayed lower nitrate-N concentrations. Both BH1 and 13 Tahī Street remain at stable, low concentrations;

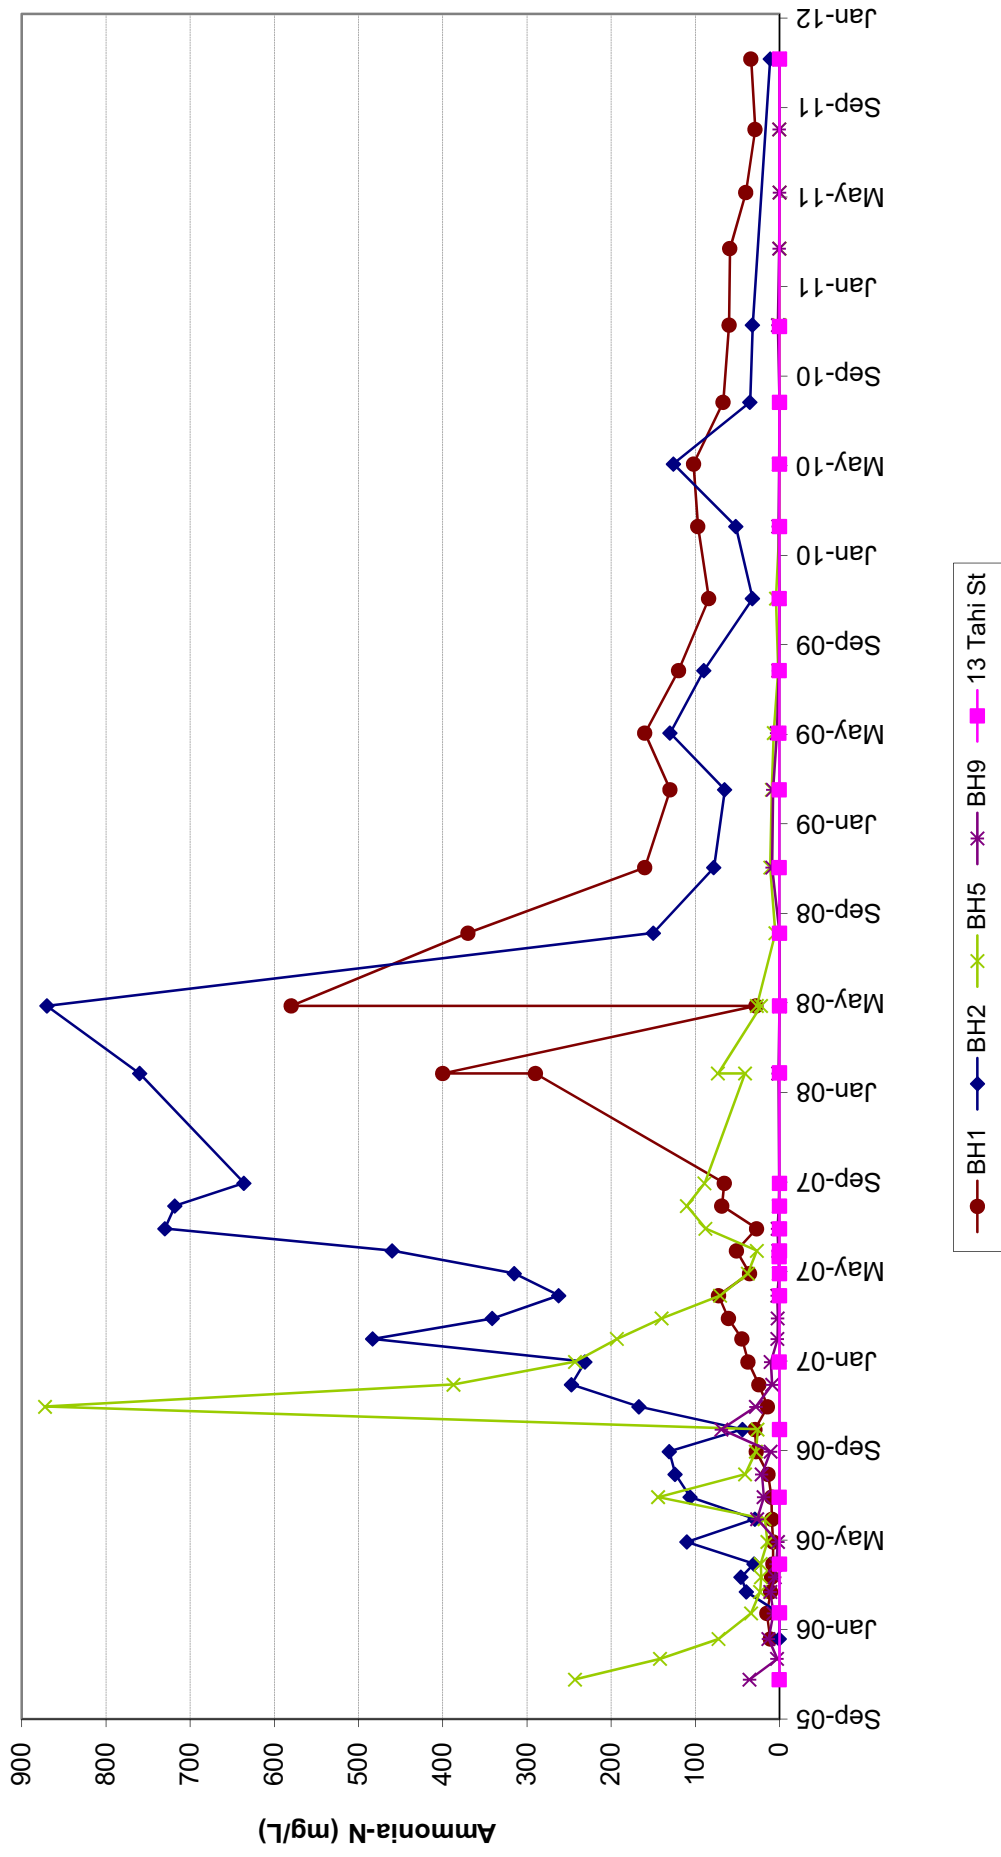
**Figure 3. Ammonia-N**  
**GV Aesthetic DWSNZ 1.2 mg/L; Aquatic Ecosystem Guideline 0.71mg/L**

- ∴ Figure 3 shows ammonia-nitrogen concentrations. The bores with elevated concentrations (BH1 and BH2) have shown a small decrease over the last year. Those bores with lower ammonia-N concentrations (Figure 3a) show stable concentrations in BH5, BH9 and 13 Tahī Street.

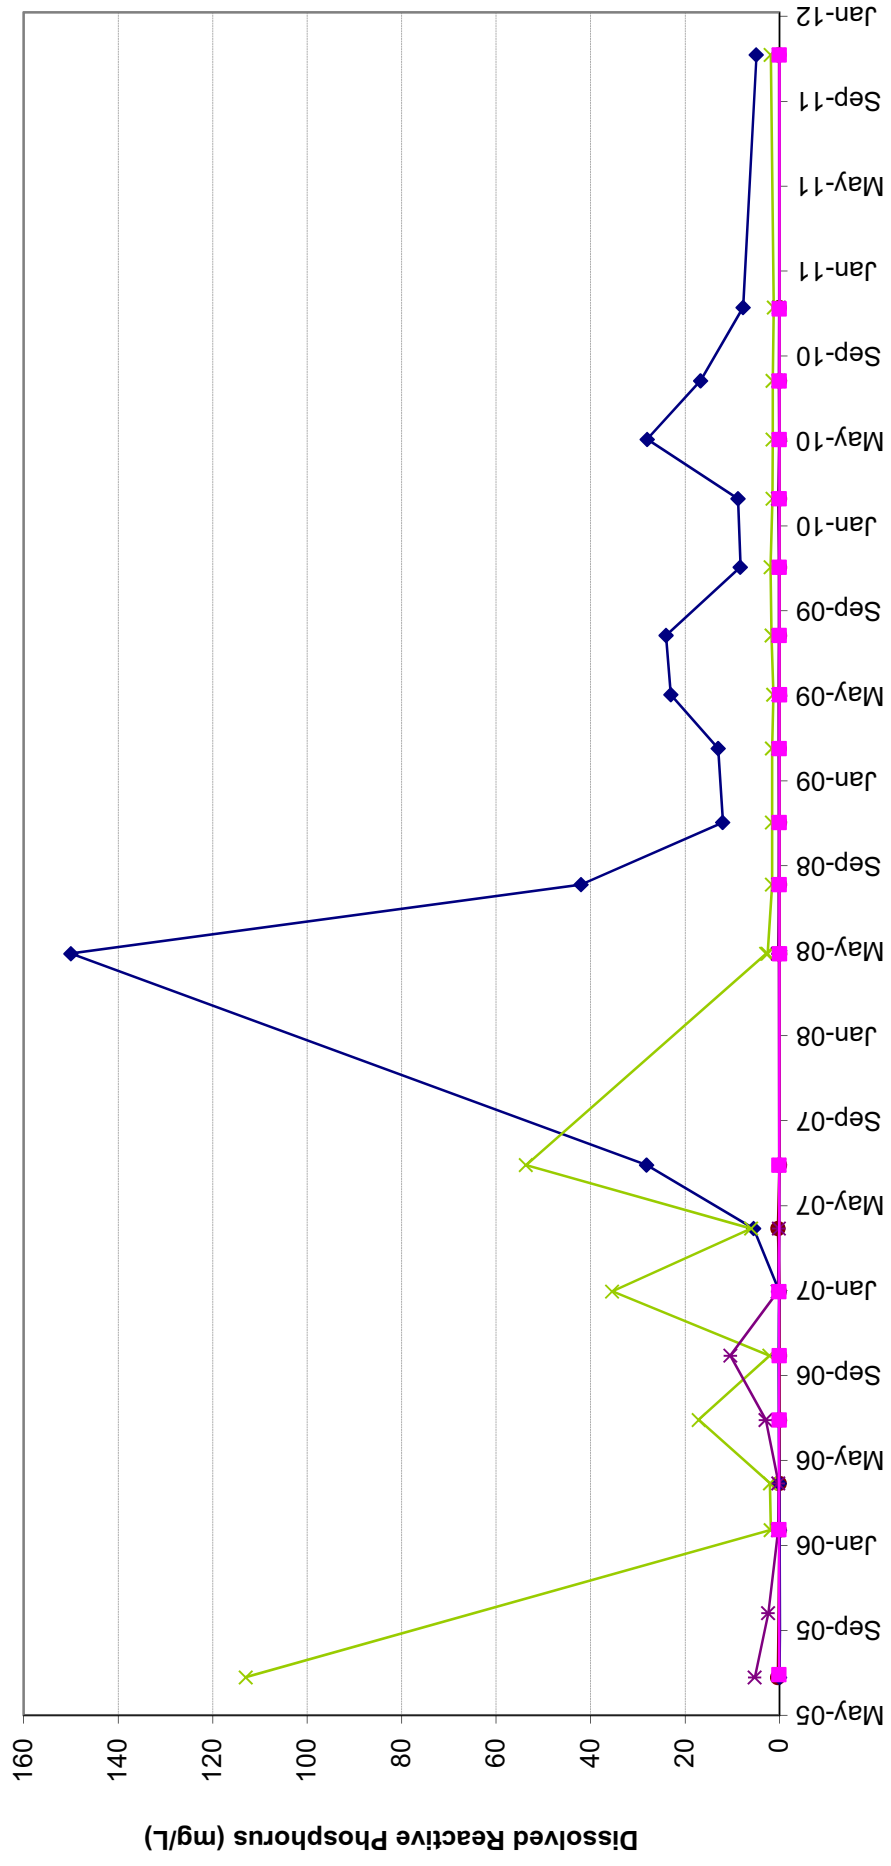
**Figure 4. Dissolved Reactive Phosphorus Aquatic Ecosystem Guideline 0.01 mg/L**

- ∴ Figure 4 shows dissolved reactive phosphorus concentrations, which have remained stable over the last year.
- ∴ Figure 5 shows DDX concentrations. The bores with elevated concentrations (BH1 and BH5) continued to fluctuate significantly during the last year. The remaining bores (BH2, BH9 and 13 Tahī St) showed stable concentrations over the last year.

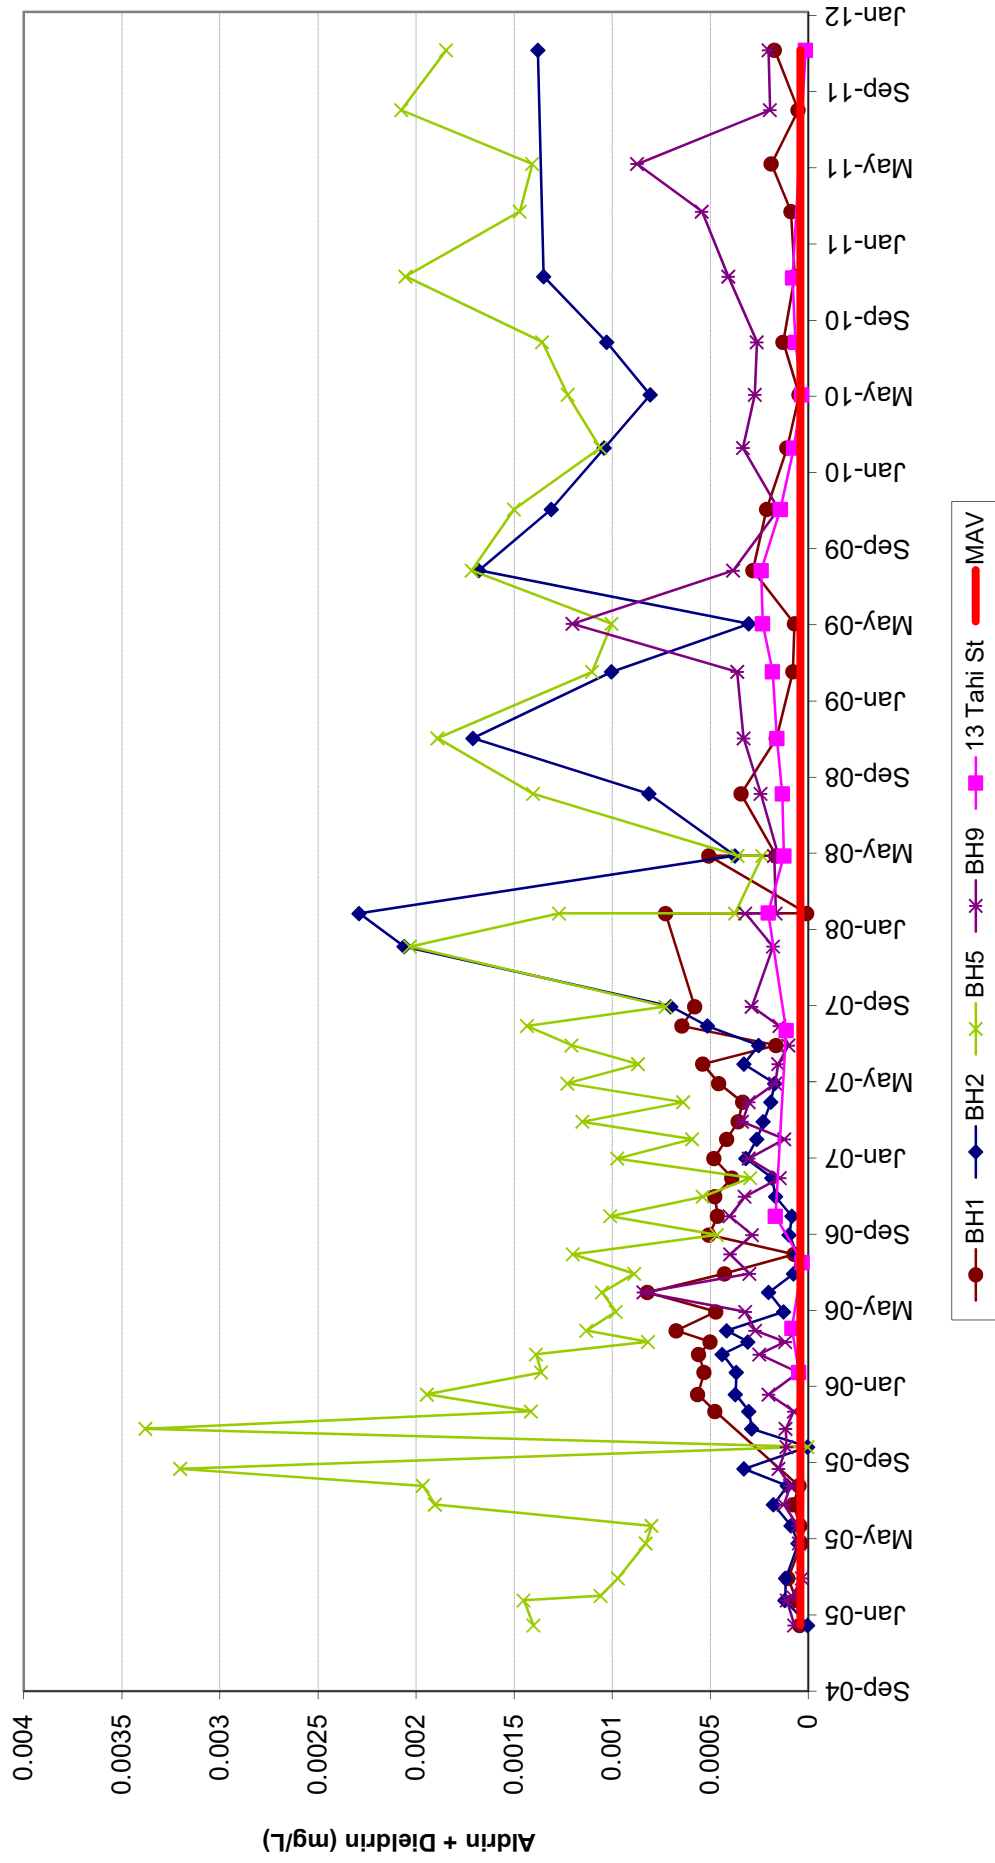
Figure 6. Aldrin + Dieldrin  
MAV DWSNZ 0.0004 mg/L

- ∴ Figure 6 shows aldrin + dieldrin concentrations, which have been relatively stable over the last year. The highest concentrations occur in BH5 and BH2 and remain at similar concentrations to those measured during the remedial works. All of the regularly sampled wells except for 13 Tahī St are above the MAV in the Drinking Water Standards (0.00004 mg/L).

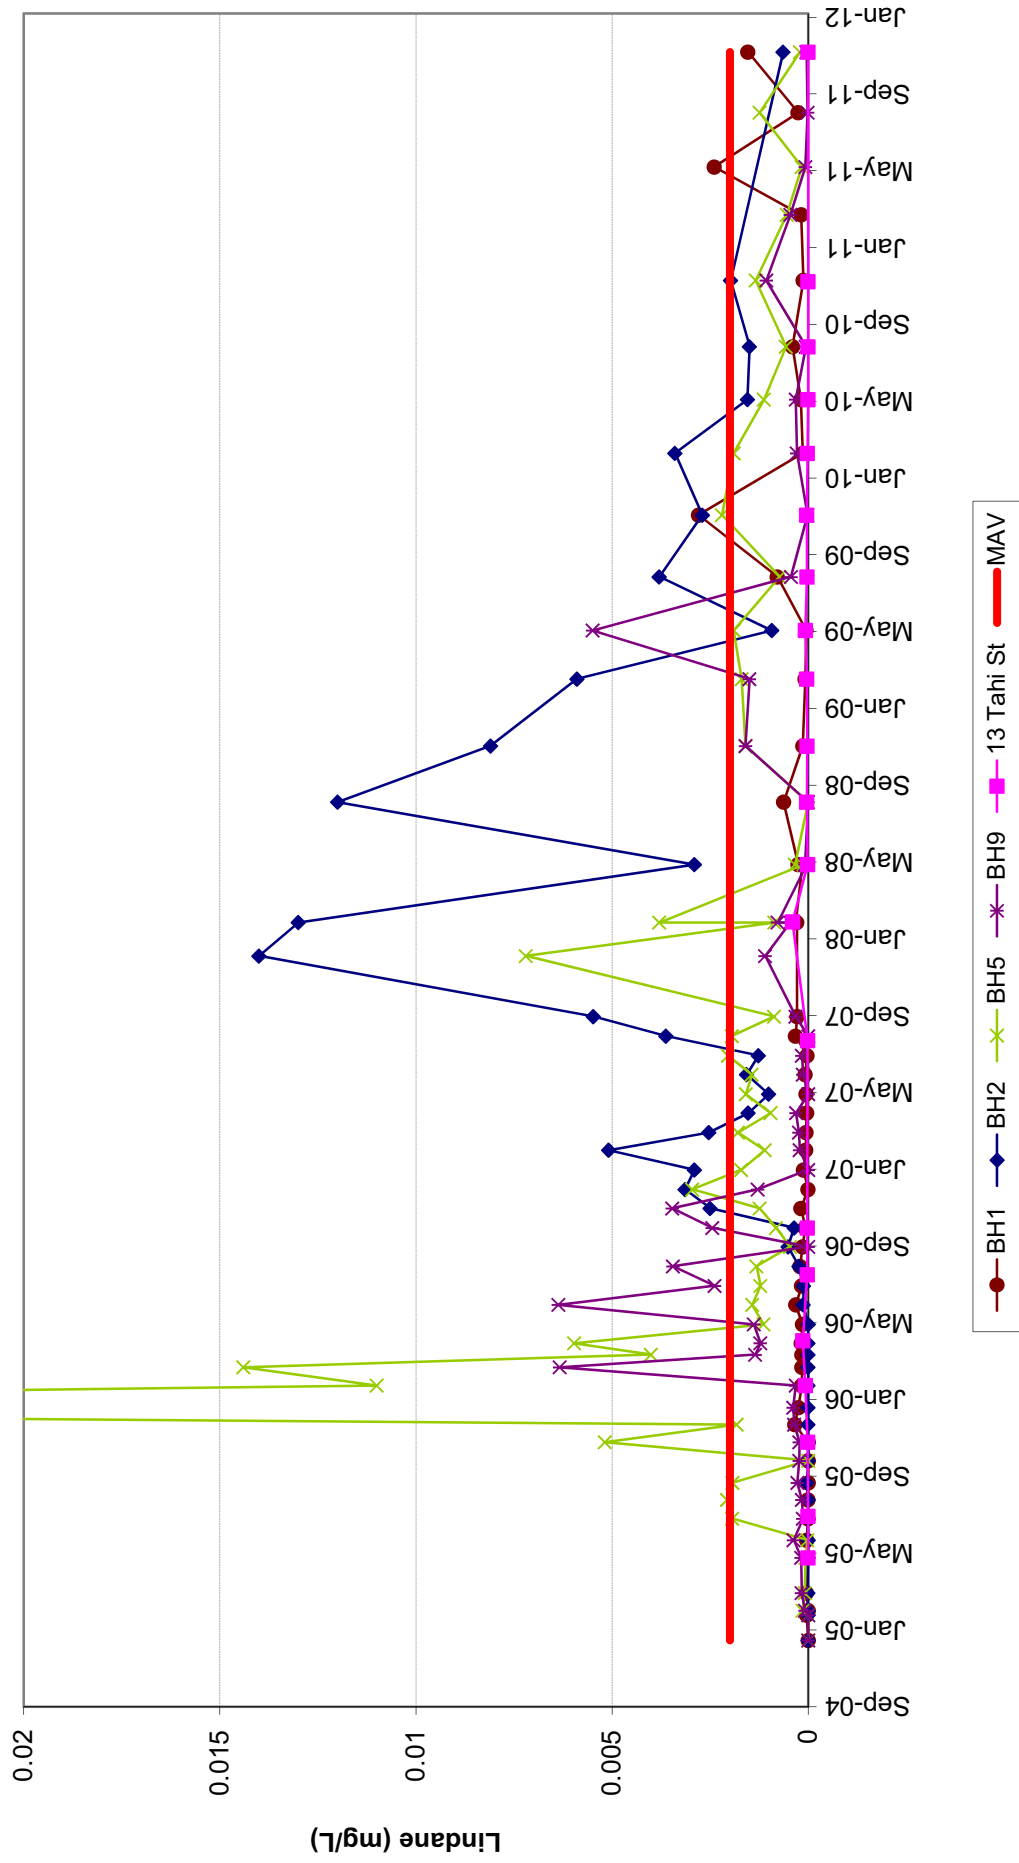
Figure 7. Lindane  
MAV DWSNZ 0.002 mg/L

- ∴ Figure 7 shows lindane concentrations, which have decreased significantly since the remedial works and have been stable over the last year. Only one of the samples (BH1 in May 2011) exceeded the MAV in the Drinking Water Standards (0.002 mg/L) on only one occasion during the last 12 months.

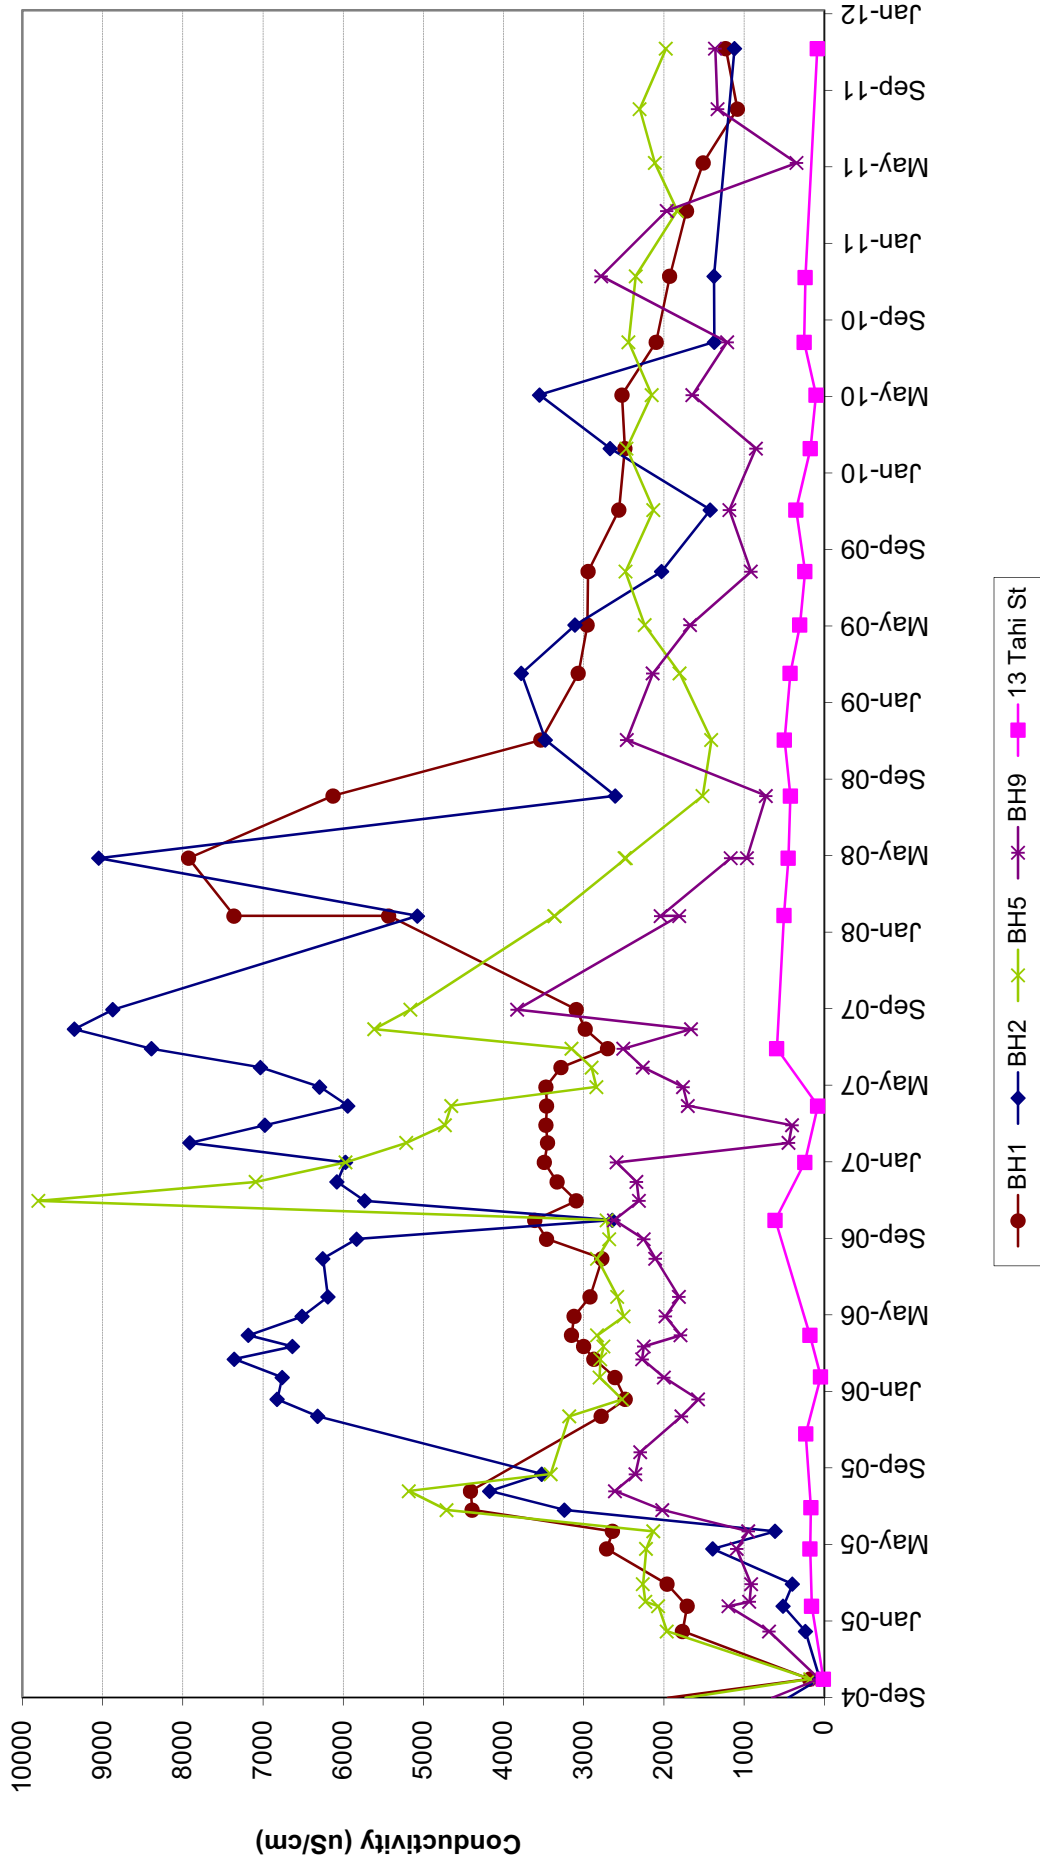
Figure 8. Conductivity

- ∴ Figure 8 shows electrical conductivity values, which are a general indicator of all the chemicals dissolved in the water. These show a gradual decline in values, indicating a general improvement in groundwater quality beneath the site.

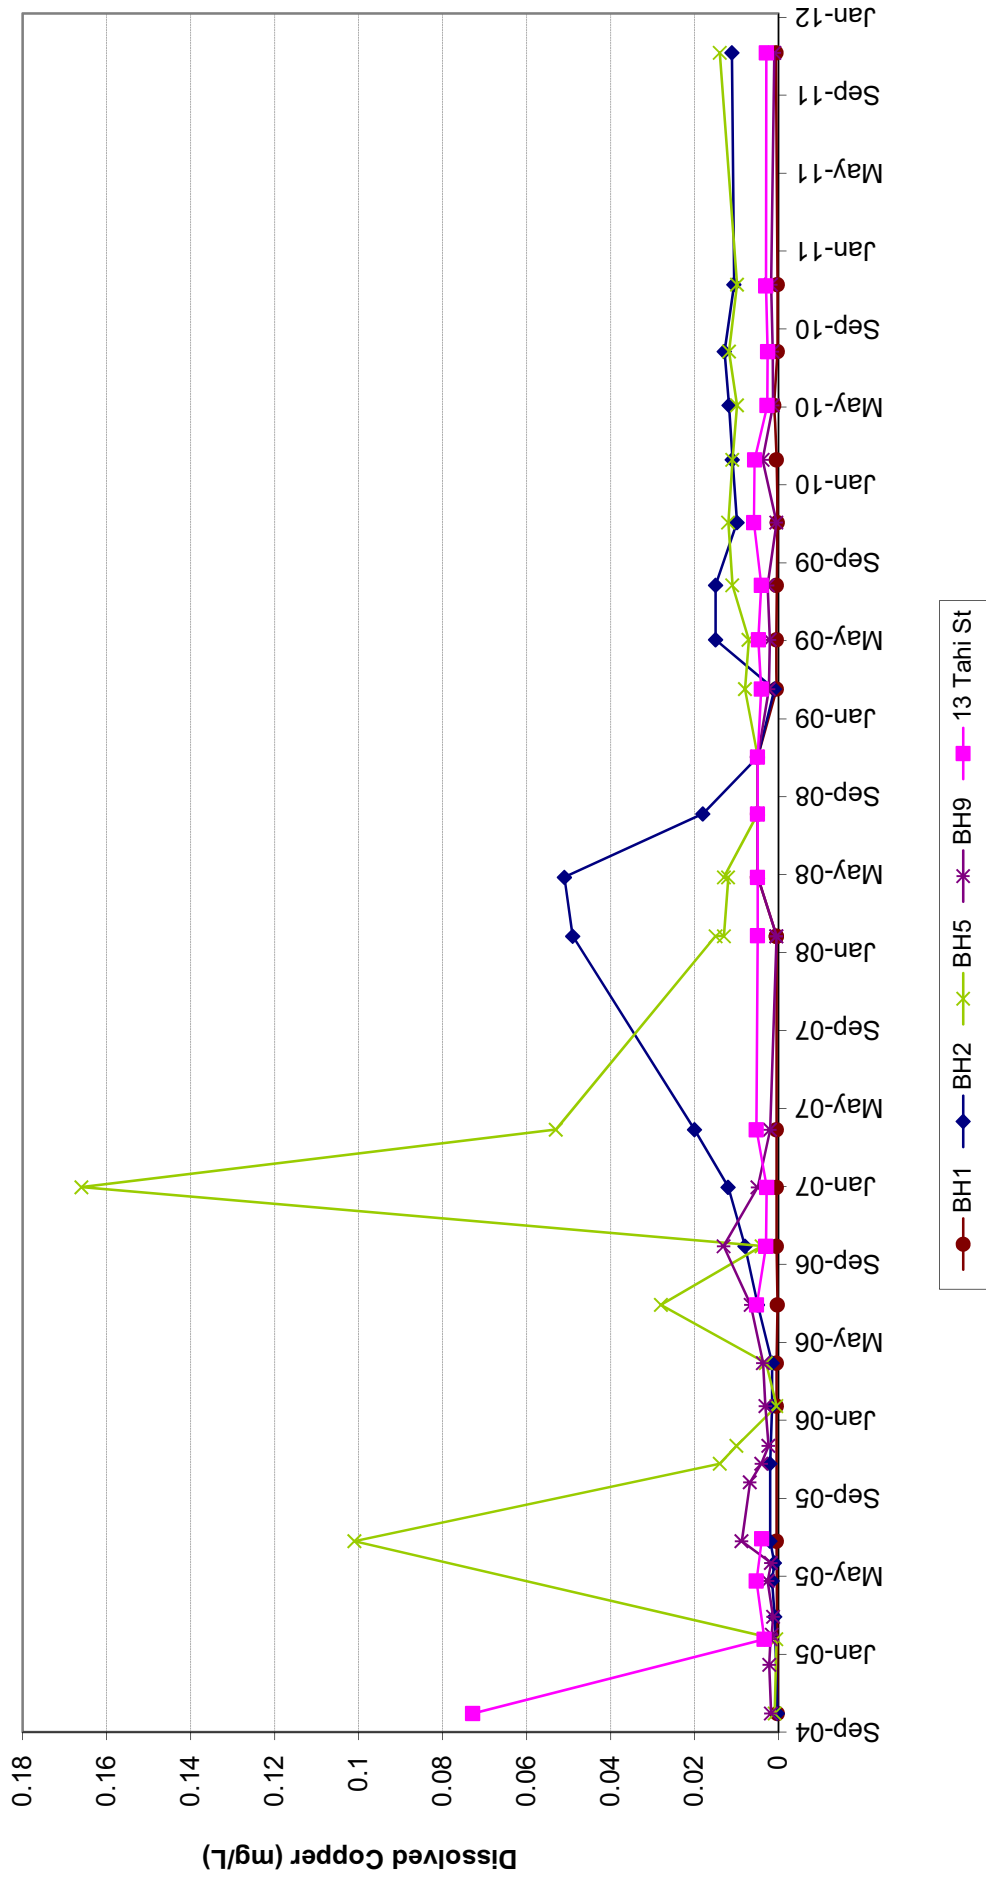
**Figure 9. Dissolved Copper**  
**MAV DWSNZ 2 mg/L, ANZECC Marine Guideline = 0.0013 mg/L**

- ∴ Figure 9 shows dissolved copper concentrations. Copper was one of the reagents used in the MCD process. The results show stable concentrations.

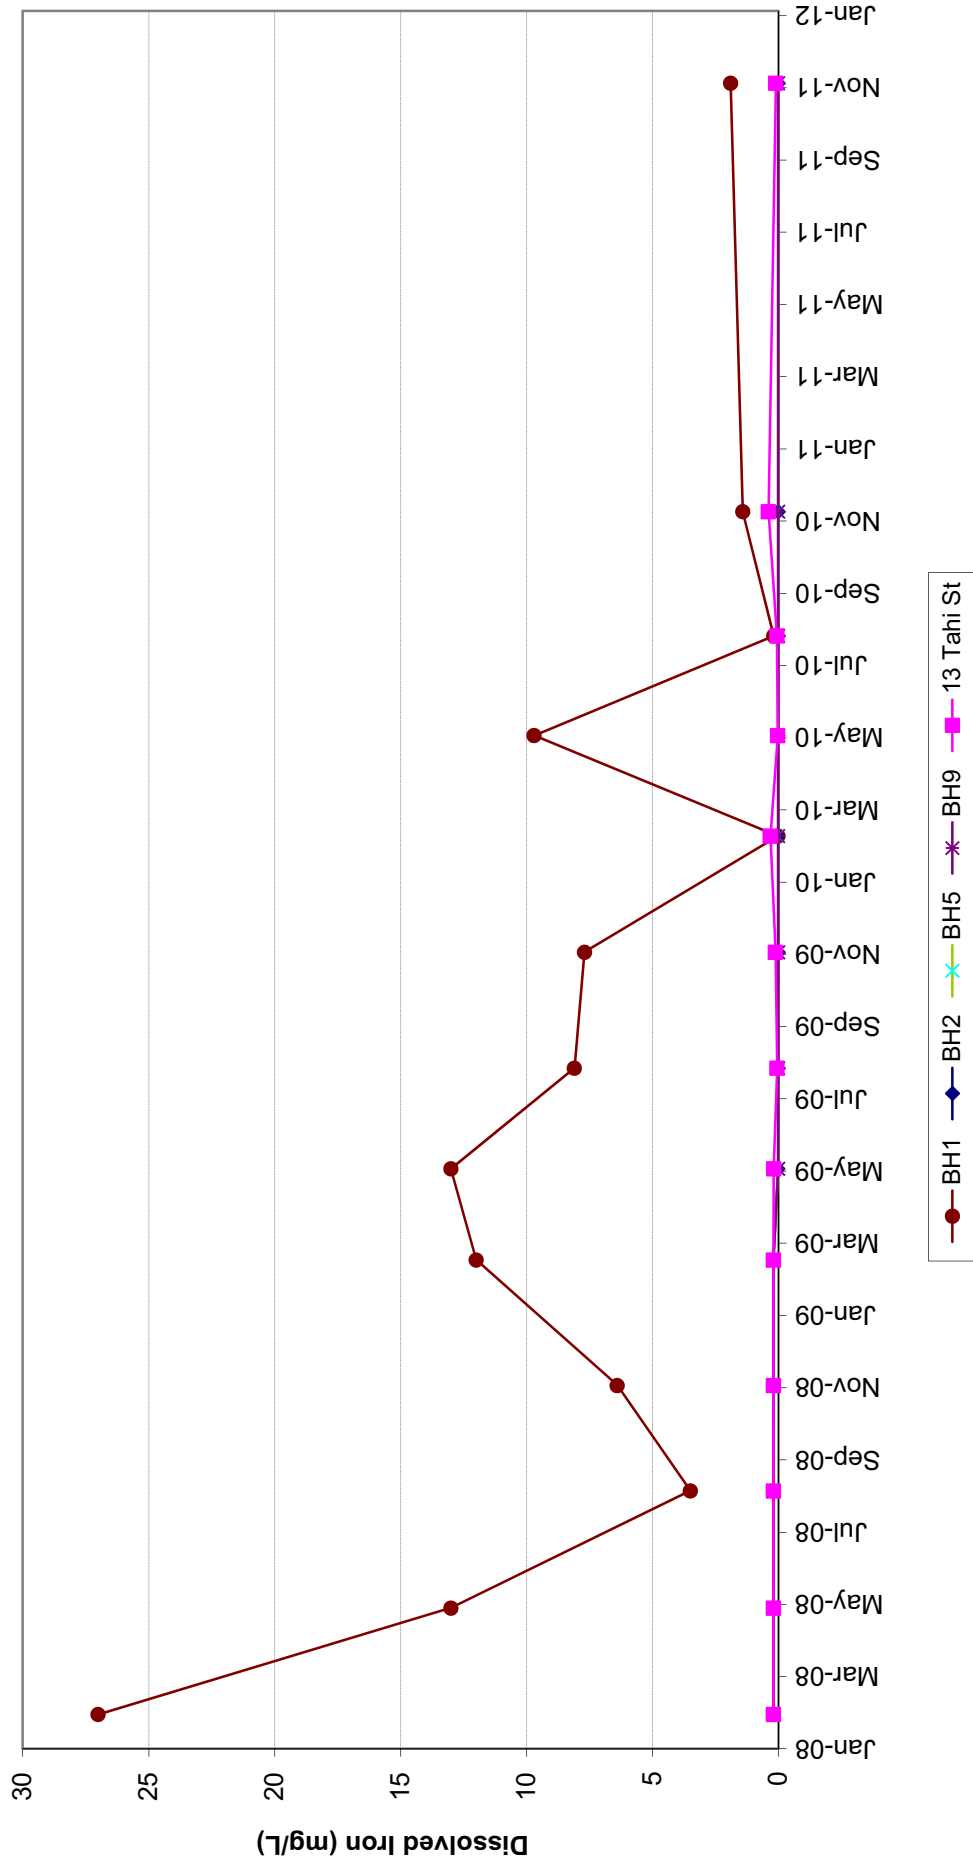
**Figure 10. Dissolved Iron  
Aesthetic Guideline Value DWSNZ 0.2 mg/L**

- Iron was utilised in the MCD process, but has only been sampled since January 2008. The results are shown in Figure 10. During the November 2011 sampling round, dissolved iron was measured in BH1 (1.9 mg/L) and 13 Tahī St (0.11 mg/L). Dissolved iron was not detected in the other three bores (BH2, BH5 and BH9).

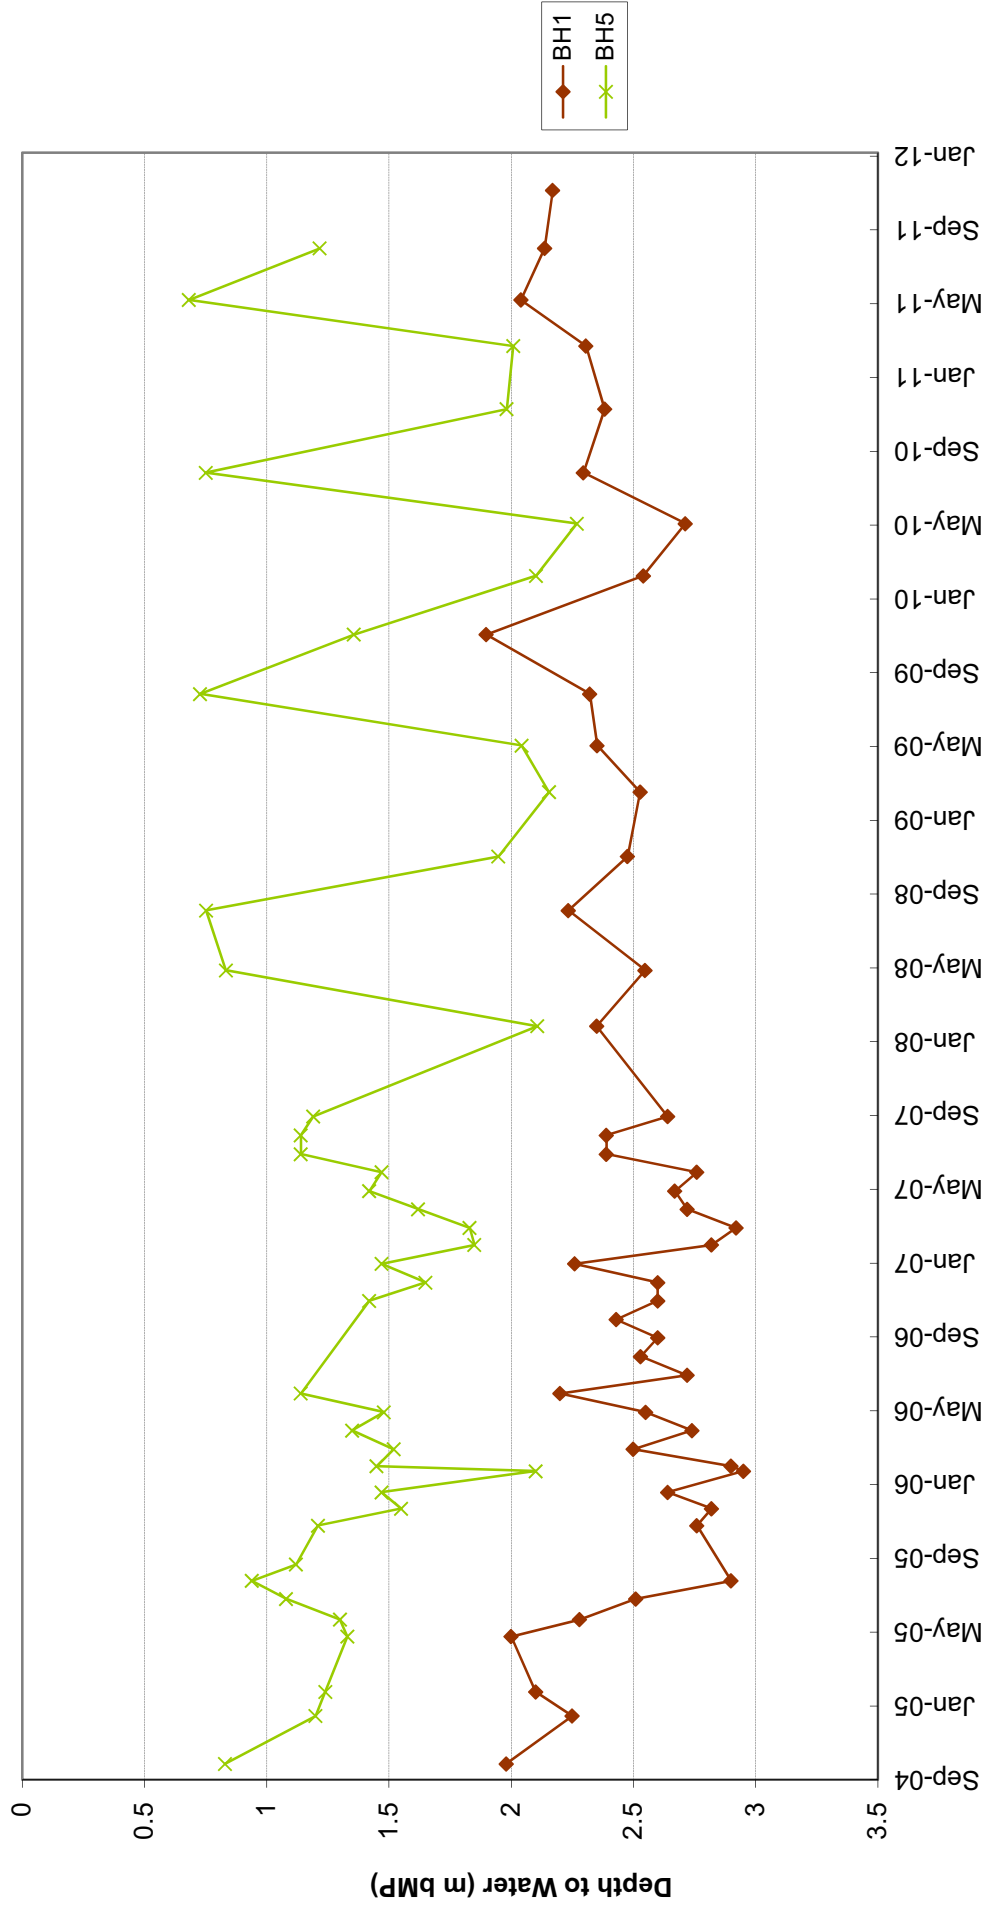
Figure 11. Water Level Plot

Figure 11 shows a plot of depth to water in bores BH1 and BH5. During the last year water levels have fluctuated within their typical range in BH5, but have tended to be higher than average in BH1. Most chemical concentrations have been generally stable or shown a slight improving trend over the last year, with the exception of nitrate-N in BH5, DDX in BH1 and BH5 and aldrin + dieldrin in BH2 and BH5. It is expected that the more significant fluctuations in these bores are related to groundwater level fluctuations causing two contrasting mechanisms to operate. At times of low groundwater level, there is less groundwater throughflow to dilute the on-site concentrations. At times of high groundwater levels there will be some areas of the site where groundwater inundates the treated fines, or where there has been a time of increased infiltration, resulting in increased leaching of chemicals. Figure 12 shows the groundwater level and nitrate-N concentration in the bore showing the most significant fluctuations (BH5). Whilst water level fluctuations in this bore may be partly affected by the artificially placed bund and backfill material it does give an indication of the times of high and low groundwater levels. The resulting pattern in Figure 12 indicates a general pattern of increased nitrate at higher groundwater levels. Figures 13 and 14 show a more variable pattern for DDX and aldrin + dieldrin, with the peak concentrations tending to lag behind the groundwater level peaks.

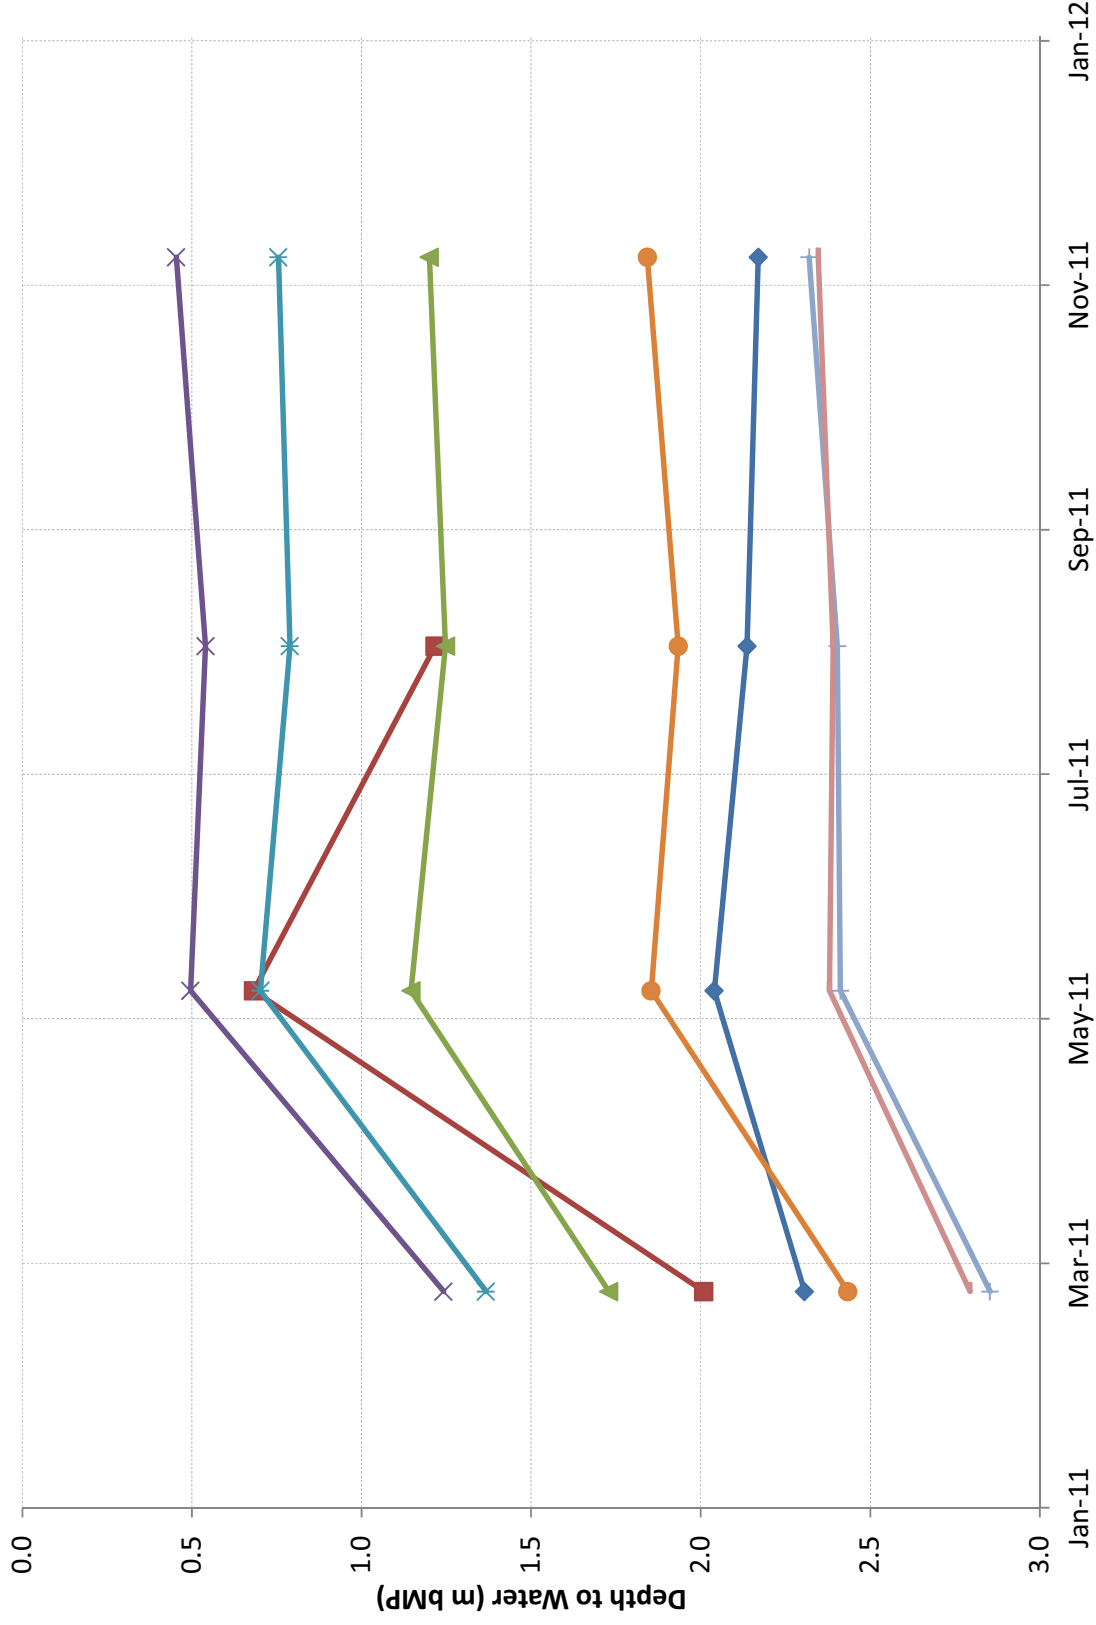
Figure 15. Water Levels in Quarterly Monitored Wells

Figure 15 shows the depths to water in these quarterly measured bores, which were relatively low in February 2011 and at a higher and more stable level for the following three quarters.

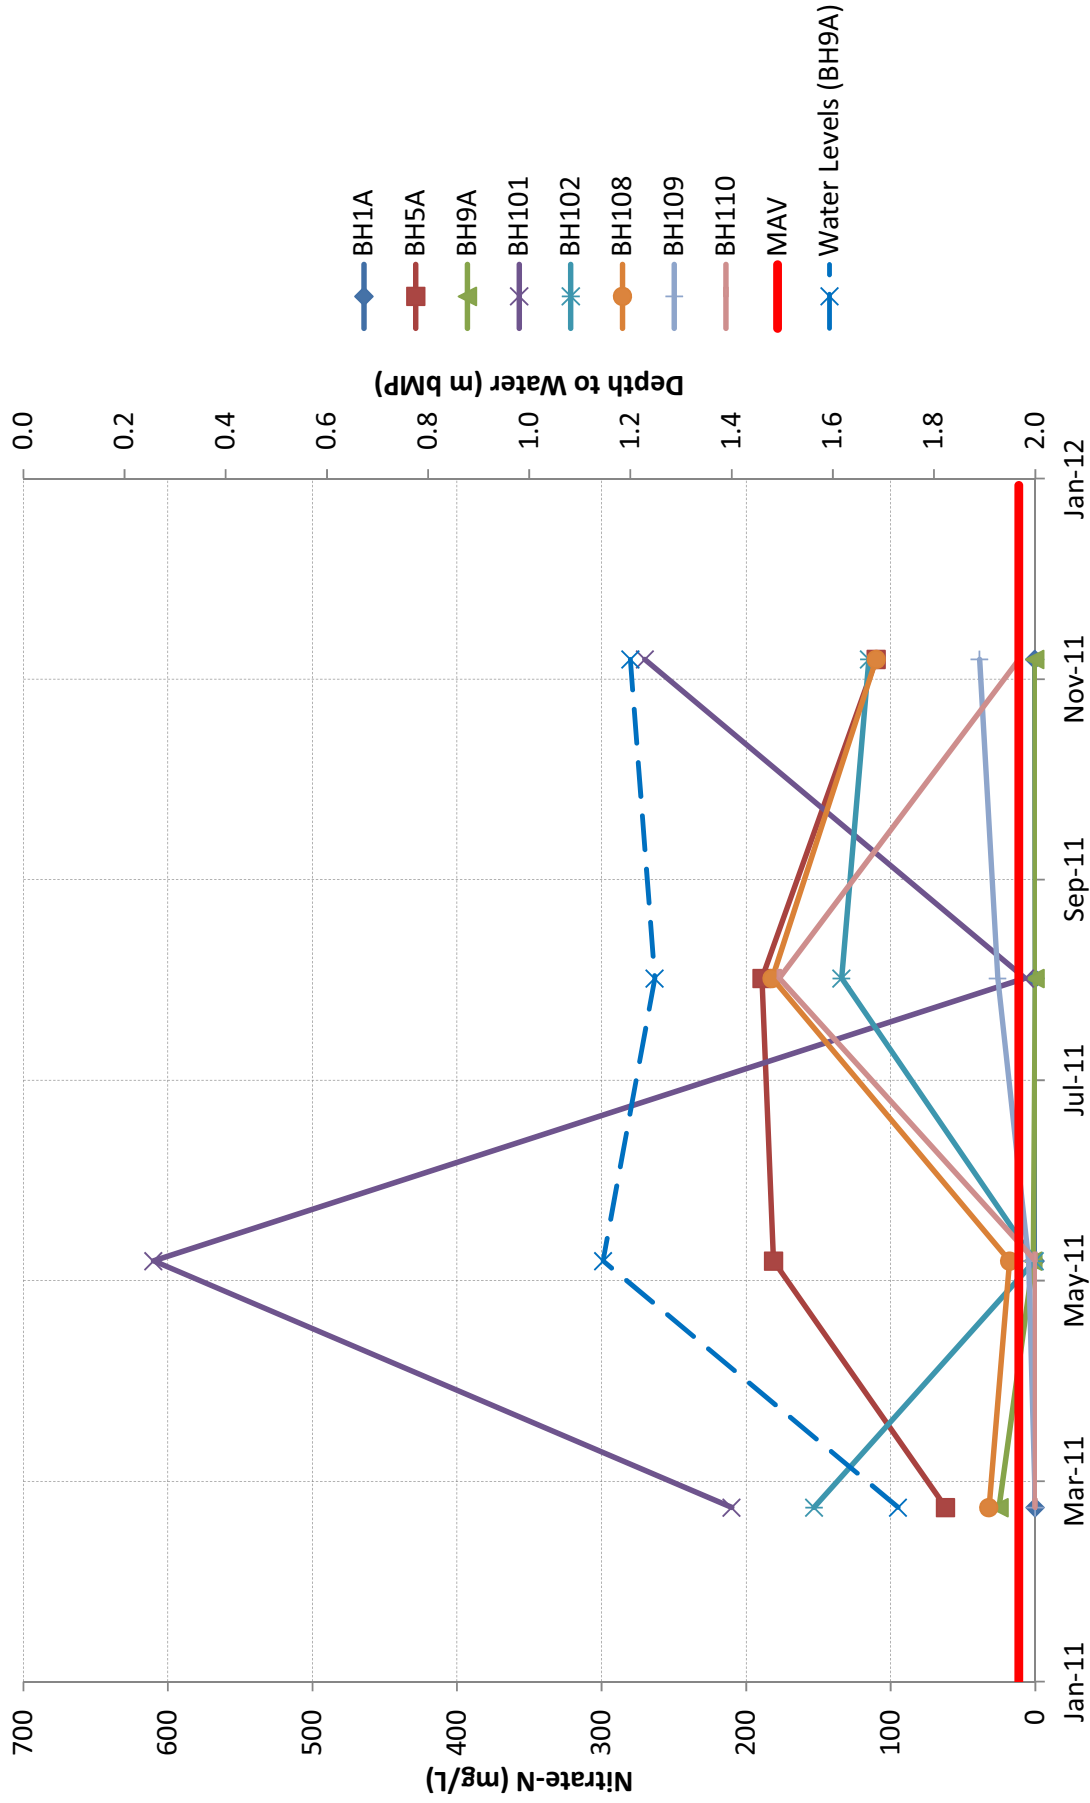
Figure 16. Nitrate-N Concentrations in Quarterly Monitored Wells

*Nitrate-N (Figure 16).* BH9A, BH102, BH108, BH110 and BH5A show a similar range of somewhat erratic fluctuations. Even greater fluctuations occur in BH101. A gradual increase has occurred in BH109 (up to 38 mg/L) and very low concentrations (<0.4 mg/L) in BH1A.
