23 March 2012

Ms Jenny Easton  
Tasman District Council  
Private Bag 4  
**RICHMOND 7050**

### **GROUNDWATER MONITORING AT FORMER FCC SITE, MAPUA – FEBRUARY 2012 SAMPLING UPDATE**

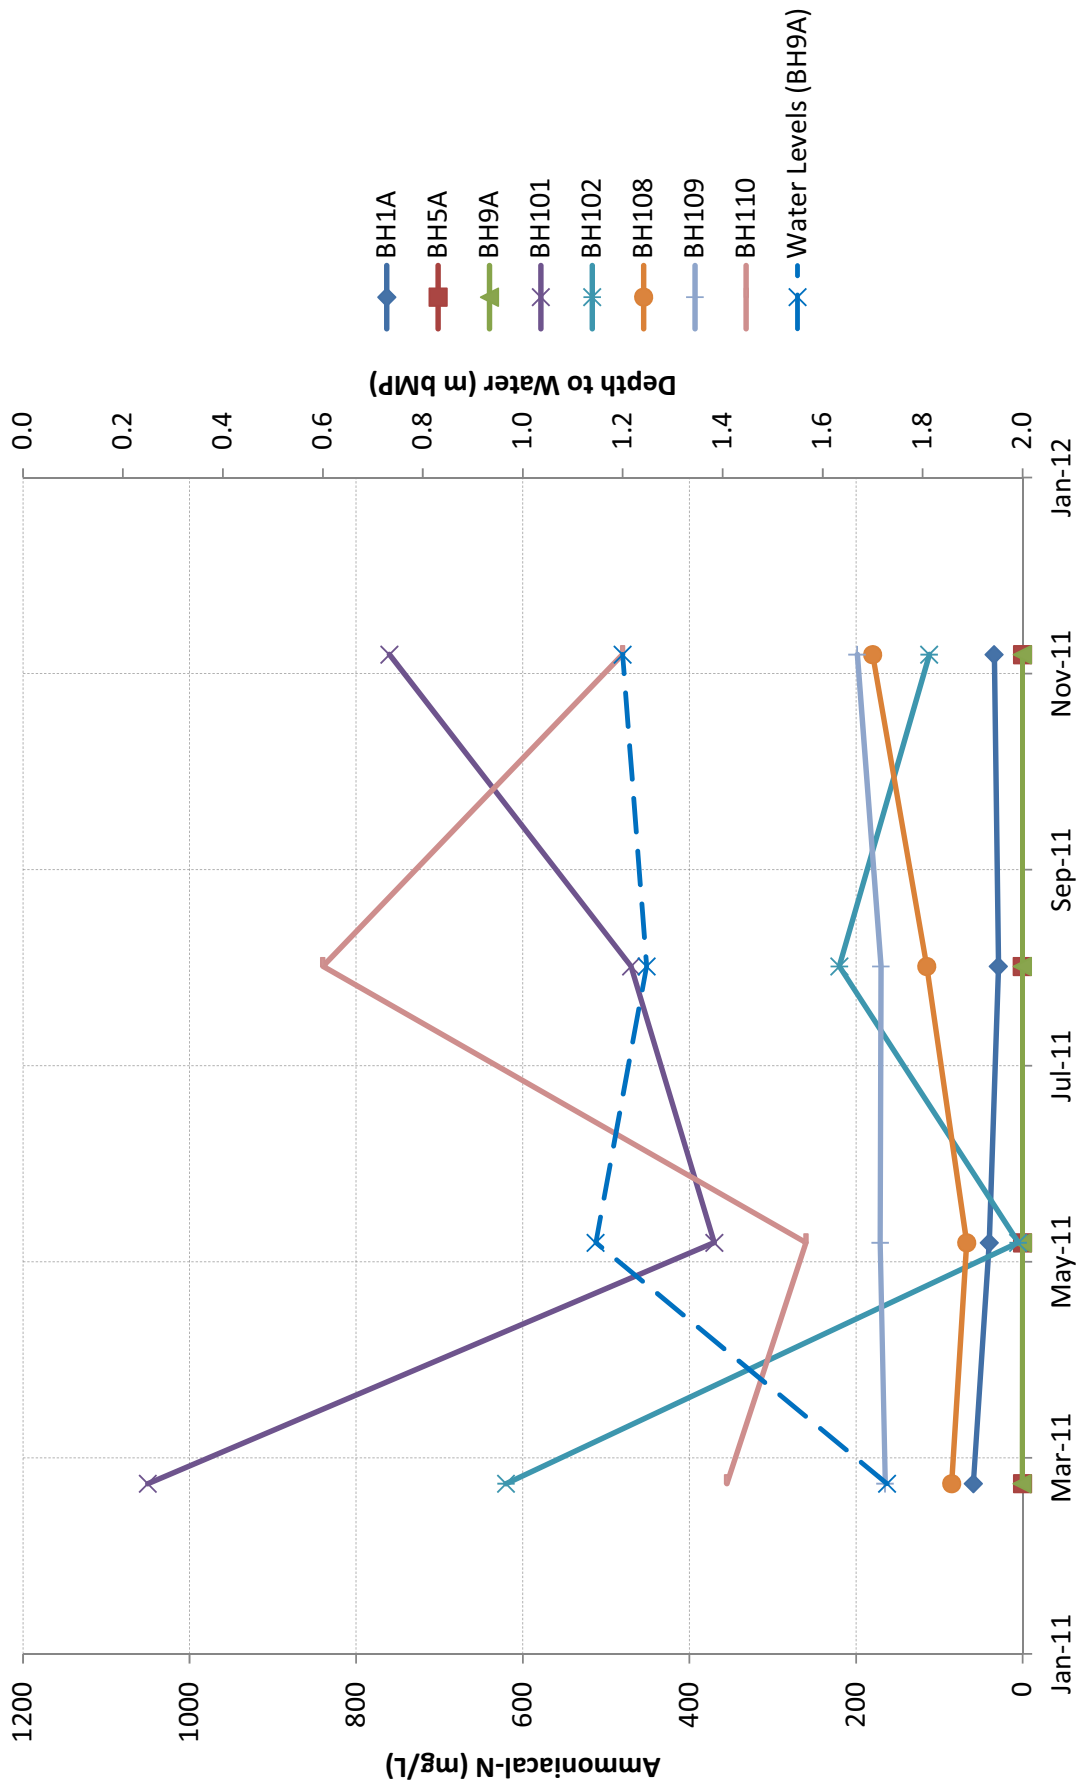
Figure 17. Ammoniacal-N Concentrations in Quarterly Monitored Wells

*Ammonia-N (Figure 17).* Large and erratic fluctuations occur in three wells, which from high to low are: BH101, BH110 and BH102, with the highest values in BH101 and BH102 associated with a low groundwater level. More stable trends show increases in BH108 and BH109, decreases in BH1A and very low concentrations (<0.5 mg/L) in BH5A and BH9A.

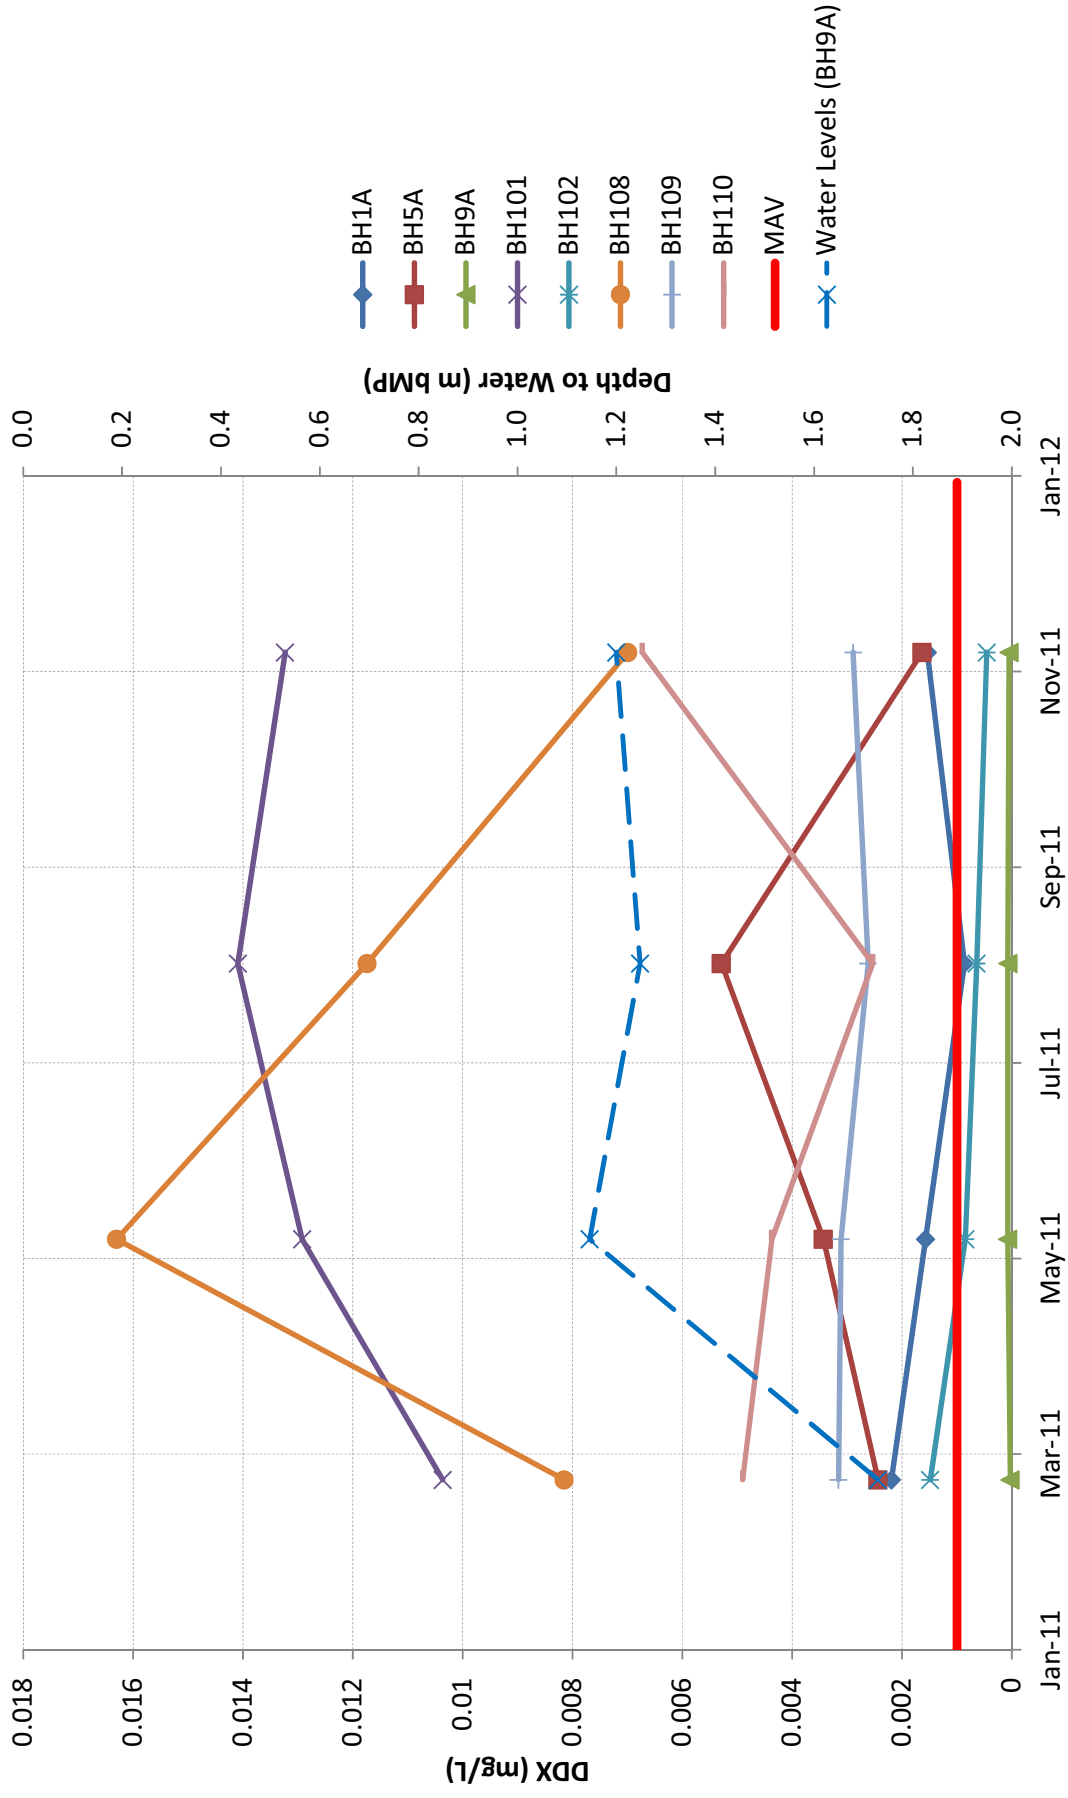
Figure 18. DDX Concentrations in Quarterly Monitored Wells

*DDX (Figure 18).* Large and erratic fluctuations in BH108, BH101, BH5A and BH110. A more stable pattern of fluctuations in BH109, BH1A and BH102. Low concentrations, well below the Maximum Allowable Value in the Drinking Water Standards, in BH9A.

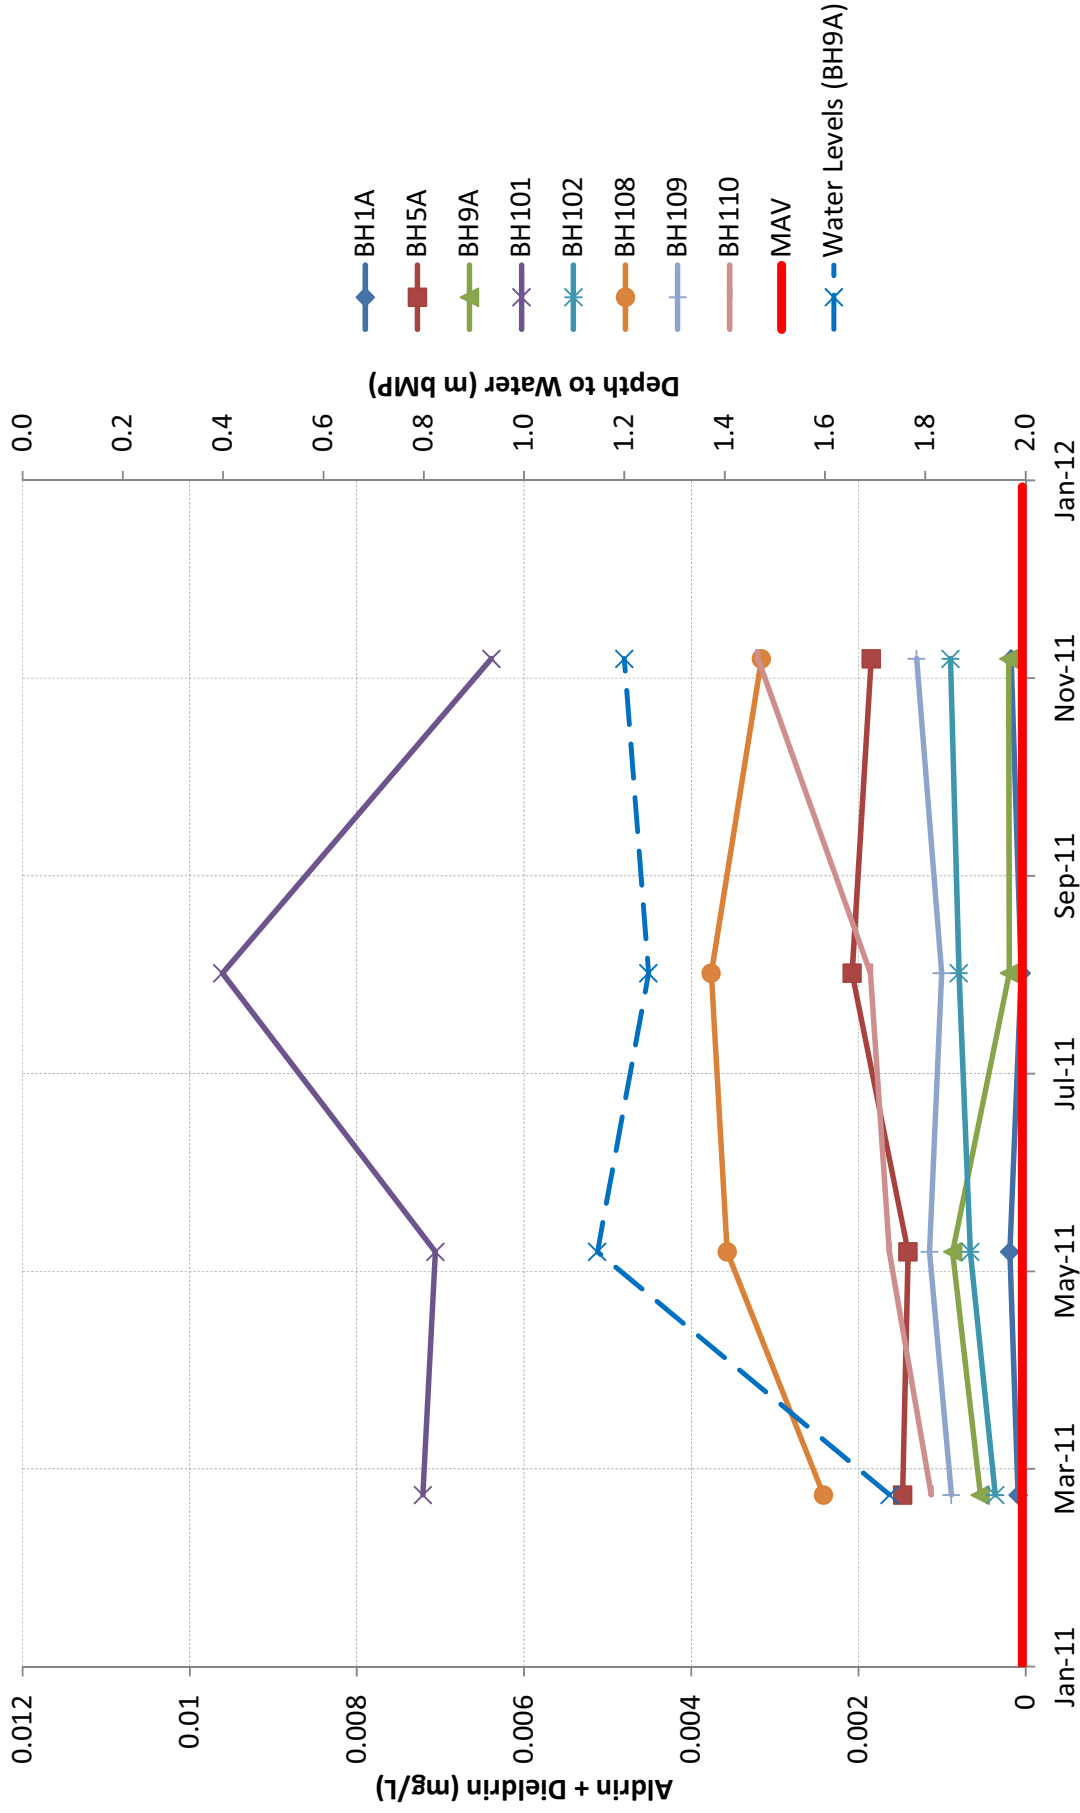
Figure 19. Aldrin + Dieldrin Concentrations in Quarterly Monitored Wells

*Aldrin + Dieldrin (Figure 19).* Large and erratic fluctuations in BH101. More stable fluctuations in the following boreholes, in decreasing order of concentration: BH108, BH110, BH5A, BH109, BH102, BH9A and BH1A.

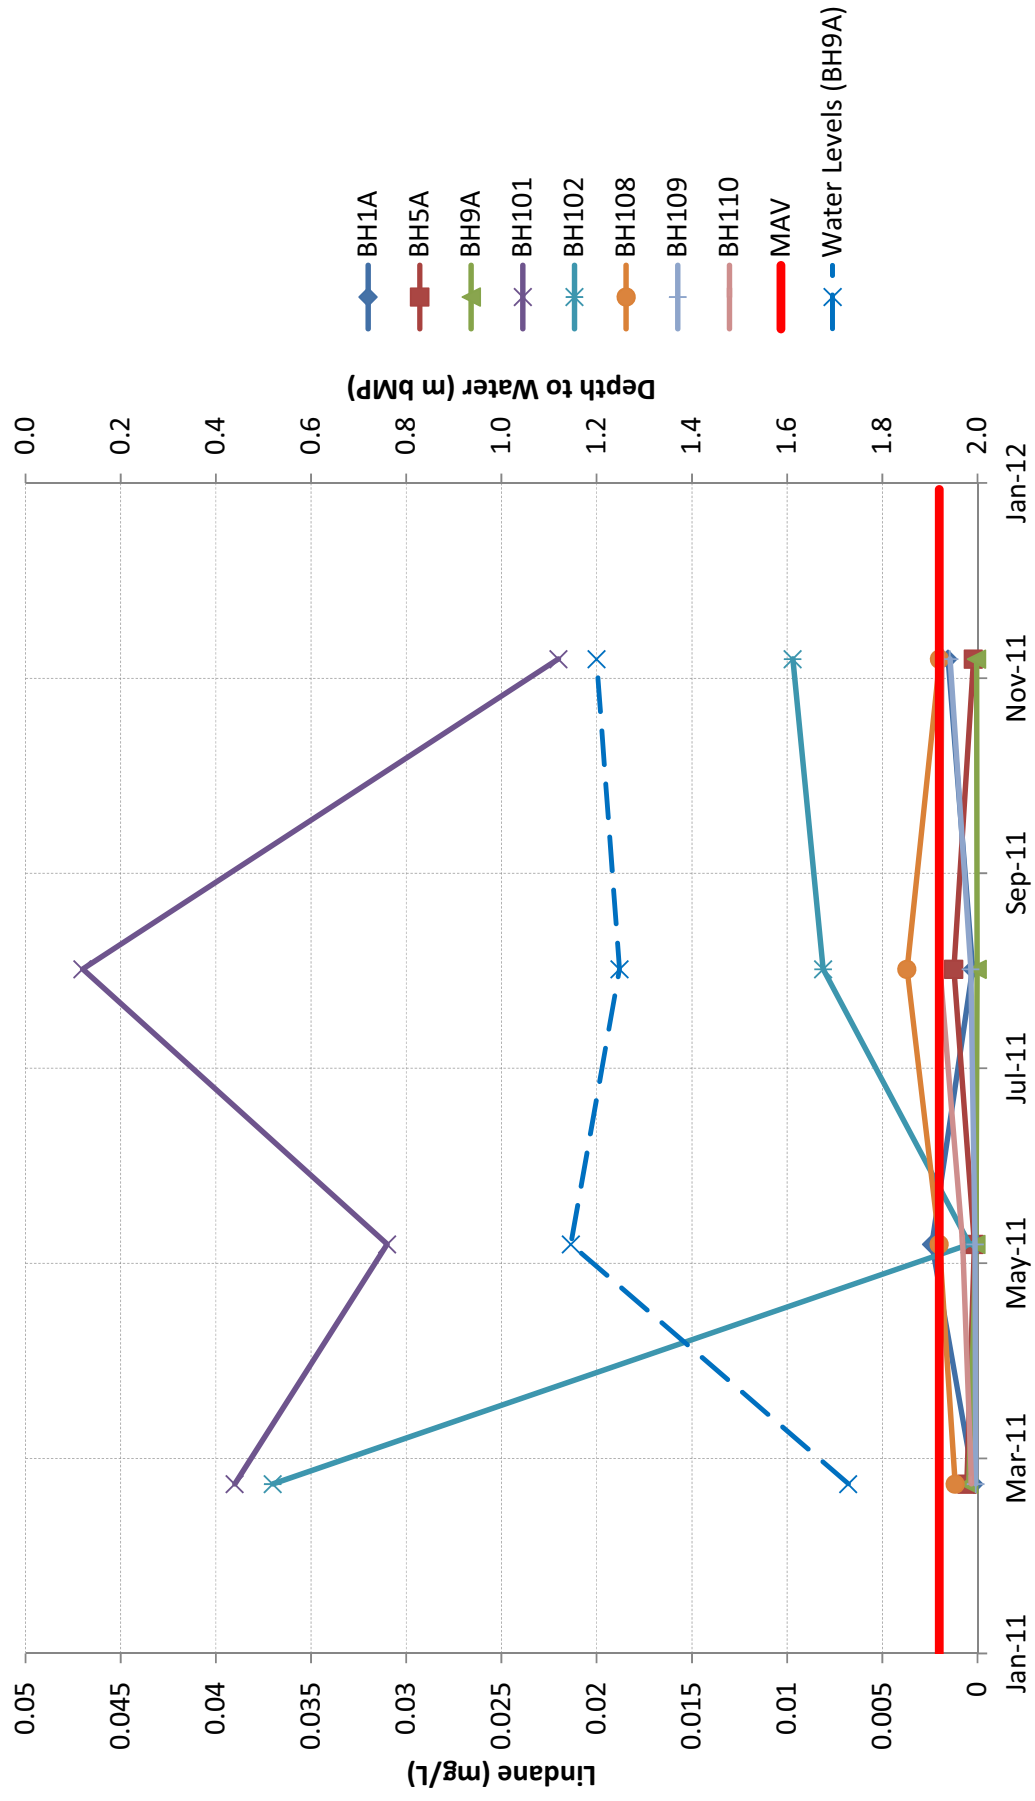
Figure 20. Lindane Concentrations in Quarterly Monitored Wells

*Lindane (Figure 20).* Large and erratic fluctuations in BH101 and BH102. More stable fluctuations in BH108, BH110, BH1A, BH109, BH5A and BH9A.

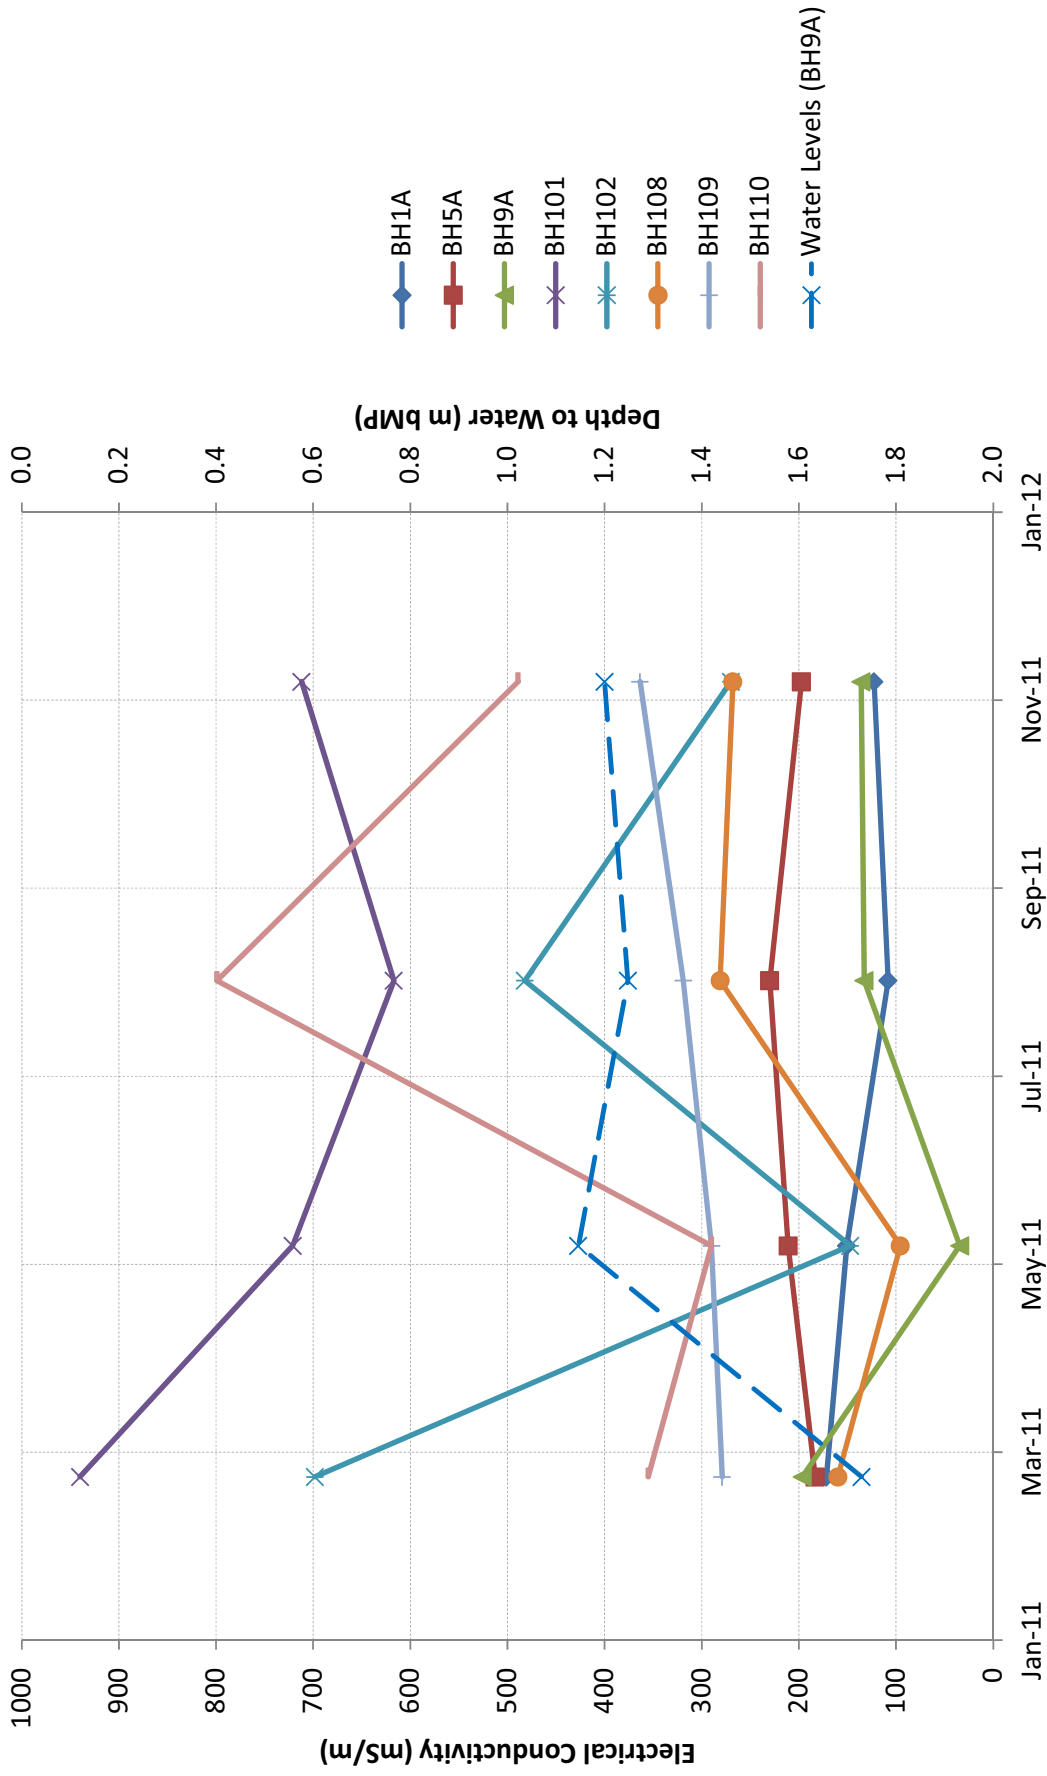
Figure 21. Conductivity Values in Quarterly Monitored Wells

*Electrical Conductivity (Figure 21).* Bores showing erratic fluctuations are, in order of decreasing magnitude: BH101, BH110, BH102, BH108 and BH9A. More stable trends are shown by BH109 (increasing), BH5A (variable) and BH1A (decreasing).

Those bores showing the more erratic fluctuations in chemical concentrations are likely to occur near areas where sources of contamination are variably affected by groundwater levels and/or pulses of recharge, although there is no consistent pattern associated with the measured water levels. The largest fluctuations occur most commonly in

The quarterly monitoring also indicates that the November sampling does not always coincide with the highest concentrations. As noted in our previous report, continuous monitoring of electrical conductivity in an indicator bore would provide a better understanding of the recharge pattern and concentrations of dissolved contaminants throughout the year.

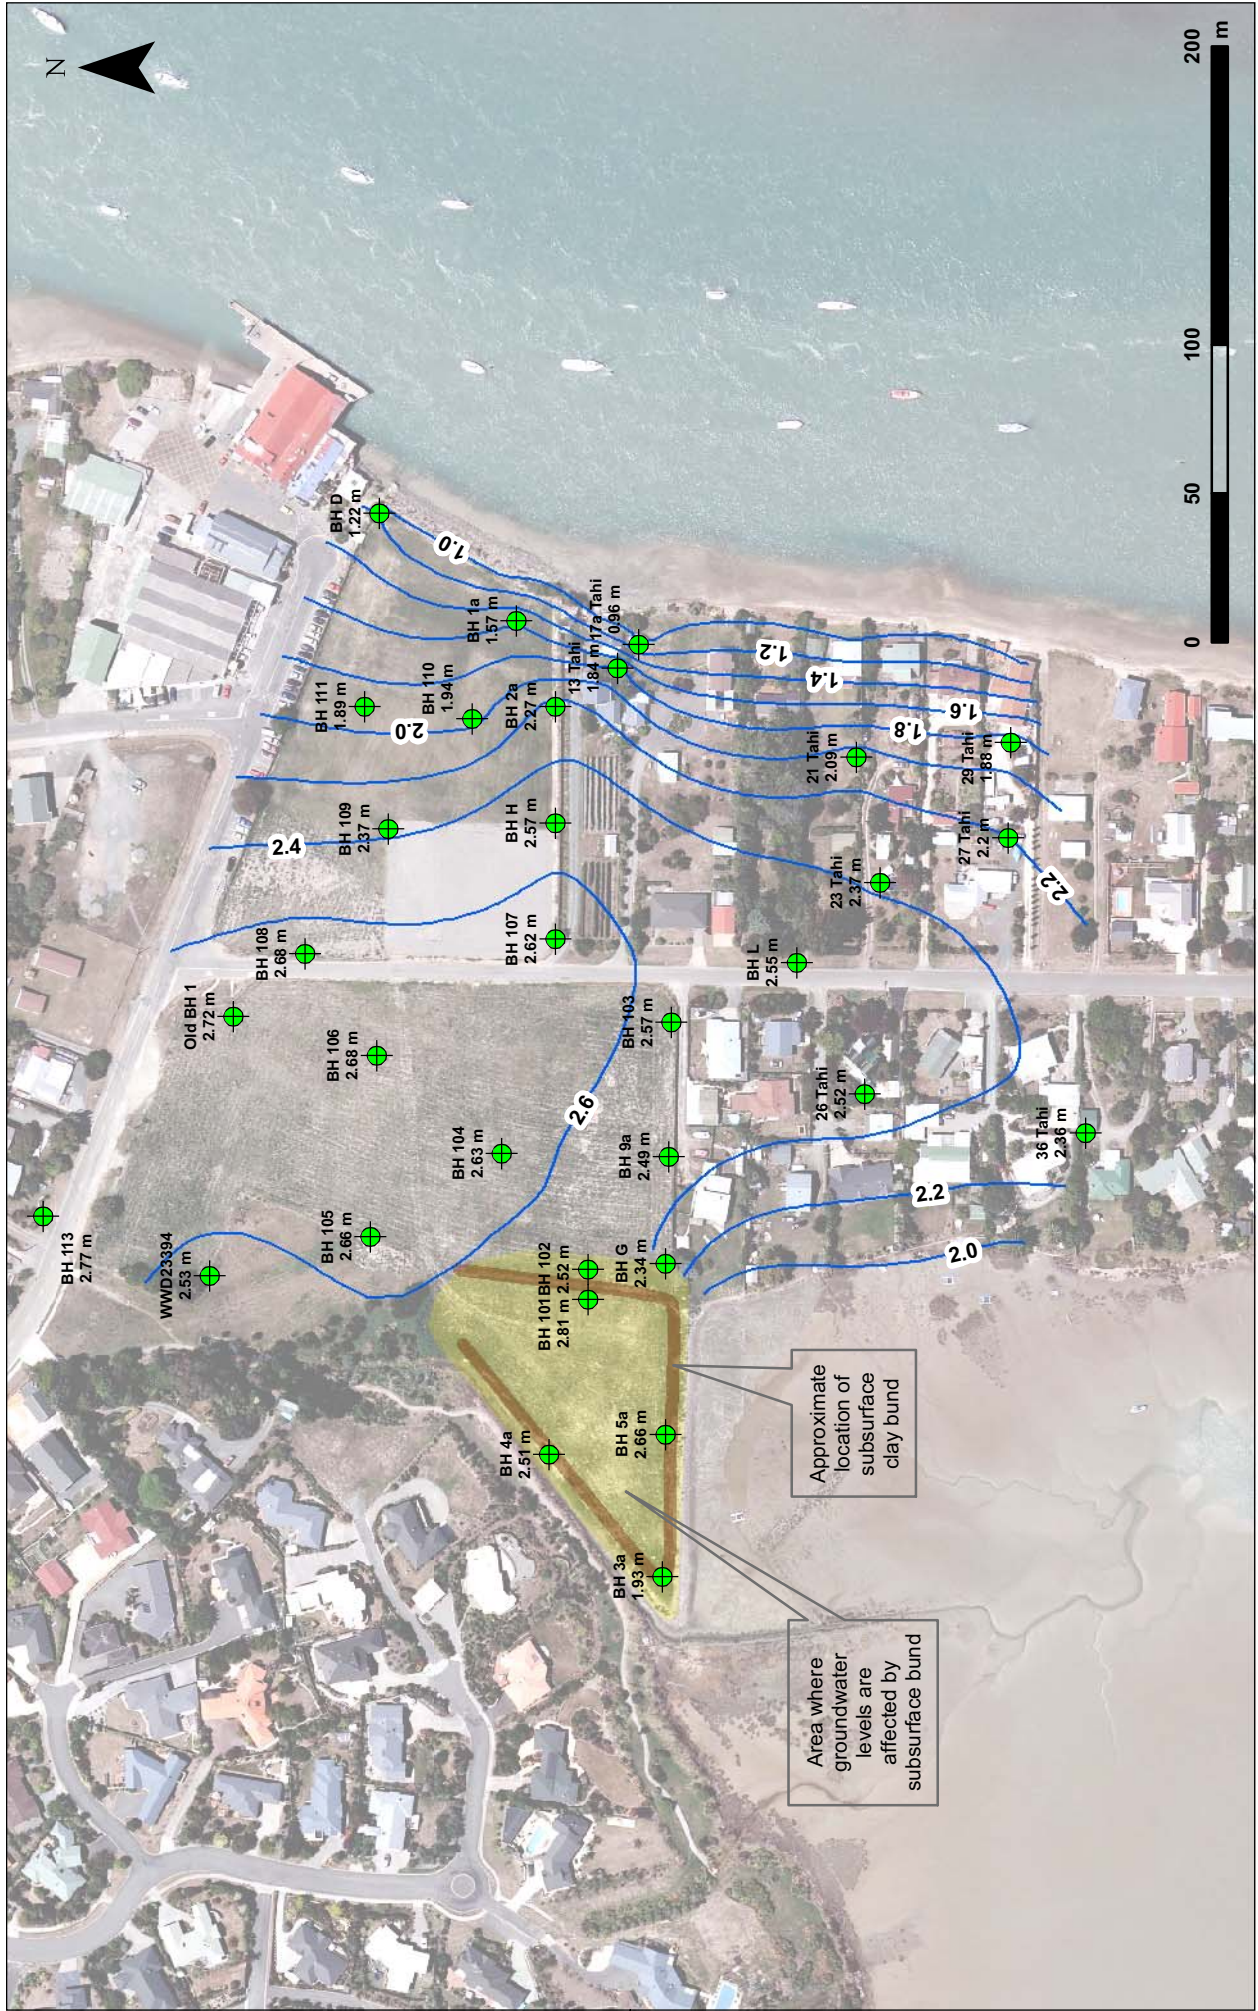
Figure 22: Groundwater levels and contours on 7 November 2011 (values in metres above mean sea level)

The elevation of the groundwater table within the on-site monitoring bores for the most recent monitoring round (7 November 2011) is plotted in Figure 22. They show that levels are similar to the high groundwater levels measured in late July 2010, with most of the groundwater discharging either to the Mapua channel to the east, or the Waimea Inlet to the south-west. The piezometric contours have not been extended into the bunded area as the presence of the bund and the backfill material within it appear to have created some distorted groundwater level elevations within nearby bores.

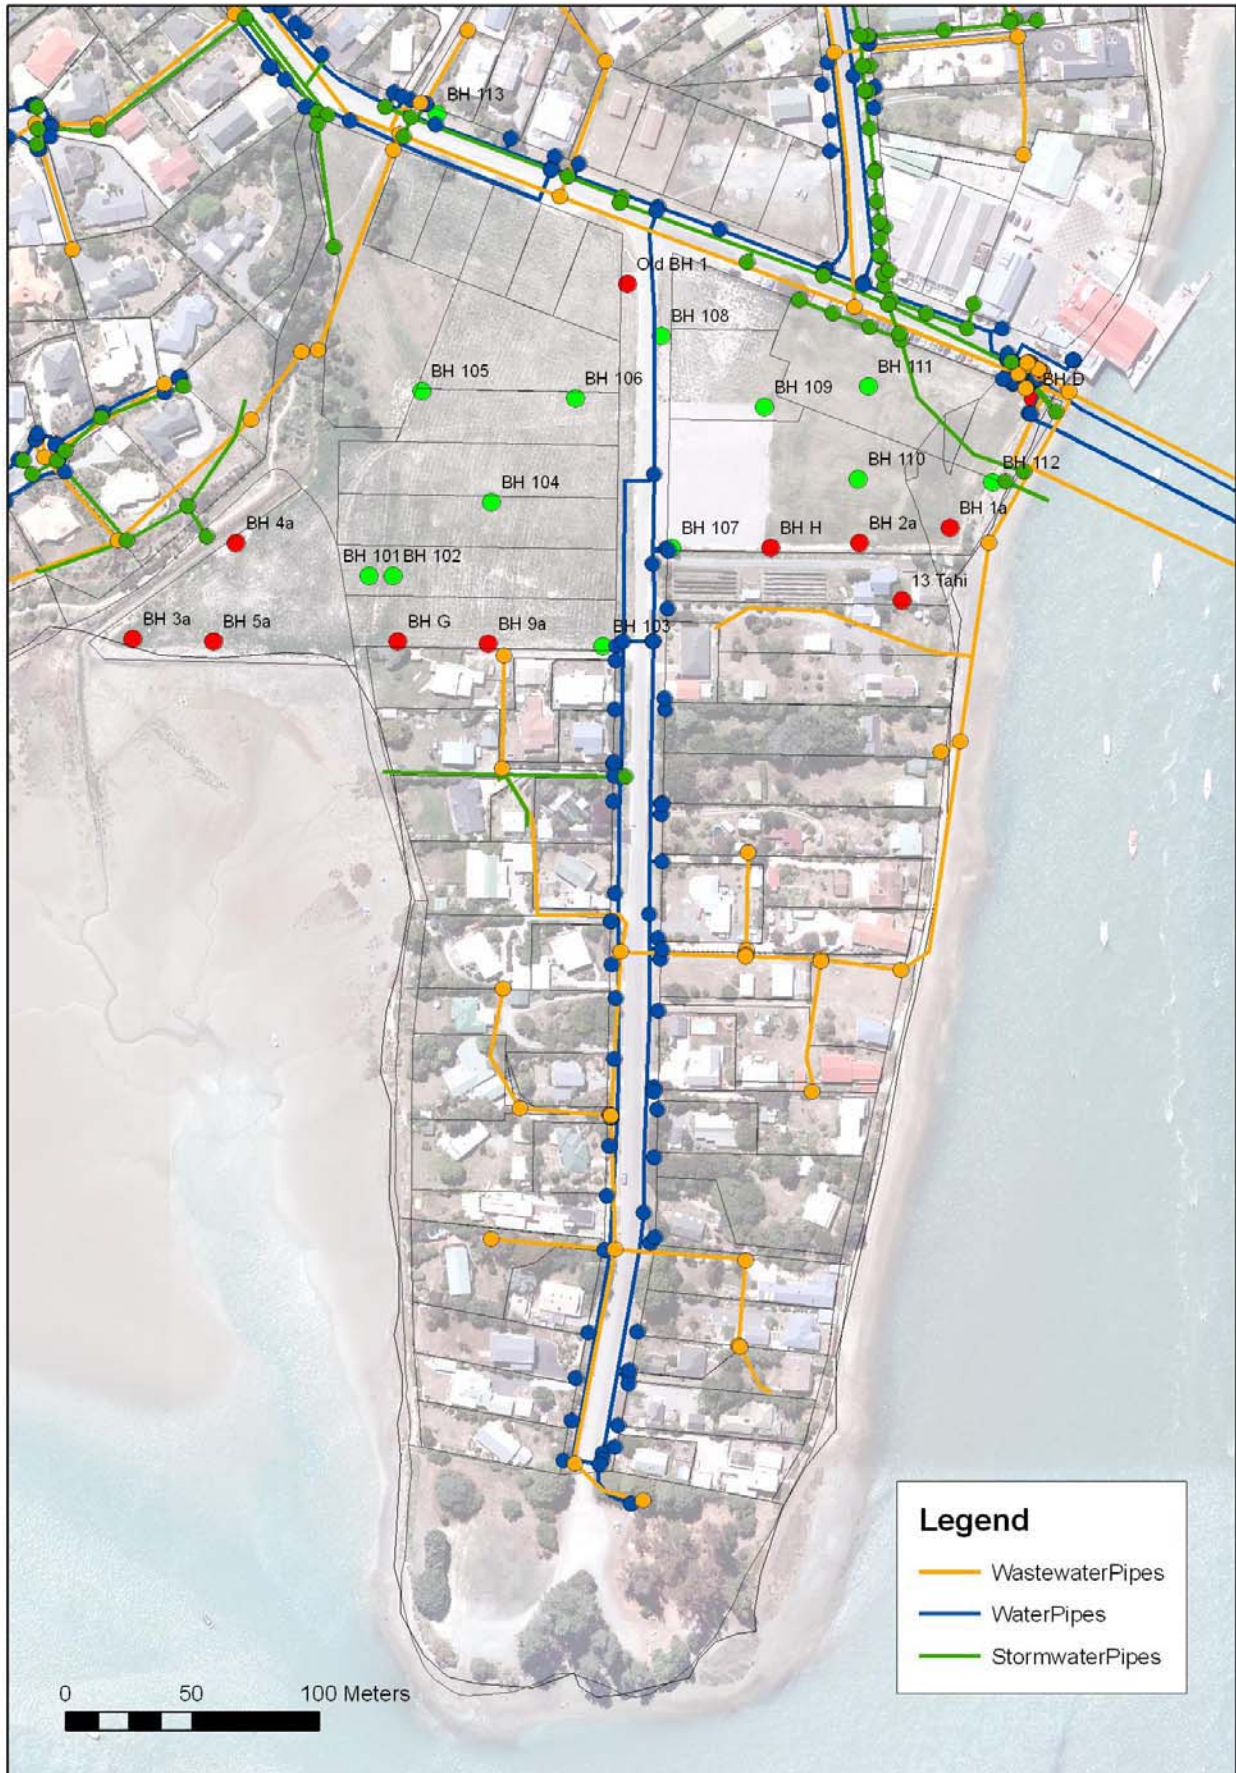
Figure 24: Location of Utilities

Of the domestic bores sampled, 26, 27 and 29 Tahi St have elevated concentrations (between 5.6 and 13.5 mg/L). These concentrations are significantly higher than the concentrations measured in November 2010 (which were between 0.53 and 5.3 mg/L) and may indicate a local source of nitrate occurring in that area, perhaps related to wastewater or fertiliser use. In particular, Figure 24 shows the layout of utilities in the area and a wastewater pipe that could be a source of leakage and nitrogen contamination to boreholes at 26, 27 and 29 Tahi St. Widespread migration of nitrate from the site through the groundwater system is unlikely as elevated concentrations were not recorded in BHG, BH9A, BH103, BHL and 23 Tahi Street, all of which occur between the site and the properties at 26, 27 and 29 Tahi Street. The possibility exists for a discrete preferential

migration pathway from the site along the trench of the wastewater pipe and this should be checked by obtaining invert levels for the pipe relative to measured groundwater levels, coupled with more detailed sampling at times when the water table might be intercepting the trench of the wastewater pipe.

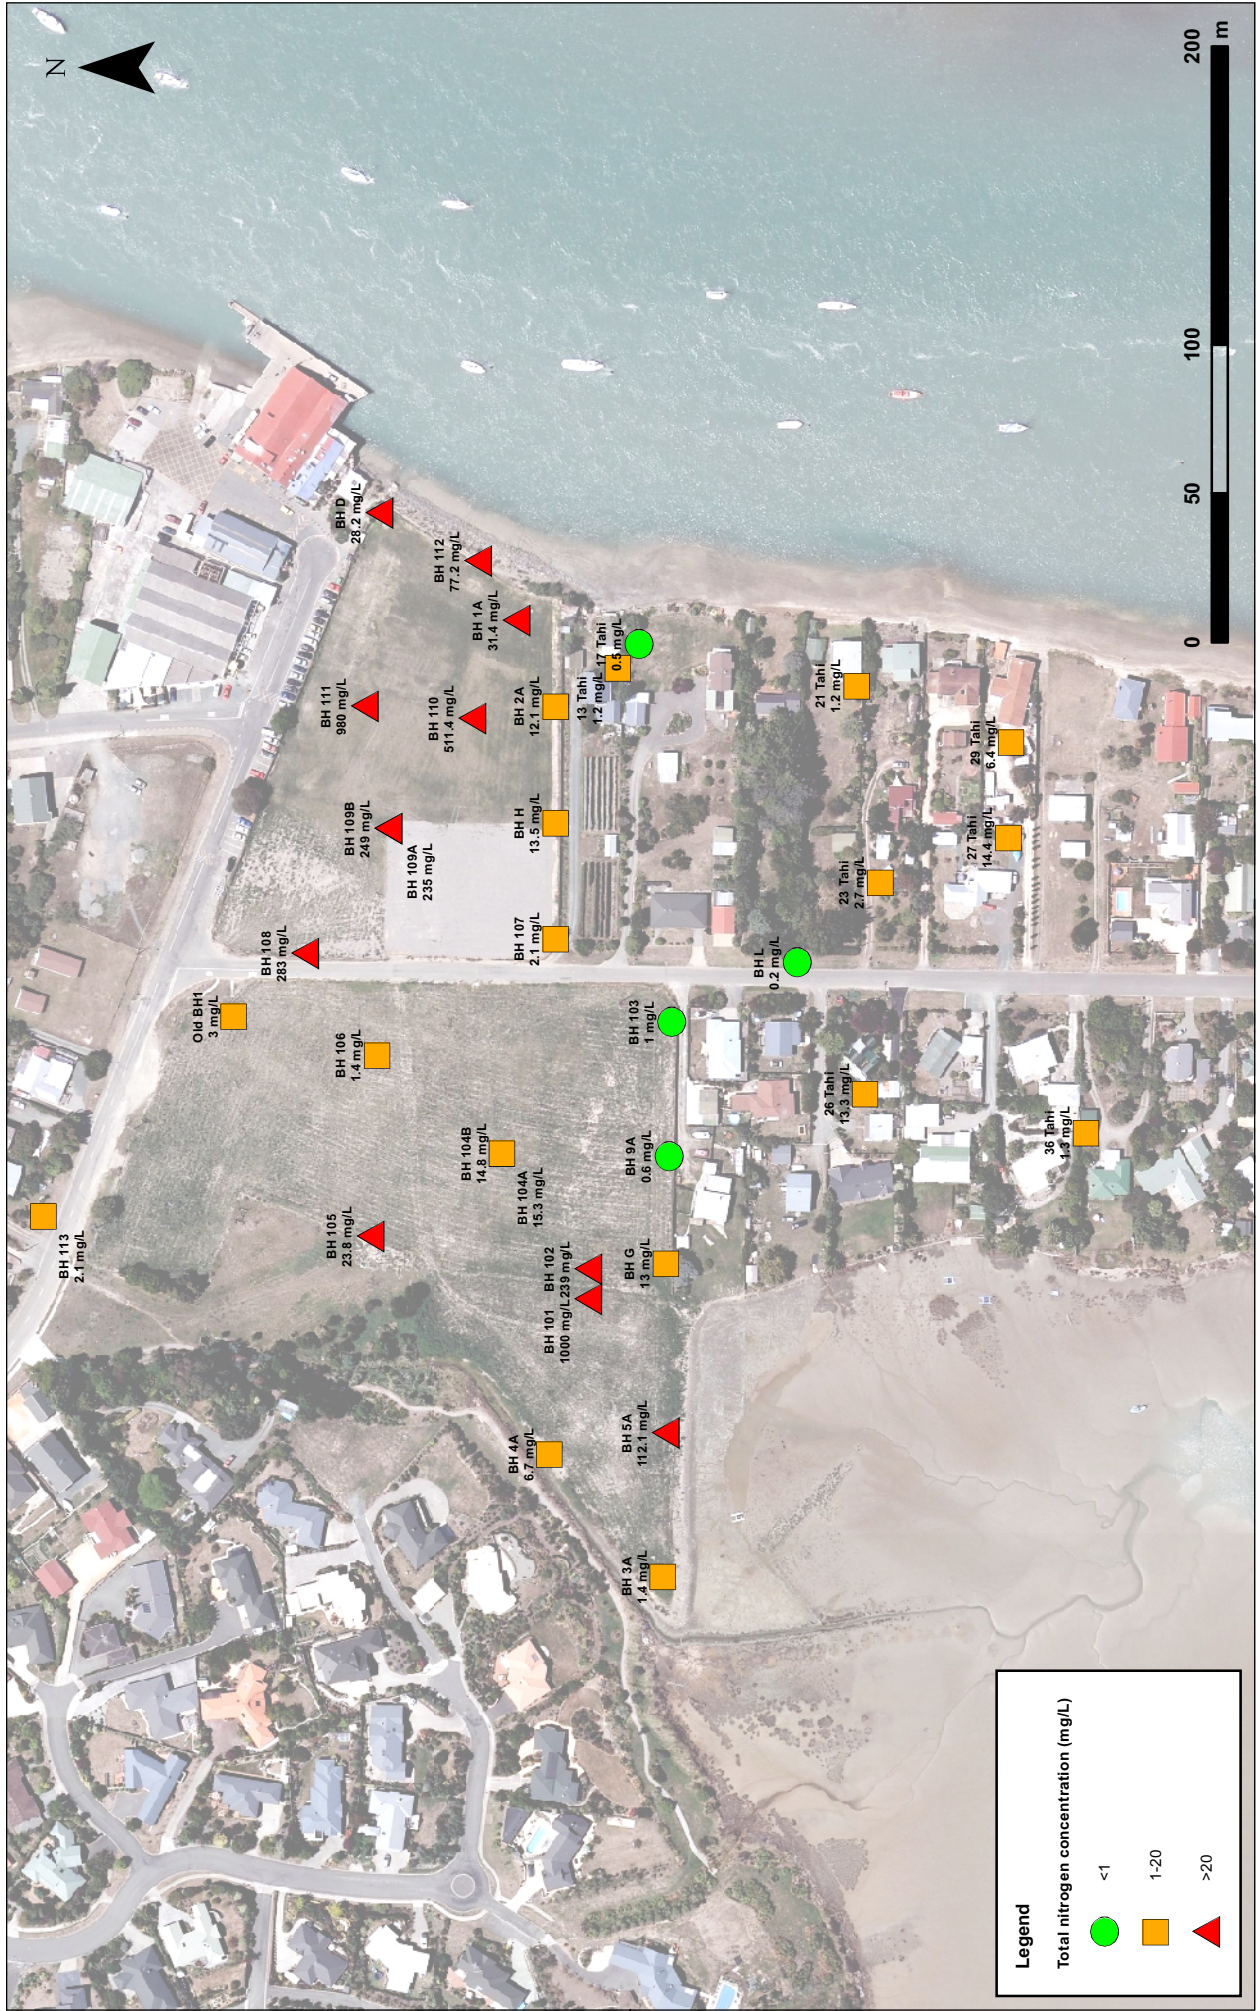
Figure 26: Total nitrogen concentrations in November 2011

The total nitrogen concentrations show the same general trend as for nitrate-N, with generally higher concentrations in the north and south compared to November 2010 and generally lower concentrations in the centre of the site.

The results indicate that the vast majority of on-site wells have elevated nitrogen concentrations, indicating the ongoing discharge of groundwater seepage to the Waimea Inlet and the Mapua Channel at concentrations above ANZECC guidelines for marine waters.

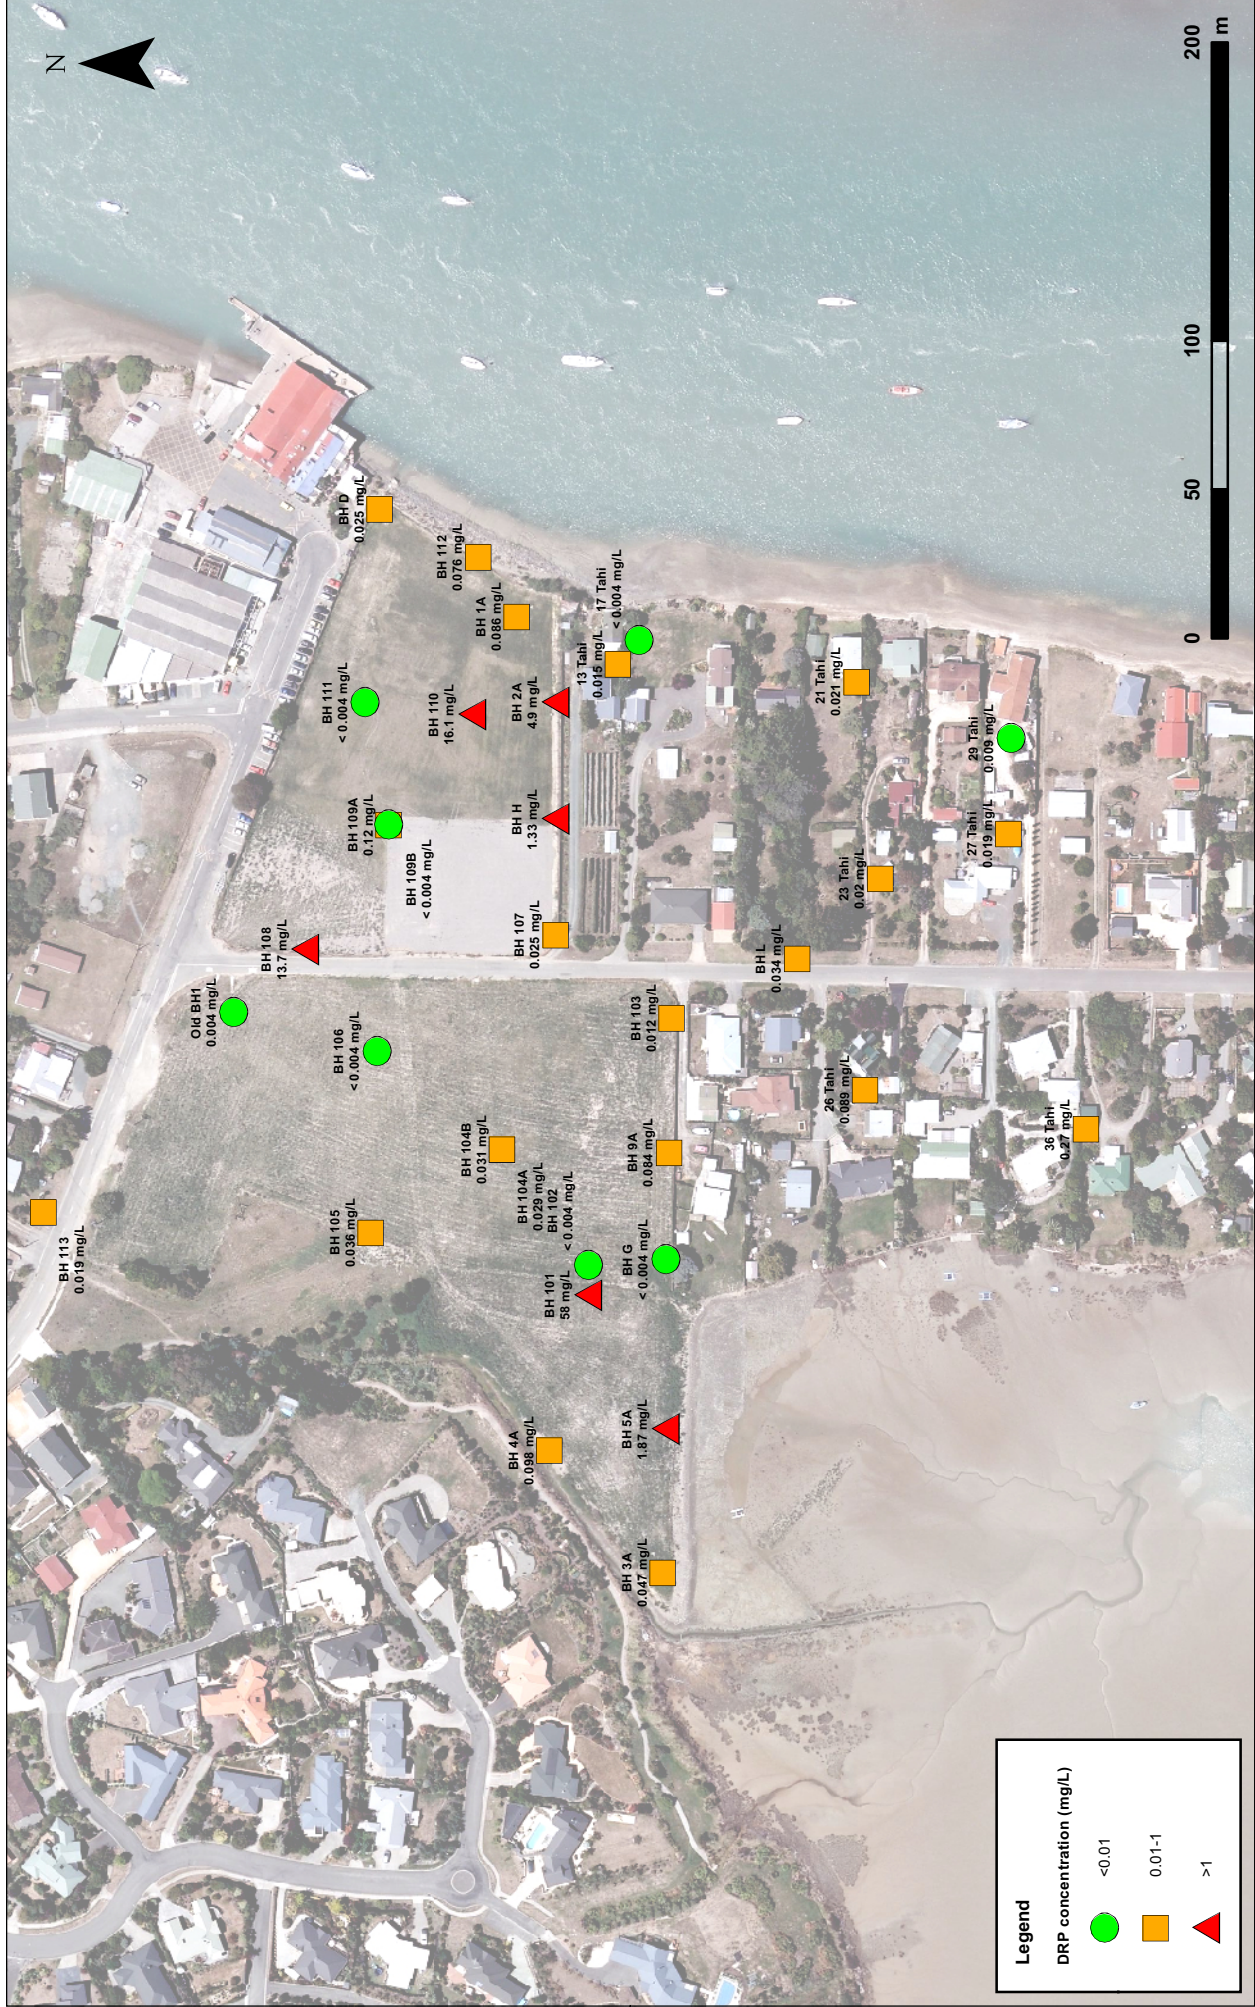
Figure 27: Dissolved reactive phosphorus concentrations in November 2011

Concentrations are generally similar to the concentrations in November 2010. Variable concentrations occur across the site, with some low and non-detectable values, and other bores showing localised high concentrations (up to 16.1 mg/L in BH110). As with nitrogen, the concentrations indicate that the groundwater discharge from the site continues to exceed ANZECC guidelines.
