23 March 2012

Ms Jenny Easton  
Tasman District Council  
Private Bag 4  
**RICHMOND 7050**

### **GROUNDWATER MONITORING AT FORMER FCC SITE, MAPUA – FEBRUARY 2012 SAMPLING UPDATE**

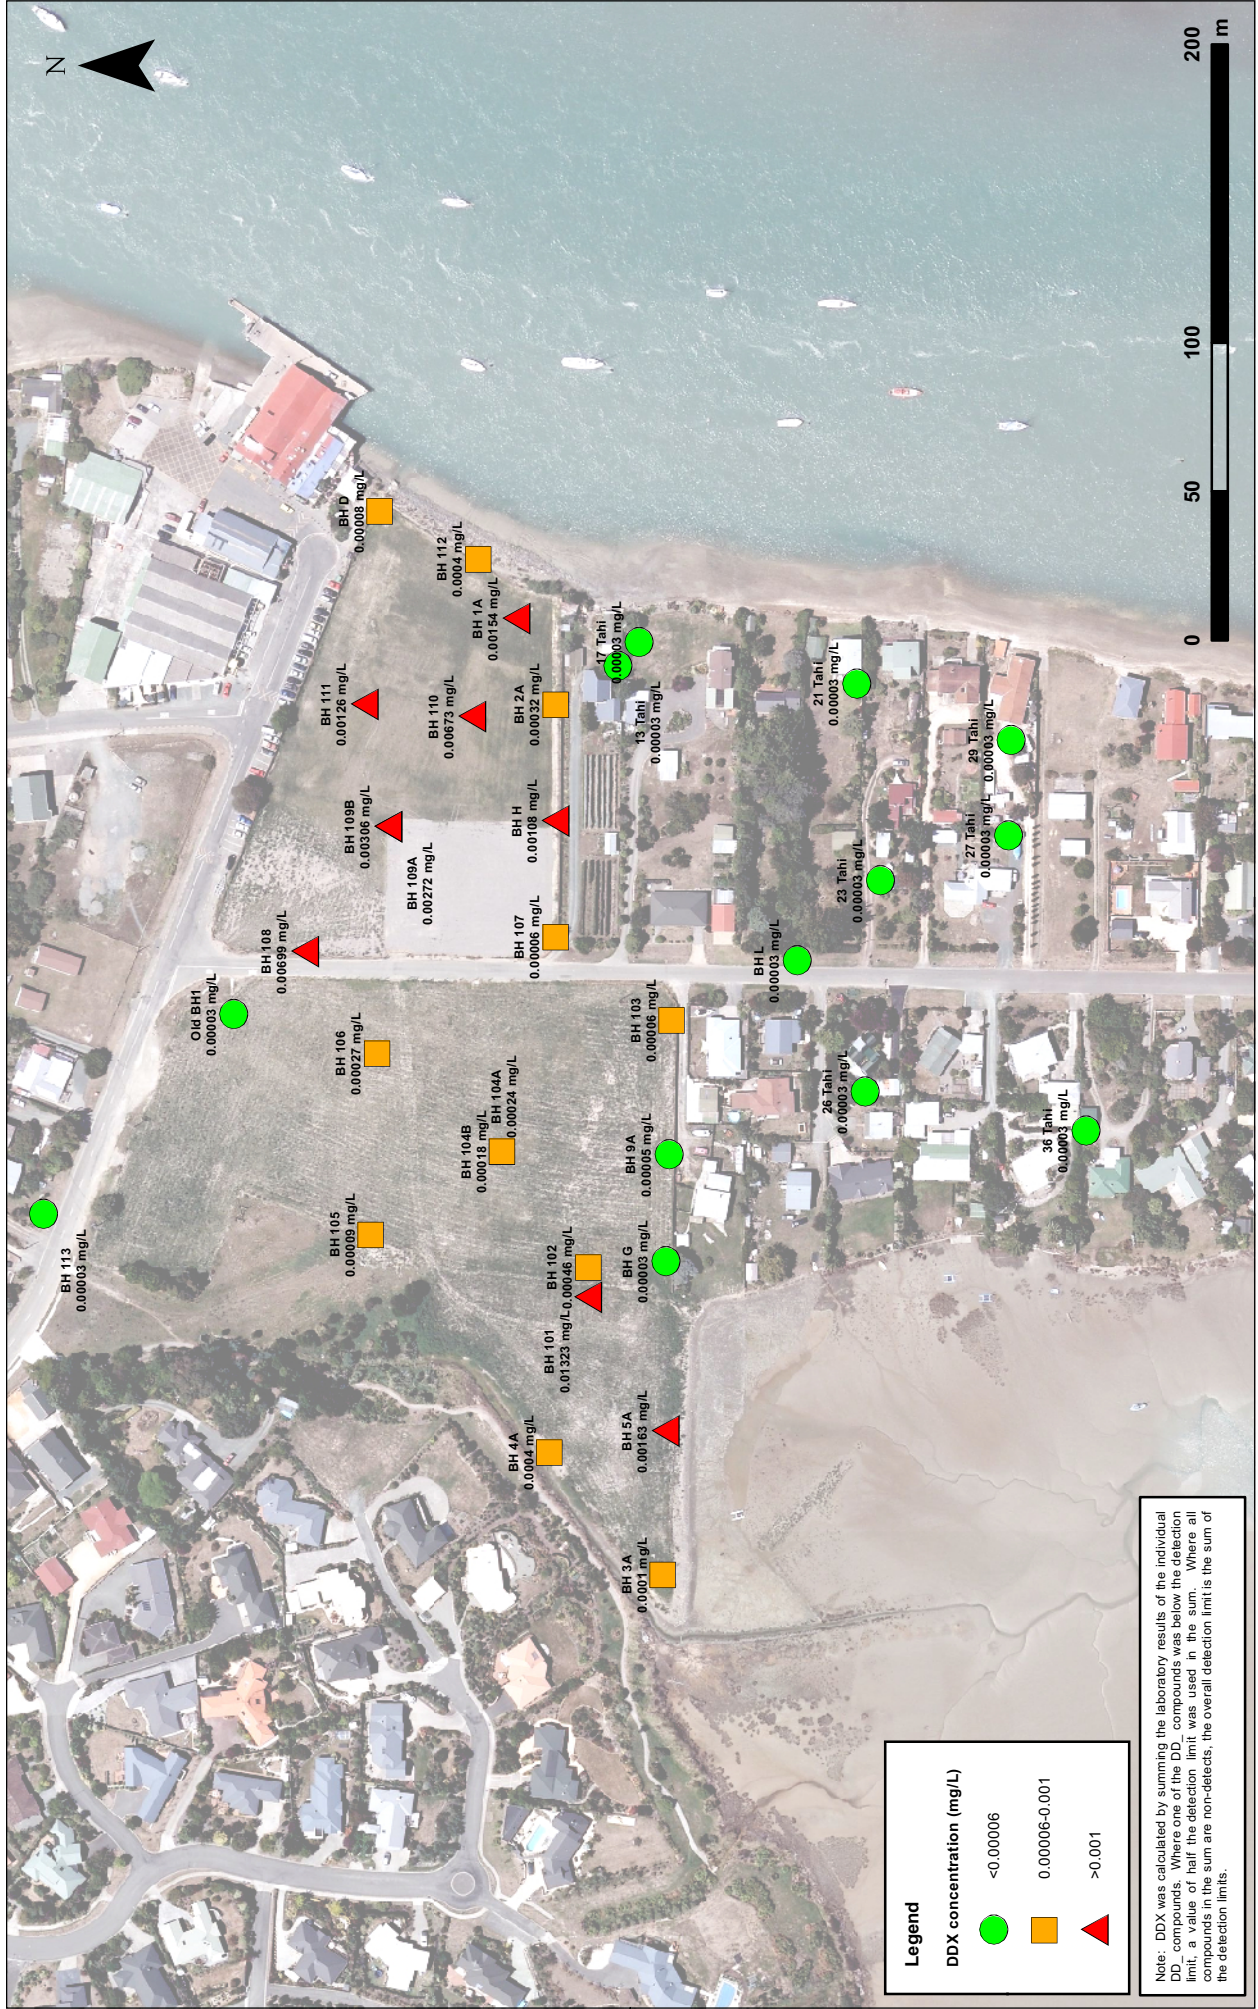
Figure 28: DDX concentrations in November 2011

The November 2011 concentrations tend to be slightly lower than for November 2010. The results show variable DDX concentrations within the site. The variation in concentrations within the site is most likely due to the localised effects of soils with elevated DDX concentrations.

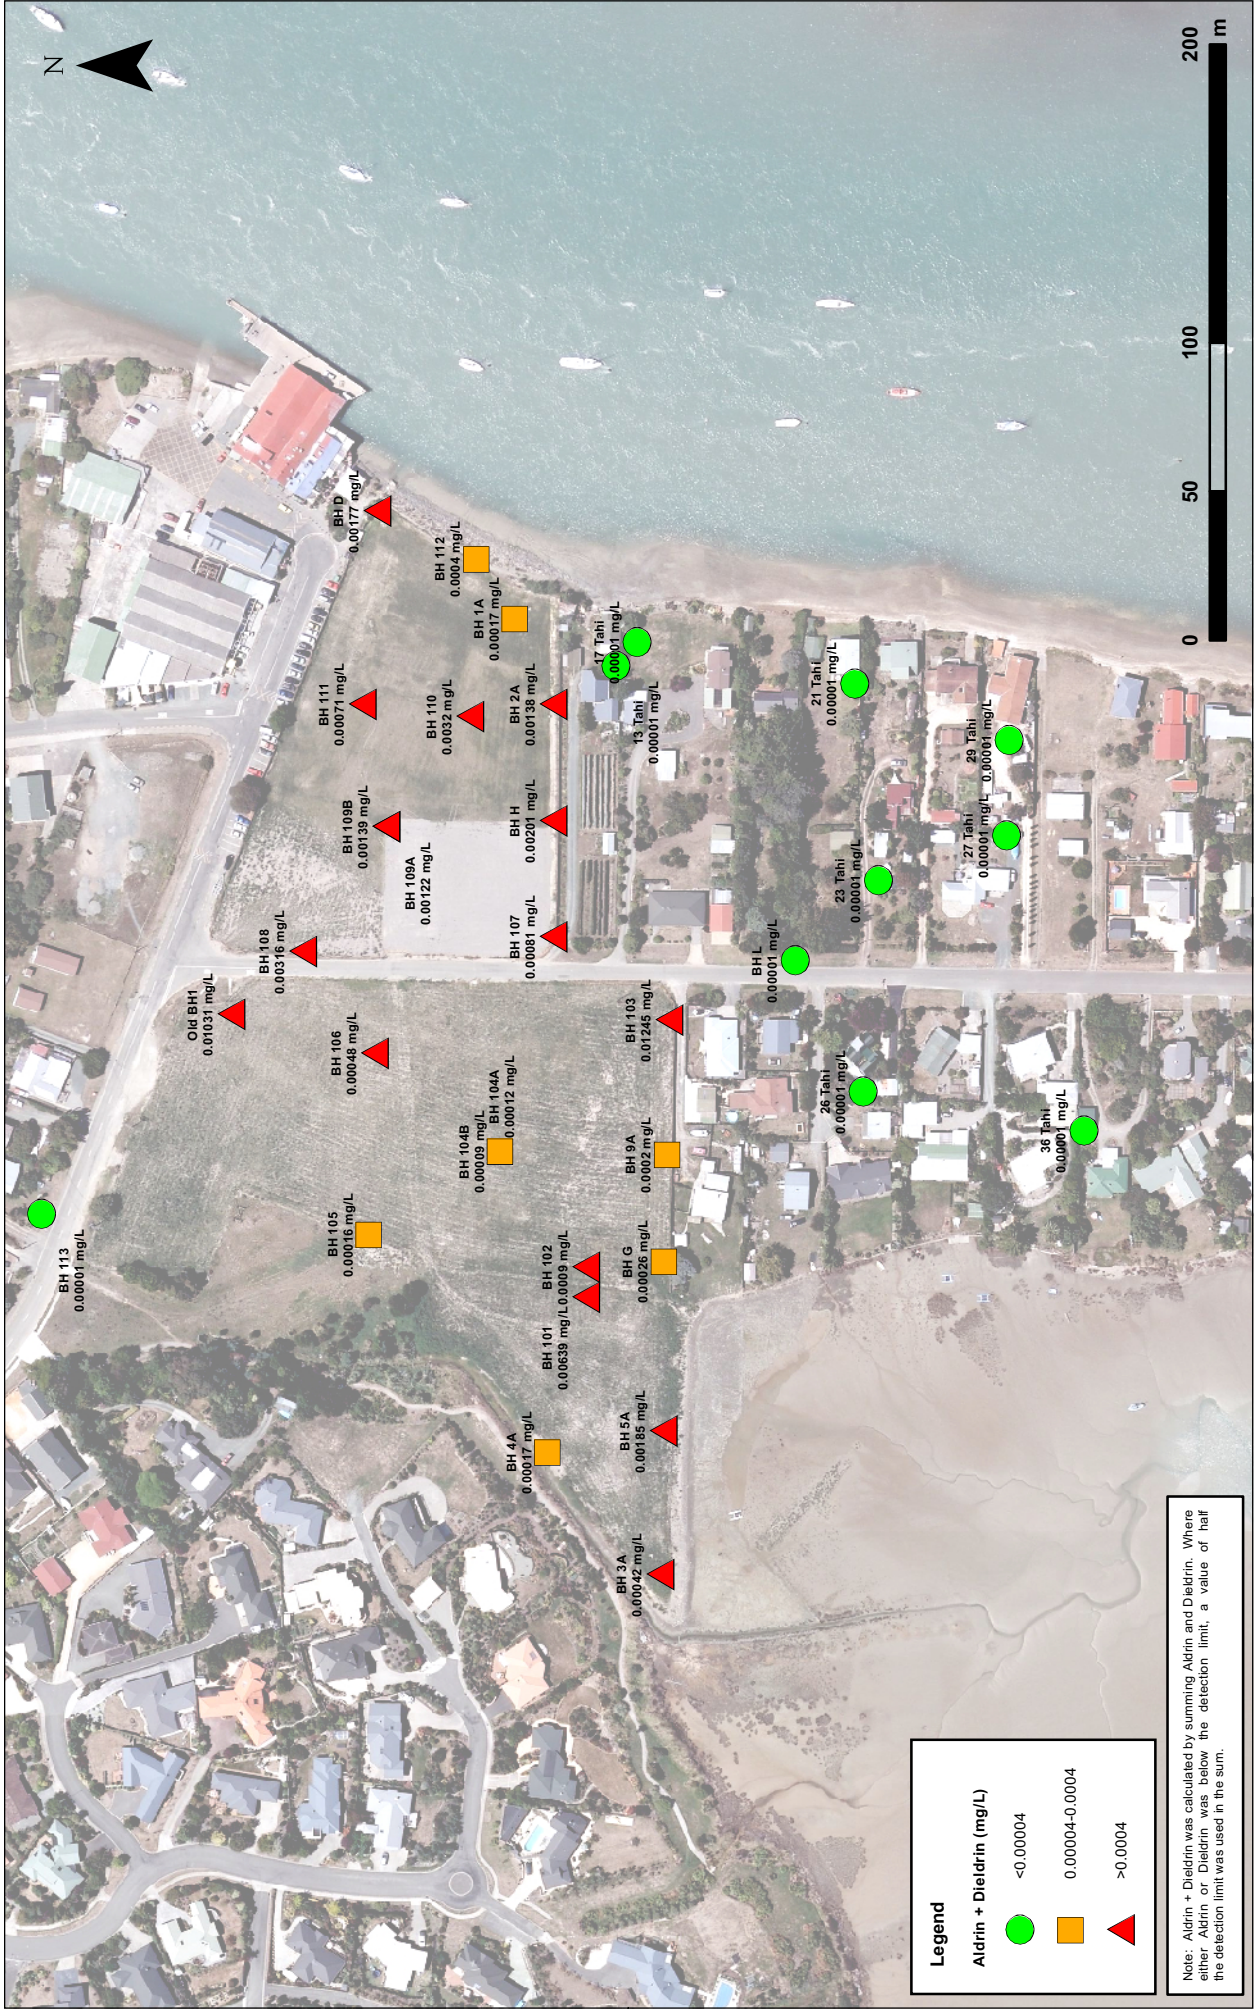
Figure 29: Aldrin + dieldrin concentrations in November 2011

There has been no consistent change since November 2010, with some bores showing increased concentrations and others showing lower concentrations. The results show that all the wells within the site have elevated concentrations above the MAV (0.00004 mg/L), with most wells recording concentrations more than ten times the MAV (0.0004 mg/L). The highest recorded concentration in November 2011 was 0.01245 mg/L in bore BH103. All of the domestic wells sampled in November 2011 had concentrations below the MAV.

Dieldrin was measured in two of the offsite bores during the November 2011 sampling round – 13 Tahi St (0.000012 mg/L) and 26 Tahi St (0.000005 mg/L). The presence of dieldrin in these two bores may be due to the migration of dieldrin from the site, however, it is worth noting that the measured concentrations are at or close to the laboratory detection limit (0.000005 mg/L).

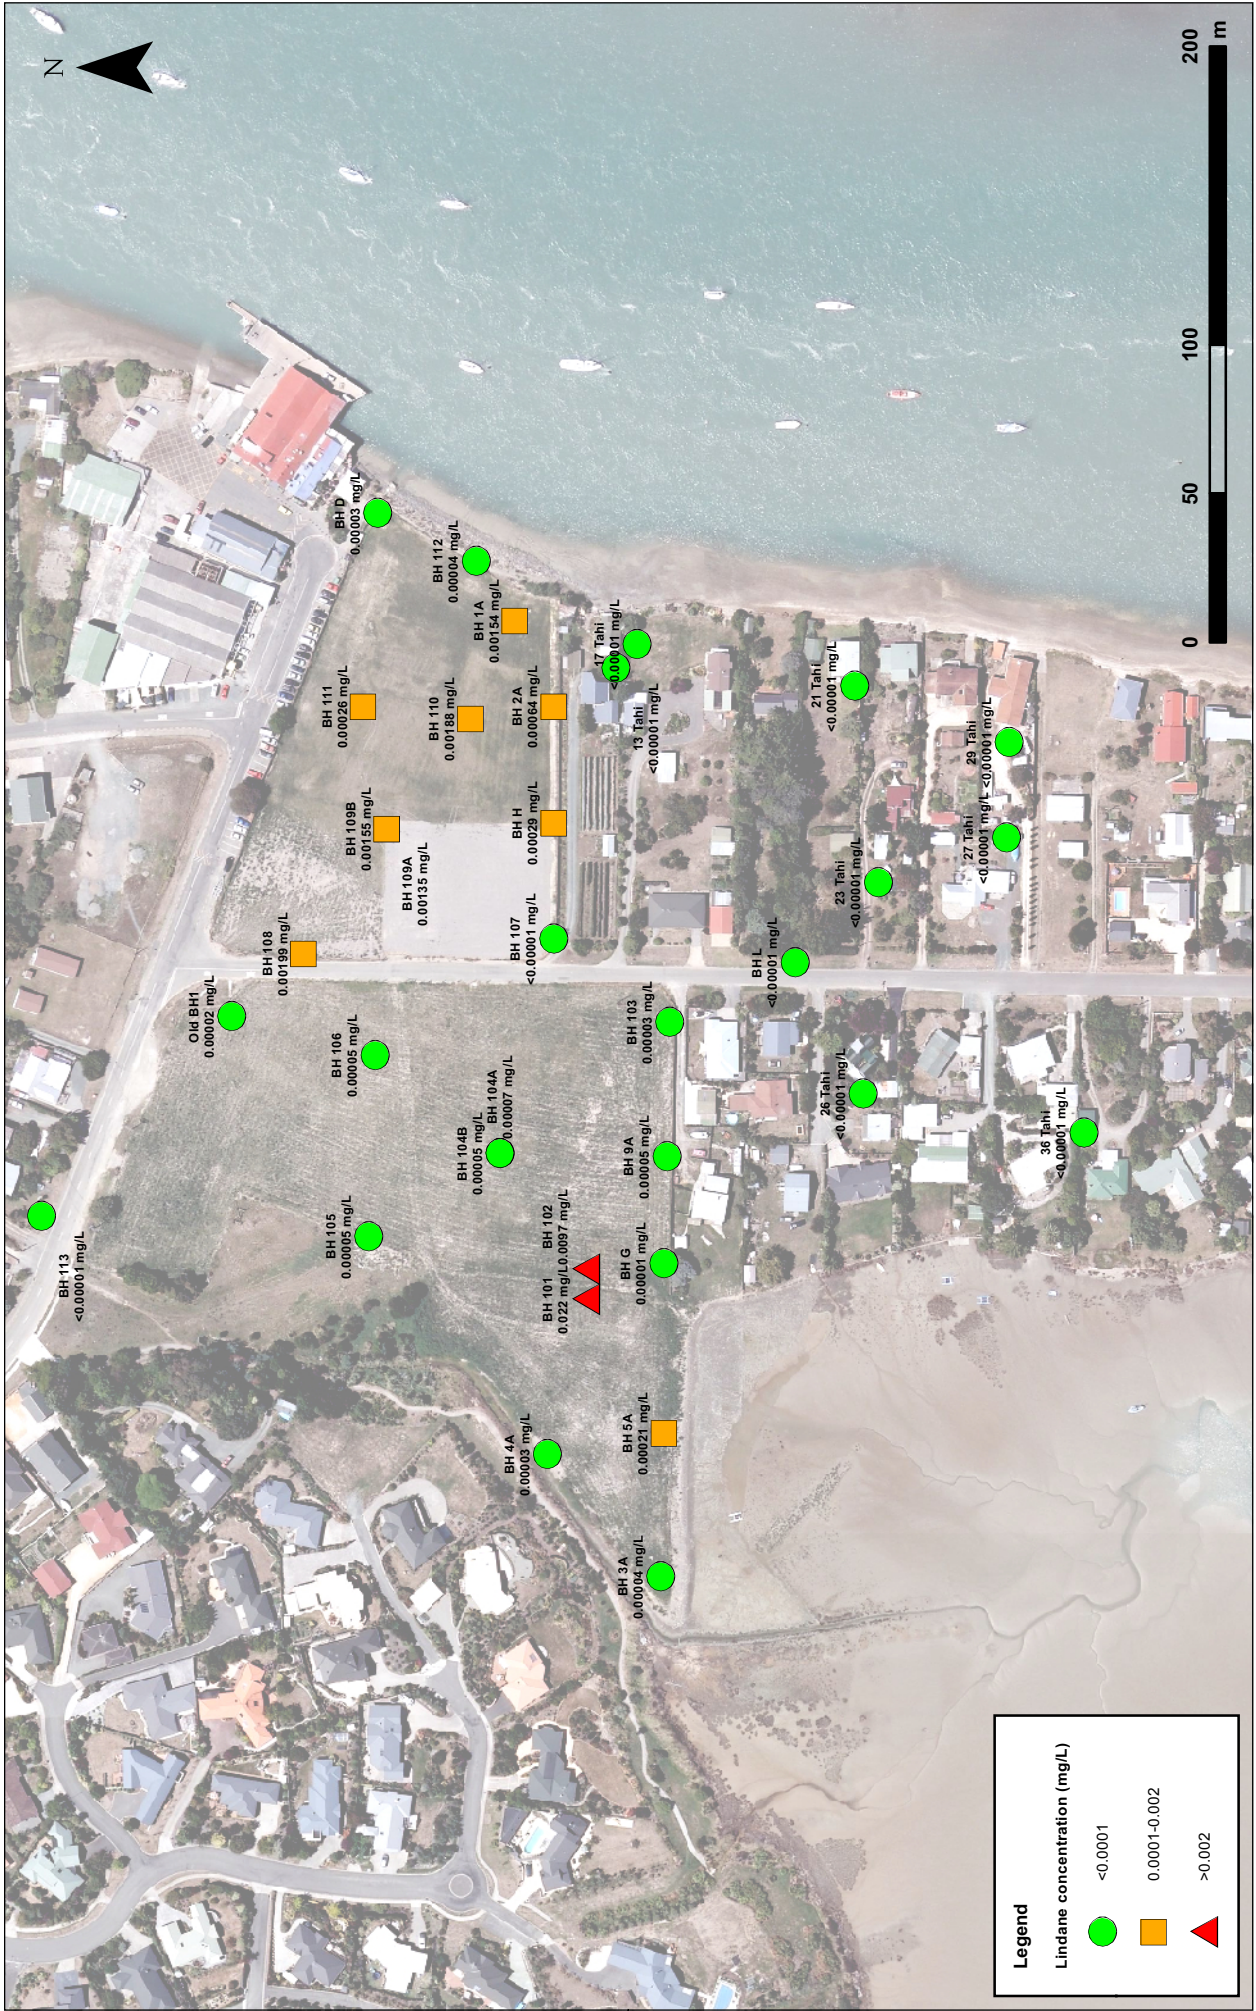
Figure 30: Lindane concentrations in November 2011

There has been no consistent change since November 2010, with some bores showing increased concentrations and others showing lower concentrations. The results show elevated concentrations occurring to the east of the site. There were no exceedances of the MAV during the November 2011 sampling round, except for bores BH101 and BH102 in the clay bund. Apart from these two bores, the highest concentration was recorded in BH108 (0.00199 mg/L in November 2011, down from 0.0028 mg/L in November 2010).

In previous sampling rounds, low levels of lindane were detected in some off-site boreholes, although subsequent checking by TDC indicated that this was due to residual lindane within the tubing used to collect the samples rather than in the boreholes themselves. The sampling procedures have been altered to rectify this problem.

Lindane was not detected in any of the domestic bores in the November 2011 sampling round.

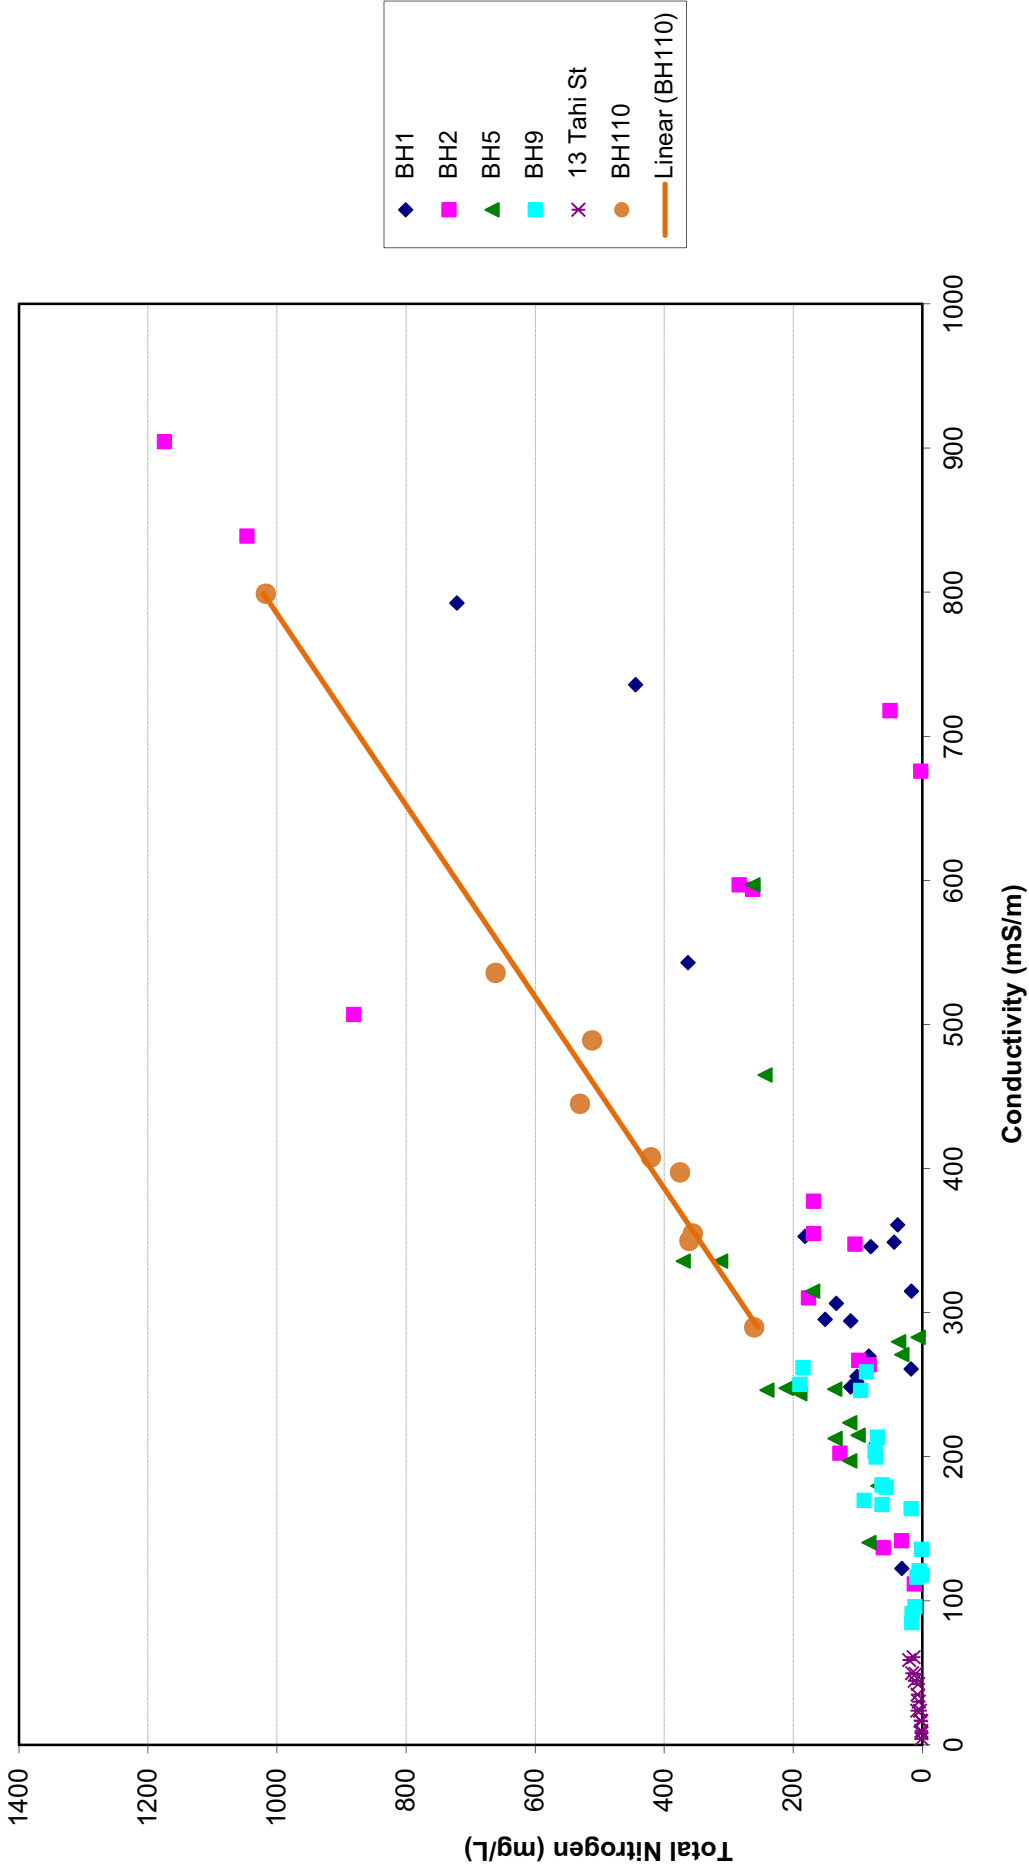
Figure 32. Conductivity vs Total Nitrogen for Regularly Sampled Wells and BH110

Figure 32 shows a plot of total nitrogen versus electrical conductivity in the regularly sampled bores, as well as values from BH110. There is a general trend of higher nitrogen concentrations with high conductivity and for that reason we remain of the view that a transducer to provide a continuous record of water level and electrical conductivity in bore BH110 would provide a useful indicator of the variability in leaching of the chemicals throughout the year, which is information that is not available from four discrete samples per year.

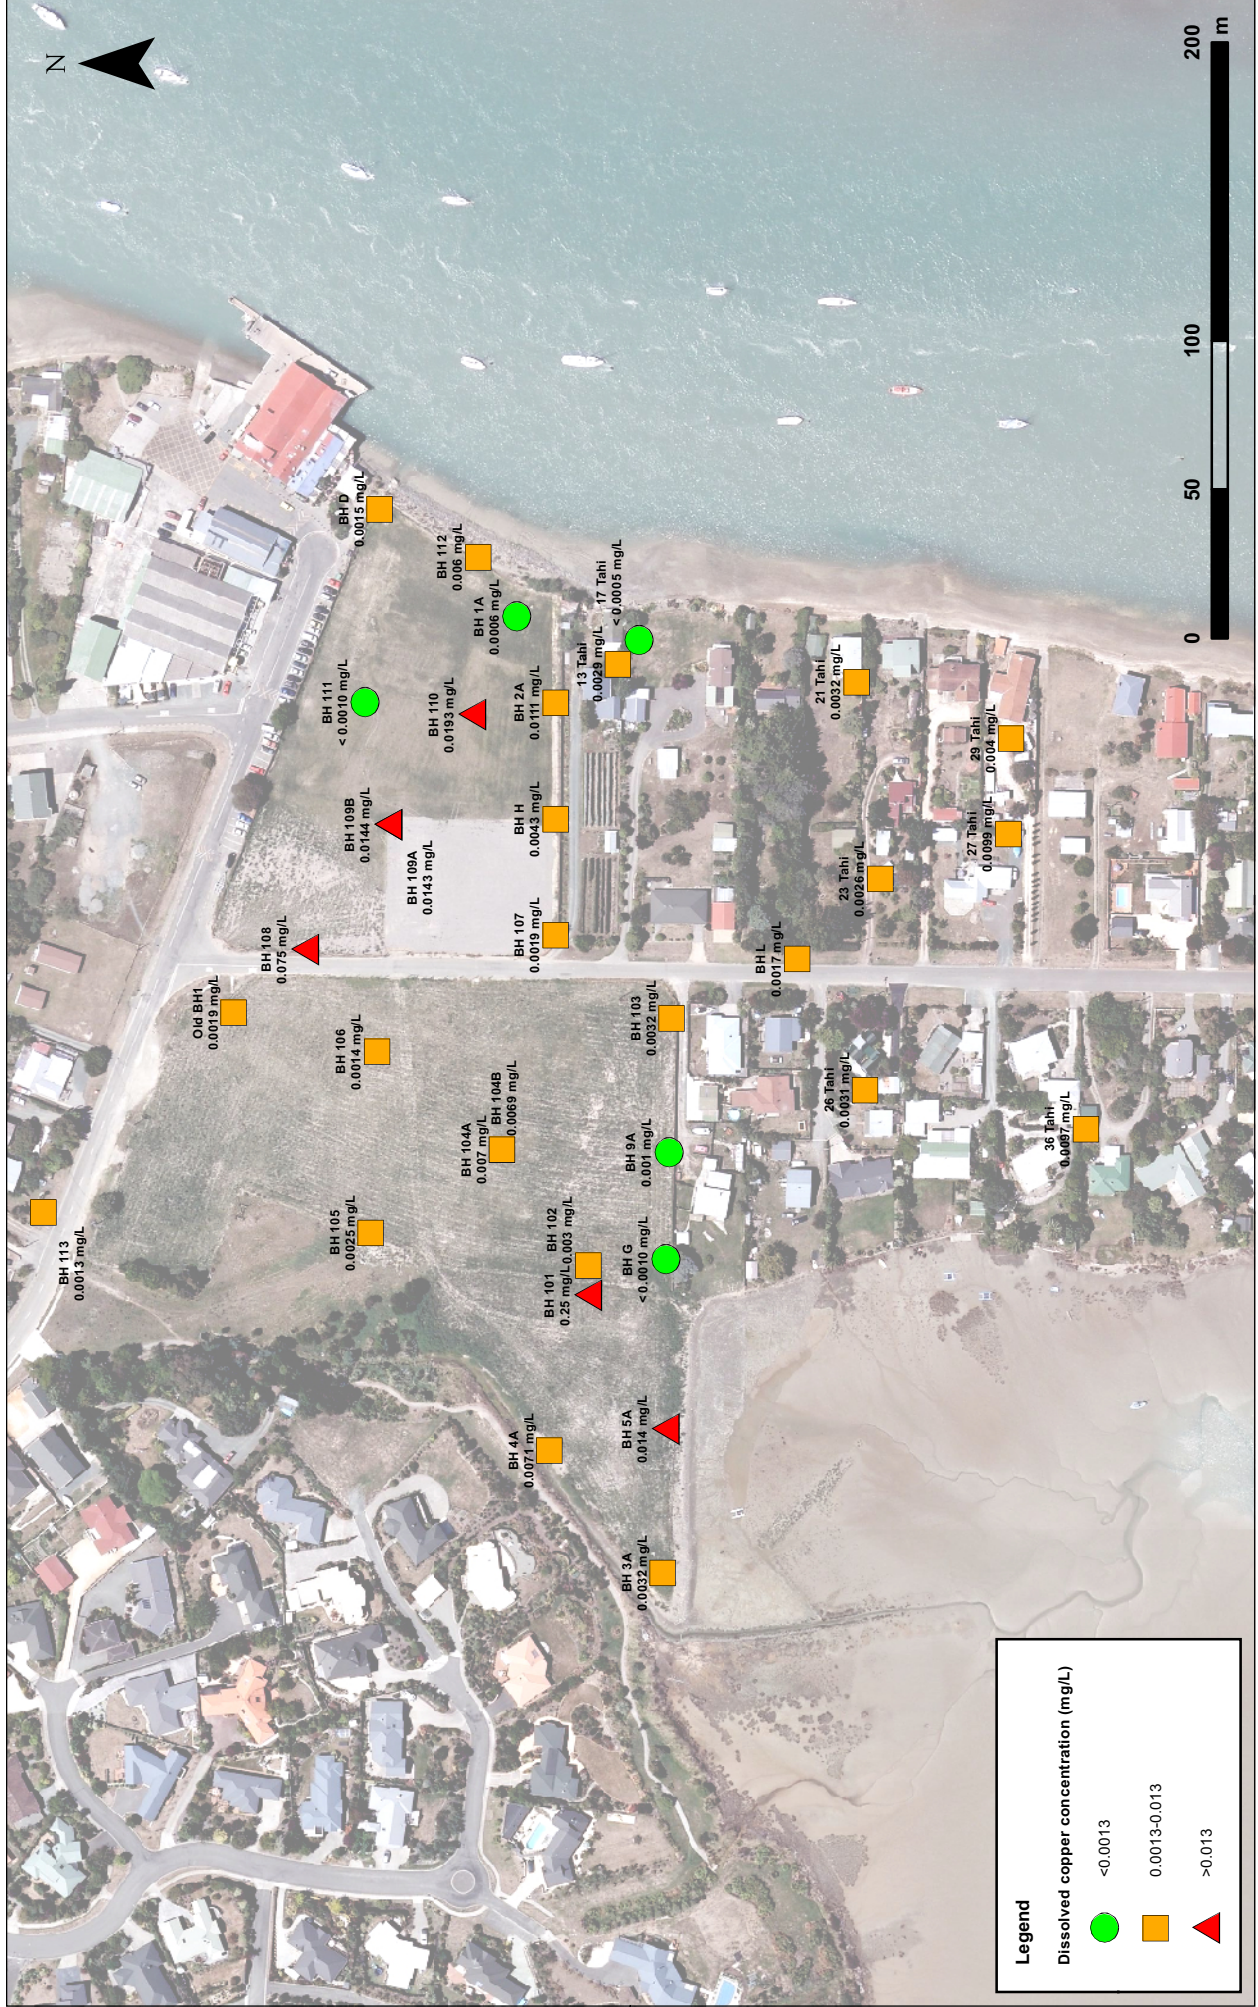
Figure 33: Dissolved copper concentrations in November 2011

Concentrations have generally increased across the site, with more points in the high (red) category than in November 2010. The highest concentration was measured in bore BH108 (0.075 mg/L in November 2011, up from 0.07 mg/L in November 2010). The upgradient control bore (BH113) is also slightly elevated (0.0013 mg/L).

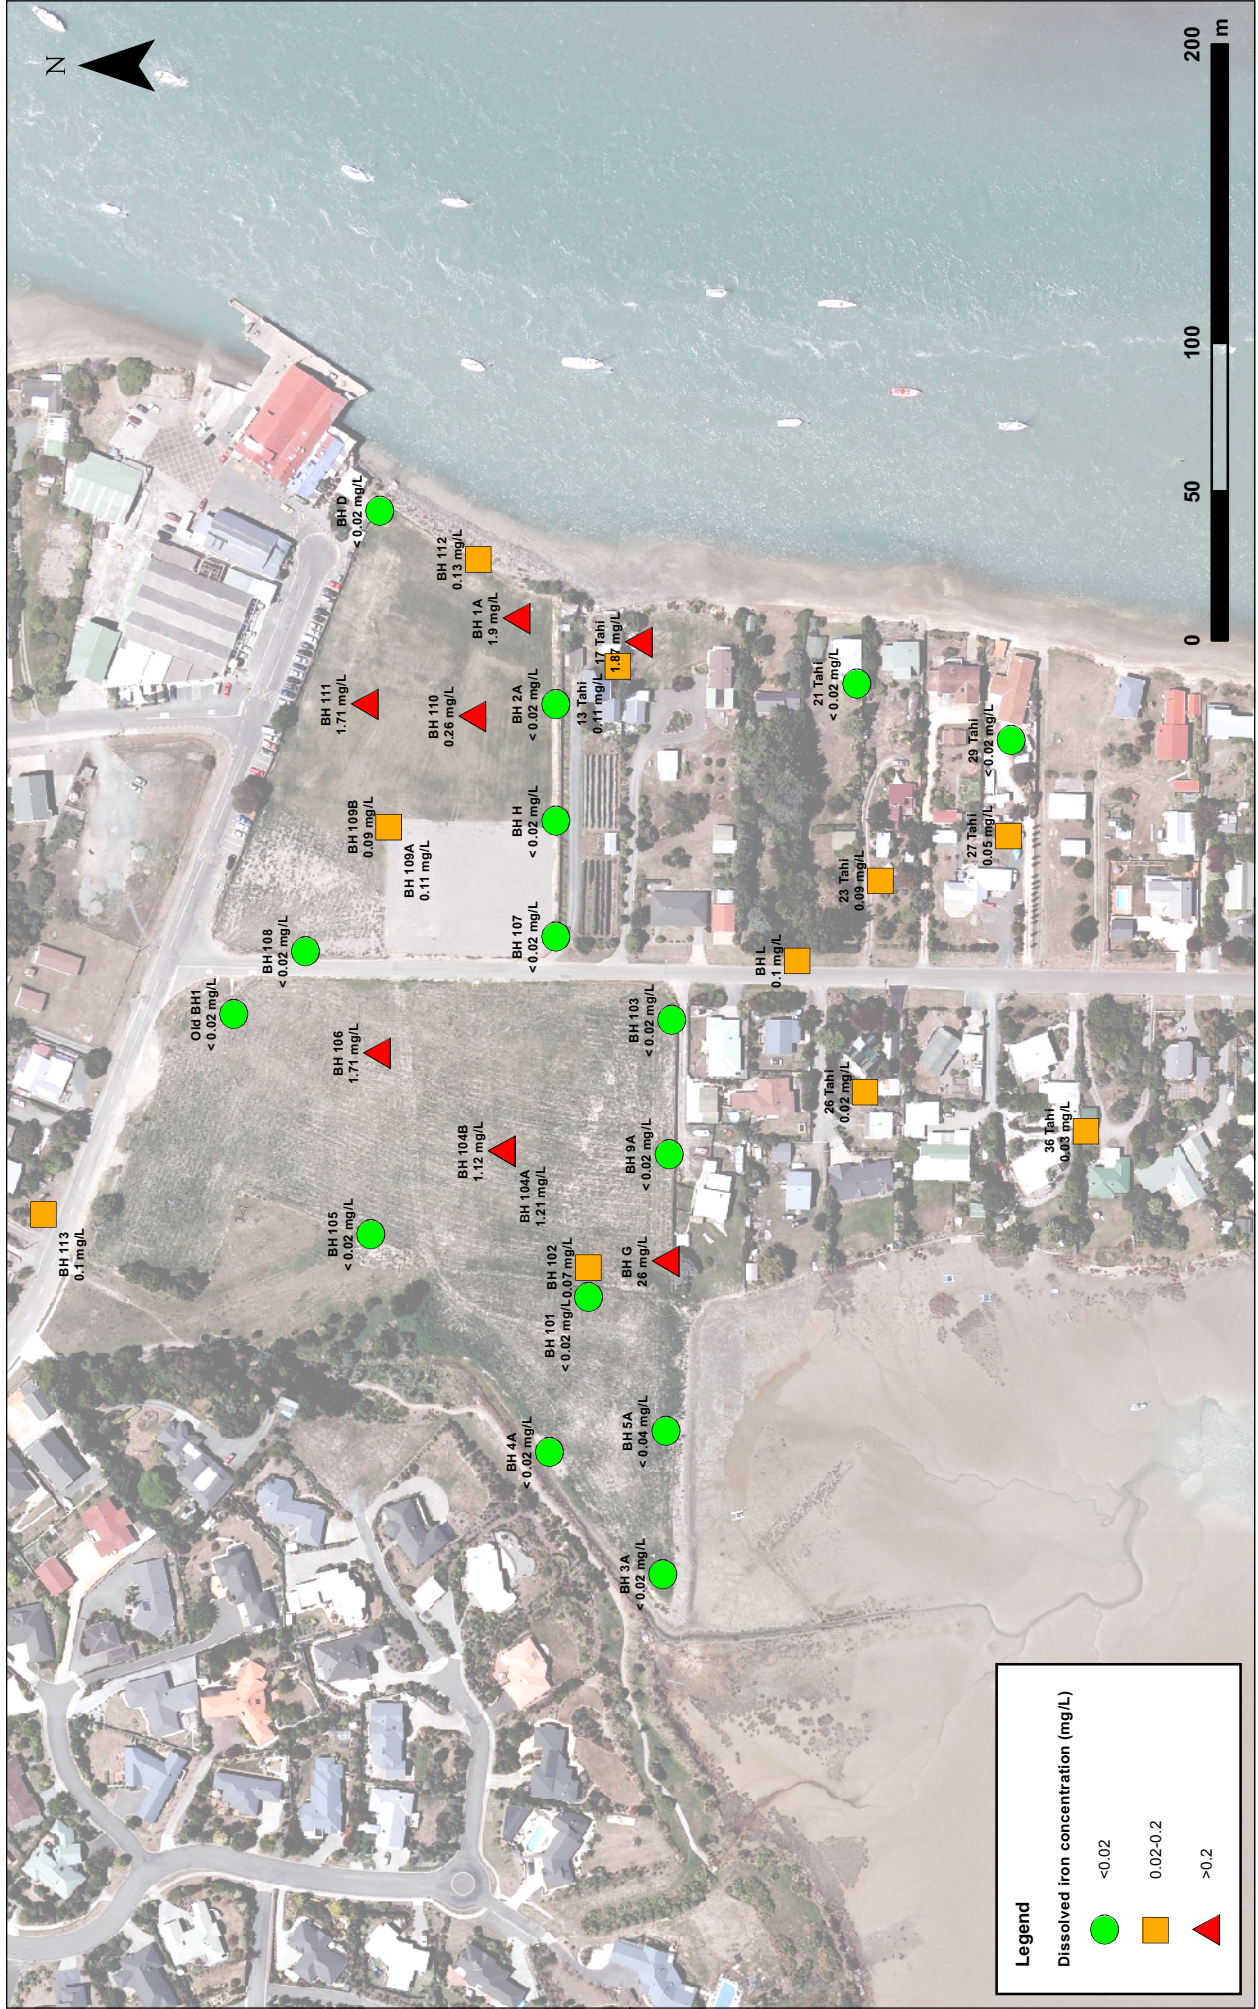
Figure 34: Dissolved iron concentrations in November 2011

There has been no consistent change since November 2010, with some bores showing increased concentrations and others showing lower concentrations. The results show elevated concentrations occurring through the centre of the site, with the highest concentration recorded in bore BH G (26 mg/L in November 2011, down from 50 mg/L in November 2010).

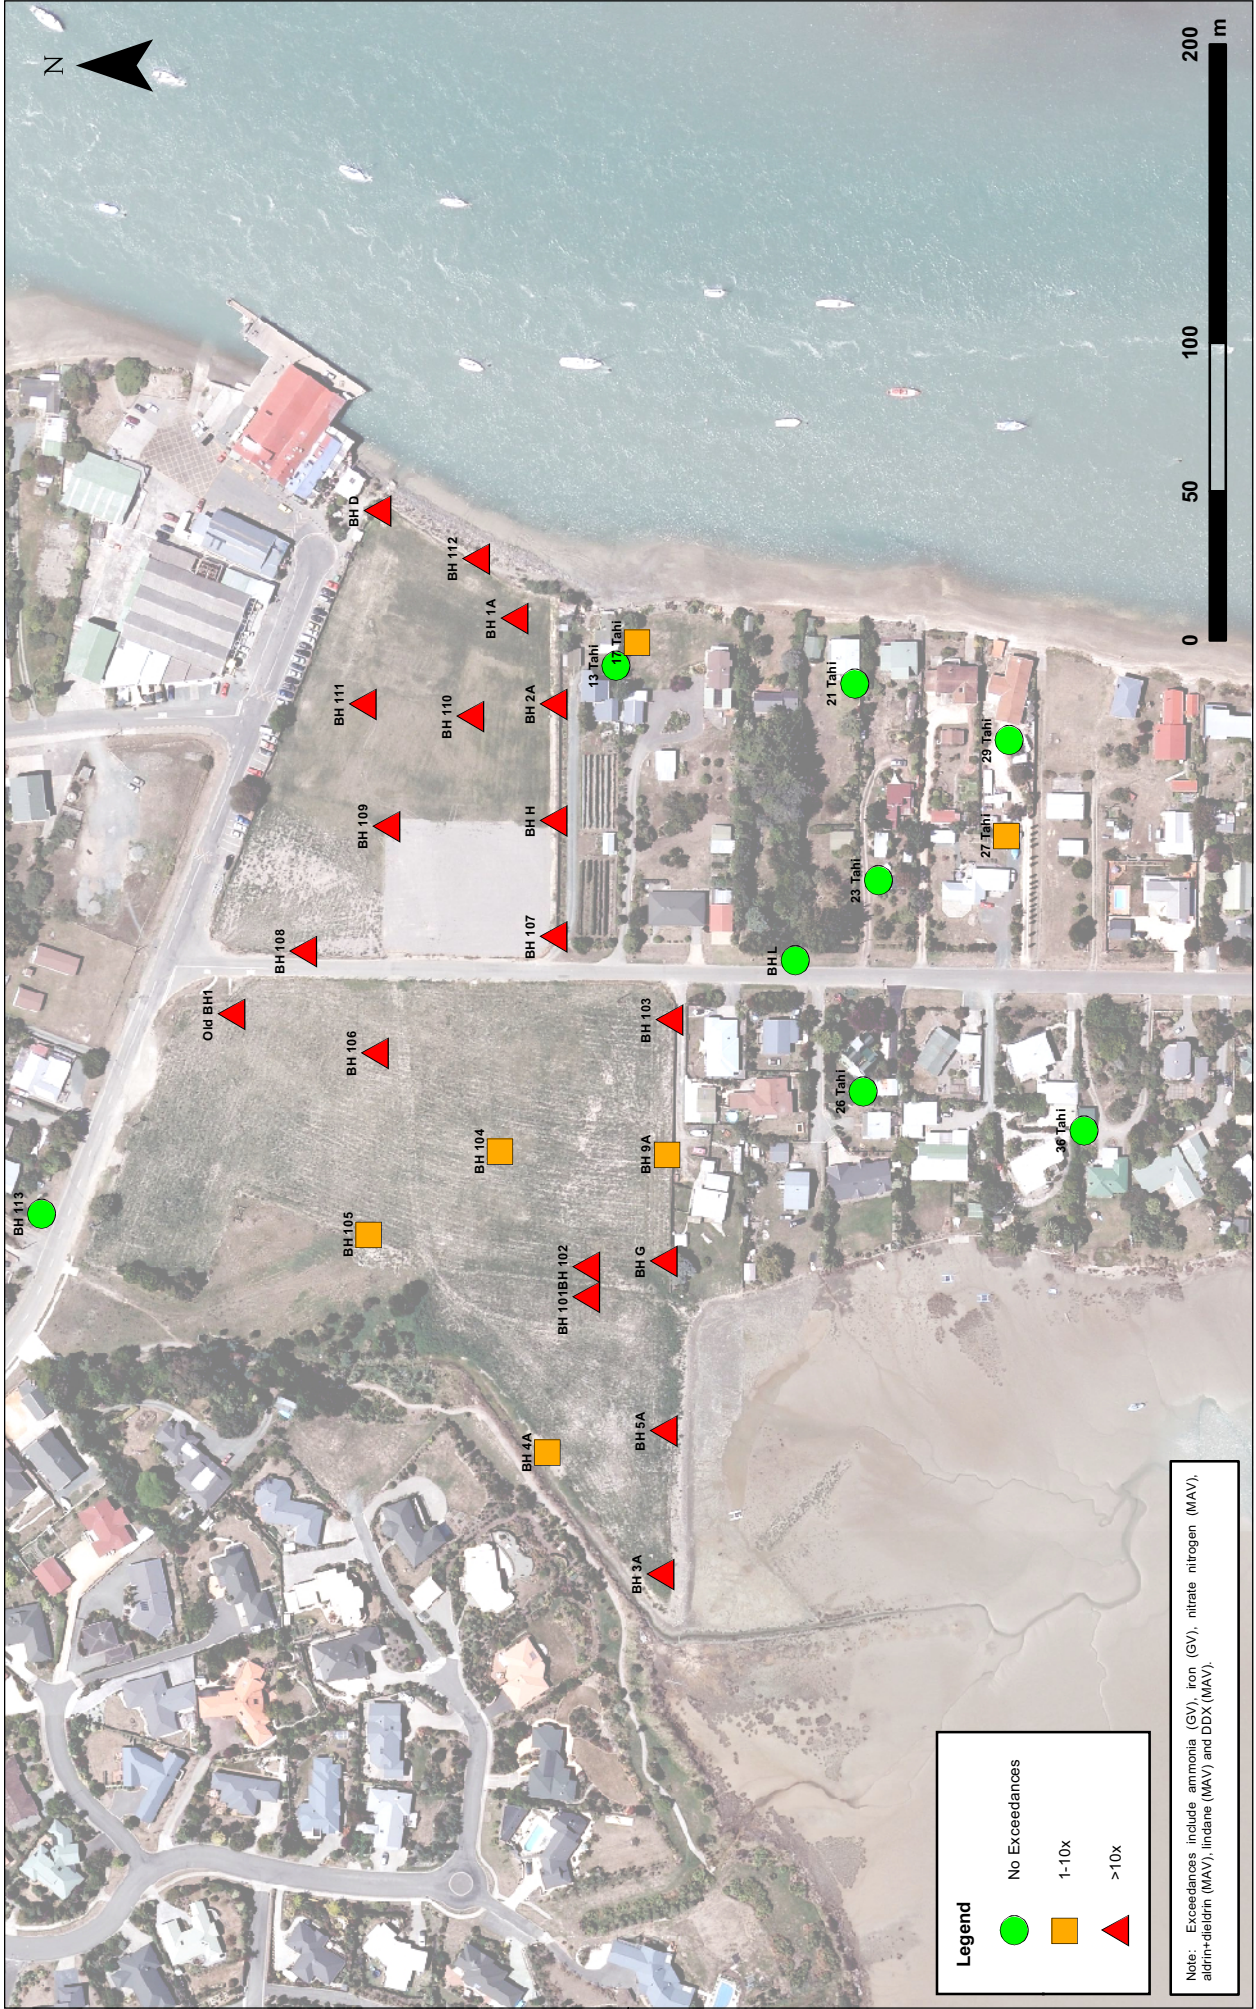
Figure 35: Exceedances of Drinking Water Standards in November 2011

Figure 35 and Table 1 show that all of the bores within the site had exceedances of the Drinking Water Standards in November 2011, with most wells having an exceedance of more than ten times the standards. Of the domestic wells, only 17 Tahi St and 27 Tahi St had exceedances of the Drinking Water Standards in November 2011.

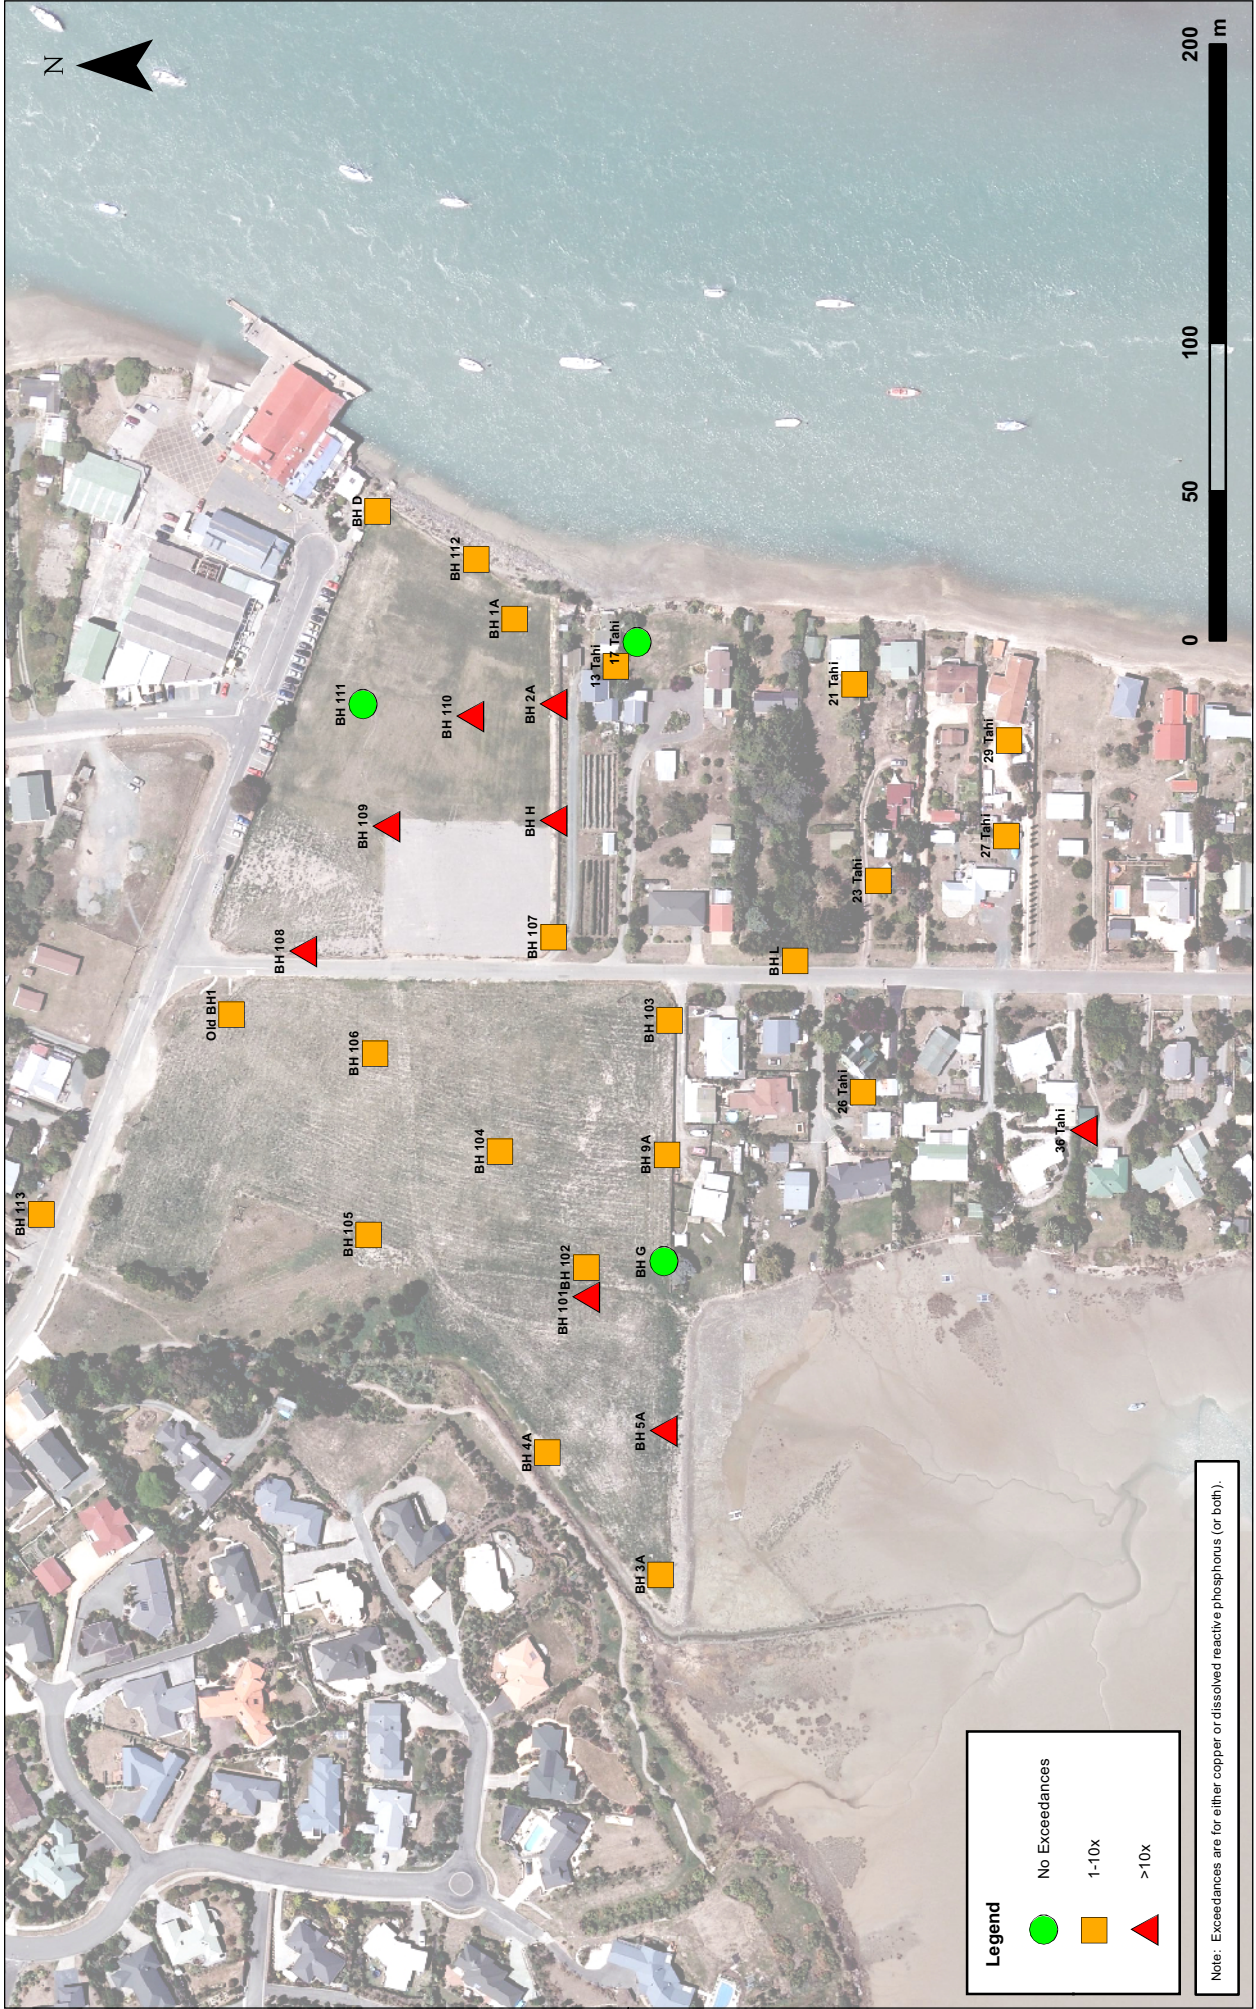
Figure 36: Exceedances of ANZECC Guidelines in November 2011

Figure 36 and Table 2 show that all of the bores, except for BH111, BHG and 17 Tahi St, had exceedances of the ANZECC guidelines in November 2011. Most of the wells exceeded the ANZECC guidelines for both dissolved copper and dissolved reactive phosphorus.
