WAIMEA WATER AUGMENTATION
COMMITTEE

Lee Valley Dam Feasibility
Investigations
Geotechnical Investigation Report

December 2009

T&T Ref: 24727.204

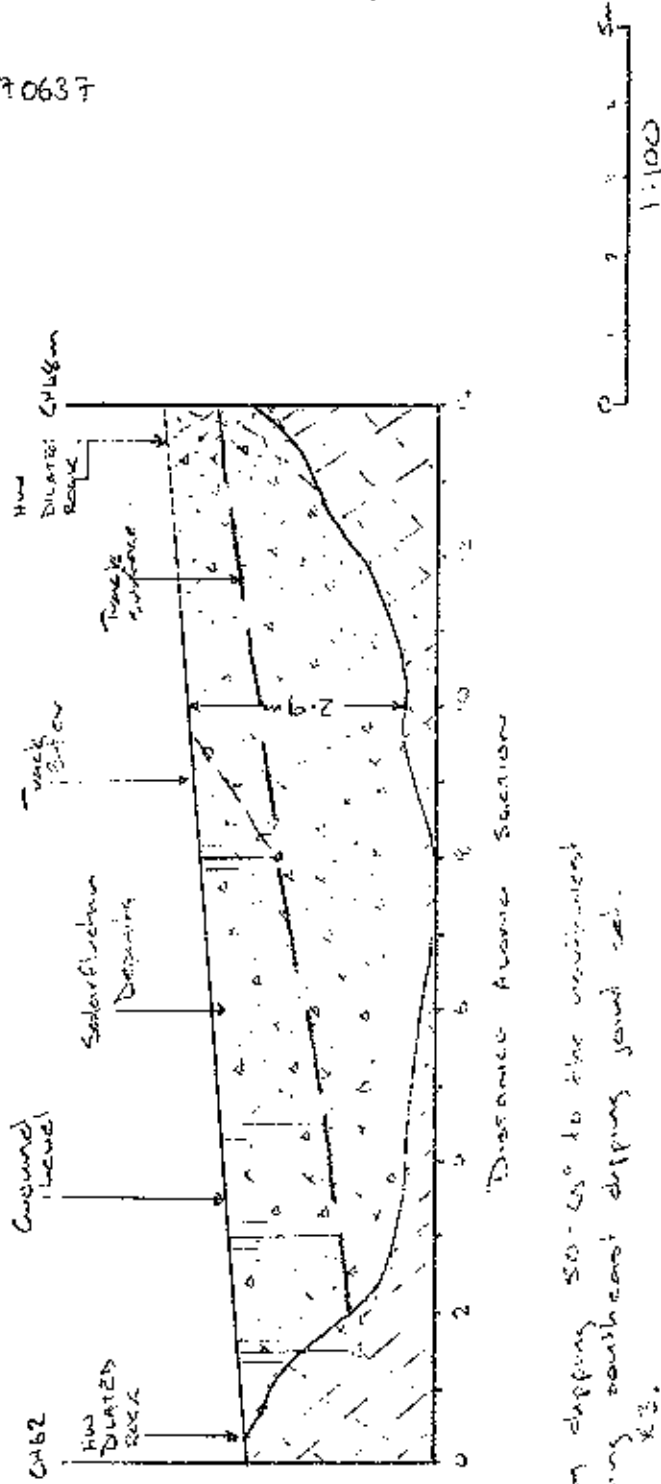
EXCAVATION LOG EX3 48m - 62m.

- Rock is steeply dipping SW-SE to the maximum with an opposing northeast dipping sand slab. Blocky, B2 to B3.
- Rock mass is consist of fragments with improving spacing towards the centre of the section.
- No distinctive shear zones observed in trench.

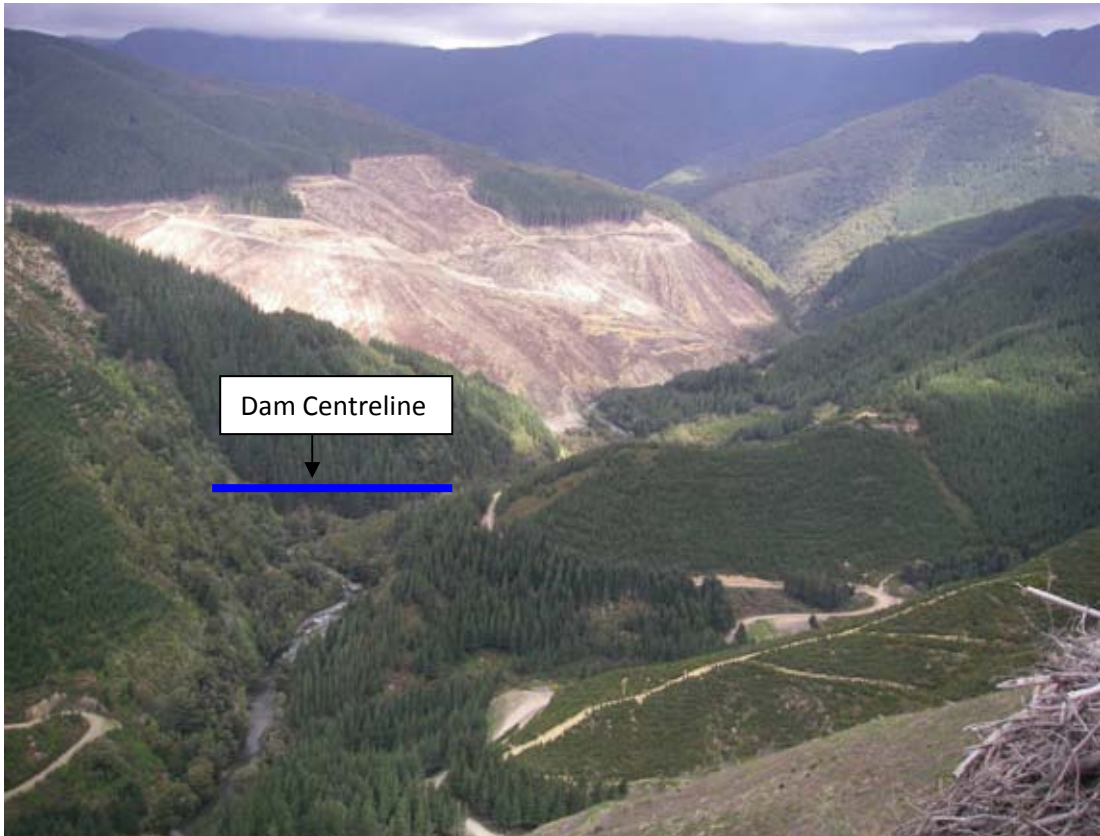
Photo 1: View upstream of dam location and upper catchment

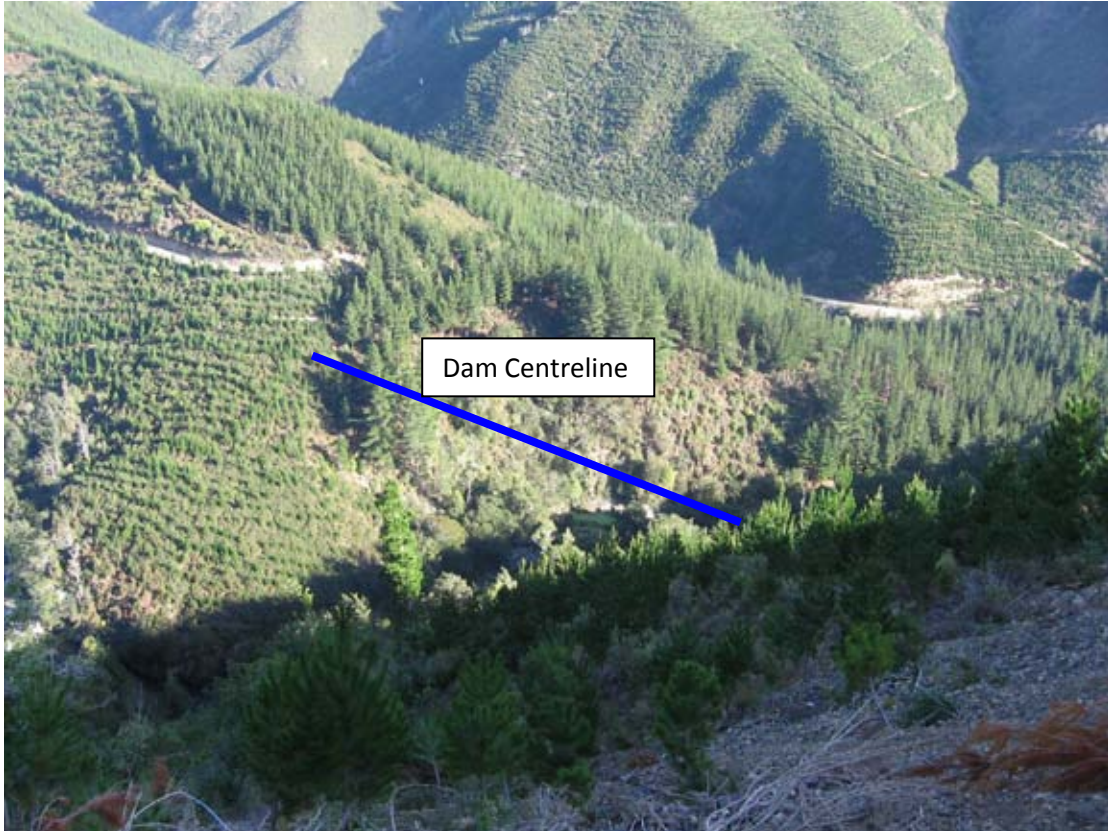
Photo 2: Dam Left abutment

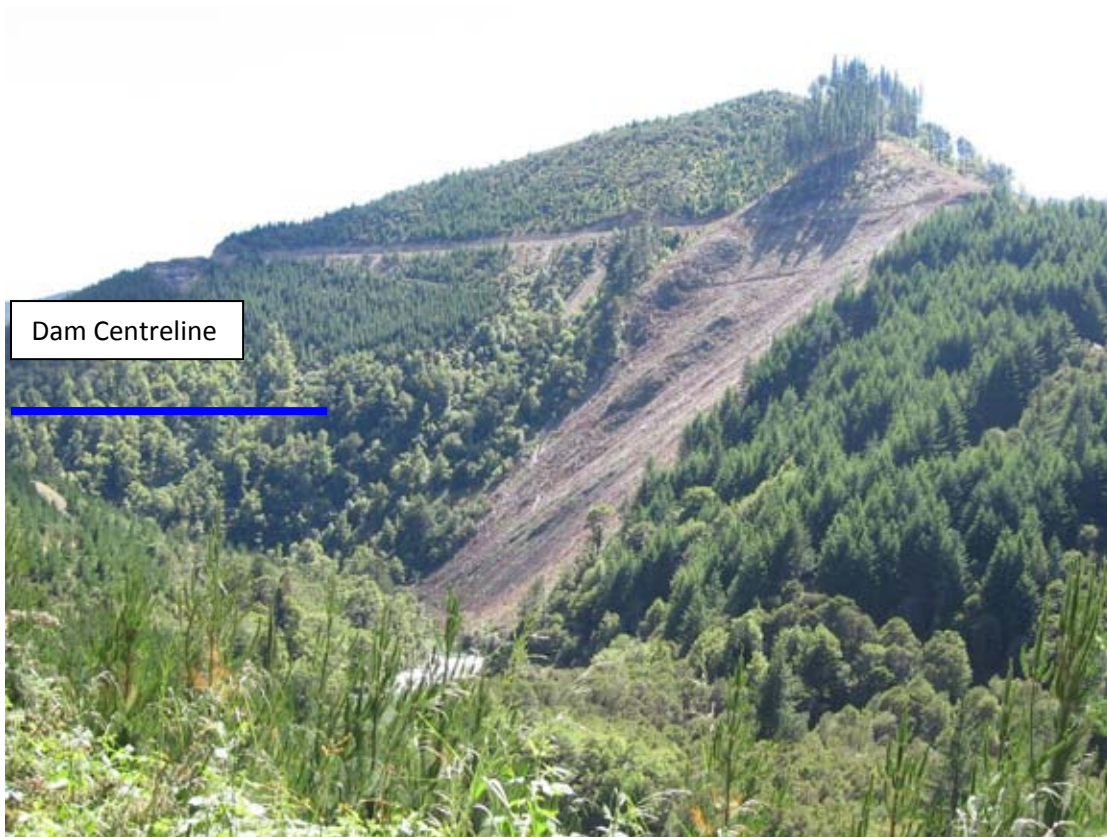
Photo 3: View of left abutment slope

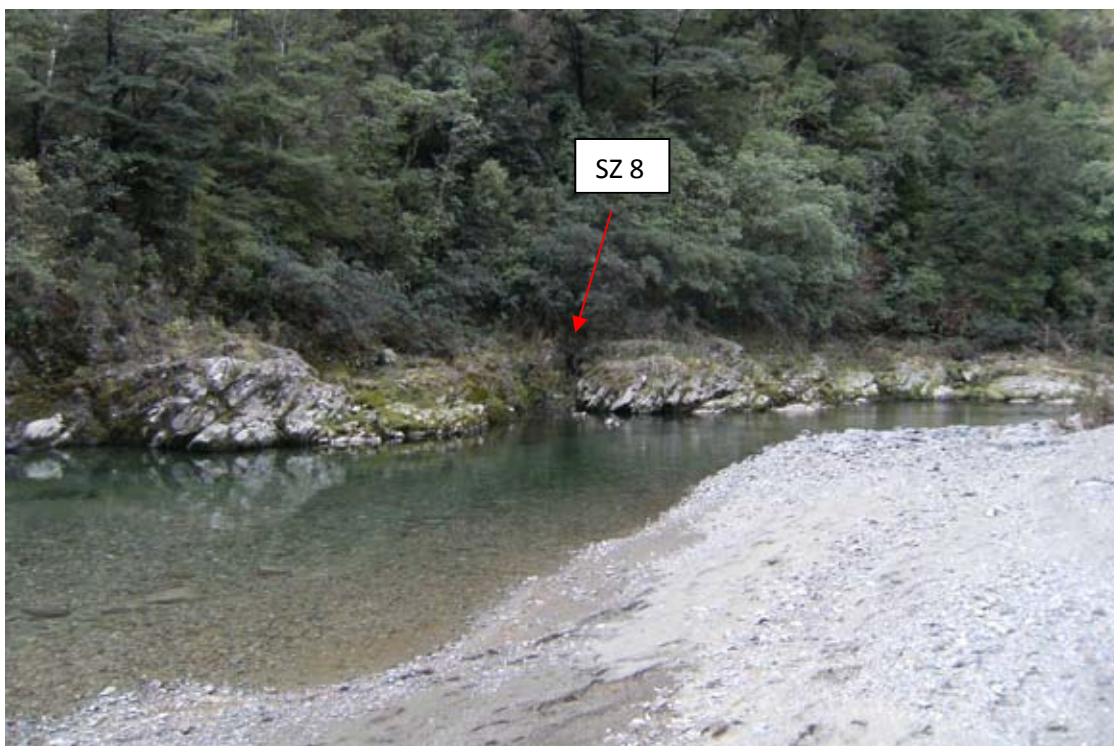
Photo 4: Rock exposed in right river bank beneath dam centreline

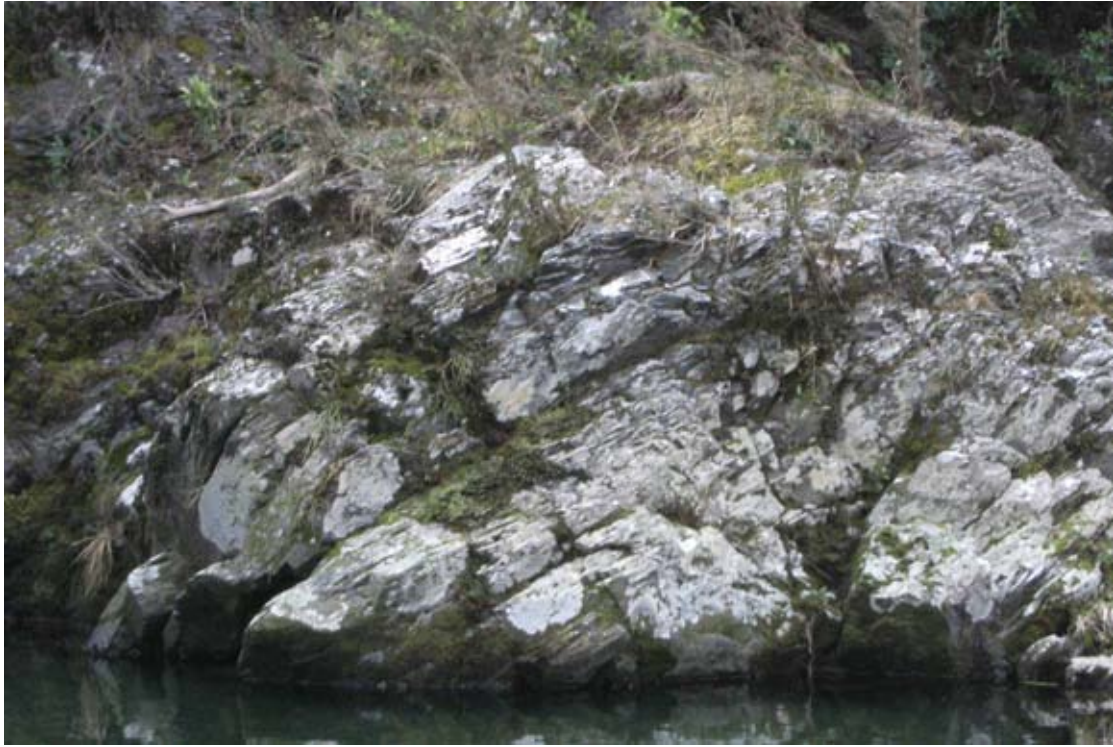
Photo 5: Greywacke exposed upstream of SZ8 (refer Photo 4)

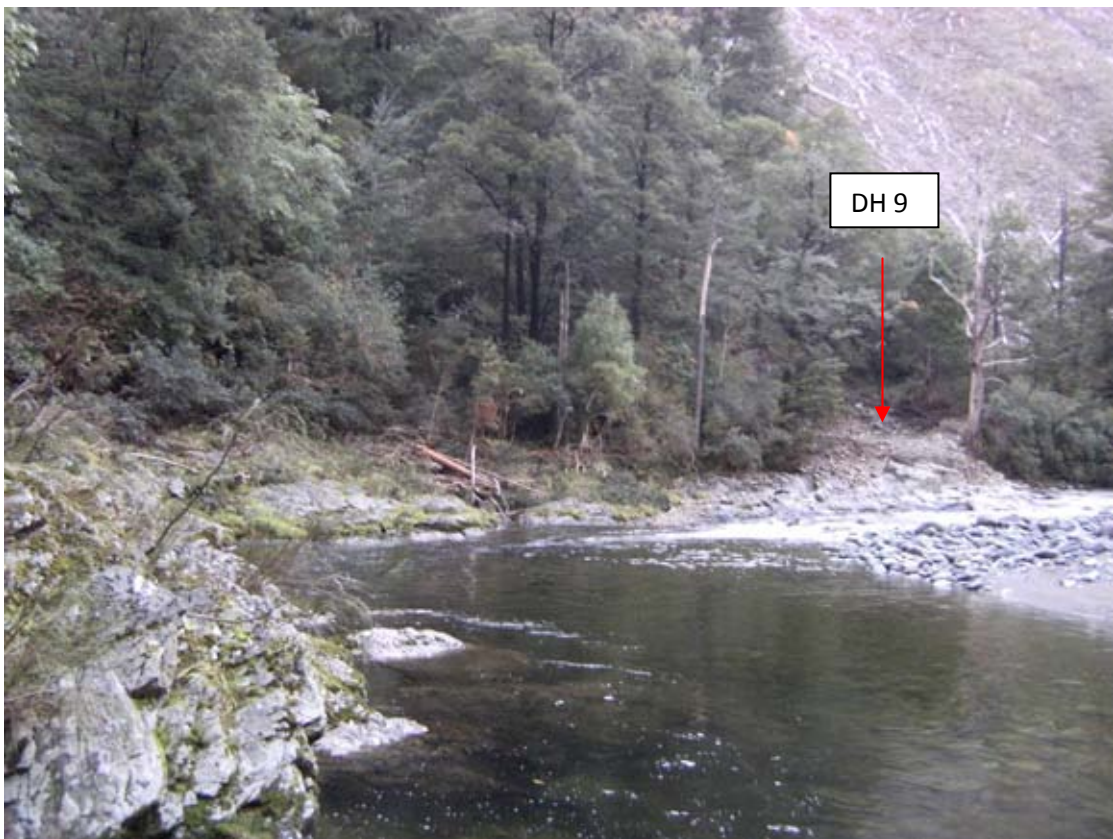
Photo 6: Dam foundation, right bank of river, upstream of dam centreline

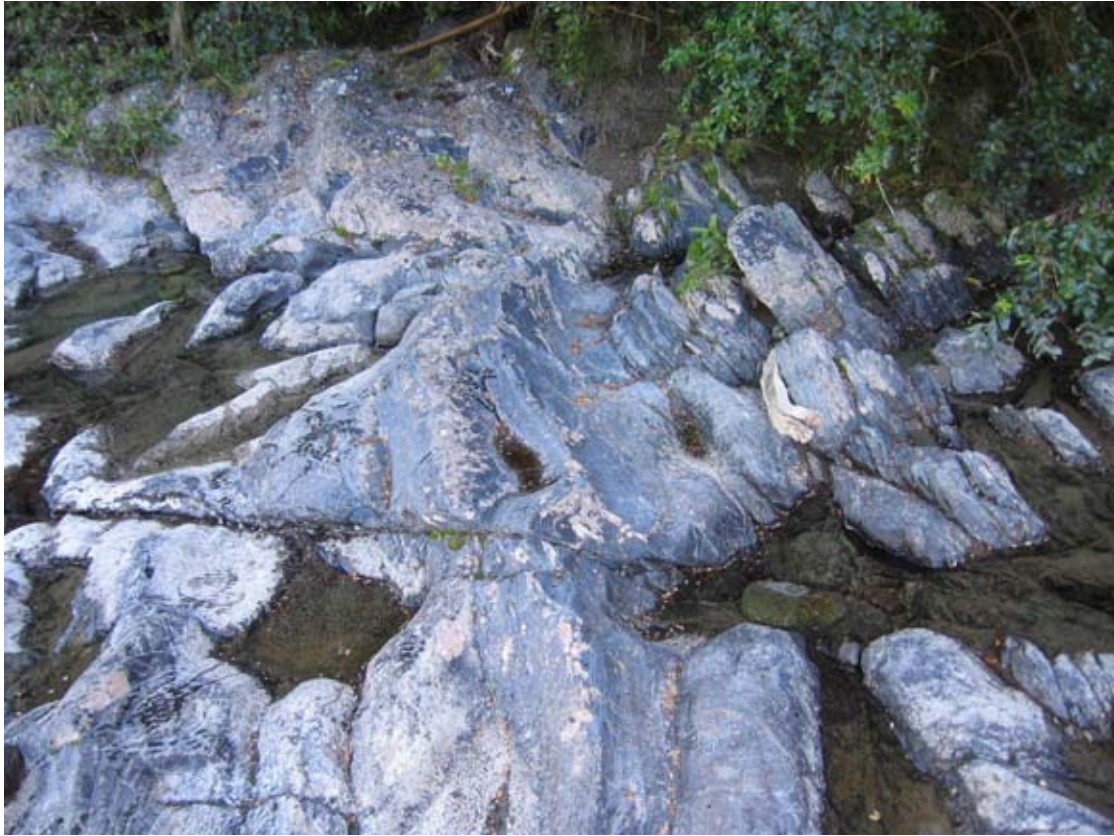
Photo 7: Greywacke exposed in river downstream of dam toe

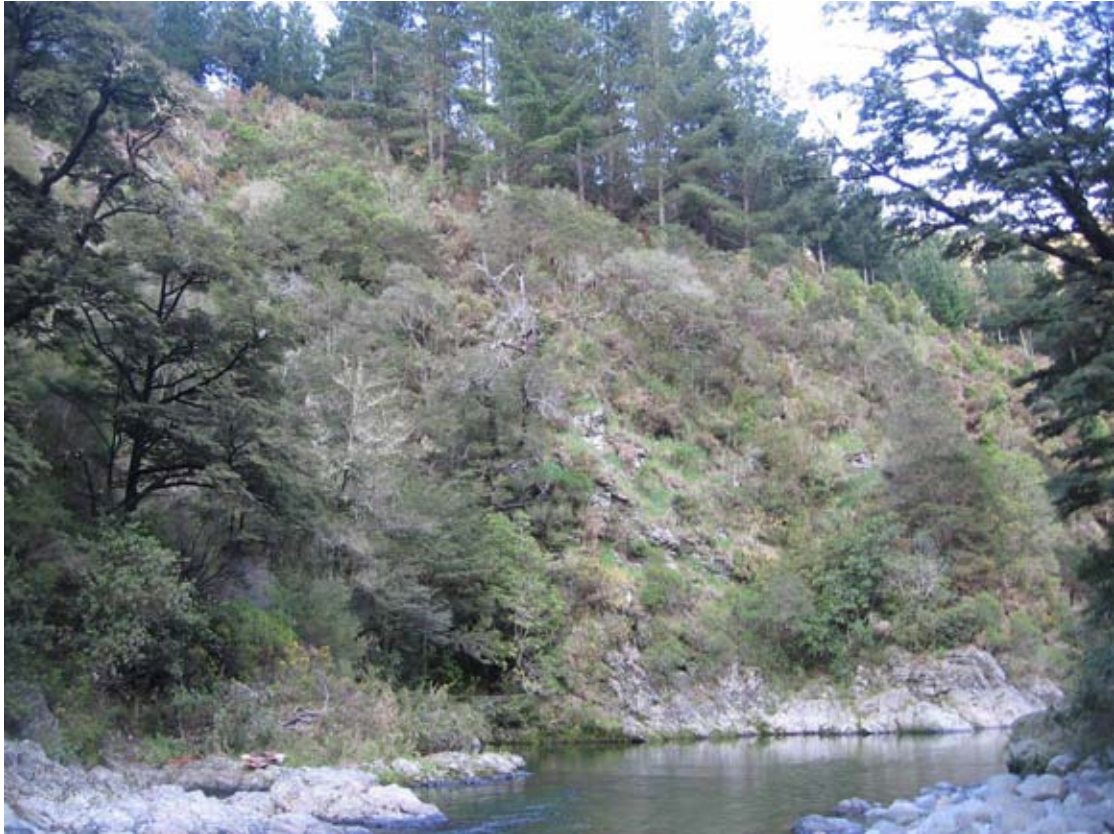
Photo 8: Downstream of centreline, left abutment foundation

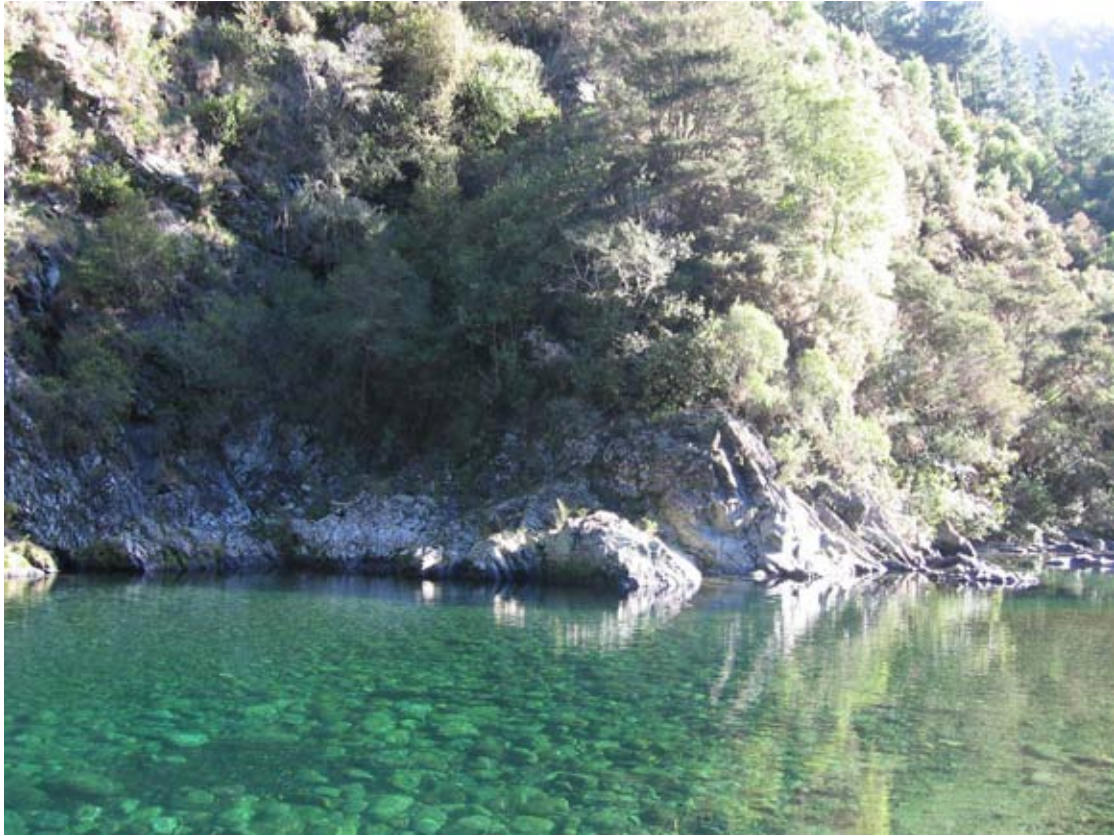
Photo 8a: Downstream left abutment near dam toe (closer view of Photo 8)

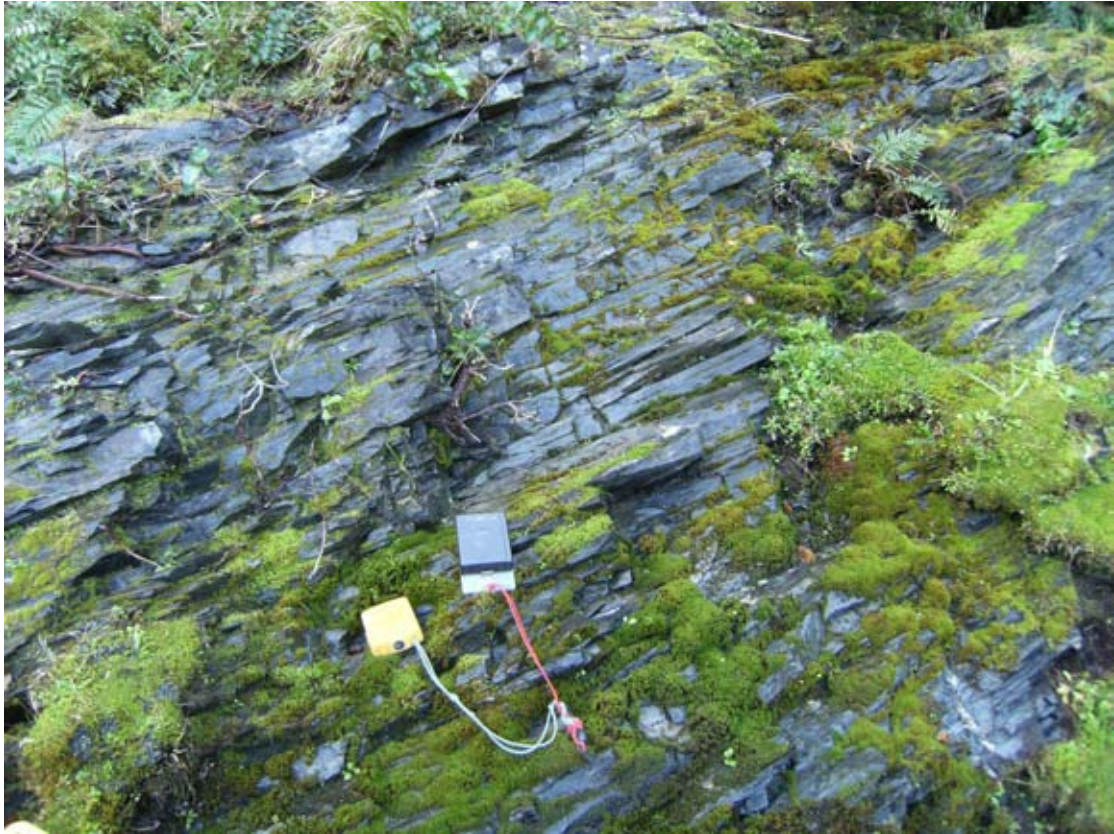
Photo 9: Laminated greywacke in river exposure in dam foundation

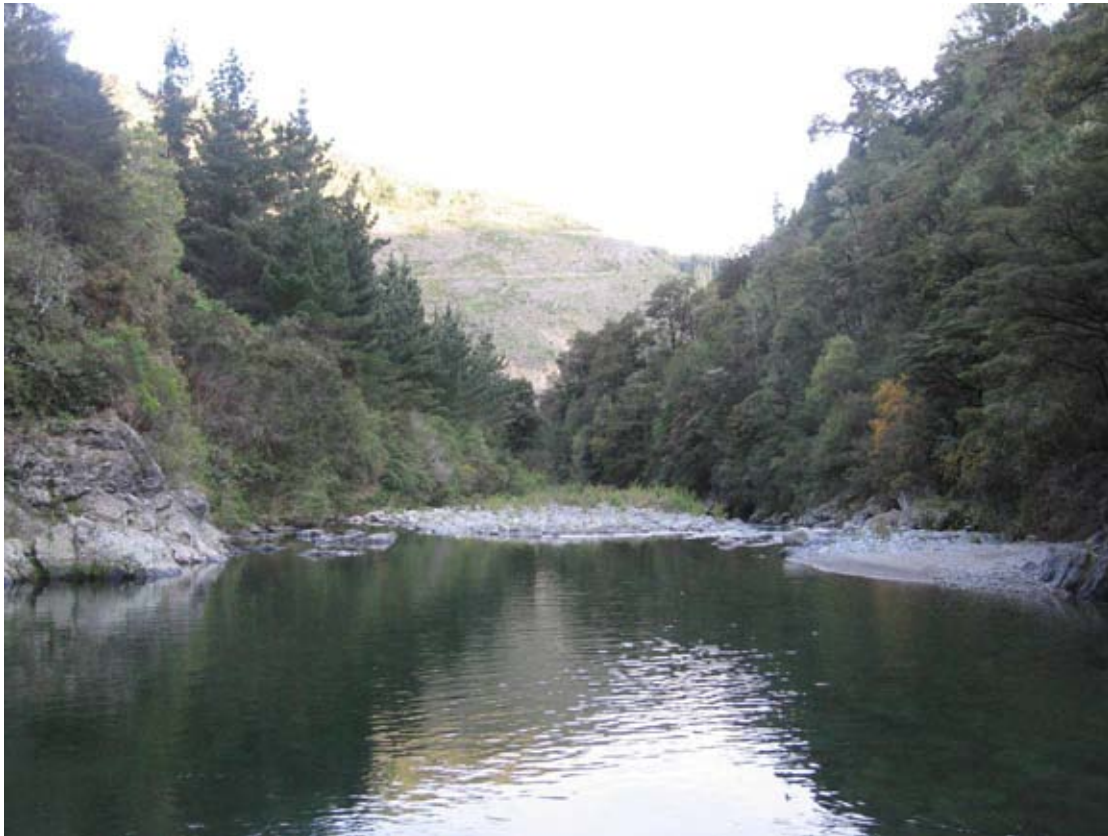
Photo 10: View downstream from dam toe

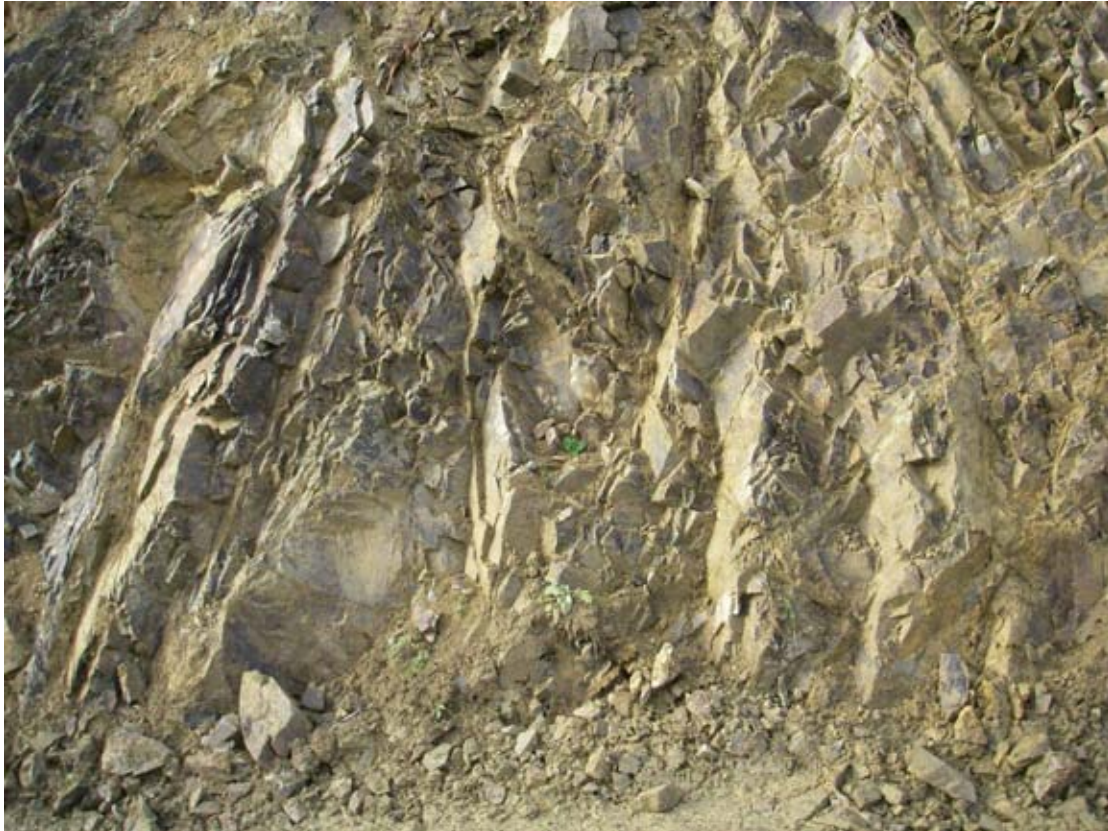
Photo 11: Moderately weathered, closely jointed rock exposed in track upslope of right abutment

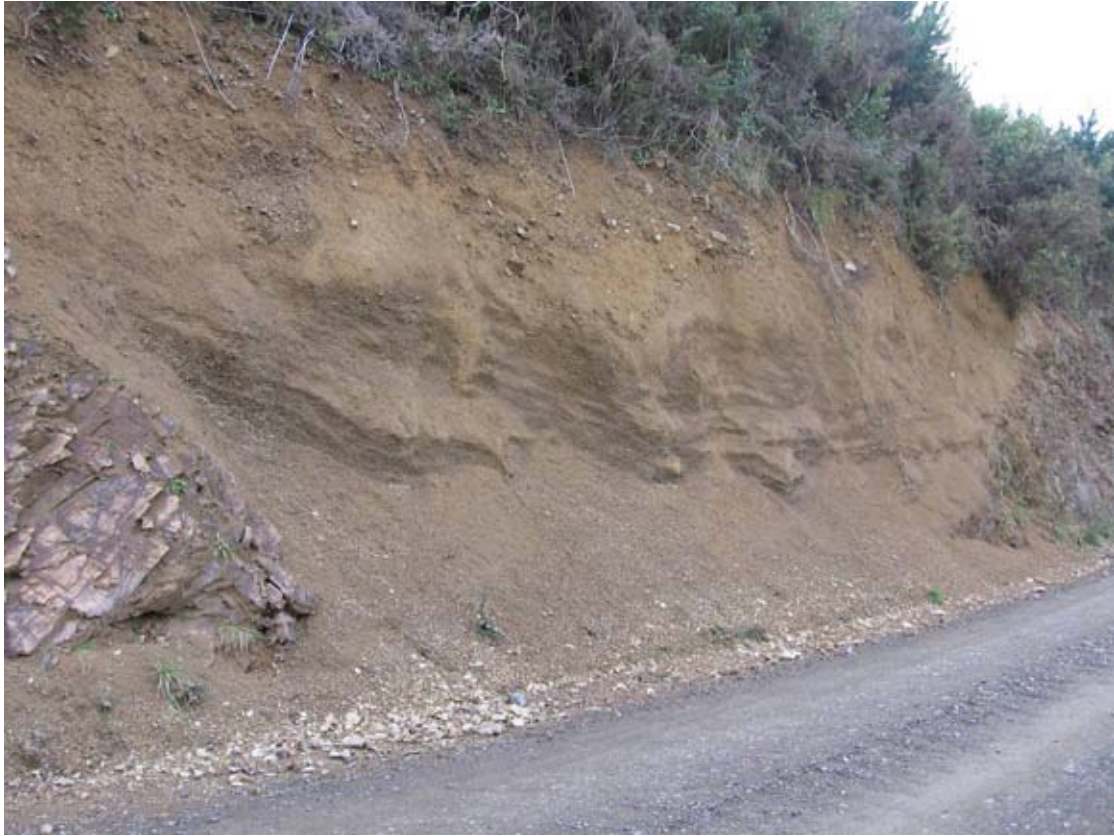
Photo 12: Solifluction deposit infilling fossil gully, upstream of left abutment
