11 March 2013

Mr Glenn Stevens  
Tasman District Council  
Private Bag 4  
**RICHMOND 7050**

### **GROUNDWATER MONITORING AT FORMER FCC SITE, MAPUA – MARCH 2013 SAMPLING UPDATE**

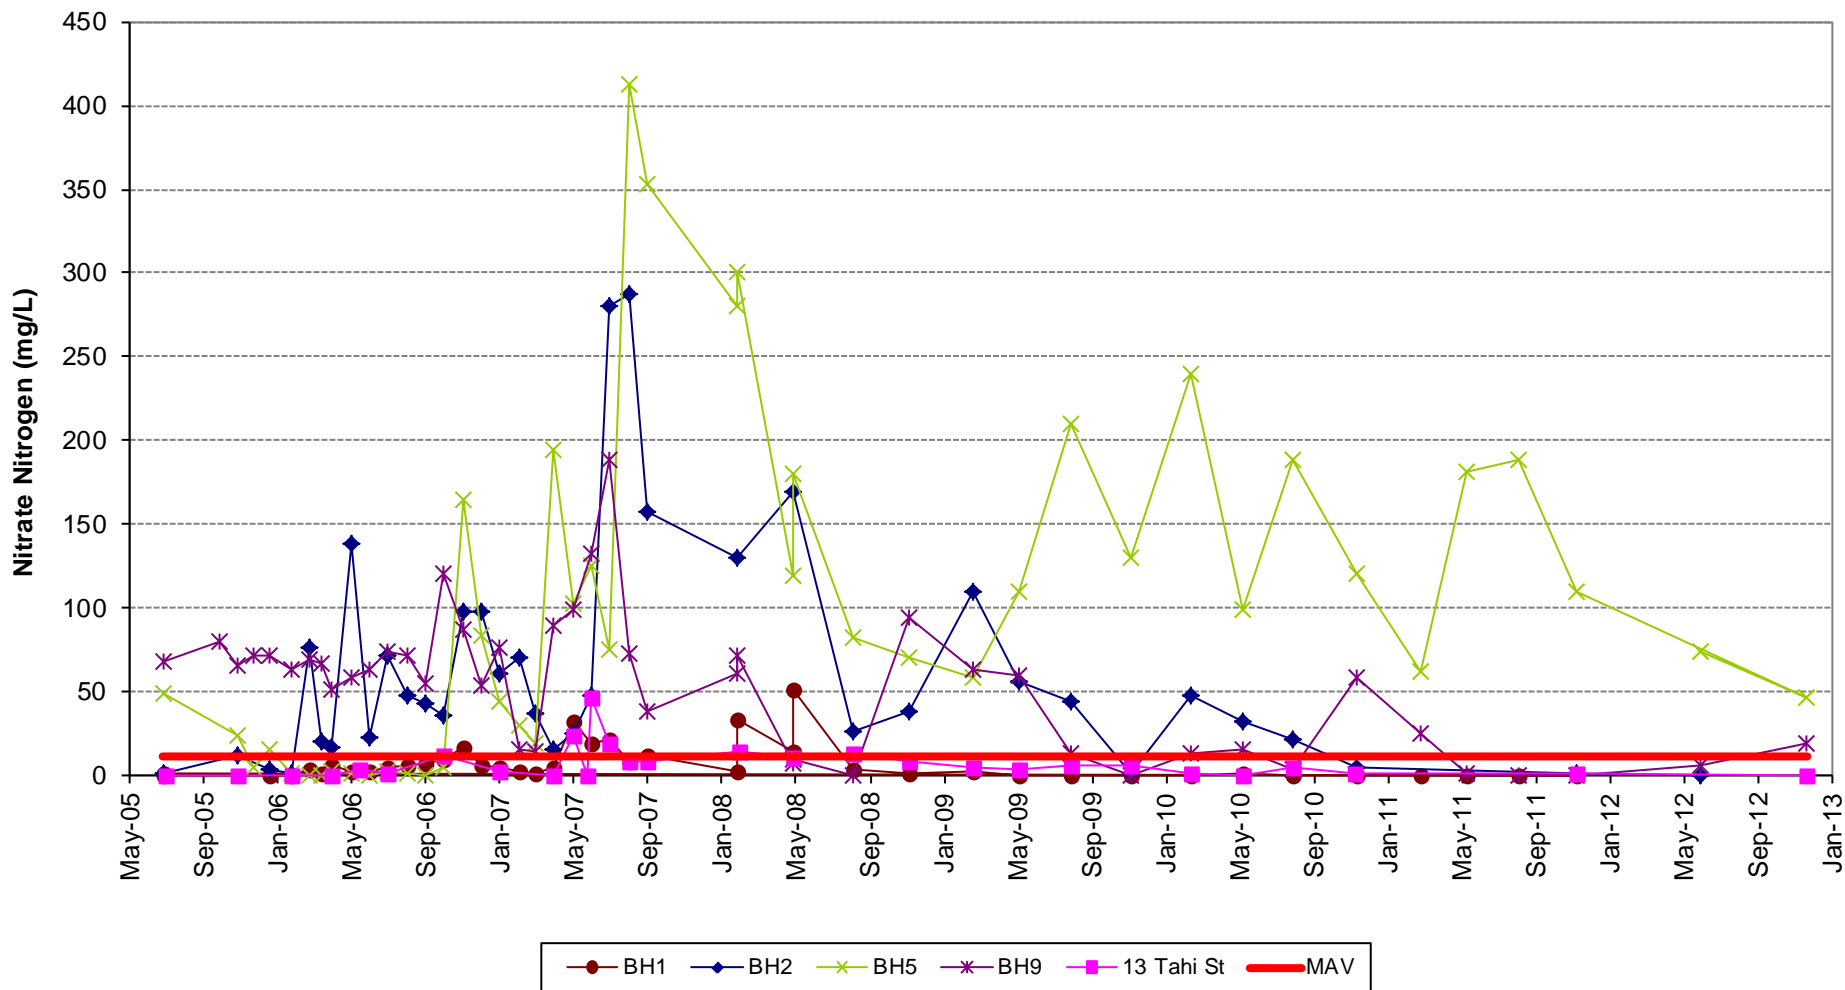
**Figure 2. Nitrate-N**  
**MAV DWSNZ 11.3 mg/L**

Figure 2 shows nitrate-nitrogen concentrations. Three boreholes have historically shown elevated concentrations: BH2, BH5 and BH9. Since late 2007, concentrations have decreased substantially, which coincides with the cessation of the MCD reactor in mid-2007. Despite this general decline, BH5 continues to show significantly elevated concentrations. During the last year, only BH5 and BH9 have had measured nitrate-N concentrations above the Maximum Acceptable Value in the Drinking Water Standards for New Zealand 2005 (Revised 2008), which is 11.3 mg/L. BH9 had one exceedence of the MAV in November 2012 (19.9 mg/L), while the concentration in May 2012 was approximately half the MAV (6.4 mg/L). BH5 recorded concentrations of 74 mg/L in May 2012 and 47 mg/L in November 2012. Figure 2a shows the boreholes that have typically displayed lower nitrate-N concentrations. Both BH1 and 13 Tahi Street remain at stable, low concentrations significantly below the MAV.

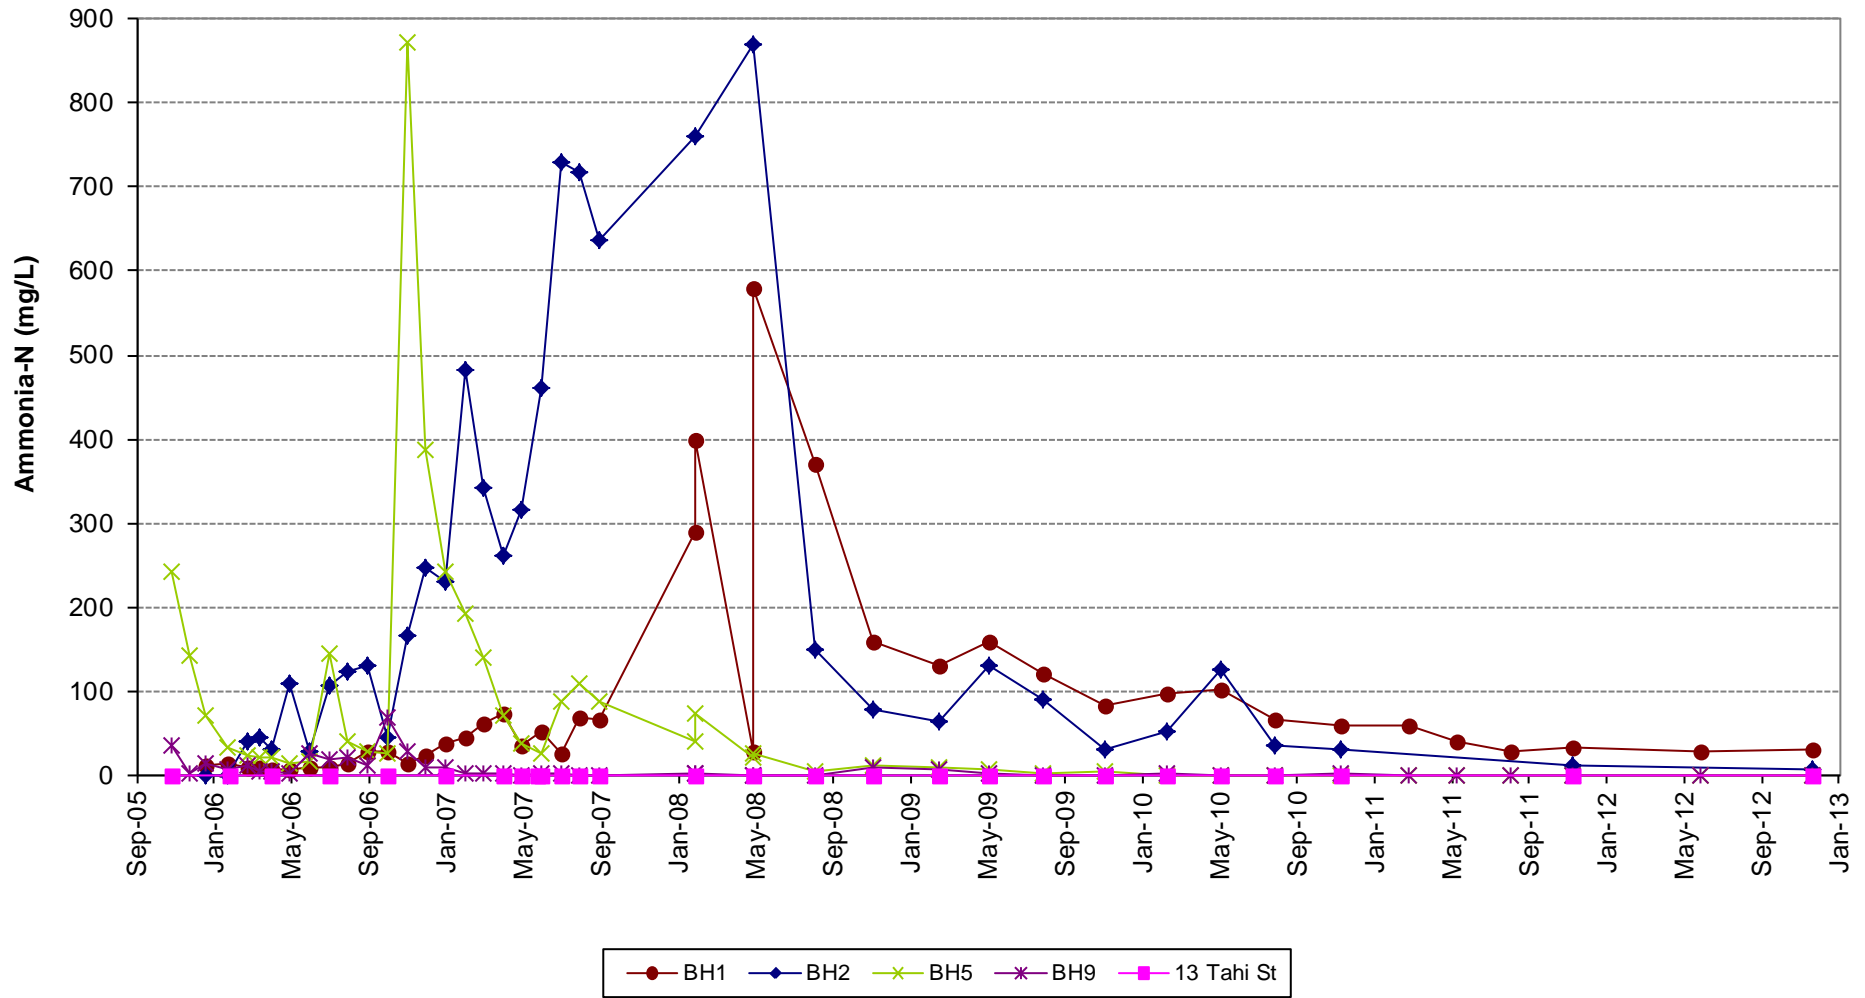
**Figure 3. Ammonia-N**  
**GV Aesthetic DWSNZ 1.2 mg/L; Aquatic Ecosystem Guideline 0.71mg/L**

Figure 3 shows ammonia-nitrogen concentrations. The bores with elevated concentrations (BH1A and BH2A) have maintained stable levels and are very similar to the previous year. Those bores with lower ammonia-N concentrations (BH5, BH9 and 13 Tahi Street, see Figure 3a) maintain stable concentrations. The slight rise observed in BH9 in November 2012 to 0.25 mg/L is still significantly below the ANZECC Aquatic Ecosystem Guideline of 0.71 mg/L.

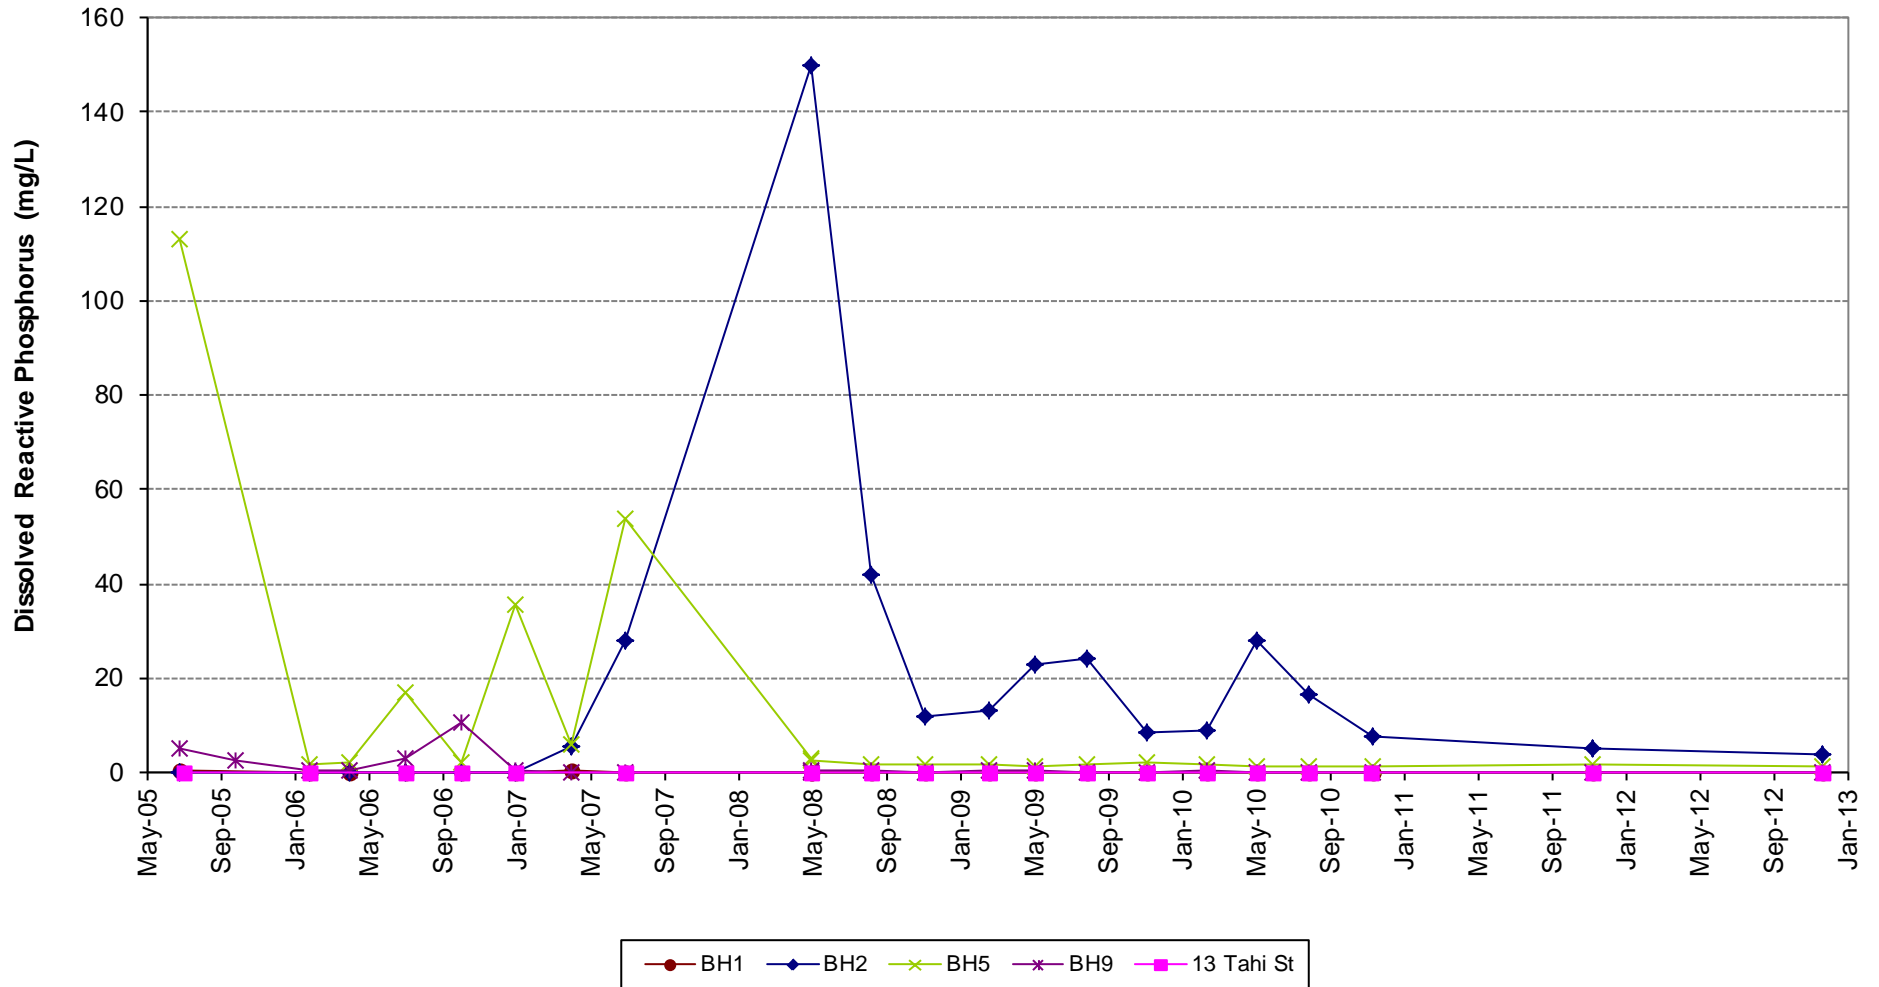
**Figure 4. Dissolved Reactive Phosphorus  
Aquatic Ecosystem Guideline 0.01 mg/L**

Figure 4 shows dissolved reactive phosphorus concentrations, which have remained stable over the last year.

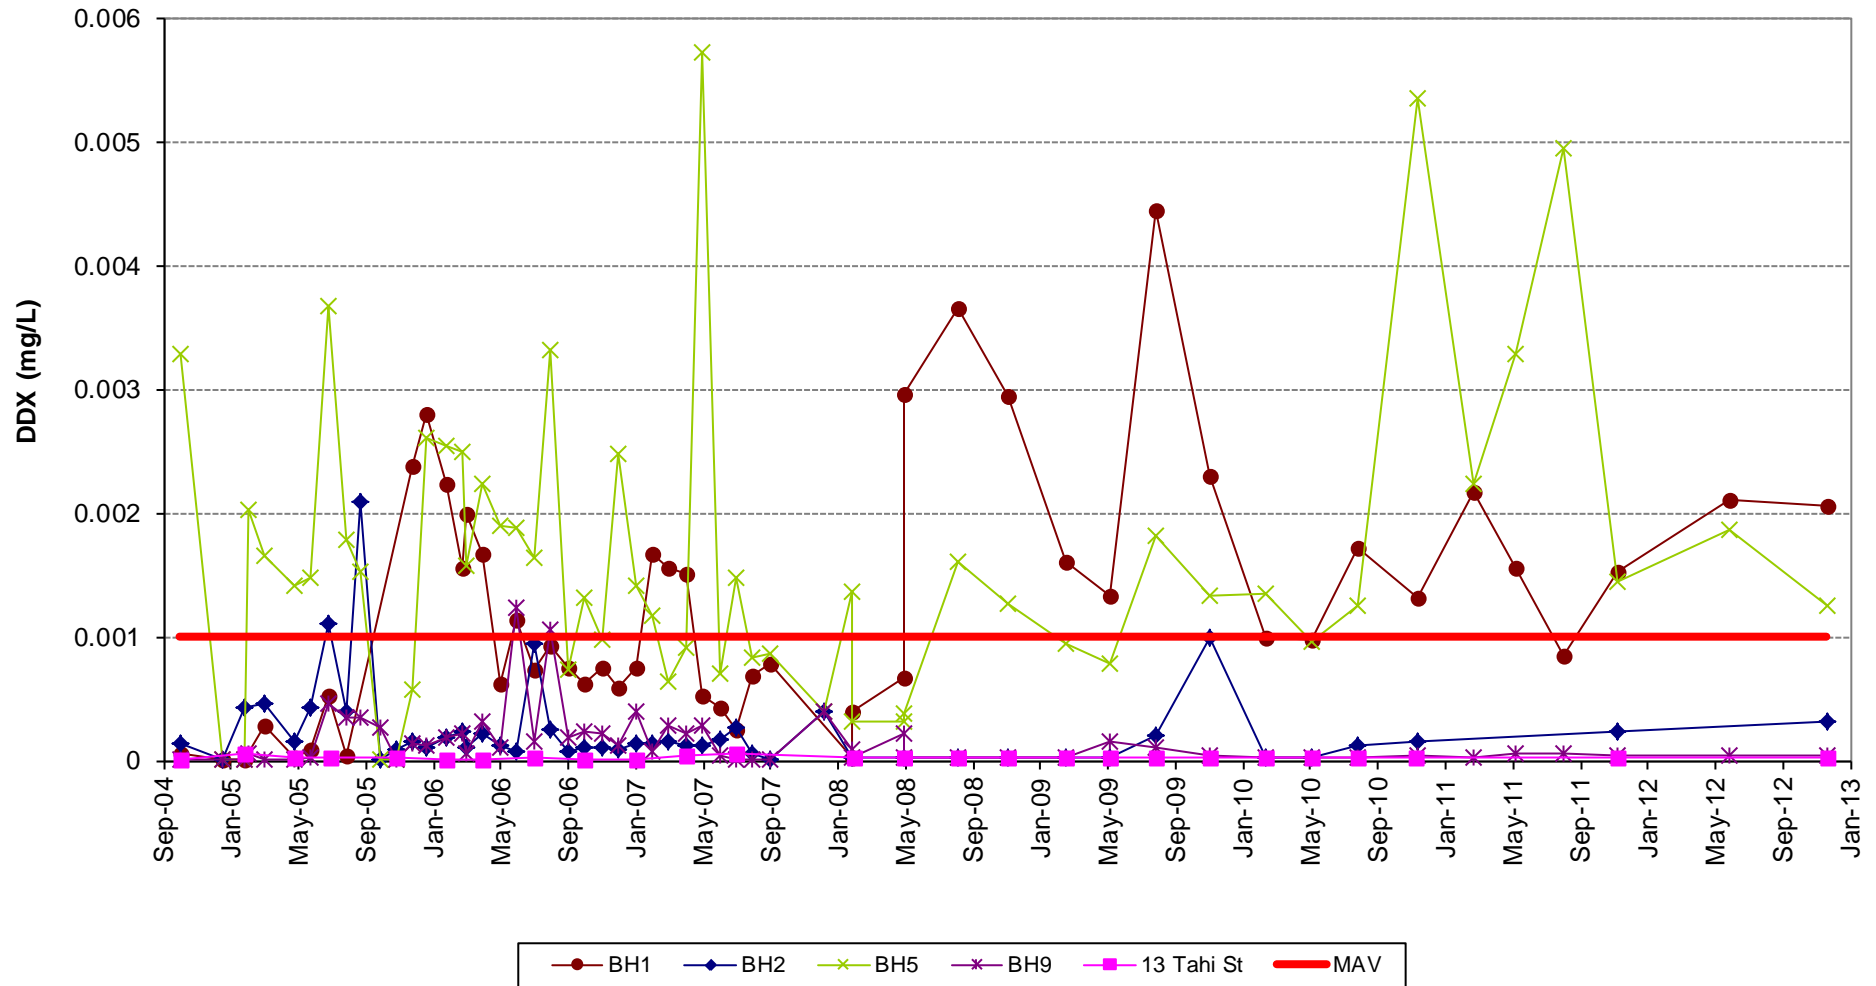
**Figure 5. DDX  
MAV DWSNZ 0.001 mg/L**

Figure 5 shows DDX concentrations. The bores with elevated concentrations (BH1 and BH5) remain above the MAV in the Drinking Water Standards (0.001 mg/L). However, the large fluctuations observed in the DDX concentrations in bores BH1 and BH5 during 2011 were not observed during 2012, possibly because the wells

were measured less frequently (six-monthly monitoring in 2012 compared to quarterly monitoring in 2011). Of the bores showing lower concentrations, BH2 has shown a slow but steady rise in concentrations, whilst BH9 and 13 Tahi St showed low stable concentrations over the last year.

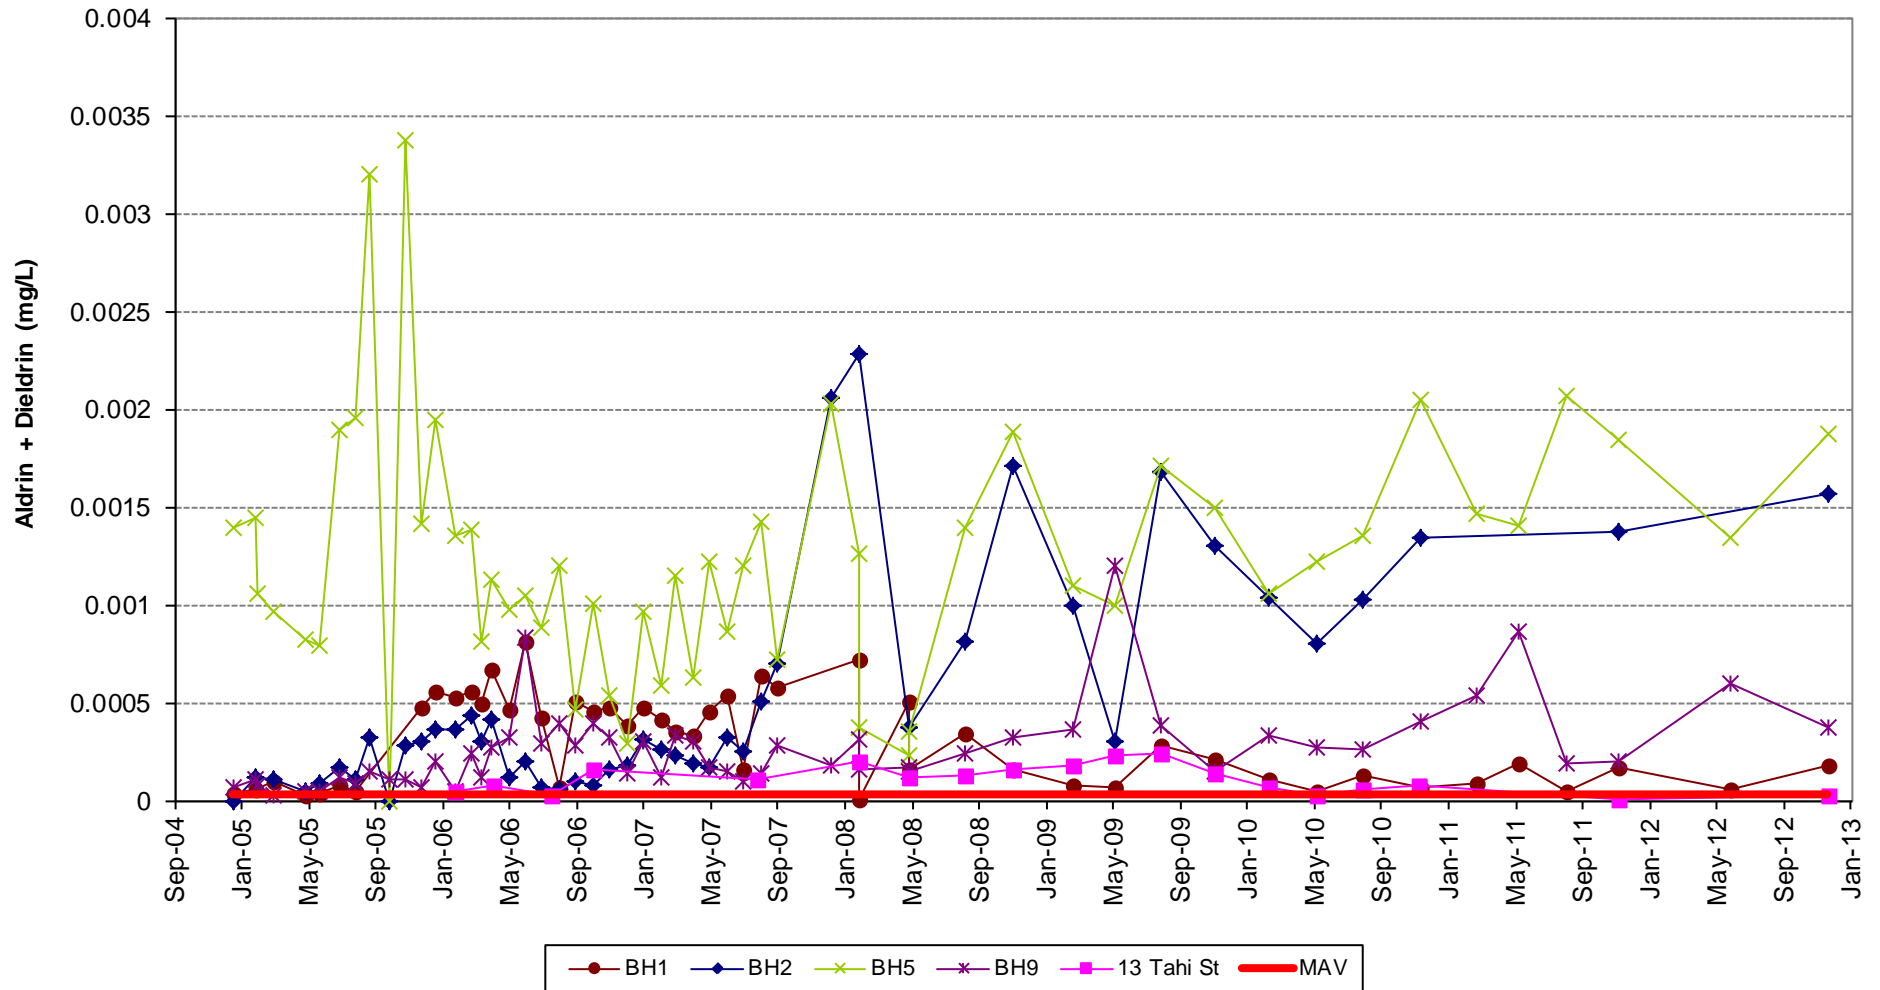
**Figure 6. Aldrin + Dieldrin  
MAV DWSNZ 0.00004 mg/L**

Figure 6 shows aldrin + dieldrin concentrations. All of the regularly sampled wells with the exception of 13 Tahi St are above the MAV in the Drinking Water Standards (0.00004 mg/L). The highest concentrations occur in BH5 and BH2 and remain at similar concentrations to those measured during the remedial works.

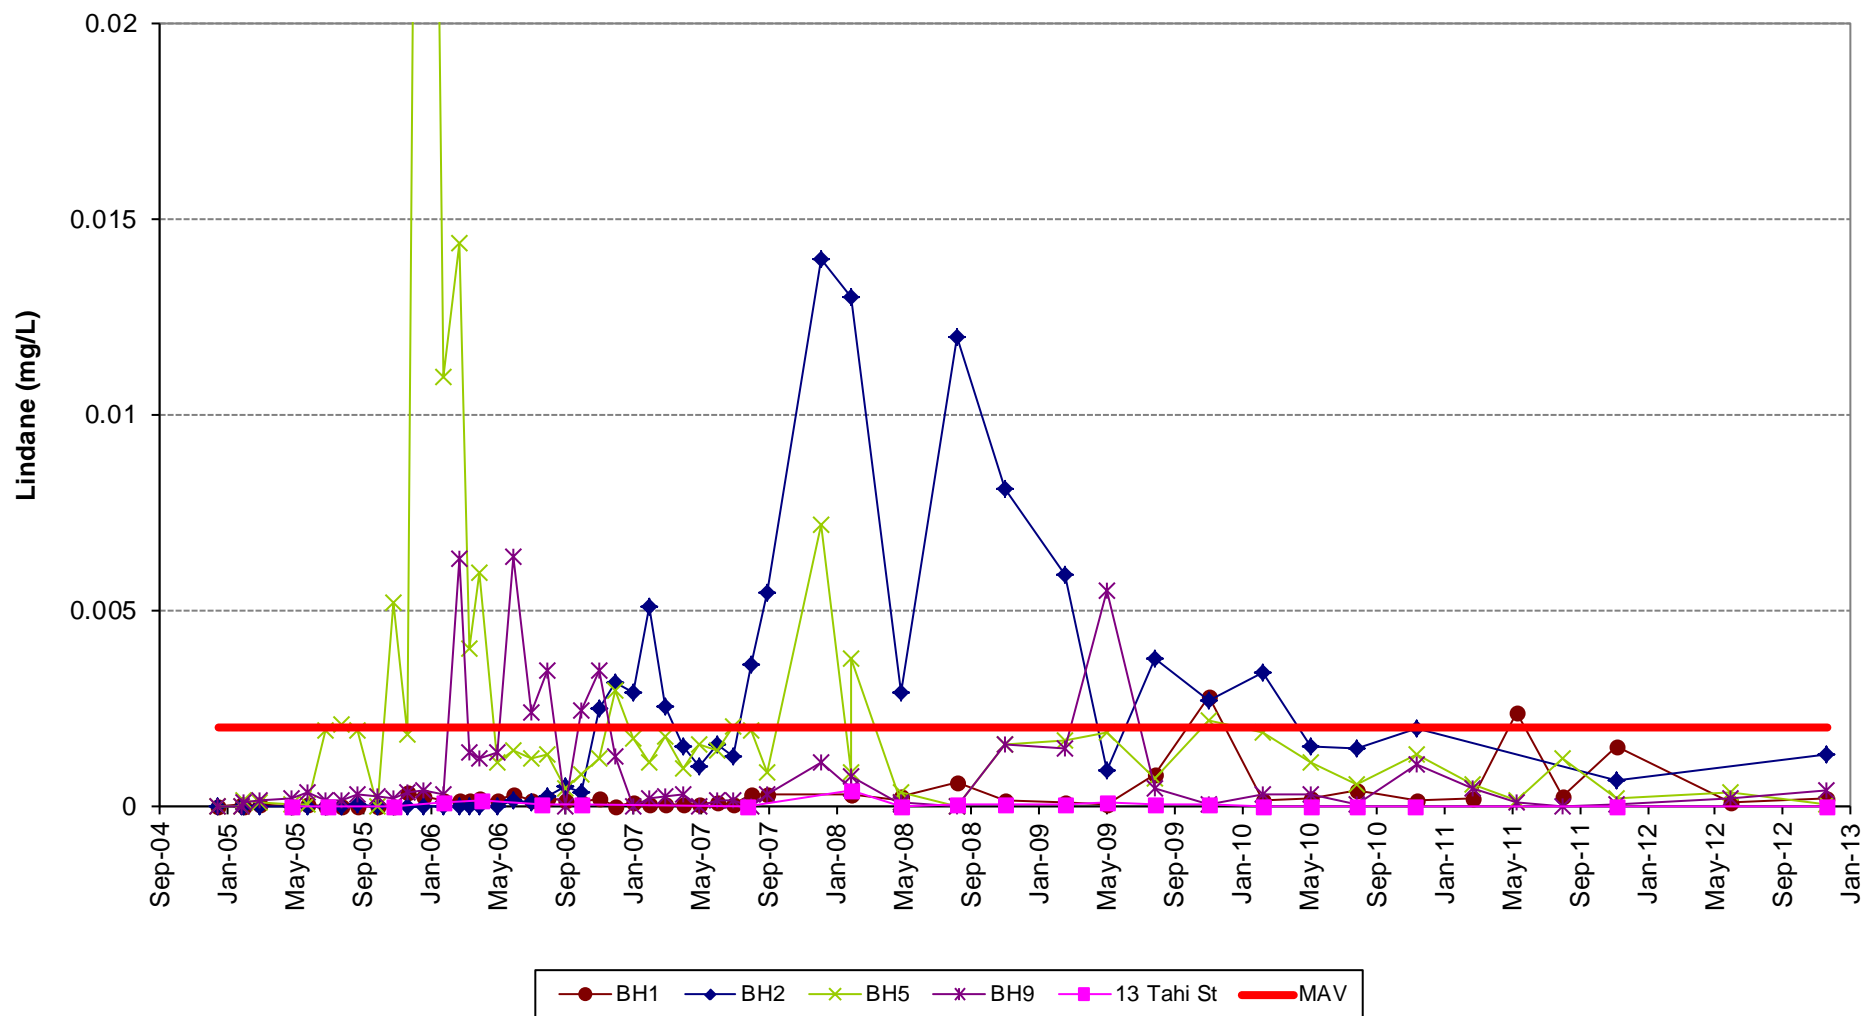
**Figure 7. Lindane**  
**MAV DWSNZ 0.002 mg/L**

Figure 7 shows lindane concentrations, which have decreased significantly since the remedial works and have been stable over the last year. All of the regularly sampled wells have concentrations below the MAV in the Drinking Water Standards (0.002 mg/L).

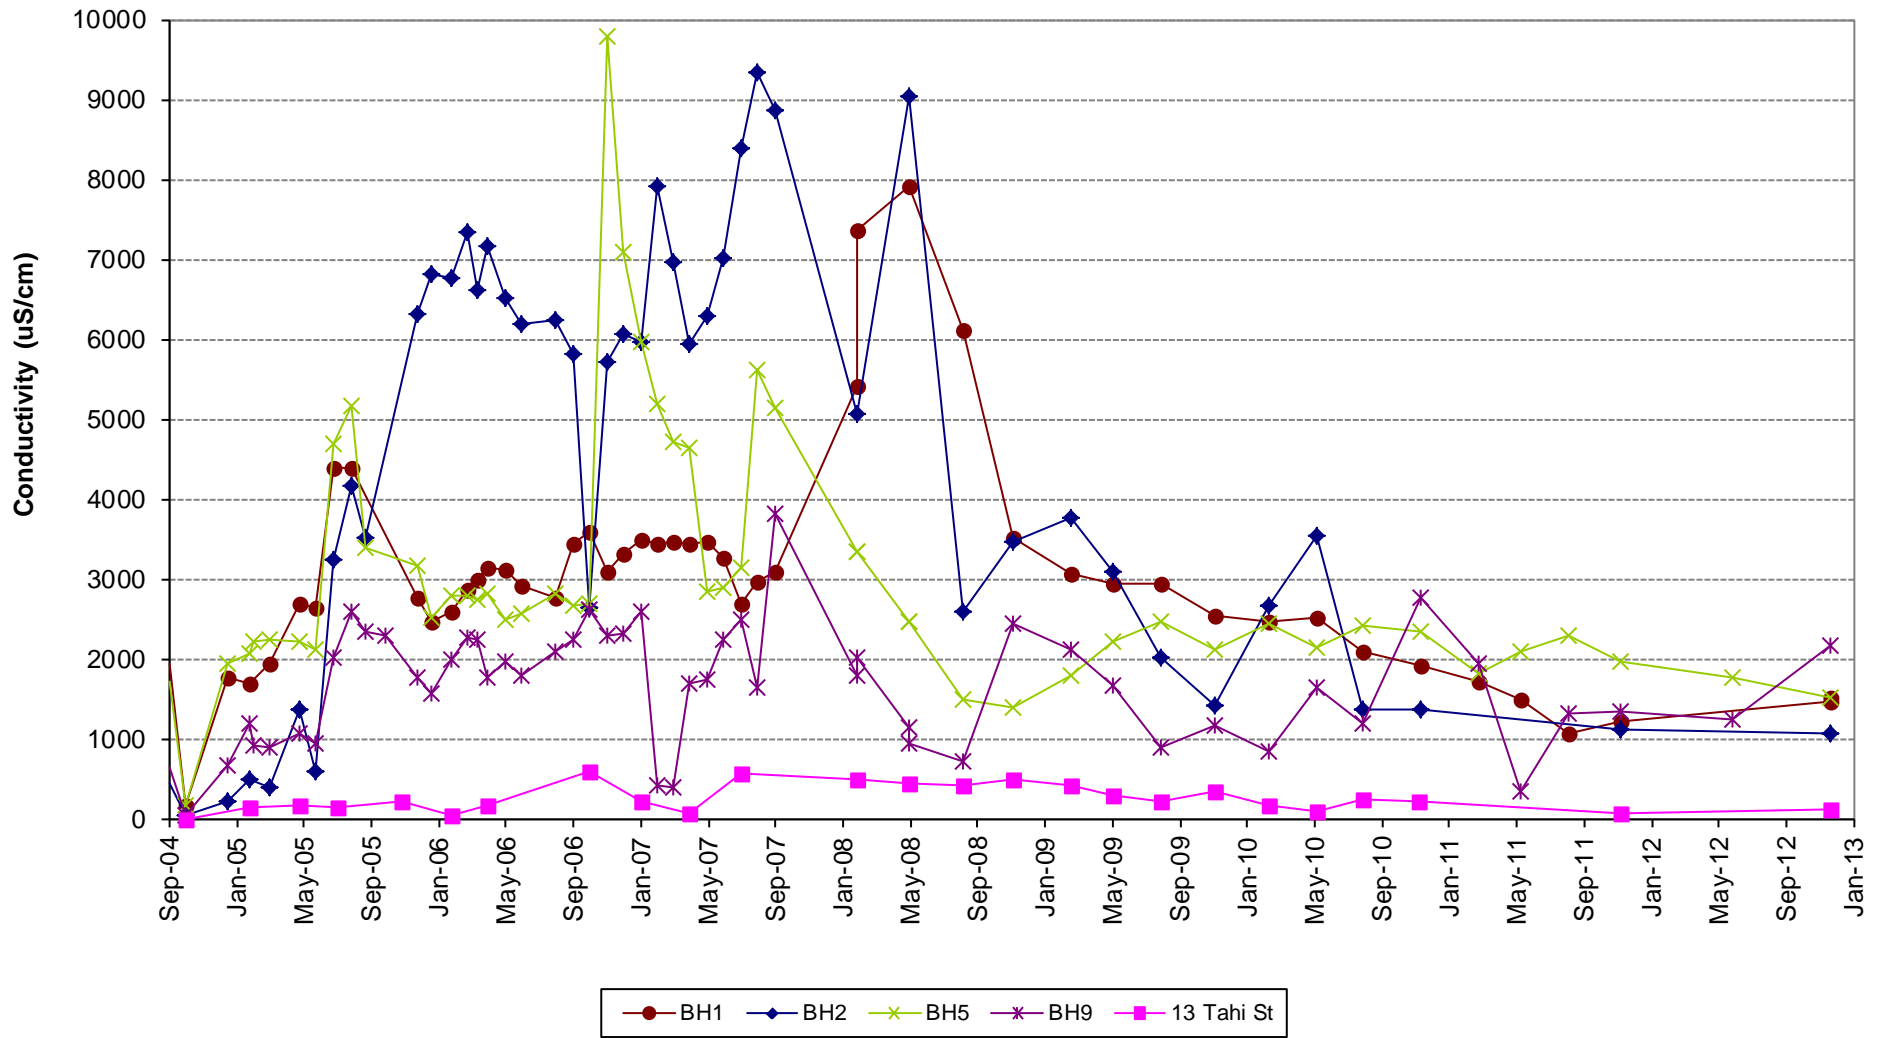
Figure 8. Conductivity

Figure 8 shows electrical conductivity values, which are a general indicator of all the chemicals dissolved in the water. These show a gradual decline in values, indicating a general improvement in groundwater quality beneath the site.

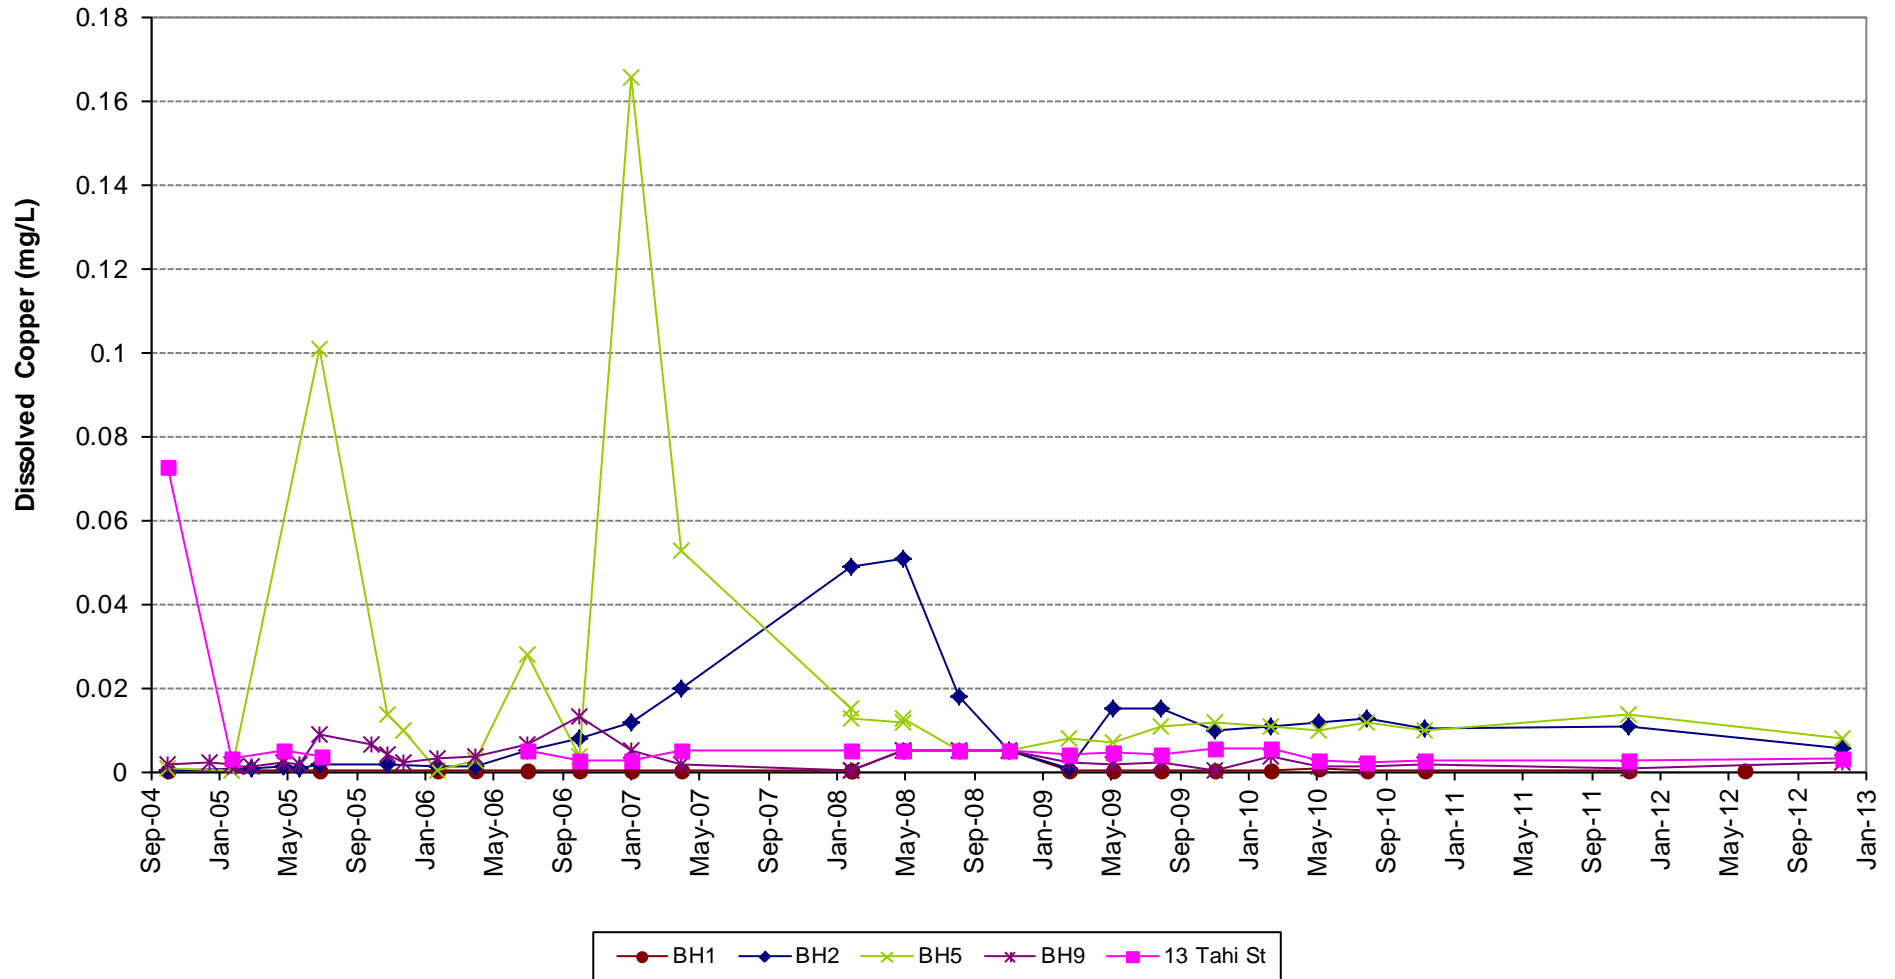
**Figure 9. Dissolved Copper**  
**MAV DWSNZ 2 mg/L, ANZECC Marine Guideline = 0.0013 mg/L**

Figure 9 shows dissolved copper concentrations. Copper was one of the reagents used in the MCD process. The results show stable concentrations with a gradual decline in levels in bores BH2 and BH5.

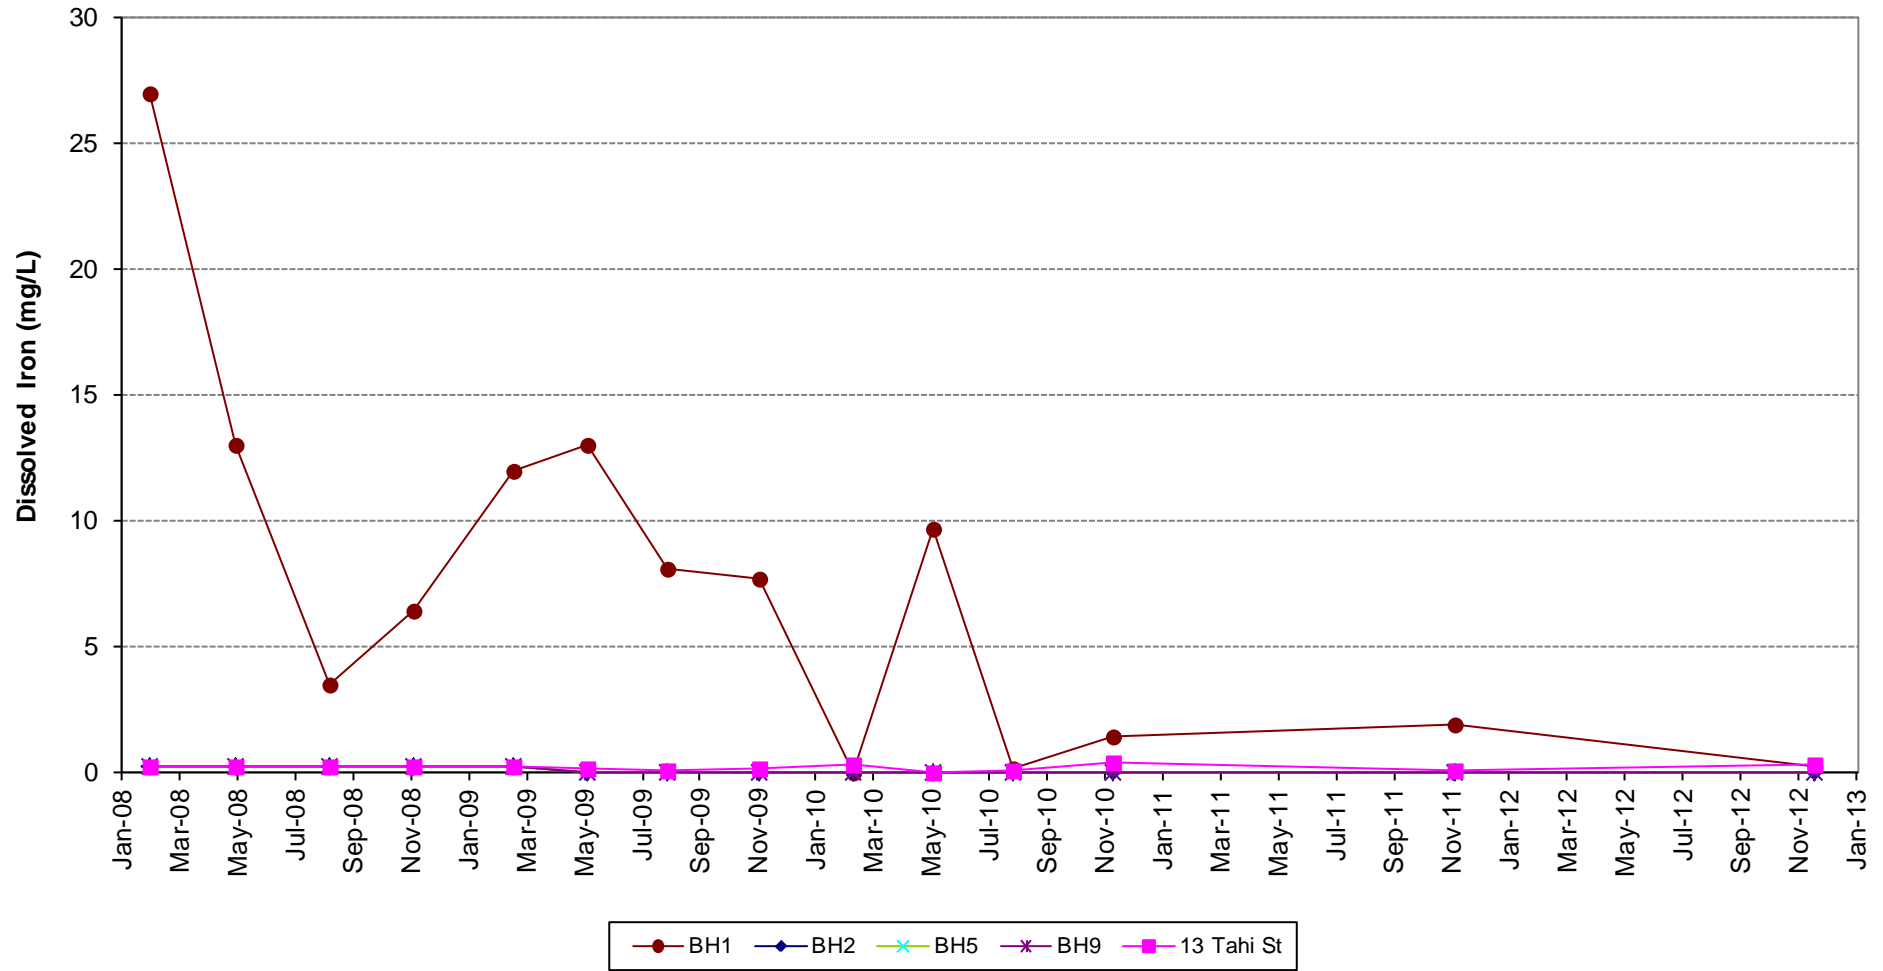
**Figure 10. Dissolved Iron**  
**Aesthetic Guideline Value DWSNZ 0.2 mg/L**

Iron was utilised in the MCD process, but has only been sampled since January 2008. The results are shown in Figure 10. During the November 2012 sampling round, dissolved iron was measured in BH1 (0.21 mg/L) and 13 Tahi St (0.32 mg/L). Dissolved iron was below the detection limit (0.02 mg/L) in the other three bores (BH2, BH5 and BH9).

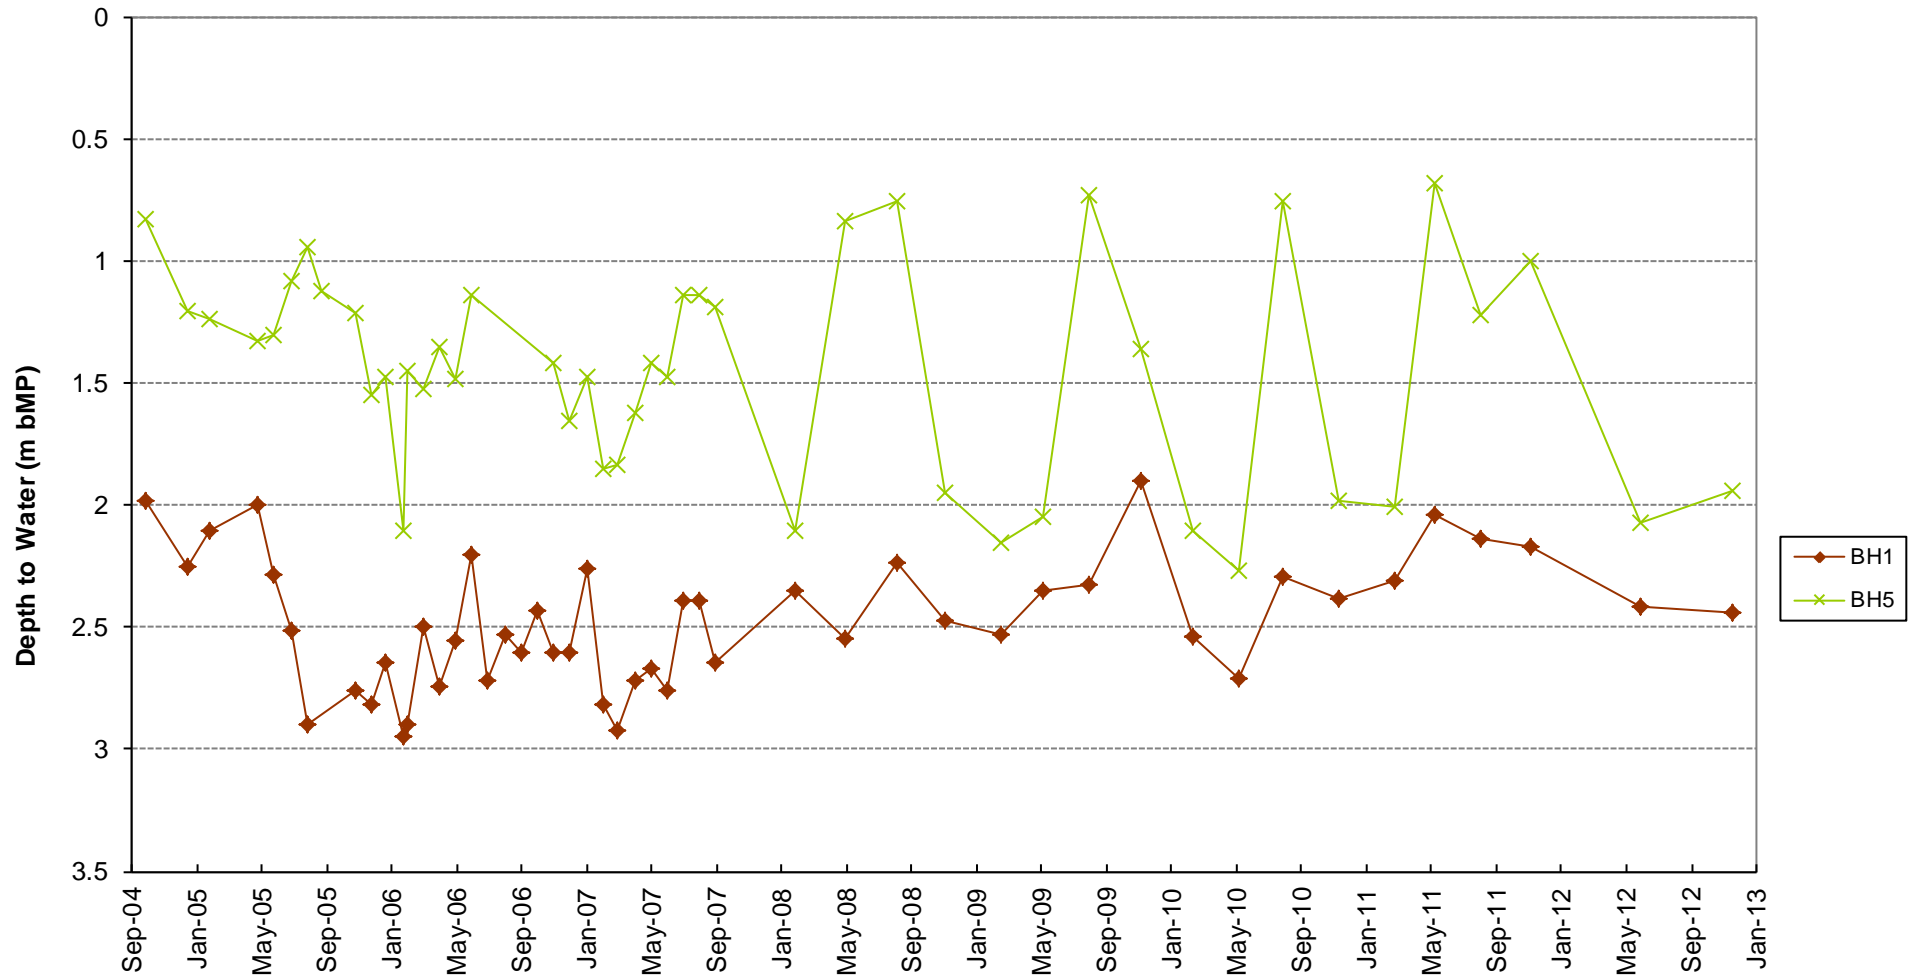
Figure 11. Water Level Plot

Figure 11 shows a plot of depth to water in bores BH1 and BH5. During the last year water levels have been at the lower end of their typical range in BH5, but have tended to be higher than average in BH1. Most chemical concentrations have been generally stable or shown a slight improving trend over the last year, with the exception of nitrate-N in BH9, DDX in BH1 and aldrin + dieldrin in BH2 and BH5. It is expected that the more significant fluctuations in these bores are related to groundwater level fluctuations causing two contrasting mechanisms to operate. At times of low groundwater level, there is less groundwater throughflow to dilute the on-site concentrations. At times of high groundwater levels there will be some areas of the site where groundwater inundates the treated fines, or where there has been a time of increased infiltration, resulting in increased leaching of chemicals.

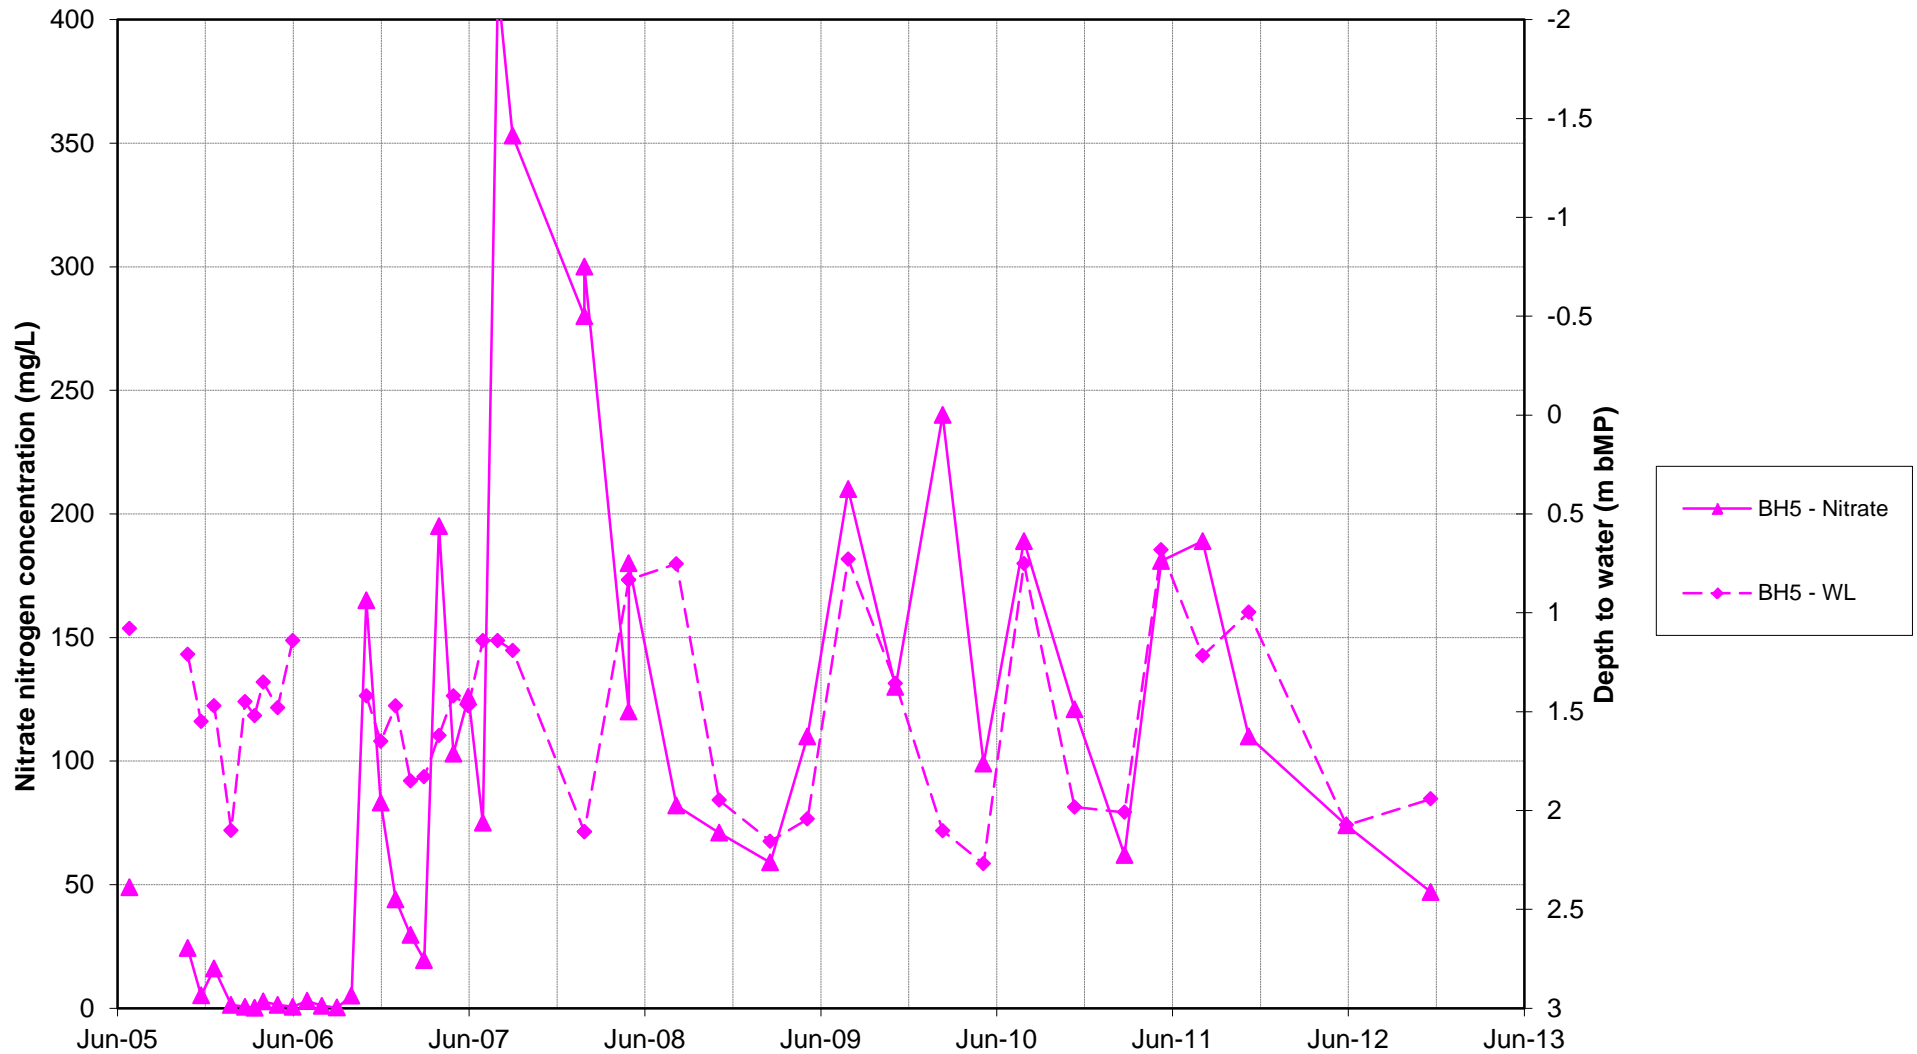
Figure 12. Nitrate vs Water Levels in BH5

Figure 12 shows the groundwater level and nitrate-N concentration in the bore showing the most significant fluctuations (BH5). Whilst water level fluctuations in this bore may be partly affected by the artificially placed bund and backfill material it does give an indication of the times of high and low groundwater levels. The resulting pattern in Figure 12 indicates a general pattern of increased nitrate at higher groundwater levels. Figures 13 and 14 show a more variable pattern for DDX and aldrin + dieldrin, with the peak concentrations sometimes coinciding with groundwater level peaks and the opposite pattern at other times, such as the more recent DDX data for BH5 in Figure 13.
