11 March 2013

Mr Glenn Stevens  
Tasman District Council  
Private Bag 4  
**RICHMOND 7050**

### **GROUNDWATER MONITORING AT FORMER FCC SITE, MAPUA – MARCH 2013 SAMPLING UPDATE**

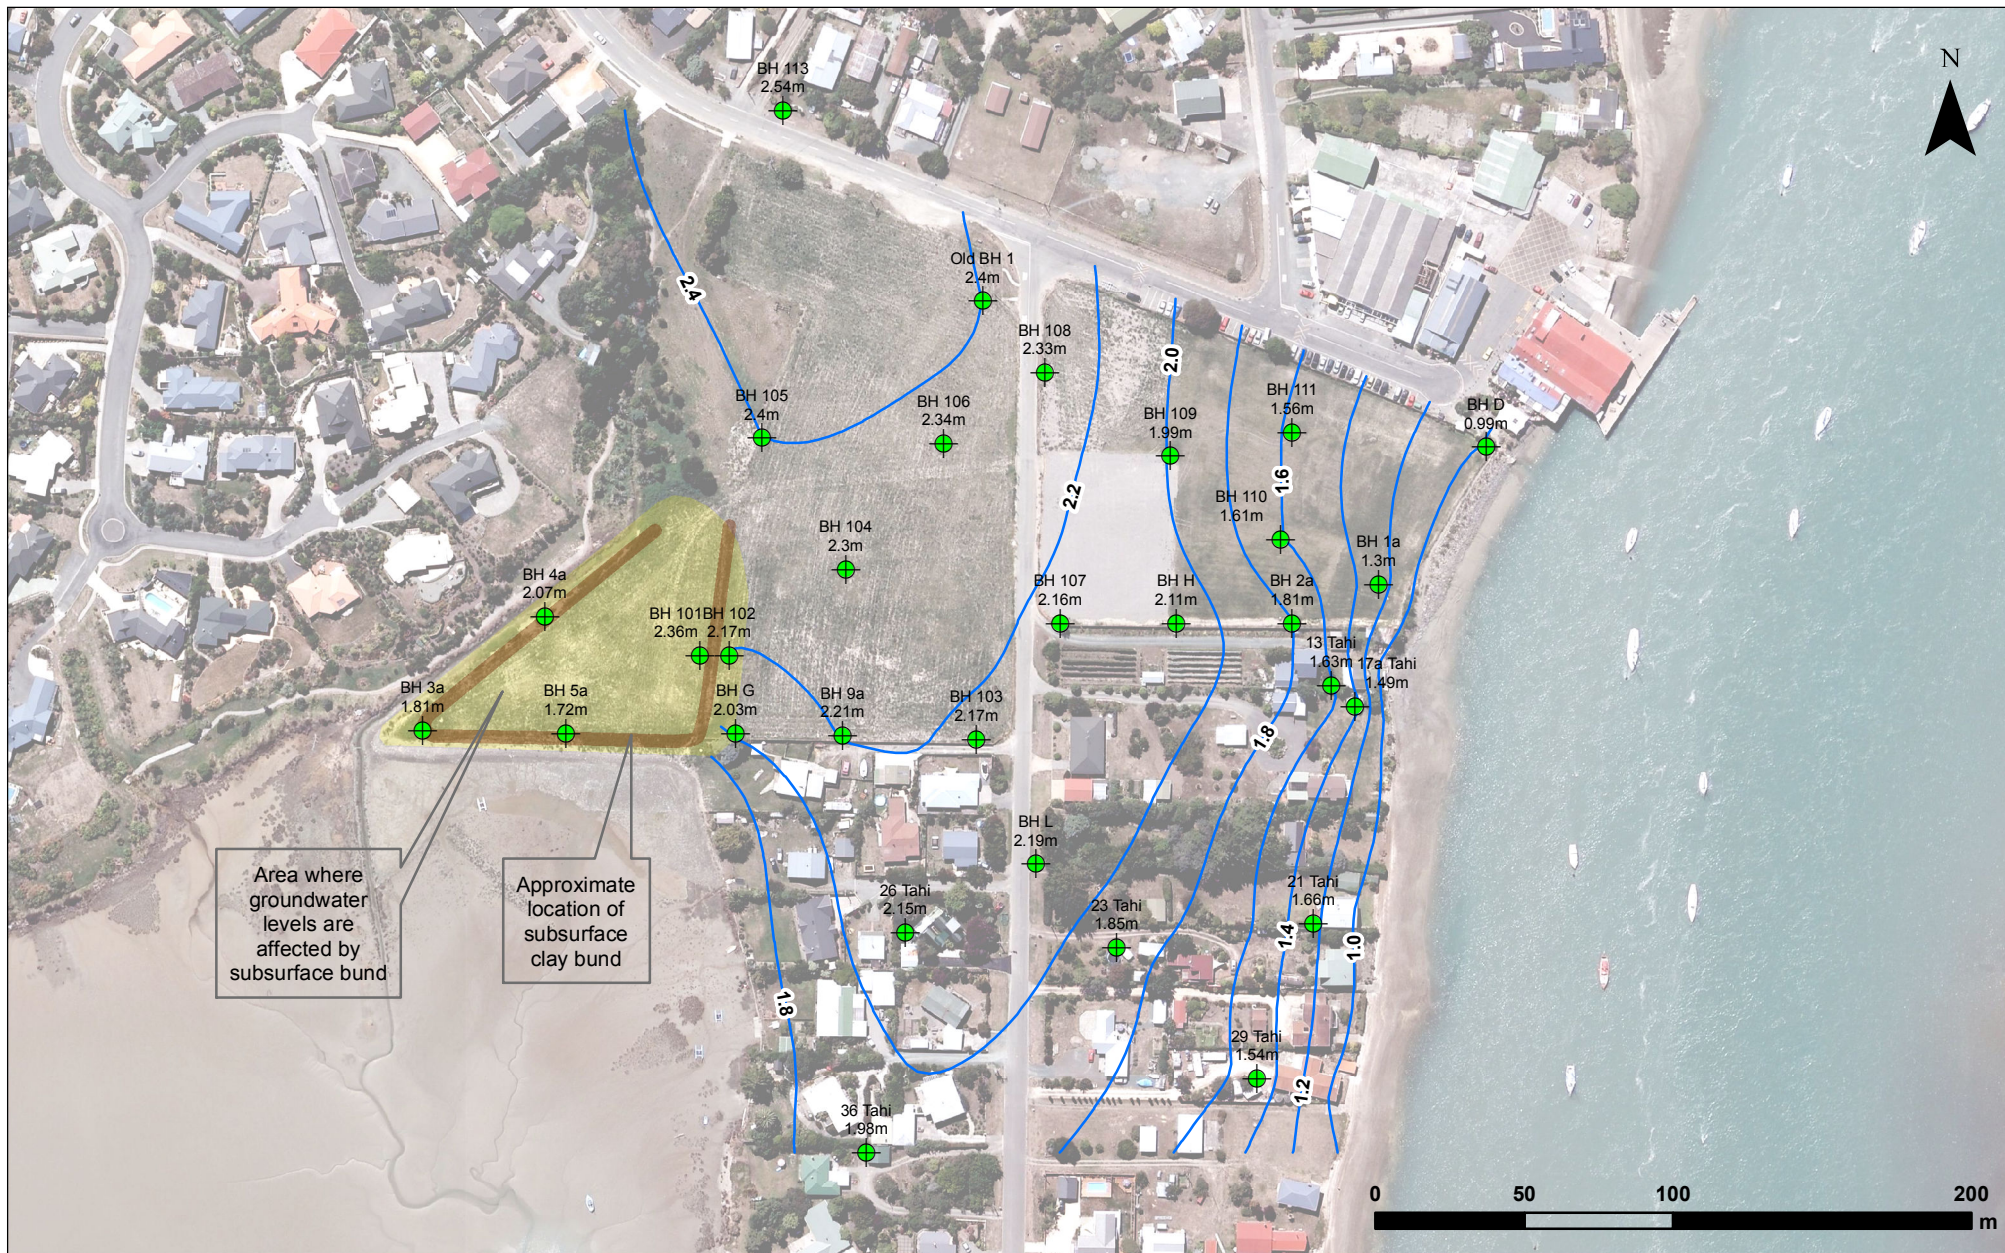
**Figure 15: Groundwater levels and contours on 19 November 2012 (values in metres above mean sea level)**

The elevation of the groundwater table within the on-site monitoring bores for the most recent monitoring round (19 November 2012) is plotted in Figure 15. The groundwater levels on 19 November 2012 are approximately 0.3 – 0.4 m lower than those recorded on 7 November 2011. Most of the groundwater discharges either to the Mapua channel to the east, or the Waimea Inlet to the south-west. The piezometric contours have not been extended into the bunded area, as the presence of the bund and the backfill material within it appear to have created some distorted groundwater level elevations within nearby bores.

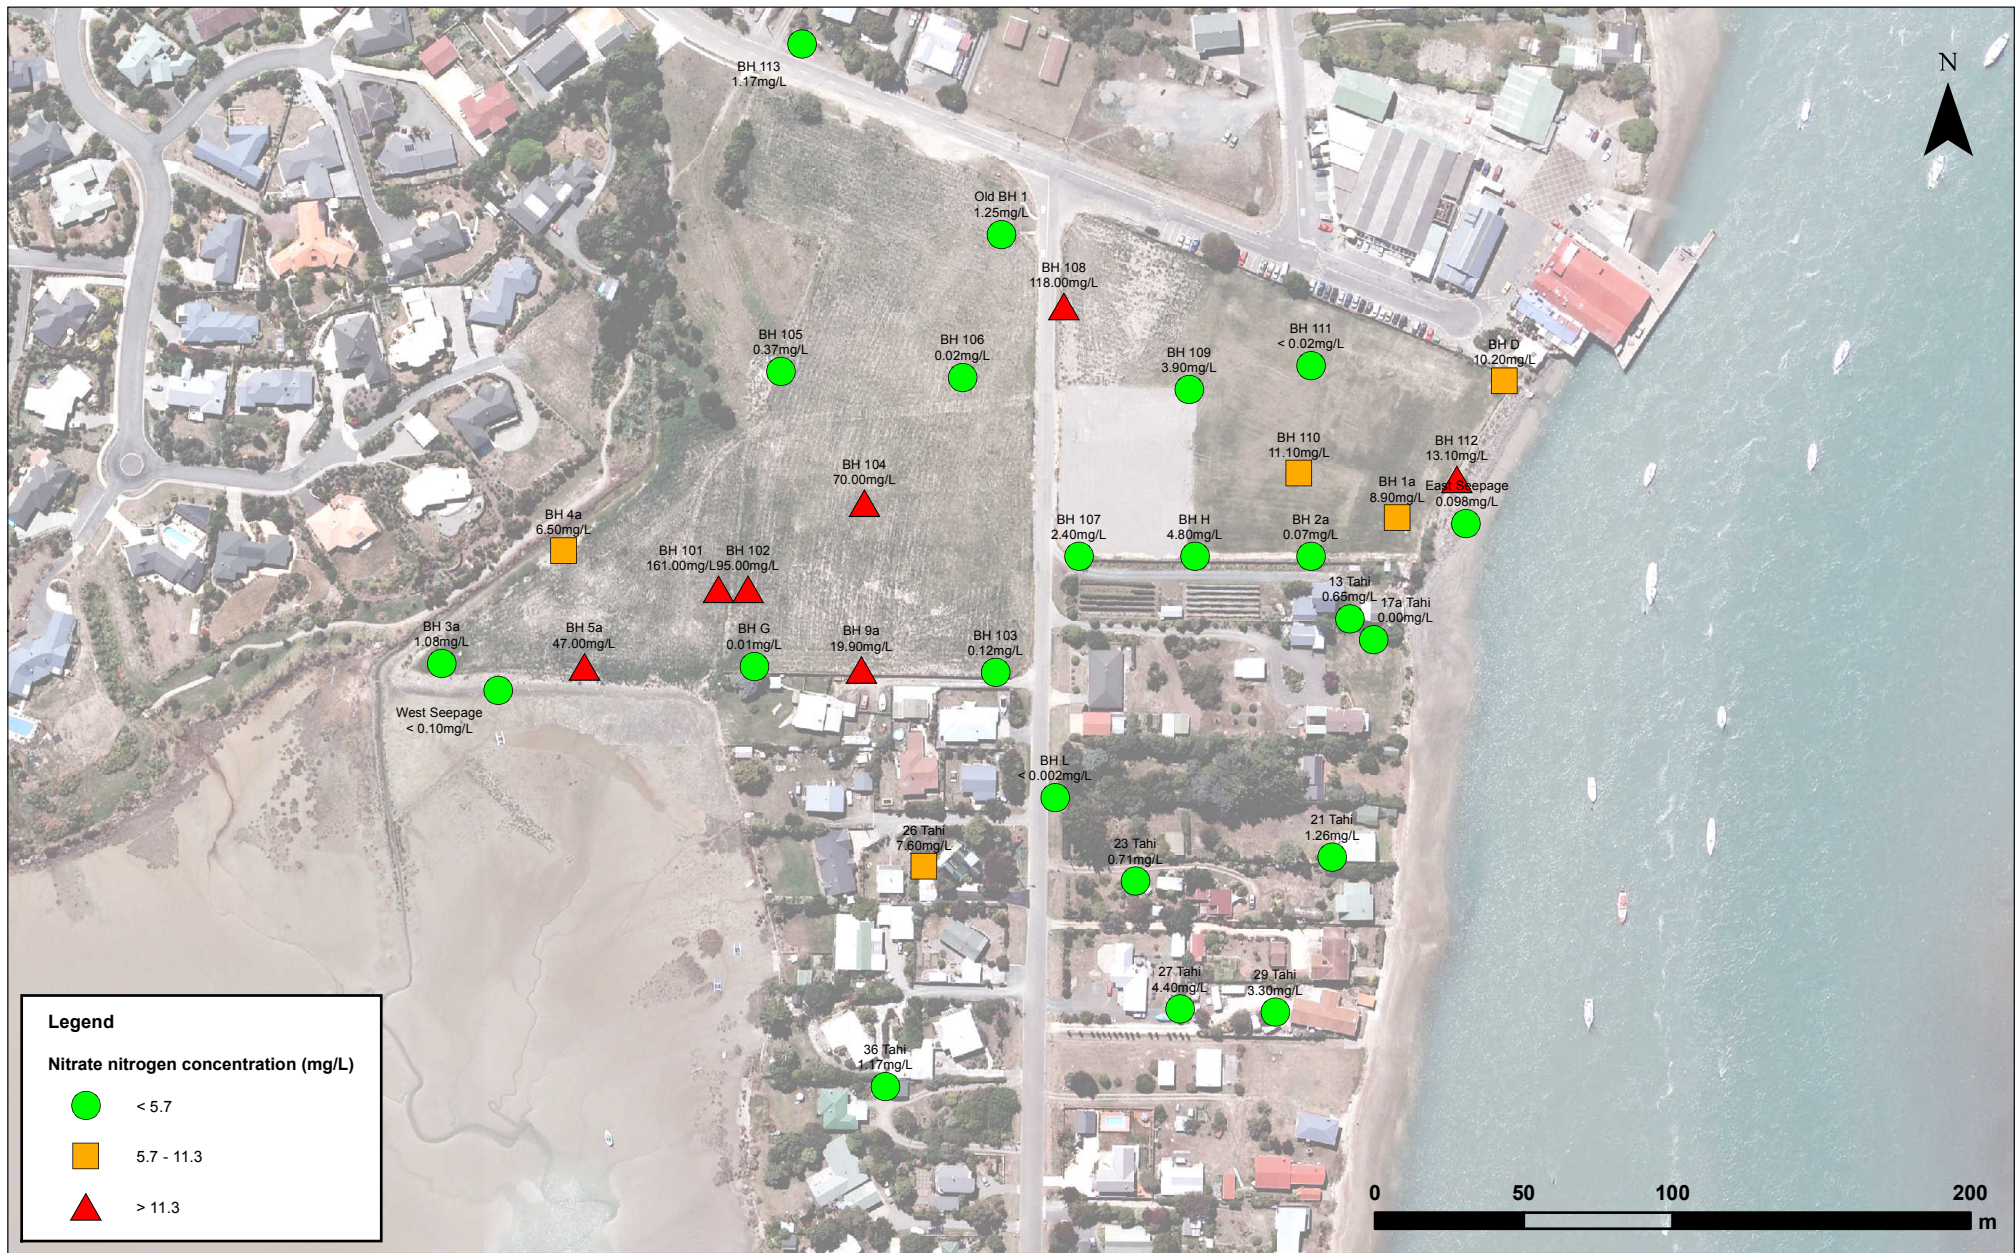
Figure 16: Nitrate nitrogen concentrations in November 2012

Comparing the individual borehole concentrations from the latest sampling round to the previous November 2011 results, most concentrations have reduced. In 2011, eight bores exceeded the MAV, down to seven in 2012. Five bores were within the half MAV bracket this year, down from six in 2011. The highest concentration (other than for bores BH101 and BH102) was recorded in bore BH108 (118 mg/L).

In our previous monitoring letter (dated March 2012), it was noted that of the domestic bores sampled, 26, 27 and 29 Tahi St had elevated concentrations (between 5.6 and 13.5 mg/L). In the latest November 2012 sampling round, the concentrations in all three of these bores had dropped by about half (to between 3.3 – 7.6 mg/L).

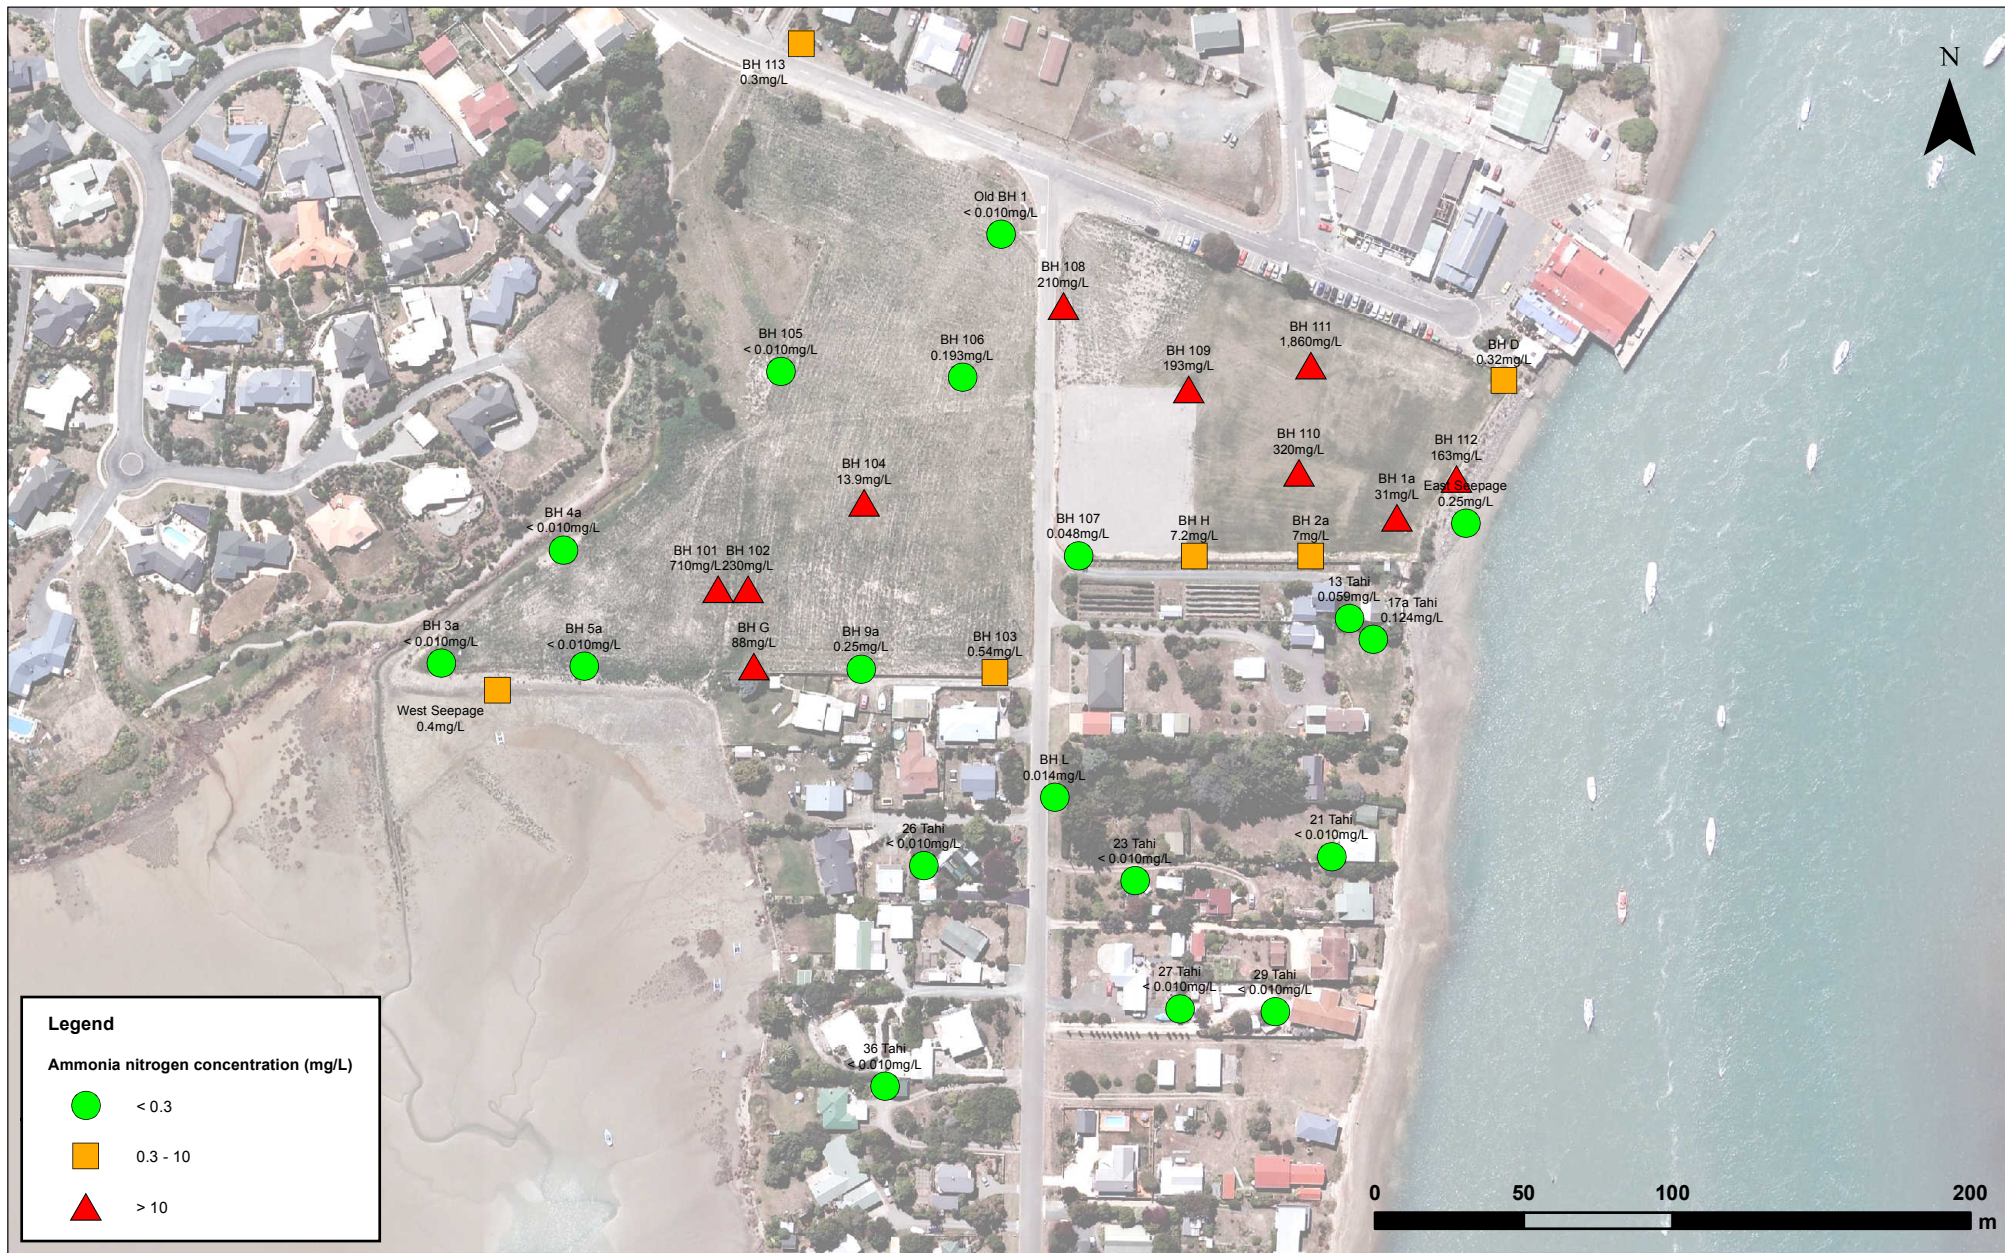
**Figure 17: Ammonia nitrogen concentrations in November 2012**

Comparing to the November 2011 results, there has been no consistent change with some bores showing higher and others showing lower concentrations. The current results show elevated concentrations occur in both the east, around bore BH111 (1,860 mg/L in November 2012, up from 1,010 mg/L in November 2011), and west of the site, around bore BHG (88 mg/L in November 2012, up from 14.6 mg/L in November 2011). The ammonia-N concentrations indicate some areas of the site have significantly higher concentrations than the values measured in the regularly monitored bores.

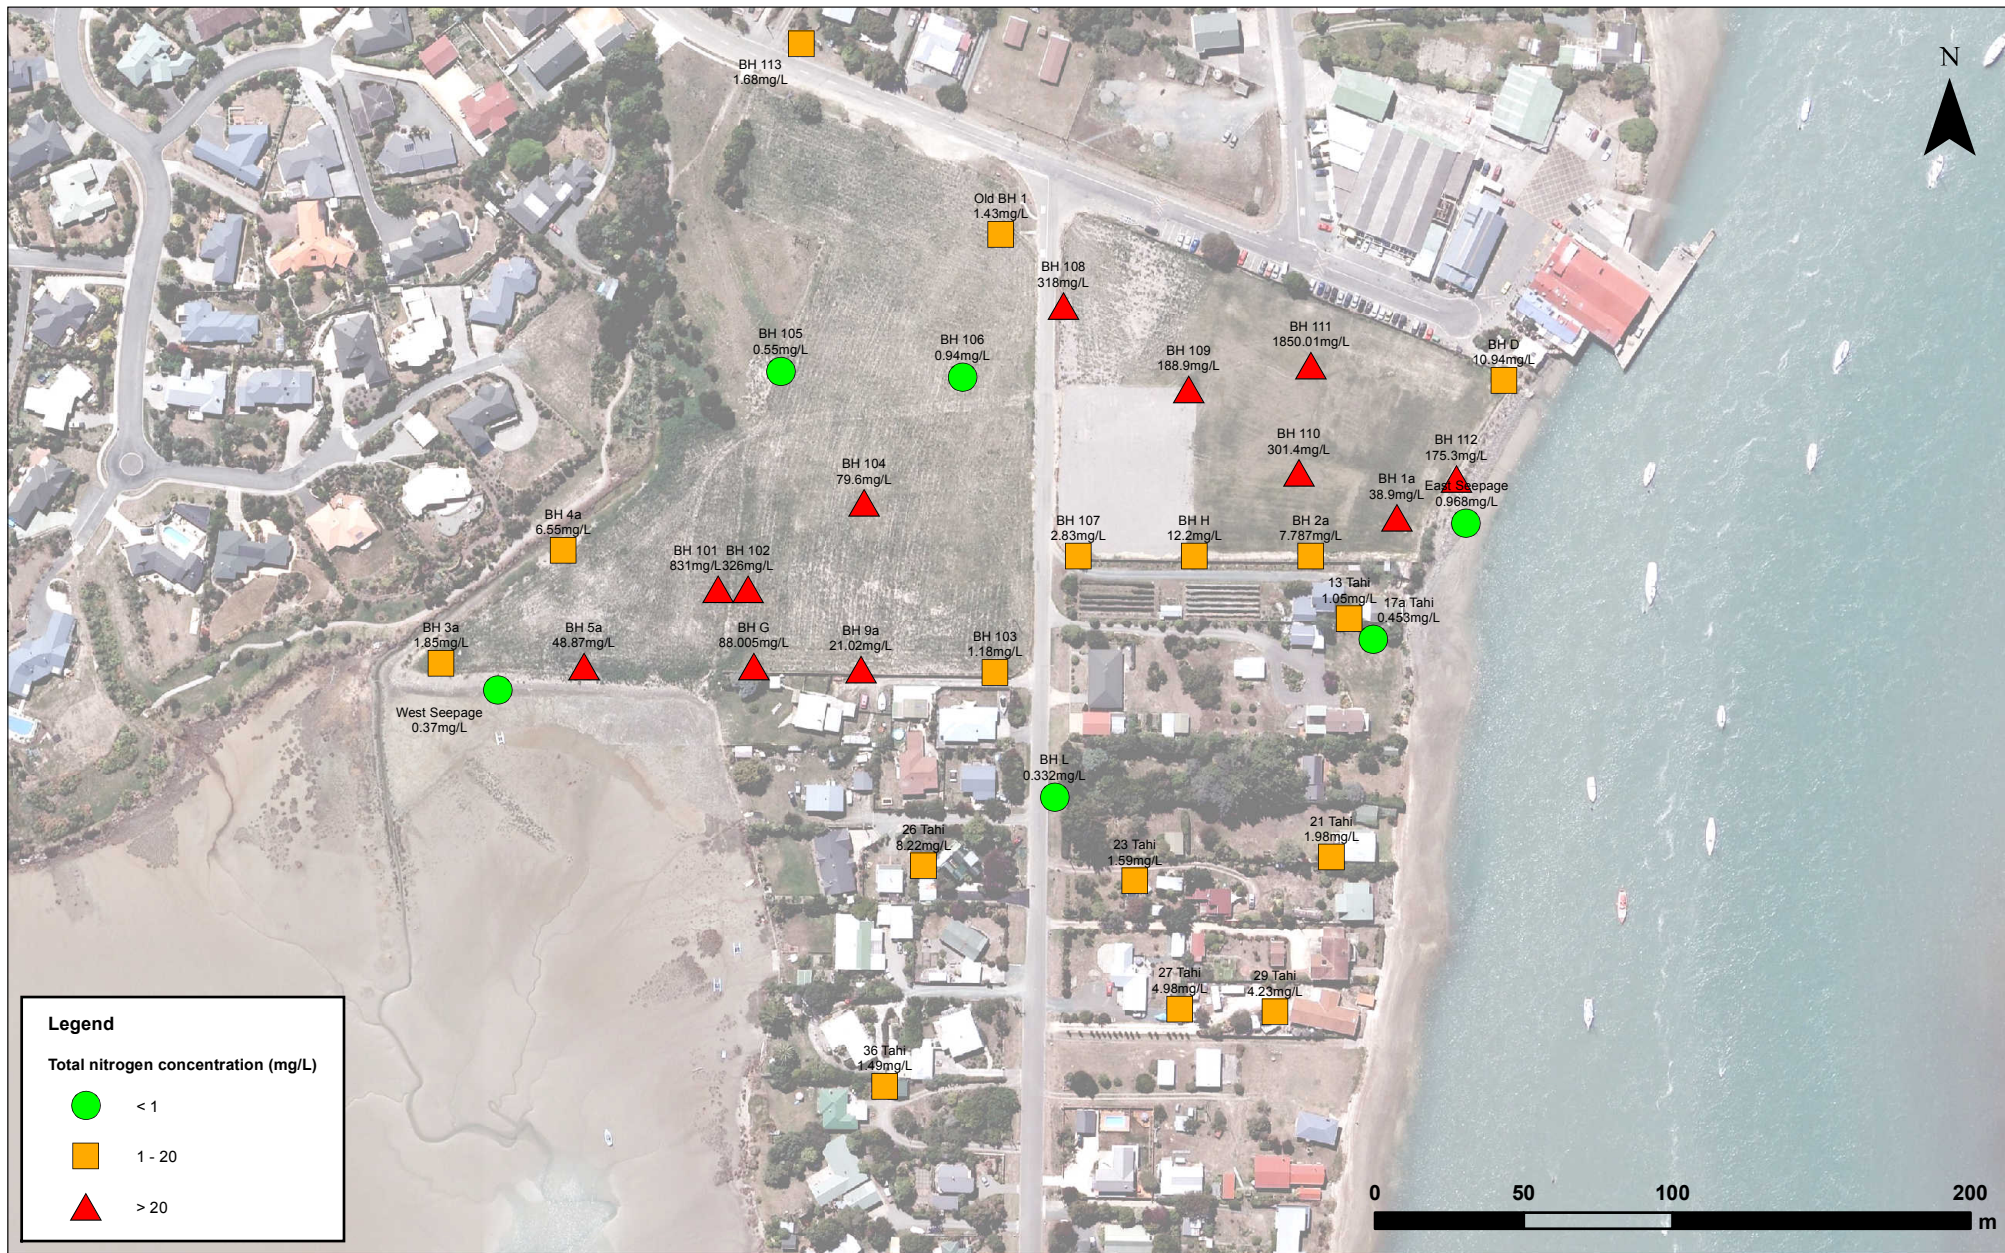
**Figure 18: Total nitrogen concentrations in November 2012**

All of the wells tested showed total nitrogen levels above the ANZECC guideline values. The spatial distribution trends for total nitrogen are the same as those for ammoniacal nitrogen with elevated concentrations occurring in both the east, around bore BH111 (1,850 mg/L in November 2012, up from 980 mg/L in November 2011), and west of the site, around bore BHG (88 mg/L in November 2012, up from 13 mg/L in November 2011).

Samples taken at the East and West Seepage locations (0.97 and 0.37 mg/L respectively) are close to but above the ANZECC guideline value for marine waters (0.12 mg/L).

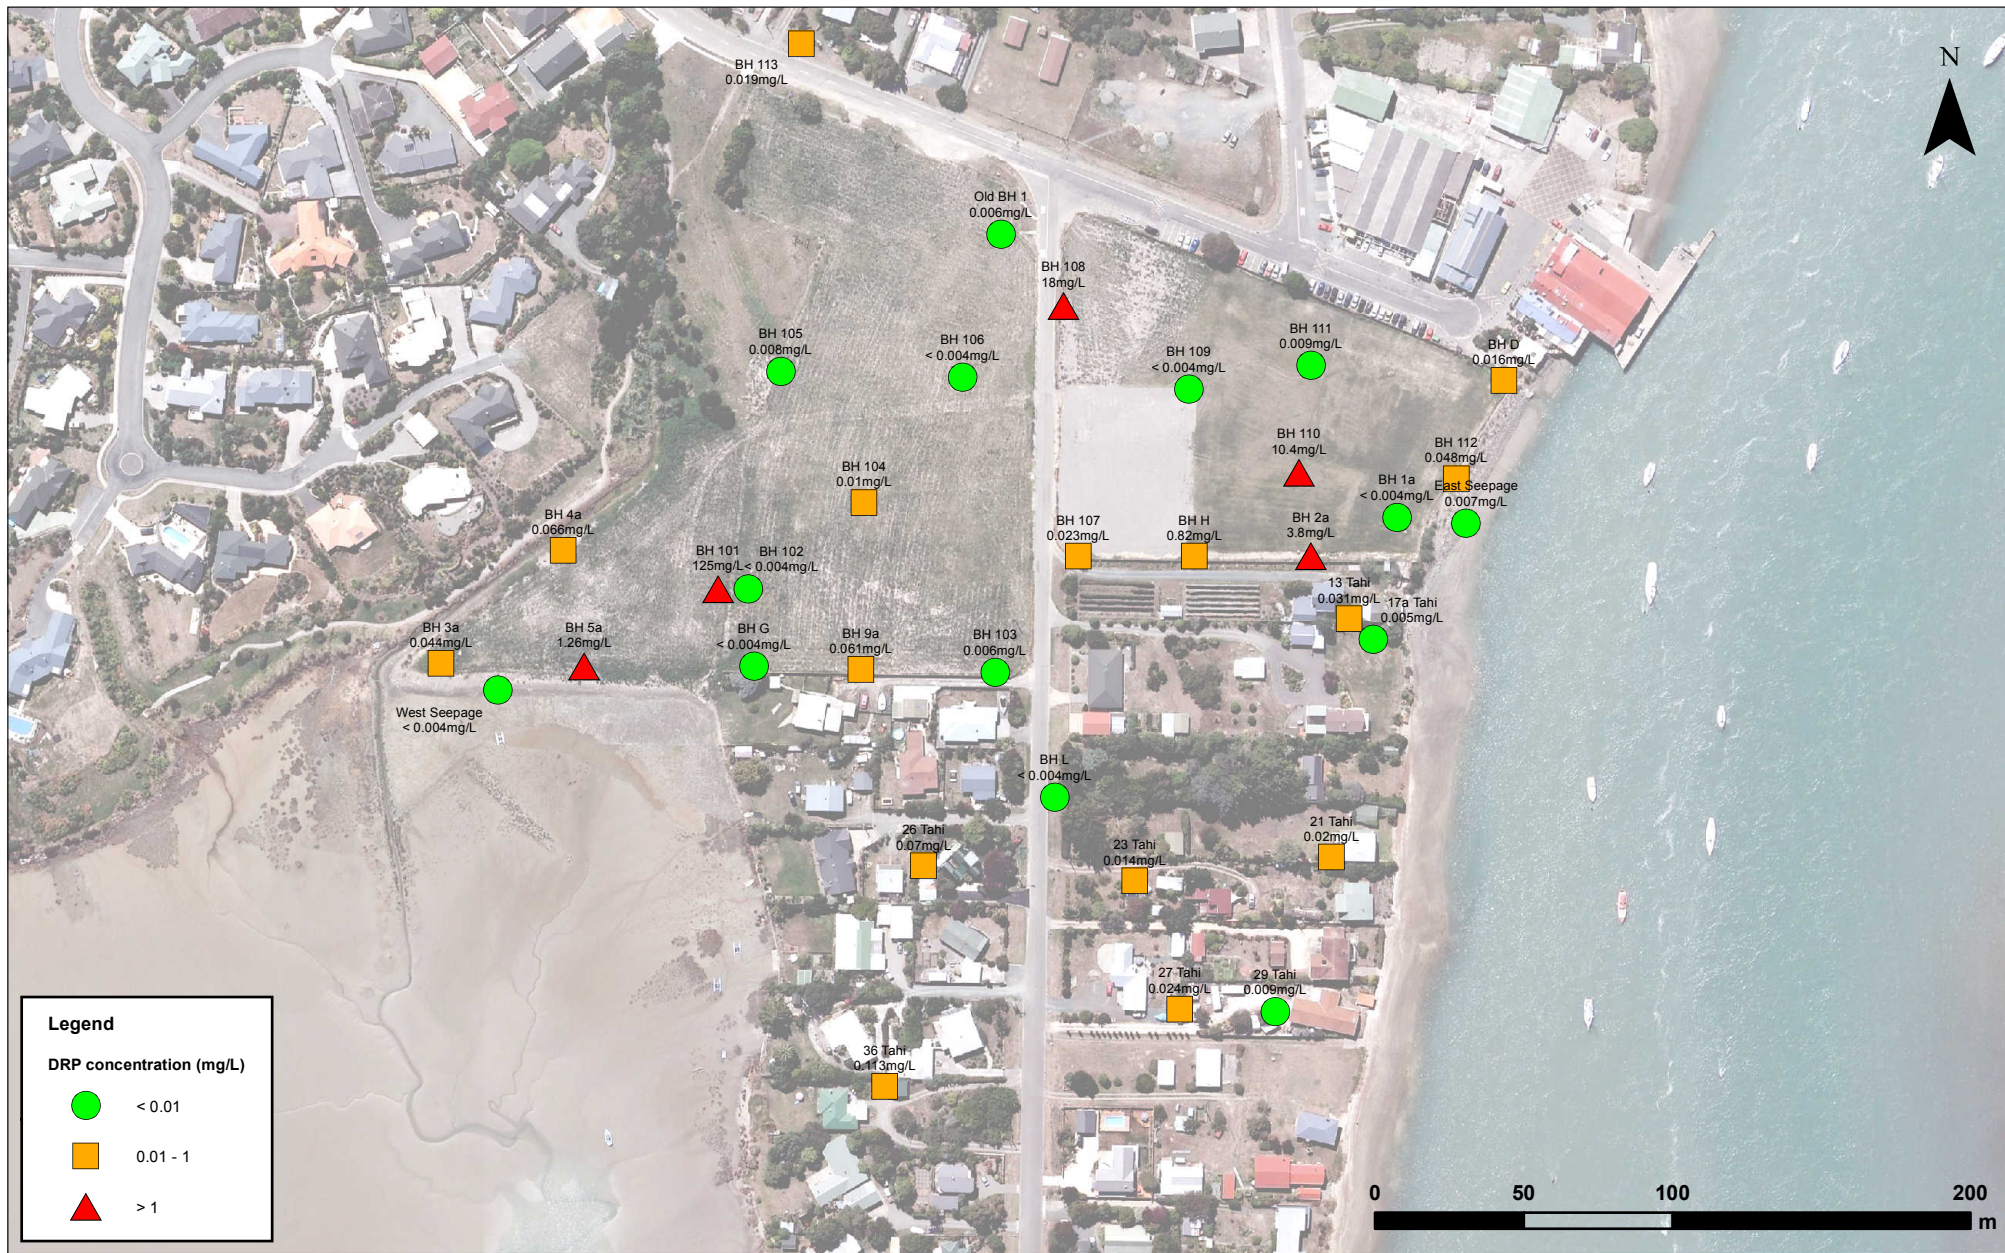
**Figure 19: Dissolved reactive phosphorus concentrations in November 2012**

Concentrations are generally lower than the concentrations in November 2011. The number of wells classified red has reduced from six to five, the number of wells classified orange has reduced from eighteen to fifteen and the number of wells classified green has increased from eight to twelve compared to November 2011. However, there continue to be some bores showing localised high concentrations (e.g. 18 mg/L in BH108, up from 13.7 mg/L in November 2011).

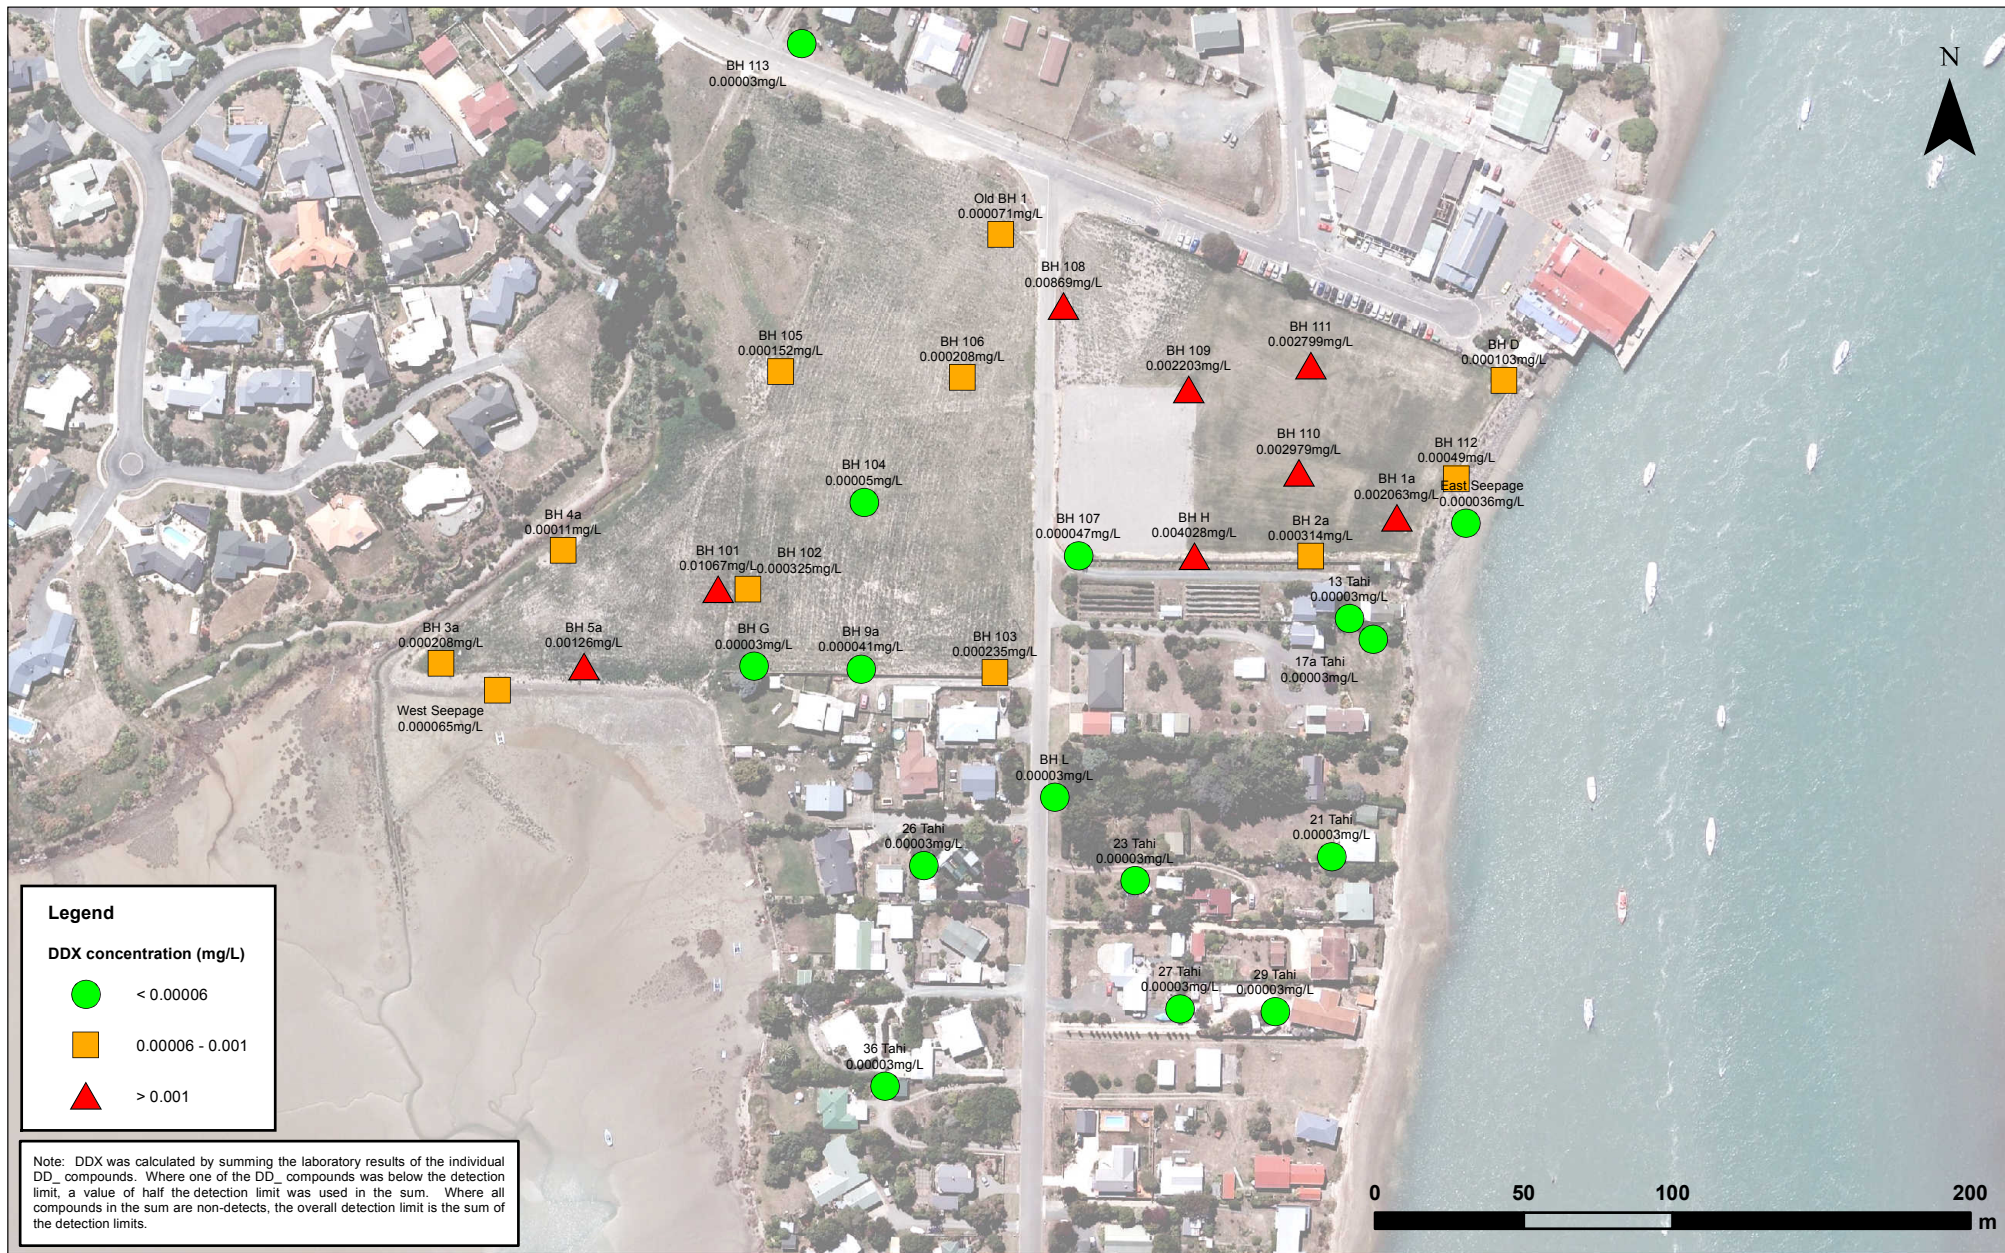
**Figure 20: DDX concentrations in November 2012**

Most of the wells are classified the same (green, orange or red) compared to the November 2011 results. There continues to be no detectable DDX in any of the private wells in the residential areas to the south and north of the site. DDX was detected in the west seepage sample, but the concentration (0.000065 mg/L) was well below the MAV in the Drinking Water Standards and very close to the detection limit (0.00006 mg/L). The variation in concentrations within the site is most likely due to the localised effects of soils with elevated DDX concentrations.

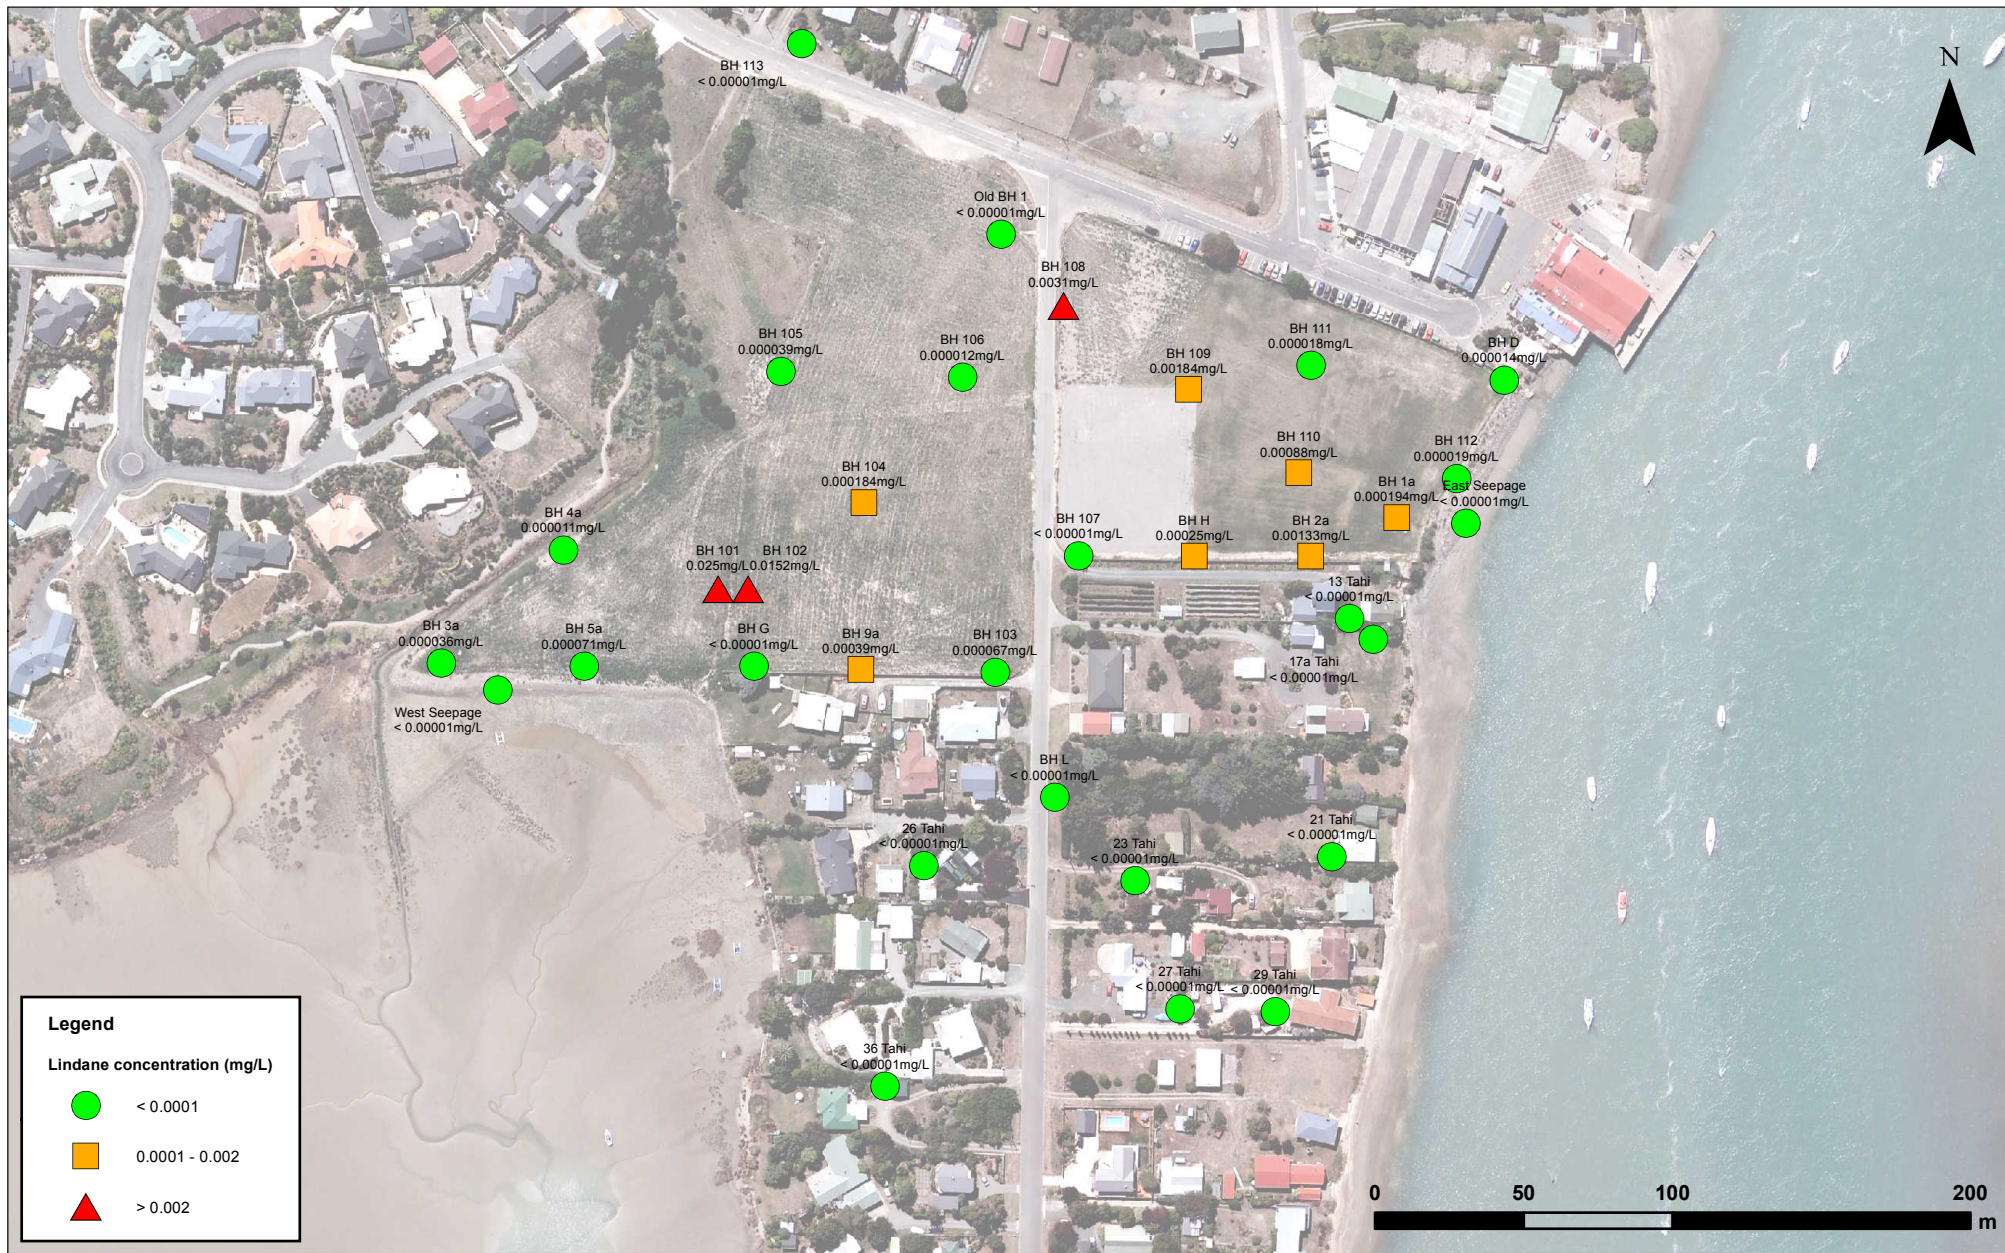
**Figure 22: Lindane concentrations in November 2012**

There has been no consistent change since November 2011, with some bores showing increased concentrations and others showing lower concentrations. The results show elevated concentrations occurring to the east of the site. With the exception of bores BH101 and BH102 in the clay bund, only BH108 (0.0031 mg/L up from 0.00199 mg/L in November 2011) registered lindane levels in exceedence of the MAV in the Drinking Water Standards.

In previous sampling rounds, low levels of lindane were detected in some off-site boreholes, although subsequent checking by TDC indicated that this was due to residual lindane within the tubing used to collect the samples rather than in the boreholes themselves. The sampling procedures have been altered to rectify this problem, although a lindane concentration of 0.000033 mg/L was reported in the rinsate blank collected during the November 2012 sampling, indicating some cross-contamination is still occurring. The low concentration detected should not influence the interpretation of the patterns shown in Figure 22.

Lindane was not detected in any of the domestic bores in the November 2012 samples.

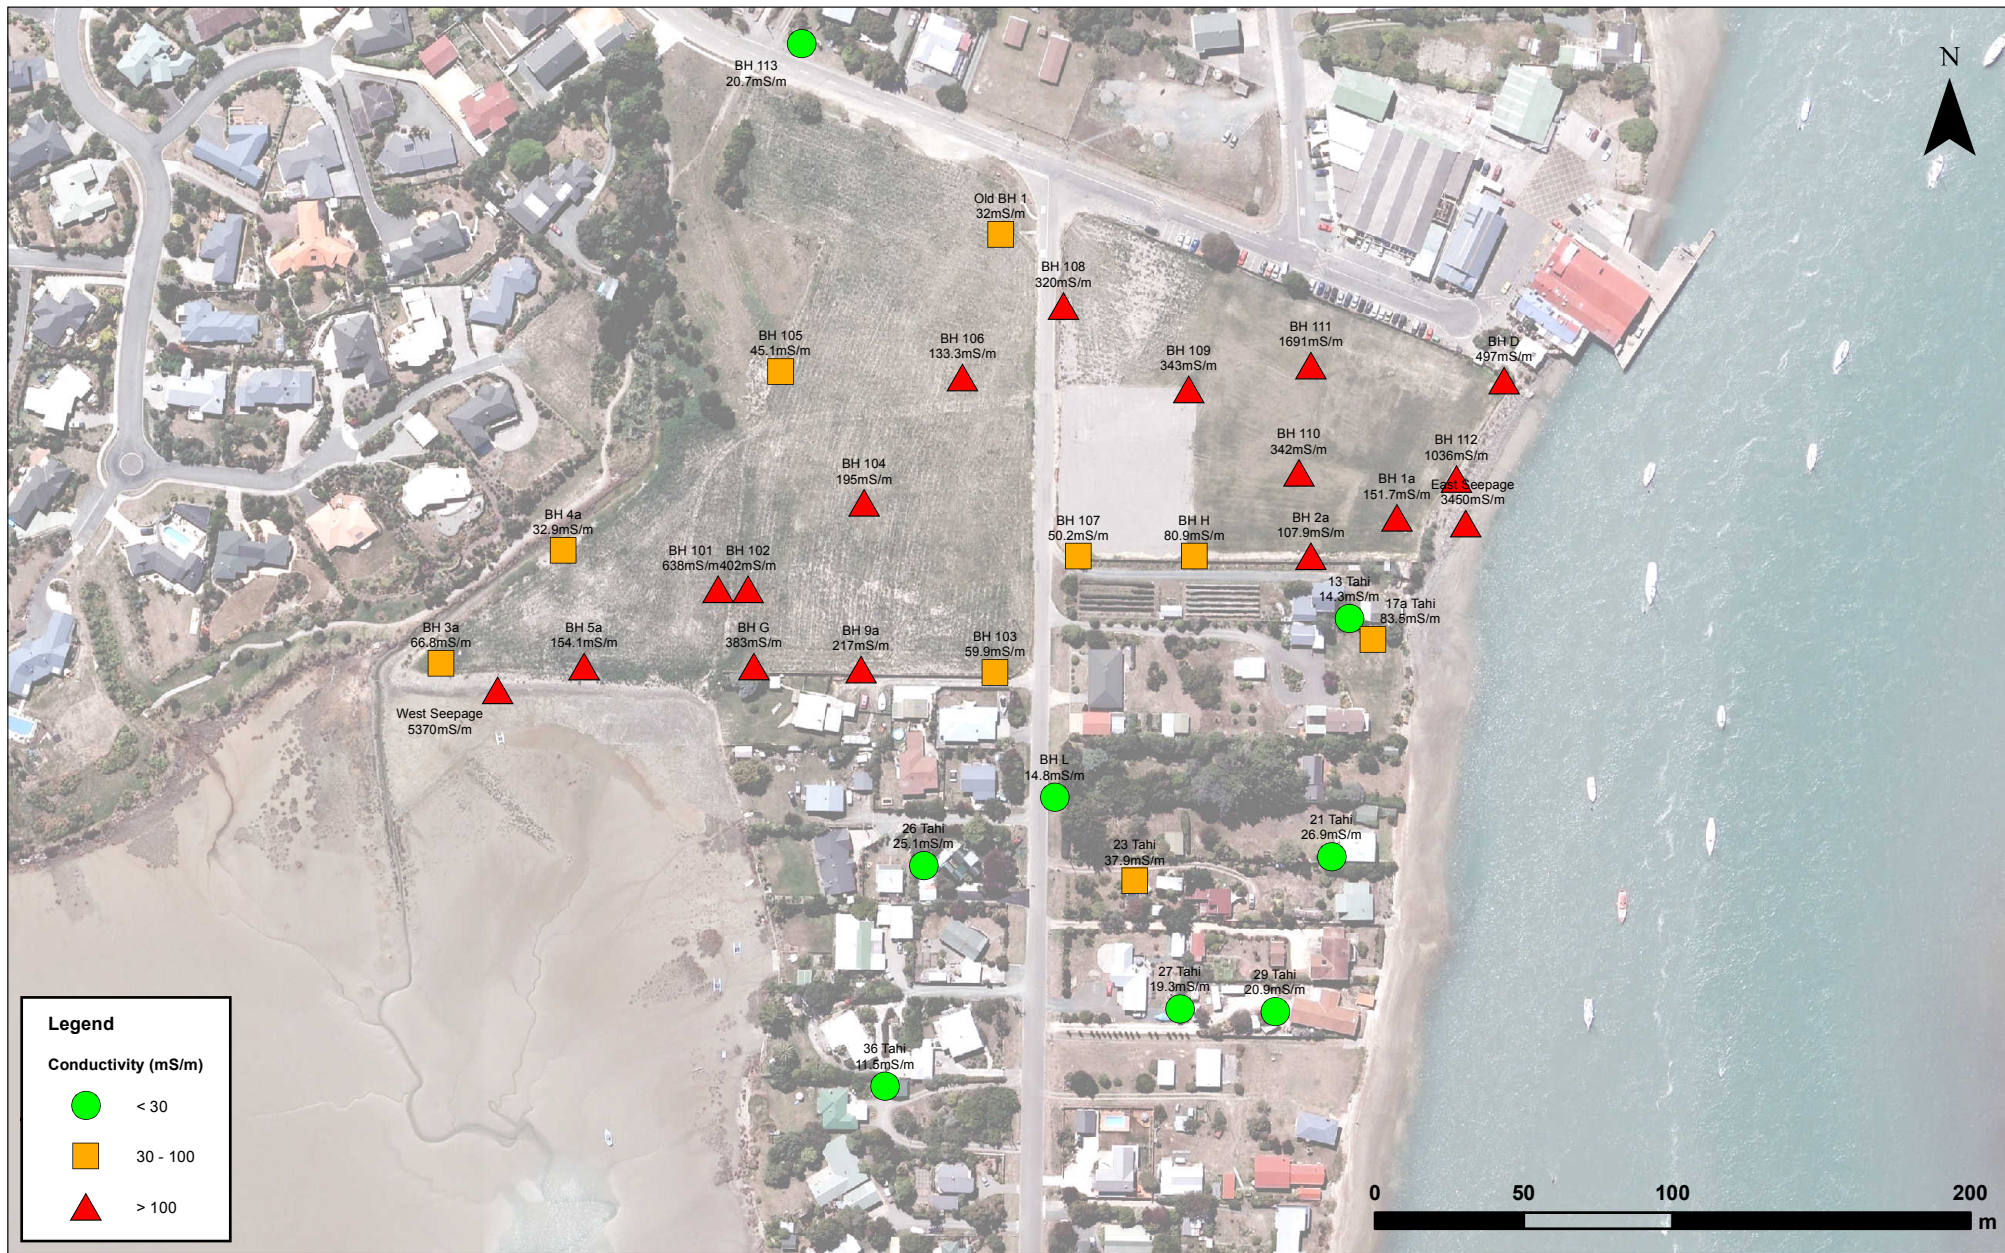
**Figure 23: Conductivity values in November 2012**

This plot shows the pattern of values beneath the site, with the highest groundwater conductivity value recorded at bore BH111 (1,691 mS/m in November 2012 up from 1,060 mS/m in November 2011). The values show a similar pattern to those measured in November 2011.
