11 March 2013

Mr Glenn Stevens  
Tasman District Council  
Private Bag 4  
**RICHMOND 7050**

### **GROUNDWATER MONITORING AT FORMER FCC SITE, MAPUA – MARCH 2013 SAMPLING UPDATE**

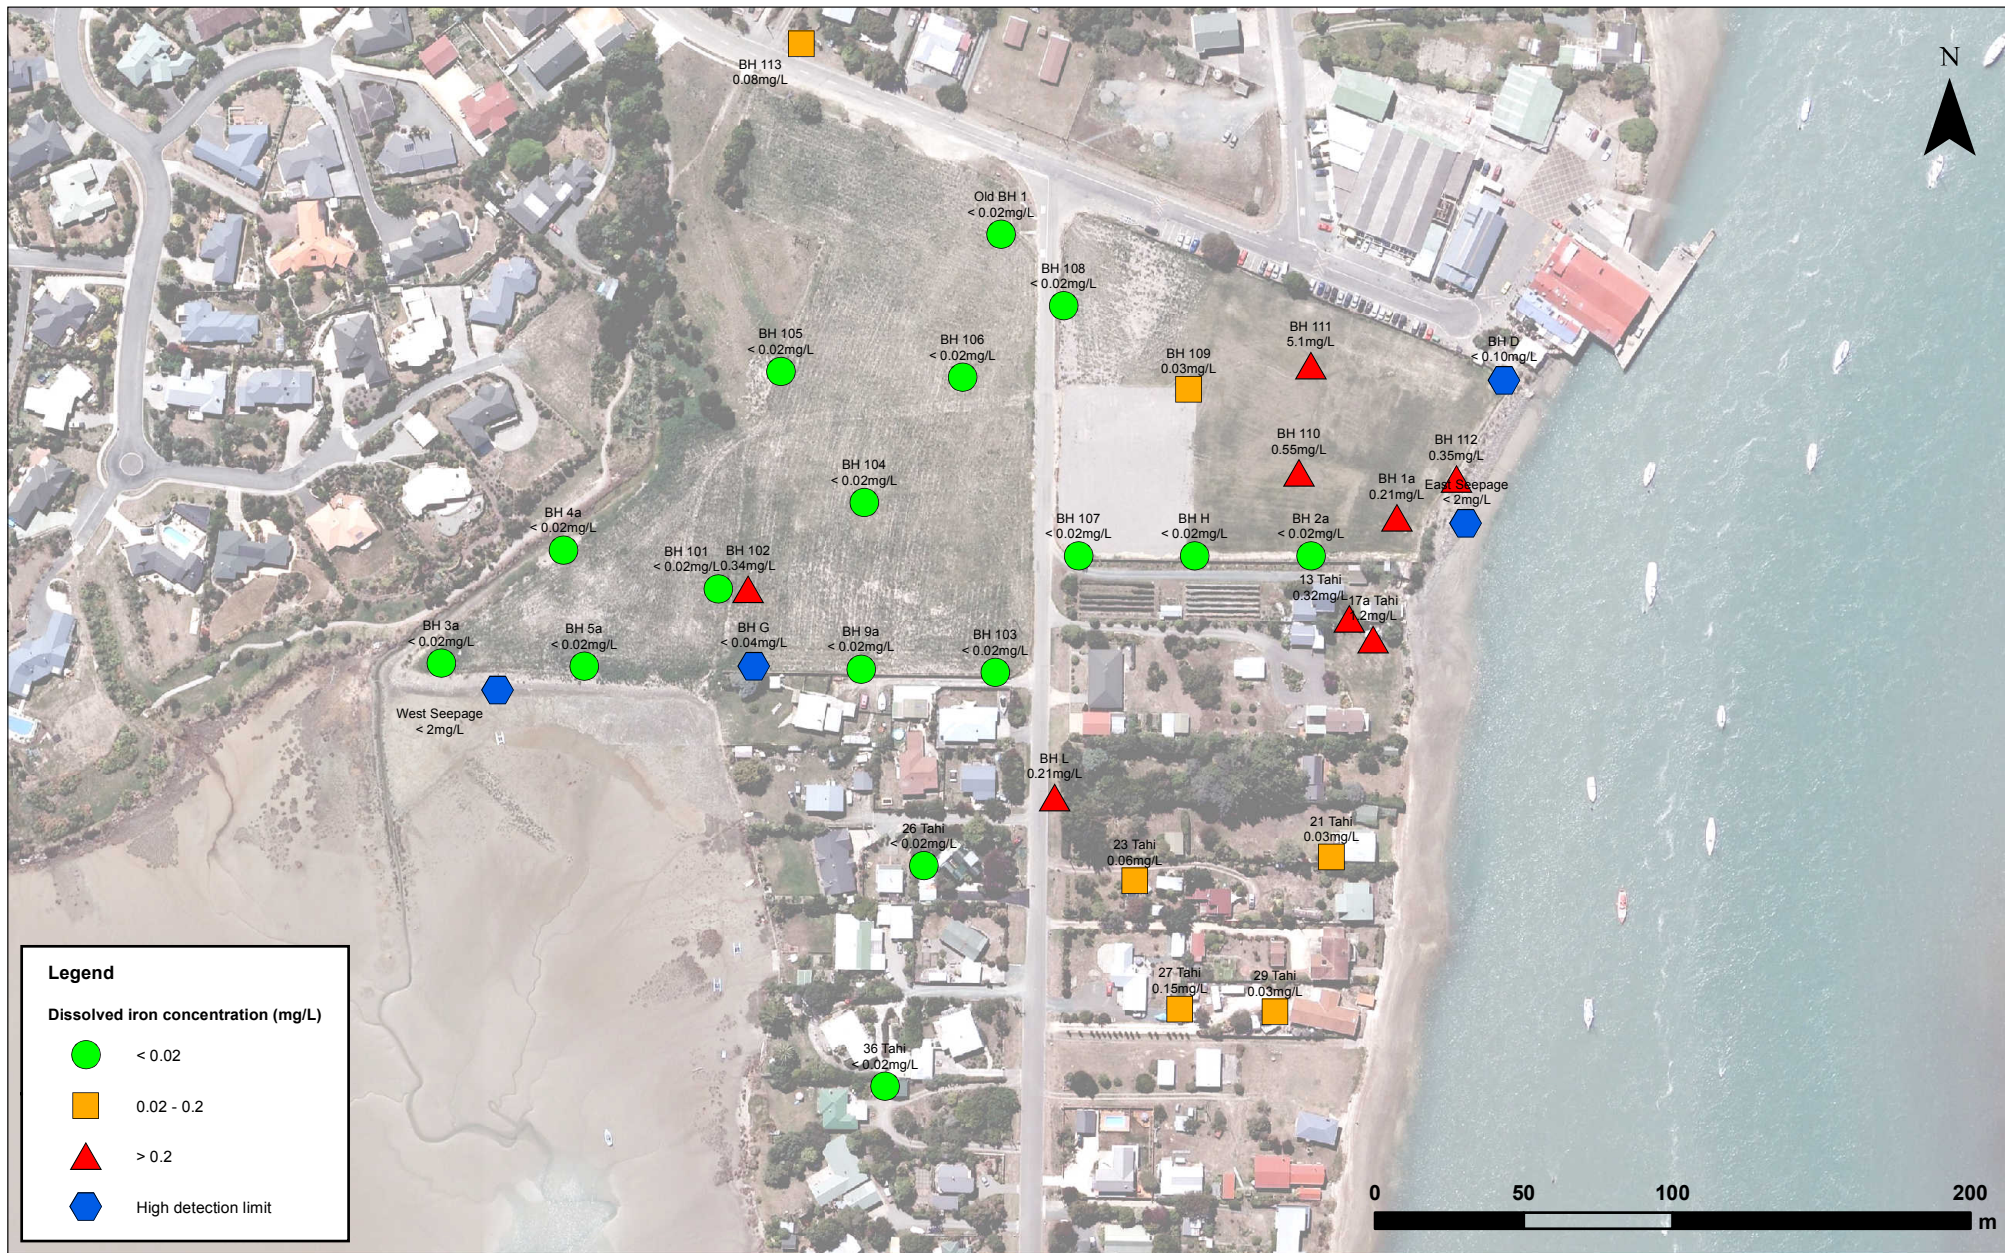
Figure 25: Dissolved iron concentrations in November 2012

There has been no consistent change since November 2011, with some bores showing increased concentrations and others showing decreased concentrations. The results show the majority of the elevated concentrations occurring at the east of the site. The concentration in bore BHG dropped dramatically (<0.04 mg/L in November 2012, down from 26 mg/L in November 2011) meaning the highest concentration was in bore BH111 (5.1 mg/L in November 2012, up from 1.71 mg/L in November 2011).

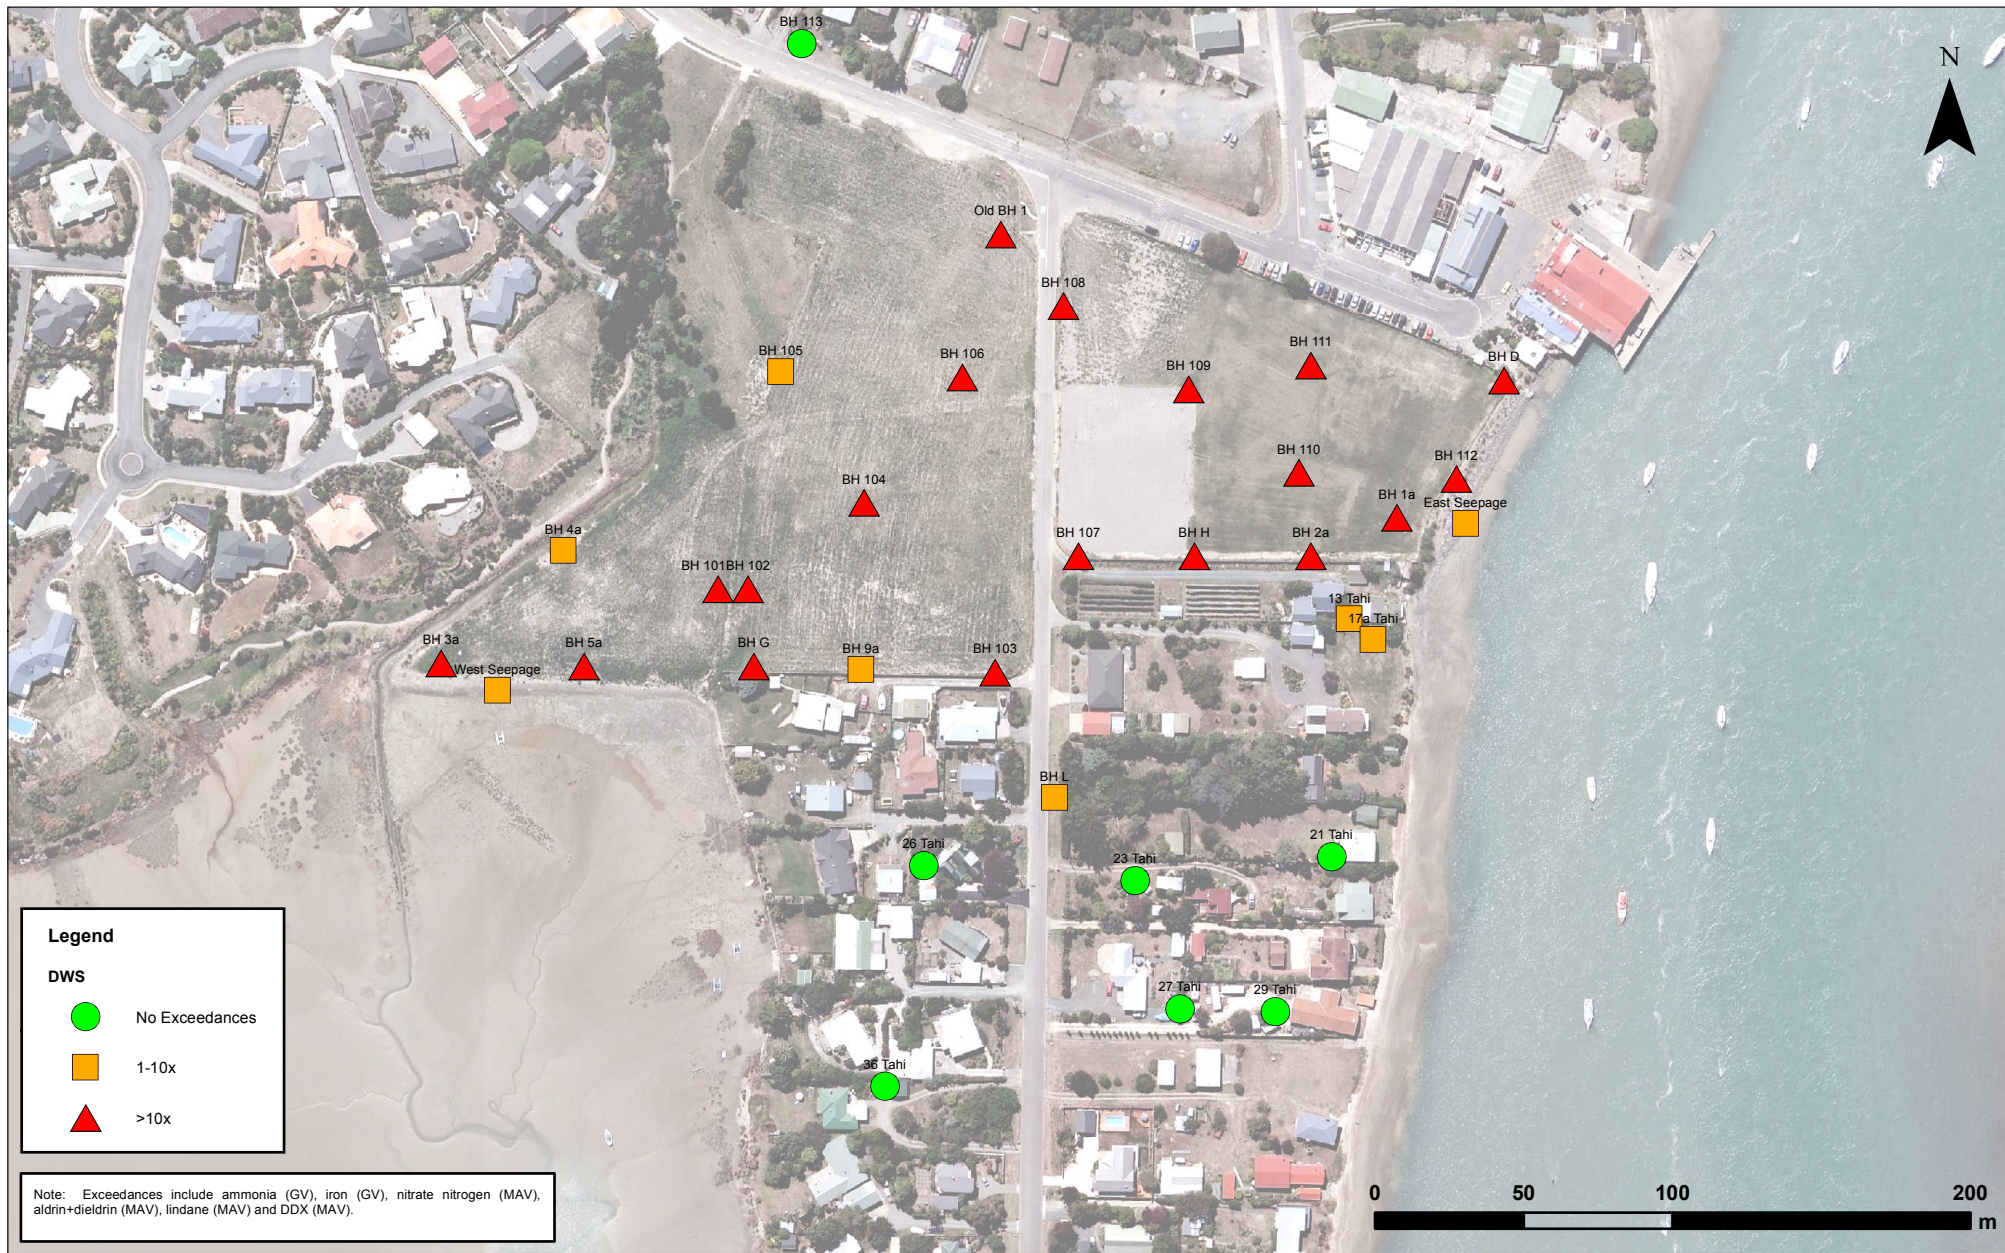
Figure 26: Exceedances of Drinking Water Standards in November 2012

Figure 26 and Table 1 show that all of the bores within the site had exceedences of the Drinking Water Standards in November 2012, with most wells having an exceedence of more than ten times the standards. The most common exceedence was for aldrin+dielddrin. Of the domestic wells, BHL, 17 Tahi St and 27 Tahi St had exceedences of the Drinking Water Standards aesthetic guideline value for dissolved iron.

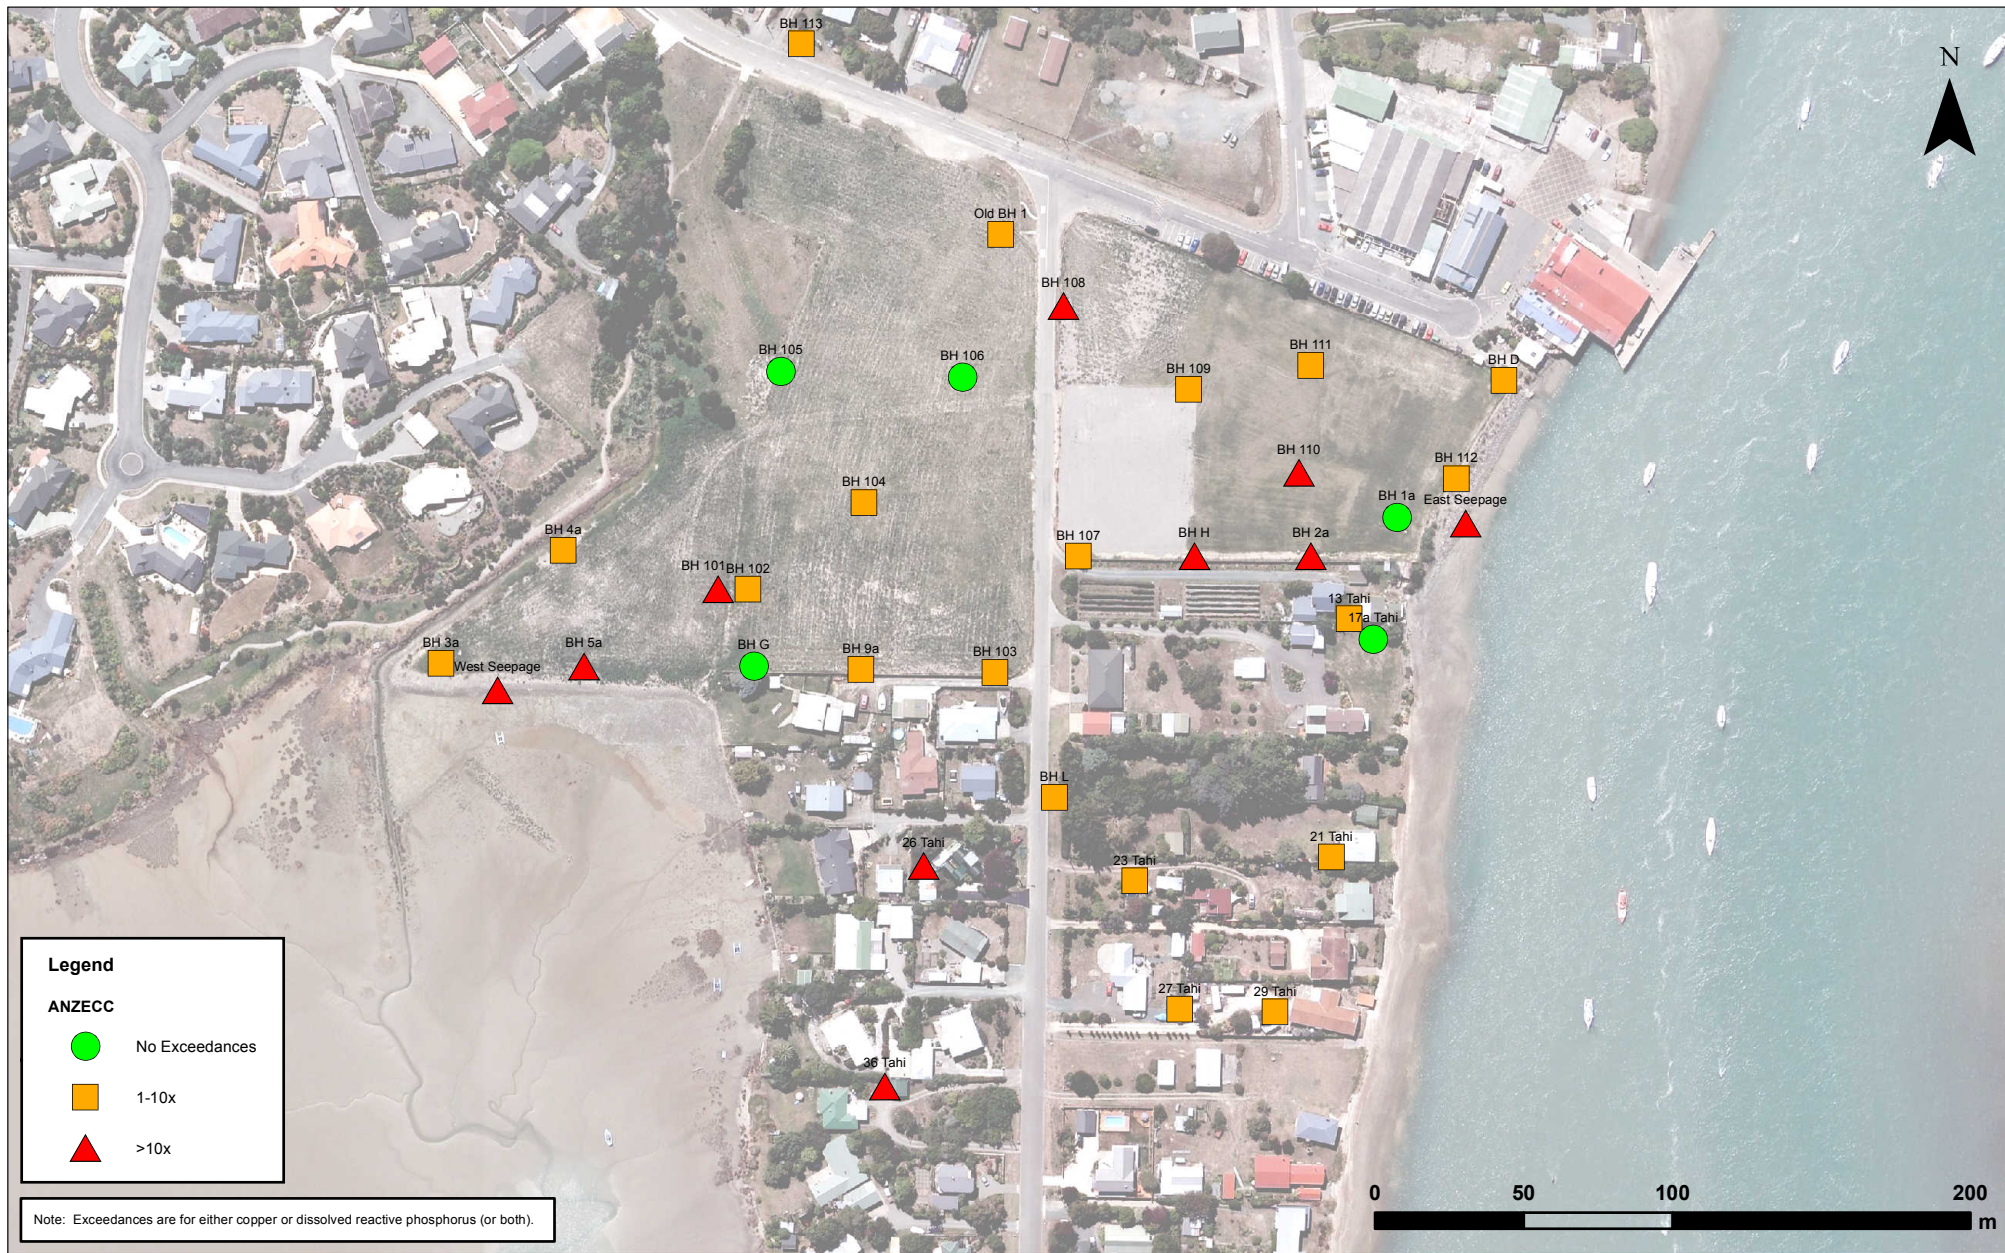
Figure 27: Exceedances of ANZECC Guidelines in November 2012

Figure 27 and Table 2 show that five bores, namely BH1A, BHG, BH105, BH106 and 17a Tahi St, had no exceedences of the ANZECC guidelines in November 2012. Many of the other bores exceeded the ANZECC guidelines for both dissolved copper and dissolved reactive phosphorus. The largest exceedence (not including BH101 and BH102) was for dissolved reactive phosphorous in bore BH108 (1,800 times ANZECC guideline value).
