Audit of the Remediation of the former Fruitgrowers Chemical Company Site, Mapua

∴ Prepared for
Ministry for the Environment

∴ June 2009

PATTLE DELAMORE PARTNERS LTD

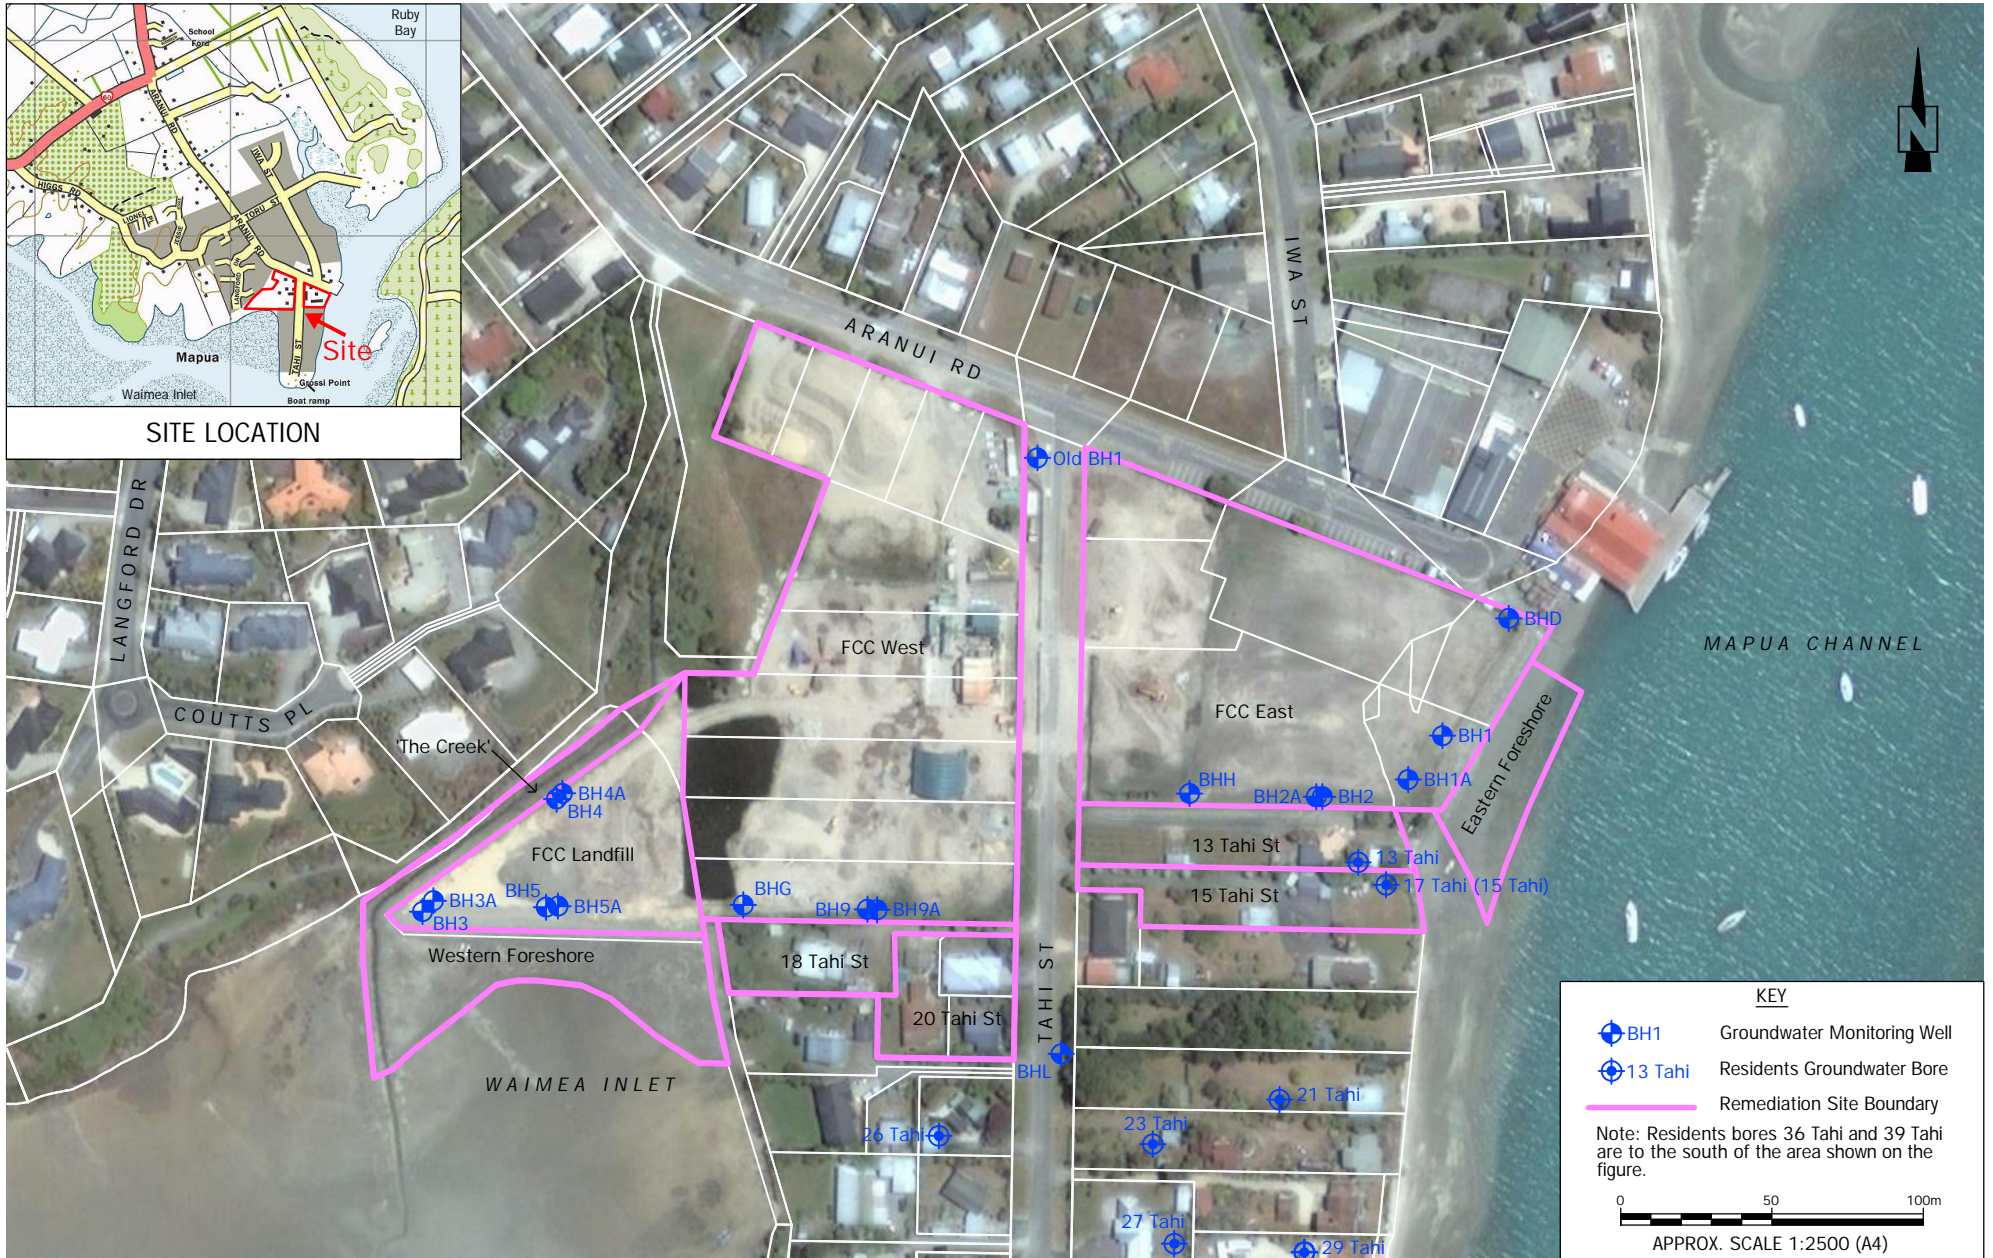
Figure 1 : SITE LOCATION

A number of groundwater monitoring wells along the southern and eastern boundary of the FCC site were monitored prior to and during the remediation as a condition of resource consent (see Figure 1). In addition, a number of private groundwater bores
