Summary of Groundwater Issues at Mapua FCC Site

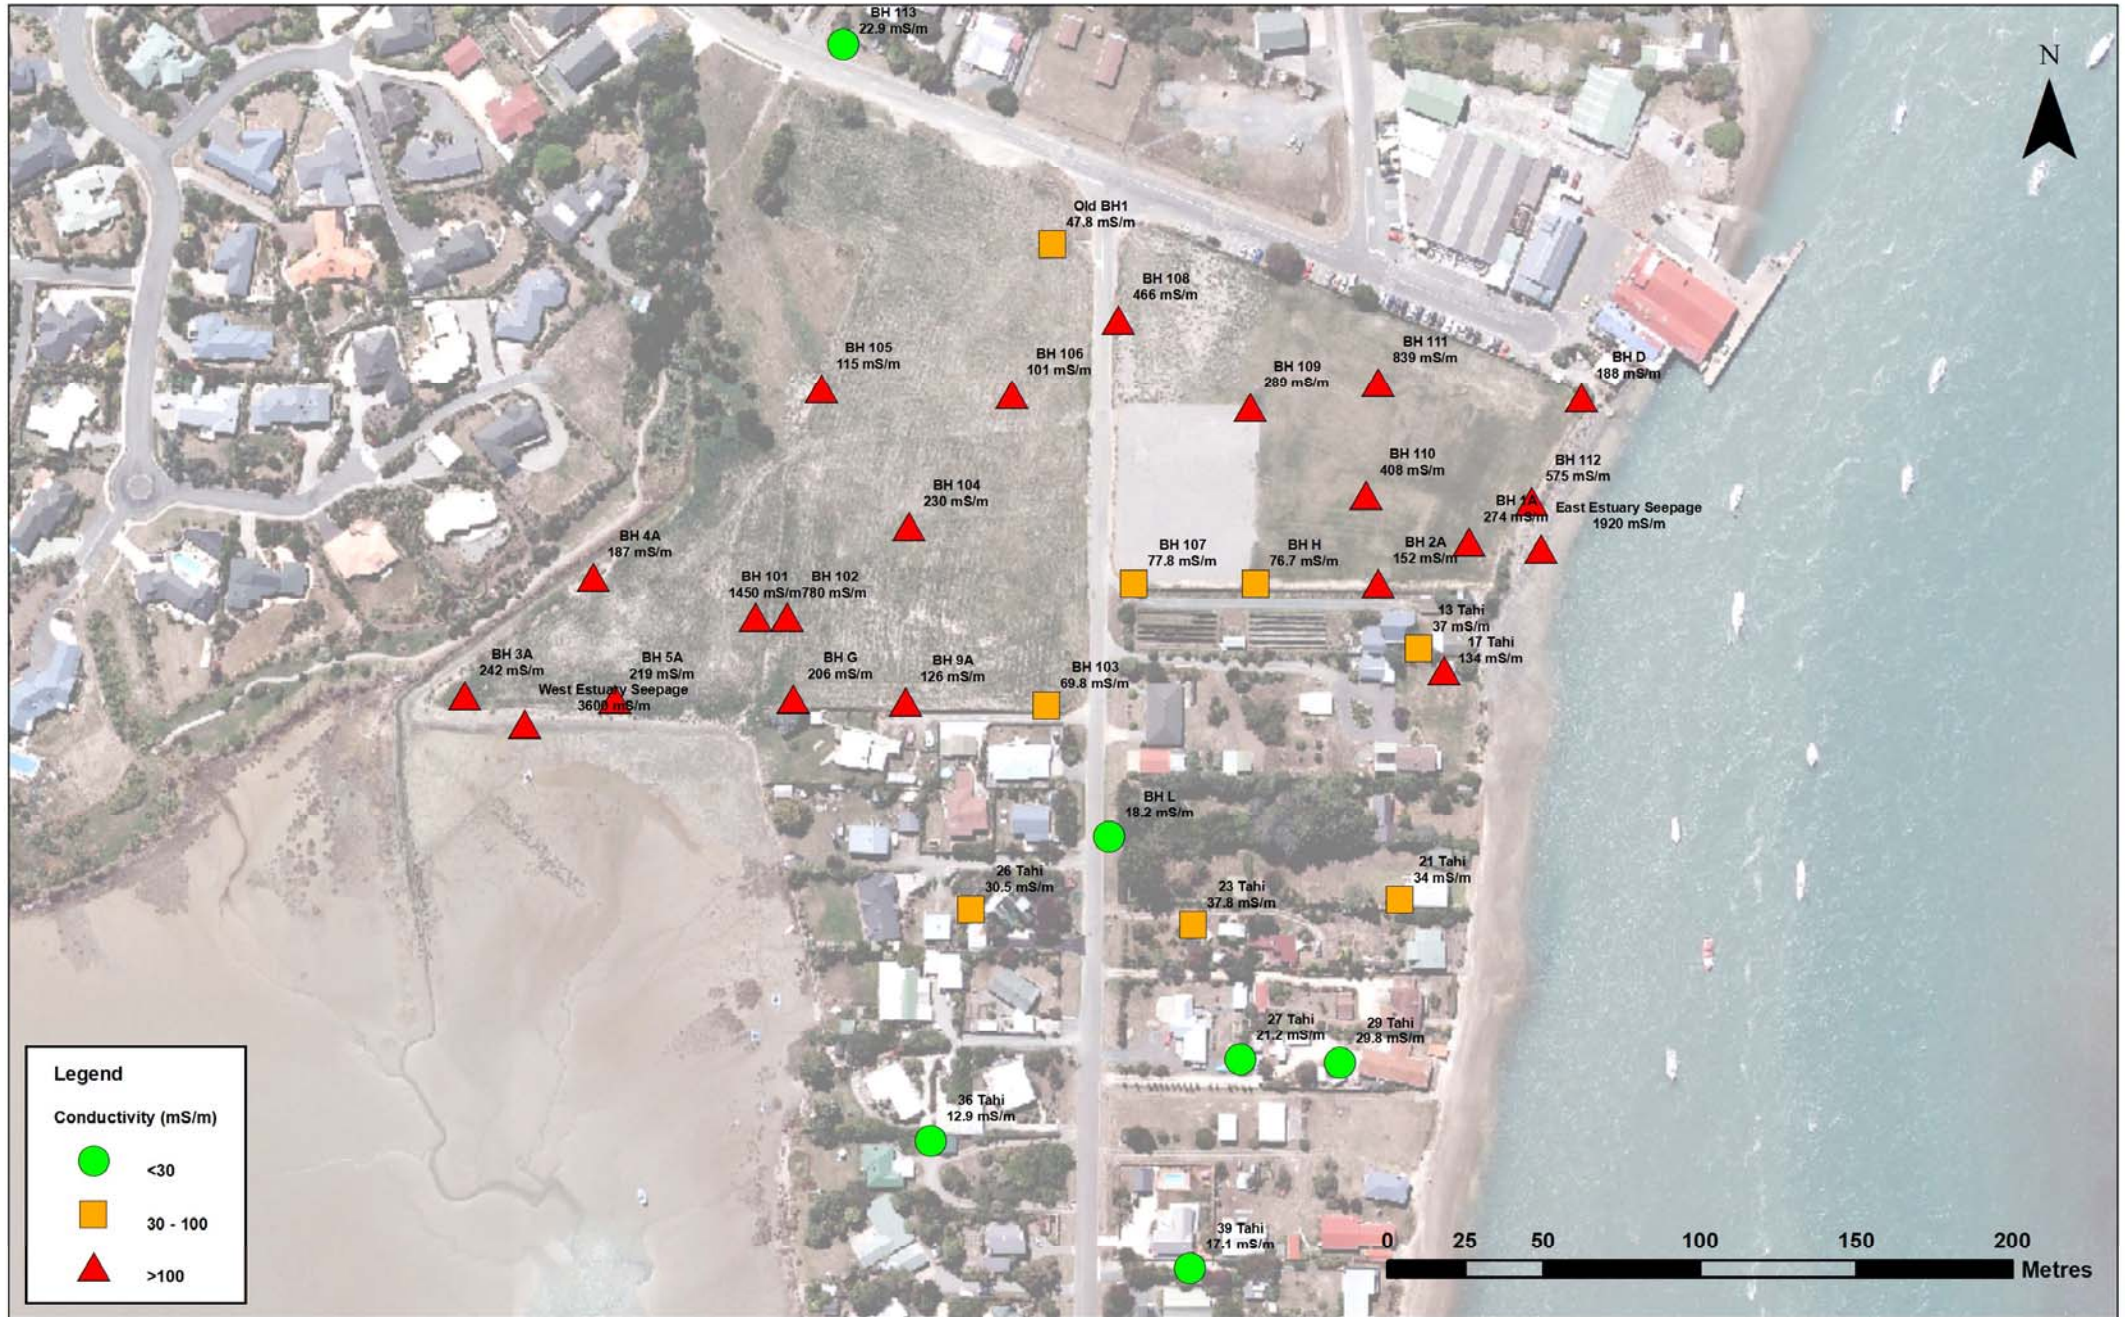
Figure A shows the general pattern of dissolved chemicals in groundwater, indicating that groundwater for a distance of around 100 m downgradient (south) may show a slight influence from the effects of the site. A full sampling survey of on-site and privately owned bores was completed in November 2009. It showed that the only exceedances of the Drinking Water Standards in off-site bores occur at 13 Tahi Street (ammonia-nitrogen, aldrin and dieldrin) and at 26 Tahi Street (nitrate-nitrogen).

Figure A: Conductivity values in November 2009
