Tasman District Council  
Private Bag 4  
Richmond  
Nelson 7050

## **Jackett Island - Action Plan for Interim Works**

TASMAN DISTRICT COUNCIL  
ACTION PLAN FOR INTERIM WORKS  
JACKETT ISLAND  
New Geofabric Bag 'with 30 Degree Return' Layout Plan and Details  
FIG. No. Figure 2

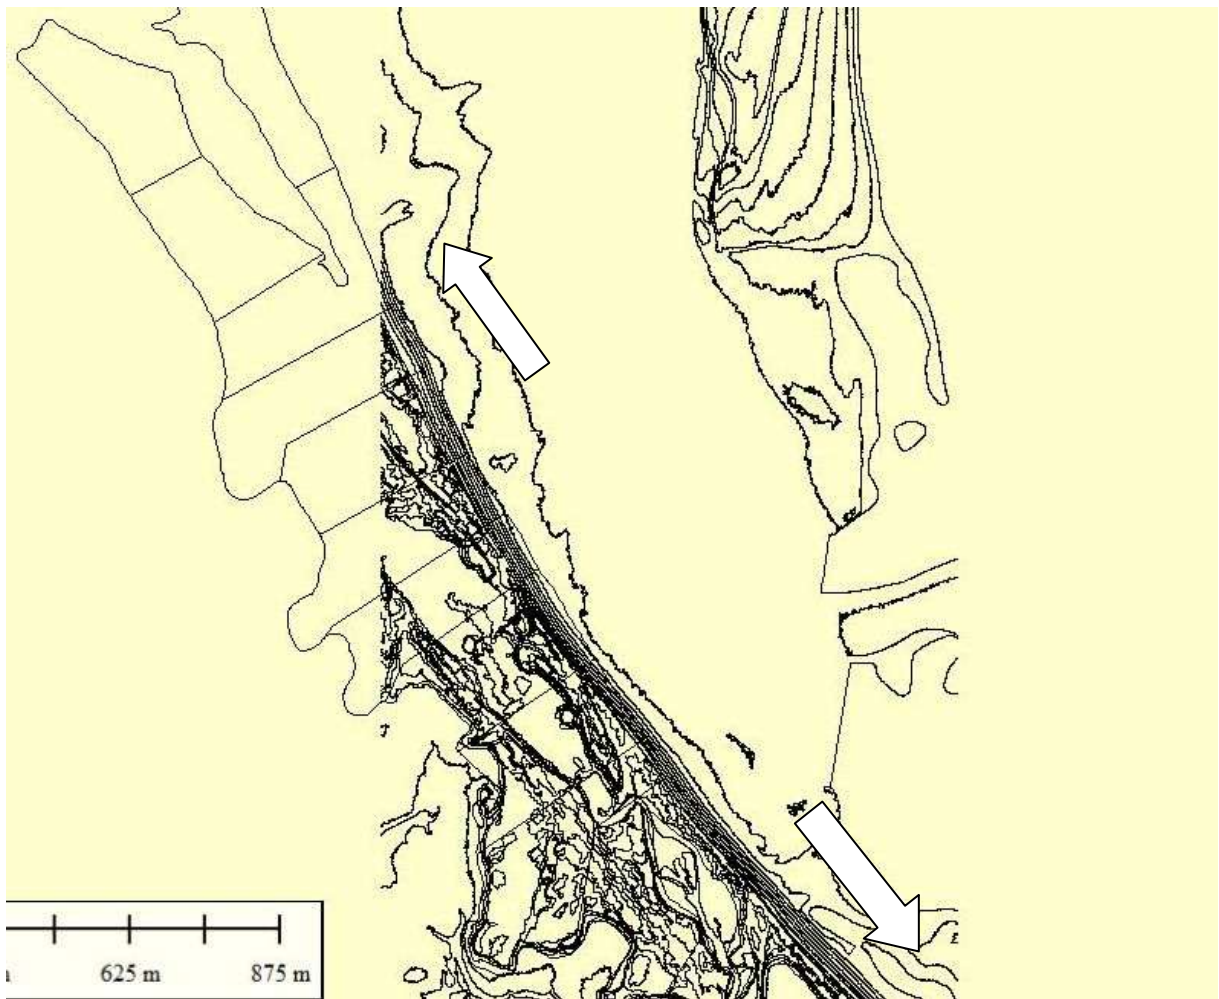
Council has obtained LiDAR survey providing the most recent topographic information of the spit and Jackett Island (6-7 May 2008). This provided 0.5 m contour information above MSL -1 m. Figure 1 shows the 2008 contours and the inferred direction of alongshore transport as evidenced by the wider beach systems either side of the central area of Jackett Island.

It is likely that as the spit extends to the south it is providing slightly greater sheltering from wave energy than in previous years and sand movement to the north is likely to be a function of wave diffraction/refraction effects around the end of the spit as well as sand moved by flood tide flows.

Figure 1- Contour information from LiDAR showing sediment movement alongshore away from central Jackett Island (LiDAR source from Tasman District Council)

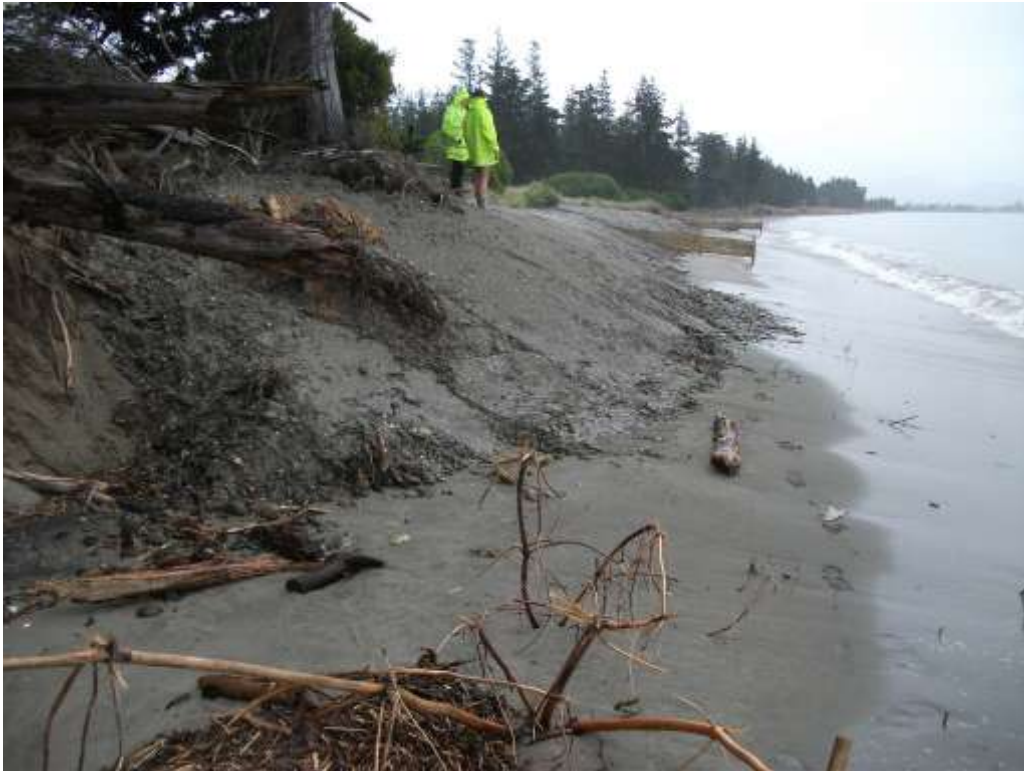
The resulting placement has resulted in a combined gravel/sand/silt bund along the southern half of the property protecting the bank and wool bales (refer Photograph 1) that appears to be providing reasonable wave protection and a volume of material on the upper beach and should provide sufficient protection while the geo bag option is progressed.

*Photograph 1 Completed emergency works as at 6 July 2011*

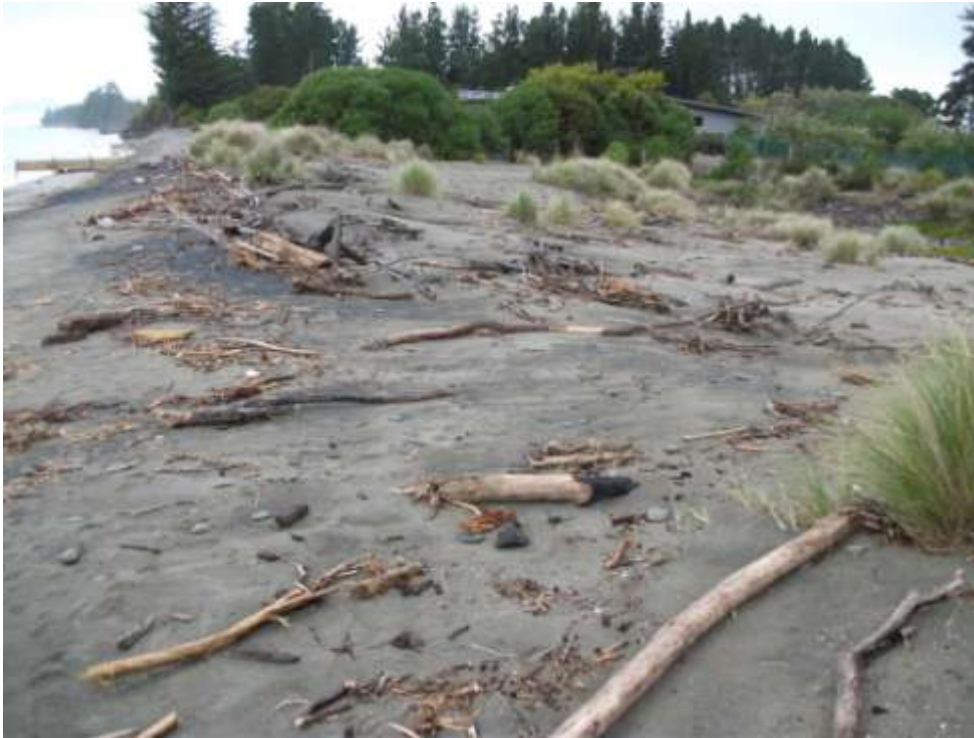
At the northern end of the property where sand had been excavated along the backshore by the Van Dykes to provide increased sand elevation in front of their dwelling, the low beach crest has been overtopped and sand infilling by wave overtopping was evident (refer Photograph 2).

*Photograph 2 Sand over wash at northern end of the property as at 6 July 2011*

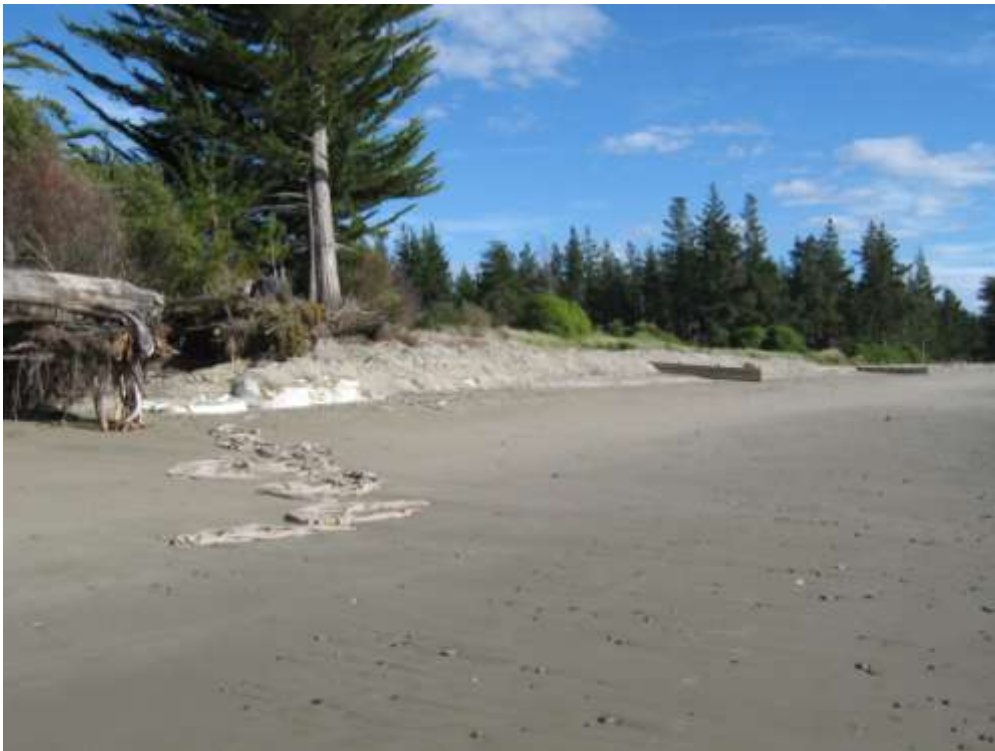
The geotextile bags will be placed along some 104.4 m. For context, the bags will extend from the southern boundary to around 20 m to the north of the second groyne shown in Photograph 3. The bags will be placed over a geotextile filter fabric that overlies a formed subgrade of beach sediments. The geotextile filter fabric will assist in reducing the loss of fines through the gaps between the bags.

*Photograph 3 - existing shoreline showing two timber groynes (8 April 2011)*

The existing timber groynes will be removed as part of these works and the timber either retained on site, or removed depending upon the requirements of the Van Dykes.
