## Engineering Services Committee ATTACHMENTS

SUBJECT: Fatal Crash 29/05/11 Moutere Highway/Golden Hills Road

### TRAFFIC CRASH REPORT

Moutere Highway/Waimca West Road, (Rust Corner) Proposed Roundabout Safety Audit Report  
 11802 Concept Safety Audit Report.docx

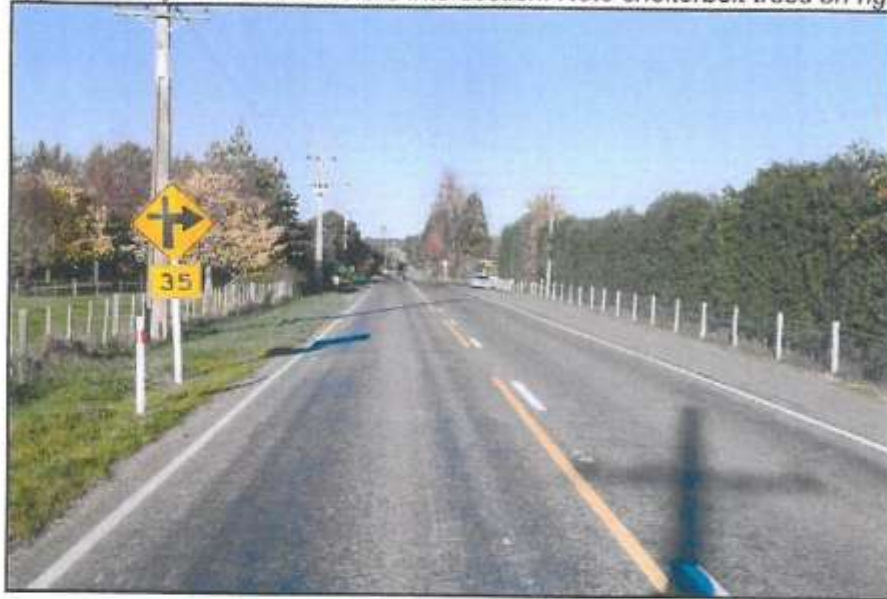
*View facing southwards approaching intersection, showing advisory sign approximately 120-metres before intersection. Note shelterbelt trees on right.*

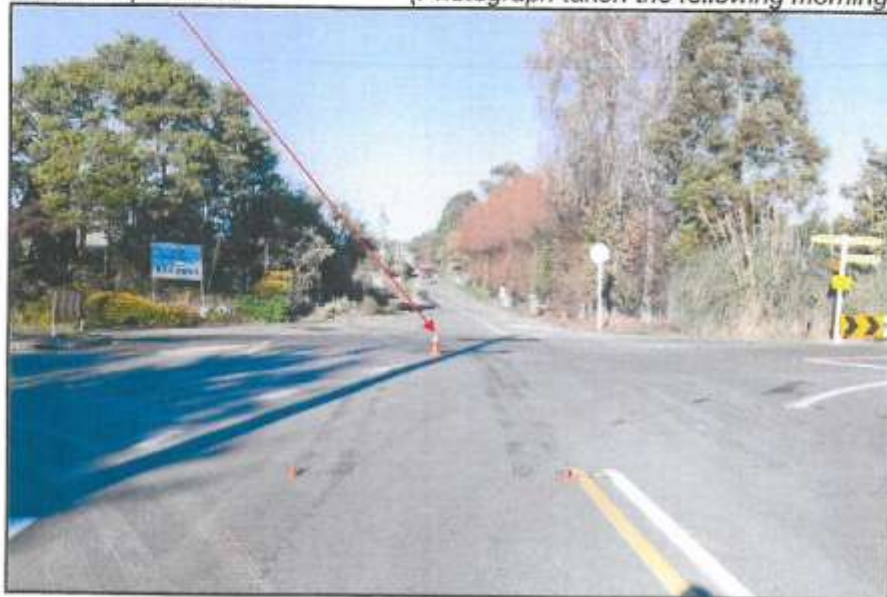
*View facing southwards at intersection showing the Trailer-Unit tyre abrasions into the impact area. (Photograph taken the following morning)*

Examination of the intersection found rubber abrasion markings, typical of heavy motor vehicle tyres under extreme braking, leading southwards into the intersection from the approach direction of the Truck and Trailer unit.

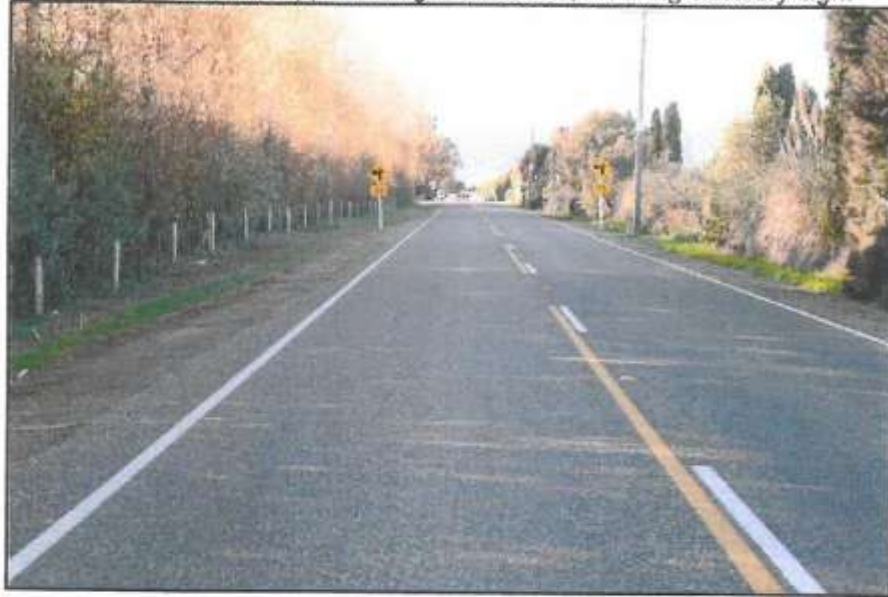
*View facing eastwards approaching intersection, showing advisory sign.*

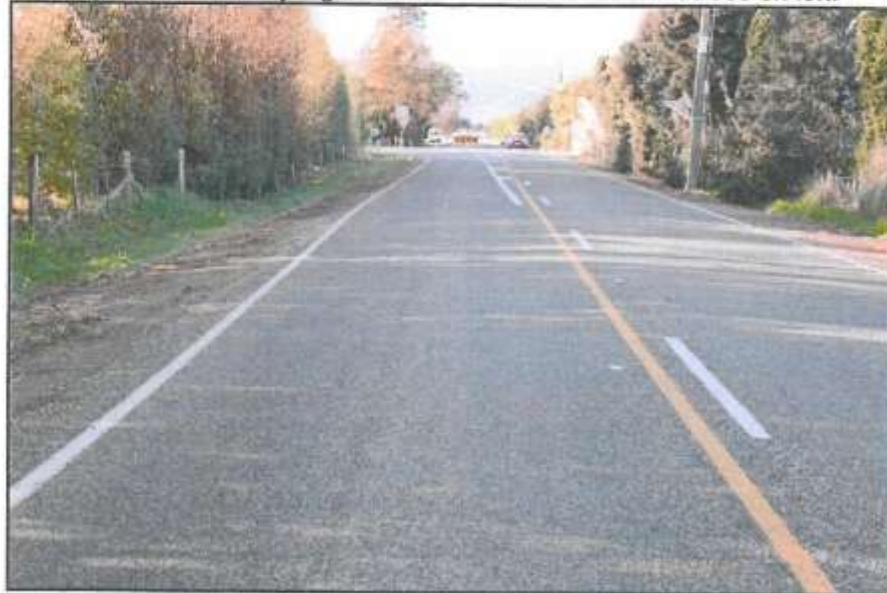
*View facing eastwards approaching intersection, showing start of lane markings and Give-Way sign ahead. Note shelterbelt trees on left.*

Observations at the crash site found that visibility is obstructed on the northwest corner by a shelter belt of trees, obstructing southbound driver's view of any approaching eastbound vehicles.

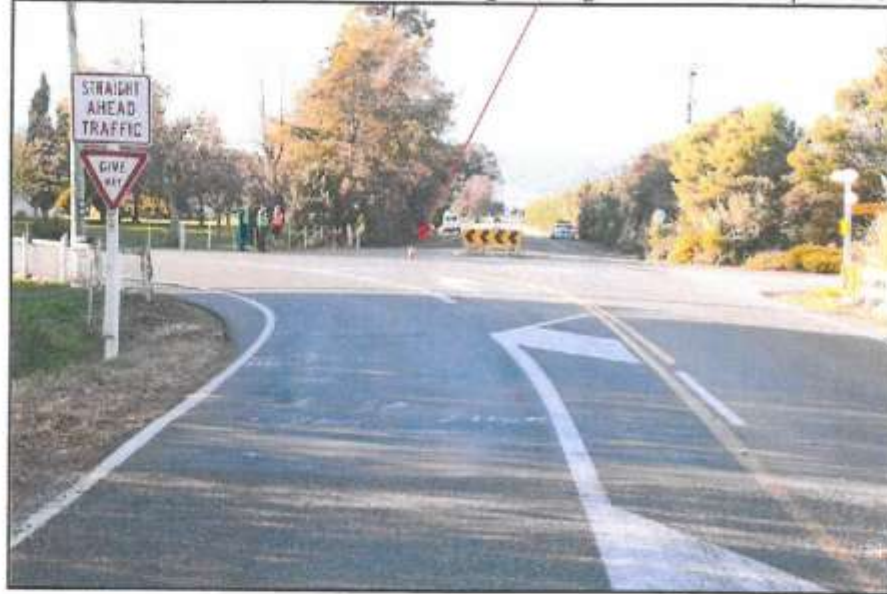
*View facing eastwards approaching intersection, showing Give-Way sign and lane marking. Orange cone marks impact area.*

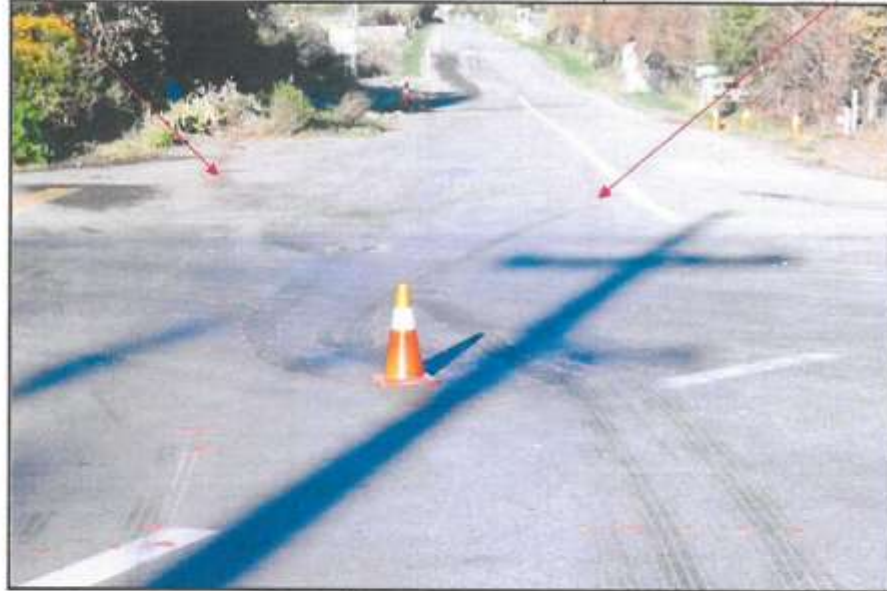
Rubber abrasion markings typical of vehicle tyres being pushed sideways, which developed into gouges in the road surface, were found and were later matched to the wheel positions of the Mercedes car, indicating its position immediately following impact.

View at impact area facing southwards towards Golden Hills Road.  
Departure marks from Truck                      Departure marks from Car

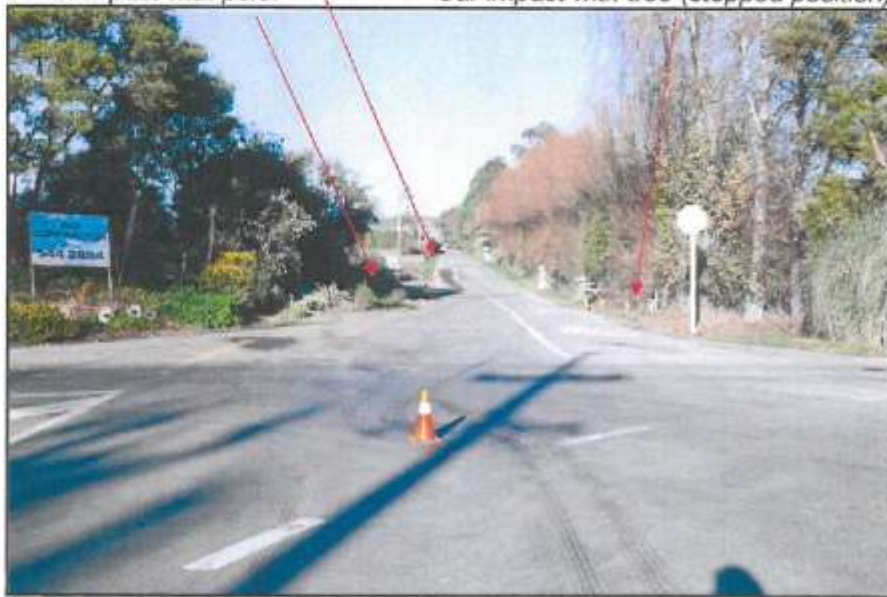
These rubber abrasion markings joined with other scratches (later matched with underside damage to the Mercedes car), and showed the post impact direction of the car as it disengaged from the front of the Truck and travelled southwest into Golden Hills Road where the Mercedes came to an abrupt halt as the right front of the vehicle impacted into a tree.

View at impact area facing southwards towards Golden Hills Road.  
Truck and Trailer stopped position  
Truck impact with pole.                      Car impact with tree (stopped position)

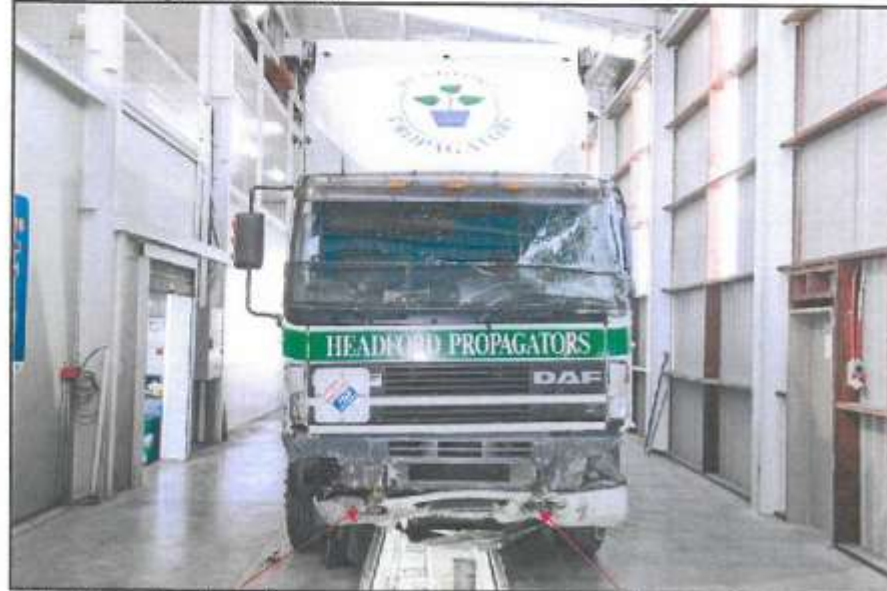
Notable was the damage to right-hand front of the truck resulting from the initial impact with the Mercedes, which included impact damage around the yellow painted towing pin.

The location of this damage indicated that the Mercedes Car had not proceeded completely across the front of the Truck when the impact took place.

The damage around the left-hand front had resulted from the secondary impact with the concrete power pole and raised vegetation surrounding it.  
*View showing front of truck.*

*Note the yellow tow pin.*

*Secondary damage from power pole.*

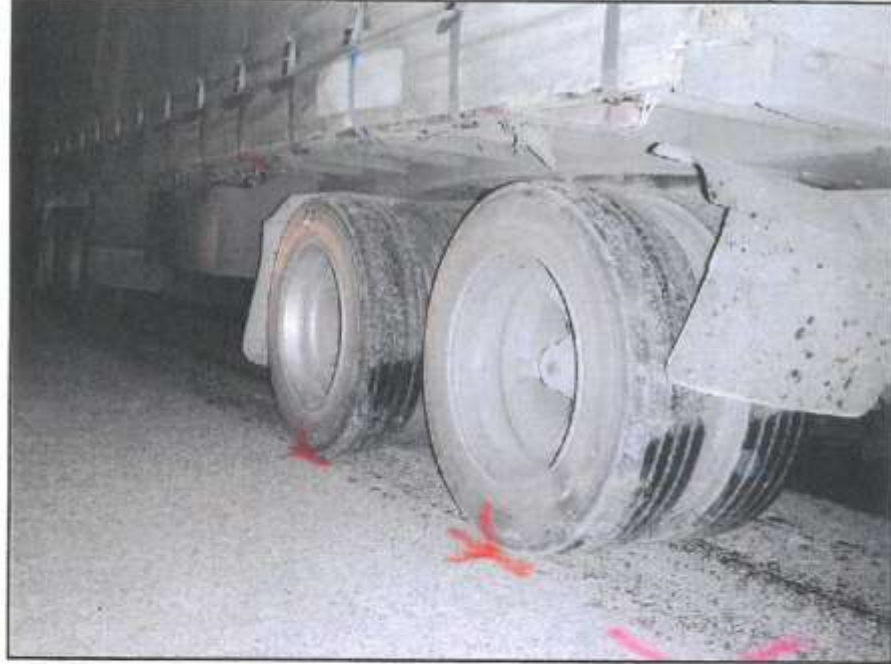
*View of trailer tyres showing signs of wheel lock-up (taken in situ).*

The tyres were inspected and it was noticed that there were no discernable abrasion markings found on any of the truck tyres, however all of the tyres on the trailer unit had defined flat-spot tyre abrasions, indicating that they had all locked-up at one stage during the crash sequence.

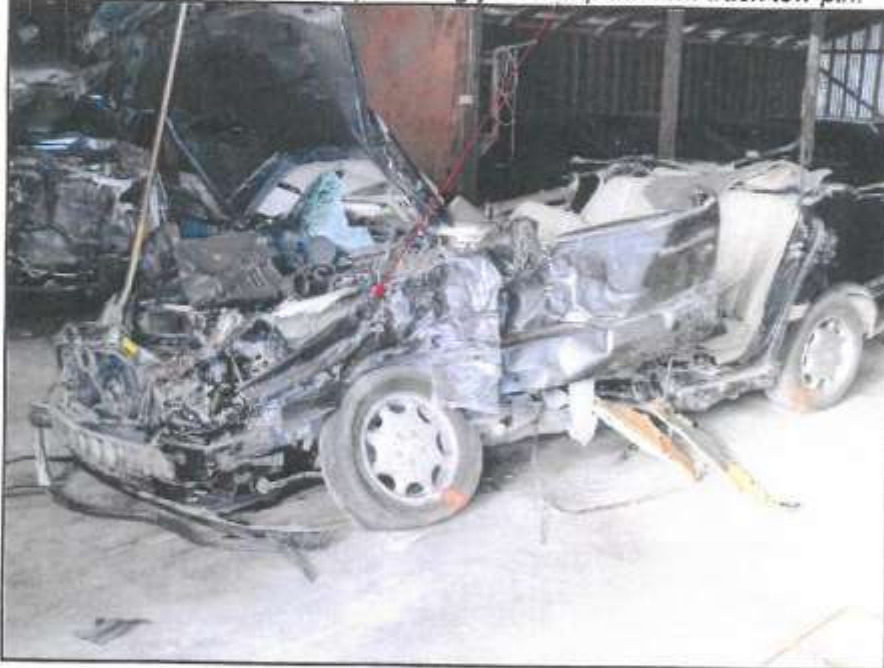
In particular it was noted that there was a clear transfer of damage from the yellow painted towing pin, located on the front of the truck, into the front left-hand guard of the Mercedes.

*View of Mercedes (recovered) showing yellow imprint from truck tow-pin.*

This determined that when the impact with the truck took place, the Mercedes had not proceeded completely across the front of the Truck.

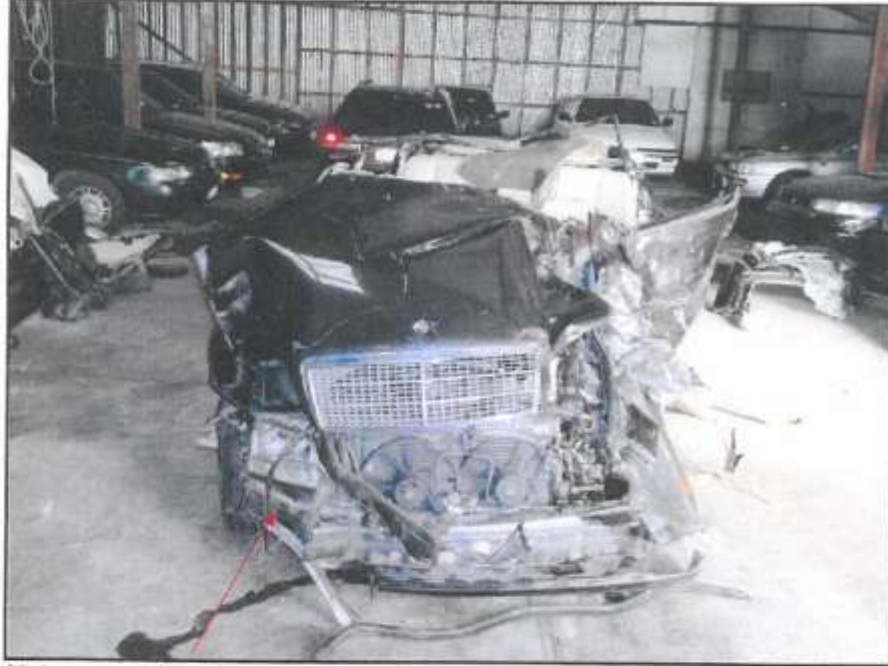
*View of Mercedes (recovered).*

*Note: secondary damage caused by impact with tree.*

The extensive damage around the right-hand front had resulted from the secondary impact with the base of the tree, indicating that the Mercedes still had a substantial forward motion when it came to its abrupt halt.

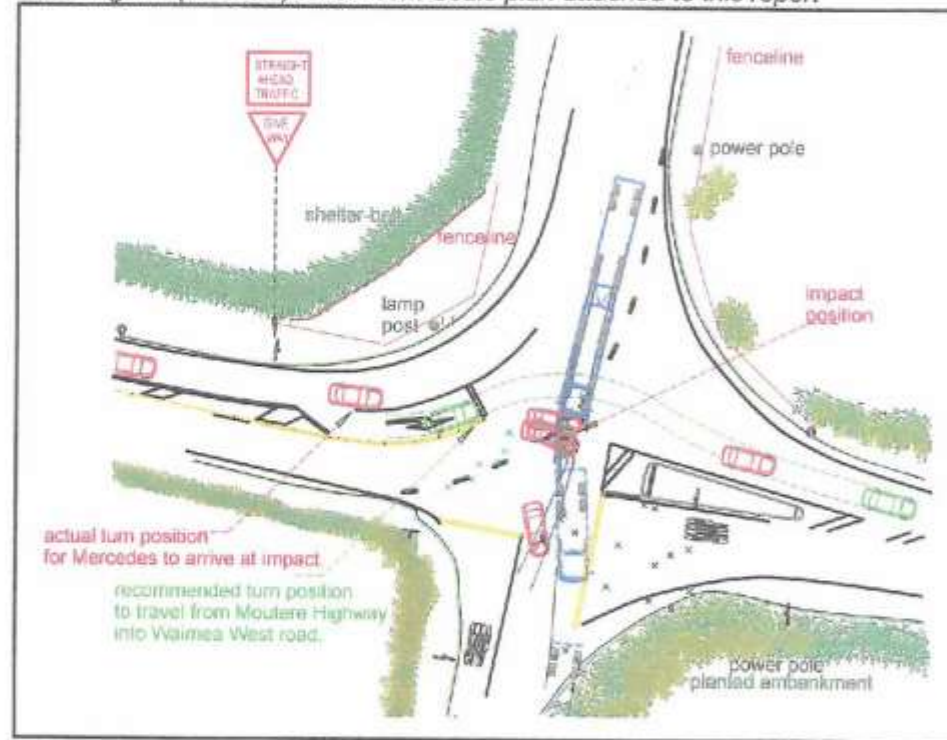
It is clear that the Mercedes driver was never attempting to comply with the lane markings and a calculation based on the radius of turn required for a vehicle to remain within the correct pathway, (shown in green on the attached plan), shows that it could not be successfully completed at any speed above 35km/h without inducing a loss of control.

*This diagram (reduced) taken from Scale plan attached to this report*

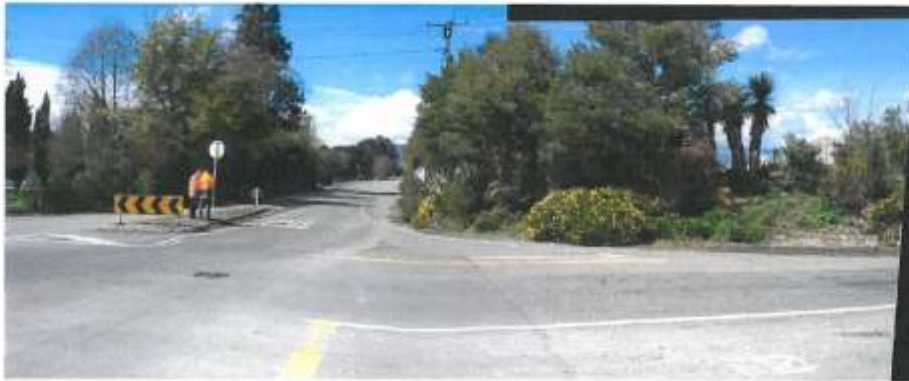
Photo 2: Panorama from Golden Hills Rd Approach showing vegetation on the Embankment

From the briefing, it was understood that sightlines were measured from 9m back from the stop-line, with the setting back of property boundaries shown so as to provide clear lines of sight of some 60m on three of the four approaches to the roundabout. Scaling of the concept plan suggests that the sightlines may only be available from a point some 7-8m back from the limit lines on three of the approaches. It is acknowledged that property constraints restrict the approach sightline to some 45-50m from the fourth (Golden Hills) approach, from a point 9m back from the limit line, even if the batter is completely cleared of existing vegetation, shown in Photo 2.

Even at 9m, this provides very limited stopping sight distance, noting that it would only be possible to come to stop on the approach from a speed of around 10km/h, in order to give way if required. On the other hand, it could be considered that this has the "benefit" of slowing vehicles down on the approach, provided that drivers are fully aware of the approaching roundabout under all conditions, and of the need to give way. Given that the sightlines on each of the other (major) approaches are in themselves relatively short, the SAT considers it highly desirable that all four approaches provide a similar available sightline to approaching vehicles from the right such that the approach speed to the roundabout on all legs is as consistent as possible for the appropriate judgement of acceptable gaps.

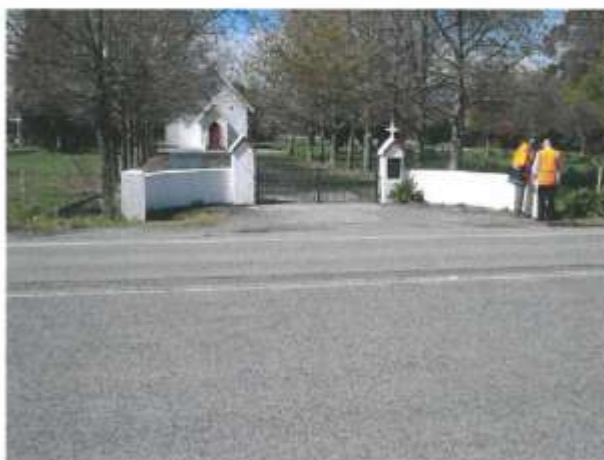
Photo 3: Existing vehicle access to Church

It is noted that as currently shown on the concept plan, the splitter island will block vehicle access to/from the church driveway on the Moutere north approach, some 40m from the intersection, as shown in Photo 3.

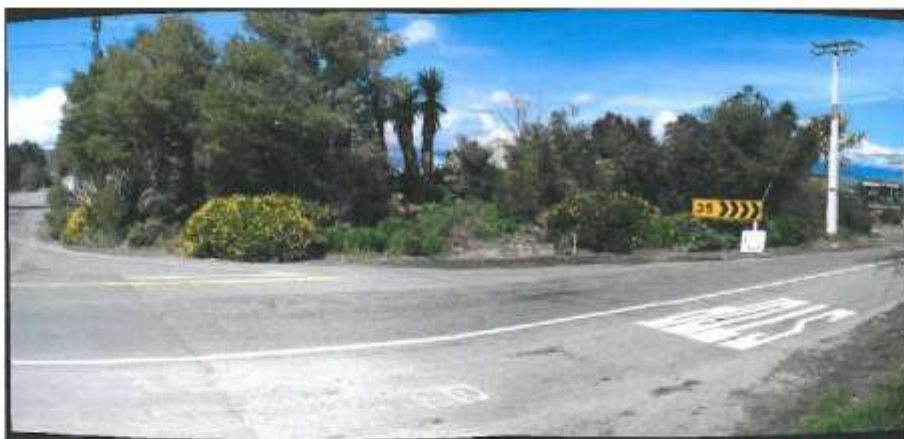
Photo 4: Close proximity of first driveway on Golden Hills Road Approach

The closest access to the property on the Golden Hills approach (currently gated) is only some 25m from the intersection, just beyond the power pole shown in the following Photo 4.

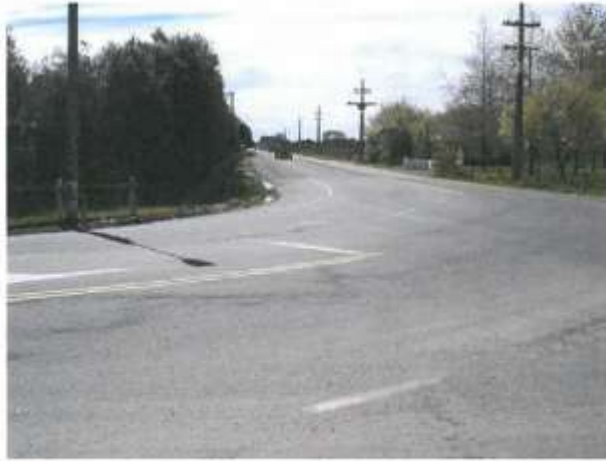
Photo 5: Ponding adjoining Existing Intersection

The SAT observed ponding of water within the road reserve adjoining this intersection, as evidenced in the previous Photo 4 and in the following Photos 5 & 6.

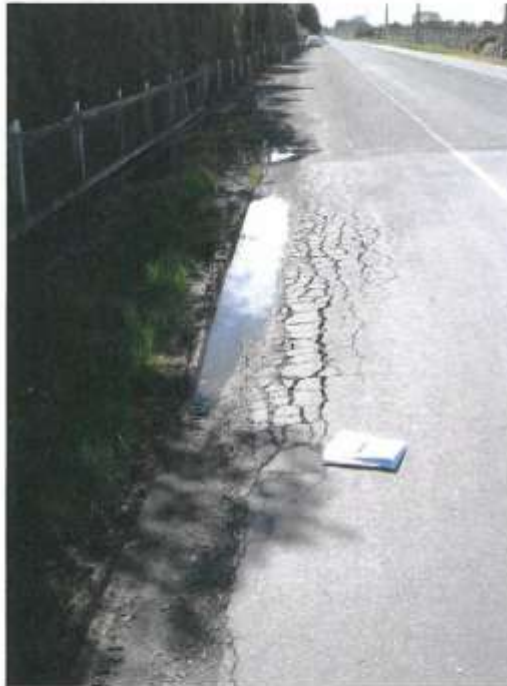
**Photo 6: Ponding at Existing Exit to Moutere Highway (north) and associated Pavement Deterioration**

The existing pavement is showing significant signs of deterioration, with a pot-hole on the Golden Hills approach and cracking at the Moutere Highway (north) exit as shown in the previous Photo 6. Both of these are likely to be as a result of water ingress, reinforcing the need for positive drainage.
