STAFF REPORT

SUBJECT: **RESULTS OF PERMITTED ACTIVITY DAIRY FARM SURVEY – REPORT EP06/05/18 - Report Prepared for 30 May 2006 meeting**

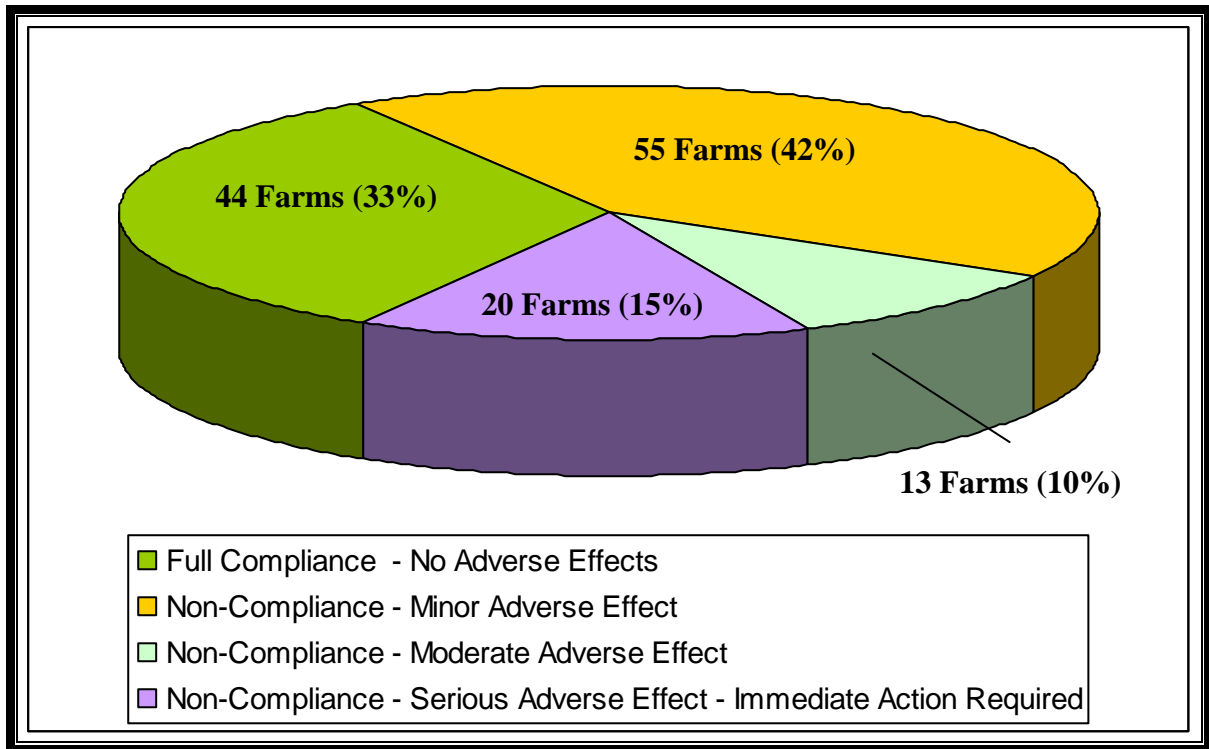
Figure 5: Compliance with respect to Rule 36.1.3 of the TRMP and Section 15(1)(b) of the RMA 1991 once initial assessment of all farm dairies had been completed and prior to any enforcement action.

Figure 5 shows that of the 132 farm dairies that operate under Permitted Activity status, 44 farms (33%) fully complied with all sections of Rule 36.1.3 and Section 15(1)(b) of the RMA at the time of the first visit.

Non-compliance which caused a minor adverse effect on the environment was found at 55 farm dairies (42%). Such non-compliance all related to these farm dairies not having an adequate contingency plan to avoid discharges to water in the event of system failure (Rule 36.1.3(c)).

Thirteen farm dairies (10%) had matters of non-compliance that are considered to cause a moderate adverse effect on the environment. Such non-compliance included:

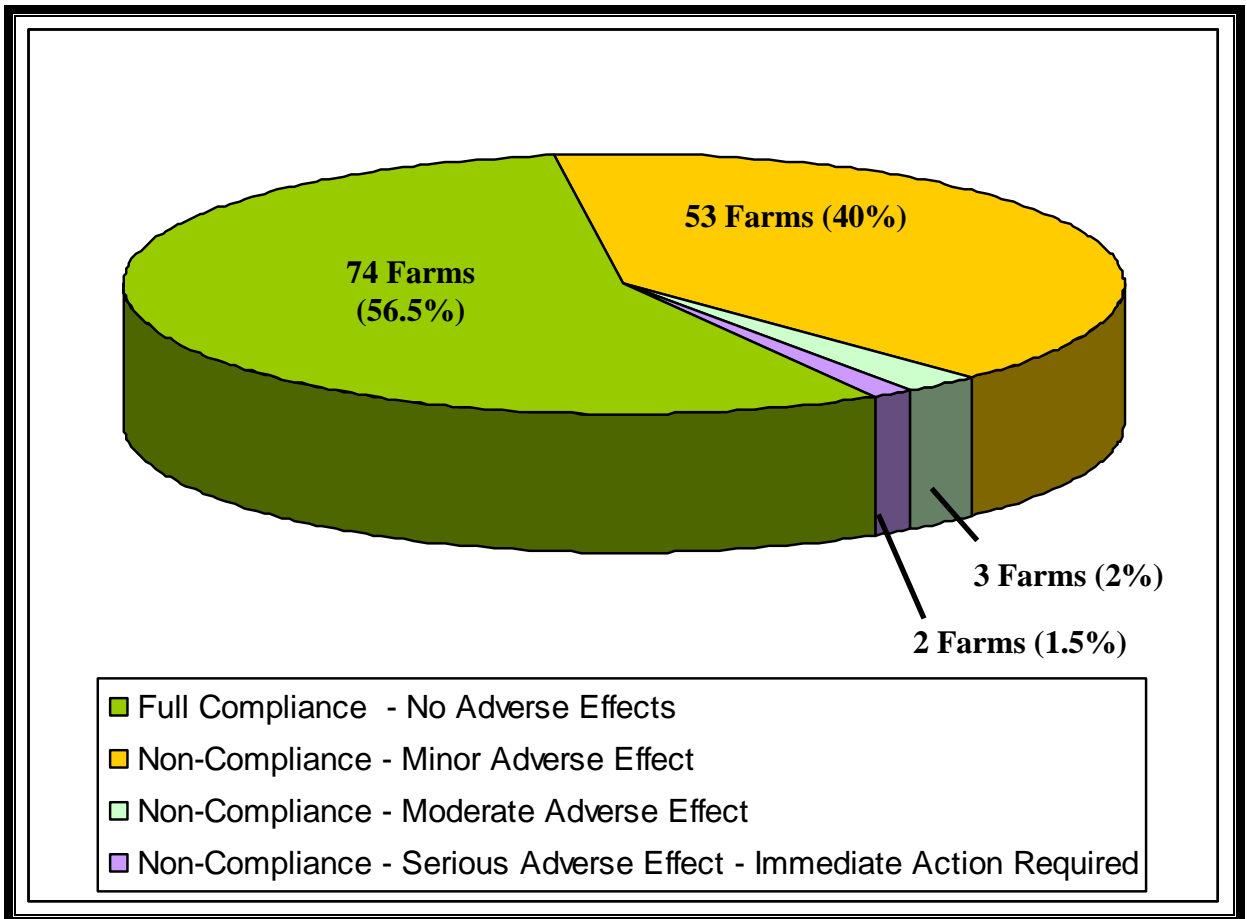
Figure 6 shows that at the time of the writing of this report that of the 132 farm dairies that operate under Permitted Activity status, 74 farms (56.5%) now fully complied with all sections of Rule 36.1.3 and Section 15(1)(b) of the RMA.

Non-compliance which caused a minor adverse effect on the environment still exists at 53 farm dairies (40%). Such non-compliance all relates to these farm dairies not having an adequate contingency plan to avoid discharges to water in the event of system failure (Rule 36.1.3(c)). This minor non-compliance makes up 91% of all non-compliance the presently exists with respect to Rule 36.1.3 of the TRMP, and highlights an area of compliance that needs to be addressed during the up-and-coming season (2006/2007).

Three farm dairies (2%) still have matters of non-compliance that are considered to cause a moderate adverse effect on the environment. In all three cases this non-compliance relates to overflow pipes/drains from the collection and holding sump directed to a stream or a farm ditch that leads to a water-way, thus a discharge to water would occur in the event of system failure (pump breakdown). All three farms had an Abatement Notice served on them that required that these issues be remedied. The due date of these notices is mid July 2006, and hence this non-compliance still statistically exists. All three farm owner have been contacted by Compliance since the issues in the Notices, and all are confident on having the respective works completed by the due date, this making them all fully compliant farms.

Two farm dairies (1.5%) still present non-compliance that results in a significant and immediate adverse effect on the environment. This non-compliance relates to the direct discharge of effluent from the farm dairy (yard and/or milking pit) to water. One farm has until mid June 2006 as prescribed in an Abatement Notice to remedy this problem and hence is still a current statistic. The other farm has a long history of non-compliance and offending both in Tasman District and in another region and continues to do so. Further enforcement action that may include prosecution will be taken against this farm owner.

Figure 6: Compliance with respect to Rule 36.1.3 of the TRMP and Section 15(1)(b) of the RMA 1991 following follow-up visits to Golden Bay and Central region farms and initial farm inspections in Murchison
