STAFF REPORT

TO: Motueka Community Board
FROM: Service Centres Manager
REFERENCE: E859
DATE: 15th June 2007
SUBJECT: June 2007 Report

Flood Gates Failure During Rain Event

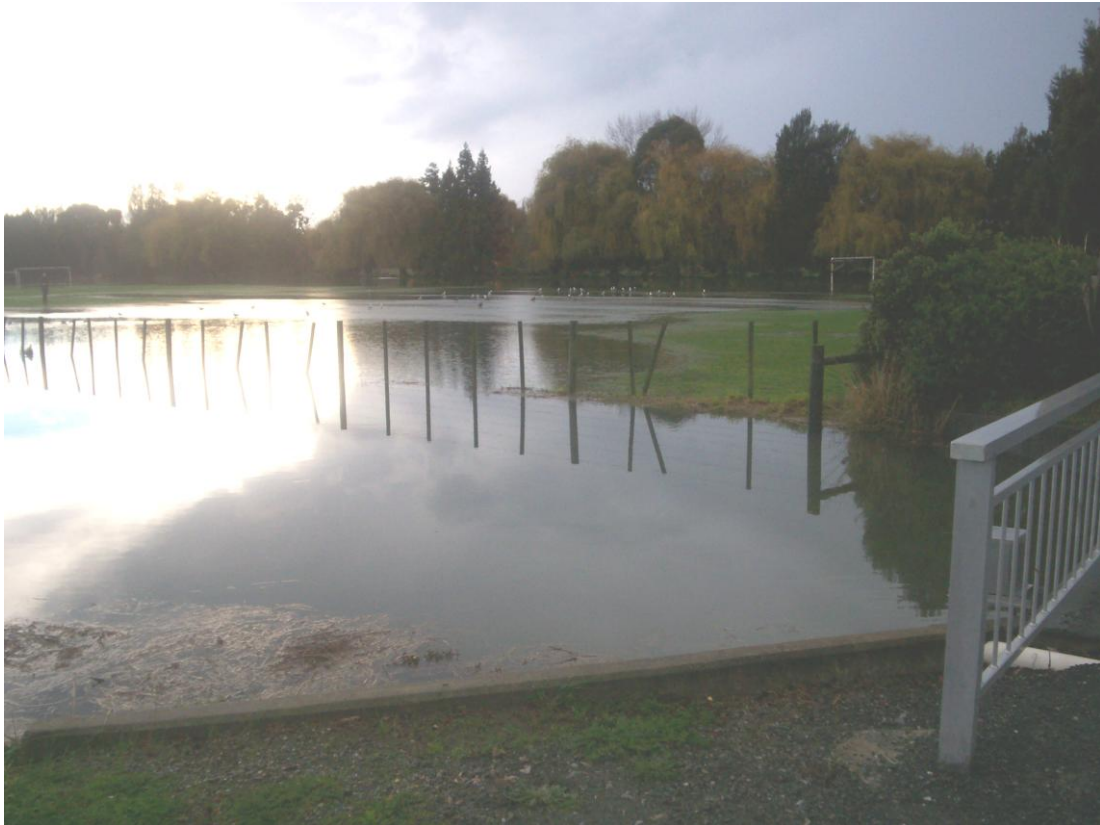
In summary, I received a call from the Chairman about 7.30 am that surface flooding was severe over the area of Goodman Park and that the Woodland Drain was backed up due to the flood gates being closed.

I then did a quick reconnaissance of the sites and noted that water was backed up the Woodlands Drain and washing across the football field areas across from the Motueka Recreation centre. The estuary catchment was empty and the main flood gates at Wharf Road were open with low tide being about 8.30am that day.

Flooding Across Goodman Playing Fields 8.00am 23/5/07

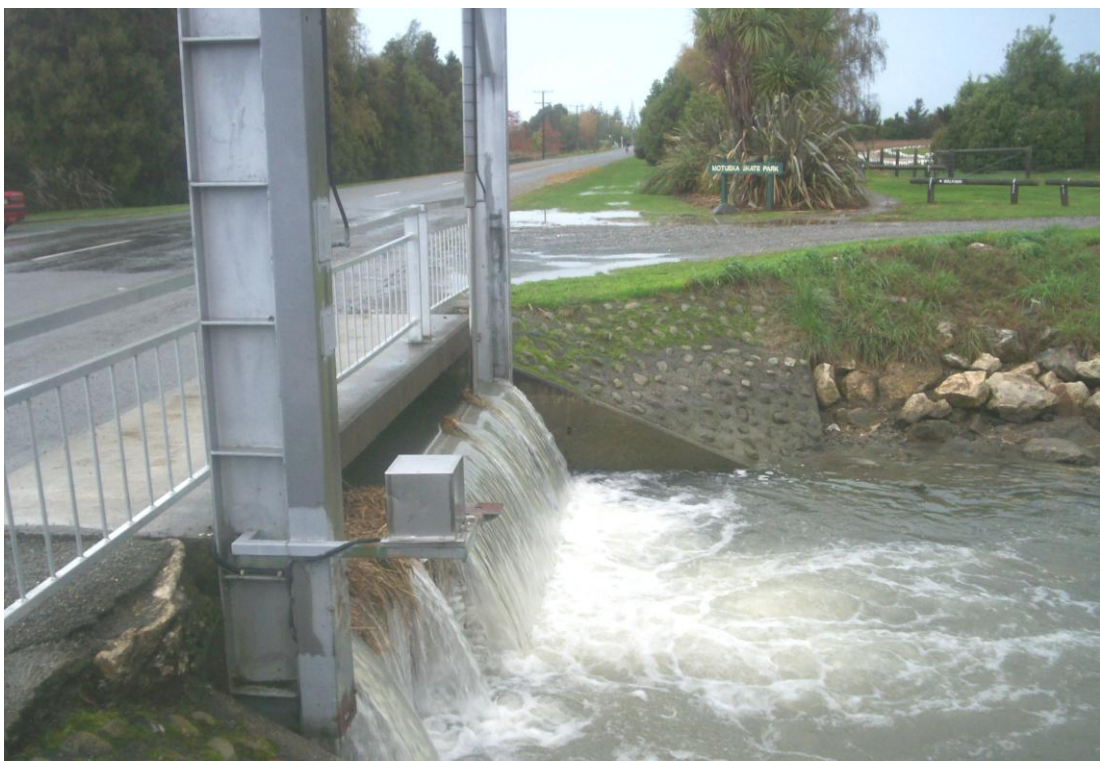
The gates are programmed to open automatically if there is a differential of 300mm between the upstream and downstream channel water levels. However whilst the information was being relayed correctly the switching to open the gates had failed causing the floodgates to remain closed and damming the water along Woodlands drain.

Water Cascading Over Weir with Gates Closed (Note no flooding to Road or Recreation Centre Site Occurred)

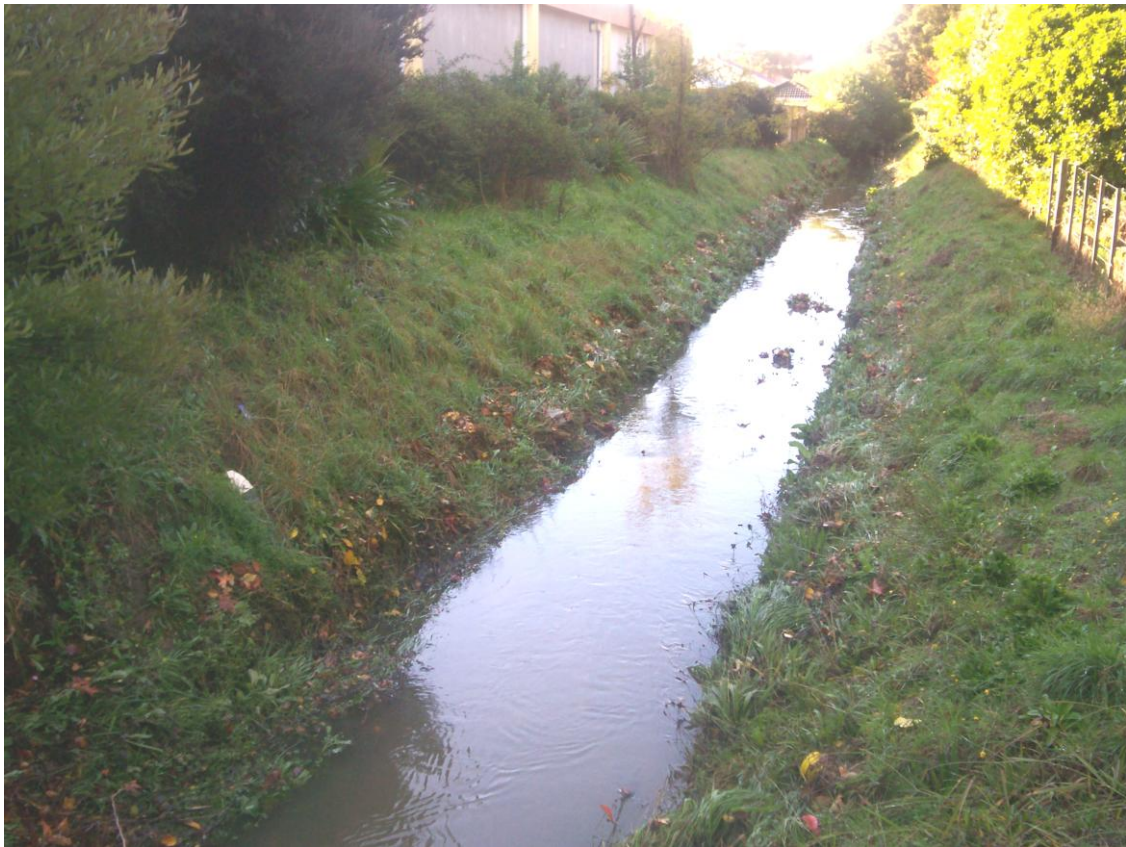
MWH also spoke to the relevant TDC Engineering Staff to update them on the situation. MWH staff also checked a number of areas on the upstream catchment to ensure no further issues had occurred, some of the upstream channels had surcharged, but not to an extent where they had overflowed and caused flooding issues (see photo start of Woodlands drain channel adjacent to New World).

Backup of Floodwaters outside New World (Head of Woodland Drain)

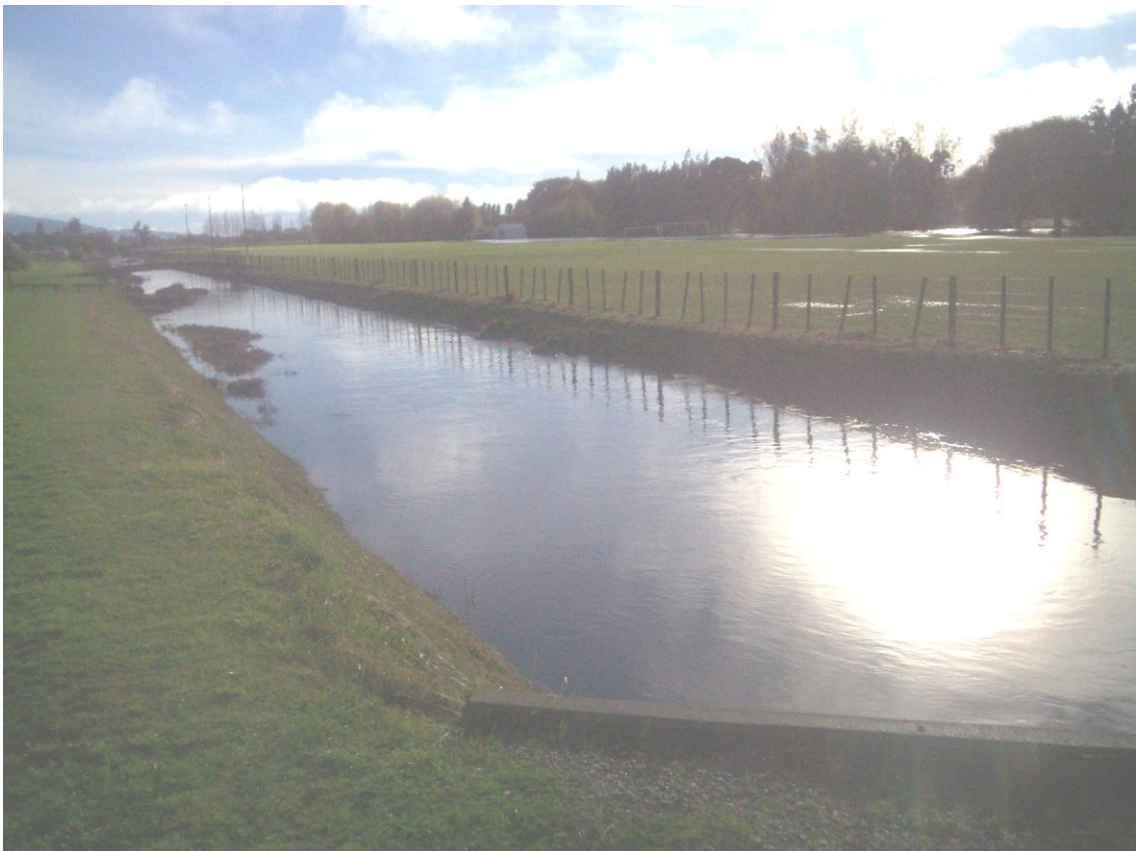
Woodland Drain after gates commenced manual opening

MWH quickly decided that the only option was to get to the site and open the gates manually. This was undertaken in a way they could control the amount the gate was opened, i.e. in stages, to control / limit the volume of stormwater being released down the channel thus avoiding any effects from a sudden release of floodwaters. This worked very well and over a period of approximately 40mins, MWH opened the gate in stages and the water levels dropped to the appropriate levels (See attached photos). Whilst one of the MWH contractors was opening the gates gradually, another of their engineers was monitoring the downstream channel area and surrounding area to ensure no detrimental effect was occurring.
