## STAFF REPORT

**REFERENCE:** RD3499

**SUBJECT: LORD RUTHERFORD ROAD SOUTH - SPEED LIMIT AND BRIDGE SAFETY REVIEW**

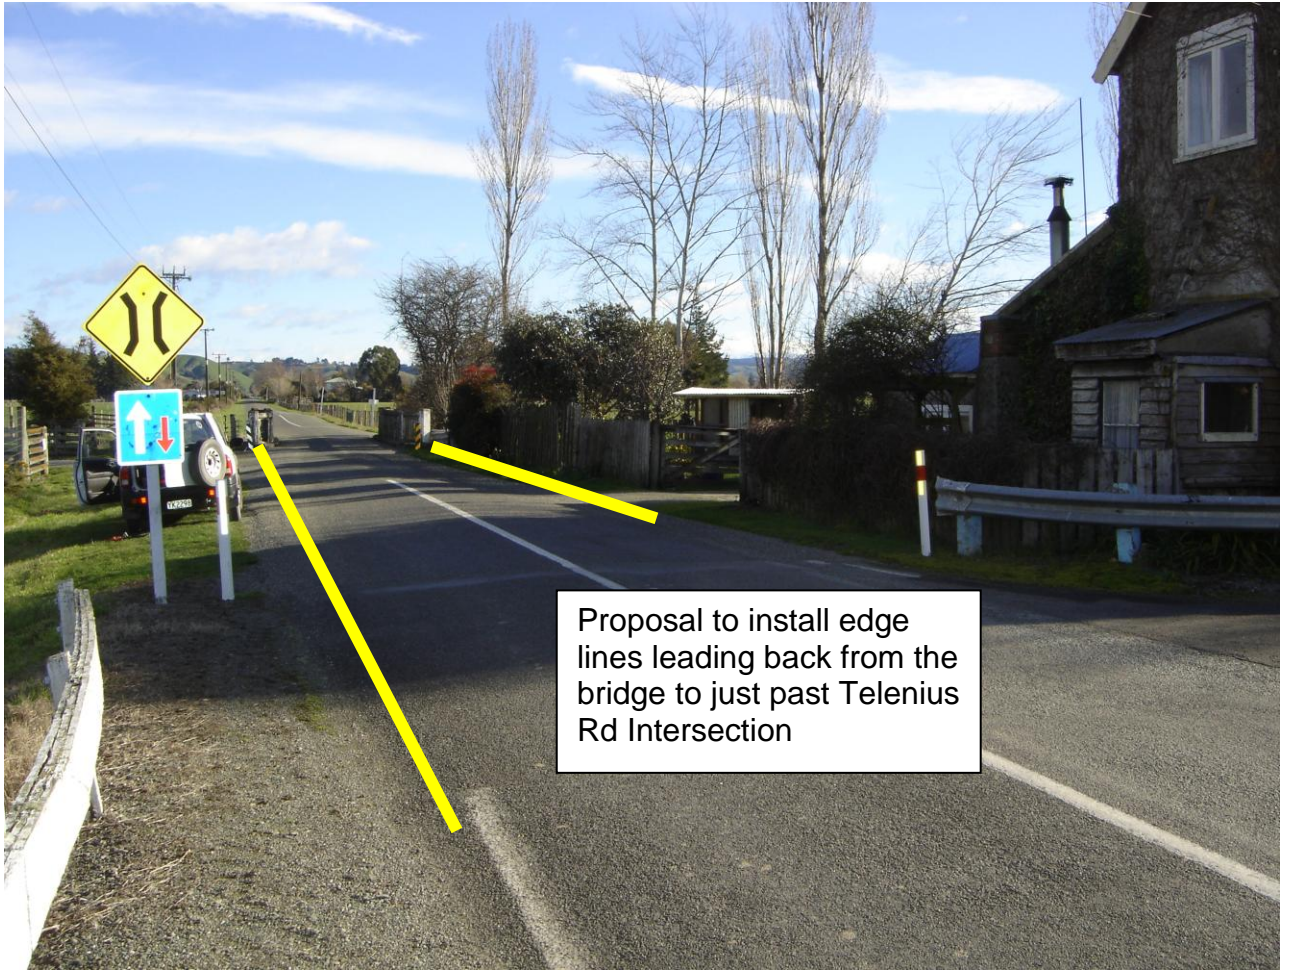
Looking South

Proposal to install edge lines leading back from the bridge to just past Telenius Rd Intersection

- 3.1 Install on Higgins Road on the southern side of Telenius Bridge for drivers travelling towards Brightwater, a Permanent Warning Sign with supplementary plate with the words "Concealed" underneath, indicating the hidden intersection of Telenius Road ahead.
- 3.2 Install edge lines leading up to both abutments of the bridge as per the Manual of Traffic Signs & Markings Manual (MOTSAM).
- 3.3 Mark on Lord Rutherford Road South on the northern side of the bridge in the South bound lane the words " ONE LANE BRIDGE" similar to the message in the North bound lane.
- 3.4 A further advanced single lane bridge warning sign installed on Lord Rutherford Road South, at the correct position approximately 160metres north of the bridge.

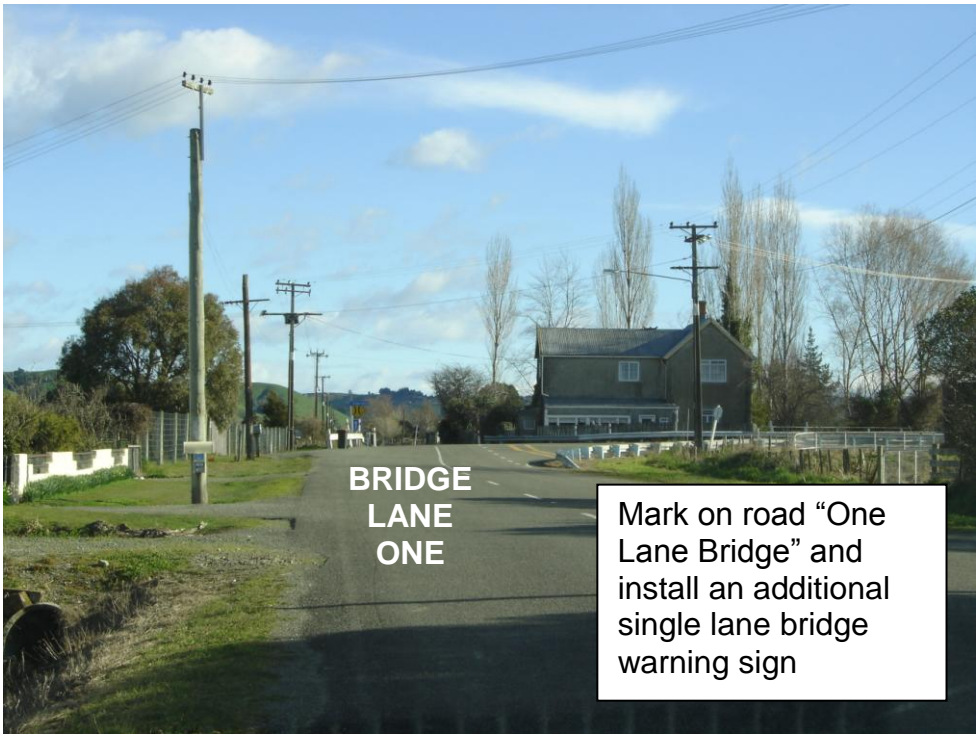
Looking South with Telenius Rd Intersection on Right

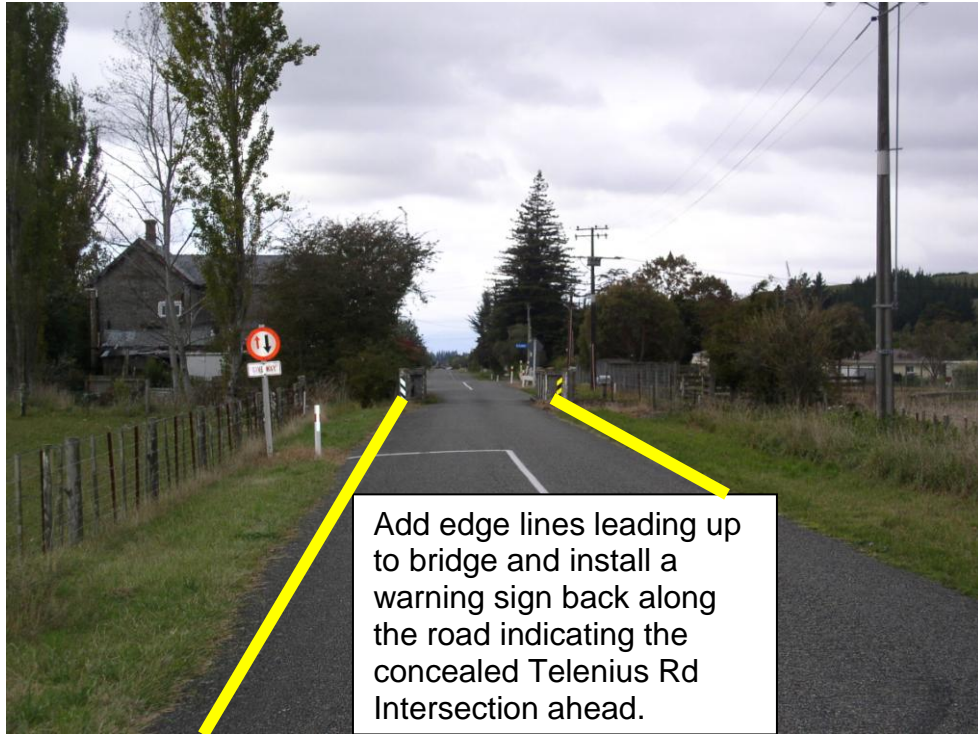
This bridge is in good structural condition and unfortunately does not justify replacing under LTNZ's economic evaluation procedures.

A recent resource consent granted to the Hannah's for a three lot subdivision near the bridge requires the upstream concrete parapet of the bridge to be removed and replaced with appropriate guard rail and end terminals. Ideally, the downstream parapet needs treating similarly and undertaken at the same time. This work would need to be paid for by Council most likely out of its Minor Safety Budget.

Telenius Bridge on Higgins Road – Looking North

**THAT the current speed limit of Lord Rutherford Road South remain unchanged for now, and that the proposed improvements to markings and signs at Telenius Bridge be undertaken as well as investigation into replacing the downstream parapet with guardrail and end terminals.**
