**Tasman District Council**

**Site Investigation of Sheep Dips and Slipways using a Portable X-ray Fluorescence Meter (XRF)**

**Contaminated Site Remediation Fund Contract Number 20369**

**October 2013**

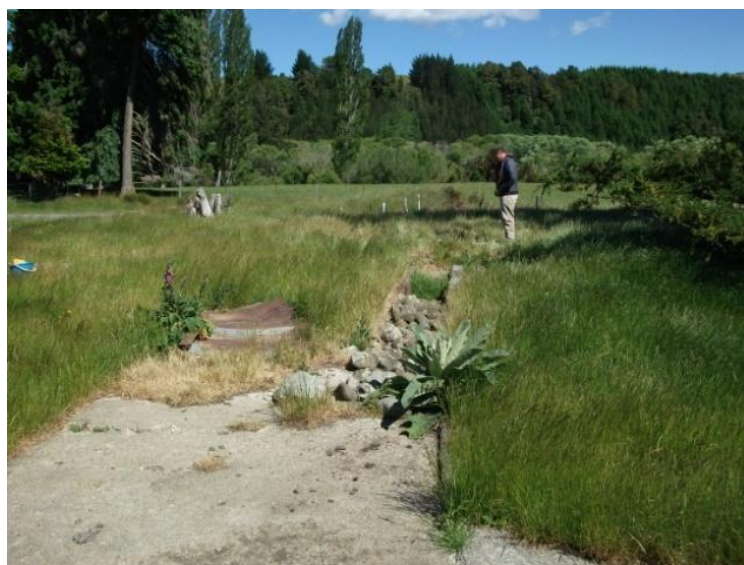
Photo 1: Old Communal dip site

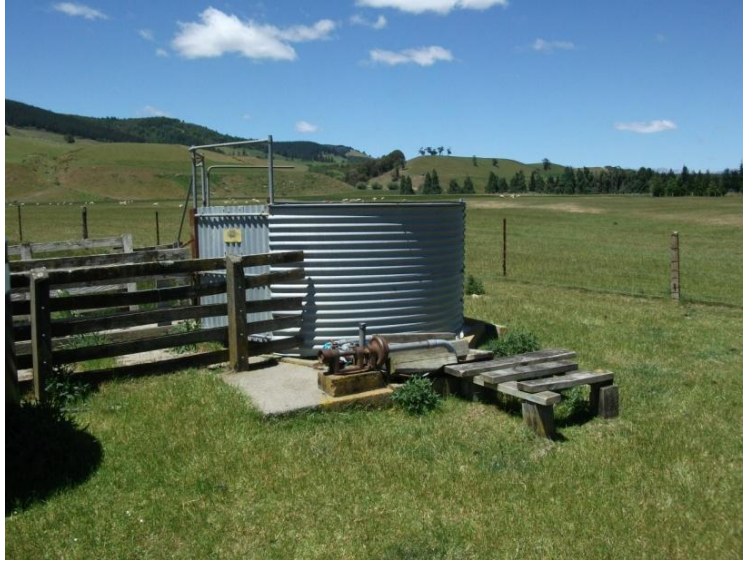
Photo 2: Private Shower Dip

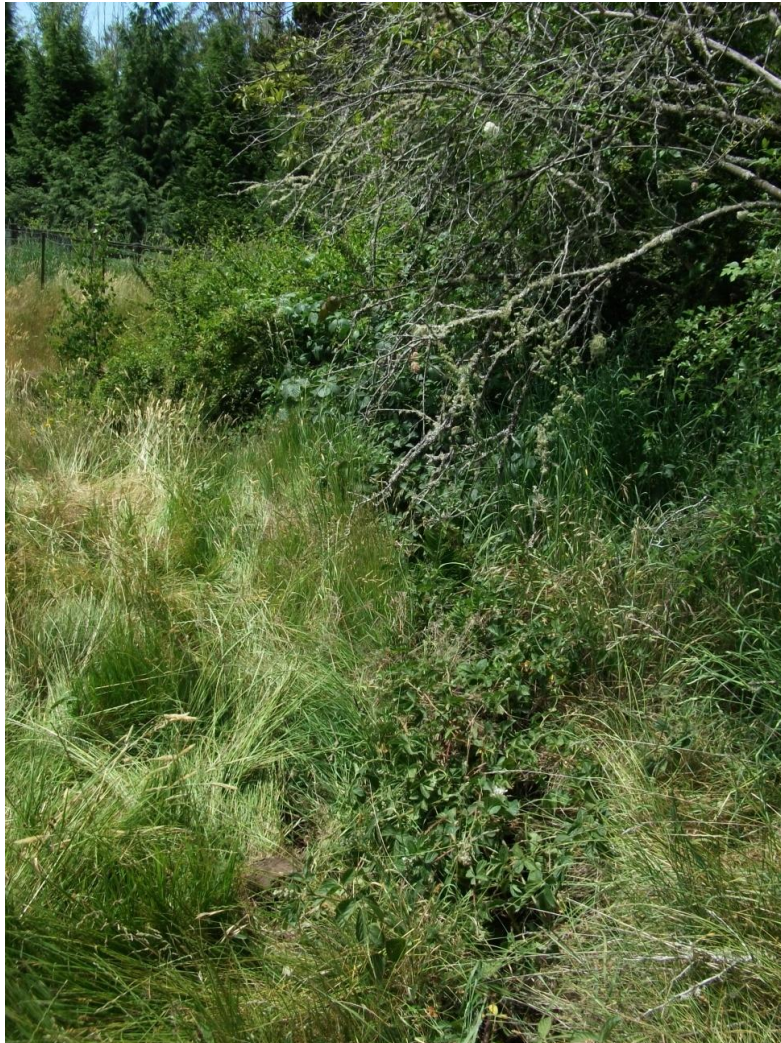
Photo 5: Cryptic community plunge dip

With the help of the previous owner it was found that the dip itself was located on the opposite side of a stream which flowed past the yards. Once the sheep were within the yards they were driven over a wooden bridge crossing the stream into a plunge dip at the far end. The sheep then exited the dip into a small holding paddock on the far bank. XRF samples around the dip showed high arsenic levels with a maximum concentration of 494 mg/kg in the immediate splash zone of the dip. (See Figure 2 below). The arsenic was spread throughout the holding paddock area on that far side of the creek. The arsenic was also present on what is now an adjoining property located downhill of the dip structure.

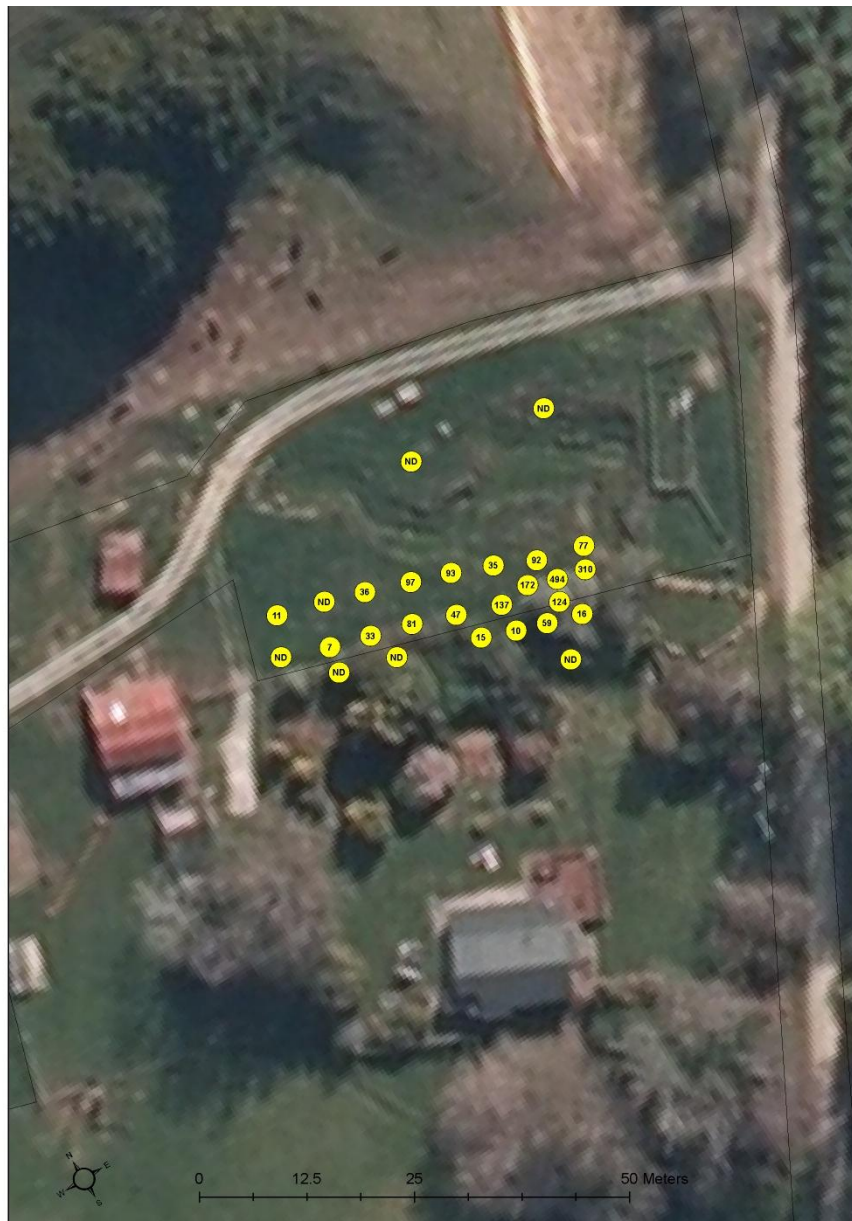
Figure 2: XRF Arsenic levels in mg/kg old Community Dip 1

A laboratory arsenic sample was taken at the location of the highest XRF result to compare against the XRF results. The arsenic concentration of the laboratory sample was over twice that of the XRF arsenic (1150 mg/kg). This difference highlights the variation which can occur between two different analysis methodologies but does confirm that both methods indicate very high levels of arsenic contamination. Arsenic results in the immediate vicinity of the dip greatly exceed the human health standards under the National Environmental Standard for Assessing and Managing Contaminants in Soil to Protect Human Health 2011 (NES) of 17mg/kg for rural residential/lifestyle use. The results also exceed the Health and Environmental Guidelines for Selected Timber Treatment Chemicals (Ministry for the

Environment and Ministry of Health, 1997) recommendations for stock health of 38mg/kg (see Table 1).

The laboratory sample was also analysed for Dieldrin with a result of 4.8 mg/kg. The dieldrin result exceeds the NES human health standard of 1.1mg/kg for a rural residential/lifestyle property and the recommended maximum stock guideline of 0.01mg/kg (Sheep Dip Factsheet No 2 Organochlorine Pesticides).

The Canadian guidelines establish a maximum zinc concentration for the protection of human health of 200 mg/kg while the Dutch Limit/ $\beta$  value is set at 500 mg/kg. The maximum zinc value recorded at Community Dip Site 1 was 427 mg/kg which exceeded Canadian but not Dutch maximum zinc values. Zinc contamination was generally found in the holding paddock area, however the area containing the maximum concentrations was located near an old shed to the west of the historic dip structure suggesting that a foot bath may have been nearer to that location rather than to the dip itself.

The landowner involved has been advised of the results of soil testing and the need to exclude people and stock from this area.

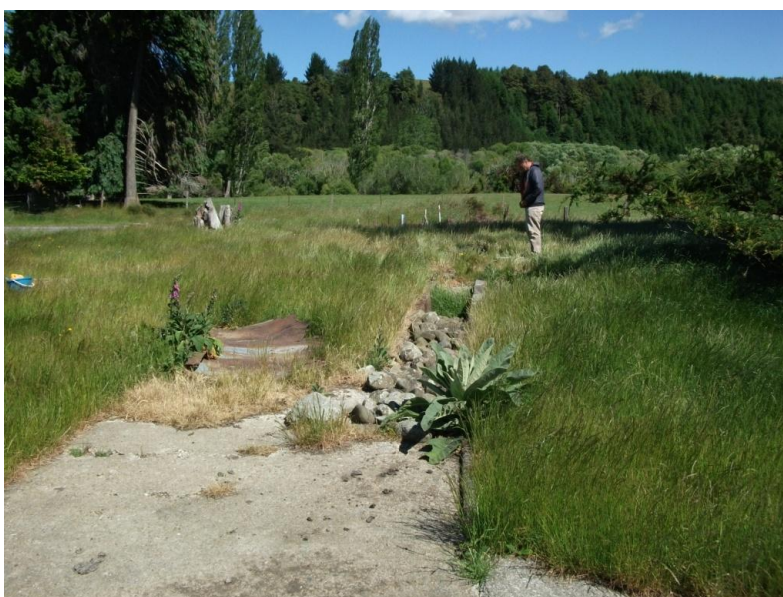
Photo 6: Old Community Dip 2

Initial sampling began with what was taken to be the disposal pit which showed very low arsenic concentrations. With the benefit of hindsight it is likely that the old disposal pit had been filled in with cleaner material following a tidy up around the site. However further testing around the splash zone of the structure soon showed highly elevated arsenic concentrations with a maximum XRF concentration of 1053 mg/kg (see Figure 3). High arsenic concentration extended for nearly 50 metres from the dip structure along the western boundary fence line which was assumed to have been the historic fence line in the days the dip operated as it is along a road frontage. A water course culverted under the road was also tested at both ends of the culvert to provide an indication of any contaminated sediment migrating off site. There was little indication of any such migration although it is likely that the culvert has been replaced since the dip was last operated.

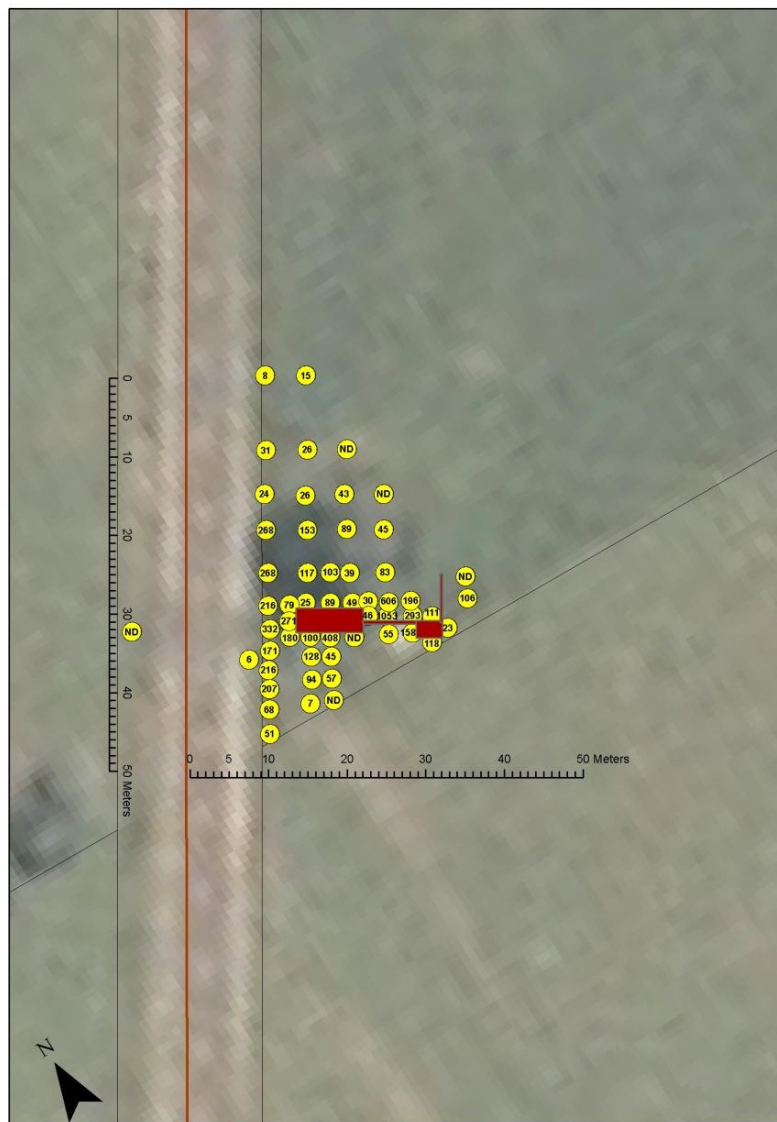
The area of land where arsenic concentrations exceed stock grazing guideline values (38 mg/kg) is approximately 650 m<sup>2</sup> while the area of land which breaches the NES for rural residential human health standard (17 mg/kg) is approximately 850 m<sup>2</sup>.

Figure 3: XRF Arsenic levels in mg/kg old Community Dip 2

A laboratory arsenic sample was taken at the location of the highest XRF concentration (1053 mg/kg) with a result of 380 mg/kg. Once again both samples confirmed that the soil was in a highly contaminated state but in this case the laboratory sample result was less than half that of the XRF result.

A dieldrin sample taken at the location of the highest XRF arsenic returned a 25 mg/kg concentration which was by far the highest dieldrin result recorded during the survey. The result substantially breaches the stock grazing guideline value of 0.01mg/kg and also the human health standard for rural residential and residential uses (1.1 mg/kg).

The maximum zinc concentration recorded was 1860 mg/kg greatly exceeding the Dutch Limit/ $\beta$  values. The distribution of zinc was very similar to that of arsenic however the area of highest concentration was located near the eastern end of the dip site suggesting this was the likely location of a foot bath.

The landowner has been advised that this area of the property should be fenced off and retired.

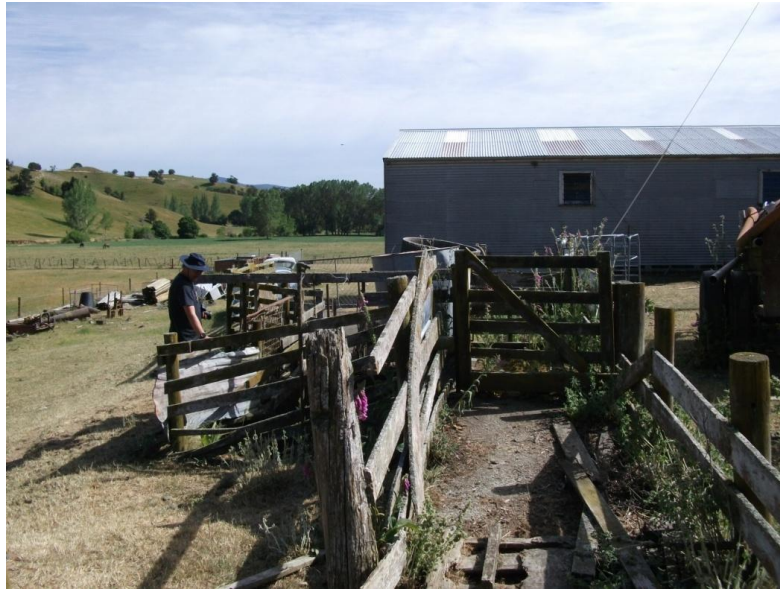
All the private plunge dips visited were disused (see Photo 7 below). The degree and distribution of contamination present varied with the age of the dip, the size of the property and decisions made by various landowners (a long time ago) regarding the type and concentration of dip chemicals.

Photo 7 disused private plunge dip

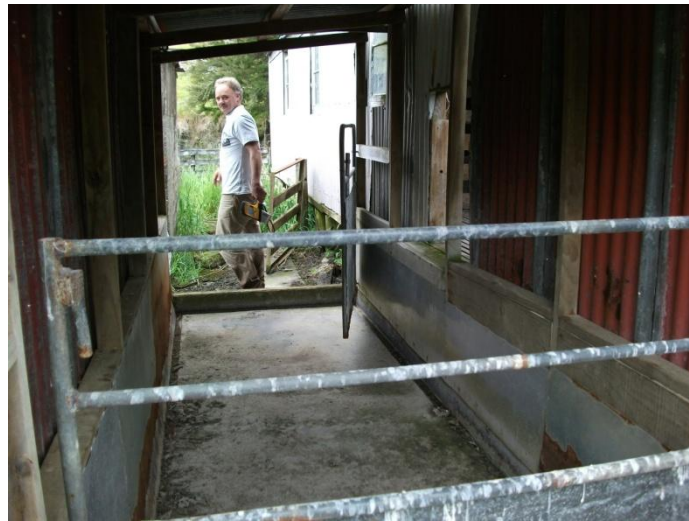
Two of the plunge dips had foot baths associated with them (2 and 3). In both cases the exit from the foot bath was in a different location to the exit from the dip itself. In and around the foot bath exit zinc concentrations were very high (>1000). Away from the foot bath location the zinc distribution mirrored arsenic concentrations within the holding paddock area. The zinc distribution associated with Private Plunge Dip 2 is shown in Figure 4 below. While the maximum zinc concentration measured at this site was a massive 3360 mg/kg, site investigations subsequently undertaken by a suitably qualified and experienced person engaged by the landowner identified zinc levels at nearly twice this concentration (5826 mg/kg) below the grate floor of the woolshed. The footbath for this site is shown in Photo.8 below.

Photo 8: Footbath at Private Plunge Dip with High Zinc Levels

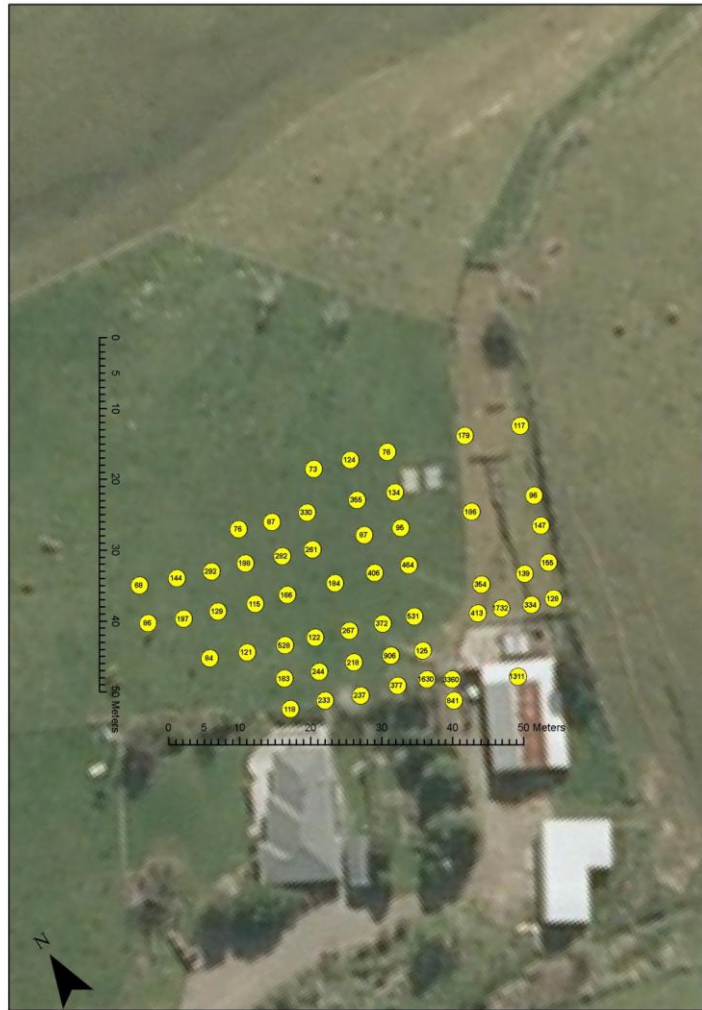
Figure 4: Zinc Concentrations (XRF) Associated with a Footbath at Private Plunge Dip 2 (mg/kg)

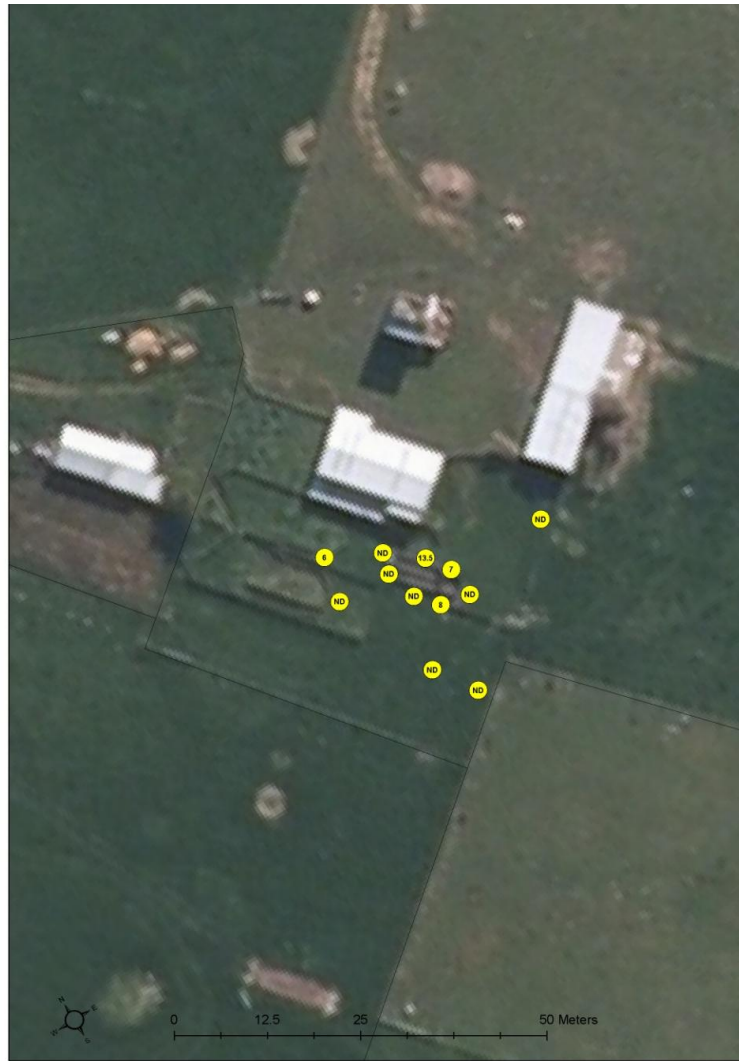
The oldest shower dip tested (Photo 9 below) had been disused for many years yet showed the highest concentration of all the contaminants tested for. In general shower dip sites showed lower concentrations of arsenic and dieldrin than did private plunge dip sites and much lower than community dip sites. In terms of extent spray dip sites tended to be smaller and more confined See Figure 5 below. The maximum contaminant concentrations for spray dip sites are given in Table 3 below.

Figure 5: Arsenic Contamination Spray Dip Site in mg/kg

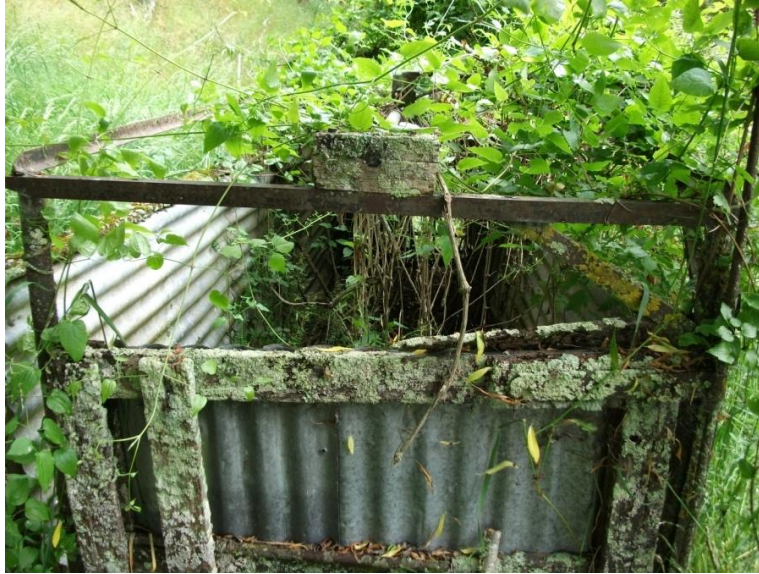
Photo: 9 Old Shower Dip Site 4

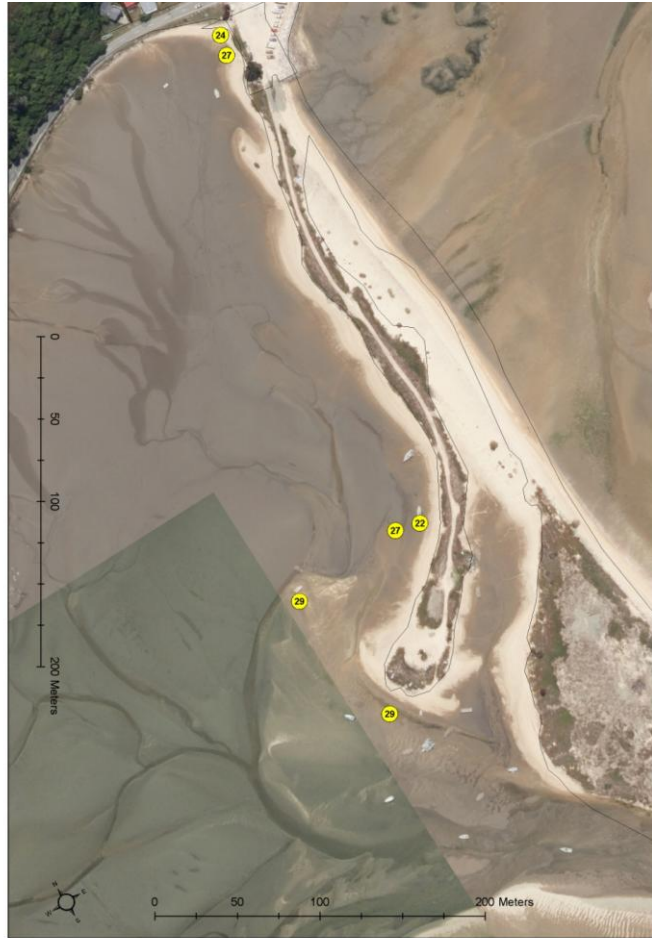
Figure 6 below shows the Otuwhero inlet in the Marahau area with small recreational vessels on swing moorings. Within the Otuwhero Inlet measured copper levels were all below the detection limits of the XRF. The zinc levels while detectable were also at very low and probable background levels for the area.

Figure 6: Zinc levels Otuwhero Inlet (Marahau) in mg/kg

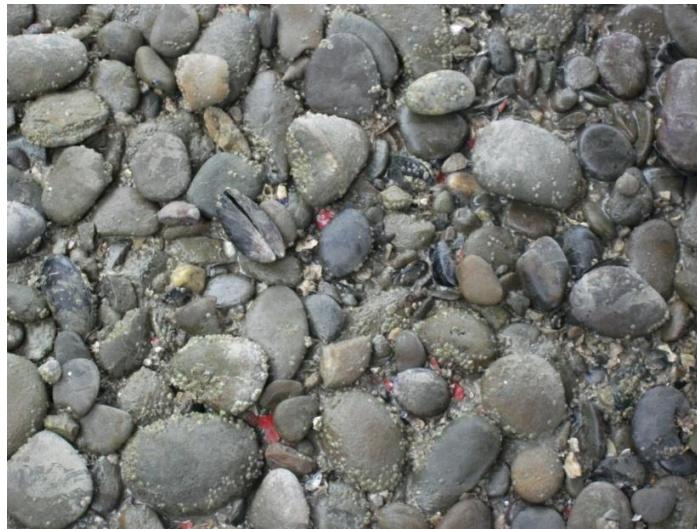
The one site where copper levels exceeded both ISQG low and ISQG high guidelines was at the Mapua wharf where a vessel was being maintained at the time of sampling. Paint flakes were clearly visible in the gravels immediately beneath the vessel (See Photo 10). XRF samples taken in the area beneath the hull amongst the paint flakes identified copper levels which just exceeded ISQG high (283 mg/kg) however away from the vessel by only a few metres copper levels had fell below ISQG Low (See Figure 7).

Photo 10: Paint Flakes below a vessel being maintained at Mapua Wharf

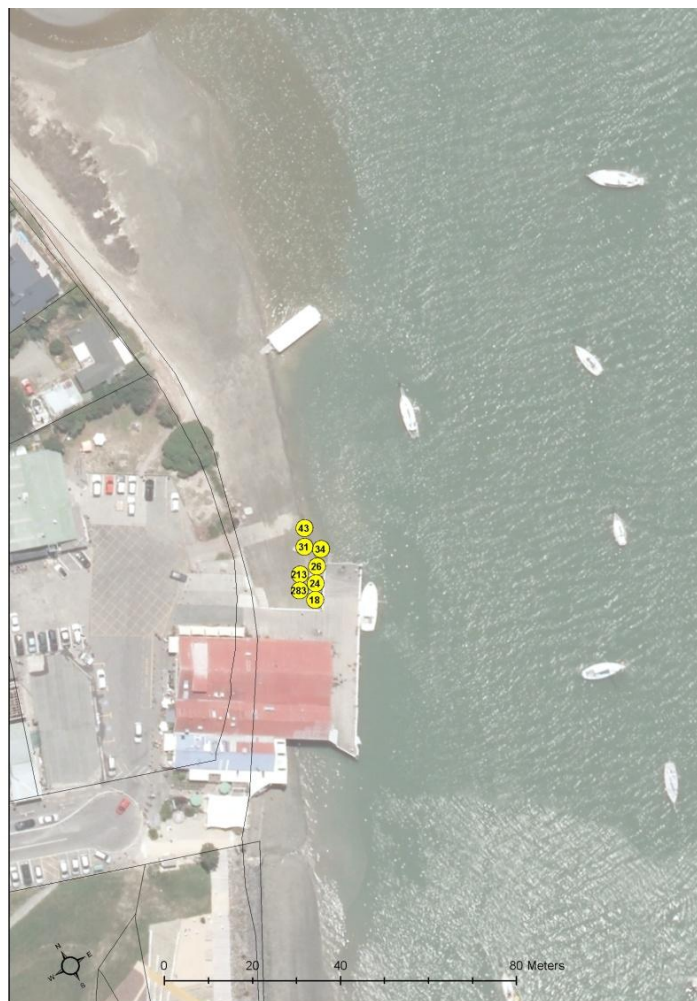
It is likely that the very strong tidal currents occurring at the Mapua Wharf quickly remove any paint material and flush it away diluting contaminant concentrations below possible effects levels.

Figure 7: Copper levels Mapua Wharf mg/kg

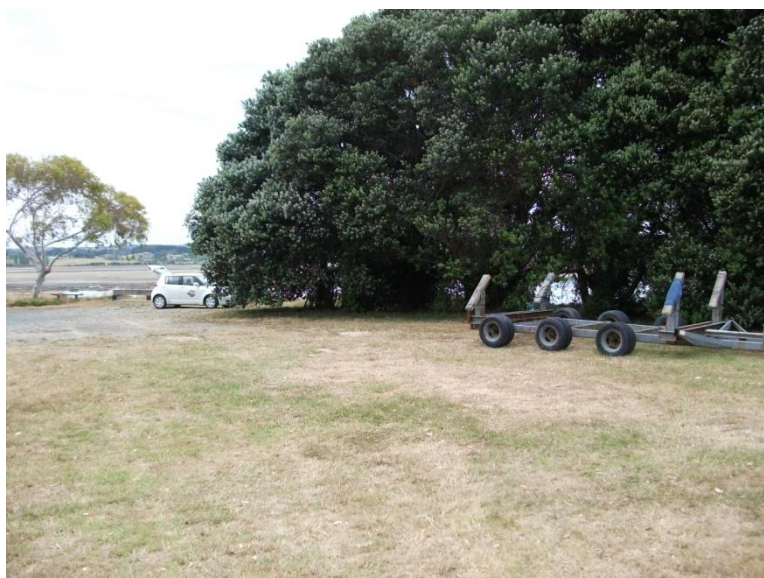
However sampling of the hard stand area at Grossi Point around the beach trailer revealed modest contamination of both zinc and copper distributed in a pattern which suggested work on a number of small vessels. Contamination levels of zinc were still below ISQG low levels, however, copper slightly exceeded ISQG Low but was well within ISQG High and well below NES standards (See Table 5).

Photo 11: Hard Stand Area Grossi Point Mapua and Beach Trailer

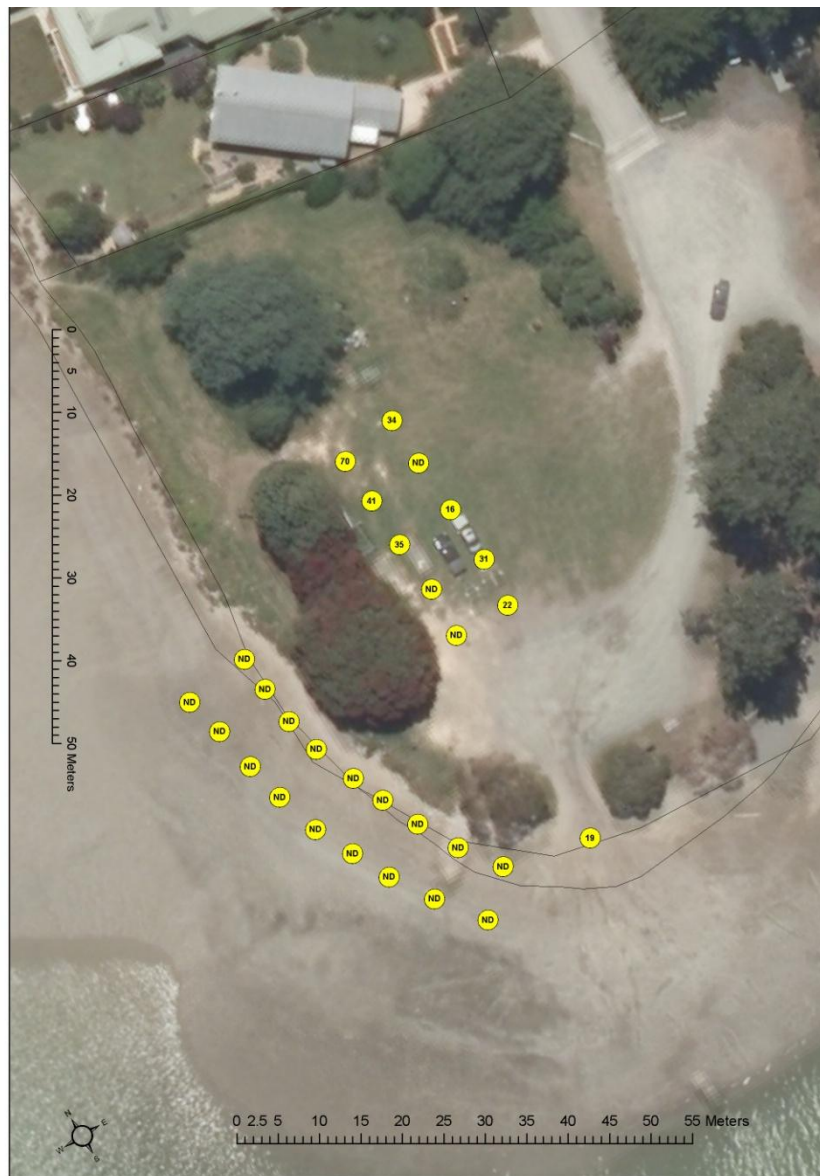
The intertidal beach area at Grossi Point was sampled using a grid pattern. Zinc levels recorded were all at near background levels. A copper detect was (19 mg/kg) occurred at the seaward end of the launching ramp. All other beach samples were non detects and all results were lower than ISQG Low (See Figure 8).

Figure 8: Copper Concentrations Grossi Point Mapua in mg/kg

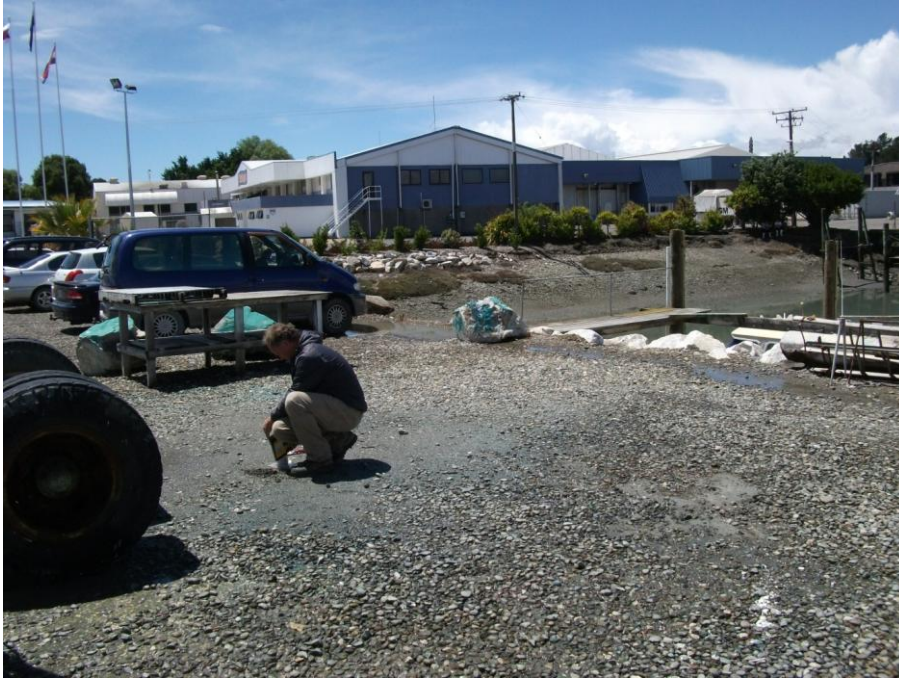
Photo 12: Motueka Slipway showing Paint Fragments in the Gravels and Paint Spray on Adjoining Rocks

Both slipways showed areas of extremely elevated copper and zinc concentrations well in excess of ISQG High levels indicating probable ecological effect. Both slipways also exceeded the NES standards for protection of human health indicating potential human health risks. The maximum concentrations of copper and zinc recorded at these two slipways are contained within Table 6 below.

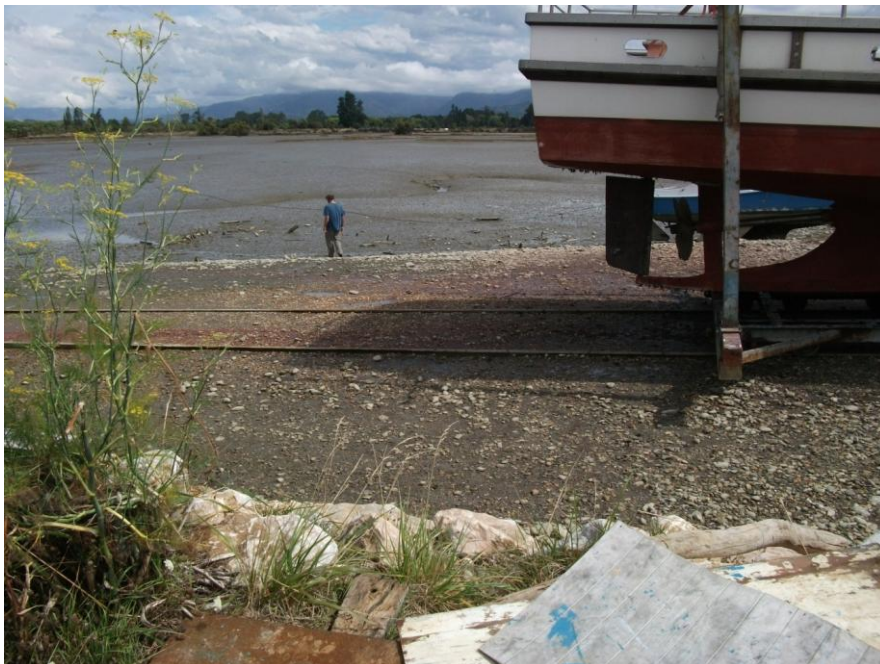
Photo 13: Waitapu Bay Slipway with Paint from Vessel Water Blasting Shown Near the Beach Cradle and on the Ramp and Beach

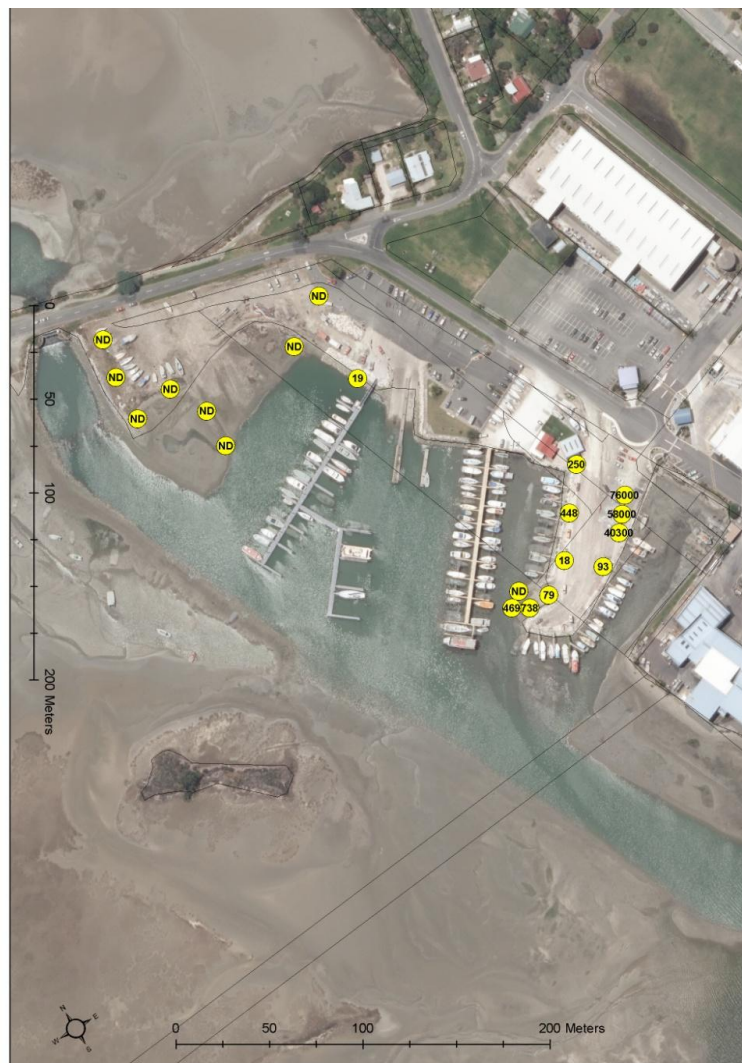
Sampling results from Port Motueka were highly variable. Much of the site had recently been resurfaced with fresh gravel and as a result some ramp and hardstand areas which otherwise may have show high contamination levels only showed low contamination levels, below the detection limits of the XRF. See Figures 9 and 10 below.

Figure 9 Port Motueka Copper levels Port Motueka in mg/kg

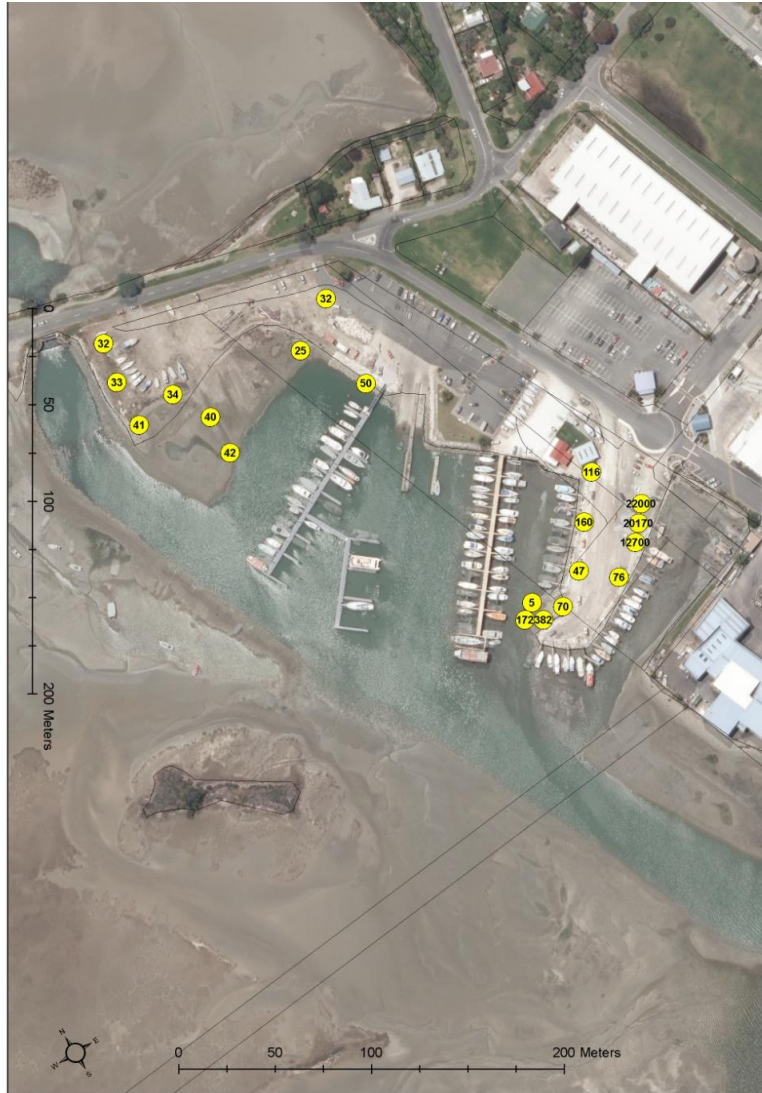
Figure 10 Port Motueka Zinc levels in mg/kg

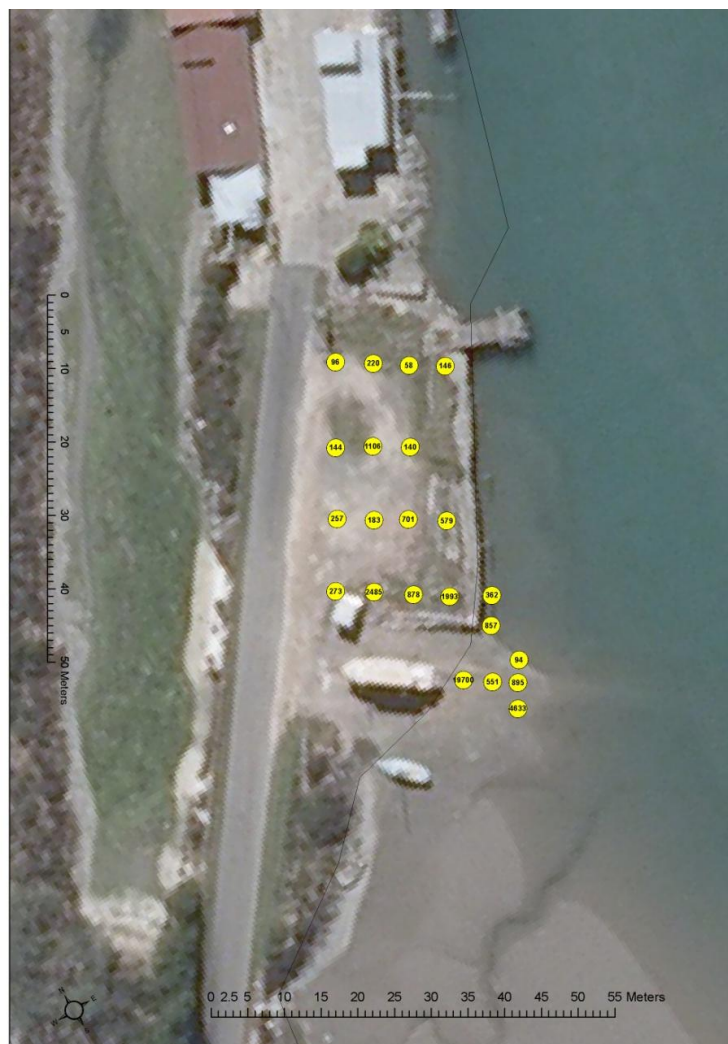
Figure 11: Waitapu Bay Copper levels in mg/kg

Within the slip rails area both copper and zinc concentrations exceeded both ISQG High and NES levels. The maximum copper and zinc levels were close to or under the vessel being maintained on the slipway at the time.

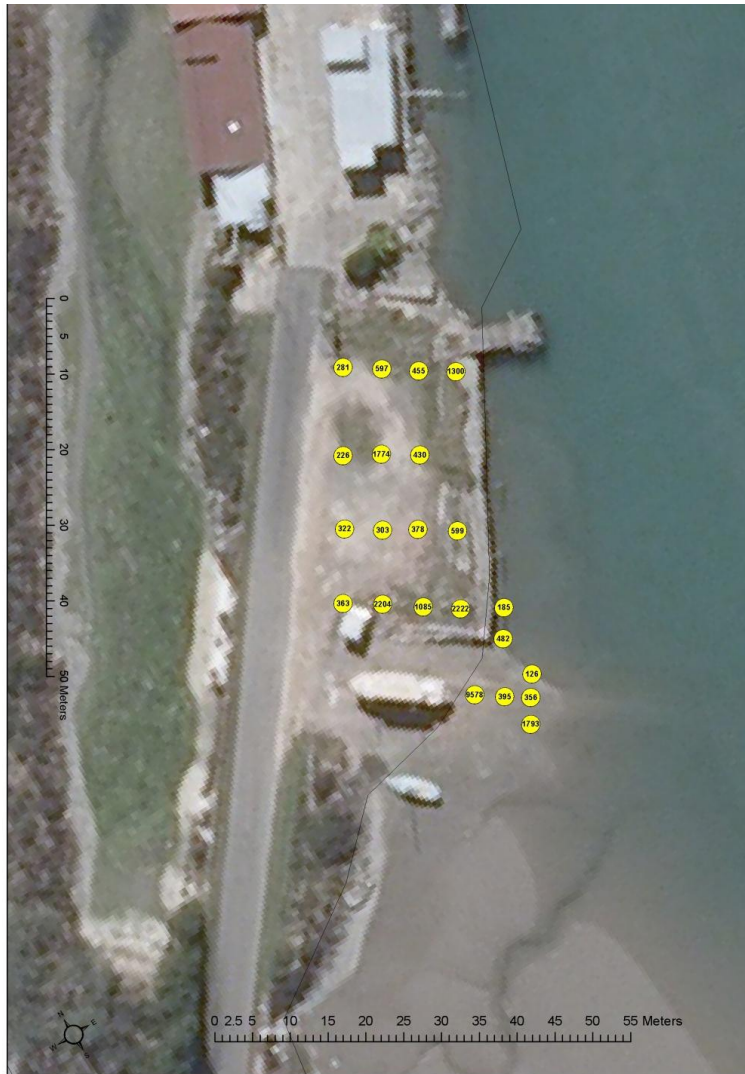
Figure 12: Waitapu Bay Zinc levels in mg/kg
