Synoptic assessment of ecological status of the southwest embayment of Kaiteriteri Estuary

Prepared for
Tasman District Council
March 2023

Salt Ecology
Report 109

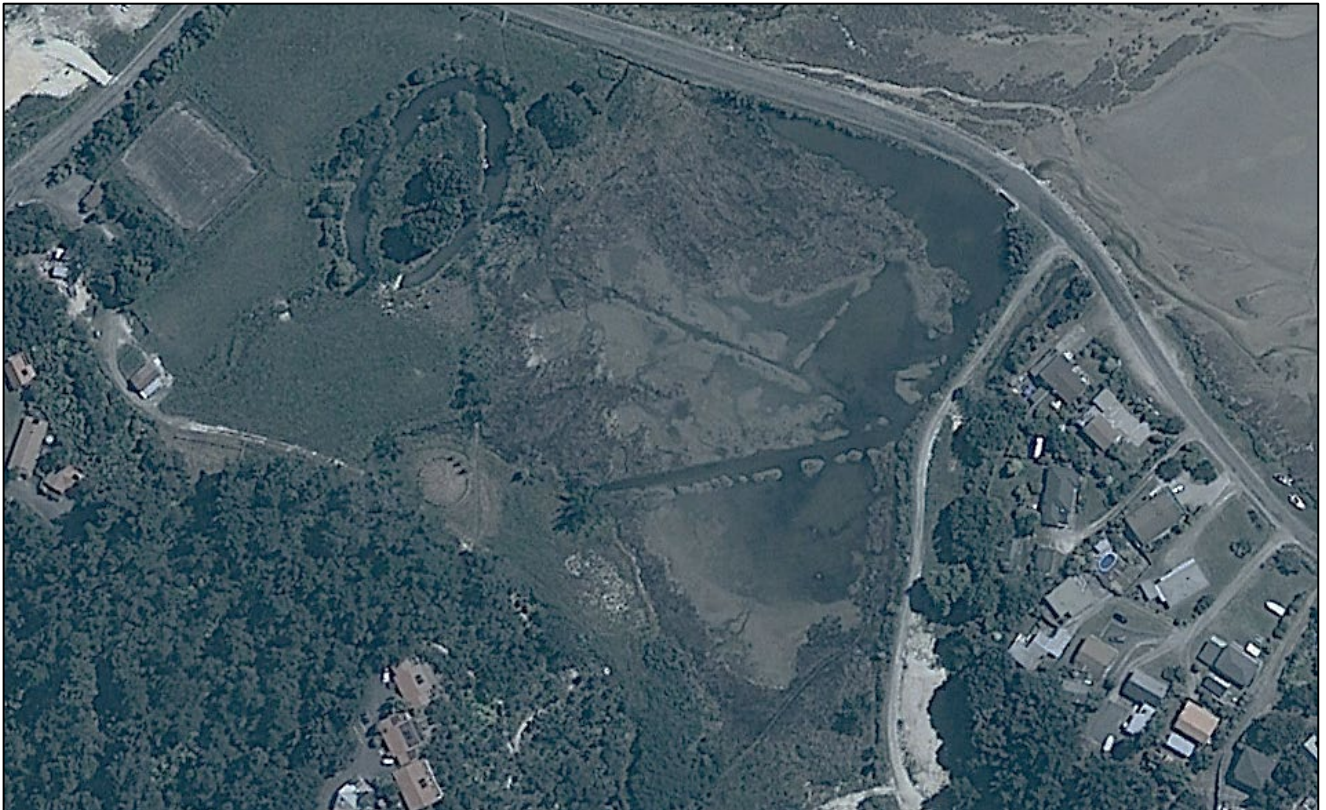
Photos taken over 2002-2006 indicate that there had been considerable re-establishment of previously lost salt marsh along the eastern side of the embayment, although salt marsh subsequently decreased between 2003 (Fig. 5) and 2011 (Fig. 6), with ponded water apparent in some areas. This decrease in salt marsh extent appears to be associated with the installation of five culverts beneath Martin Farm Rd in 2007, which was undertaken to "improve stormwater drainage from the catchments on the south side of Kaiteriteri Inlet and improve tidal flow through to the lagoon..." (TDC 2007).

Fig. 6. Kaiteriteri Estuary embayment in 2011 (source: Google Earth Historic Imagery) showing reduced salt marsh cover compared with 2003 (see Fig. 5), with the eastern and southern sections covered by ponded water.

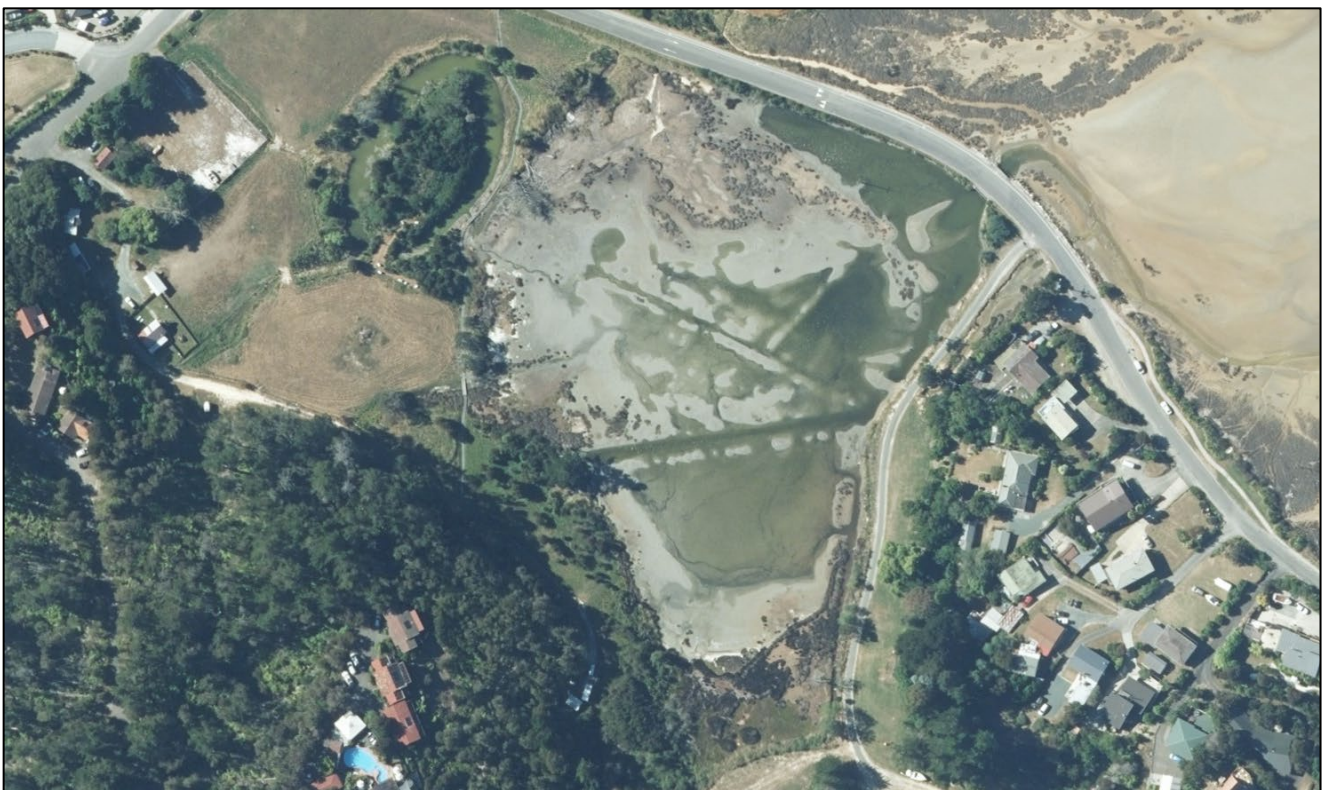
Present day salt marsh has receded even further than in 2011, now being limited mainly to the embayment margins (Fig. 7). Considerable ponding of water is evident even at low tide, reflecting slow and incomplete drainage of embayment water. Among other factors, ponding of water is almost certainly the key contributor to the salt marsh recession that has occurred (see Section 3).

Fig. 7. Kaiteriteri Estuary in March 2022 (source: LINZ Data Service – Tasman 0.3m Aerial Photos), showing that salt marsh has receded further since 2011, with only fringing areas remaining. The eastern and southern sections of the embayment are covered in ponded water.

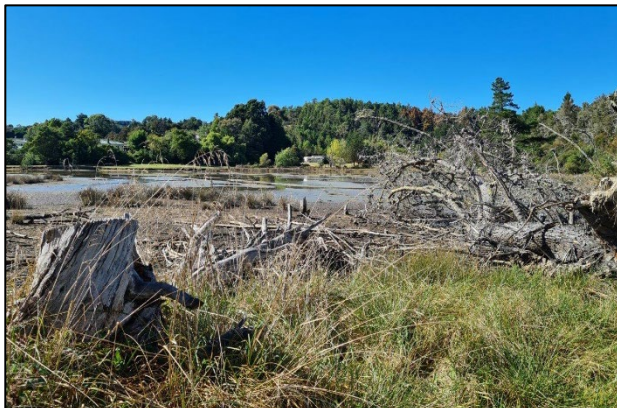
Superficially, the area of interest has a degraded appearance due to terrestrial weeds around the margin of the estuary, a fallen pine tree, and a constructed channel that was likely originally intended as an artificial wetland. Except for sand-dominated sediments in tidally-elevated areas in the northwest corner of the embayment, the sediment in the western side of the embayment consists of soft mud in a layer 50-250mm deep that overlies a firm base. The base material comprises soil with an entrained root mass, and is probably a remnant of the pasture and salt marsh habitats that have come and gone over time (Figs 2-7).

View of western margin of the embayment from Kimi Ora pathway, showing fallen pine tree and terrestrial grasses and weeds.

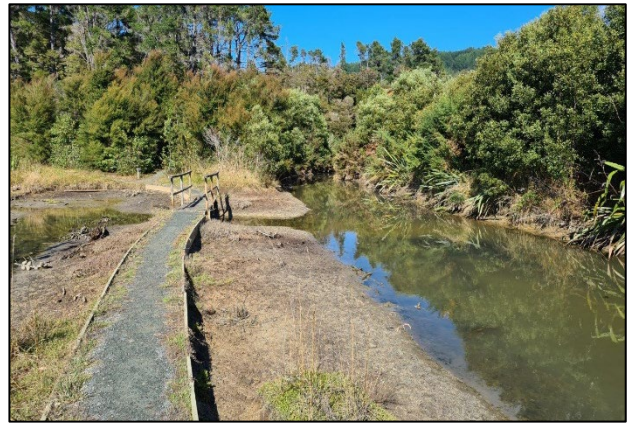
Constructed channel west of the embayment, which first appeared in aerials in the 1980s. The Kimi Ora Resort pathway follows the embayment's western margin.

sediments (i.e. anoxia). Other inputs that may be contributing to the poor condition of the sediment include ongoing inputs of terrestrial detritus that accumulate in the artificial channel, and intermittent inputs of stormwater.

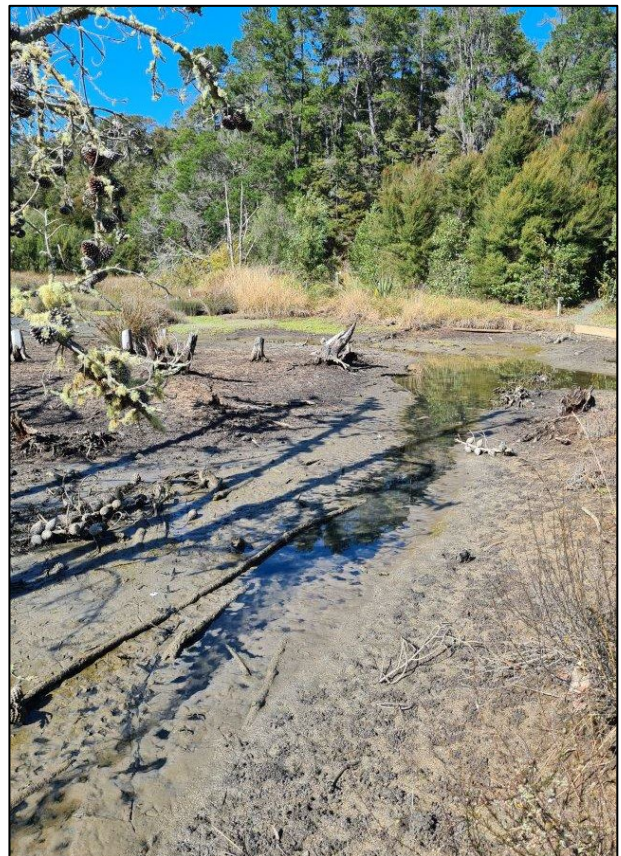
Sediments in muddy areas show strong symptoms of severe organic enrichment, in particular:

- A deep black colour throughout the sediment profile and in places at the sediment surface.
- A strong 'rotten egg' smell of hydrogen sulfide, which results from microbial decay of organic matter.
- Presence of yellow/green mats of microalgae, or white mats of sulfate-oxidising bacteria.

Black, anoxic surface sediments next to Kimi Ora walkway.

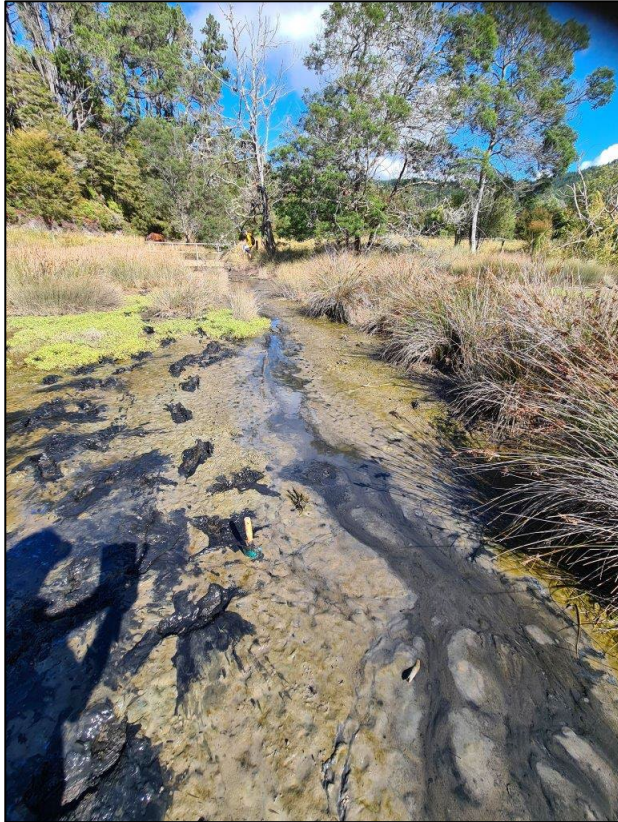
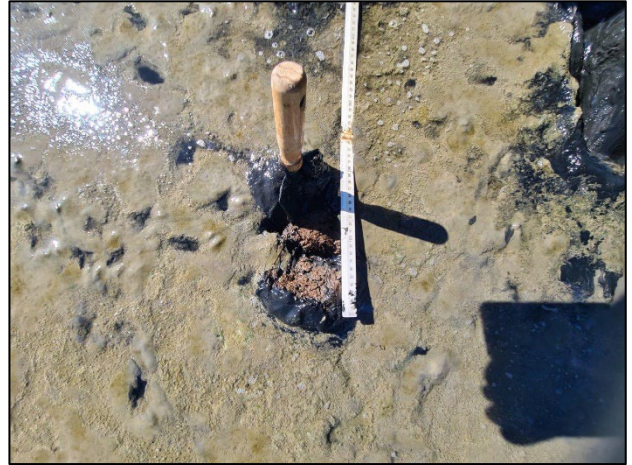
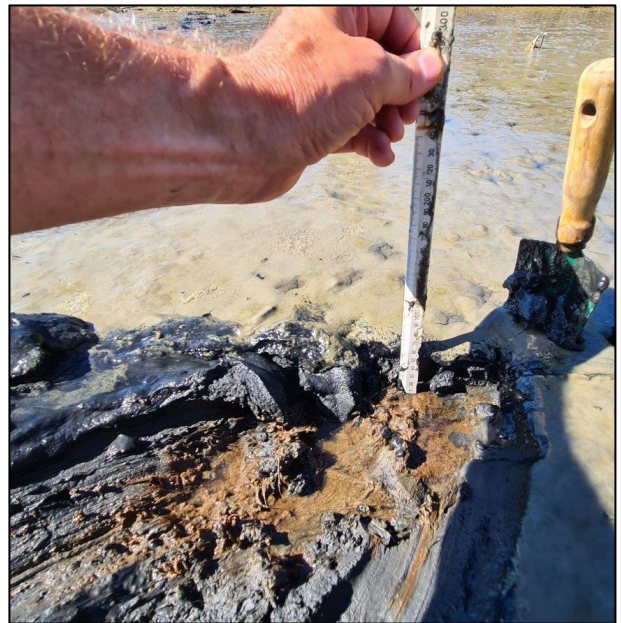
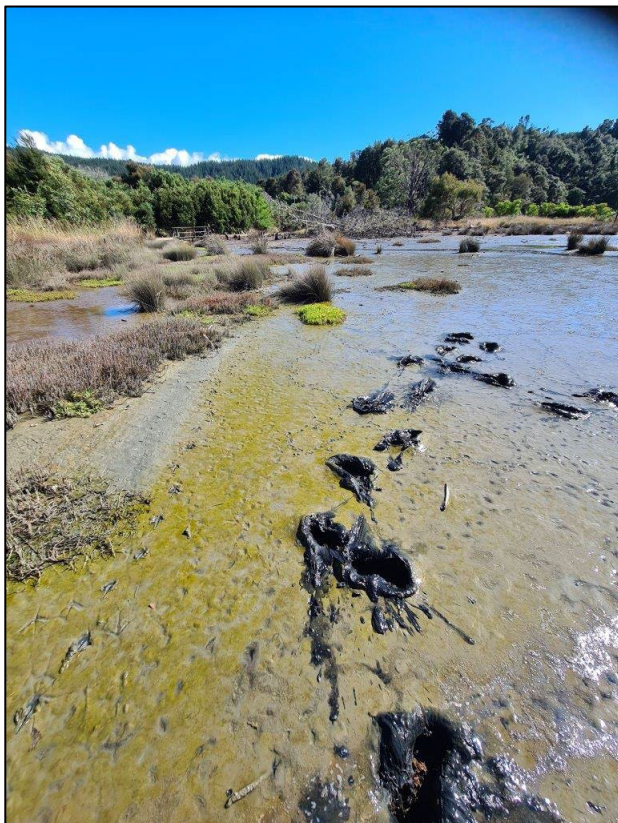
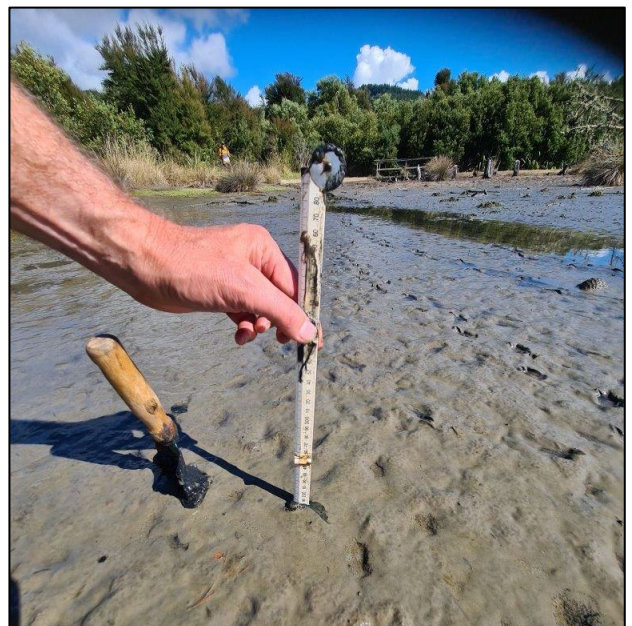
Soft muddy sediments along the blind channel entering the western margin of the embayment (top), and along the embayment margin (bottom), were highly anoxic, evident as black colouration with a strong hydrogen sulfide odour (rotten egg) when disturbed. In places yellow/green mats of microalgae, or white mats of sulfide-oxidising bacteria, were also present, which are indicators of extreme sediment enrichment.

The depth of the anoxic muddy sediments was approximately 50-250mm deep, and overlaid a firm soil base in which the root mass of former vegetation is still present.

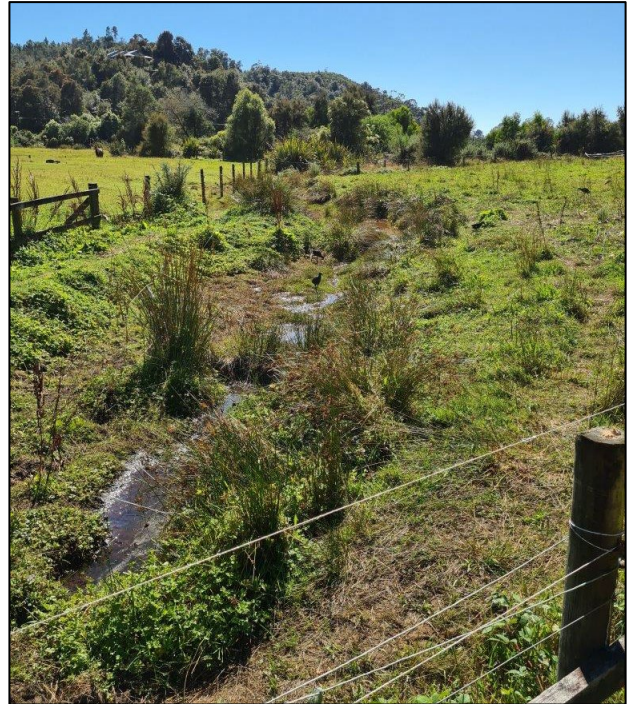
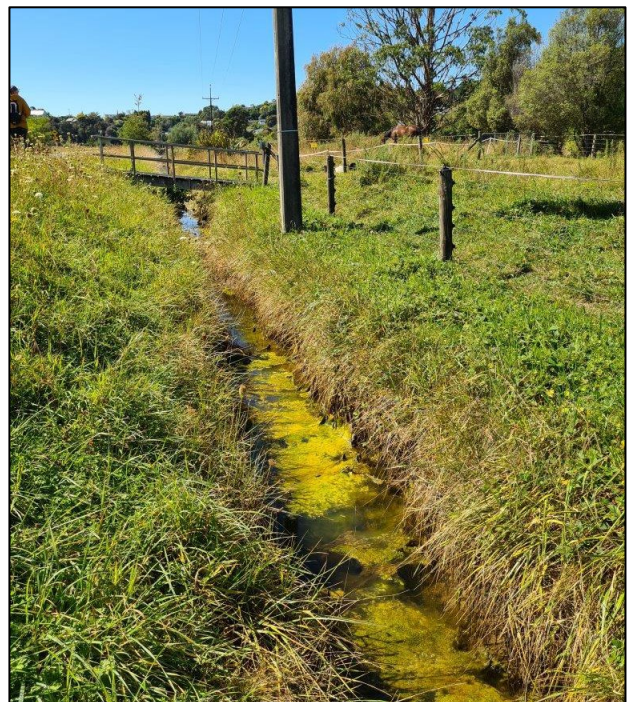
The embayment has no regular catchment inputs such as perennial stream flows. Four 'blind' input channels that were identified in the field and/or from aerial photos are shown in Fig. 8. Some of these retained stagnant water and algal growths but none were flowing. These channels would potentially carry stormwater during heavy rain, and such events would also contribute direct stormwater runoff to the embayment.

Water ponded in blind channels connected to the embayment

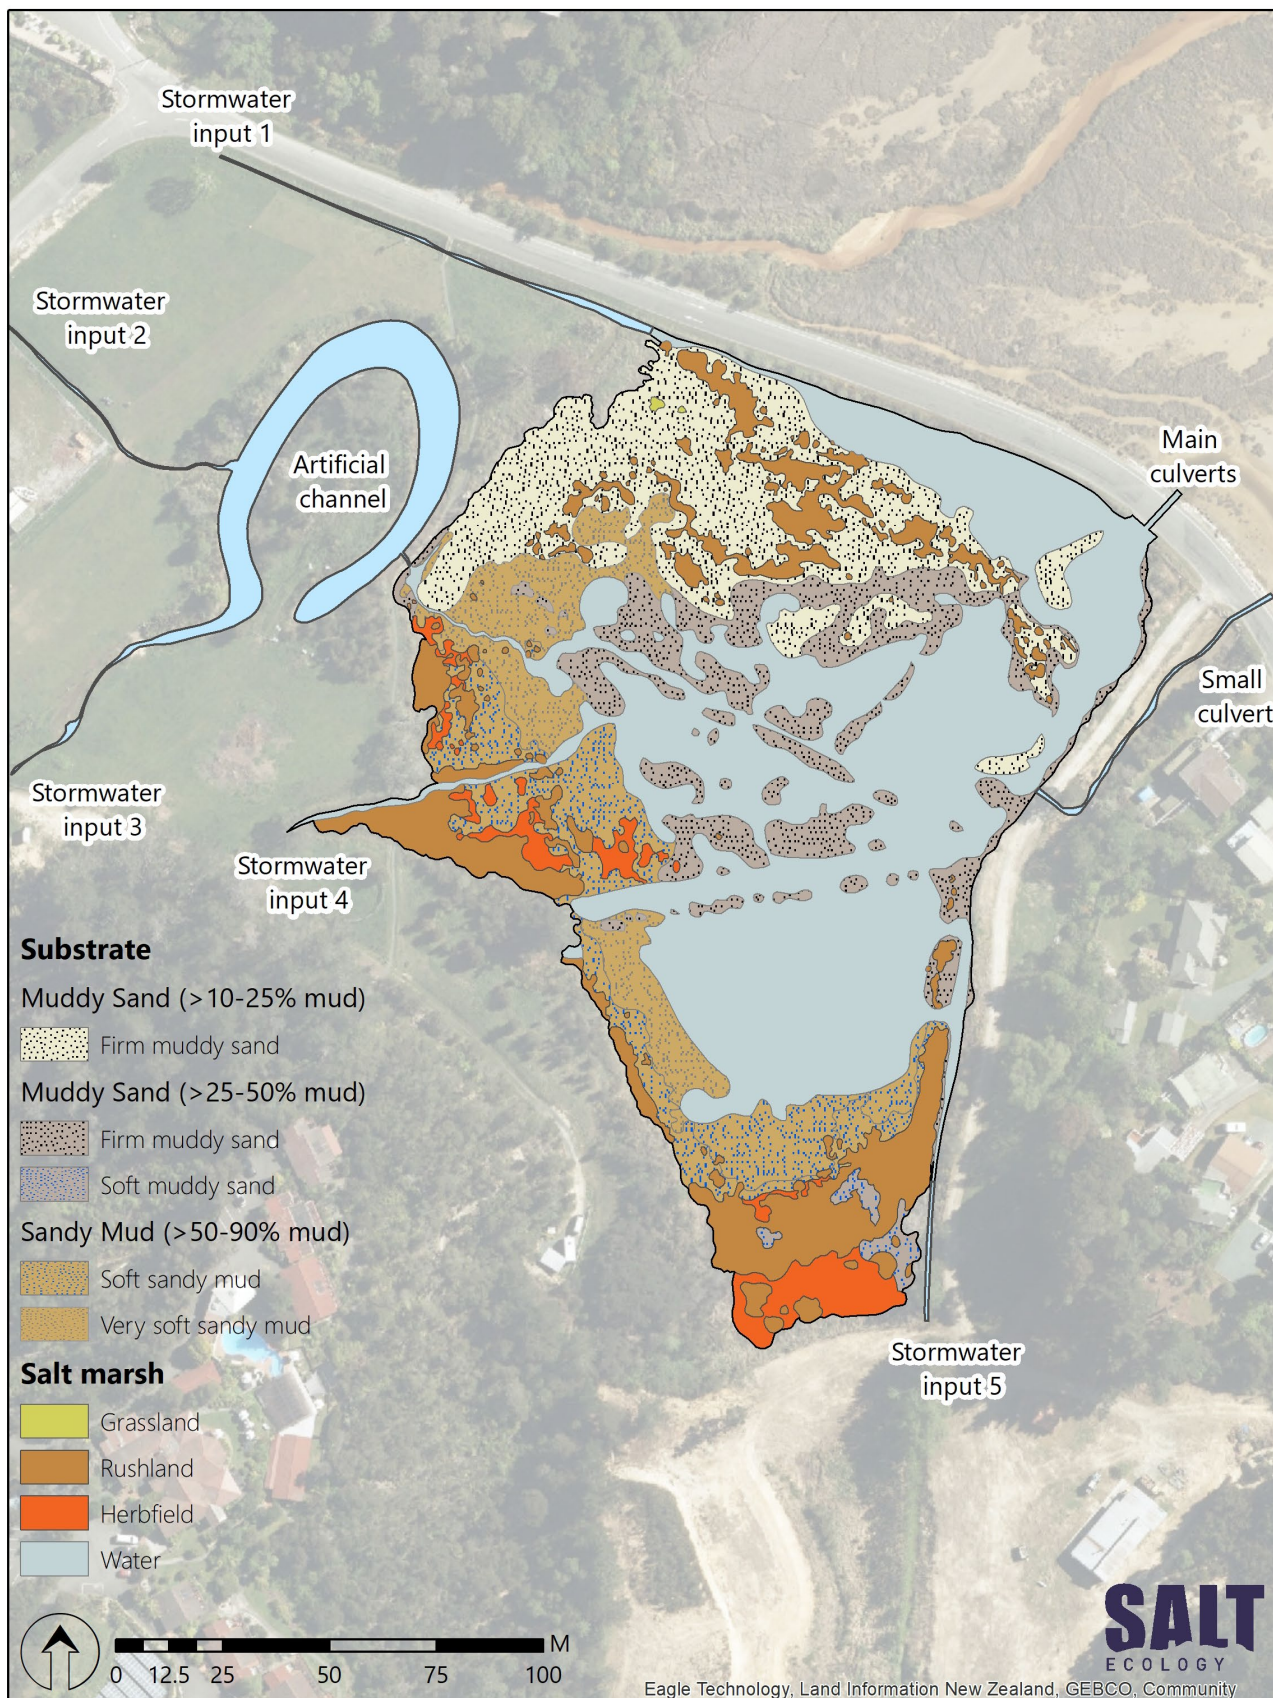
A habitat map showing GIS layers for sediment type and salt marsh across the entire embayment was constructed from a combination of recent aerial imagery, maps produced by Rayes et al. (2019), ground-truthing undertaken along western side in February 2023, and related photographic records and observations (Fig. 8). In February 2023 we did not investigate the eastern two thirds of the embayment beyond the area owned by Kimi Ora, but it appeared superficially similar to the western side. Our preliminary assessment suggests that the overall embayment area of ~2.4ha consists of ~0.5ha of muddy and likely enriched anoxic sediments, with a fringing salt marsh covering an area of ~0.4ha.

Fig. 8. Dominant salt marsh vegetation and sediment types in Kaiteriteri Estuary embayment. Constructed from a combination of recent aerial imagery, maps produced by Rayes et al. (2019), ground-truthing undertaken along western side in February 2023, and related photographic records and observations. Note that the embayment is connected to the main estuary by the main culverts under Martin Farm Road toward the northeast.

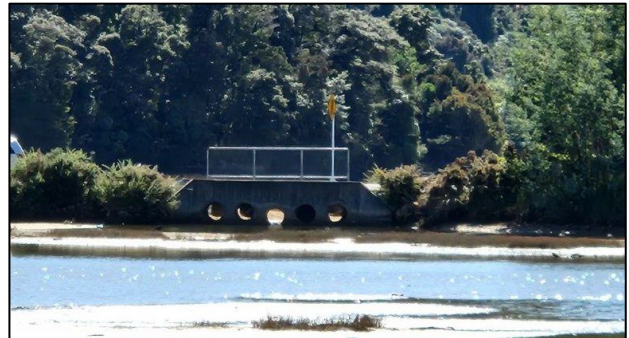
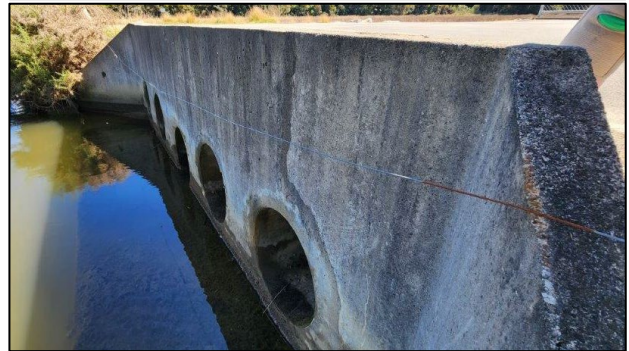
While the culverts will have improved tidal exchange, their design does not enable the embayment to fully drain, leading to a shallow layer of seawater that remains trapped at low tide. Drainage is impeded by the fact that four of the culverts were deliberately perched above the embayment bed level, with a single central culvert positioned at a lower tidal elevation to enable ongoing water outflow during low tide. The purpose in doing this was to "retain the status quo in terms of high water levels and habitat values in the lagoon area" (see discussion of these values in Section 4 below). Flap gates fitted to the four perched culverts were intended to prevent tidal water entry, with the gates intended to be open on ebbing tides and during heavy rainfall events when stormwater flows exceed the capacity of the lower central culvert.

Culverts from embayment side (top and middle), with only one flowing during the mid-outgoing tide.

Underpinning all three outcomes is improving the flushing of the embayment. Removing the flap gates from the four culverts would improve tidal exchange, but the perched nature of all but one of the culverts means that ponded water will remain. We suggest that TDC consider undertaking an engineering assessment to determine the works that would be required to achieve complete tidal flushing of the embayment. Among other matters, such an assessment would involve:

- Determining the number and/or size of culverts required to enable tidal water exchange without a significant lag.

- Ensuring the invert of the culverts was at least as low as the sediment bed level of the embayment, noting that the bed level may lower if existing mud is gradually eroded by increased tidal water flow.

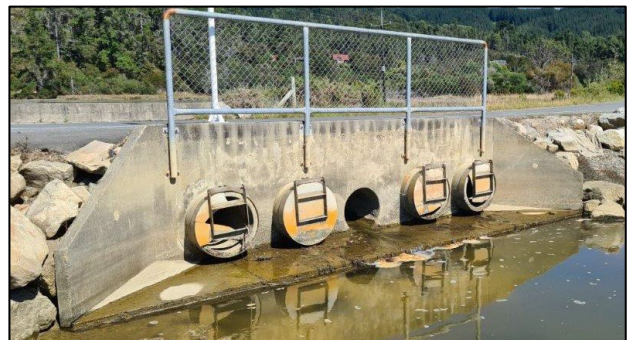
The adjacent photos show that the flap gates on the four perched culverts are partially closed and/or broken, which will impede tidal water inflow and outflow. Furthermore, even though the central culvert is positioned lower in the tidal zone, it is insufficient to drain the entire volume of the embayment during tidal outflow. As well as leading to ponding of water across much of the embayment, the resulting present-day poor flushing means even low-level muddy sediment inputs from catchment disturbance, stormwater inputs and/or tidal inflow will be readily retained and deposited.

Culverts at mid-outgoing tide on main estuary side (bottom), showing flap gates on the four culverts that are perched above the bed level. Only the central culvert is draining the embayment. The flap gates on the four perched culverts were partially closed and/or broken.
