Plan Change 65 Dambreak Assessment

Prepared for
Tasman District Council

Prepared by
Tonkin & Taylor Ltd

Date
July 2017

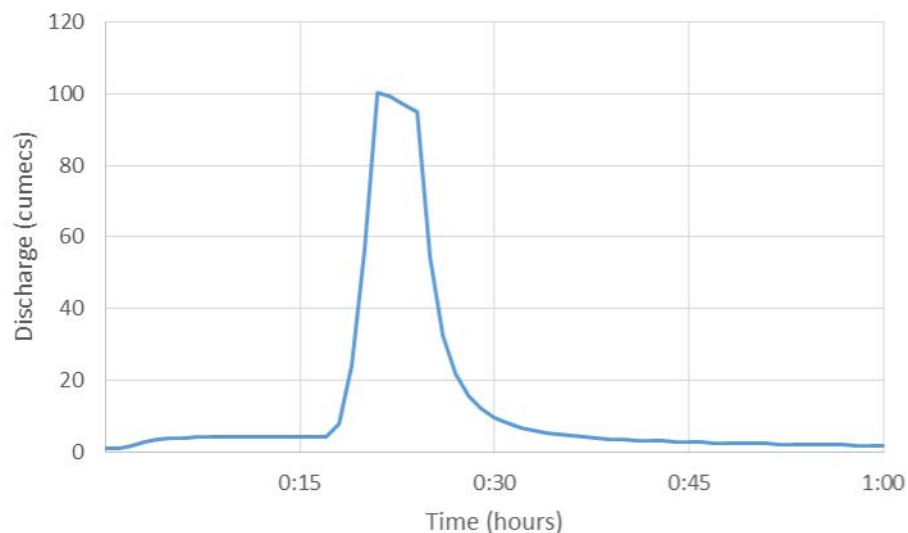
Figure 3.2 Breach discharge hydrograph

The dam breach hydrographs were computed using HEC-HMS and the above parameters as inputs. We note that the stored volume is critical to this assessment, and that we have assumed values from information provided to us by TDC. We do not have any sub-surface survey data, and there is therefore some uncertainty around the actual storage volumes. Figure 3.2 shows the lower dam dambreak hydrograph.

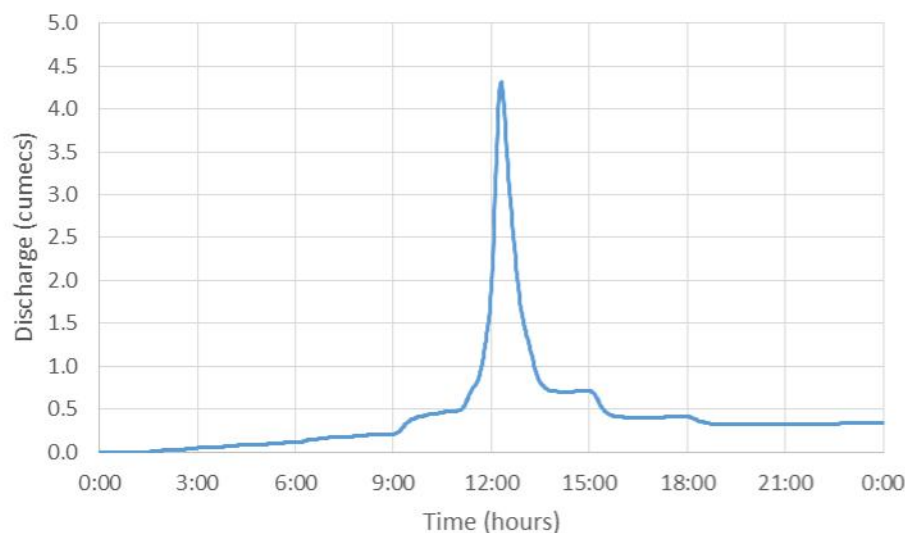
Figure 3.4: 1% AEP storm hydrograph for the catchment draining to the dams

The 1% AEP hydrograph for the dams' catchment was computed using HIRDS v3 data and the above parameters as inputs into a HEC-HMS v3.5 model. Figure 3.4 shows the hydrograph calculated from HEC-HMS for a 1% AEP storm draining to the two dams. As is standard practice, the hydrograph was developed for the simulation of a 24-hour event using a nested rainfall pattern. This means that design rainfall intensities for different durations (from rainfall statistics) up to 24 hour duration are embedded within the temporal rainfall distribution. The resulting hydrograph is then timed so that its peak coincides with the peak of the dambreak hydrograph.

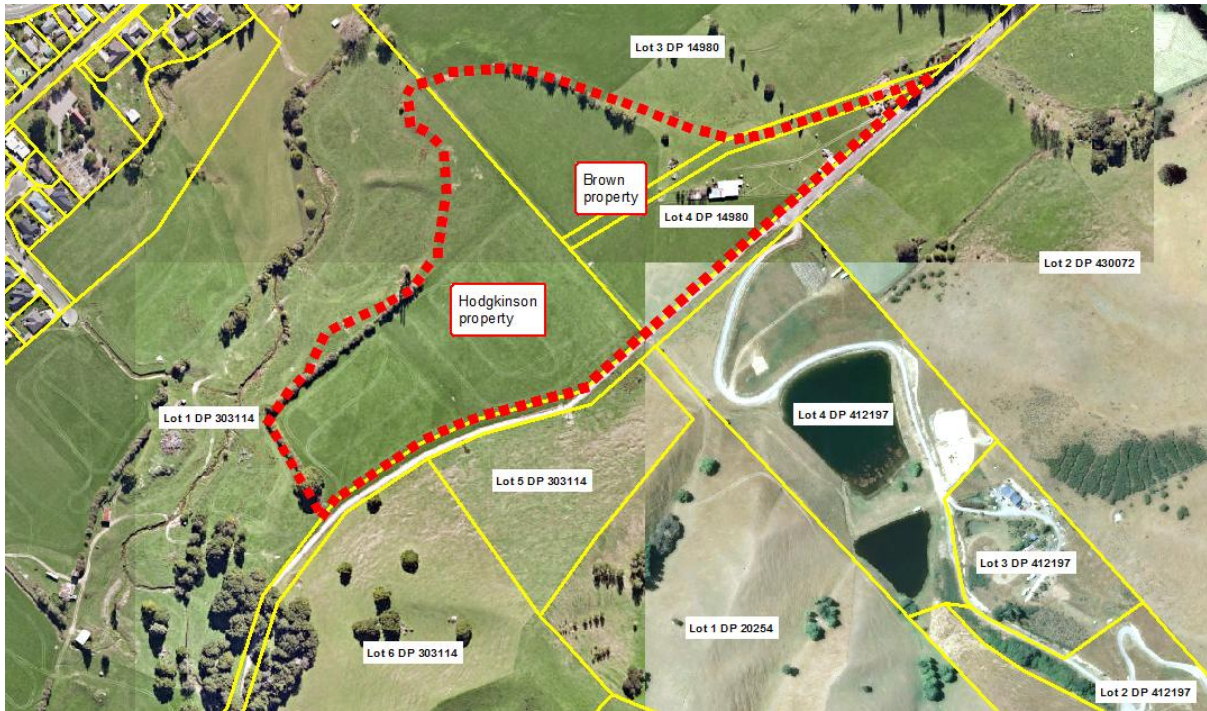
Figure 6.1: Ownership of land affected by DA 17. Approximate DA 17 boundary shown in red. Land ownership information provided by TDC.

The dambreak modelling shows that without any mitigation, the Brown property could potentially be subjected to significant inundation, while dambreak inundation is confined to a relatively small area within Hodgkinson property (refer T+T Figure 1003353-F1 in Appendix A).

- Excluding land shown as likely to be subject to dambreak inundation from the area to be rezoned;
- Bunding to reduce flooding on Hodgkinson and Brown properties. Some land on the southern boundary of either or both properties could be used to limit flood extents. An assessment would be required as to the impact of any such bunding on flooding and flowpaths in adjacent properties;
- Lowering the normal top water level (NTWL) of the dam, and/or infilling the lower contours of the reservoir to reduce stored volume available for release in a dambreak event. This would require temporary dewatering of the dam;
- Increasing the PIC rating of the dam based on the proposed development areas (considering population at risk and potential loss of life), and upgrading the dam structure and monitoring regime accordingly.

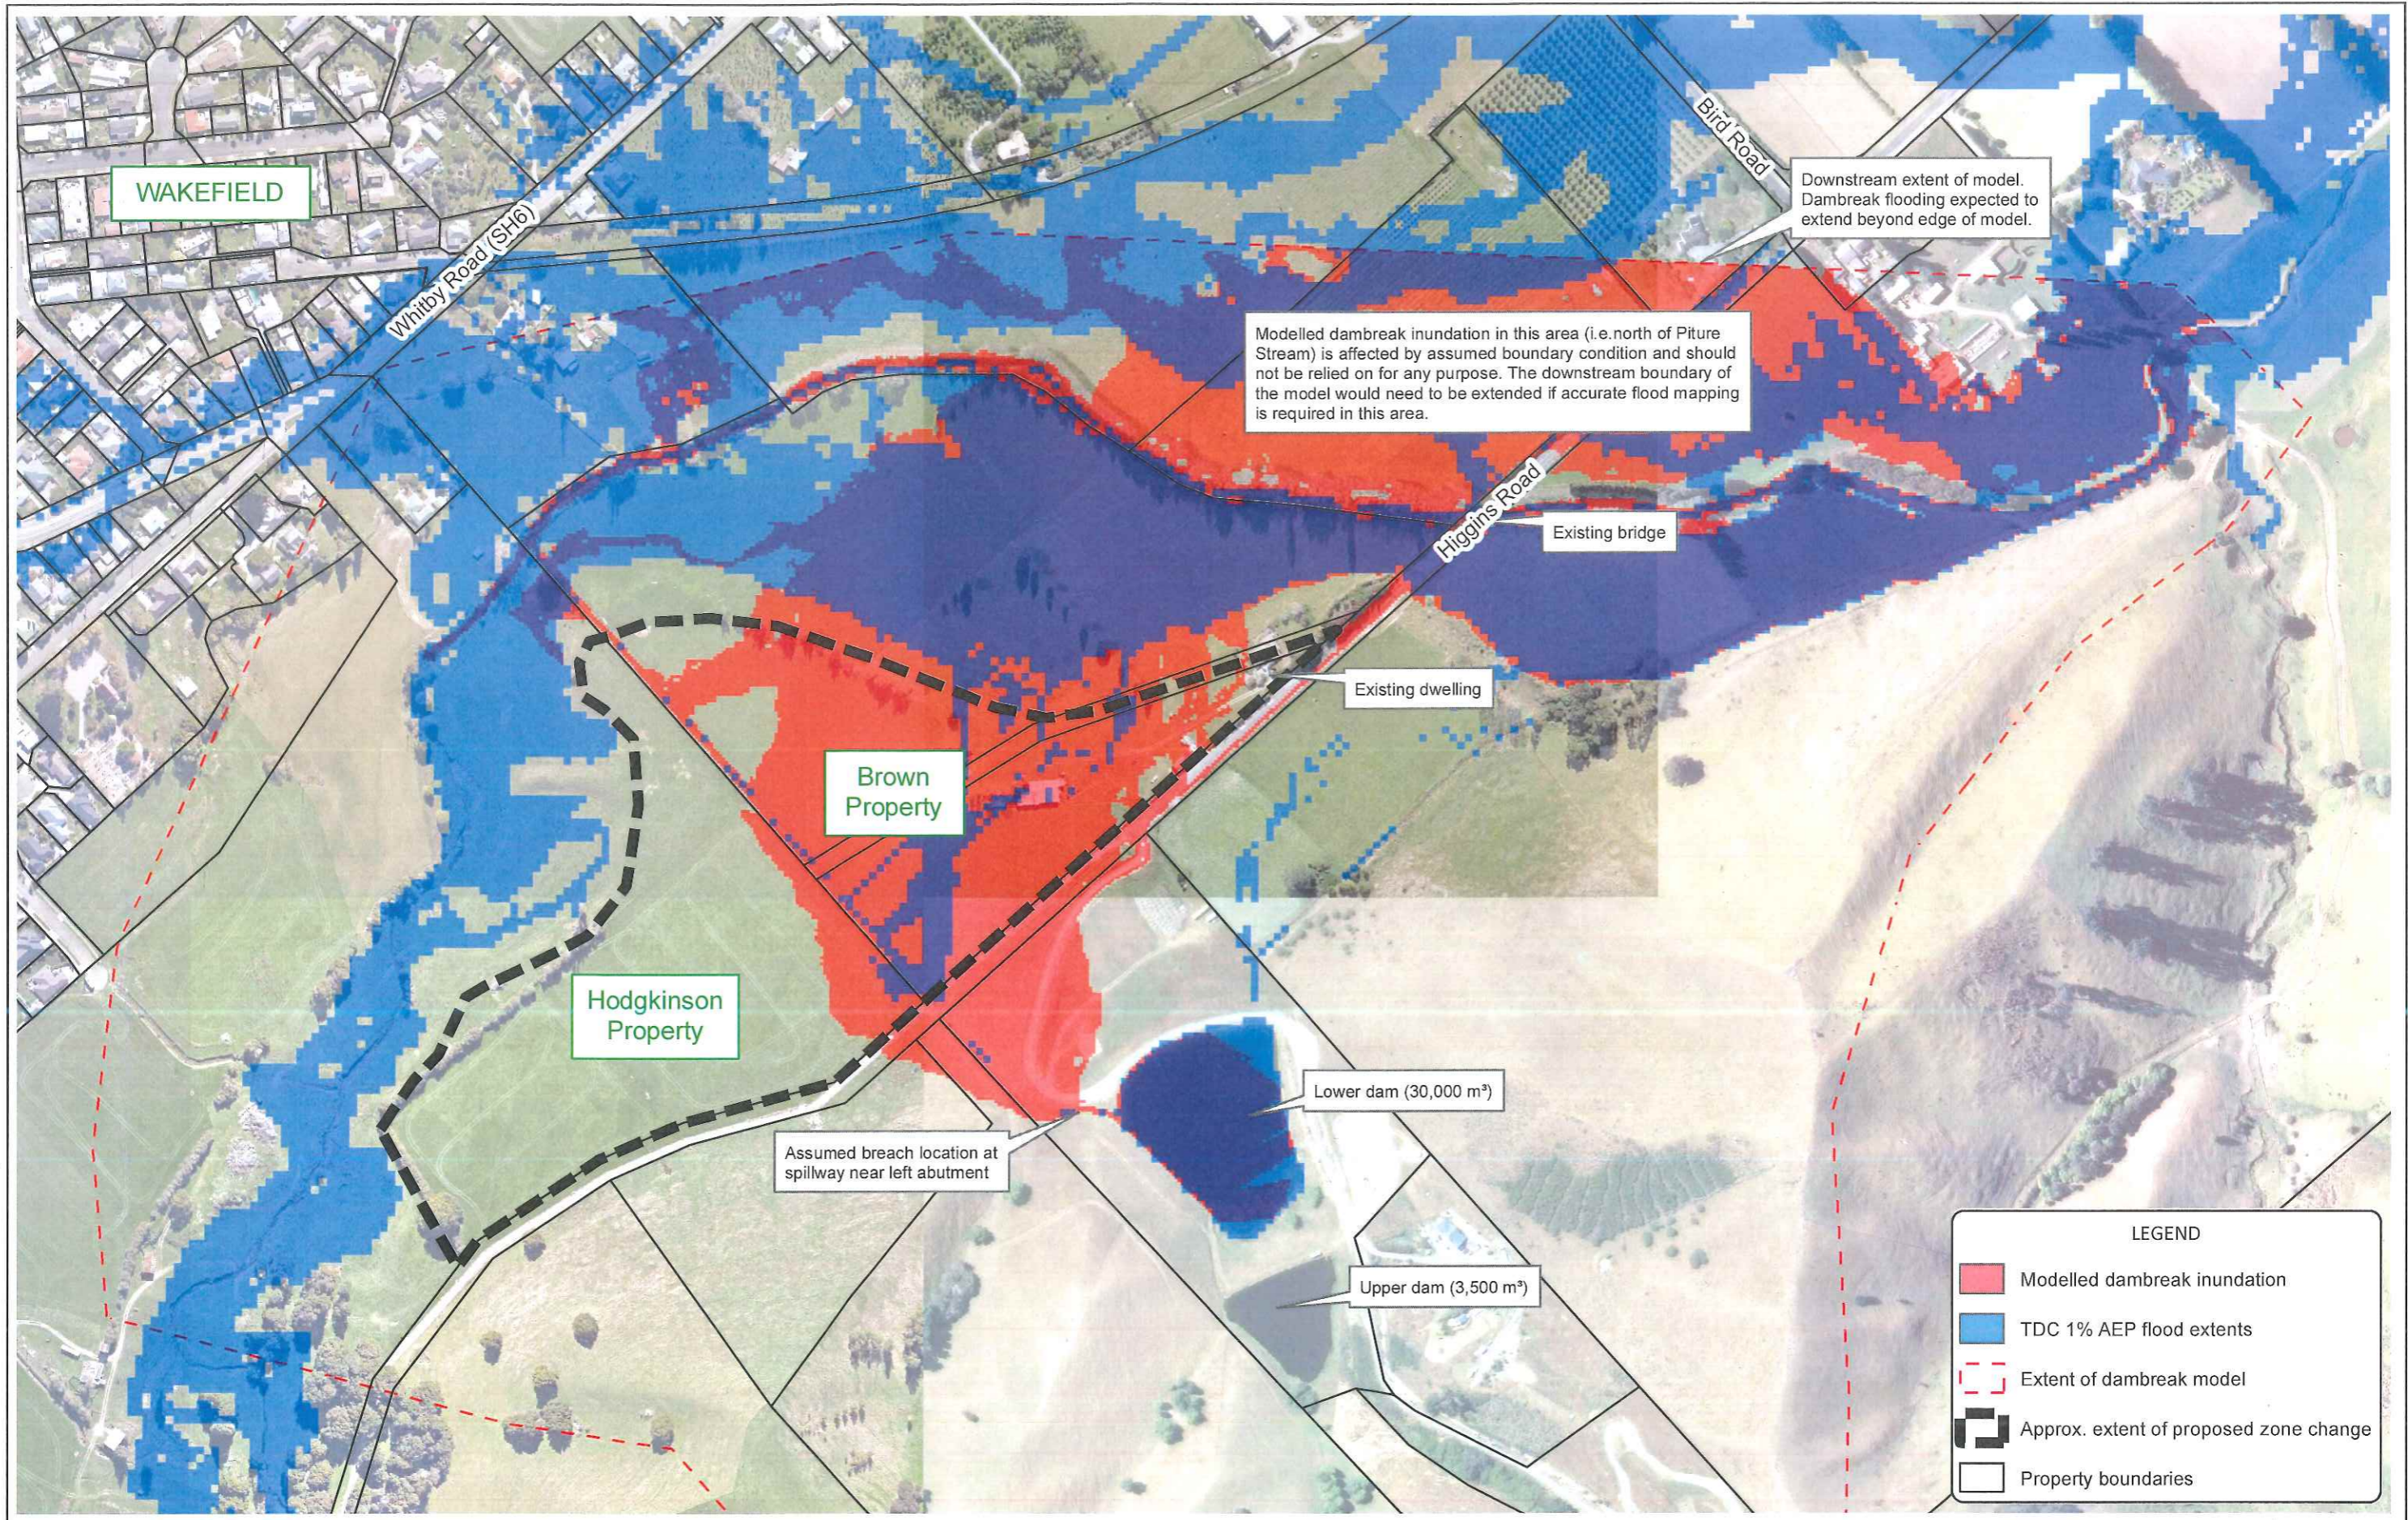
T+T Figure 1003353-F1: Modelled dambreak inundation extents

The modelled dambreak flooding is presented in T+T Figure 1003353-F1 in Appendix A. The inundation modelling shows that for a dam breach near the left abutment of the dam, the flooding is predominantly within the Brown property, with some flooding along the eastern boundary of the Hodgkinson property. This means that most of the Hodgkinson land can be developed without any mitigation and without any risk of dambreak inundation. It is also likely that with some bunding and/or overland flowpath works, dambreak inundation risk to the eastern edge of Hodgkinson land could be mitigated to allow development of the whole property. The assessment and design required to confirm this is outside the scope of this study.

Modelled flood depths and velocities within the two properties are generally in the order of up to 0.9 m and 1.8 m/s respectively. This compares with modelled 1% AEP flood depths (provided by TDC) in the order of 0.2 m through the Brown property.

Overlaying the results of the 1% AEP modelling and the dambreak modelling (as in Figure 1003353-F1) shows that there is no 1% AEP flooding of the DA 17 land outside of the modelled dambreak flood extents; i.e. that the dambreak inundation is the worst case right across the DA 17 area.

Modelled dambreak inundation in this area (i.e. north of Pitire Stream) is affected by assumed boundary condition and should not be relied on for any purpose. The downstream boundary of the model would need to be extended if accurate flood mapping is required in this area.

Downstream extent of model. Dambreak flooding expected to extend beyond edge of model.
