Appendix G: Archaeological Assessment

Archaeological Assessment of six areas/fixtures in the Pohara area of Golden Bay designated for remedial action by Tasman District Council.

Assessment Commissioned by: Tasman District Council

August 2017

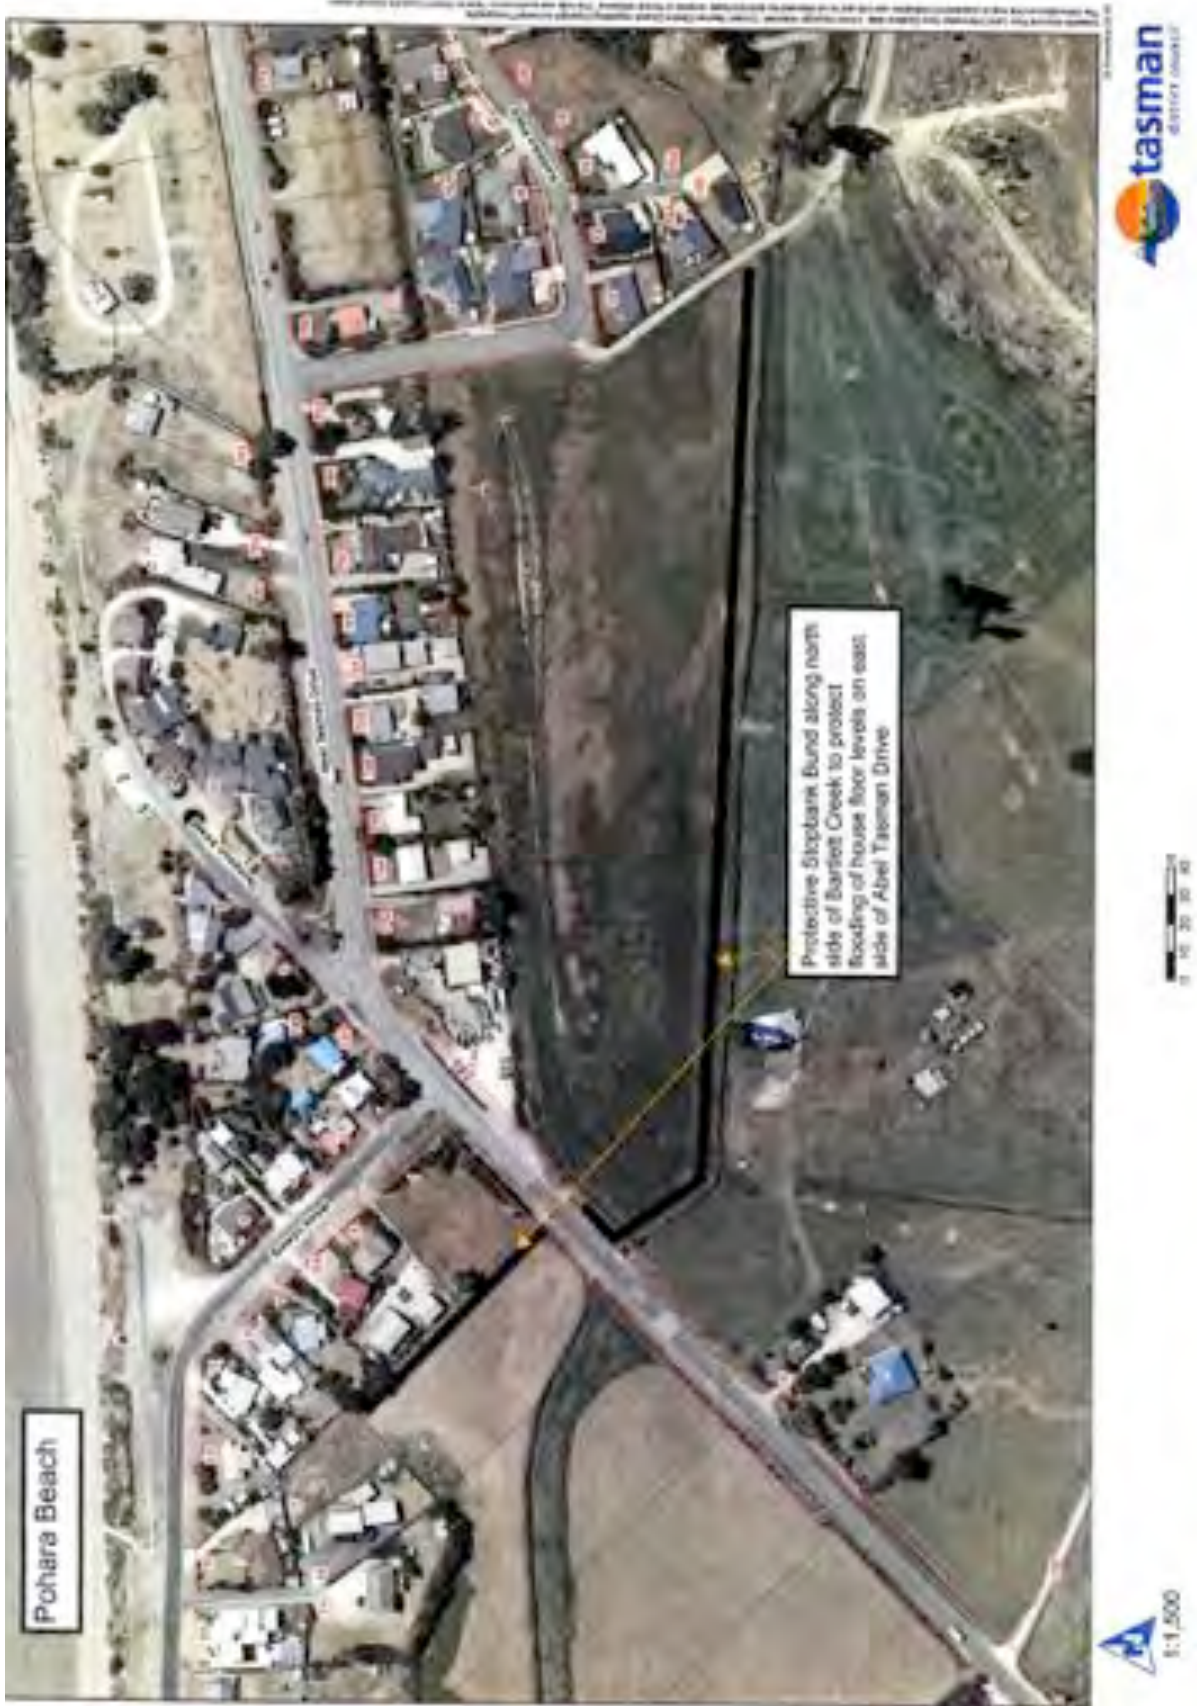
Fig. 1. Aerial view showing site of protective stop bank bund along the north side of Bartlett Creek (east side of Abel Tasman Drive) and the continuation on the northwest side of Abel Tasman Drive. This is described in 2 and 2a above. Current views of area in figs 2-5 below

2. The construction of a protective stop-bank along the north side of Bartlett Creek to protect flooding house floor levels on the east side of Abel Tasman Drive (fig.1). This would require the removal of topsoil and sod and the building of the bund to a height of 1.2m from 14B Kohikiko Place –following the creek westward to Abel Tasman Drive where the bund would turn northward to a culvert under Abel Tasman Drive (see figs.2,3 and 4).

2a. As can be seen in Fig. 1 the bund continues on the northwest side of Abel Tasman Drive behind 1, 5 and 7 Selwyn Street at a height of approximately.5m. Again topsoil would be removed before the addition of new material but there is already some elevation in this area (see figs. 5).

3. As has been noted there is a culvert underneath Abel Tasman Drive which links the two ends of the bund at Abel Tasman Drive. The plan requires the upgrading of this culvert (4m x 1m) and therefore the excavation and removal of the current culvert (see fig. 1)

The first area starting from the east is the construction of a protective stop bank along the north side of Bartlett Creek to protect flooding house floor levels on the east side of Abel Tasman Drive. This can be seen in Fig. 1. This would require the removal of top soil and sod and the building of the bund to a height of 1.2m from 14B Kohikiko Place – following the creek westward to Abel Tasman Drive where the bund would turn northward to a culvert under Abel Tasman Drive. The area this bund encloses- ie to the north - an extension of an area discussed in three Authority reports noted on Fig.16 as HPT 2003/135 and 2005/228 an area generally included in NZAA 25/99. As well as an earlier exploration in a sewer trench excavated in 1995/1996.

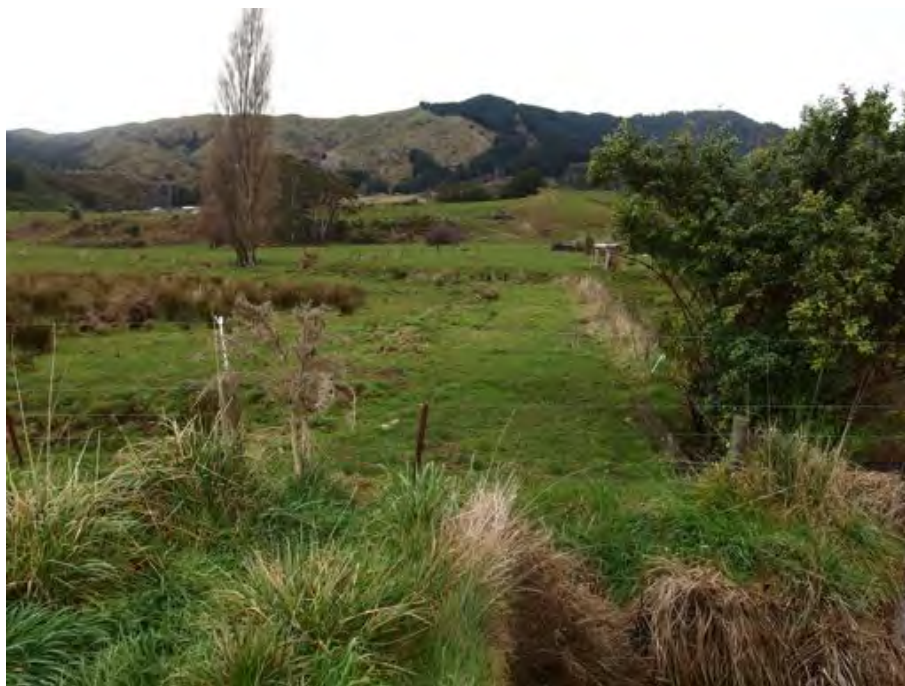
Fig. 2. View from Abel Tasman Drive along north side of Bartlett Creek – looking south east to the bend in the creek as it turns eastwards.

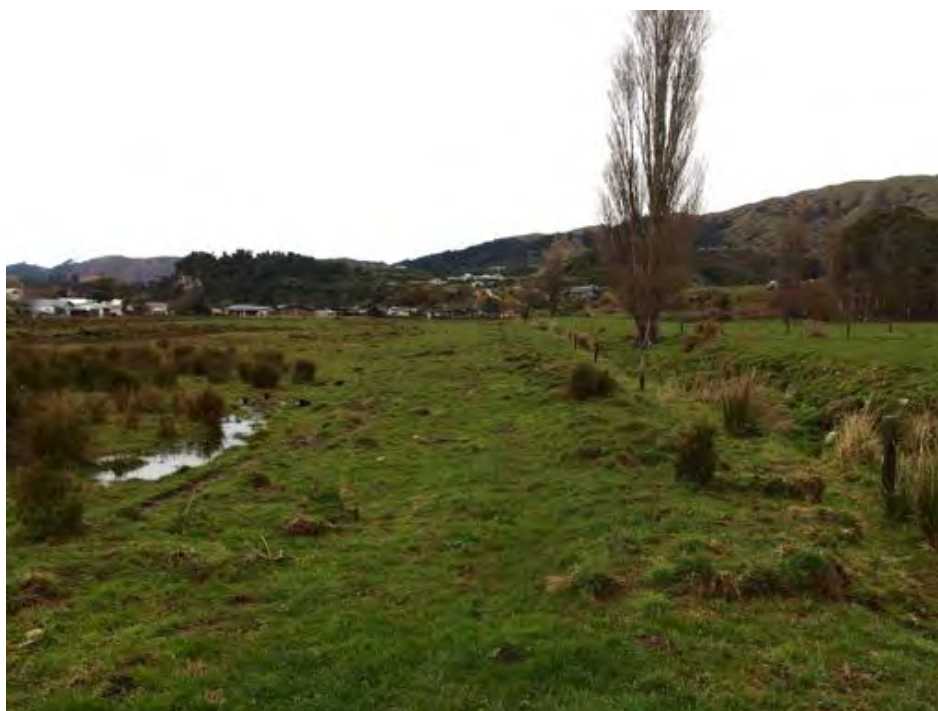
Fig. 3. View looking east along Bartlett Creek towards Kohikiko Place

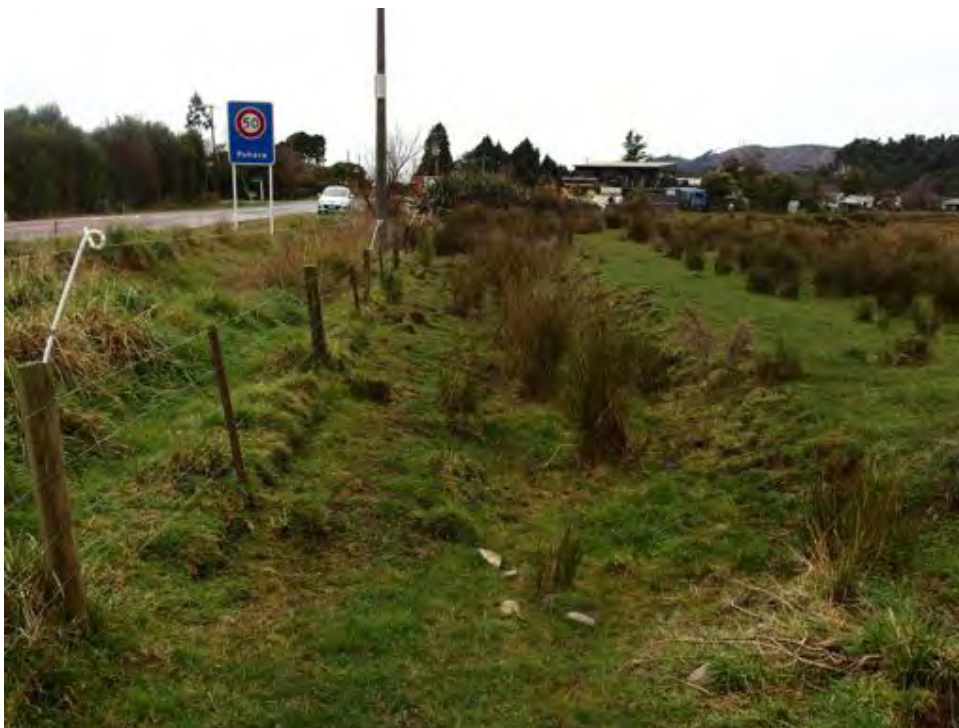
Fig. 4. View of return on bund north along Abel Tasman Drive

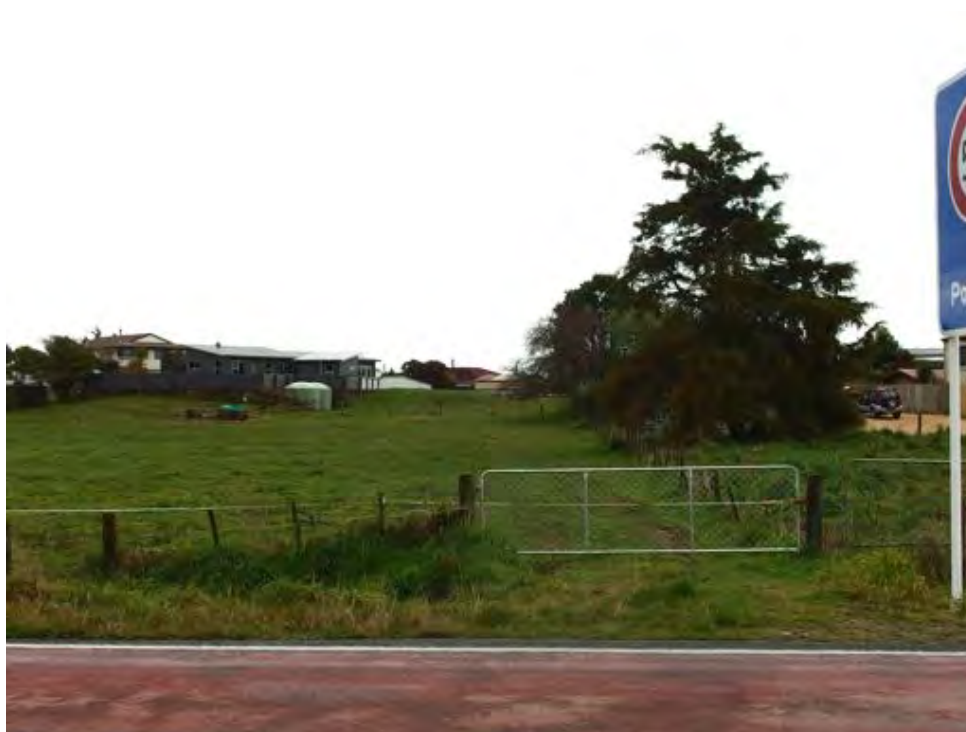
Fig. 5. View of area for continuation of bund on the west side of Abel Tasman Drive

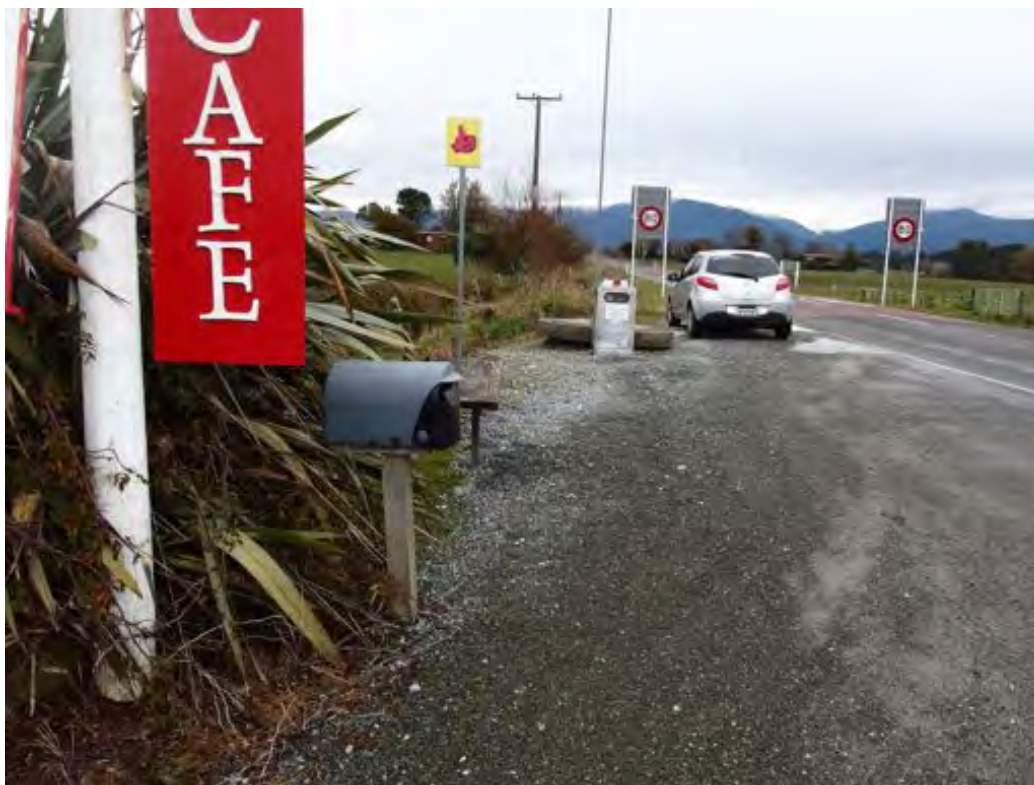
Fig. 6. View of existing 4 Winds pump station. Location to be changed and pump station replaced.

1) Replacement of 4 Winds wastewater pump station. This requires the disestablishment of one that is currently located on the side of the main road just south of 734 Abel Tasman Drive (see Fig. 6). The relocation at **(location?)** on road reserve will require the excavation of a 20sq m area to a depth of 3 -4m for the establishment of the new pump station.

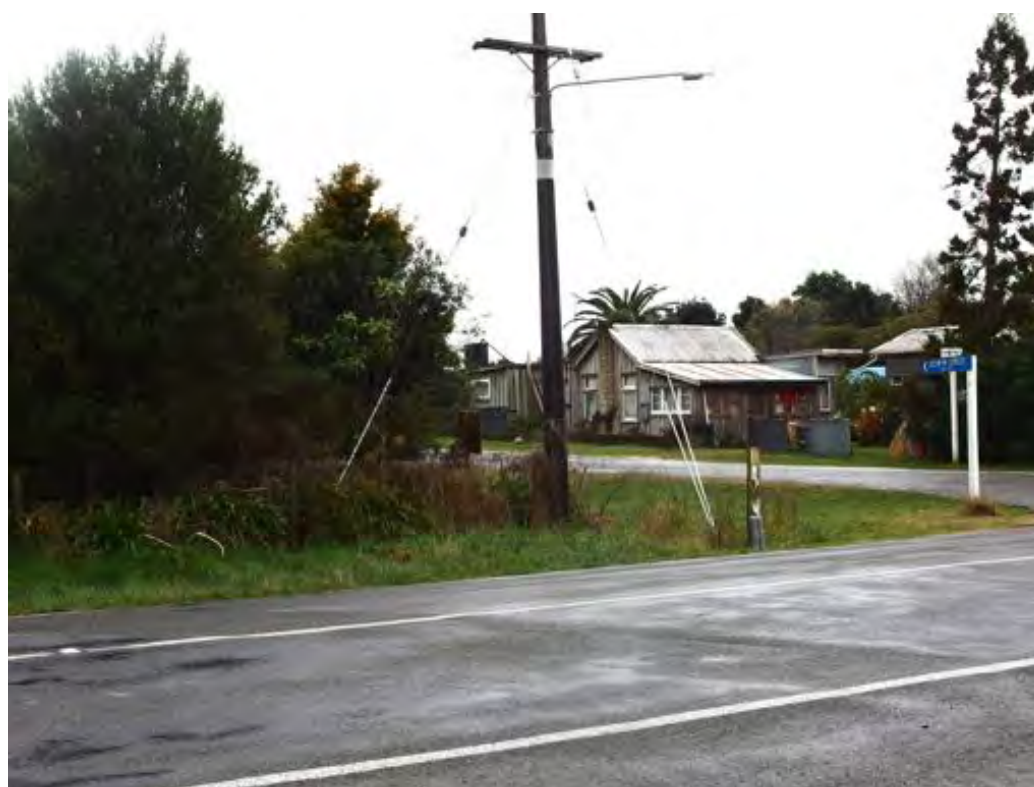
Fig. 7. Possible area for the new 4 Winds Pump Station (see (1) p.4)

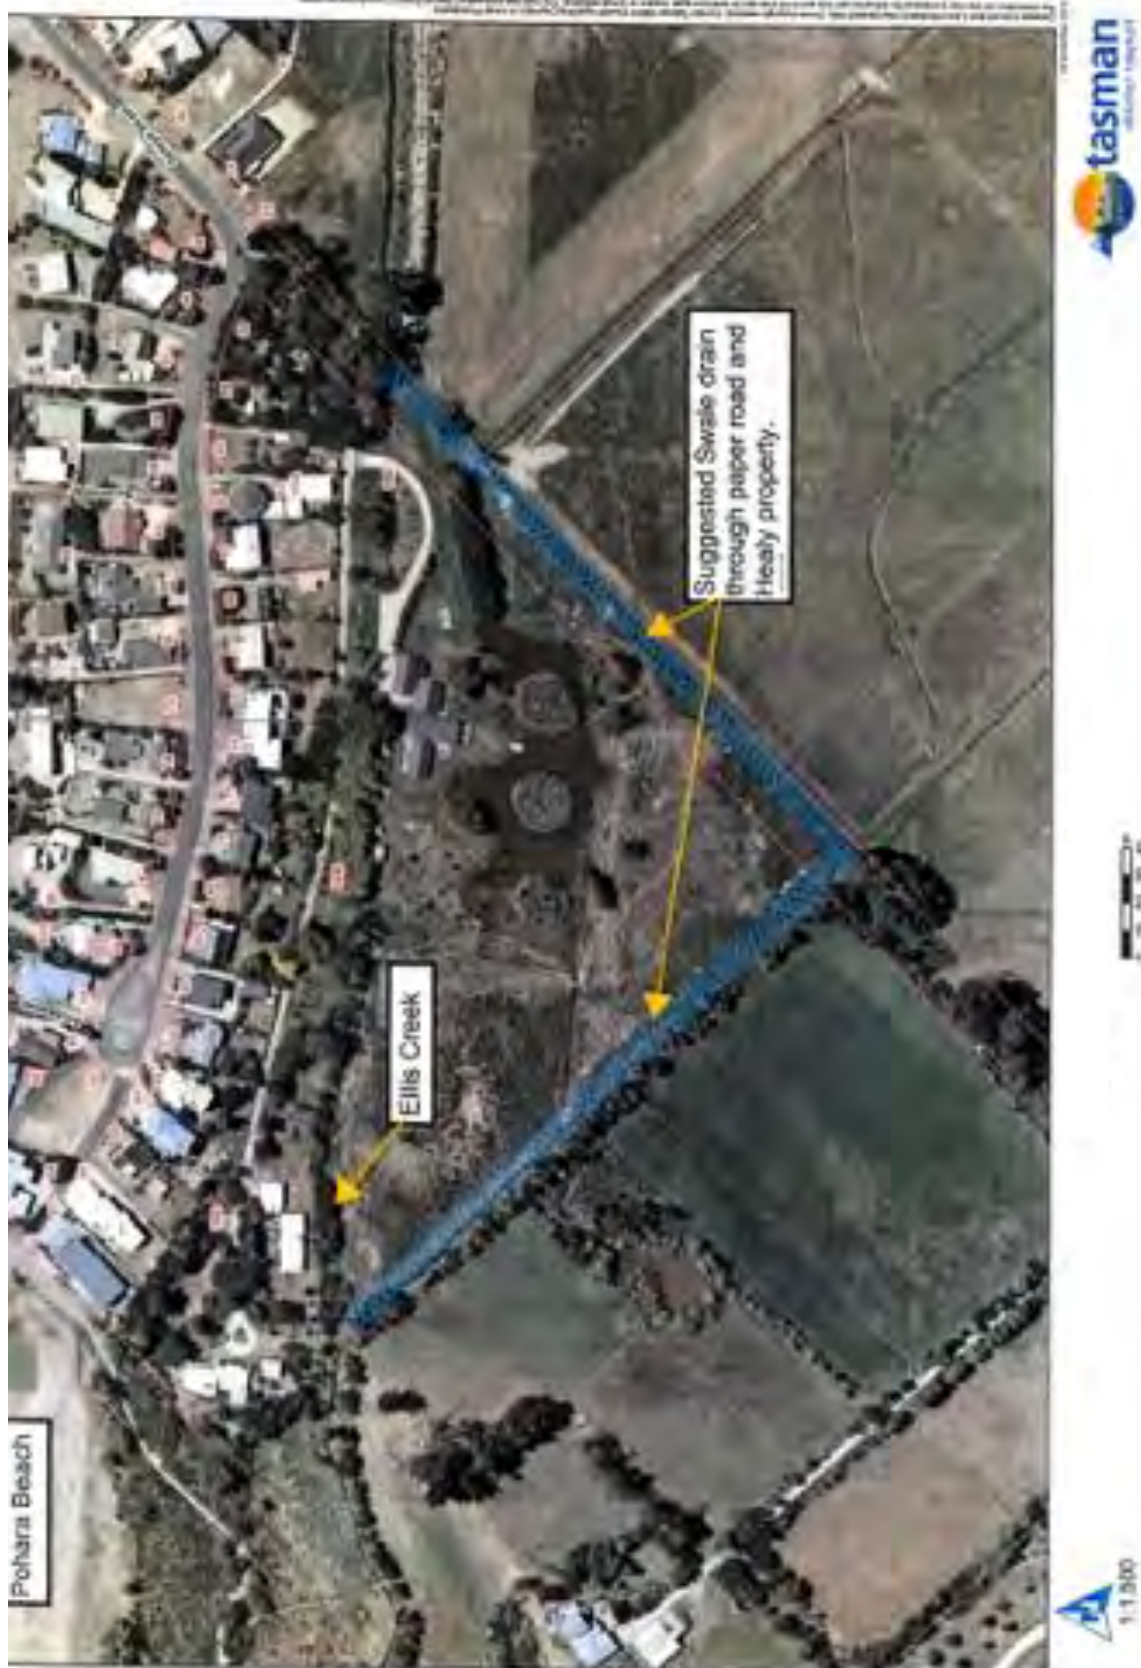
Fig. 9. Aerial view for the location of the swale described in (5) p5. terminating at the confluence of two streams (Ellis on the right and Bartlett on the left) visible in fig.10 below.

5. Establishment of swale drain along paper road starting from the northeast corner of 59 A at Selwyn Street and following a paper road/ south east side of 59A to the southern corner of the 59A (Healey property) and then following the property line northwest to Ellis Creek (see fig.9).

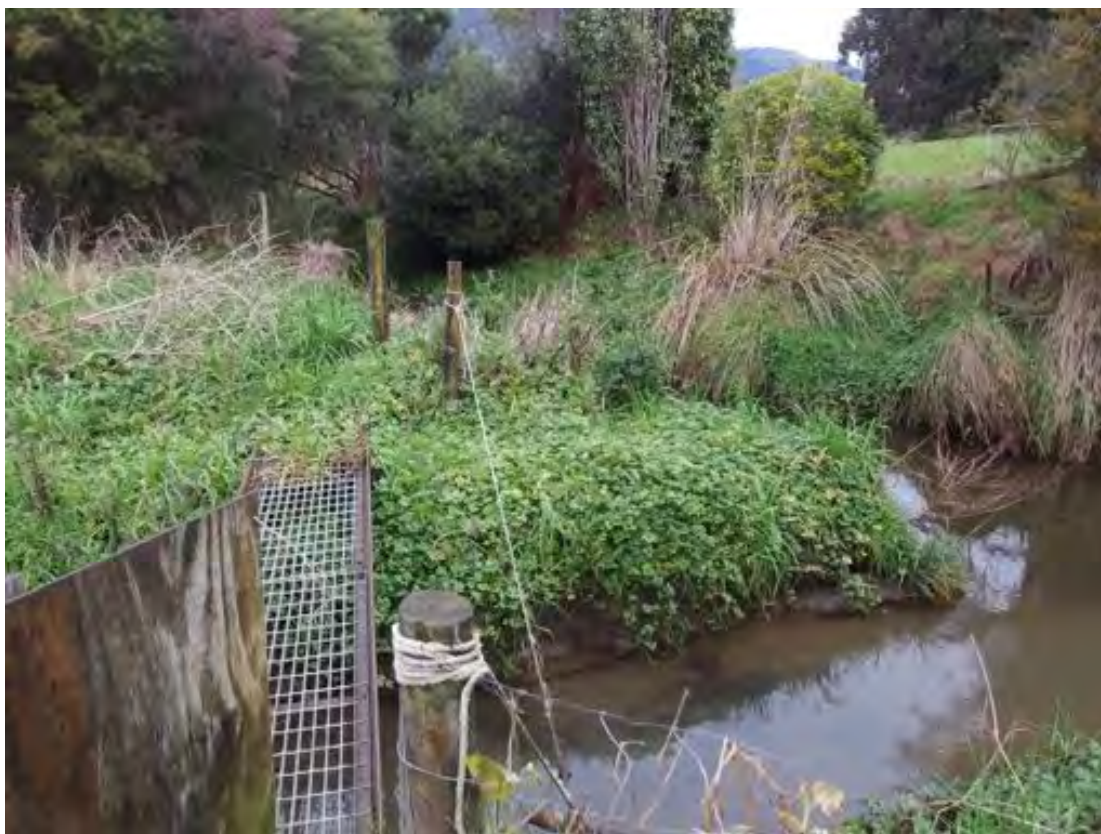
Fig. 10. Confluence of Ellis Creek (foreground) and the Bartlett Creek (right). The swale may terminate shortly before it reaches this confluence.

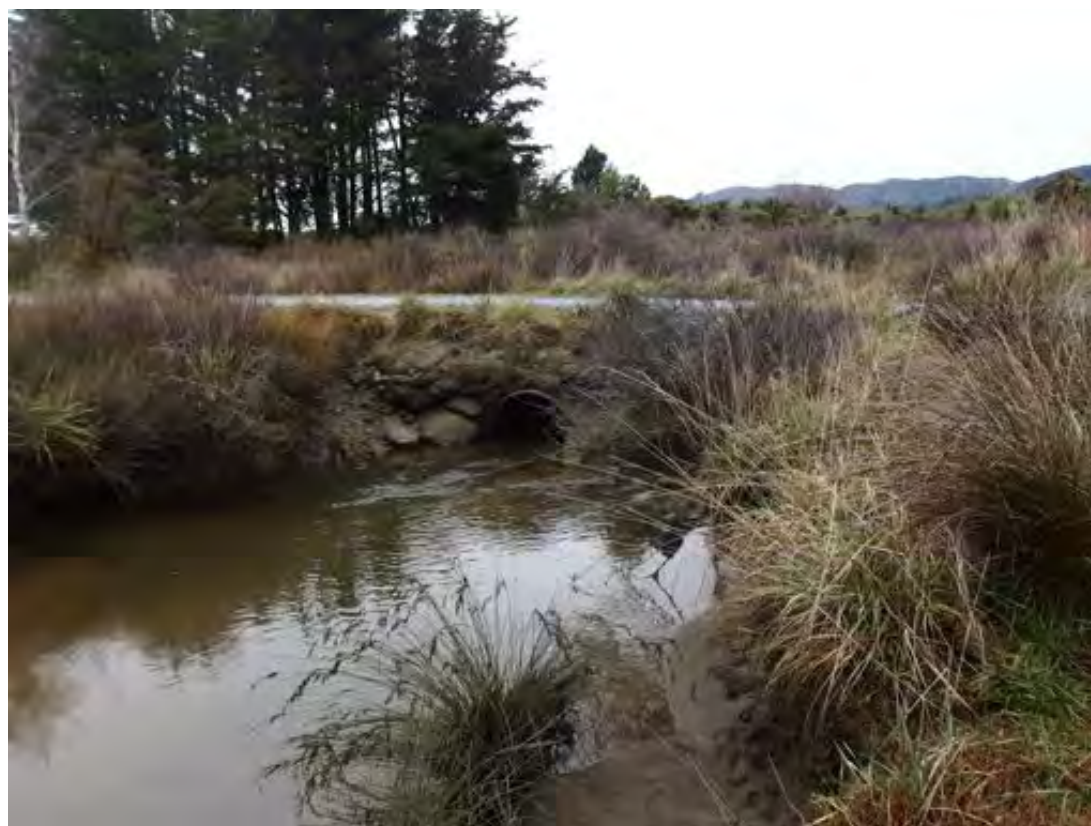
Fig. 11. View of Boyle Street culvert looking east

The final action is the replacement of Boyle Street culvert just before the entrance to

the Takaka Golf Club (see figs. 9 and 11). The culvert going east to west empties into the estuary visible in Fig. 12 below.

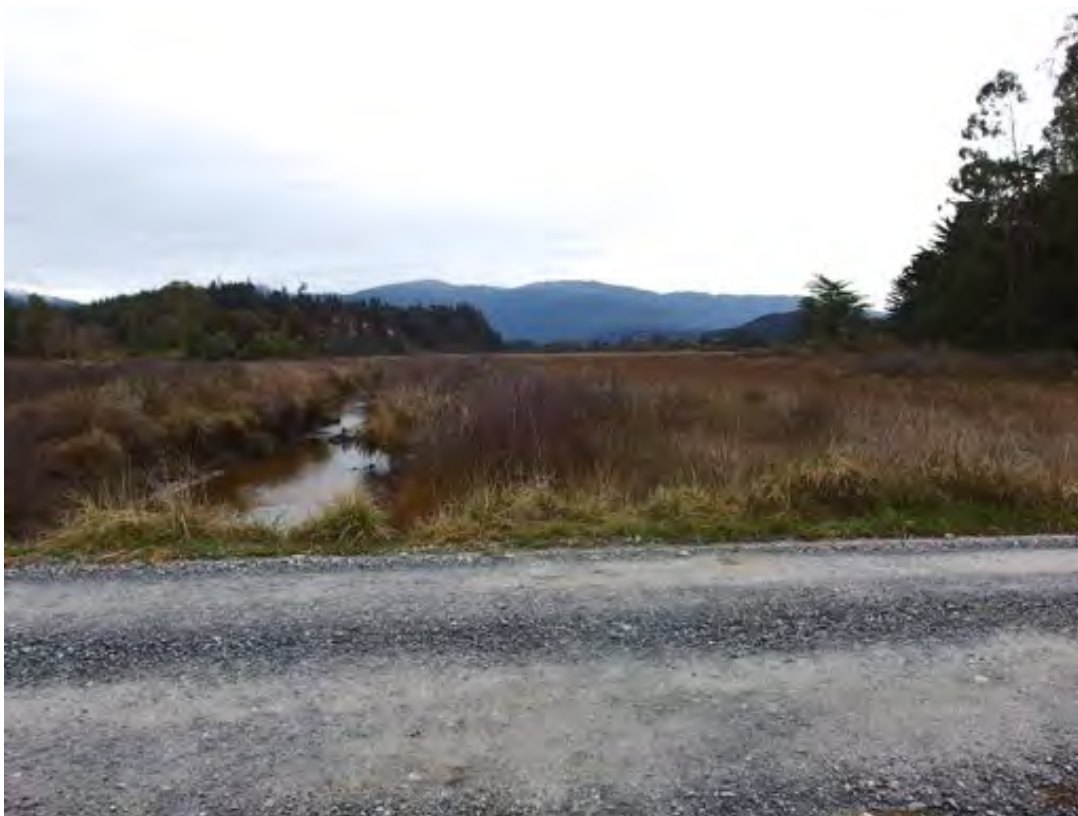
Fig. 12. View of culvert looking west to the East Arm, Motupipi Estuary

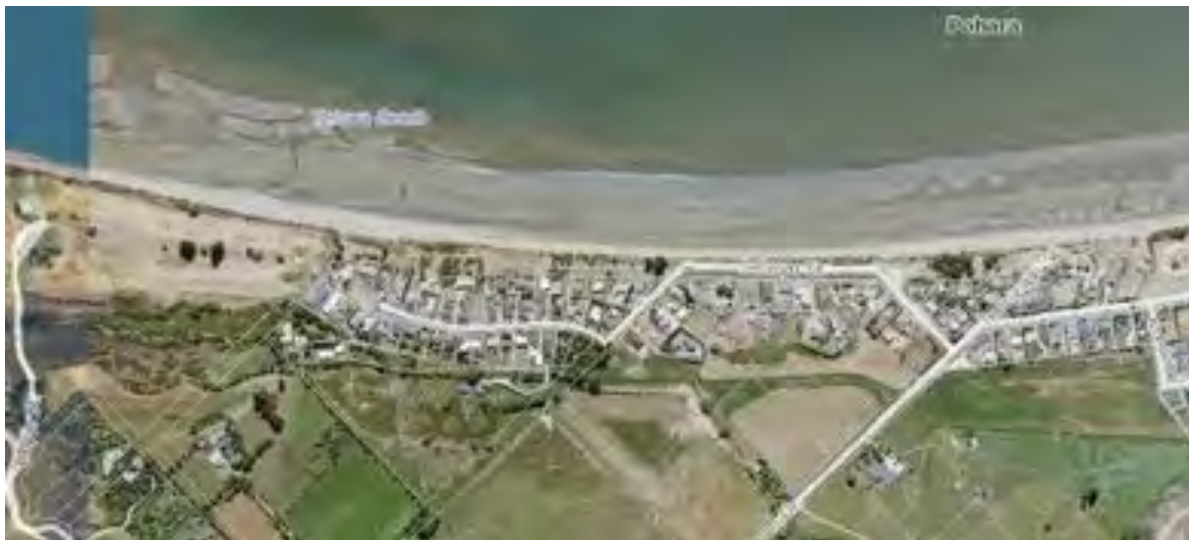
Fig. 14 shows and overview of the area from Kohikiko Place (Pohara subdivision) in the east (right side) to Boyle Street in the west where it enters the Takaka Golf Club. This also shows the current residential occupation, which has increasingly moved southward from the original establishment along the coastline. The greatest extent of this encroachment is east of the area shown in fig. 14 (see below).

Fig. 14 Aerial view of assessment area along the Pohara coastline.

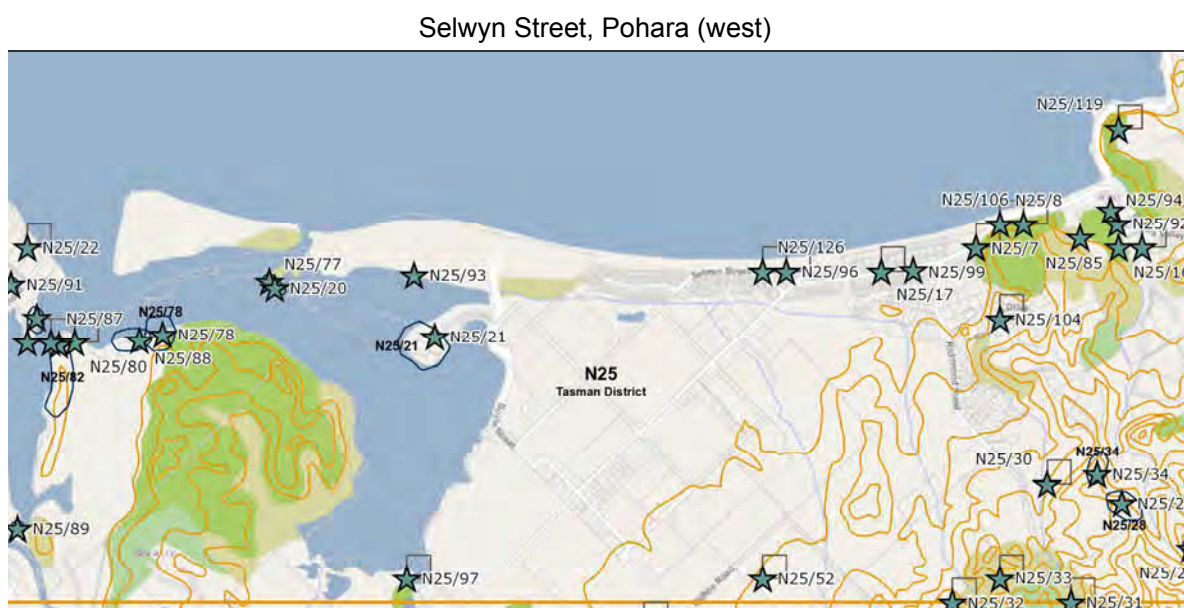
Fig. 15 NZAA recorded sites in the area of the assessment.

One is therefore hesitant to suggest that the evidence in the Bartlett assessment represents the end of occupation along the foreshore. As noted in Fig. 15, site records exist for the end of the Pohara peninsula even though this area has been subject to considerable change in form over the years. One of the sites is not far from one of the last planned actions namely the replacement of Boyle Street culverts just before the entrance to the Takaka Golf Club.

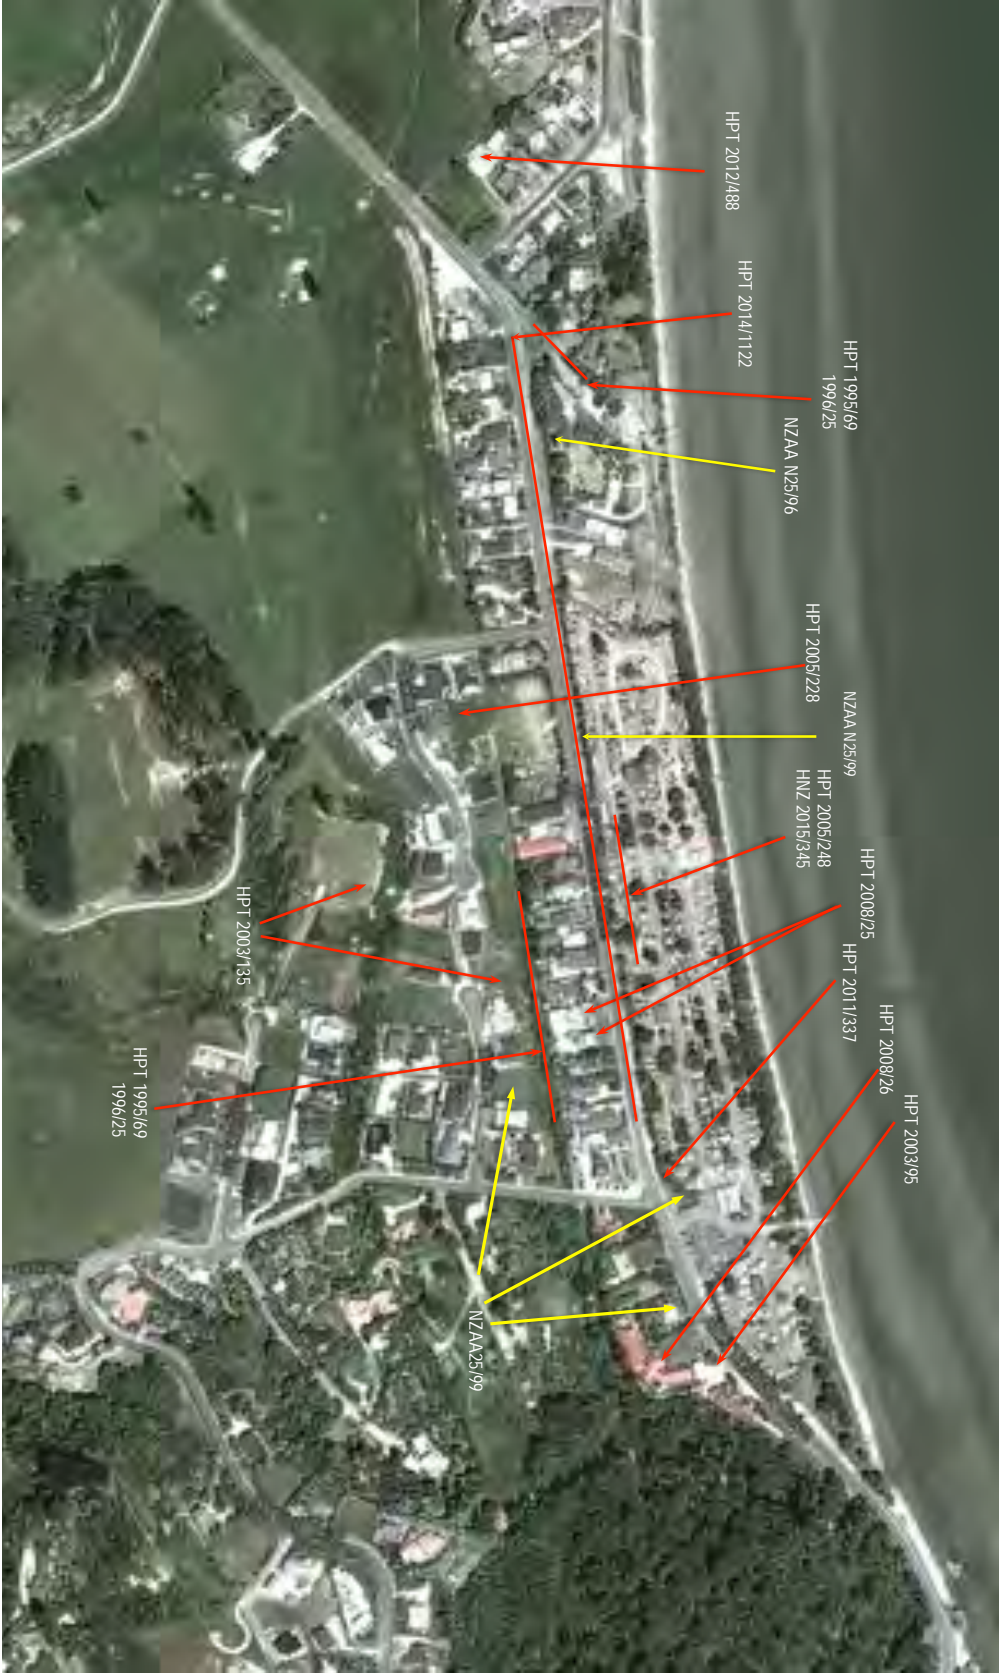
Fig. 16

Pohara (central) NZAA sites and HPT-HNZ authorities

Note 1: N25/99 was recorded as N25/17 in 1961
Note 2: 1995/69 and 1996/25 are reported by Barber, I. 1998. Archaeological report on the Pohara sewerage scheme.
Note 3: In 1961 N25/17 was used to describe archaeological evidence located in the Pohara campground adjacent private houses and farmland, and included what is now the Takaka golf club.

The fact that Tennyson Street and the juncture with Abel Tasman Drive (see Fig. 16) has evidence of occupation that has been exposed through the excavation for the sewerage scheme in 1995/96, HPT 2014/1122 and in the site report NZAA N25/99 suggests that the occupation area could extend over a wider area southwards. The replacement of 4 Winds wastewater pump station with a new pump station as well as a rising main (to be located on the northwest side of Abel Tasman Drive extending from the pump station to Boyle Street will require considerable excavation and could well expose the extent of the occupation area described before.

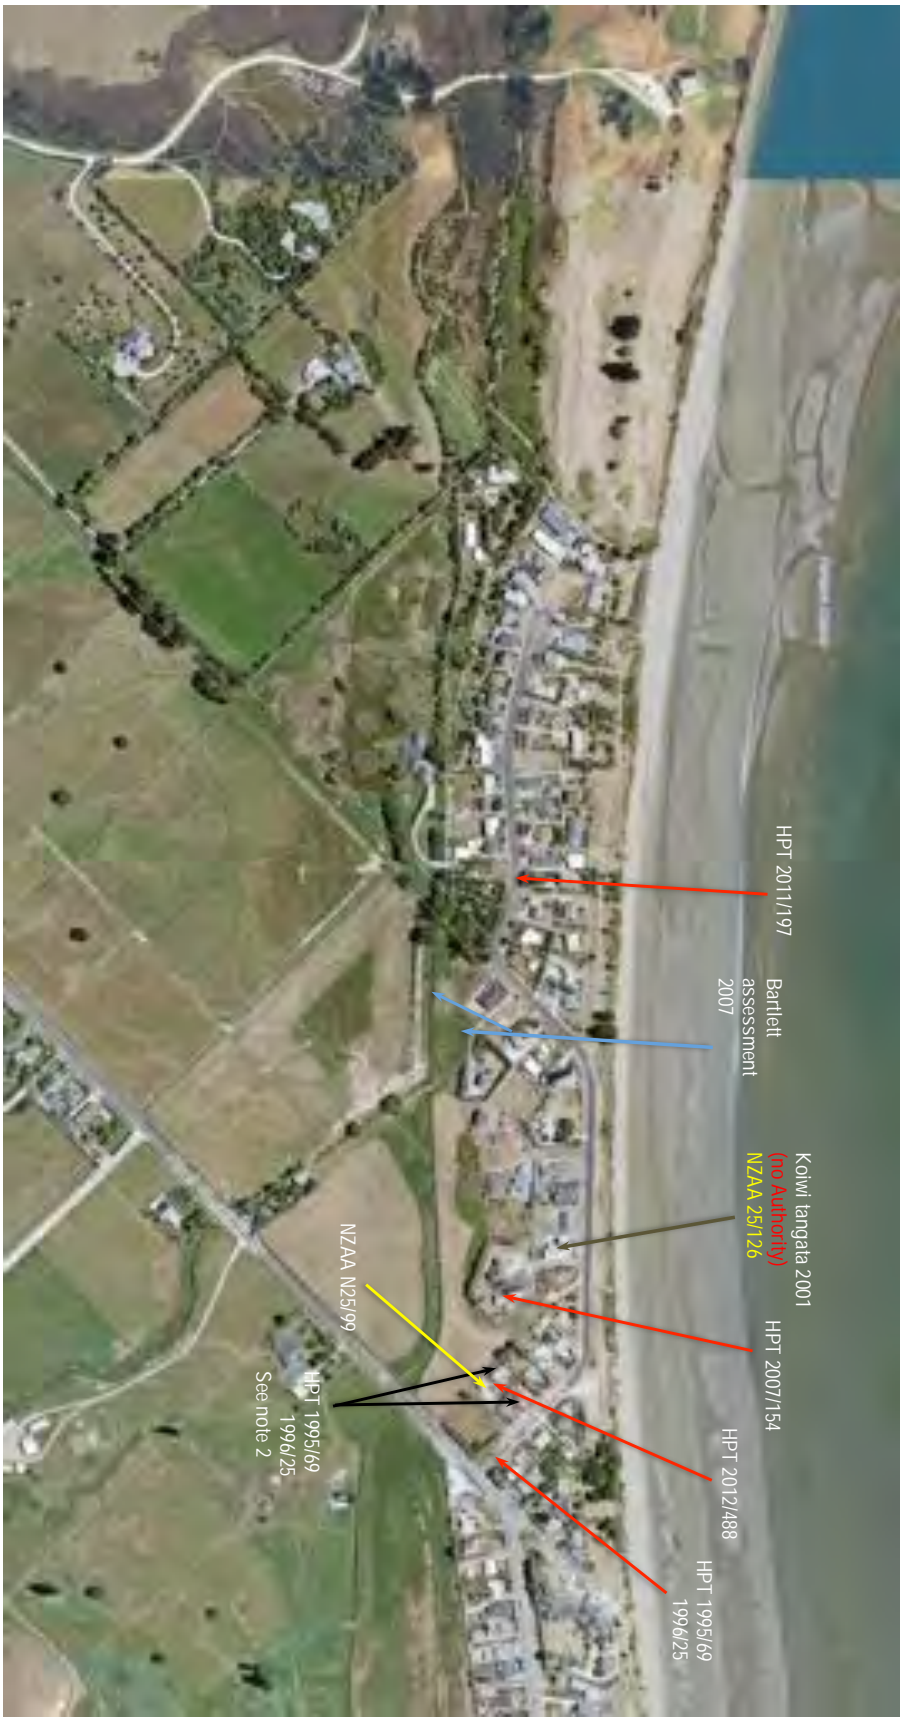
Fig. 17

Pohara (west) NZAA sites, assessments, and HPT-HNZ authorities

Note 1: 1995/69 and 1996/25 are reported by Barber, I. 1998. Archaeological report on the Pohara sewerage scheme.
Note 2: From 1996 to 1999 lateral connections of the sewer line were monitored for individual residences, 5a and 3 Selwyn Street were connected in 1997 and 1999 respectively, both revealing evidence of occupation.
Note 3: In 1961 N25/17 was used to describe archaeological evidence located in the Pohara campground adjacent private houses and farmland, and included what is now the Takaka golf club.

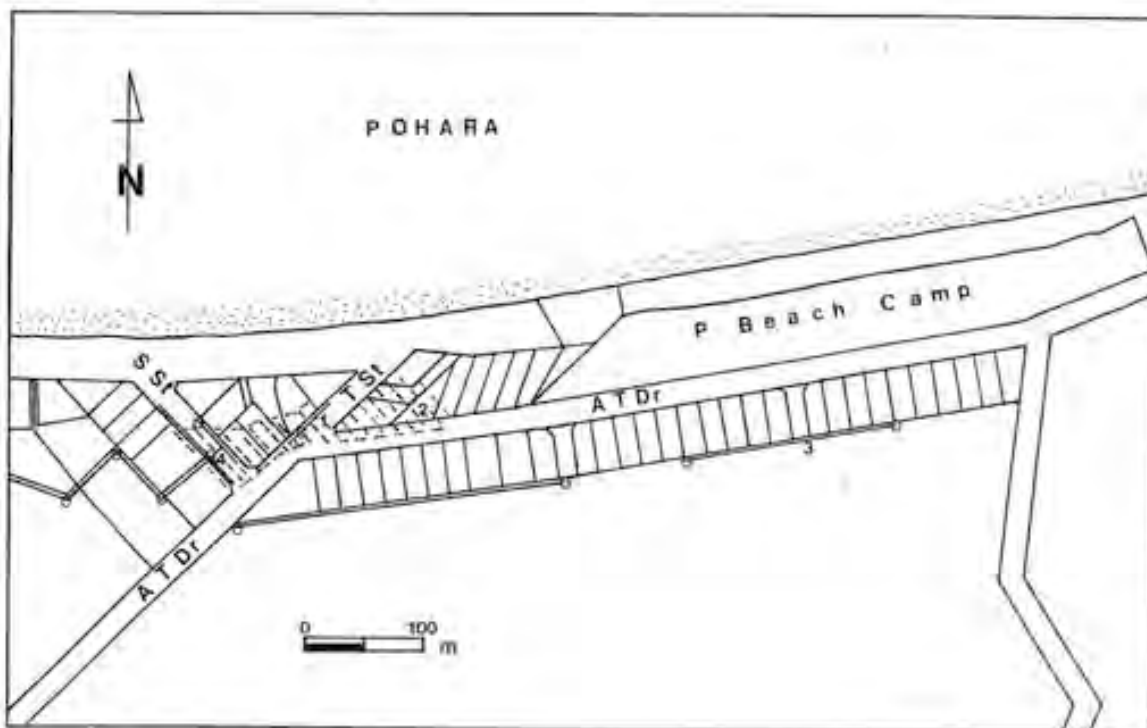
Fig. 18 Figure 17 from (Barber 1998:42-43) indicating archaeologically significant areas around the juncture of Abel Tasman Drive, Selwyn Street and Tennyson Street Pohara (dashed lines).

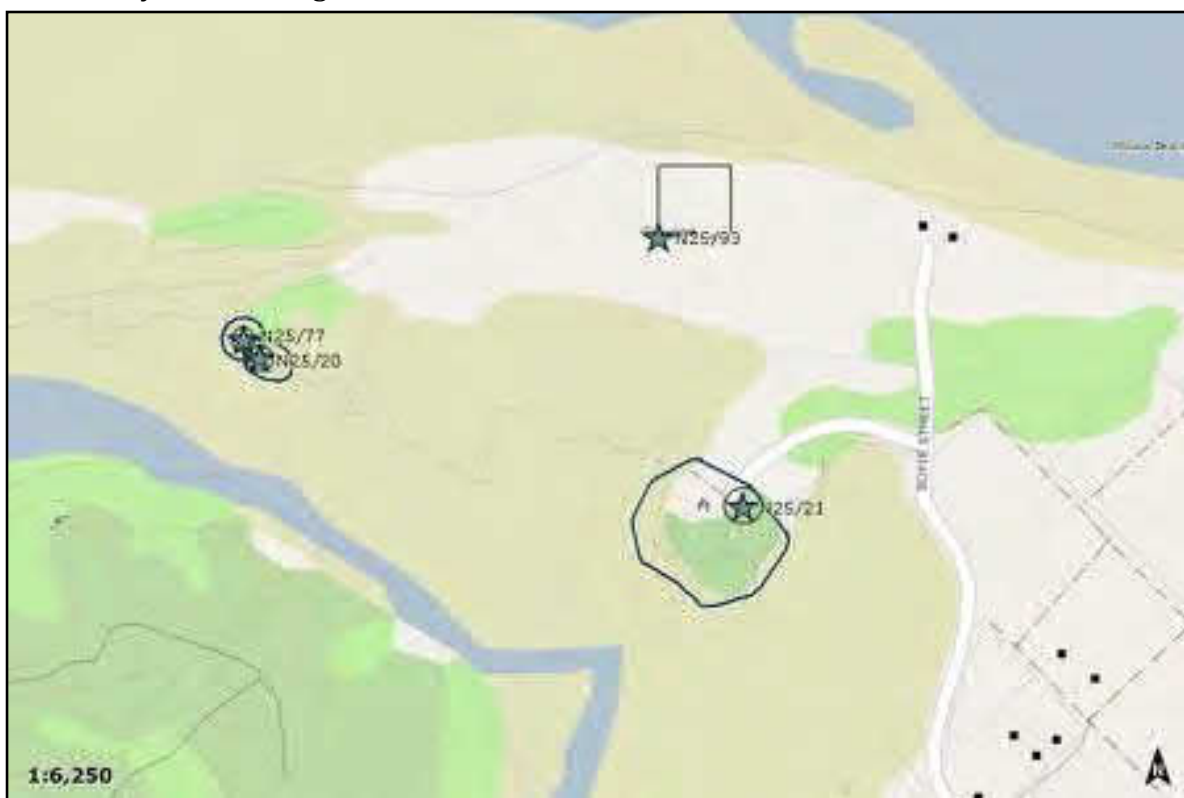
Fig. 19 Archsite map of recorded sites on Motupipi Spit

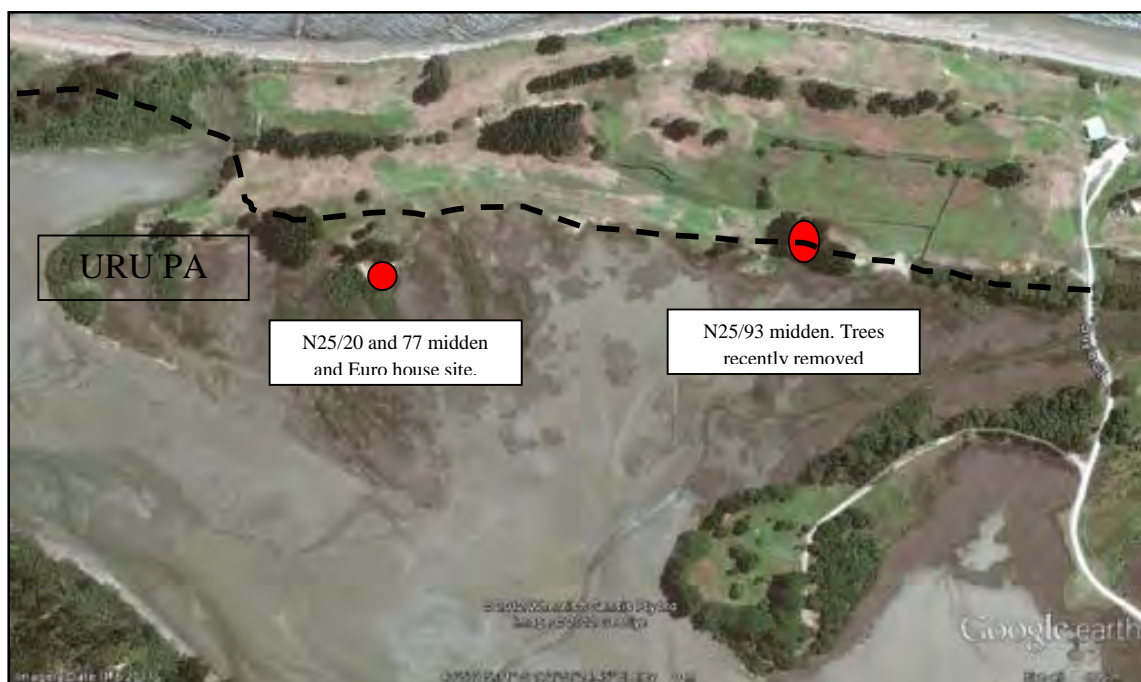
Foster, (2012:12) in her **Figure 8** (below) has indicated the real location of N25/93. Walls described the exposed area of this site in 1991 as layer of midden, 4 metres long with pipi, cockles, white rock shell, snails, whelk and oven stones. Foster observed that this site had been further distributed in 2012 by a digger's operation removing

vegetation along the margin of the estuary. It was also observed that the midden existed for some distance to the west along the estuary, but had been heavily disturbed by the digger.

Fig. 20 Detail of area encompassing Gold Course. Dashed line is indicative route of the cycleway.
