of an application by C J Industries Ltd for land use consent RM200488 for gravel extraction and associated site rehabilitation and amenity planting and for land use consent RM200489 to establish and use vehicle access on an unformed legal road and erect associated signage

# EVIDENCE OF GARY PAUL CLARK ON BEHALF OF CJ INDUSTRIES LTD (TRANSPORT)

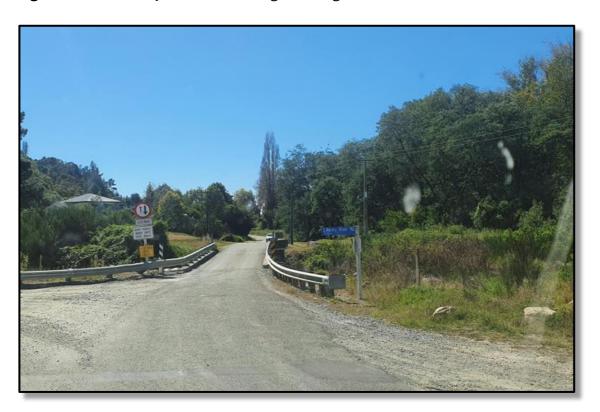
- 4.6 **Figure 1** shows Rocky River Road Bridge looking north.

Figure 1: Rocky River Road Bridge

- 4.7 The approaches to the bridge have good sight lines and there is a speed restriction for heavy vehicles.
- 4.8 The Alexander Bluff Bridge provides the connection from Motueka River West Bank Road to Motueka Valley Highway. The bridge is a relatively wide one-lane bridge with vehicles coming off Motueka Valley Highway having priority when crossing the bridge. The right turn bay provides a safe waiting area, clear of through traffic for vehicles turning to go across the Alexander Bluff Bridge. There are good sight lines for traffic waiting on the approaches to the bridge.

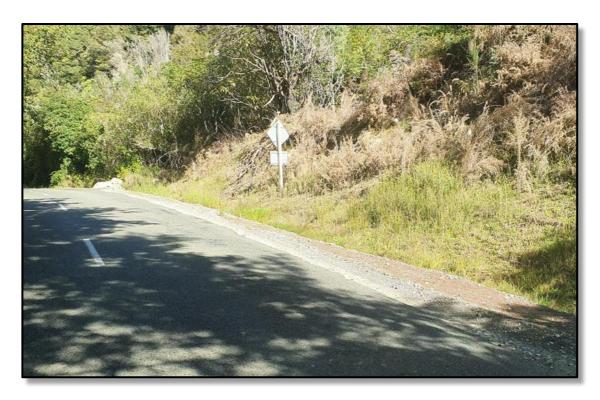
- 7.9 My inspections of the road showed very little tracking off the road surface except in one location. This location (near 681 MRWBR) appears to be a site where a recent slip and road remedial works have occurred. These works appear to have reduced the road width at this location. It is recommended that this particular location is considered for some seal widening to enable trucks to stay on the sealed road surface.

- 7.10 **Figure 6** shows the site and road damage.

Figure 6: Road Damage

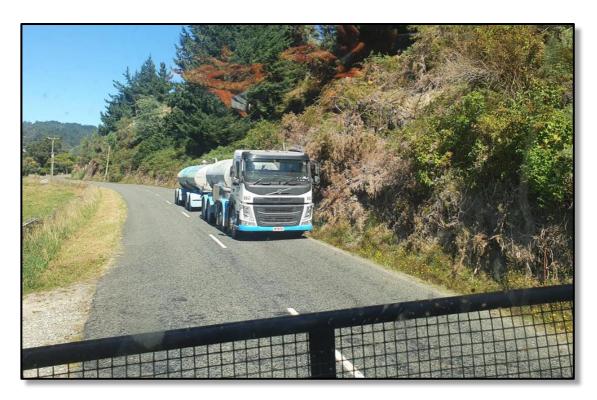
- 7.12 Submitters have also raised concerns about the road design and that it is not suitable for the proposed increase in truck movements. As previously stated, the number of truck movements is small at four in the hour. The route (MRWBR and MVH) already carries trucks along its length and with one reported crash as described above. Truck drivers have been able to travel along the road with the appropriate care without having head-on crashes or other safety impacts.
- 7.13 **Figure 7** shows a photograph of an opposing truck on MRWBR as it passes a truck in the opposite direction.

Figure 7: Opposing trucks passing on Motueka River West Bank Road

7.14 The absence of crashes and signs of road seal shoving or off-road tracking (exception noted above) suggests that the road design is capable of accommodating the existing truck movements and the small increase from the application.

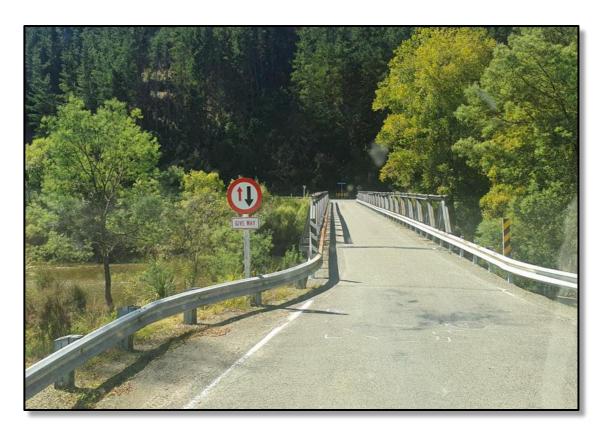
- 7.35 There is sufficient SSD for vehicles to turn right on to the bridge safely and meets the minimum requirements set out in Austroads.
- 7.36 **Figure 8** shows the driver eye height across the bridge rails.

Figure 8: MRWBR approach sight lines for a truck.

- 7.37 The vehicles coming from MRWBR have good sight lines (which are better for trucks due to higher driver eye height) across the bridge of vehicles entering the bridge.
