DETAILED SITE INVESTIGATION

42454 / 3 ARANUI RD AND 11 TAHI STREET, MĀPUA 7005, LOT 2 DP
11502 AND LOT 2 DP 11106 / MĀPUA BOAT RAMP TRUST

Title: Detailed Site Investigation: 11 Aranui Road, Māpua 7005

Client: Māpua Boat Ramp Trust

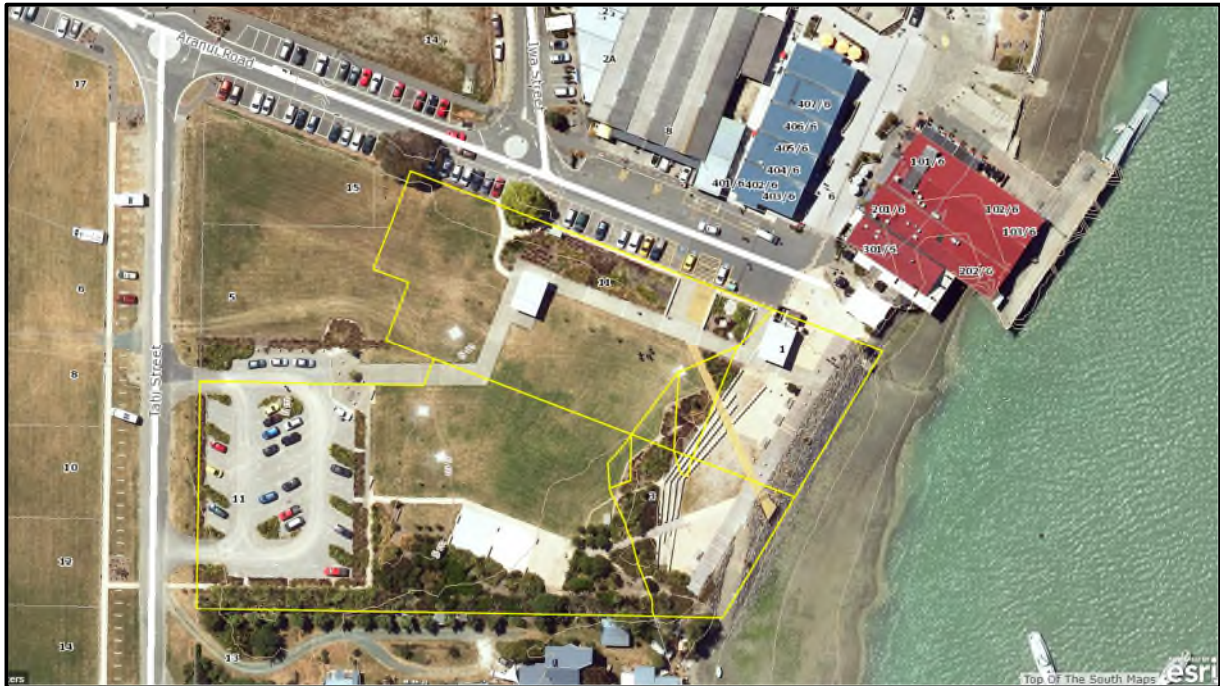
Figure 1: Site Location, showing existing lot boundaries. Recent aerial imagery from Top of the South.

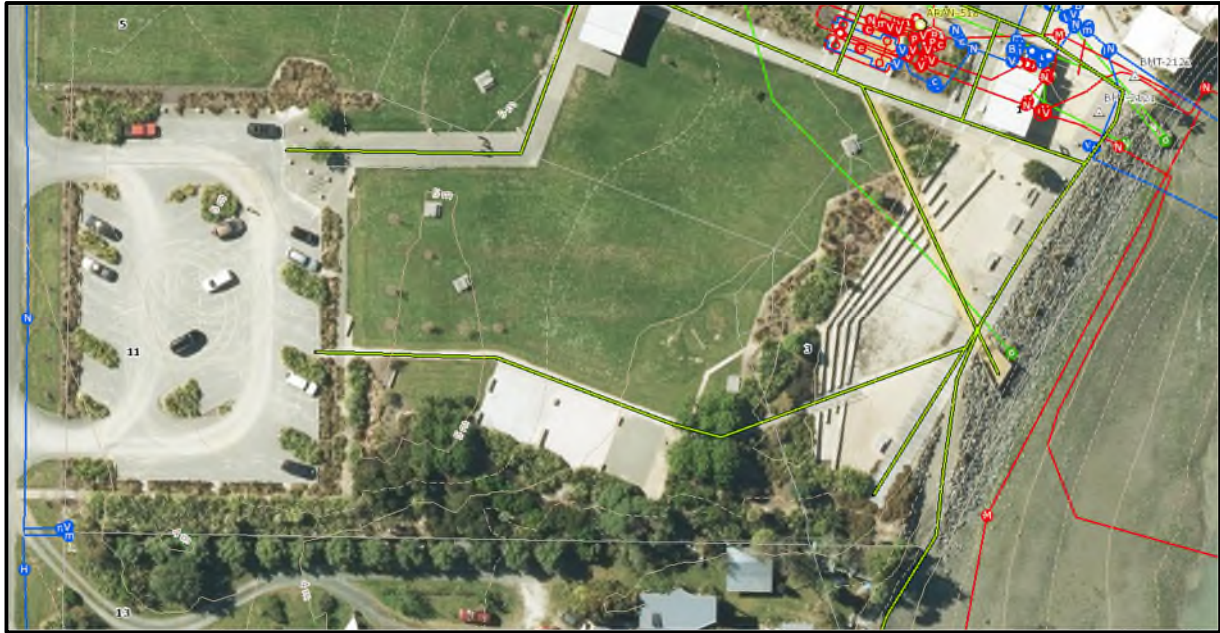
The site is generally flat lying, although slightly (approximately 1 m) higher than surrounding land, particularly in the centre of the site with a gradual slope east toward the foreshore and Waimea inlet. According to LiDAR contours the difference in elevation between the highest and lowest areas of the site is approximately 1.5 m. The higher elevation land extends through the site in a slightly mounded ridge running north to south to the east of the car park. The topography steepens towards the south of the site within the landscaped areas (refer to Figure 4).

Figure 4: Site Location with LIDAR contours, footpaths, and services. Source GRIP.

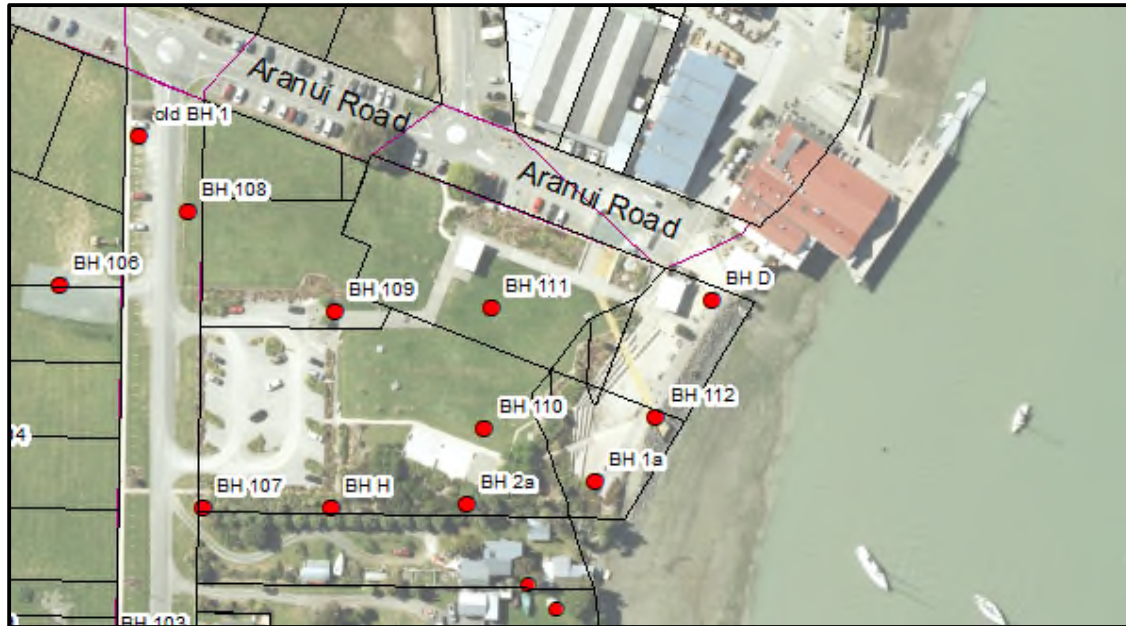
Several monitoring wells (Figure 5) were observed during the site walkover and generally appeared to be in a suitable condition. BH1a appeared to be located close to or within the proposed path of the boat ramp. Through discussions³ with TDC we understand the monitoring wells are accessed annually to conduct groundwater sampling to evaluate discharges from the site to the marine environment.

Figure 5: Site Plan showing groundwater monitoring wells. Source TDC.

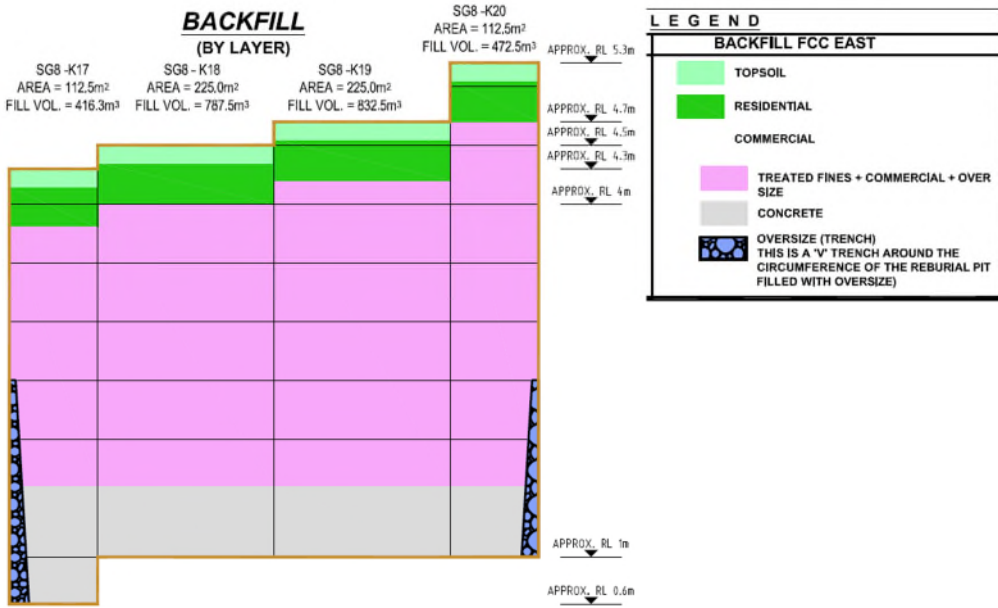
SG8 Southwest cell of FCC East. Sub cells K17 – K20 depicted below show approximately 0.6 m of capping material consisting of topsoil and residential grade soil over treated fines (which contains DDT concentrations max of 300 mg/kg, 95% UCL of the mean 114 mg/kg, aldrin and dieldrin max 16.8, 59.9 mg/kg). It is unclear if the concrete depicted at the base of the cells was poured concrete or crushed concrete. No details are provided in the validation report on this.

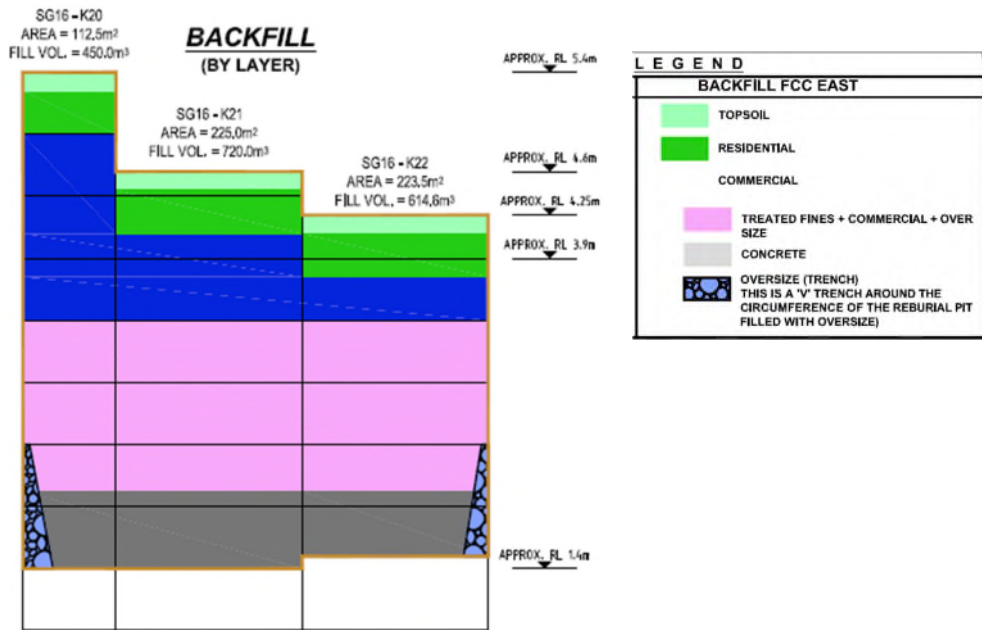
Central southern remedial cell SG16 and sub cells K20 0 K22 depicted below showing topsoil overlying residential soils over commercial over treated fines and commercial and oversized material.

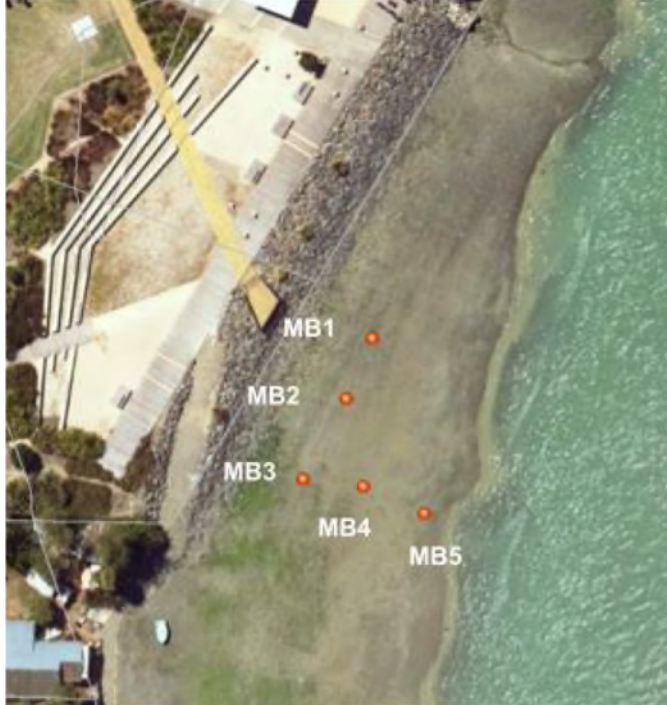
The report summarises the results from five shallow (top 0.25 m) sediment samples collected to the east of the site within the proposed location of the boat ramp. Four of the five sediment samples contained concentrations of total DDT in excess of the ANZ Sediment Quality Value, while the fifth sample detection limit was higher than the guideline value and therefore may have also exceeded the value. DDT concentrations ranged between 0.14 – 0.55 mg/kg.

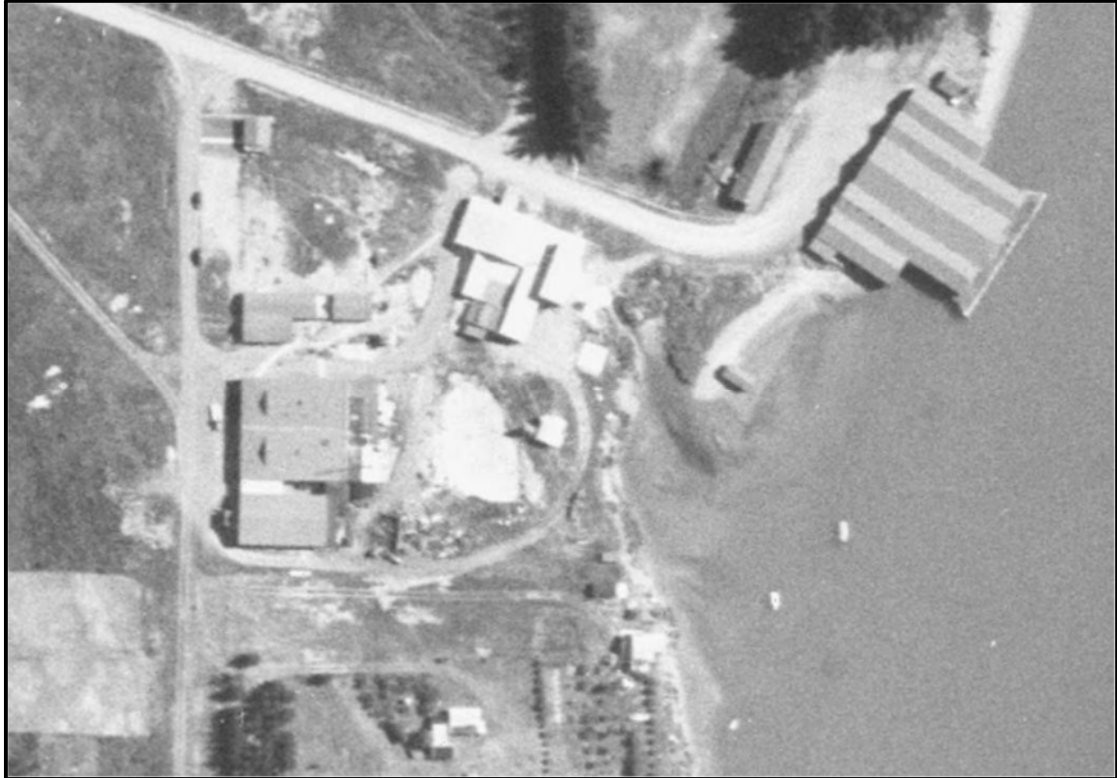
Figure 6: Historical aerial, 1940 - 49. Source Top of the South Maps. Several manufacturing buildings are visible, and the coastline is notably different to present day.

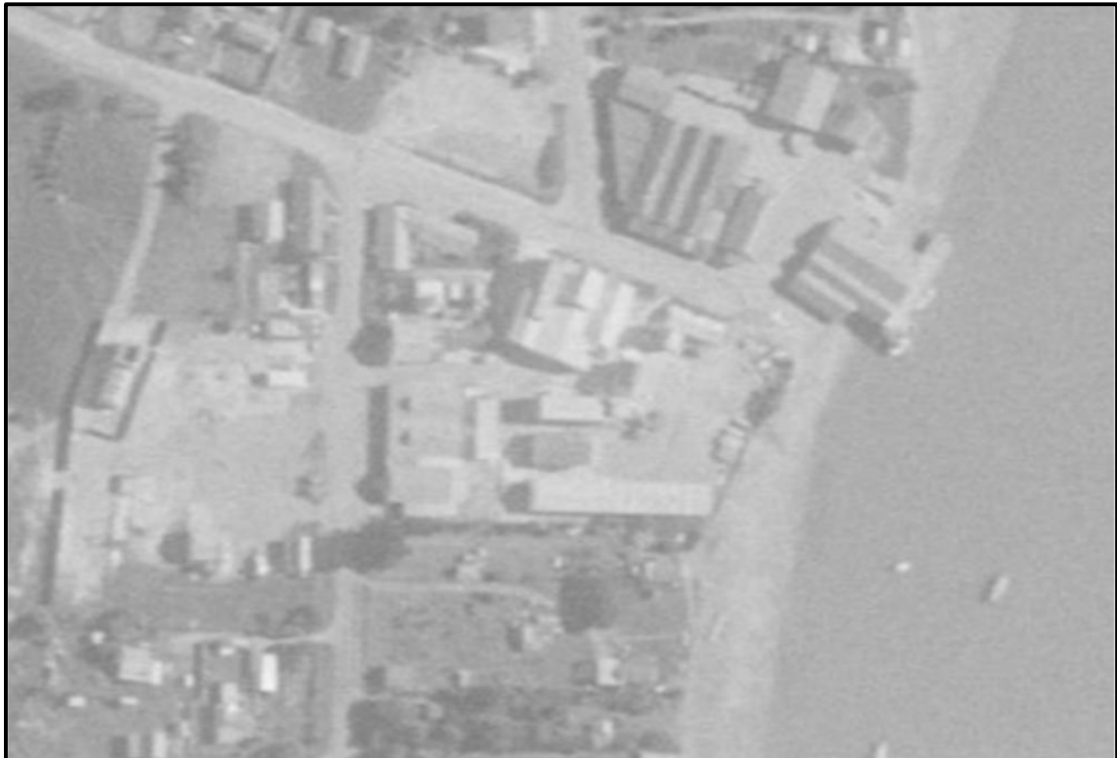
Figure 7: Historical aerial, 1980 - 89. Source Top of the South Maps. The site has further been developed and the property boundary on the east has been formalised and presumably the low lying area with the coast was filled.

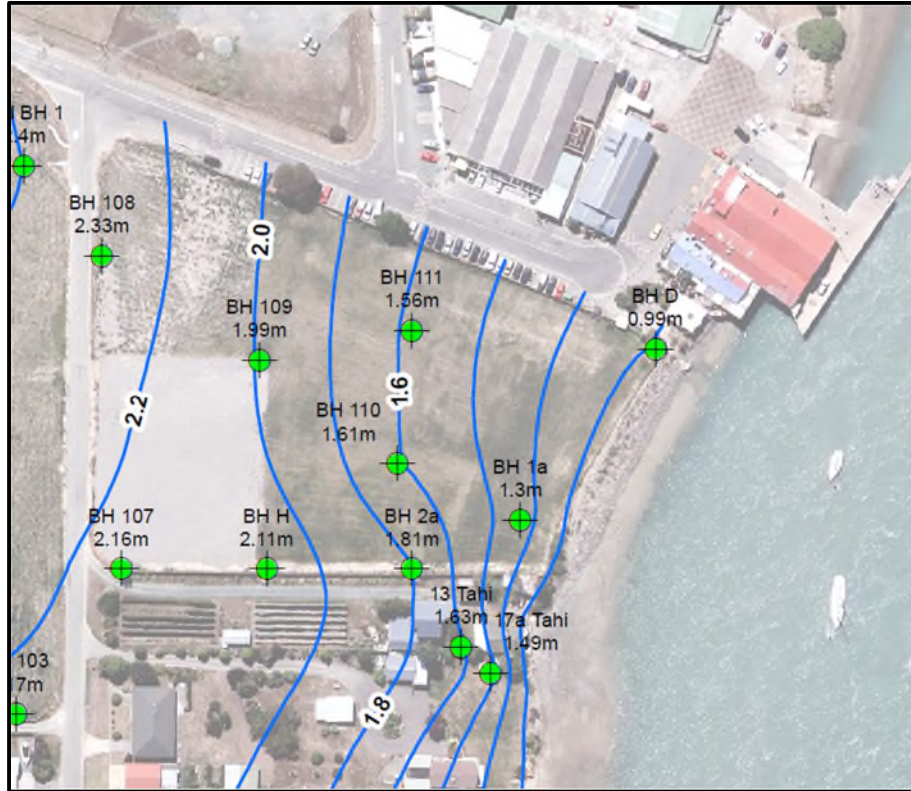
Groundwater has been recorded by PDP at the site in numerous monitoring wells to be at a depth of between 2-3 m bgl and inferred to flow east across the site towards the Waimea inlet. The piezometric contours at the site during a 2012 monitoring round are presented in Figure 11. Groundwater monitoring is conducted annually by TDC to evaluate groundwater quality at the site and potential discharges from the site to the marine environment. Monitoring well BH1a is located in the proposed route of the boat ramp and will need to be relocated during construction.

Figure 11: Groundwater levels and contours on 19 November 2012 (values in metres above mean sea level). Source PDP, 2013.

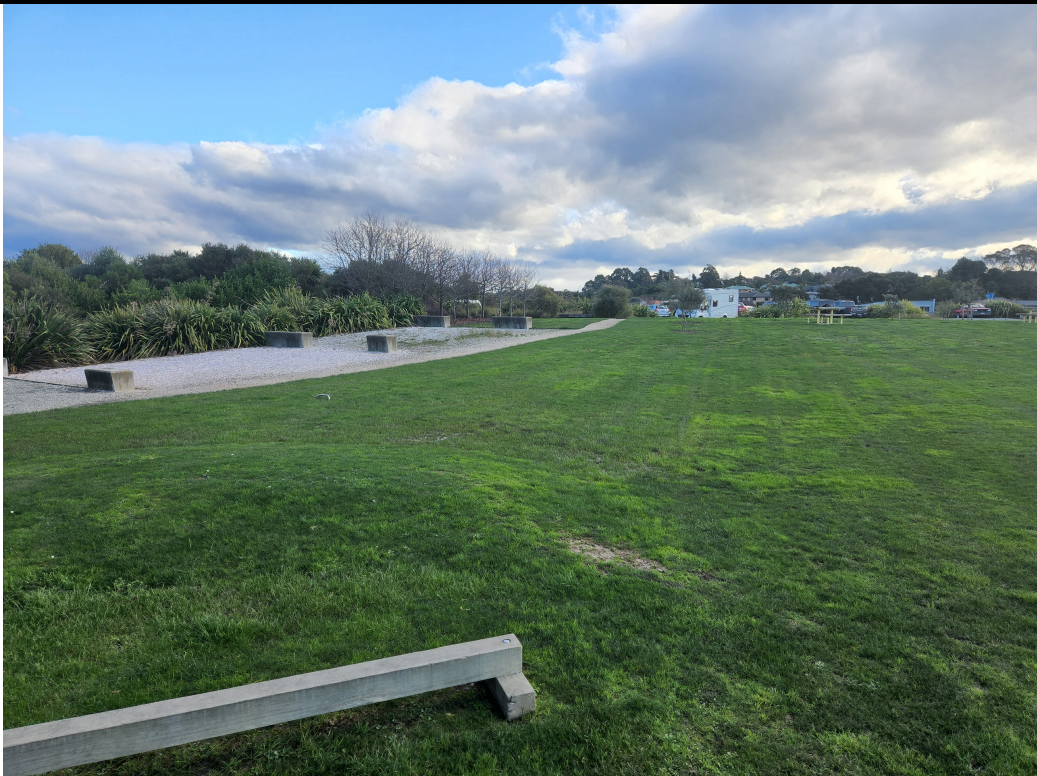
Photograph: 1

View west across site.

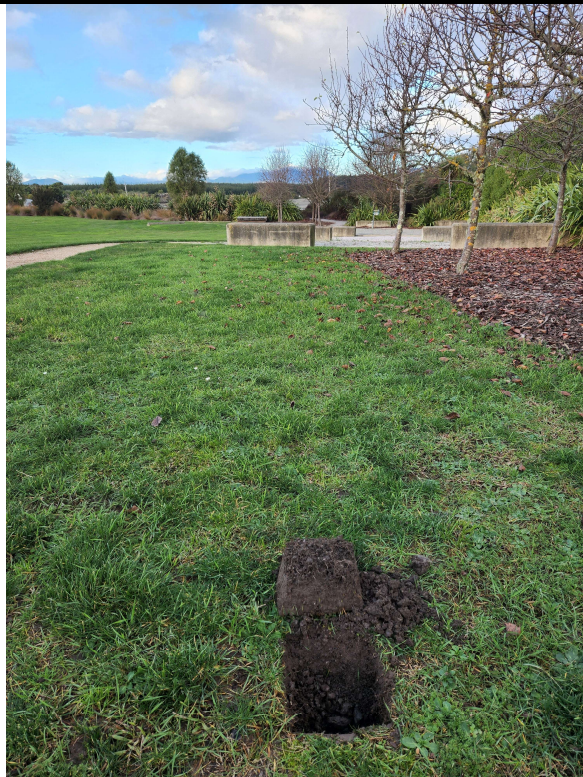
Photograph: 2

View East from SB1

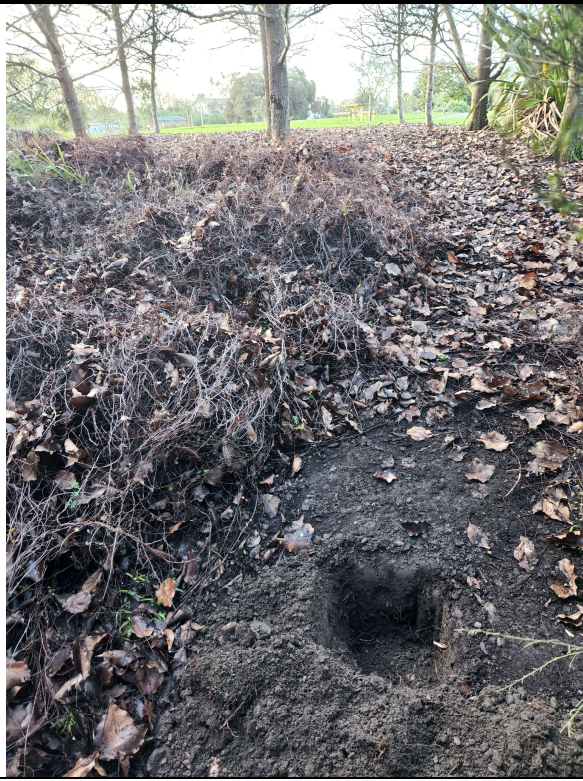
Photograph: 3

View north from SB2

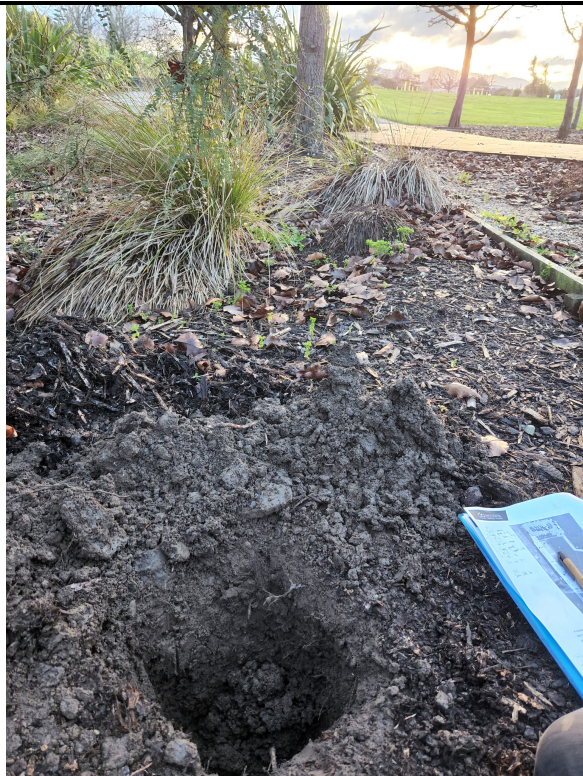
Photograph: 4

View west from SB3

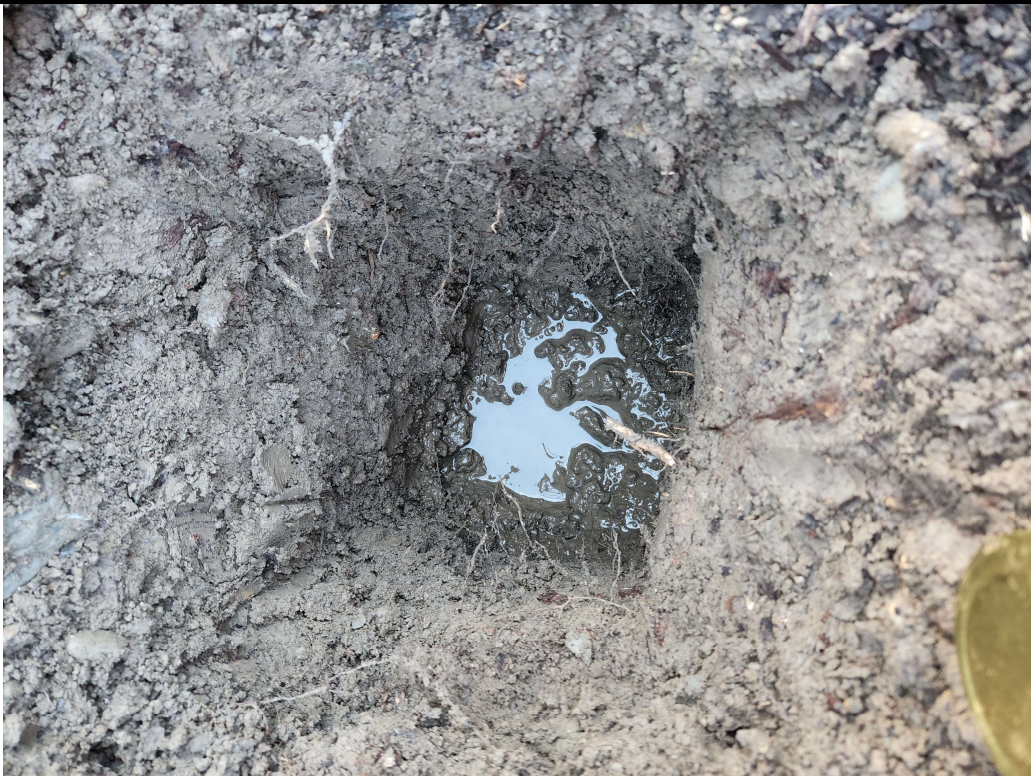
Photograph: 5

Perched water in SB3.

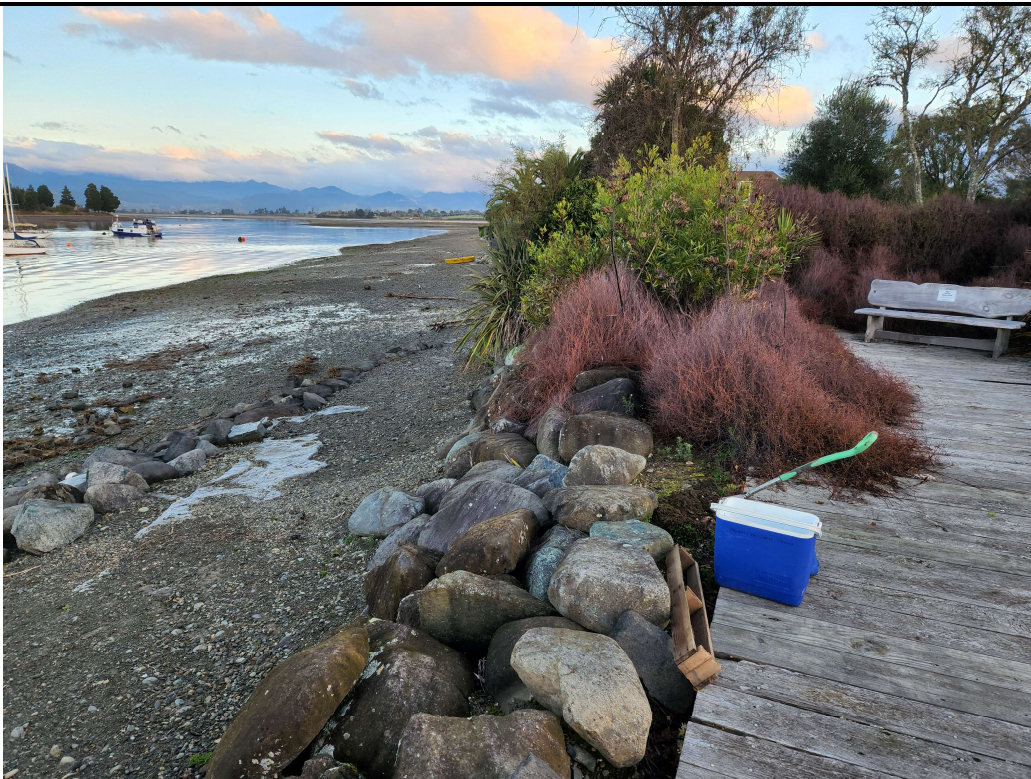
Photograph: 6

View south of SB4 and 5a
