Motupipi Estuary

Vulnerability Assessment & Monitoring Recommendations

Tasman
District
Council

March 2008

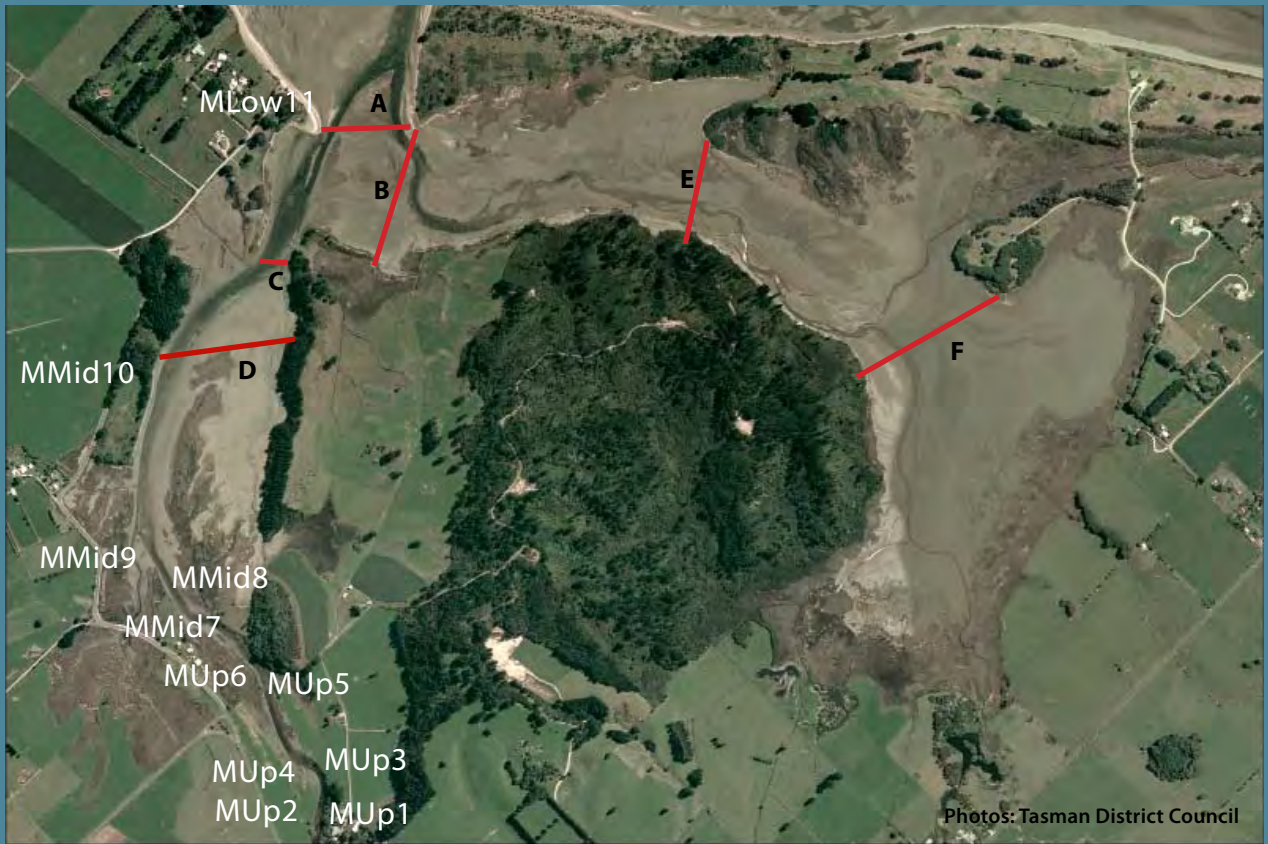
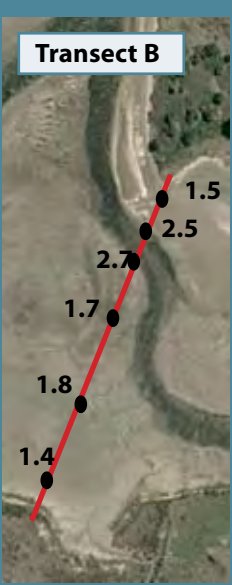
Figure 3. Motupipi Estuary synoptic survey sample locations (top), and depth transects in metres (bottom) taken at high water, 25 November 2007.

The lower Motupipi Estuary covers the small section just up from and including the mouth that is well flushed each tide with incoming marine waters (mean depth approximately 1.5 m). Sampling details from a typical channel site (e.g. Transect A, Figure 3) are presented in Table 1.

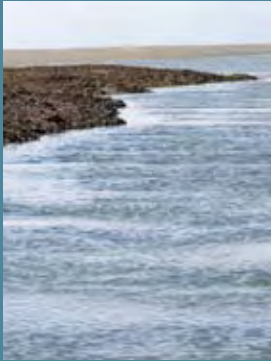
Oyster bed in lower estuary.

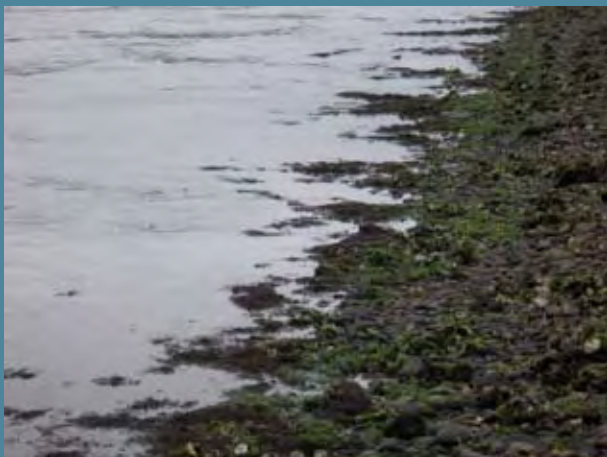
Macroalgae and cobble habitat.

Station	Measure	Results	
MLow11	Depth	Pool 1-3m.	
	Sediment Type	Clean cobbles, gravel/sand. No sulphides. <i>Gracilaria</i> and <i>Ulva</i> common.	
	Water	Clear water. No salt wedge. Salinity 25ppt, temp. 21 degC surface, secchi disc >1.5m.

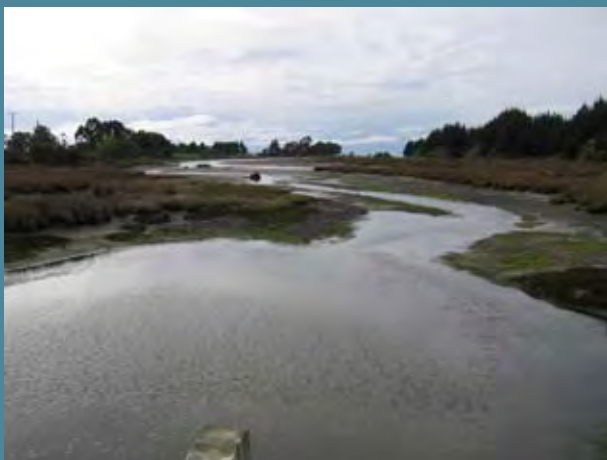
Middle estuary showing saltmarsh, macroalgal blooms and tidal flats.

Western Arm: In comparison, the western arm of the middle estuary, which was also dominated by large areas of saltmarsh and some intertidal flats, was relatively dirty and in poor condition. Symptoms of eutrophication were present, particularly along the main channel and adjacent intertidal flat section. In this section, anoxic and sulphide-rich deep soft muds and macroalgal and microalgal mats were common and phytoplankton blooms (*Cryptomonas* sp.) occurred regularly in the upper section (close to the upper estuary and source of nutrients). Symptoms of excessive sedimentation were also present in the same section, with deep beds of very soft muds and low water clarity.

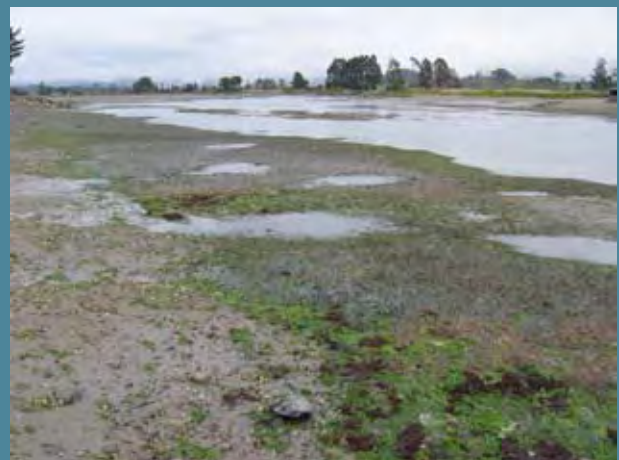
Middle estuary macroalgal blooms and tidal flats.

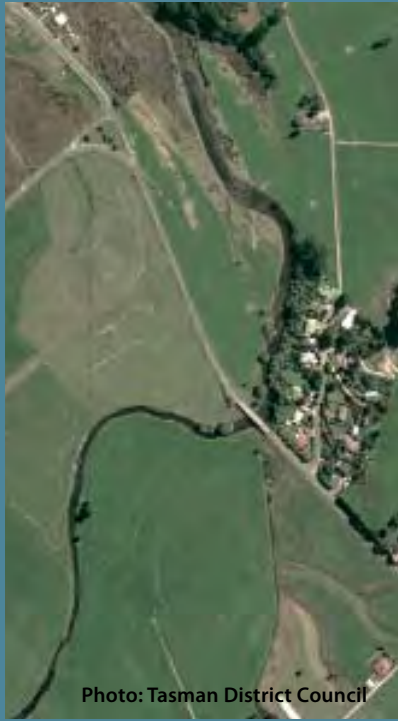
Photo: Tasman District Council
Aerial view of the upper estuary.

The upper estuary or low salinity zone occupies the upper 1 km of the estuary where it meets the Motupipi River, consisting of a single main channel (15-20 m wide, less than 2 m deep and covering approximately 2 ha) that meandered through farmland initially in the upper reaches, and then broadened as it reached the middle estuary (western arm). The upper estuary can be defined as the section of the estuary where river input (rather than tidal seawater) dominates the water column and the water is generally less than 10 part per thousand (ppt) salinity. In addition, the biota include both typically freshwater organisms, as well as estuarine and marine species.

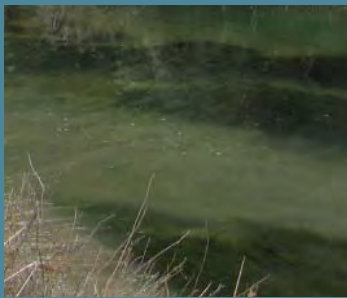
Seagrass in the upper estuary.

In terms of habitats, the upper estuary had the following: subtidal and intertidal seagrass beds, macroalgal beds, unvegetated mud and sand bed deposits, cobble beds in riffle sections and the water column itself.

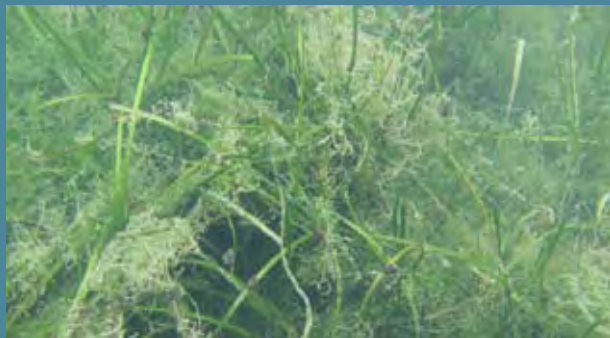
Eelgrass with macroalgal cover.

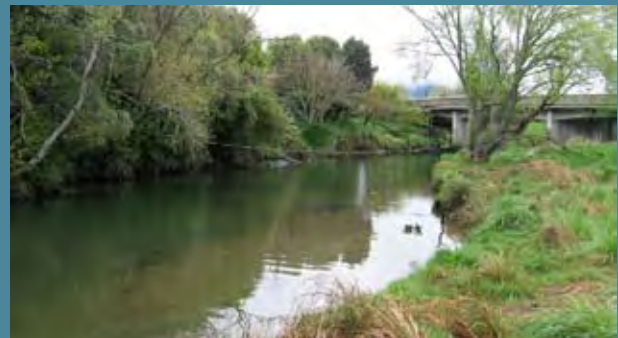
Upper estuary prior to cryptomonad bloom.

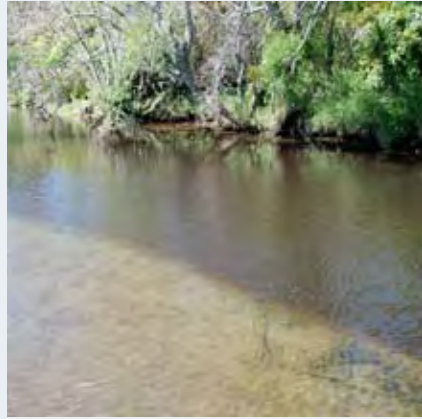
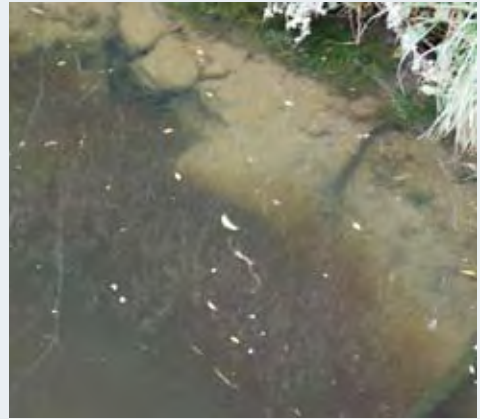
Algal bloom in deeper water below Abel Tasman Rd Bridge.

During the second field visit (26-27 November), a phytoplankton bloom (dominated by *Cryptomonas* sp.) occurred in the water column, which (according to local residents) began around 20 November and persisted until at least February 2008. The bloom was brown in colour and concentrated in the high salinity bottom water (see photos on following page). Similar blooms have been observed in the upper estuary since 2001 (Fred Winter pers. comm.), with the first sample being collected in early May 2007. This sample was dominated by various diatoms as well as a small unidentified flagellate (presumably *Cryptomonas* sp.).

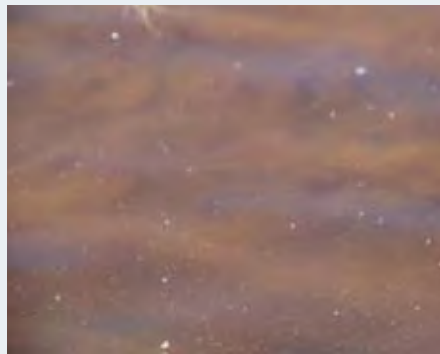
Close-up of algal bloom.

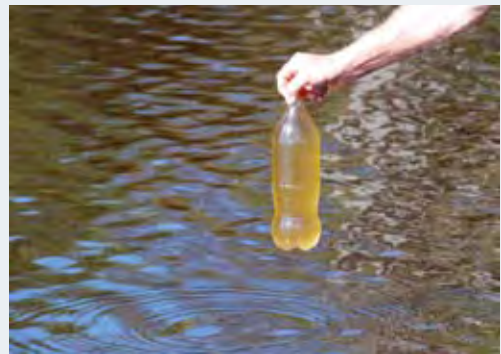
Sample of water with algal bloom.

The key feature of the survey in the upper estuary was symptoms of eutrophication, in particular, phytoplankton and macroalgal blooms and anoxic black sediments.

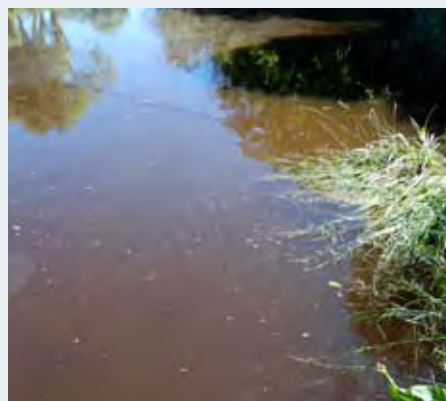
Bloom the following day on incoming tide (mixed through water column).

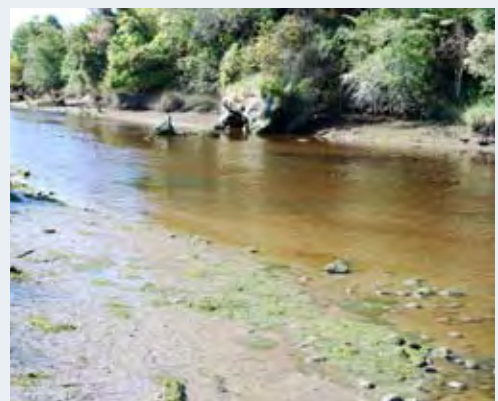
Bloom in shallower water showing strands in high salinity patches.

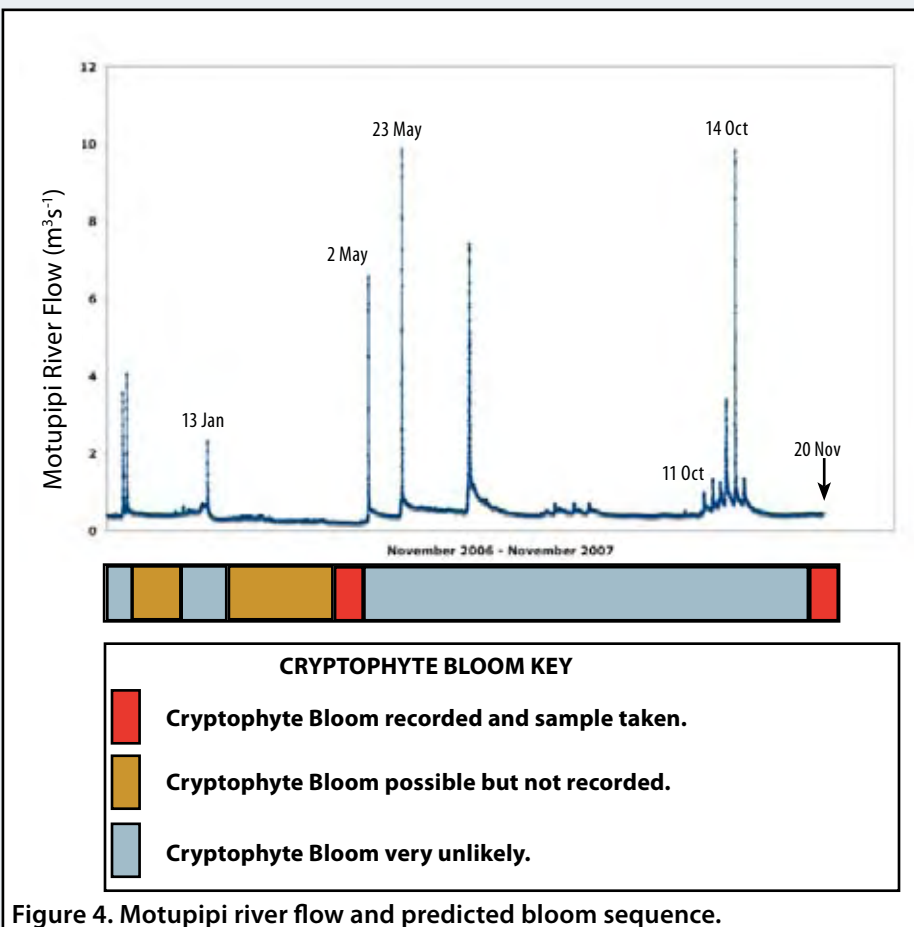
Figure 4. Motupipi river flow and predicted bloom sequence.

From 2 May to mid July several high flow events ensured turbulent mixing and from mid July to late September the spring conditions of small flushing flows and rising water temperature likely favoured diatoms. Subsequently, as water temperatures became higher and river flows declined, a cryptophyte bloom was becoming more likely. However, before this could happen, a period of high river flows occurred in October which delayed the cryptophyte bloom by keeping the water turbulent and well-mixed. In late October, the dry period began, river flows declined, the salt wedge became more stable, and the diatoms likely began to sink. This made way for cryptophytes to bloom, probably utilizing their heterotrophic abilities to use organic nutrients at low light intensities (light disappeared in 10cm within the bloom on 27 November) as well as their motility and tolerance of elevated temperatures to out-compete the diatoms. Nutrients may also have been a controlling factor (high nutrients concentrations are common in the Motupipi River).

Once the November bloom began it spread throughout the upper estuary from just upstream of the Abel Tasman Drive Bridge to approximately midway down the middle estuary (western arm) at low tide. At high tide it was restricted to the salt wedge area, which extended over much of the length of the upper estuary. Dissolved oxygen levels in this high salinity bottom water were low ($<1 \text{ mg/l}$). Such low concentrations were likely to be causing adverse effects to fish in the water column. In addition, possible impacts to seagrass may occur through shading effects.

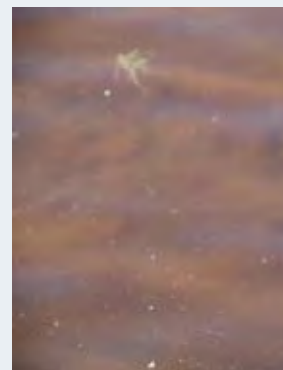
During Bloom (26 November).

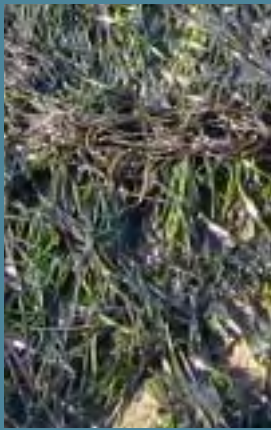
Eelgrass.

Description: New Zealand has primarily one species of seagrass, (*Zostera muelleri*), called eelgrass. Apart from its common intertidal habitat, eelgrass can also grow as subtidal fringes in New Zealand estuaries if water clarity is high enough (i.e. there is sufficient light penetration). Eelgrass can grow in bottom sediments ranging from coarse sand to mud.

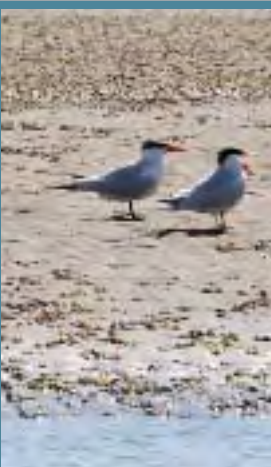
Sandflats and Caspian Terns.

Description: This habitat includes both dune areas near the mouth and along the sand barrier spits, as well as extensive areas of sand flats in the main basin (which often include a mud or silt component and shell fragments) and sandy channel areas. In these highly dynamic environments, sand is moved by tides, winds, and storm surges, and this movement is responsible for shaping these habitats. Sand flats typically occur in higher energy areas than mud flats where the substrate is predominantly sand and is exposed to sorting from wave and current action.

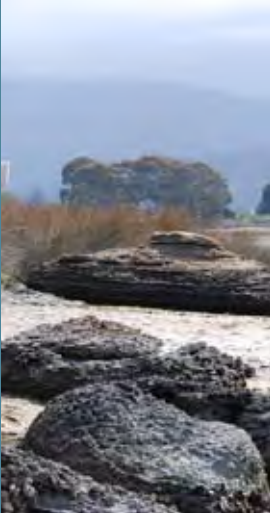
Rock habitat.

Description: Includes a range of larger material from solid rock ledges and boulders to cobble and gravel. This size regime strongly influences the composition of the biological community in the rocky habitat. A typical intertidal rock ledge community, for example, includes attached organisms with relatively long life spans (such as brown algae, anemones, barnacles, and mussels), while cobble beaches that are frequently disturbed by wave action tend to host small and ephemeral creatures, such as amphipods and isopods (e.g., beach hoppers and scuds). Rocky subtidal habitats commonly harbour seaweeds, crabs, sea urchins, and a variety of fish species. Some of the organisms found attached to rock ledges and boulders include mussels, oysters, limpets, chitons, and anemones. Finally, the biota of subtidal rocky habitats is distinct—many of the species found in these habitat types can only be found attached to rocky substrates.

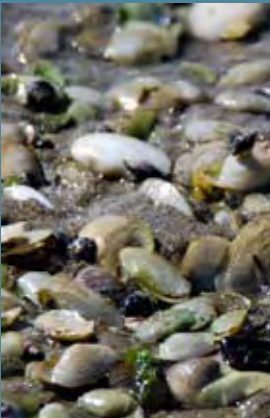
Pipi bed lower estuary.

Description: In dense groupings, bivalve molluscs (e.g. mussels, cockles, oysters and pipi), form a habitat type known as shellfish beds. Small organisms, such as polychaete worms, juvenile crabs and snails find refuge in the spaces between the shells, while other organisms attach to the shells' hard surfaces, which provide an anchor unavailable in the surrounding soft sediments. Each species of bed-forming shellfish has different habitat requirements, which means that shellfish beds can be found in a range of depths, salinities, or substrates (surfaces, such as sand, rock, or mud).
