Memo

28 May 2021

RM190876 and ors Pōhara flood mitigation works hearing

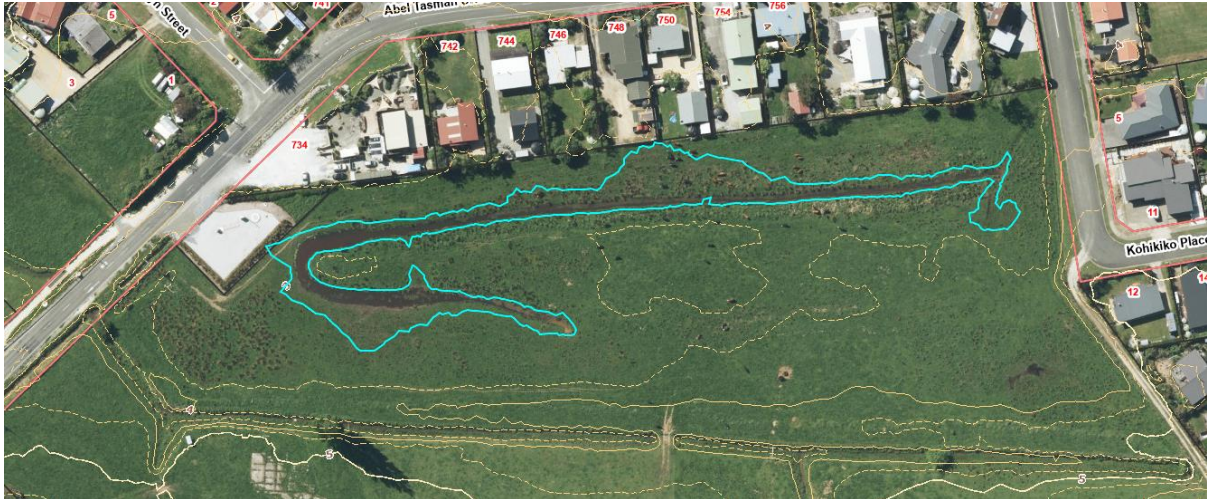
Figure 1: Aerial image – current (Council GIS) - 3m contour is highlighted in the above picture.

The area above is a low level depression typically found behind dunes. It is drained in two directions to the east and west, the levels of these drainage systems are just above RL 3 (as built from 4 wind pump station RL 3.2 and the subdivision to the east RL 3.15). So water cannot flow from the area until the flooding exceeds the blue contour.

The water shown in the picture above corresponds with the likely groundwater level in this area. A geotech bore was drilled as part of the pump station to the west and this found groundwater at a level 1 m below the ground level with wet soils above this. Communications with Joseph Thomas (Senior Resource Scientist - Water & Special Projects, Environment & Planning) suggested that the expected groundwater in this area would be very shallow say in the order of 0.5 m deep.

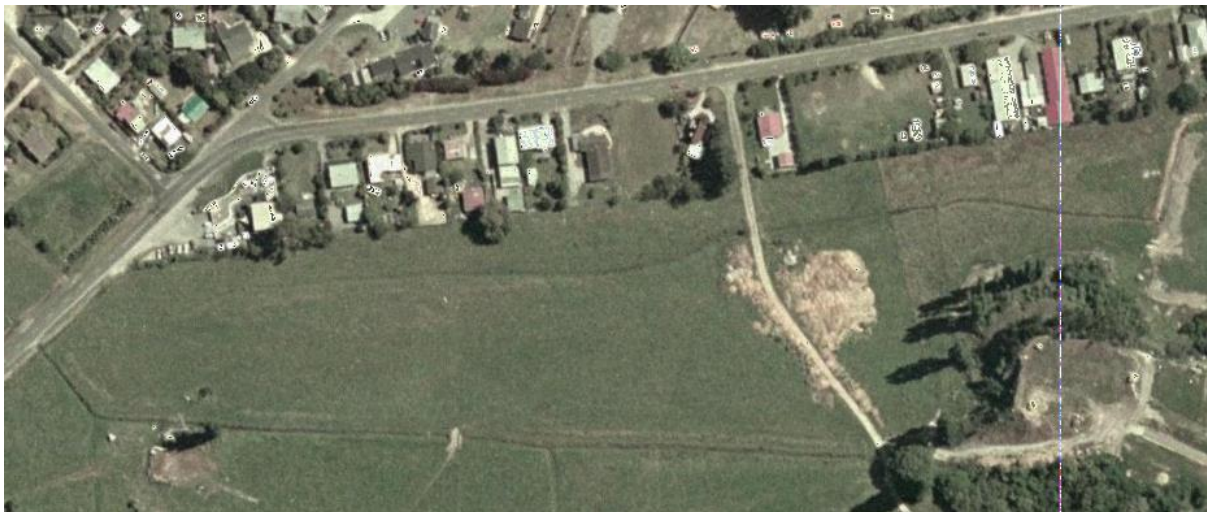
Figure 2: Aerial image – 2004 (Council GIS) - Prior to subdivision to the east.

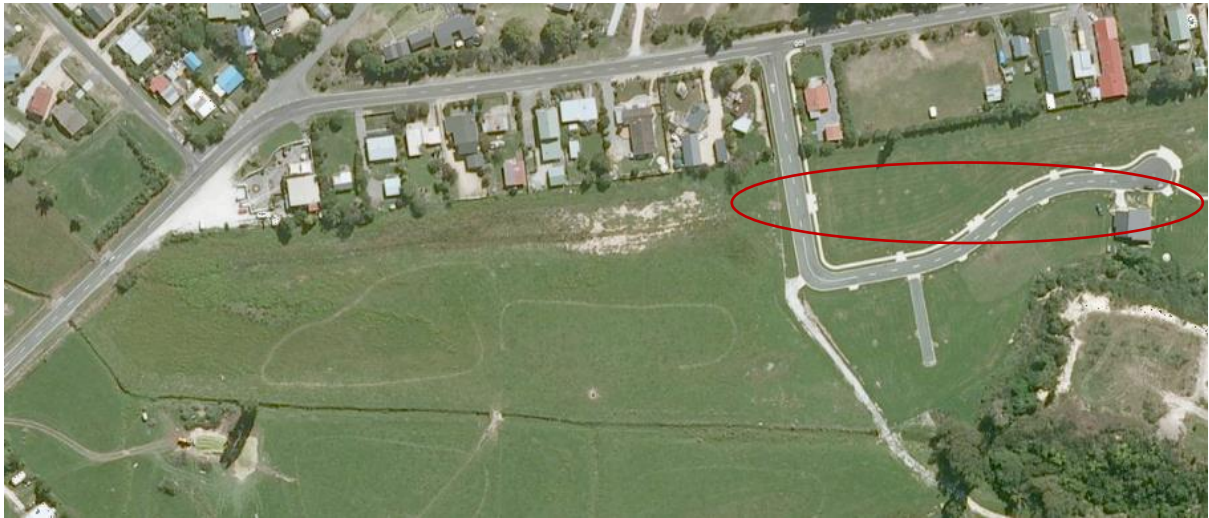
Figure 3: Aerial image – 2007 (Council GIS). Shows the blocking of the drain. As built plans suggest the outlet was raised to an RL of 3.15 m

The formation of the subdivision in the 2000's looks like it has resulted in the drain running down behind the houses being blocked and increased the ponding in this area.

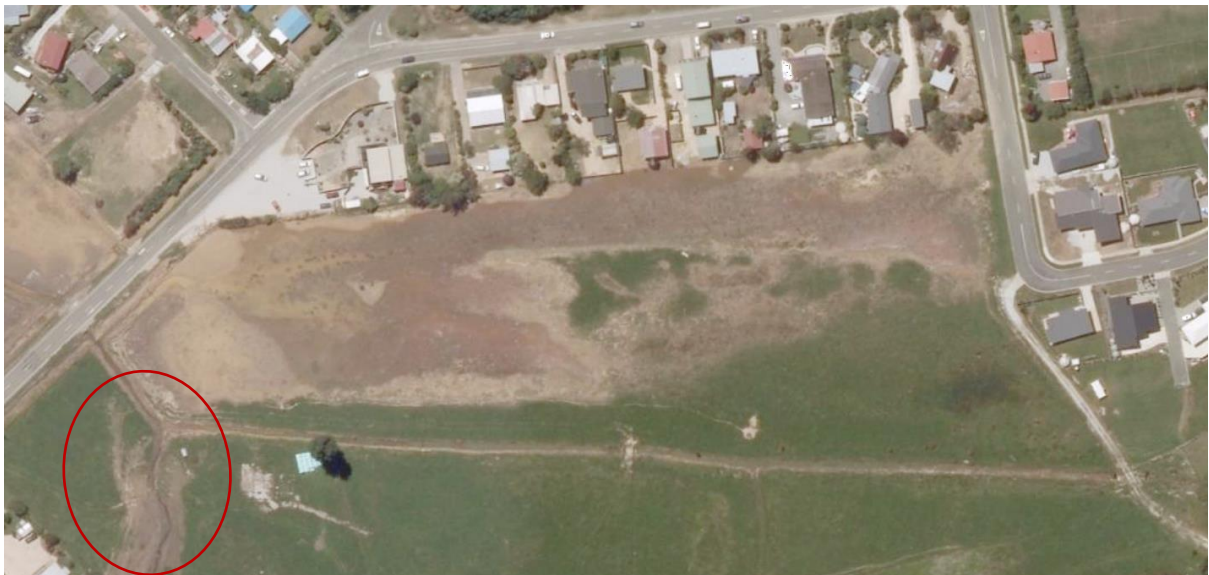
Figure 4: Aerial image – 2011 (Council GIS).

Figure 4 was taken a few days after 2011 flood event. There seems to have been no over flow over most of the drain. Material seems to have come from the lower left corner of the above image.

A low bund, formed by clearing of the drain, already exists in the approximate location of the proposed stop bank. Figure 4 taken after the 2011 event does not show signs of water flowing over most of the proposed stop bank.

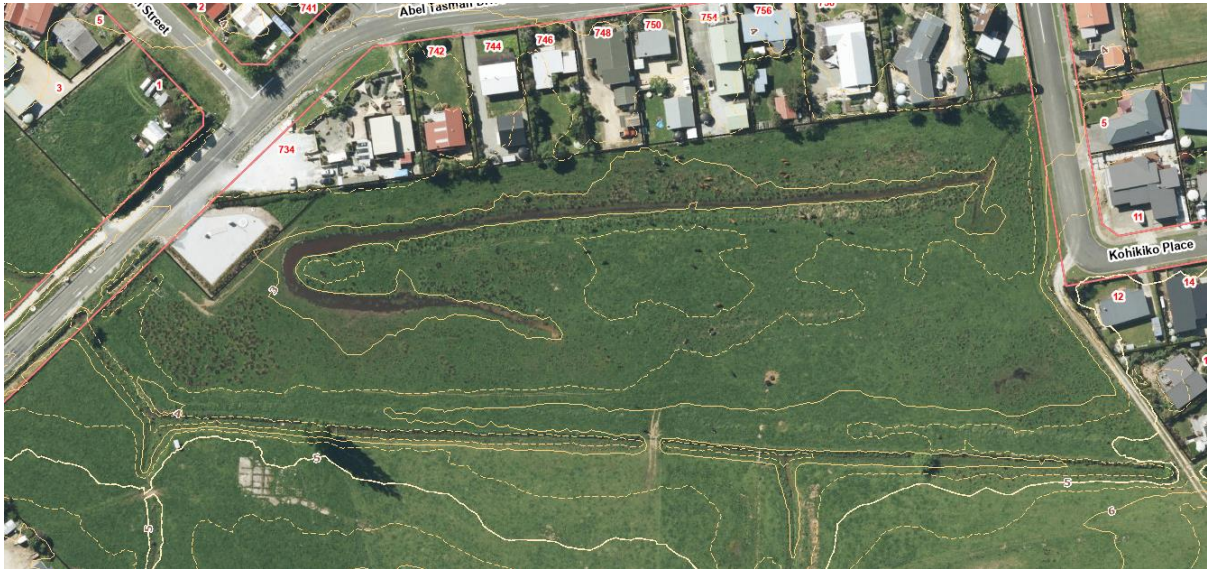
Figure 5: Aerial image – current (Council GIS).

Figure 5 shows the contours and the Four Winds Pump Station to the left of the wetland. The drain around the pump station embankment has an RL of 3.2 m

Maintenance (drain clearance) of Elise Creek has resulted in a low bund being placed between the wetland and the creek (contours are from 2016 LIDAR).

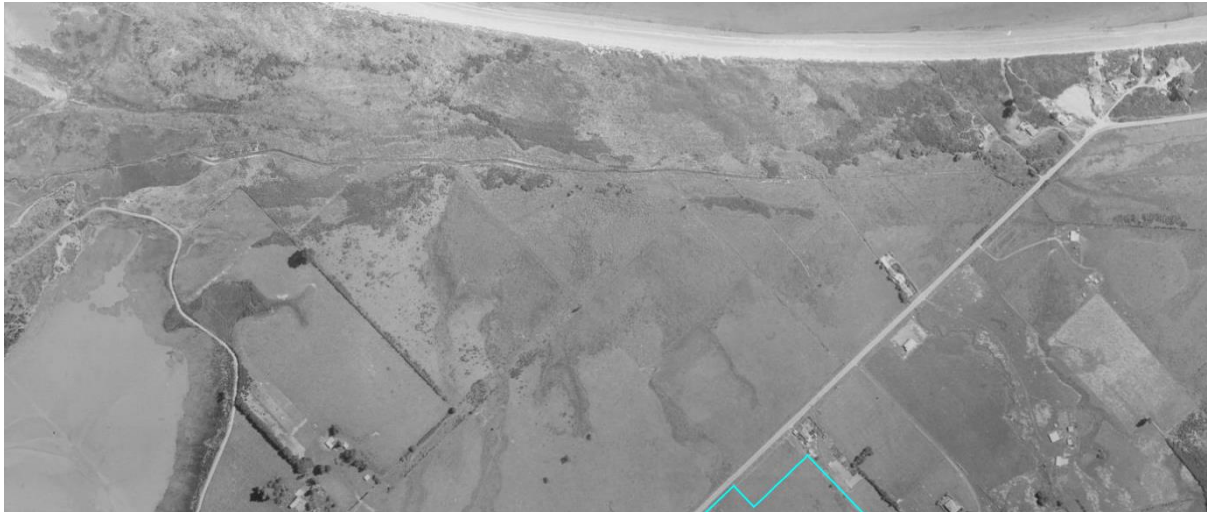
The current water course is still in a similar place to the 1940's image. It runs along the back of the dunes.

Houses were typically built in the higher areas to avoid flooding, the ground behind the properties drops relatively quickly to the flood plain. Most of the wetlands in the 1940's image see to be to the South of the drain/waterbody.

Figure 6: Aerial image 1940 (Council GIS)

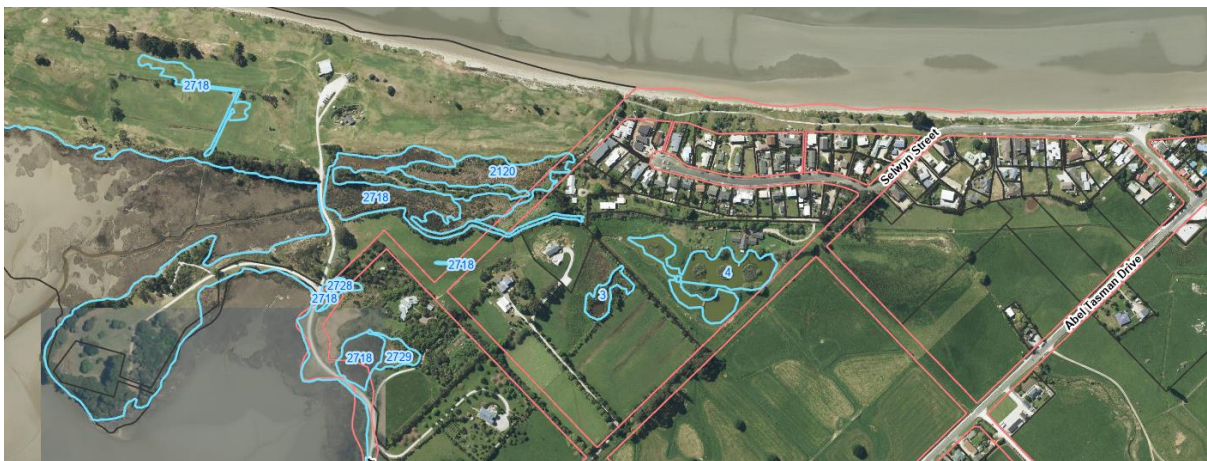
Council has mapped this area for wetland as shown on the image below. These are to the south of the proposed works.

Figure 7 TDC wetland mapping of the area (Council GIS)

It is possible that very small remnant wetland exist in the alignment of the proposed flood protection works however these have not been mapped as TDC wetland mapping

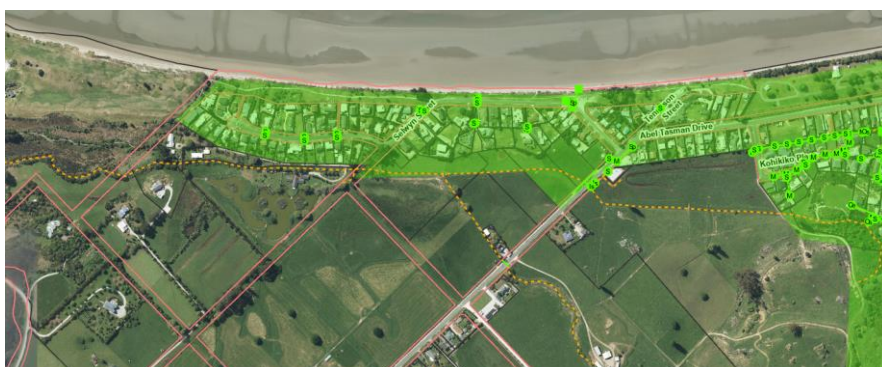
Figure 8 Urban drainage area - intersects with the proposed works to the west of Able Tasman Drive

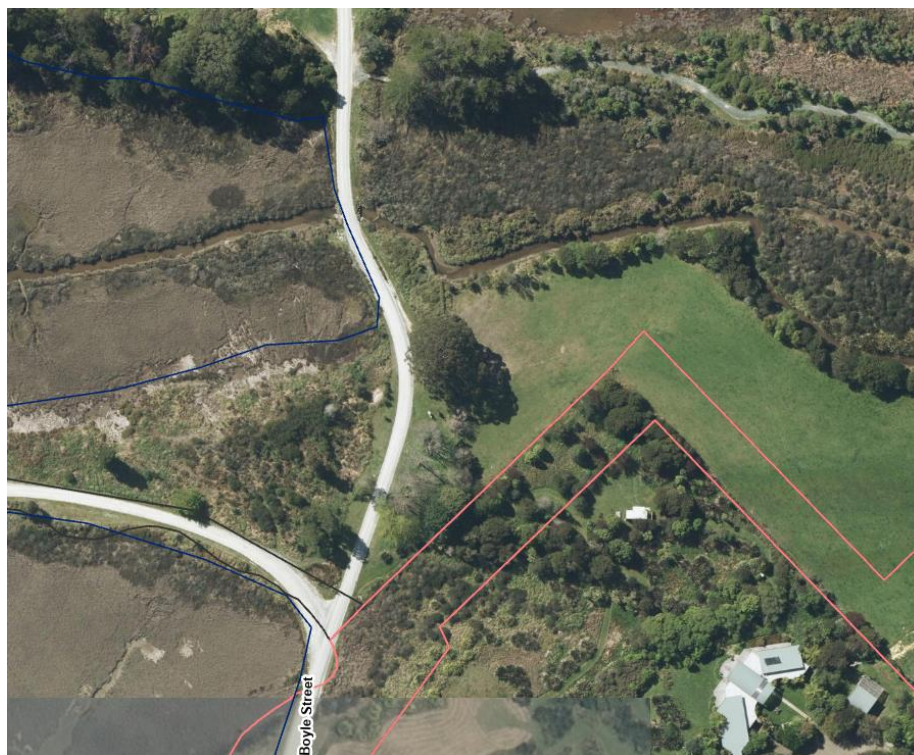
The CMA boundary is defined for specific locations only in the district. For specific proposals or projects the Council starts with the planning maps and then may get MHWS surveyed on site. In this case the planning maps show the CMA to be downstream of the road, noting that the ortho rectification is often not great in rural areas.

Figure 9 Coastal marine area boundary – dark blue line (Council GIS)

The works in the CMA are permitted by rule 25.1.5.5 (see rule below) and the applicant has applied for a consent for works outside the CMA ie above MHWS. The commissioner has scope and authority to issue a consent for the works landward of the CMA boundary.
