A preliminary assessment of salt marsh rehabilitation options for Waimea Inlet

Stevens LM, Southwick M. 2021. A preliminary assessment of salt marsh rehabilitation options for Waimea Inlet. Salt Ecology Report 058 prepared for Tasman District Council. March 2021. 56p.

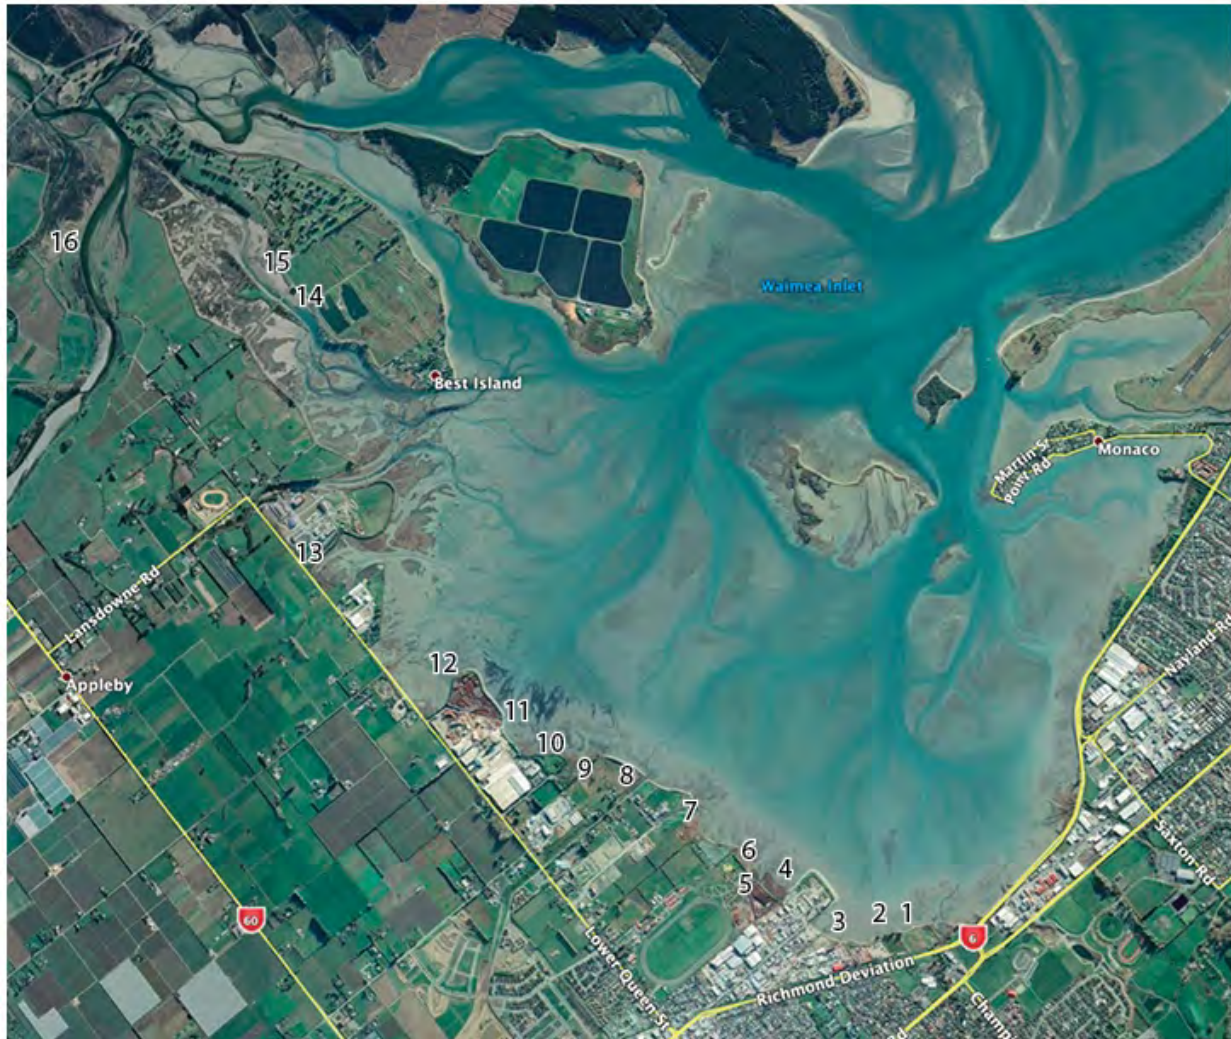
#	Site	Area (ha)	#	Site	Area (ha)
1	Wakatu Drive	2.1	9	Sandeman Reserve (stream)	0.3
2	Reservoir Creek (west)	0.5	10	Sandeman Reserve (coast)	0.3
3	Vercoes Drain and Delta	2.9	11	Bark Processors east	0.3
4	"Greenwaste"	0.1	12	Bark Processors west	0.6
5	Pastoral Stream	0.8	13	Lower Queen Street	0.8
6	A&P reclamation	0.3	14	Best Island Golf Course	0.8
7	Estuary Place	0.1	15	Best Island	0.9
8	Borck Creek to Sandeman	4.5	16	Waimea River Delta	4.2

Fig. 2 Location of potential restoration sites identified by TDC as initial options for assessment in the eastern arm of Waimea Inlet.

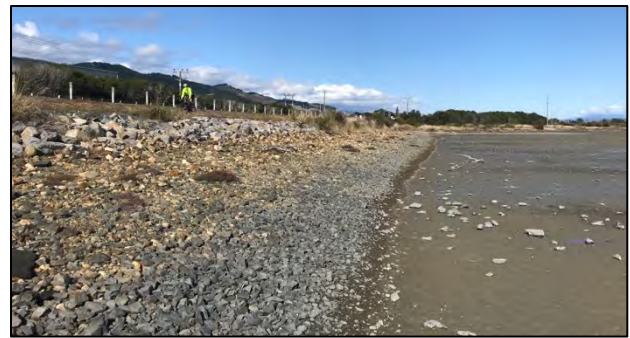
Artificial rip-rap and cobble protection adjacent to the cycle lane and Whakatu Drive

Because of the modified upper shoreline and relatively high wave exposure, the following is recommended.

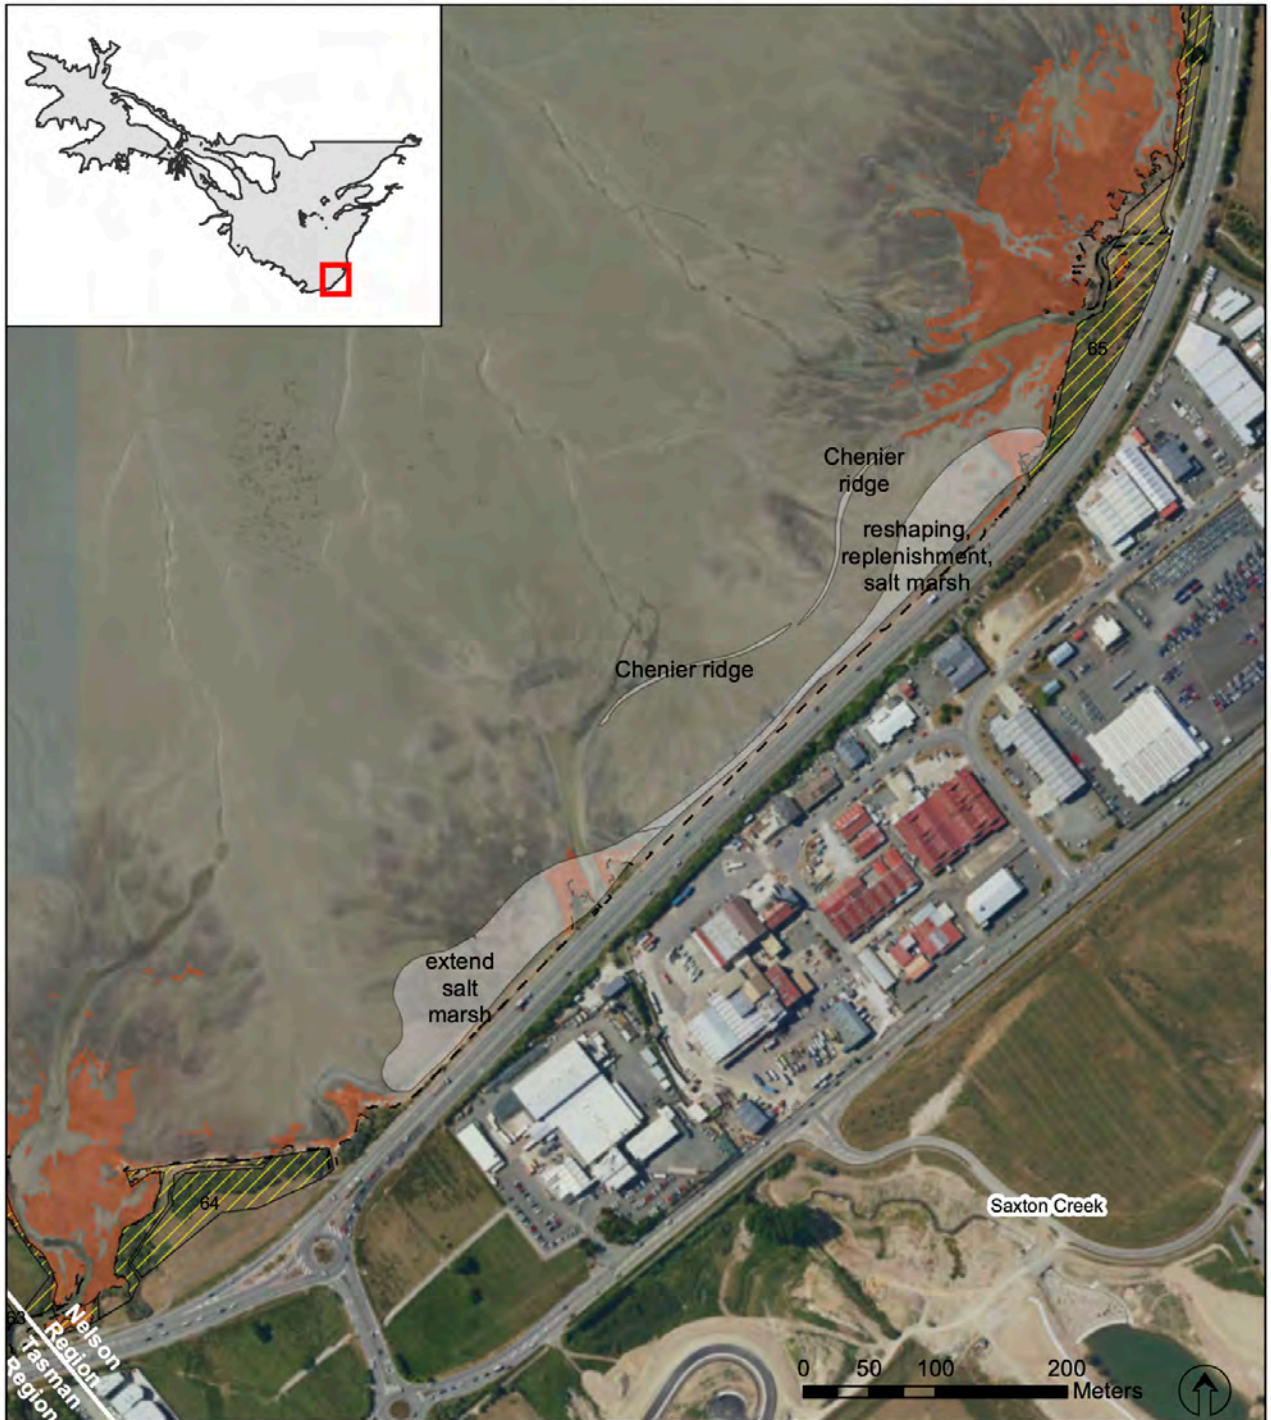
Fig. 3 Outline of proposed restoration footprint, Whakatu Drive.

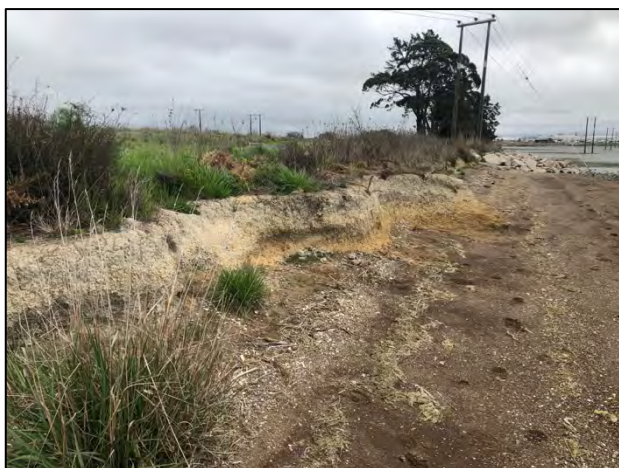
The upper shoreline comprises a relatively narrow and steep strip of gravel immediately in front of a 0.5-1m high vertical clay bank. Seaward is a near horizontal muddy intertidal flat with slightly elevated unvegetated gravel beds located 80-100m offshore. Over the past decade the shoreline has eroded and migrated ~10m landwards as a consequence of the relatively high wave energy at the site. Large rock reinforcing has been introduced to protect power poles on the shoreline (see photo below). There has been minor disturbance of the estuary bed as a result of digger access for maintenance of power poles in the estuary.

Eroding shoreline (foreground) and rock rip-rap protecting power poles in the background west of Reservoir Creek.

Because of the modified upper shoreline and relatively high wave exposure, the following is recommended.

dense stands of growth on the most exposed edge but to minimise the cost of plants overall. Planting in several patches is recommended initially to trial different planting densities and configurations.

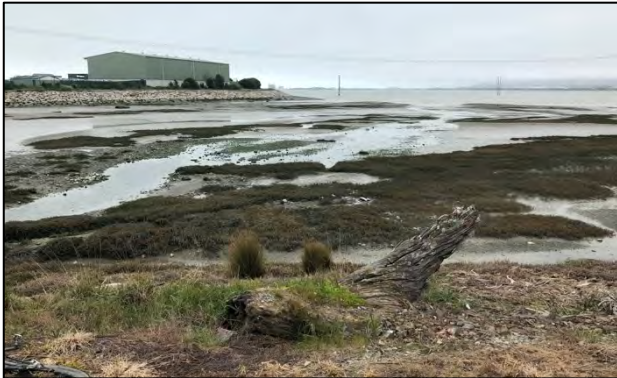
Vercoes Drain delta showing herbfield growing on raised gravel beds.

Where the streams discharge, there has been a build-up of intertidal gravels over time. These areas are elevated relative to the surrounding mud flats and support patchy areas of salt marsh (predominantly herbfield and some searush). There are virtually no terrestrial plantings or salt marsh on the upper shore (see photo above).

- Plant pockets of searush at high densities (10-15 plants/m²) on the gravel delta to see if rushland can be established in the mid-intertidal reaches.
- Protect the seaward edge of plantings with small rock Cheniers (e.g. 10cm high). Planting in several patches is recommended initially to trial different planting densities and configurations.

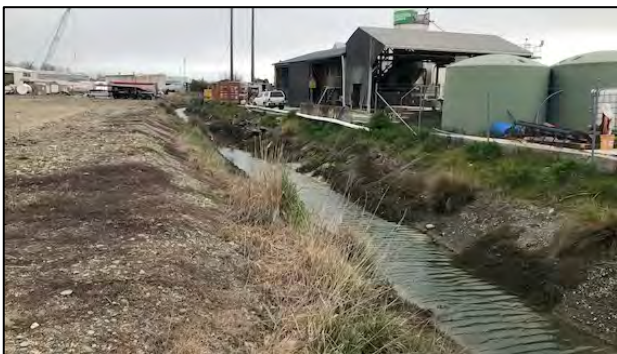
Vercoes Drain and Jimmy Lee Creek (Fig. 5) enter the estuary east of the refuse transfer station. The shoreline has been extensively modified through historical reclamation and drainage, with the waterways straightened and channelised. Reclamations extend to the edge of the estuary where they are protected by rock walls or concrete rubble.

Vercoes Drain showing channelisation and surrounding landuse. Note the presence of salt marsh along the channel edge.

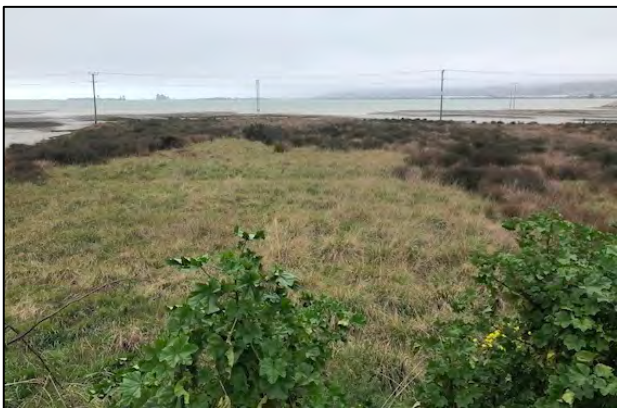
The Greenwaste site is an area of established salt marsh located immediately seaward of the Great Taste trail which is constructed on a raised earth bund that runs along the foreshore (Fig. 6). The salt marsh is relatively intact and in good condition but contains a small (80m²) patch of tall fescue grassland and various terrestrial weeds (see photo below).

Grassland and weeds growing within salt marsh adjacent to the Greenwaste site

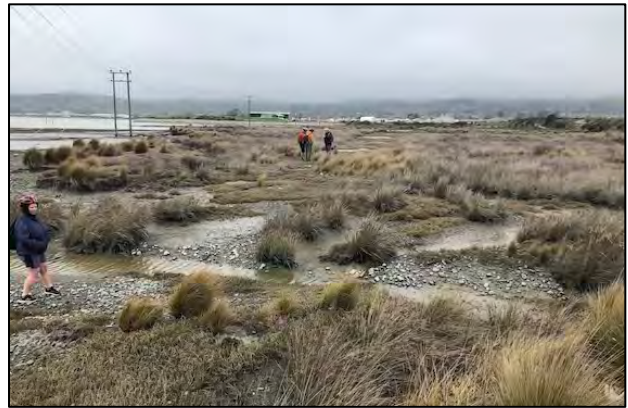
The A&P reclamation site is an area of salt marsh seaward of the bunded shoreline that was disturbed during attempts to reclaim ~2ha of land ~15 years ago (see following photo). Salt marsh in this area is relatively extensive but has been very slow to recover from the earlier disturbance.

Recovering salt marsh at the A&P Showgrounds reclamation site

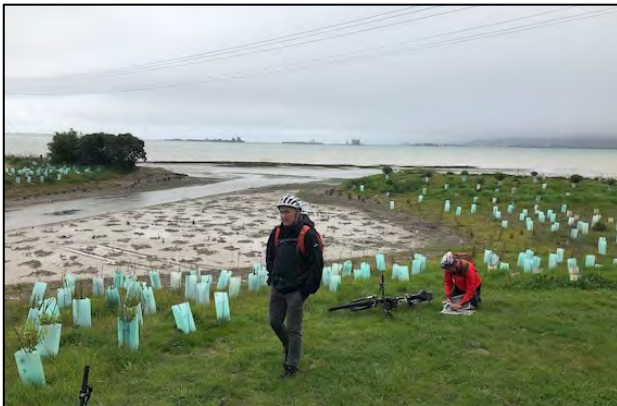
Tidal reinstatement through the previously bunded mouth, and restoration plantings at Estuary Place

- Maintain existing plantings through regular weed and pest control.
- Infill plant within intertidal rushland to increase shoot densities and increase cover. This will help protect against desiccation and limit the damage from animals (rabbits and hares).

- Scrape/reshape the area seaward of the cycleway to allow for additional salt marsh planting.
- Plant additional salt tolerant rushland and herbfield species near the tidal margin.

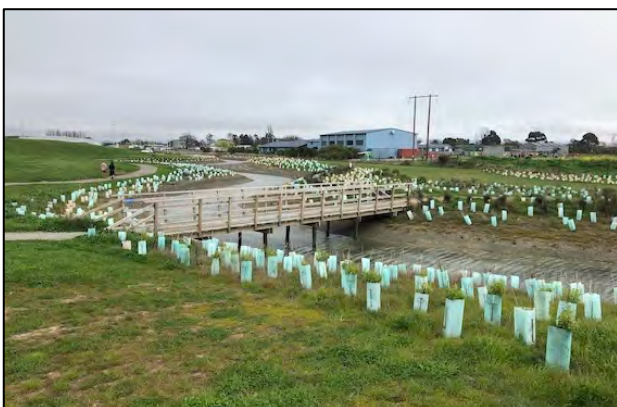
Meanders were built into the lower streamway and the edges reshaped to have a gentle slope prior to planting

The restoration is quite different to the adjacent salt marsh which provides a good indication of what it would have been like prior to reclamation. The reason the restoration is so different to the natural salt marsh is primarily because of logistical constraints and costs in removing excess earth dumped when the site was reclaimed. It provides a good example of how retaining existing salt marsh is far more straightforward and cost effective than trying to recreate it. Restoration scoring criteria are presented in Table 11.

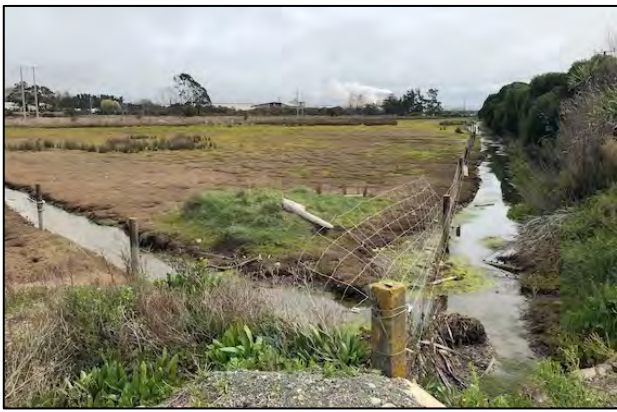
The Borck to Sandeman section is a large (~4ha) low-lying area of salt marsh largely cut off from the estuary by bunds constructed along the foreshore. The remaining salt marsh is in a compromised state due to limited inundation, historical modification and stock grazing. Tidal flows reach the site through small pipes under the earth bund, while flow paths within the salt marsh have been channelised in an attempt to drain the area (see photos below).

Grazed salt marsh cut off from the sea by a large earth bund (right) and channelising to drain water

- Remove stock and fencing.

- Significantly increase culvert size or open bunds to reinstate tidal flows at both east and west ends of the site.
- Maintain existing salt marsh through weed and pest control.
- Infill plant within the rushland to increase shoot densities and increase cover. This will help protect against desiccation.
- Open the eastern side of the site to improve connection to Borck Creek particularly for flood flows to create a delta system with sediment retention.
- Investigate re-routing the cycleway to the inland side of the site.

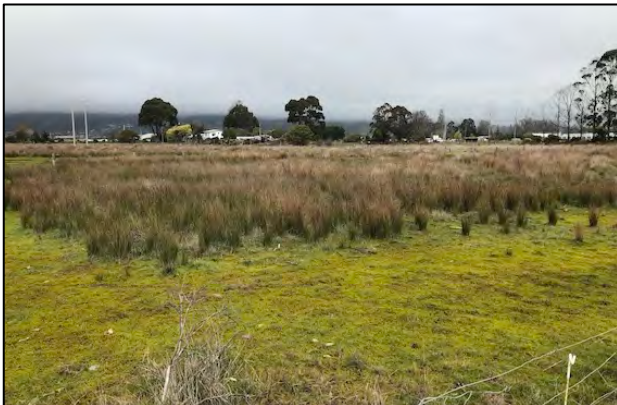
Rushland and herb field currently within paddocks used for grazing stock

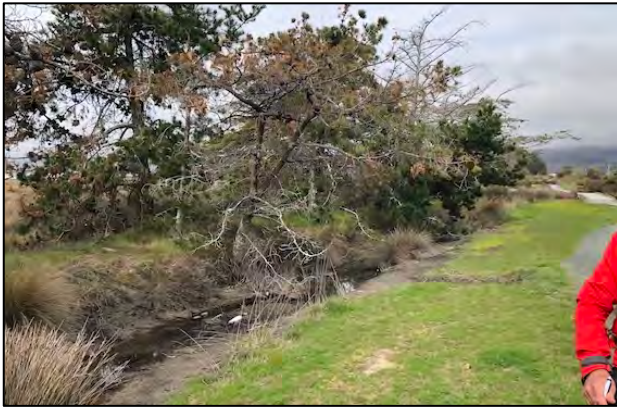
The reserve is cut-off from the estuary by a drainage channel and bund that runs along the shoreline. There is a stand of pine trees growing on the bund (see photo below). Water quality in the drainage channel is frequently poor due to flows being trapped and water becoming stagnant.

Pine trees growing on an earth bund seaward of a drainage channel running parallel to the shore

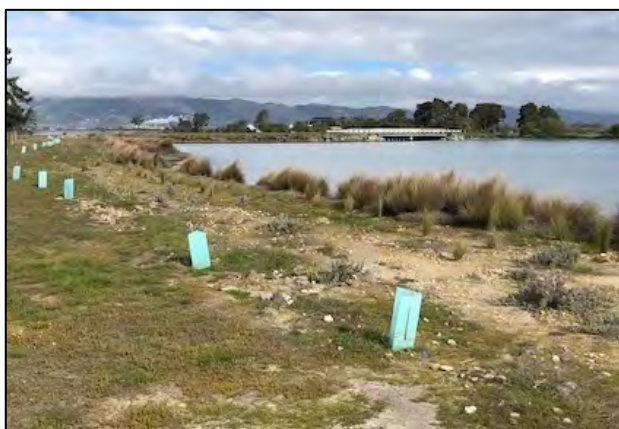
Initial work by TDC has removed some pine trees and planted narrow strips of salt marsh along the upper shore (see photo below).

Grassland and weeds growing among salt marsh plantings adjacent to the Golf Course entrance

- Undertake infill planting to further enhance the existing plantings.
- Continue with ongoing weed removal and pest control. Consider exclusion fencing (for vehicles).
- Rip and plant decommissioned road areas in the northwest.

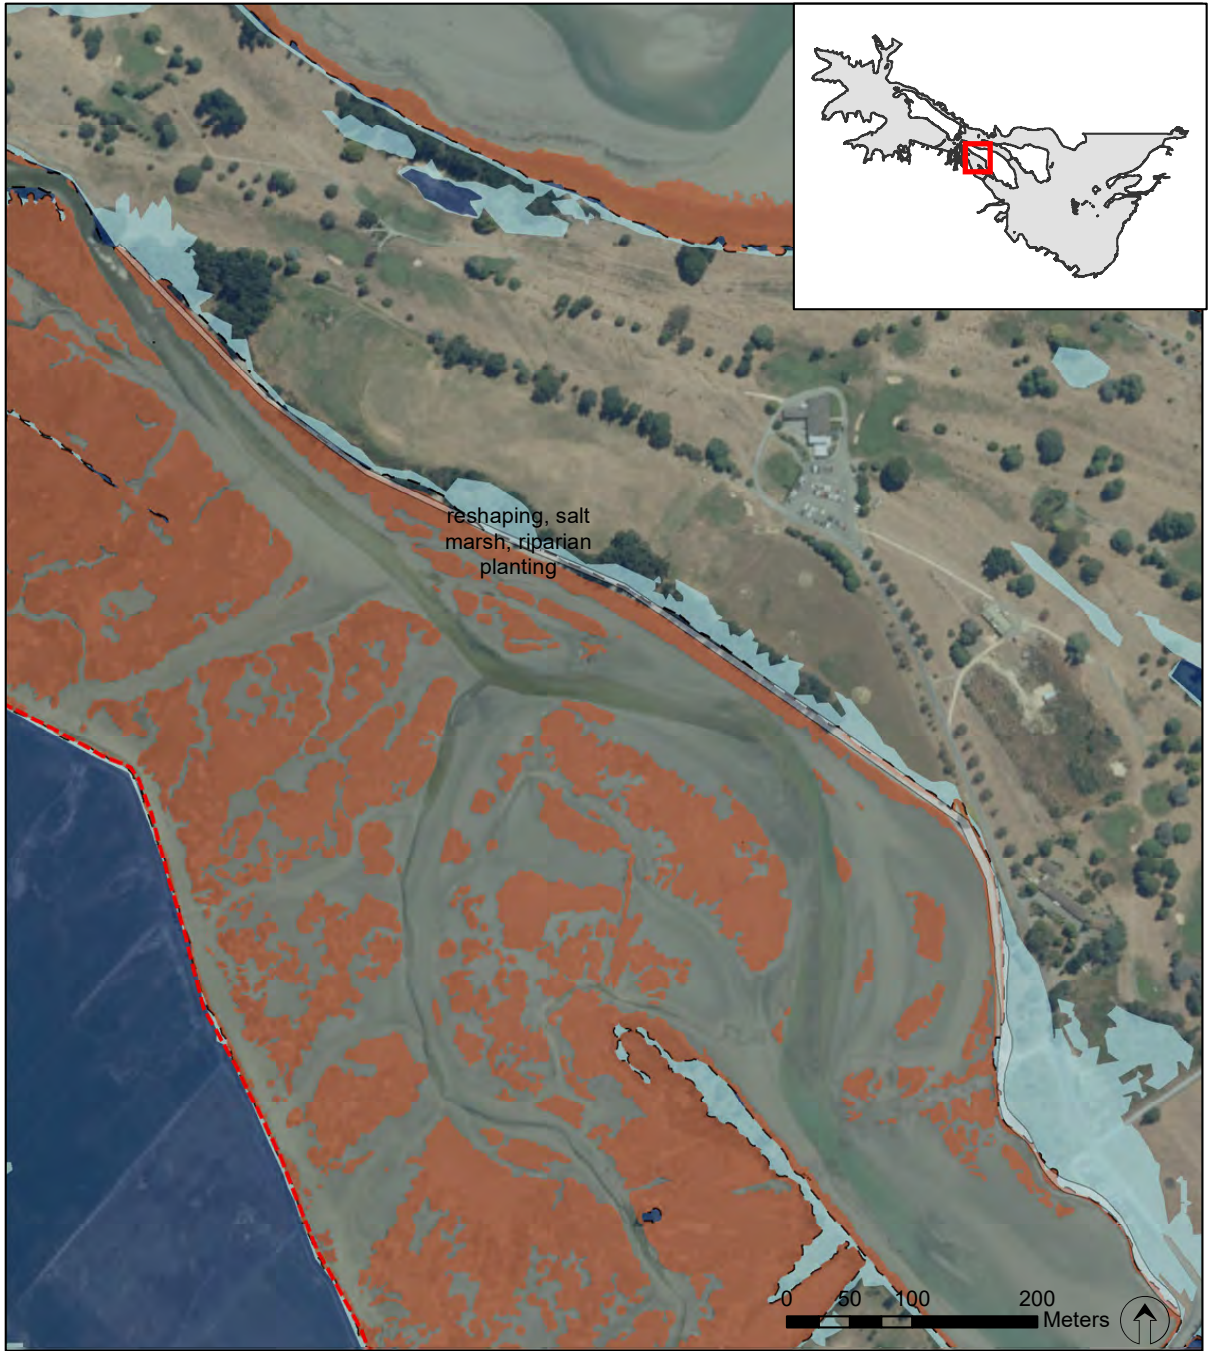
Fig. 13 Outline of proposed restoration footprint, Best Island Golf Course.

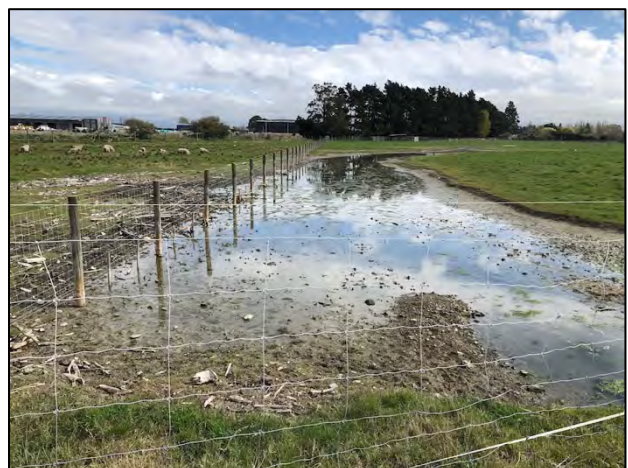
Example of fenced farmland subjected to estuary inundation at high tide

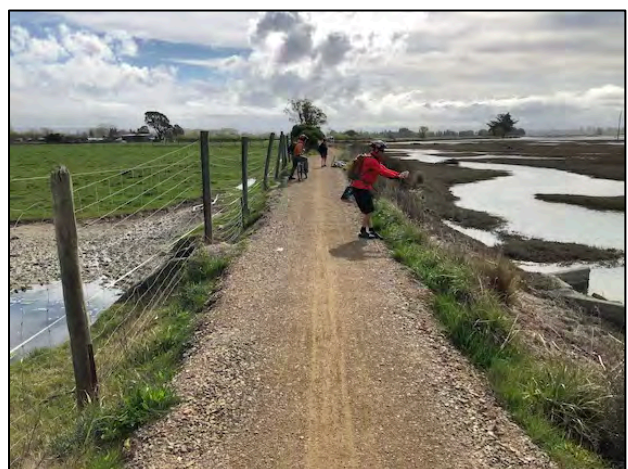
Farmland at the same tidal elevation as the estuary, but separated by an earth bund that restricts tidal inundation

Due to the potential sensitivity of highlighting such locations in advance of talking to landowners, it is recommended that the GIS outputs be used as an in-house tool to prioritise areas where further investigation would be potentially valuable.
