Takaka Water Management Zone: River Health Update

Trevor James

(Resource Scientist – Environmental Quality)

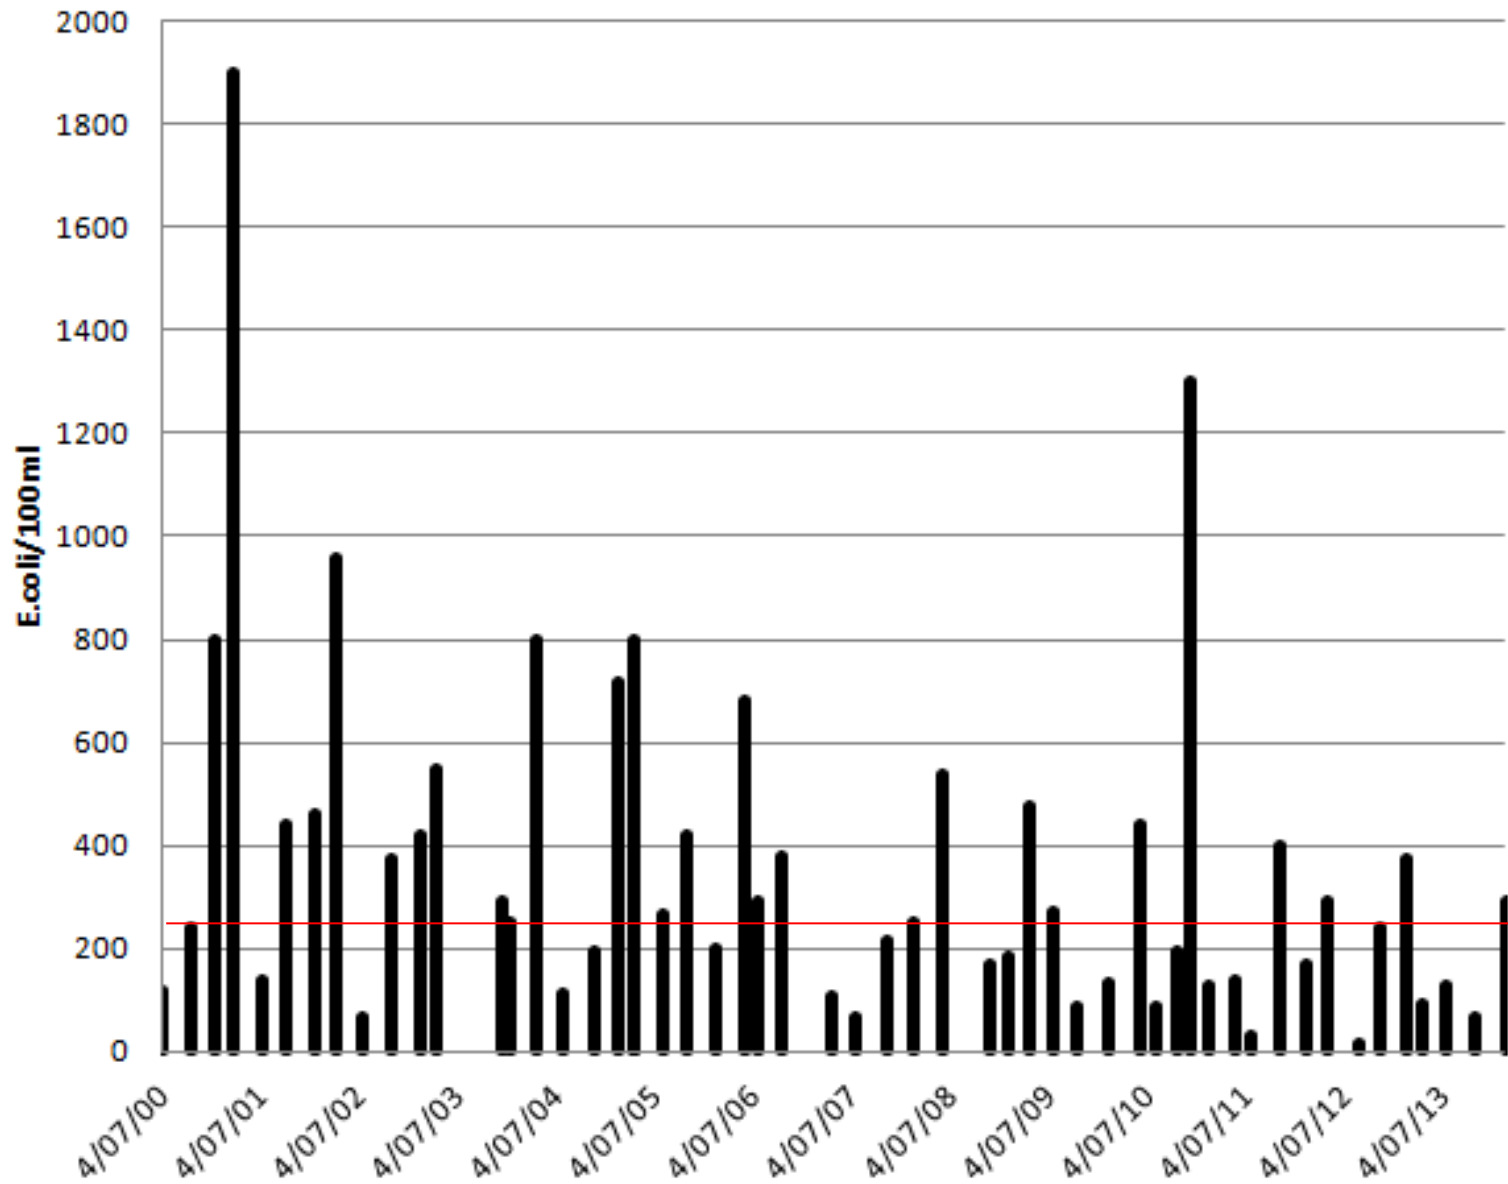
Comparison of *E.coli* at TDC's Onekaka River Monitoring Sites

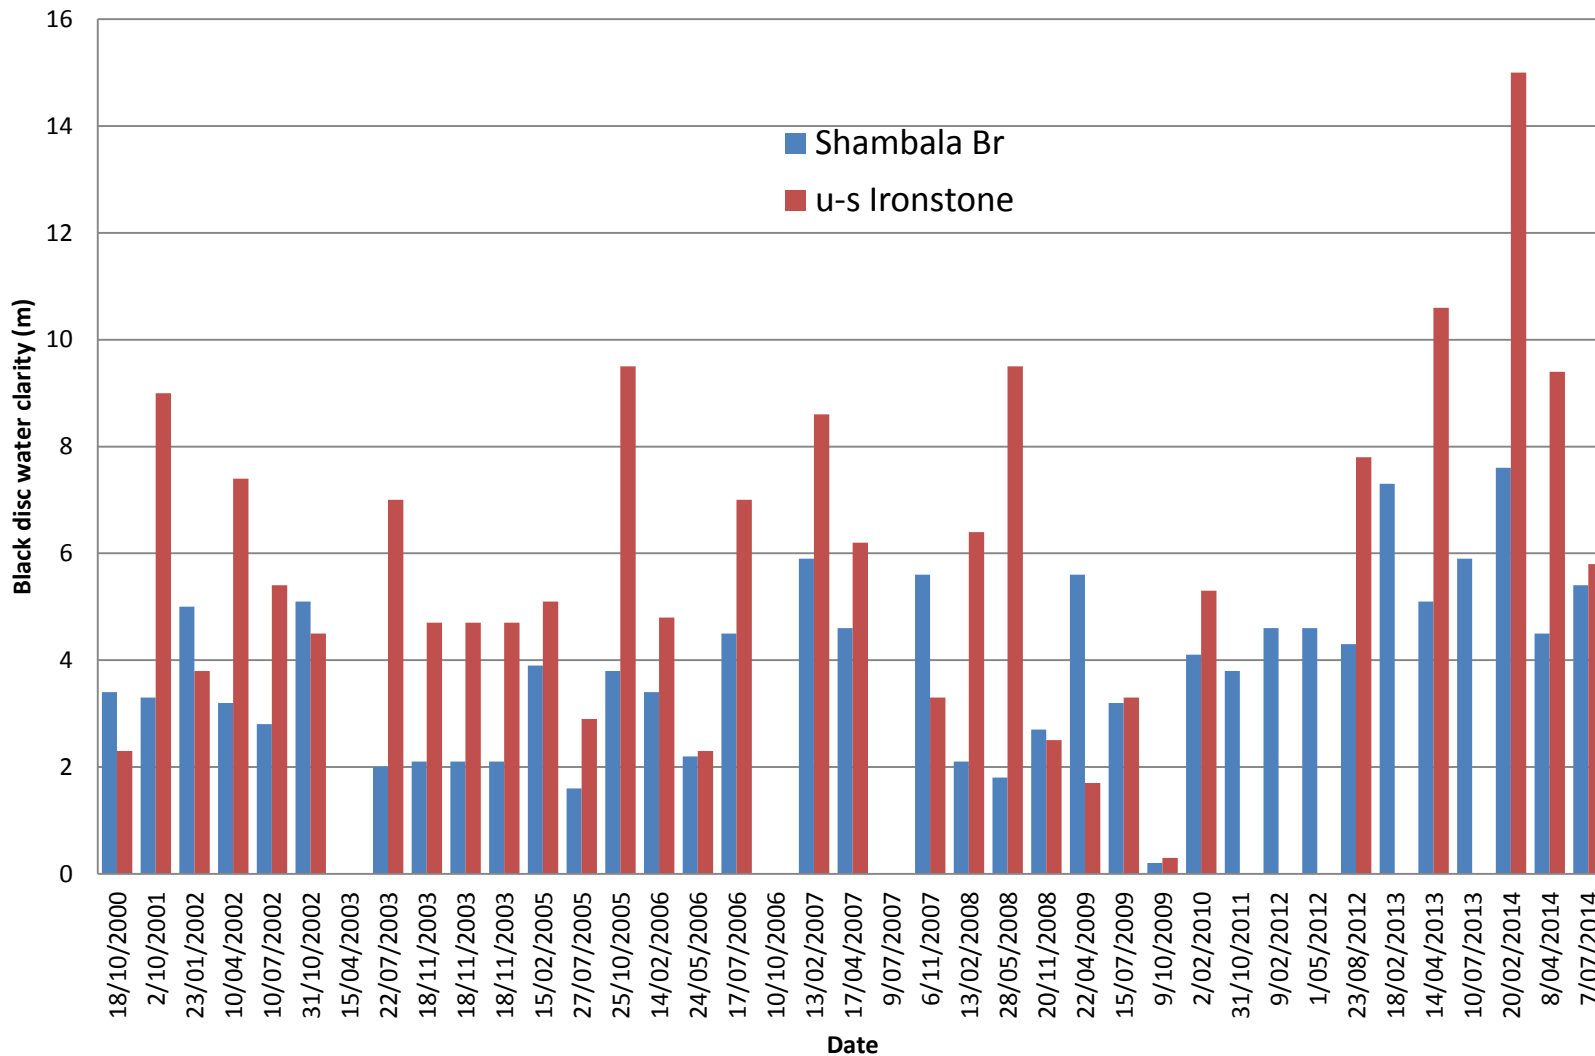
Comparison of Water Clarity at Onekaka River Monitoring sites

Shambala has 64% of the clarity

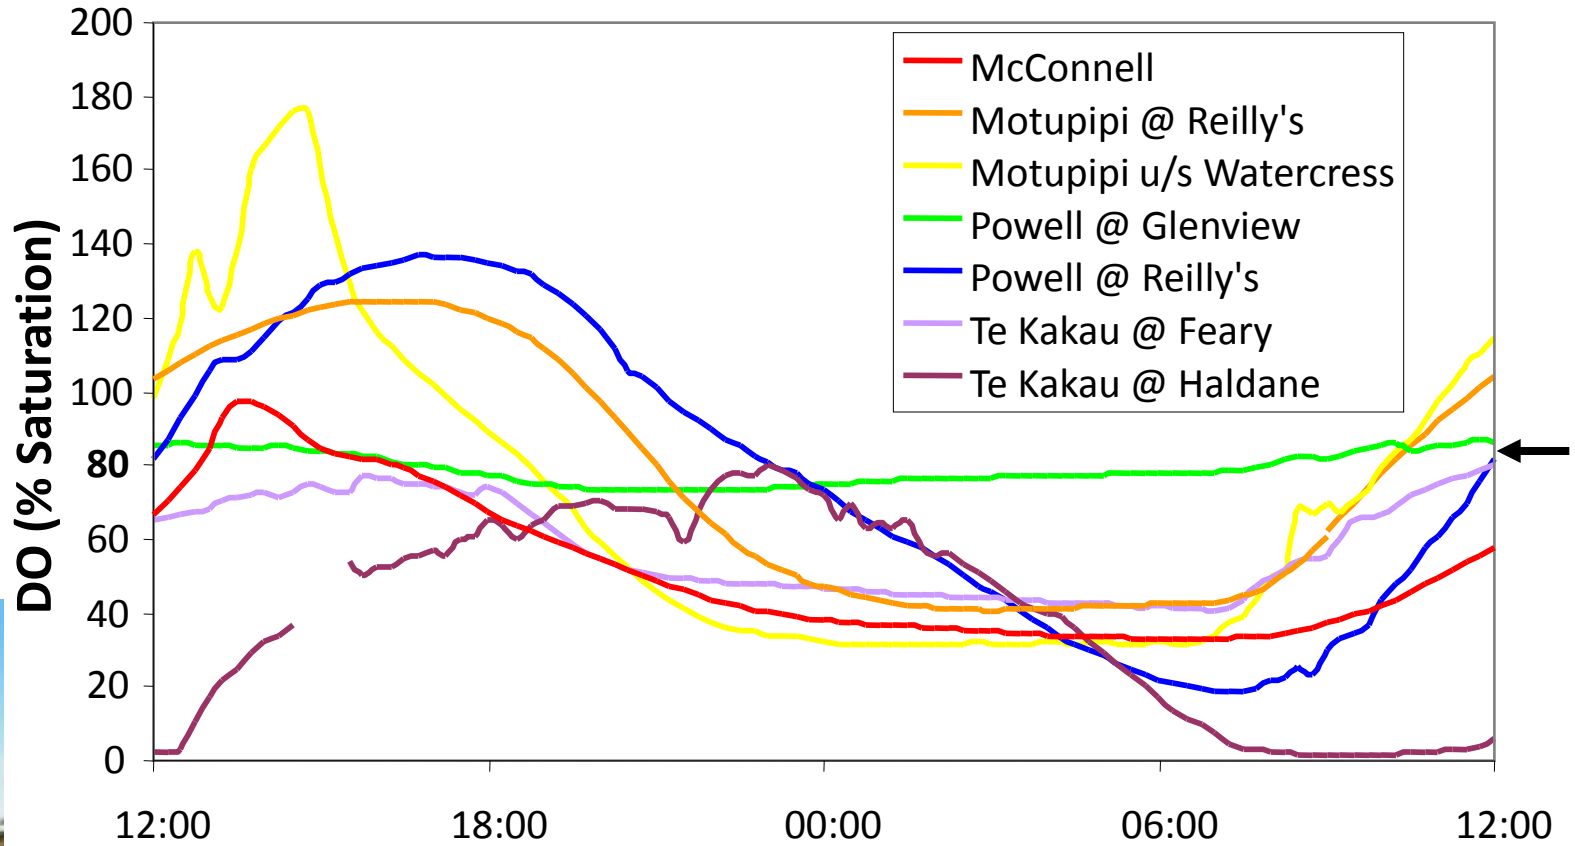
Dissolved Oxygen Over a Typical Day

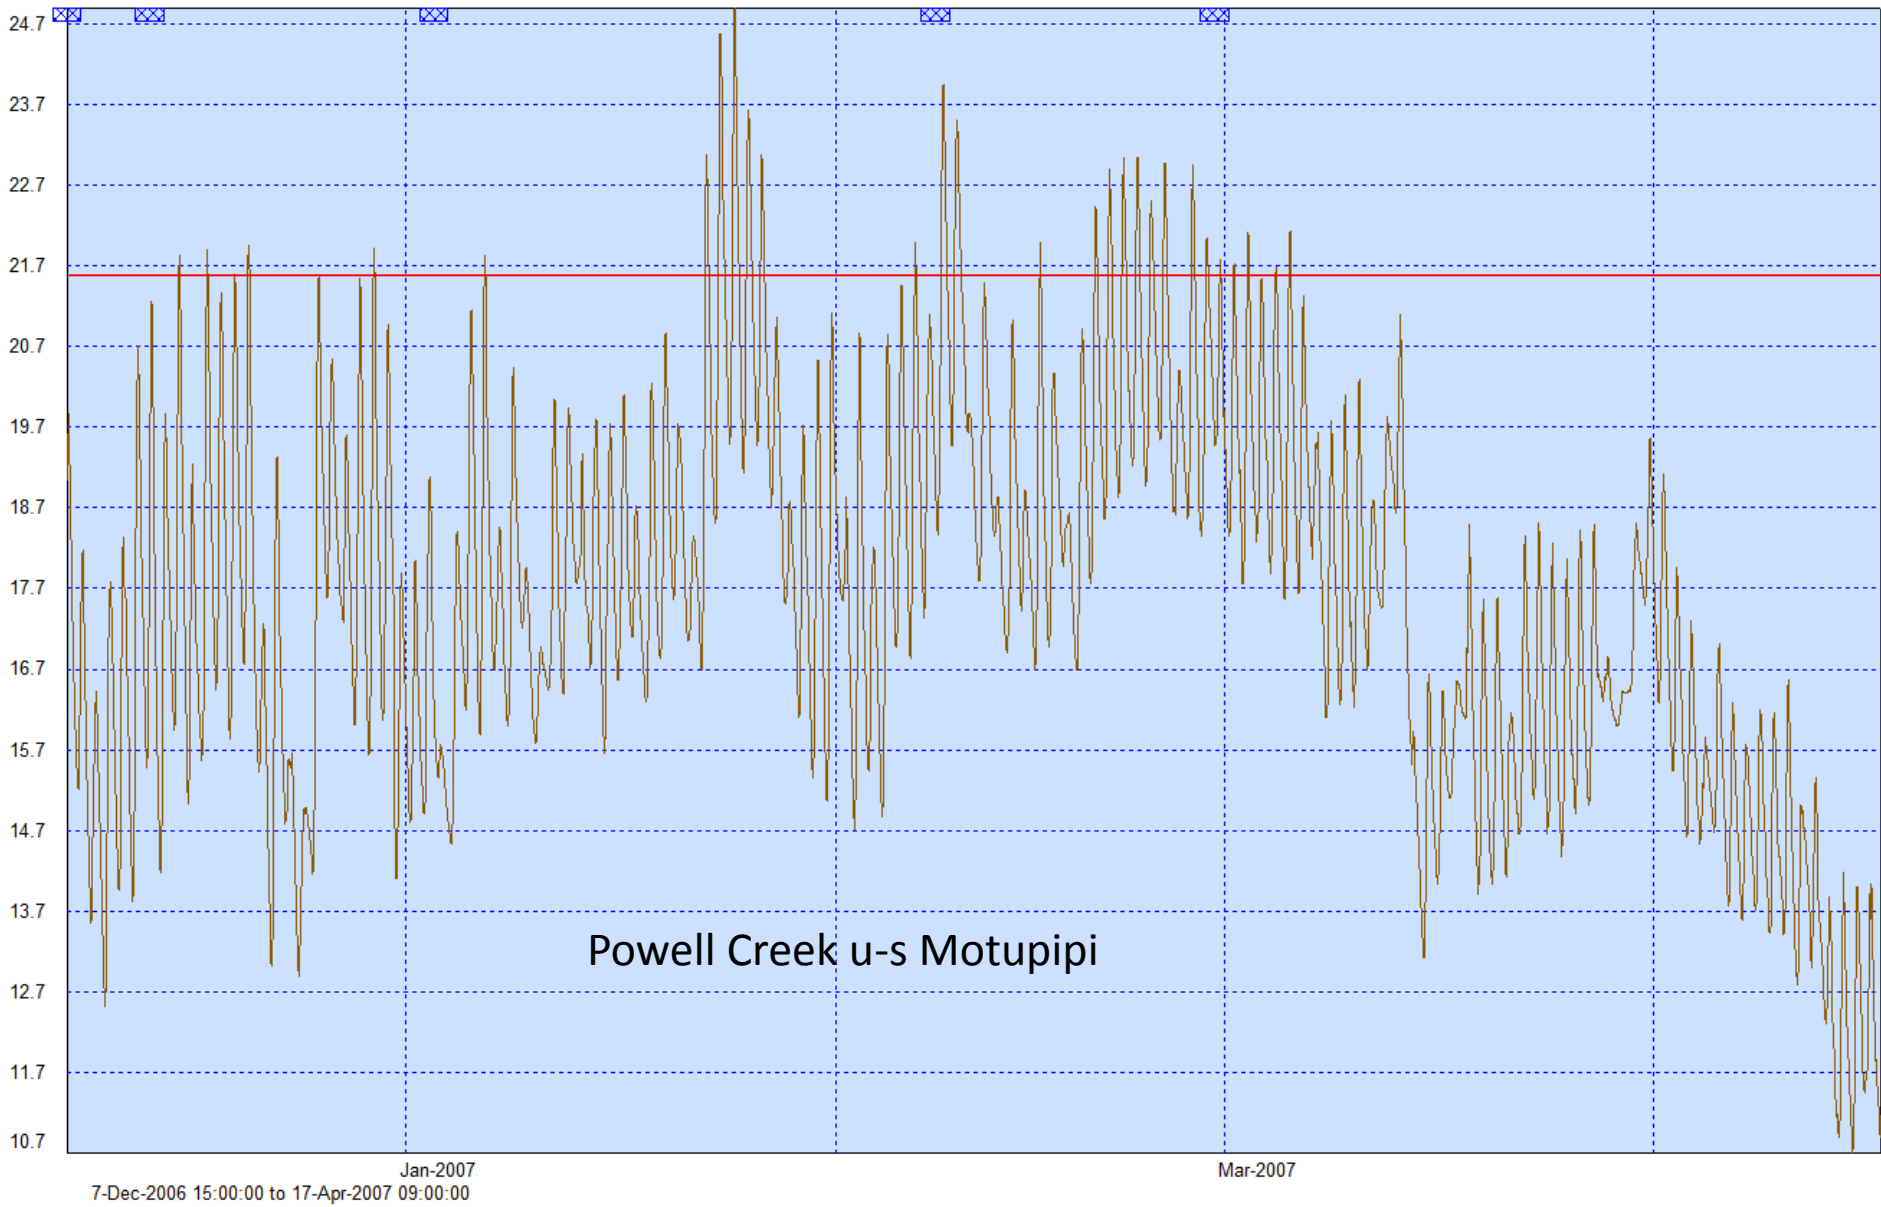
Stream Temperature

case studies in the Motupipi catchment

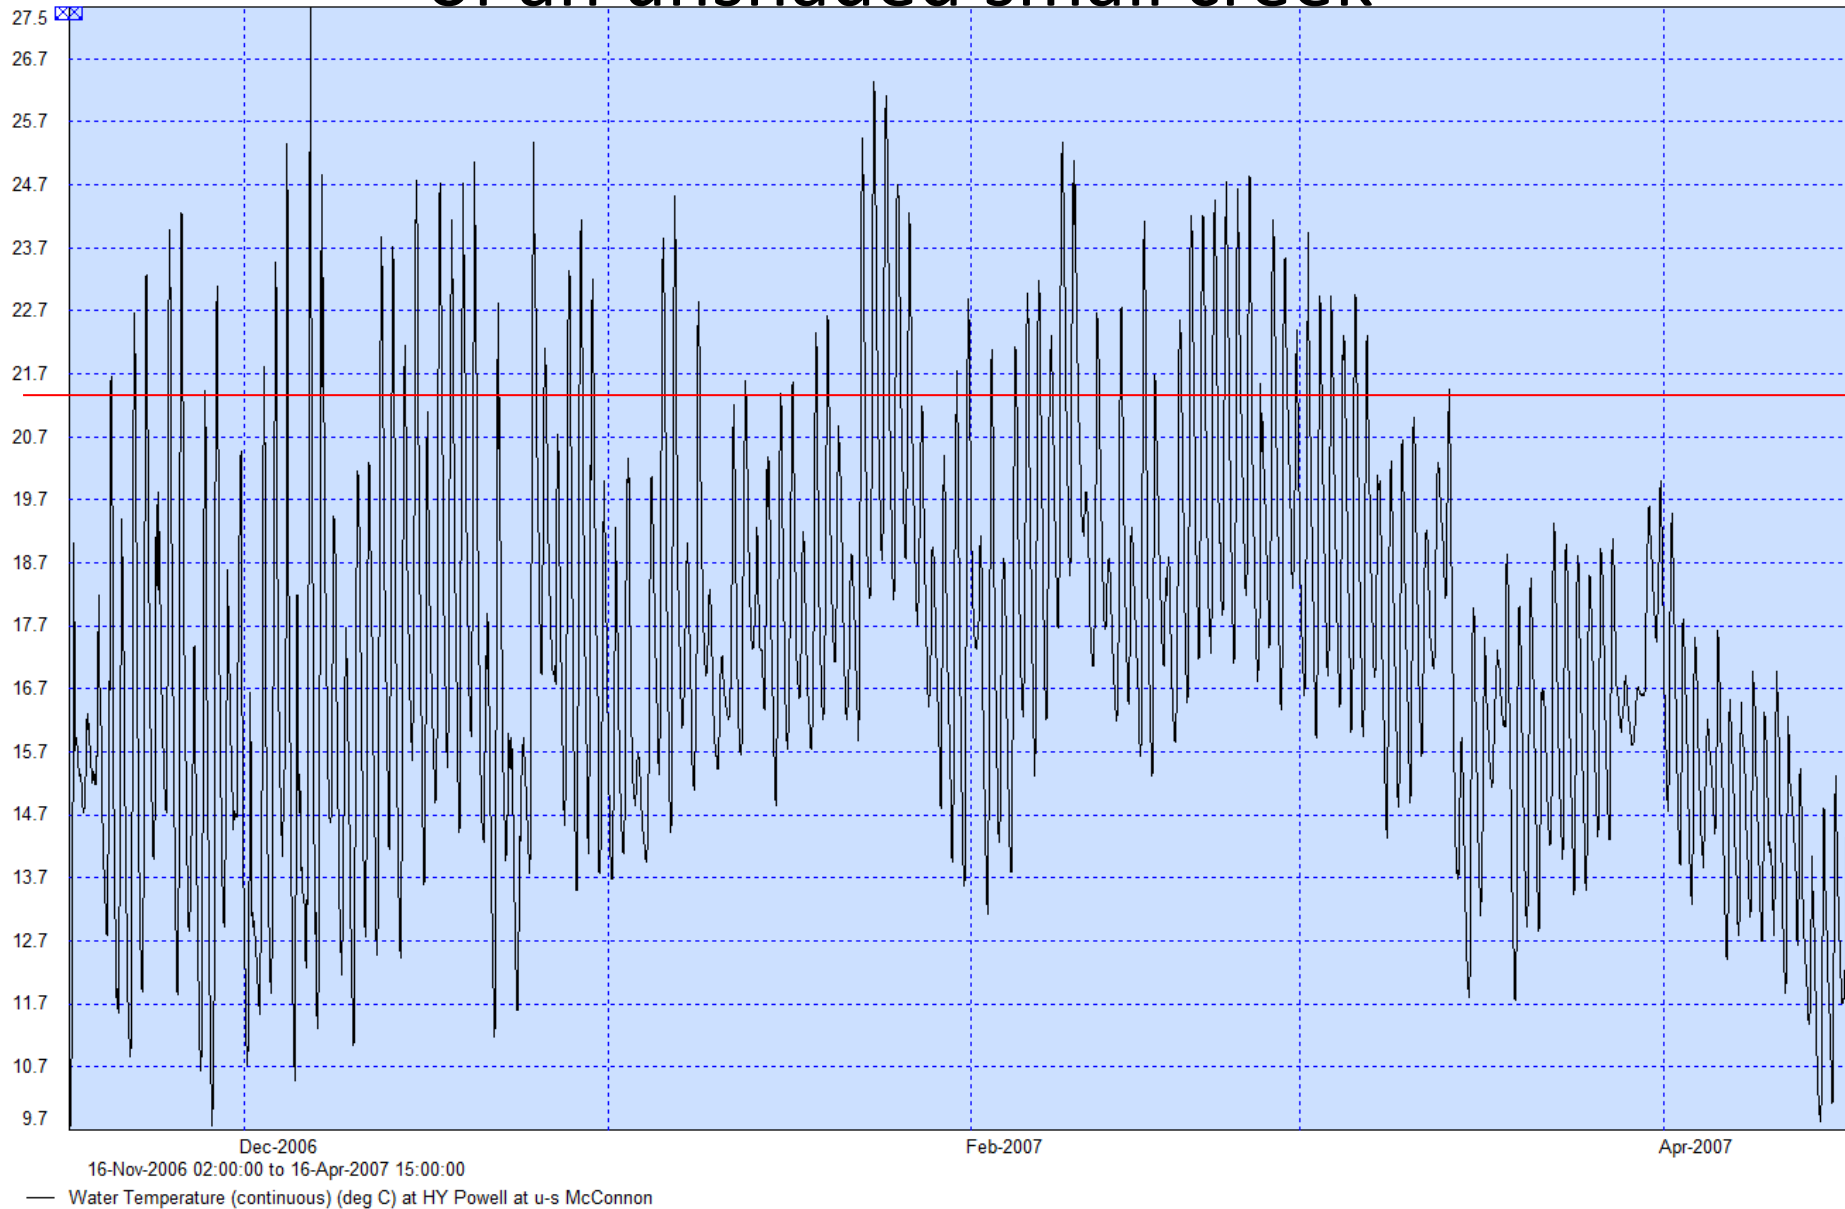
Stream Temperature – another typical example of an unshaded small creek

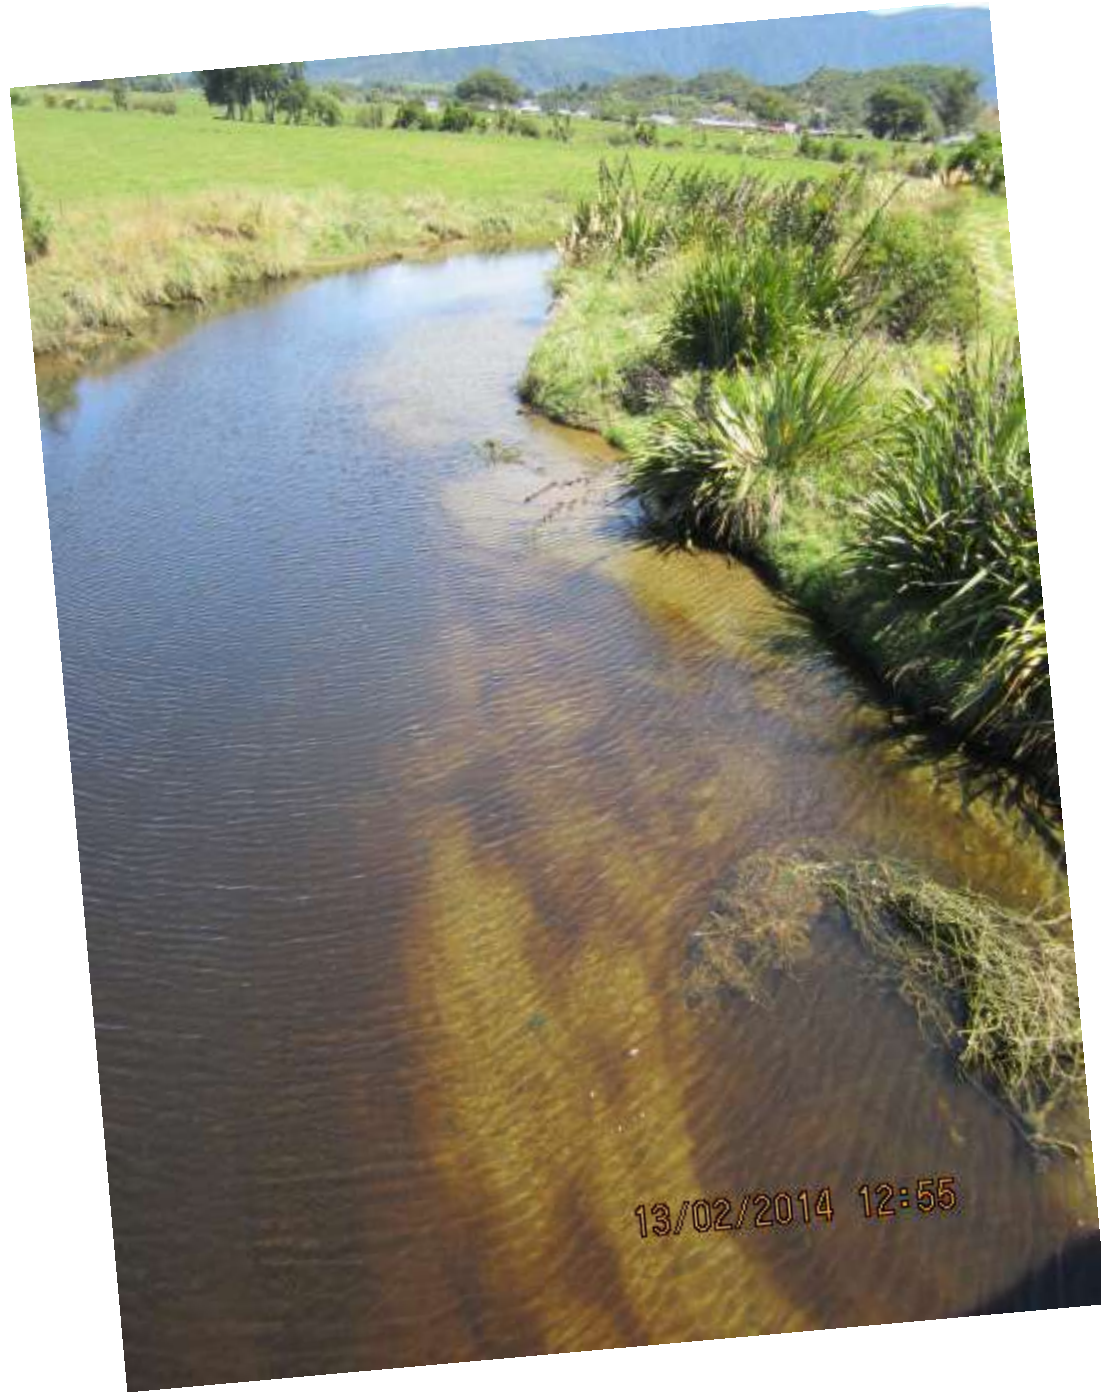
Motupipi River's summer algal blooms...

elevated nitrate gets
'caught' in the upper
tidal 'pools' and
flushing by floods is
now limited

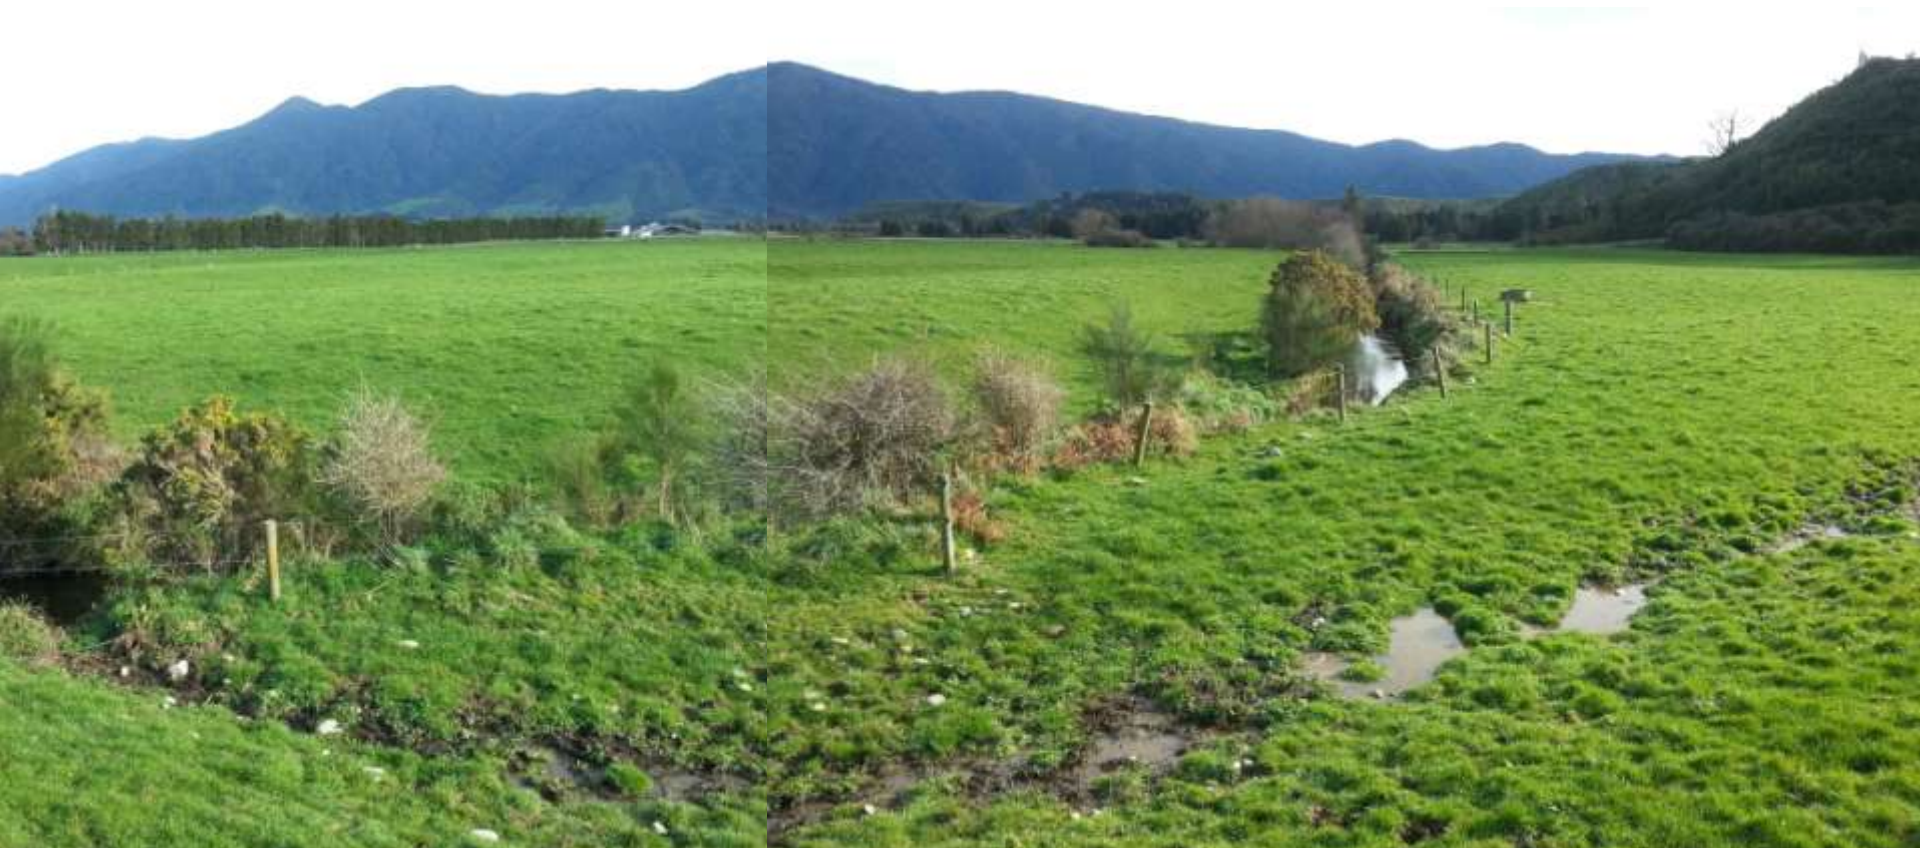
Fencing Point-source Paddock Runoff

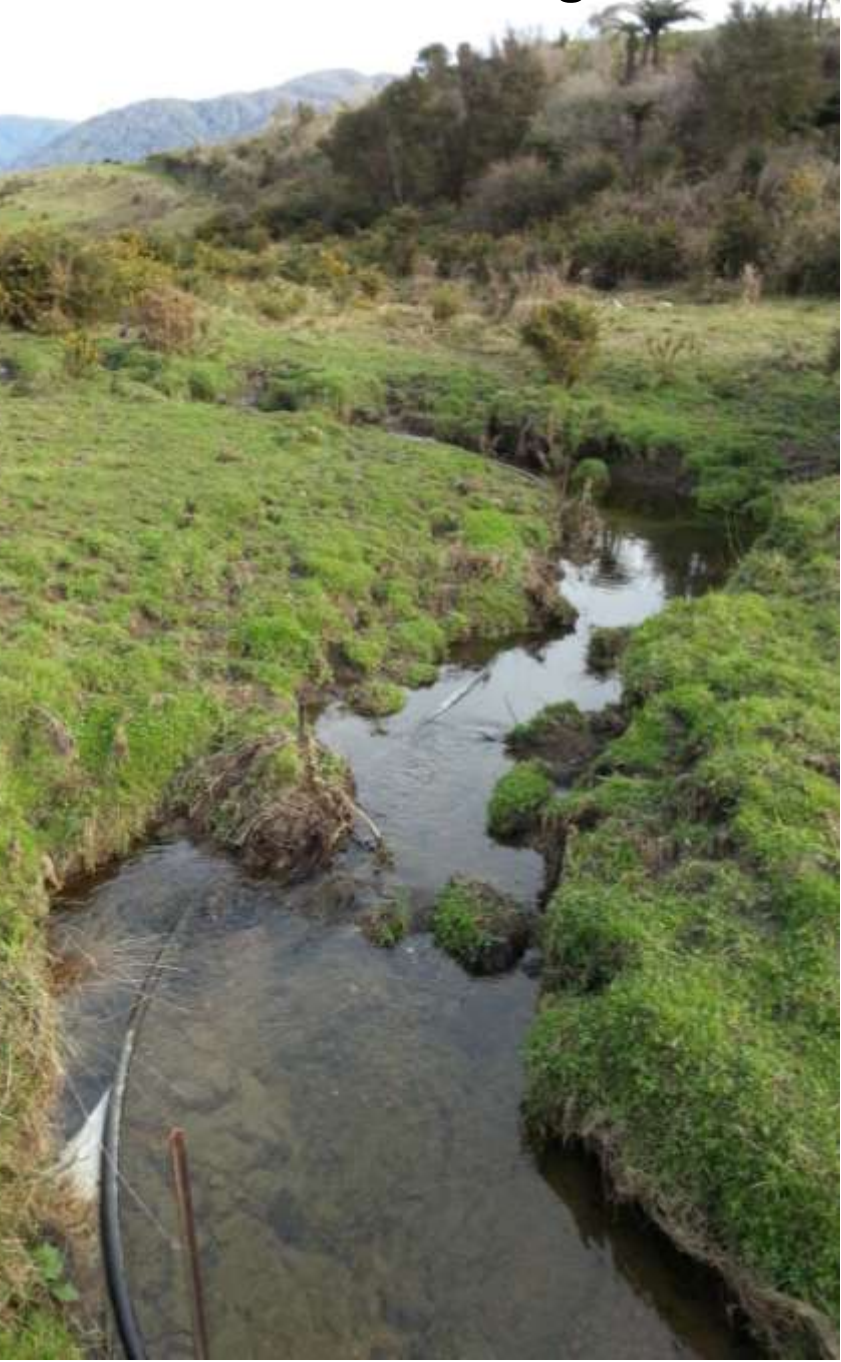
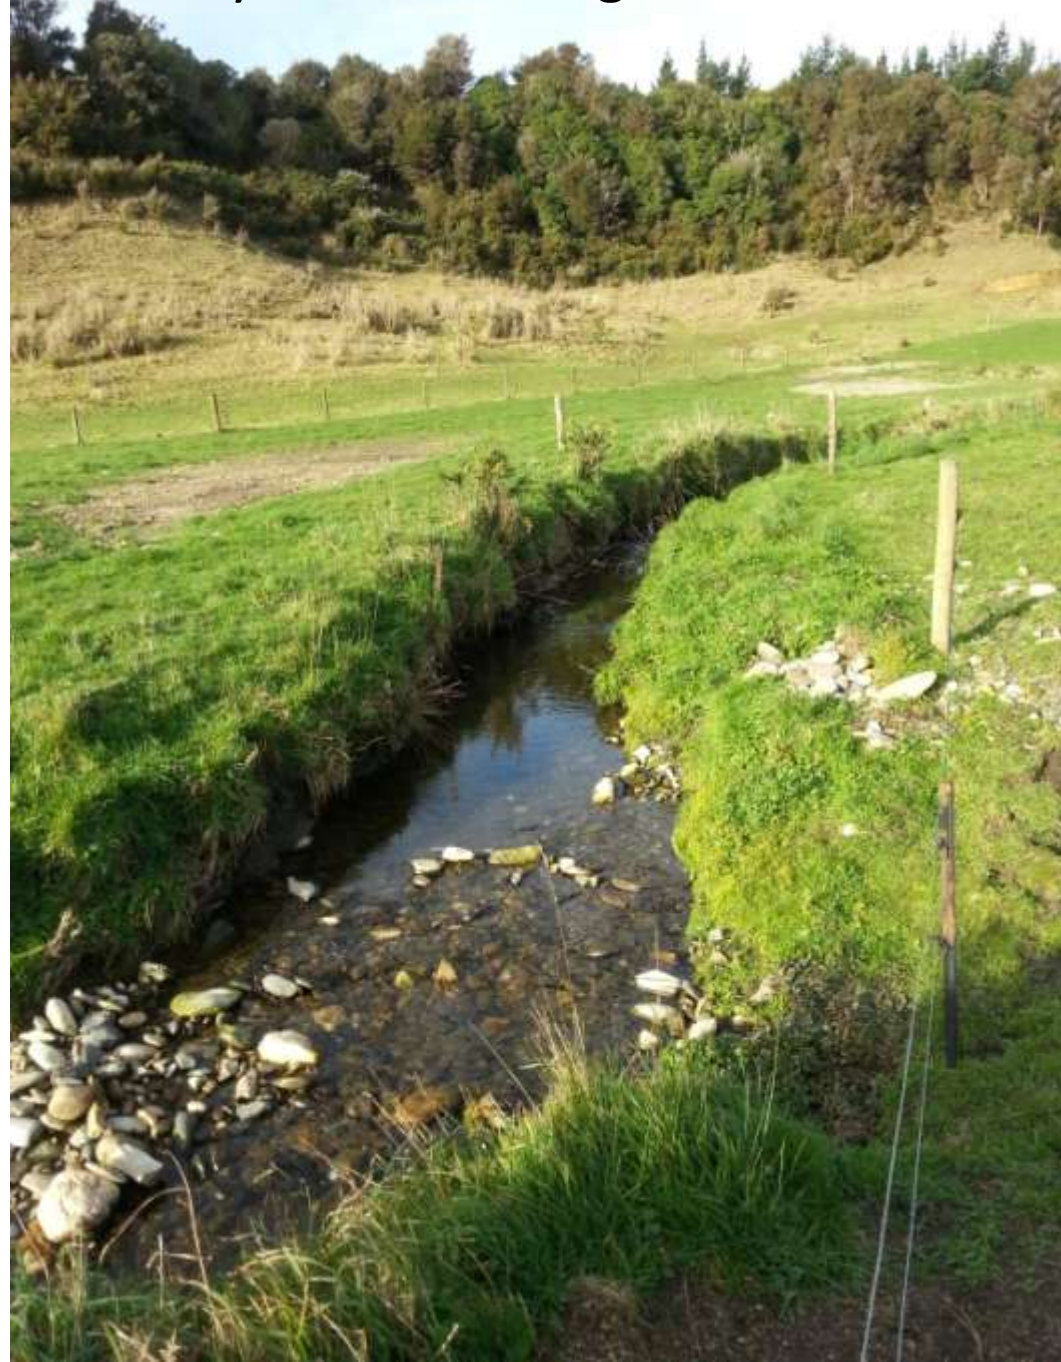
Fine sediment discharge from unfenced dry-stock farming

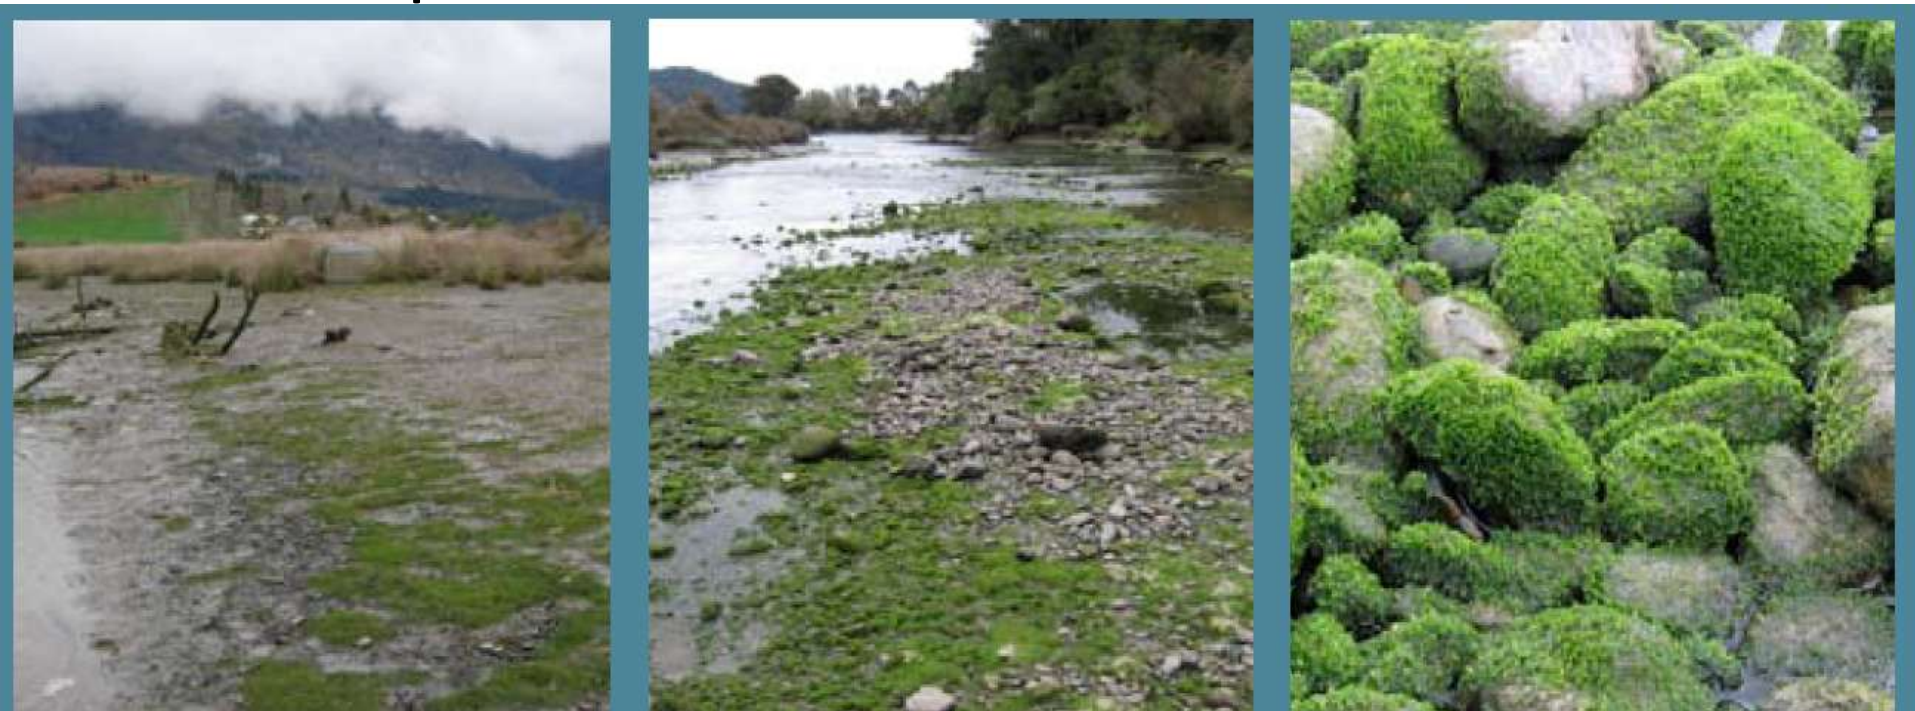
Enteromorpha in the middle and upper reaches of the western arm of the Motupipi Estuary.
