Appendix C Test Pit Logs

1614451 E 5421080 N Richmond South Reservoir Coordinates: Project:

NZTM Tasman District Council Ref. Grid: Client:

Project No.: 5-G3104.09 R.L.: Not established

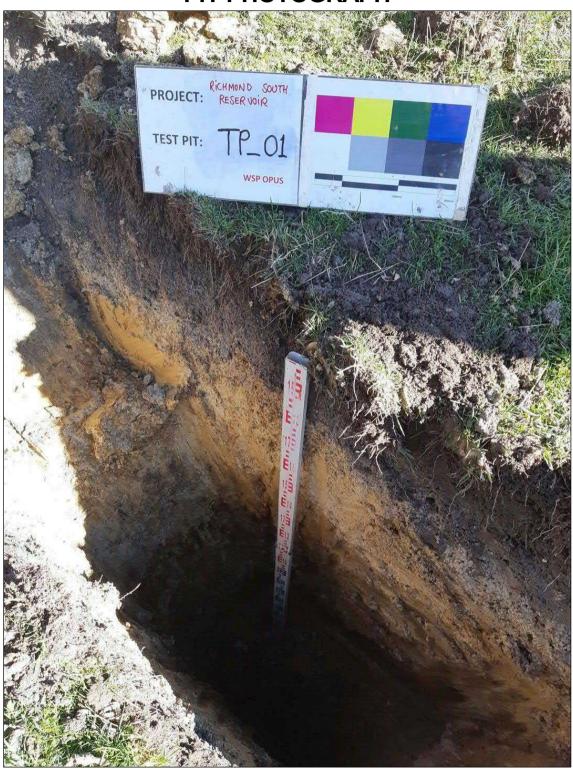
Testpit TP_01

PIT PHOTOGRAPH

Notes: Test pit dry

520 Hill Street, Richmond						
			ဗ	ی			SOIL TESTS	
≽	ا		GRAPHIC LOG	WATER LEVEL		<u></u>	SCALA PENETROMETER _ 프	ွ
GEOLOGY	DEPTH (m)) H	ERI	(m)	DЕРТН (m)	SCALA PENETROMETER (Blows per 100mm) (KDa No. 1	SAMPLES
GEC	DEP	DESCRIPTION	GR _A	WA	R.L. (m)	띰	(Blows per 100mm) (Blows per 100mm) (CKPs) (SAN
TS		Clayey SILT, some sand, trace of gravel; greyish brown. Soft, moist, moderate plasticity. Gravel, fine; sand, fine. Organic soil with grass and fine rootlets	×—×;					
	_	[TOPSOIL]. Silty CLAY, some sand and some gravel; mottled light orange grey. Soft,	X X X X			_

-	moist, moderate plasticity. Gravel, fine to coarse; sand, fine. Iron oxide present.	× × ×			-		
		present.	^_					
	_	City OLAN	× × ×			_		
	-	Silty CLAY, some sand and some gravel; mottled orange grey. Firm, dry to moist, moderate plasticity. Gravel, fine to coarse; sand, fine. Iron oxide	× × ×			-		
١,	1-	common.	× _ × _ ;			1_		
ALLUVIAL	'_		× ×			'_		
ALLI	-		X X			-		
			× × ×					
	_		× —× – × —>			_

-		× × ×			-		
		Gravelly CLAY, some sand, some silt and trace of cobbles, orange brown.						
	_	Firm, moist, moderate plasticity. Weathered sandstone gravel, fine to coarse; sand, fine. Cobbles maximum 90mm size. Iron oxide common.				_		
	2	END OF PIT AT 2m - Target Depth Reached				2

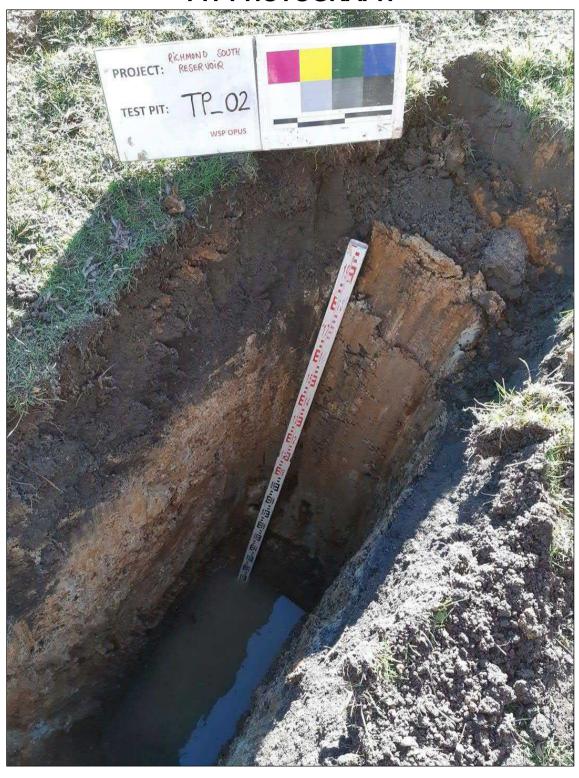
Testpit TP_02

PIT PHOTOGRAPH

GWL at 2.00m (ground water slowly seeping into test pit).

520 Hill Street, Richmond									
			_O	یے ا				SOIL TE	STS		
≻	Ê		ļ Č	EVE		Ē	SCALA PENETE	OMETER	I ᡓ │		ω l
GEOLOGY	DEPTH (m)		GRAPHIC LOG	WATER LEVEL	Œ	DEPTH (m)	(Blows per 1	00mm)	AR ENG	TS E	SAMPLES
GEO	DEP	DESCRIPTION	GRA	×	R.L. (m)	PE	0 2 4 6 8 10 12	2 14 16 18 20	SHEAR STRENGTH (kPa)	OTHER TESTS	SAN
	_	Clayey SILT, some sand, trace of gravel; dark greyish brown. Soft, moist,	× — × ;			_					
TS	_	moderate plasticity. Gravel, fine. Organic soil with grass and fine rootlets [TOPSOIL].	× × ×			-

-		$\times \times \times$			-					
		Sandy SILT, some clay; mottled light orange grey. Firm, moist, low plasticity. Iron oxide present.	× ·× ;								
	_	non oxide present.	× ·× × .×			-					
	_		× × ×			-					
		Silty CLAY, some sand and some gravel; mottled orange grey. Firm, moist, high plasticity. Gravel, coarse, sand, fine. Iron oxide common.	× × ×								
	1—	riigh plasticity. Graver, coarse, sand, line. Iron oxide common.	<u> </u>			1-					
¥	-		× × ×			_					
ALLUVIAL			× × -								
4	_		~ × ~ ;			_					
		Sandy fine to coarse GRAVEL with some clay, some silt and trace of cobbles;	°0.00								
	_	orange brown, homogeneous. Dense; wet; well graded; subrounded to angular; moderately weathered sandstone gravel; sand, fine to coarse; silt and	0000			_		$\frac{1}{1}$			
	_	clay, low plasticity. Cobbles maximum size 110mm. Iron oxide common. Increased moisture from 1.70m.	0.00			_					
	2-	increased moisture from 1.70m.	0000	<u></u>		2-

END OF PIT AT 2.1m - Target Depth Reached	0,00	2m 22/06	_						
	-	END OF PITAL 2.1III - Target Depth Reached				-					
	_					-					
	-					-					
	_					-					
	3-					3-					
						_		i i i

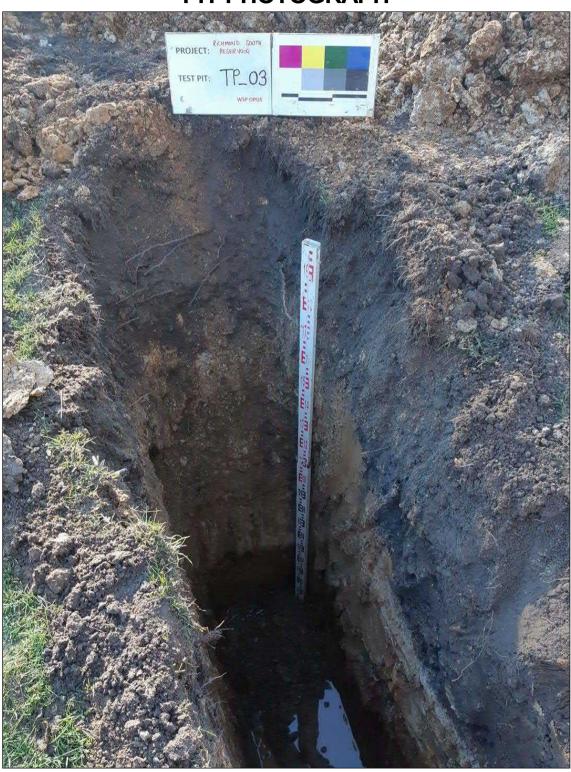
Testpit TP_03

PIT PHOTOGRAPH

GWL at 2.00m (ground water seeping into test pit).

520 Hill Street, Richmond	1			r		
			၂ ဥ	ᆸ			SOIL TESTS	_
>5	(E		GRAPHIC LOG	WATER LEVEL		Ê	SCALA PENETROMETER	<u>,</u>
GEOLOGY	DЕРТН (m)		H	TER.	R.L. (m)	DEPTH (m)	(Blows per 100mm) (KPa) (MPa) (BIOWS PER NGT) (WAMPLES (APPLE NGT) (WAMPLES (APPLES NGT) (WAMPLES NG	i :
GEC	DEF	DESCRIPTION	GR/	.WA	R.L.	DEF	SCATA DENELEM (Blows ber 100mm) STRENGTH (COTHER TS) OT THE R (COTHER TS	
		Clayey SILT, some sand and trace of gravel; greyish brown. Soft, dry to moist, low plasticity. Gravel, fine. Organic soil with grass and fine rootlets [TOPSOIL].	× — ×			_		
	_	low plasticity. Graver, line. Organic soil with grass and line rootiets [TOF SOIL].	$\times \times -$			_		
TS	-		x <u>x</u> x			-

* * *					
	-	Sandy SILT, trace of clay; mottled light orange grey. Firm to stiff, dry,	× ×			_		
	-	non-plastic. Iron oxide present.	× × ×			-		
		Gravel trench with red tile drain pipe intercepted at 0.80m depth. Drain pipe is 130/95mm (OD/ID) and 300mm long segments. Appears to be the end of the	× . × .					
	1-	drain pipe, as not possible to trace pipe on other side of test pit.	× × ×			1-		
	+	Sandy SILT, trace of gravel; mottled orange grey. Soft to firm (softer towards	× × · ·			_		
'AL		the base with increased moisture), moist, low plasticity. Gravel, medium. Iron oxide common.	××××					
ALLUVIAL	_	oxide common.	×××			_		
₹	_		× . × .			-		
			×··×·

-	Clause fine to seems CDAVEL with some and some silt and some scholar.	× · × · · · · · · · · · · · · · · · · ·			_		
	-	Clayey fine to coarse GRAVEL with some sand, some silt and some cobbles; orange brown. Dense; wet; well graded; subrounded to angular, moderately to	0-00	_		-		
	2-	highly weathered sandstone gravel; sand, fine; silt and clay, low to moderate plasticity. Iron oxide common [weathered MOUTERE GRAVELS].		2m 22/06		2-		
	_	END OF PIT AT 2.1m - Target Depth Reached		22,00		_

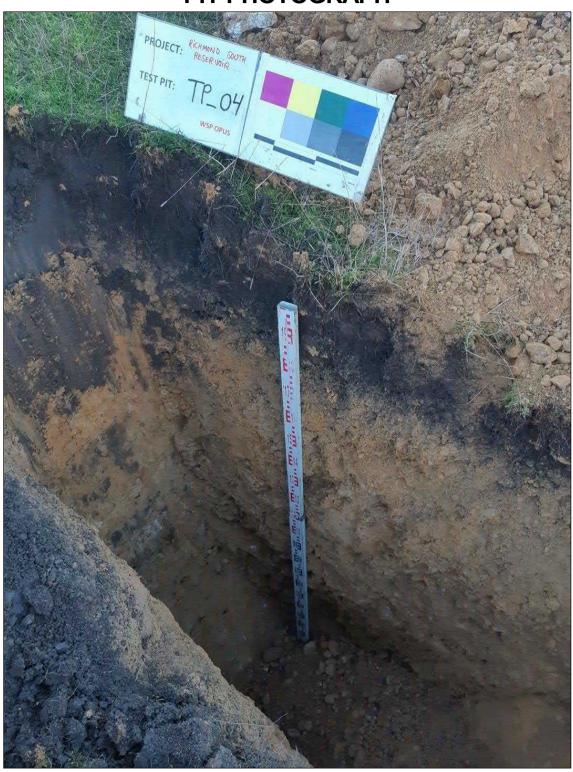
Testpit TP_04

PIT PHOTOGRAPH

Notes: Test pit dry

320 Filli Oticet, Montholid		_			SOIL TESTS
չ	(m)		GRAPHIC LOG	WATER LEVEL		Œ	SCALA PENETROMETER # ###
GEOLOGY	DEPTH (m)		RAPH	ATER	R.L. (m)	DEPTH (m)	SCALA PENETROMETER (Blows per 100mm) (Kpa) 0 2 4 6 8 10 12 14 16 18 20 (Kpa) 0 2 4 6 8 10 12 14 16 18 18 10 (Kpa) 0 2 4 6 8 10 12 14 16 18 18 10 (Kpa) 0 2 4 6 8 10 12 14 16 18 18 10 (Kpa) 0 2 4 6 8 10 12 14 16 18 18 10 (Kpa) 0 2 4 6 8 10 12 14 16 18 10 (Kpa) 0 2 4 6 8 10 12 14 16 18 10 (Kpa) 0 2 4 6 8 10 12 14 16 18 10 (Kpa) 0 2 4 6 8 10 12 14 16 18 10 (Kpa) 0 2 4 6 8 10 12 14 16 18 10 (Kpa) 0 2 4 6 8 10 12 14 16 18 10 (Kpa) 0 2 4 6 8 10 12 14
TS	_	DESCRIPTION Clayey SILT, some sand, trace of gravel; greyish brown. Soft, moist, low to moderate plasticity. Gravel, fine; sand, fine. Organic soil with grass and fine rootlets [TOPSOIL].	$\frac{\times}{\times}\frac{\times}{\times}\frac{\times}{\times}$	>	œ'	_	0 2 4 6 8 10 12 14 16 18 20 あいま ら声 あ

- - - -	Silty CLAY, some gravel; light orange brown. Soft to firm, moist, low to moderate plasticity. Gravel, fine to coarse, angular (weathered residual clasts). Iron oxide present.	× × × × × × × × × × × × × × × × × × ×			- - - -	
MOUTERE GRAVELS	1—	Clayey fine to coarse GRAVEL with some sand, some silt and some cobbles and boulders; light orange brown, indistinctly bedded. Dense; dry; well graded; bedding, sub-horizontal, moderately thick; subrounded to angular, moderately weathered sandstone gravel; sand, fine; silt and clay, low plasticity. Boulders maximum 260mm size [MOUTERE GRAVELS].				- 1- - -	
MOUT	- - -					- - -	
	2-					_ 2 _	
	_ _ _	END OF PIT AT 2.1m - Target Depth Reached				_	
	_ _ _					_

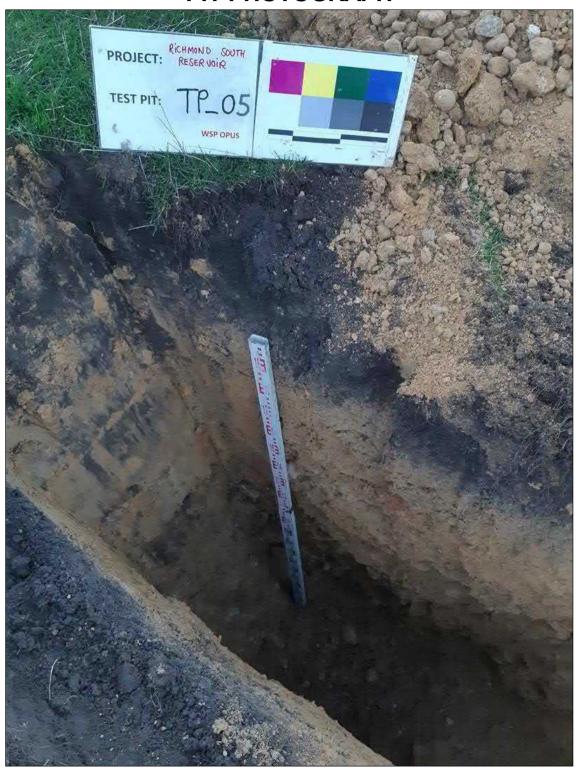
Testpit TP_05

PIT PHOTOGRAPH

Notes: Test pit dry

320 Filli Oticet, Moninoliu	(0)	_							s	OIL	TE	STS		
GEOLOGY	DEPTH (m)	DESCRIPTION	GRAPHIC LOG	WATER LEVEL	R.L. (m)	DEPTH (m)		CALA F	s pe	er 100	Omn	n)	1	SHEAR STRENGTH (kPa)	OTHER TESTS	SAMPLES
TS	_	Clayey SILT, some sand, trace of gravel; greyish brown. Soft, moist, moderate plasticity. Gravel, fine; sand, fine. Organic soil with grass and fine rootlets [TOPSOIL].	× × × ×	>			0 2	4 6 	8 1 	0 12 · 	14 10 	6 18 : 	20 	0000	OF

- - - -	Silty CLAY, some gravel; orange light brown. Soft to firm, moist, low to moderate plasticity. Gravel, fine to coarse, angular (weathered residual clasts). Iron oxide present.	× × × × × × × × × × × × × × × × × × ×			- - - -					 					
MOUTERE GRAVELS	1— — — — — — — — — — — — — — — — — — —	Clayey fine to coarse GRAVEL with some sand, some silt and some cobbles and boulders; light orange brown, indistinctly bedded. Dense; dry; well graded; bedding, sub-horizontal, moderately thick; subrounded to angular, moderately weathered sandstone gravel; sand, fine; silt and clay, low plasticity. Boulders maximum 240mm size [MOUTERE GRAVELS].				1										
		END OF PIT AT 2.1m - Target Depth Reached	0-0-0					+	1							
	3					3

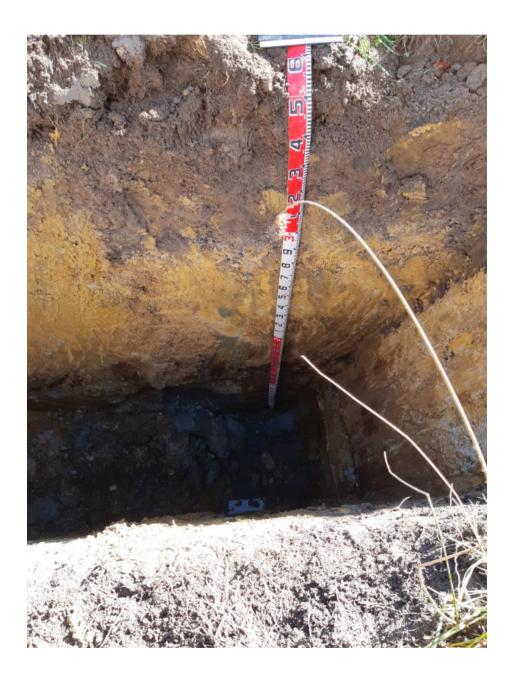
PIT PHOTOGRAPH

520 Hill Street, Richmond										s	OIL	. TE	STS		
	=		GRAPHIC LOG	WATER LEVEL		=	S	CAL	A PE	NE	TRO						
GEOLOGY	DEPTH (m)		PHIC	ER L	Œ	DEPTH (m)			lows						SHEAR STRENGTH (kPa)	음	SAMPLES
GEO	DEP	DESCRIPTION	GRA	WAT	R.L. (m)	DEP	0 2	2 4	6 8	3 10	0 12	14 1	6 18	20	SHE STRI (KPa	OTHER TESTS	SAM
	_	SILT, brown. Moist, very soft, high plasticity. Organic soil with grass and rootlets to 0.3 m	7 77 7 7 7 7 7			_											
(0	-		1 1/2 · 1 1/2			_				 				_			
TS			12 - 71 12 - 7			_				 							
	_		<u> </u>			_					İ			_			
		CLAY, light brown. Very soft, moist, high plasticity.				_					į	i i		_

-					-											
	2-					2-		 		 				_			
VIAL	-					-		 		 							
ALLUVIAL						_					İ			_			
	-	Sandy CLAY, brown. Soft, moist, low-plasticity. Sand, well-graded.				-					İ	i i		_			
						_	İ				į	ij		1			
	_					-	į				į	ij

-	i										
	3-					3-	i				-						
		Sandy SILT; bluey gray with orange mottle. Soft, moist, low-plasticity.	× ·× ·>			_					-						
	_	Small amounts of vegetation noticed in hole	× ·× ; × .× ;			-											
		Official difficulties of vegetation floateed in flote	× .×			_				 							
	_		× · × · × · × · × · × · × · × · × · × ·	_		_				 							
	_	Seepage noticed in hole	· ×· › × . × . ×. ›	3.7m 21/07		-		 		 							
		END OF PIT AT 3.8m - Target Depth Reached		21/07		_		 									
	4-					4-				 							
						_					1

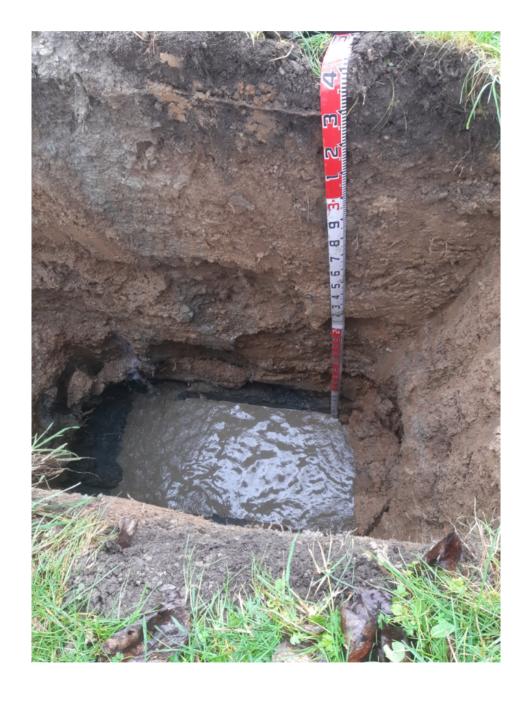
PIT PHOTOGRAPH

520 Hill Street, Richmond						SOIL 1	ESTS		
			LOG	VEL			SCALA PENETRO				
.06	Œ		呈	H.	ε	Ē	(Blows per 100		R NGTI	ĸω	LES
GEOLOGY	DEPTH (m)	DESCRIPTION	GRAPHIC LOG	WATER LEVEL	R.L. (m)	DEPTH (m)			SHEAR STRENGTH (KPa)	OTHER TESTS	SAMPLES
		SILT with some gravels and minor sands; dark brown. Moist, soft,	\(\frac{1}{2\frac{1}{1}\frac{1}{2}}\)\(\frac{1}{2\frac{1}{1}\frac{1}{2}}\)	_	<u> </u>		0 2 4 6 8 10 12 1	16 18 20	0 0000	<u> </u>	
TS		low-plasticity. Gravel, well-graded, loosely packed, sub-rounded to rounded. Sand, fine. Organic soil with grass and rootlets [TOPSOIL].	1/ 1/1/ 1/

-	SILT with minor gravels and sand; light brown. Moist, soft, high-plasticity.	× × ×			-					
		Gravel; well-graded, sub-angular to sub-rounded. Traces of rootlets to a depth.	× × :								
	_		× × × :			_					
	_		× × × :			-		<u> </u>			
			× × :								
	1-	Silty fine to coarse GRAVEL with some cobbles; light brown. Dense; moist; well-graded; sub-angular to sub-rounded. Silt; soft; high plasticity. Soil	**Ox0**O:			1—

-	becomes saturated at 1.1 m, traces of rootlets to a depth of 1.0 m. At approx 1.8 m, trench starting collapsing (non-cohesive behavior in soil)	*0,0*0.	1.1m		-

-		°0×0°0			-					
			® 0 x ○ 8 0 :								
	_		* 4 × 4			_		- i i i			
	-		2 × 2			-					
		SILT with some gravels; blue. Saturated, very soft, low-plasticity. Gravels, fine,	× × :								
	_	sub-angular to angular.	× × × :			-					
	3-	Fine to coarse GRAVEL with some silt; blue. Saturated; well-graded;	°0 0 0			3-					
		sub-angular to sub-rounded. Silt, high-plasticity, firm.	0000					ii			
		END OF PIT AT 3.3m - Target Depth Reached	000								
	_					_

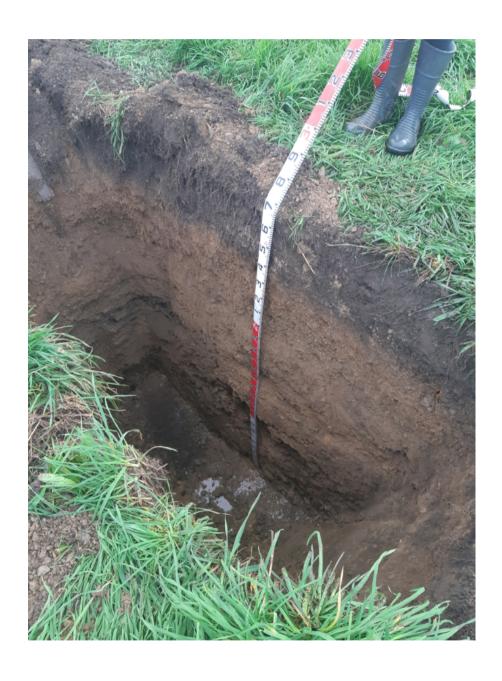
PIT PHOTOGRAPH

Redundant services encountered on initial dig. Pt moved 5 m south and repeated.

520 Hill Street, Richmond	1								00	,, T-	-CTC		
			90	Æ									STS		
ЭСУ	Œ		°	⟨ LE∖	٦	Ē	S		ALA PENETROMETER (Blows per 100mm)			TE	~ .	ES	
GEOLOGY	ОЕРТН (m)	DECORPORTO:	GRAPHIC LOG	WATER LEVEL	R.L. (m)	DEPTH (m)		(BIOV	ws pei	1001	rim)		SHEAR STRENGTH (kPa)	OTHER TESTS	SAMPLES
5	۵	DESCRIPTION SILT with minor gravels; dark brown. Very soft, moist, low plasticity. Organic	<u>2</u>	3	<u> </u>	Ճ	0 2	2 4 6	8 10	12 14	4 16 1	18 20	<u>∞</u> %≍	0 =	Ŝ
TS	-	soil with grass and rootlets [TOPSOIL].	1, 11, 1			-									
Ĕ			$\frac{\sqrt{l_{\ell}}}{l_{\ell}} \cdot \frac{\sqrt{l_{\ell}}}{l_{\ell}}$			_	lili		ij	ijij	į	ij

-	Fine to coarse GRAVELS with some silt with minor sand and trace cobbles;	0000			_		ni i							
		light brown. Loosely packed; moist; well-graded; sub-angular to sub-rounded. Trace rootlets	0000			_

-	nace reside	0000			_									
		Gravelly CLAY with trace cobbles; brown. Moist, high plasticity, soft. Gravel;	<u> </u>			_		 	\nearrow						
	1-	loosely packed, well-graded, sub-angular to sub-rounded.				1-

-					_									
						_					İ				
]AL	-					-			ii	ij	į				
ALLUVIAL		Silty fine to coarse GRAVEL with some sand and trace cobbles and boulders; light brown. Loosely packed; moist; sub-angular to sub-rounded; coarse. Silt,	® 0 x ○ 0 x			_					į				
ΙΨ	-	soft, low plasticity. At 2.1 m soil becomes saturated.	*			-			ii		į				
			& B & B & B & B & B & B & B & B & B & B			_									
	2-		0 0 0 2			2-									
			8 28	2.1m 21/07		-

-	light brown. Saturated; sub-rounded to rounded; well-graded. Silt, very soft, low plasticity.	\$ 0 \$ 0 \$ 0 \$ 0 \$ 0 \$ 0 \$ 0 \$ 0 \$ 0 \$ 0			-						 			
		END OF PIT AT 2.7m - Refusal - Excavator Lifting Up	0 × 0 3					 	++	++	+
