Assessment of 30 potential salt marsh rehabilitation options for Waimea Inlet

Stevens LM. 2024. Assessment of 30 potential salt marsh rehabilitation options for Waimea Inlet. Salt Ecology Report 138 prepared for Tasman District Council. April 2024. 99p.

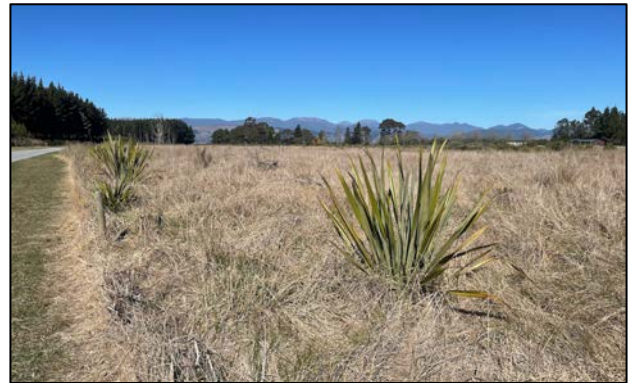
Upper wetland area now largely cut off from tidal flows with terrestrial grasses and weeds growing in former salt marsh.

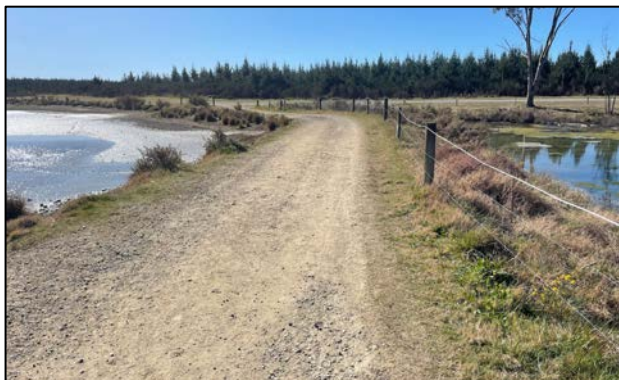
Earth causeway separating the estuary from the embayment.

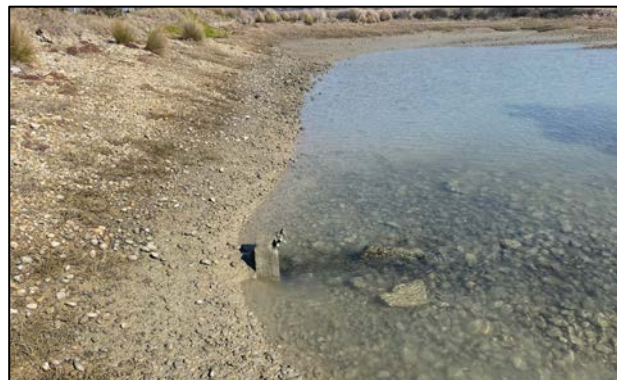
Small pipe and flap gate restricting tidal flows to the site.

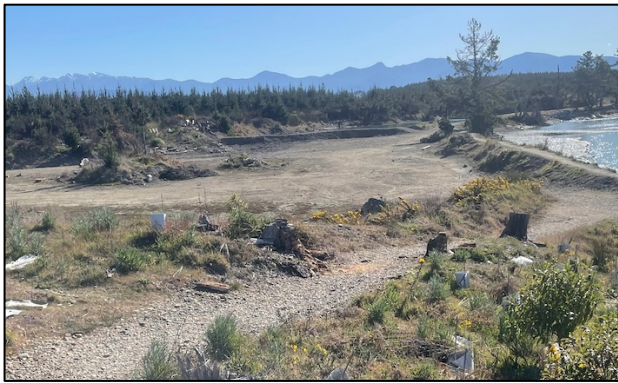
Coastal berm and walkway/cycleway with new (early 2023) raised berm to prevent tidal inundation on the seaward edge.

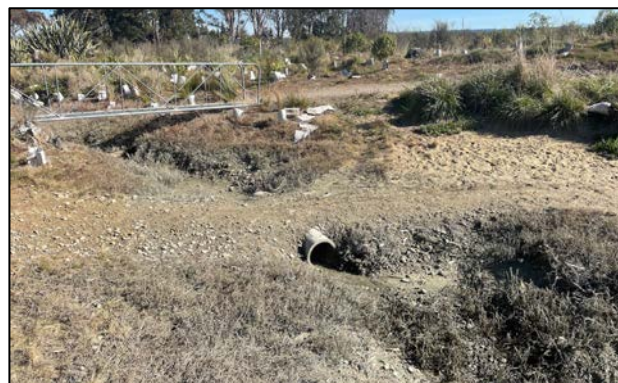
Small pipe and causeway restricting tidal access to upstream salt marsh. Footbridge in background.

- Remove the small pipe and causeway to allow regular tidal exchange to the site.
- Exclusion fencing a small area of salt marsh adjacent to the Great Taste Trail is also recommended (see photo below).

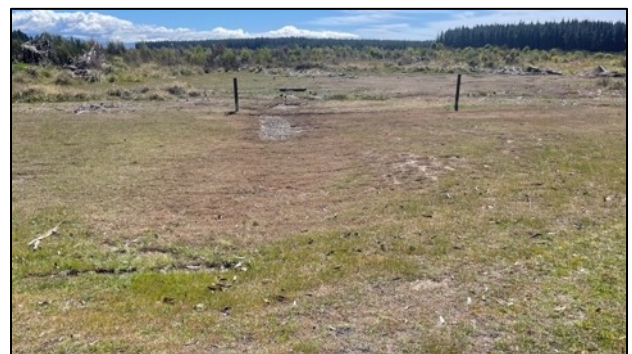
Tidally inundated herbfield located between the fenced restoration plantings and the Great Taste Trail. Vehicle, bike and foot traffic impacts are evident.

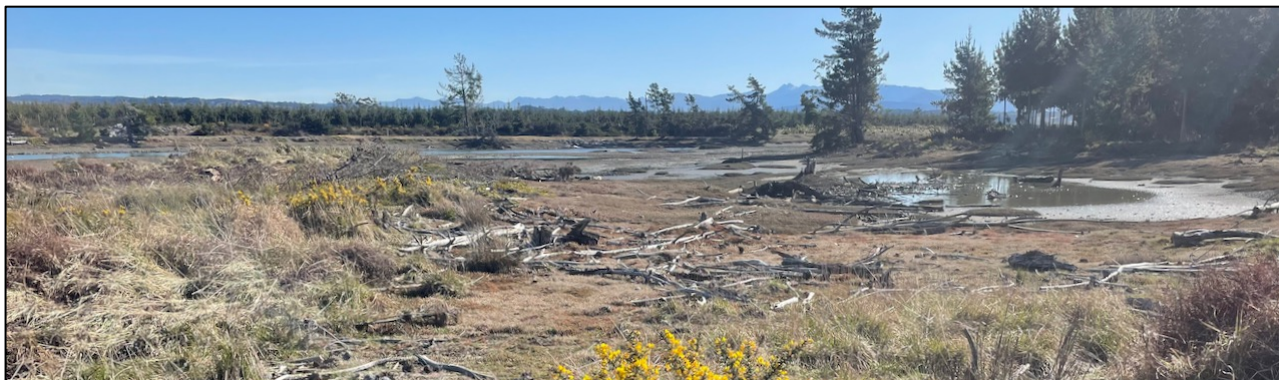
Tidal water and pine slash trapped behind the historical causeway. The grassy area to the left of the picture has recently been cleared of mature pine trees.

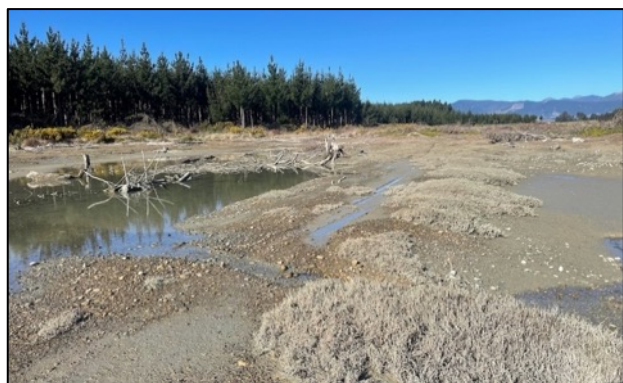
Ponded tidal water draining through the historic causeway.

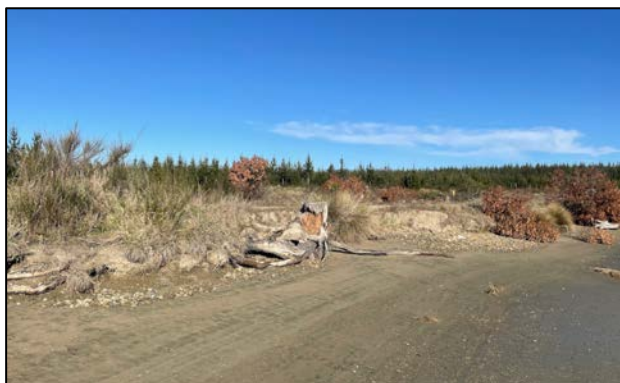
Elevated causeway blocking the site from tidal exchange.

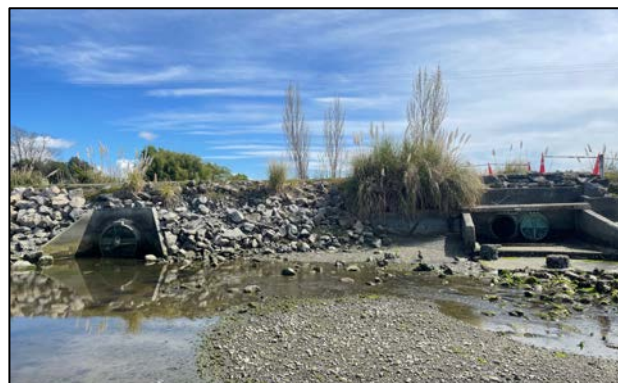
Flapgates on causeway culverts restrict tidal exchange to the embayment (note 2 of 3 flap gates are closed in photo).

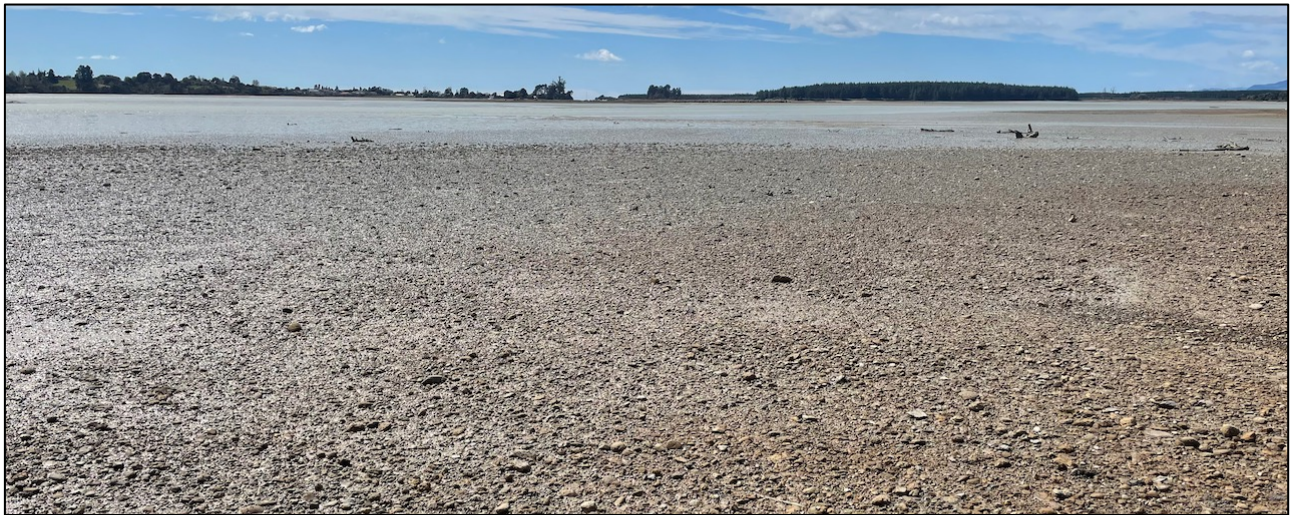
Raised gravel bed which likely supported rushland. There is potential to re-establish rushland at this site behind a rock chenier located at the seaward edge of the gravel bed.

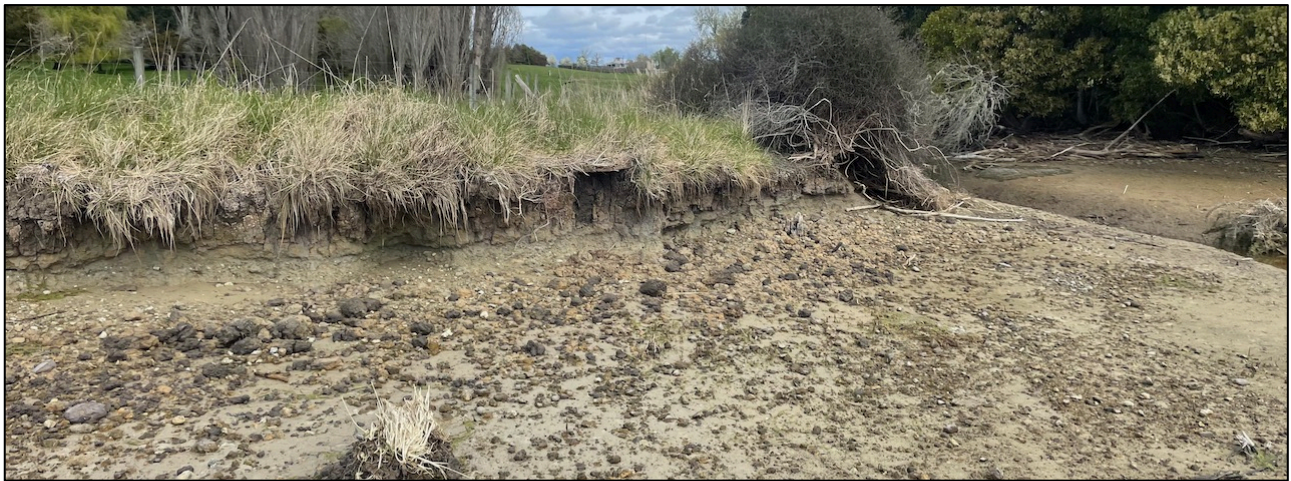
Eroding shoreline where rushland is no longer growing.

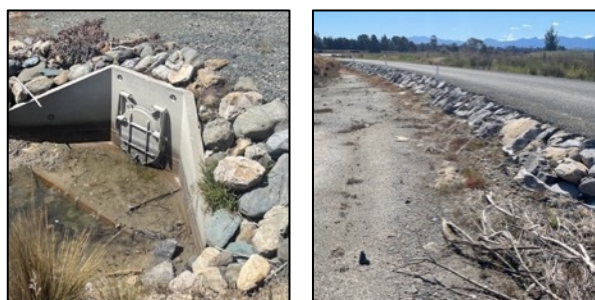
Flap-gate and causeway limiting tidal exchange to the site.
