Engineering Services Committee ATTACHMENTS

Proposed Scheme Layout for Richmond / Waimea

Stormwater Level of Service additional background material

Safer Journeys to Schools

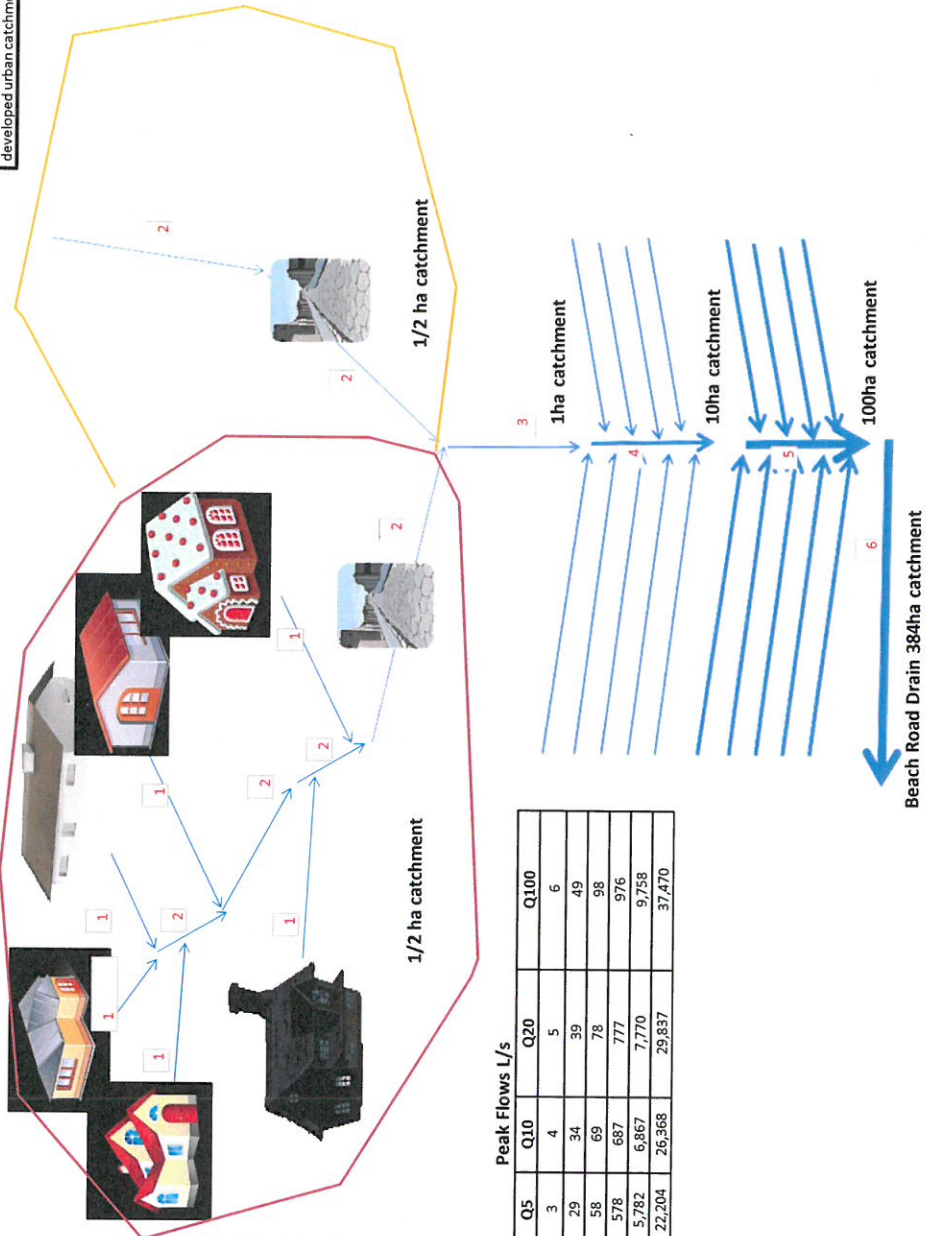
EXAMPLE OF CAPITAL COST INCREASE WITH LOS CHANGE

Summary
 \$5m to go from Q5 to Q10
 \$8m to go from Q5 to Q20
 \$20m to go from Q5 to Q100
 Jimmy Lee is 44% of the existing developed urban catchment area.

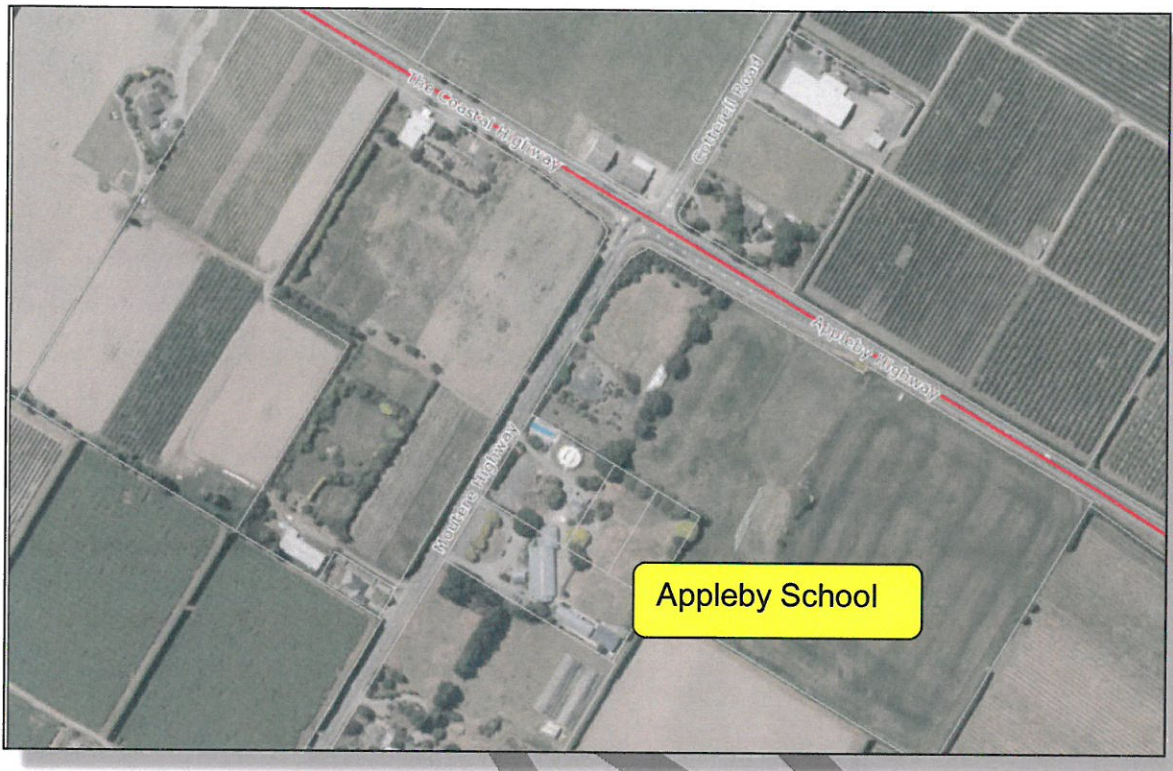
The aerial image below shows the immediate location of Appleby School and the surrounding road environment.

As shown, the school is located relatively close to the intersection of the Moutere Highway and SH60. The location of this intersection and its proximity to the school affects both driver behaviour and the speed environment along the frontage of the school. Typically motorists are adjusting their speed as a result of needing to stop or accelerate due to the major intersection. Drivers are also more alert in terms of the driving task because of the nearby intersection.

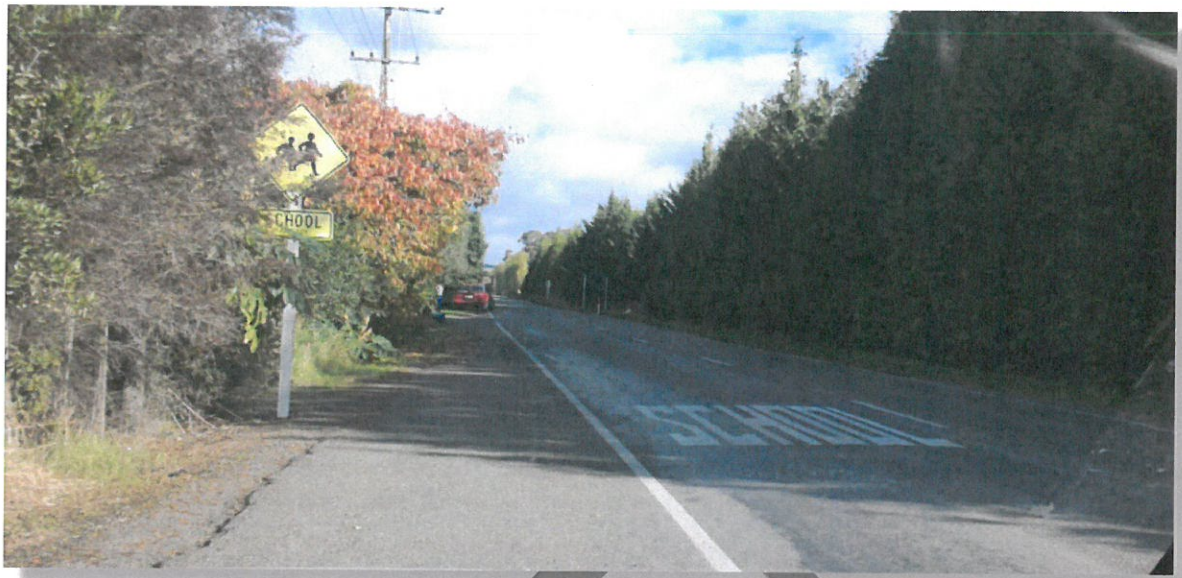
The Moutere Highway along the frontage of the school is around six metres wide with no kerb and channel or footpaths along its length. The road is marked with a centreline, edge lines and has edge marker posts along the road berm. The photos below provide an indication of the road environment in the vicinity of the school.

Prior to June 2014 there were yellow diamond school warning signs on both approaches to the school. However there was only one sign on the approach to the school nearest to the State Highway and this was covered by overhanging vegetation. The word 'SCHOOL' was painted in white letters on the road at this location. The photograph below (taken in June 2014) provides a view of the road environment on the north approach to the school.

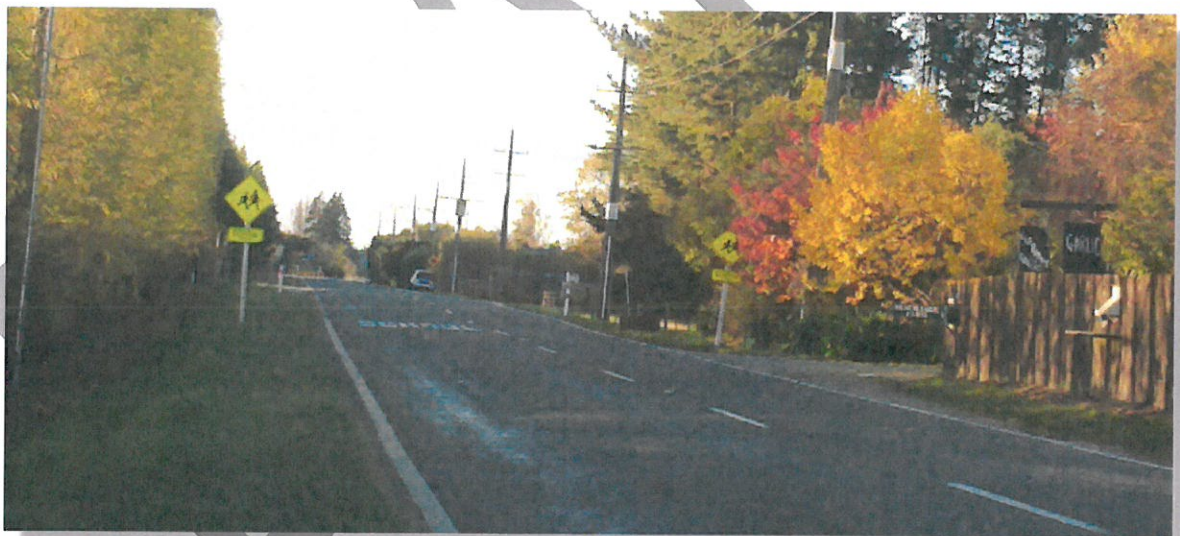
On the approach to the school as you approach SH60 there were two school warning signs before the school, although the one on the right side of the road can be obscured by an overhanging tree. The word 'SCHOOL' is painted in white letters on the road at this location. The photograph below (taken in June 2014) provides a view of the road environment on the south approach to the school.

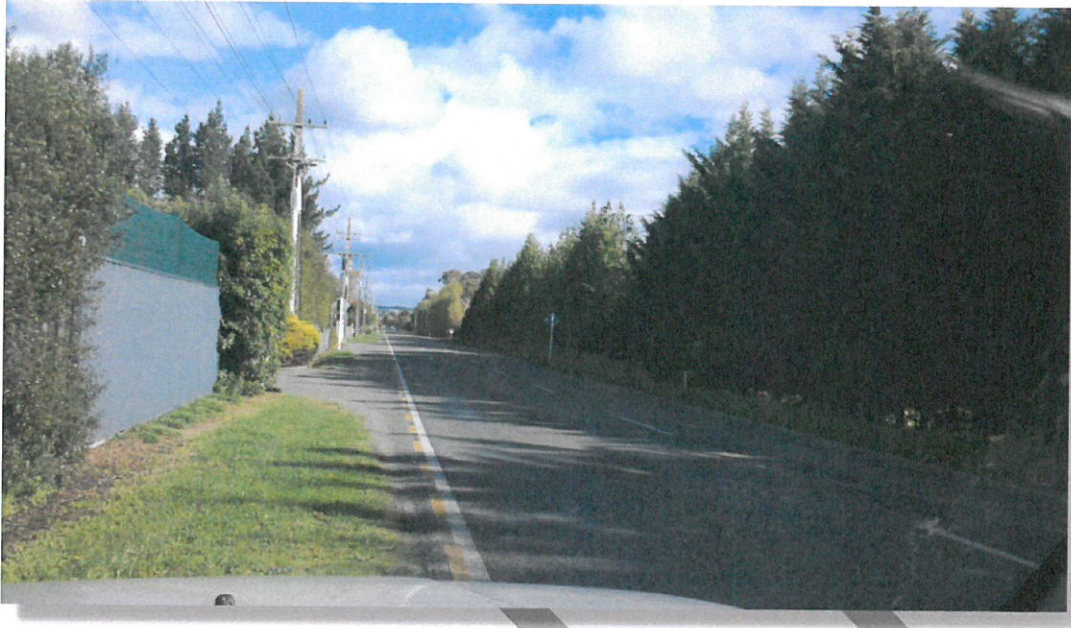
In late 2014 broken yellow lines were painted on both sides of the Moutere Highway to help with visibility for traffic leaving the school car park and to control parking arising from parents not using the onsite parking facilities. The school reports that these lines have assisted with visibility and also reduced the number of parents parking on the opposite side of the road. See photo below.

Of particular note is the lack of identification of the school entrance. The school is set back behind trees and the parking is located well off the road. This is clearly evident in this last photo.

During these discussions there have been several changes in board of trustee members. The first discussions with the Council were in regard to painting broken yellow no-parking lines on the Moutere Highway either side of the school's entrance/exit. After receiving feedback from the current board of trustees in 2013 these lines were painted in December 2013.

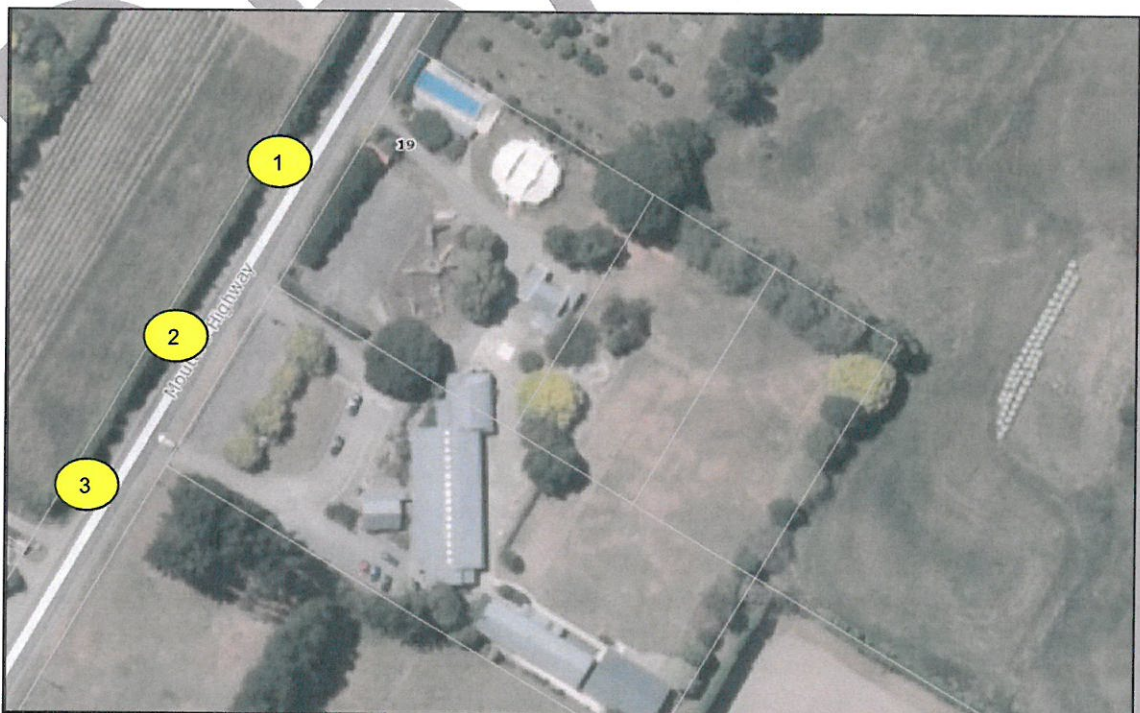
The school has three entrances/exits.

One of these entrances is only used by the school buses and is separate from the entrance to the main school car park. The bus parks up just past the swimming pool.

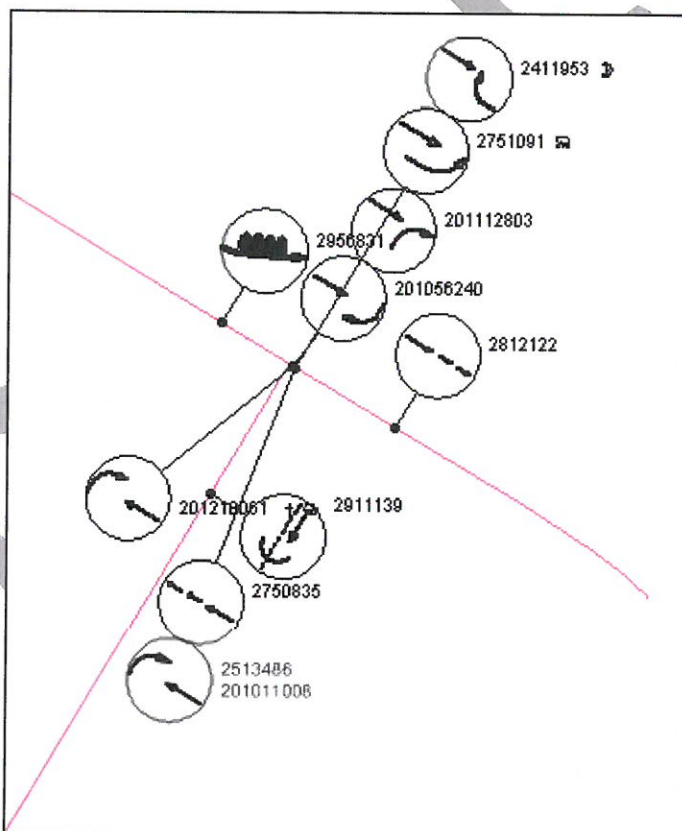
The diagram below shows the crash type for each of the crashes

Crash type	All crashes	% all crashes
Overtaking crashes	1	9
Straight road lost control / Head on	1	9
Rear end / Obstruction	3	27
Crossing / Turning	6	55
Bend – lost control/head on	0	0
Pedestrian crashes	0	0
Total	11	100

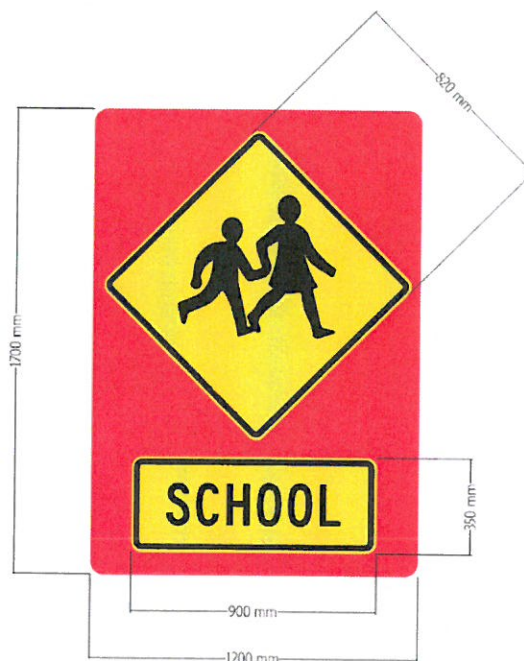
New signs are to be placed on both approaches to the school. These signs will be larger than the standard school warning signs and will not be obscured by overhanging vegetation.
