Measuring the cultural health of Reservoir Creek

Using tangata whenua environmental indicators for wai

June 2008

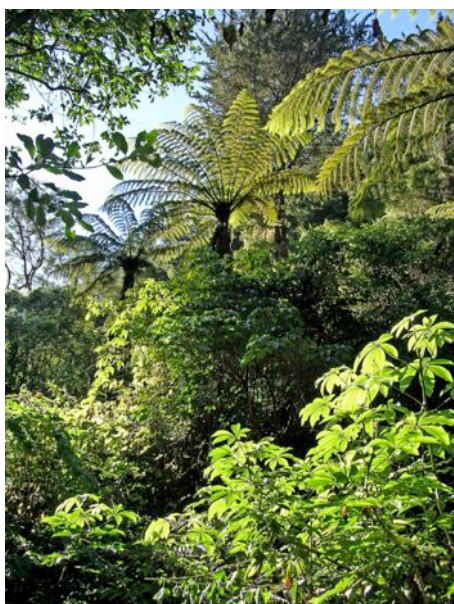
i. Upper creek (above reservoir)

This site is located near the source of Reservoir Creek. It is surrounded by pine forest, but the riparian margin is mostly native shrubs and trees. Public access is on a small-unformed track along the creek.

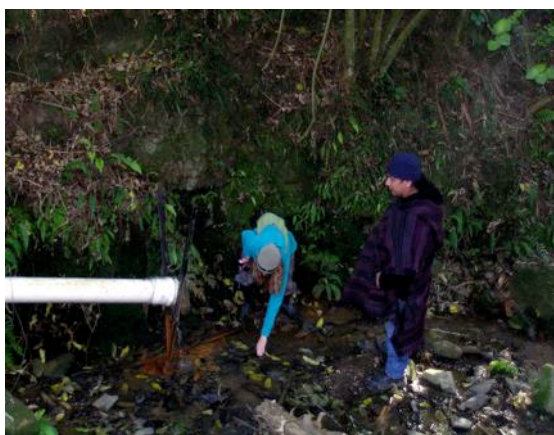
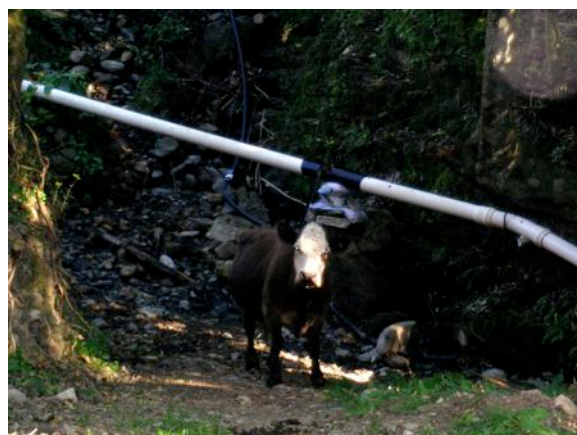
ii. Below reservoir

This site is highly modified. A culvert connects the Reservoir with the Creek below. Indigenous vegetation consists mainly of ferns with the area predominately covered in grass and scrub. Cattle are often seen grazing in and around the Creek.

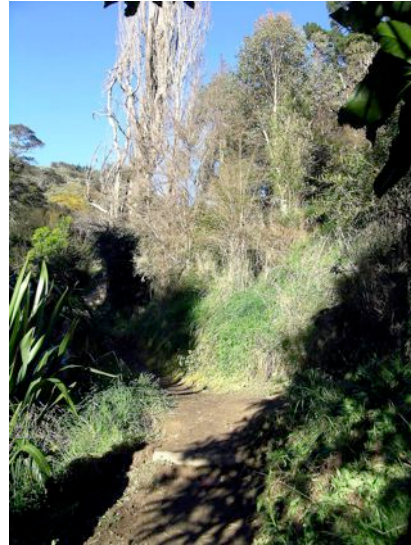
iii. Easby Park

This site is located along Keith's walkway near the Tasman District Council boundary with private property. A large number of middens have been reported in the area along with the discovery of an adze. Although grasses dominate the riverbank, there are some indigenous scrubs and trees shading the creek.

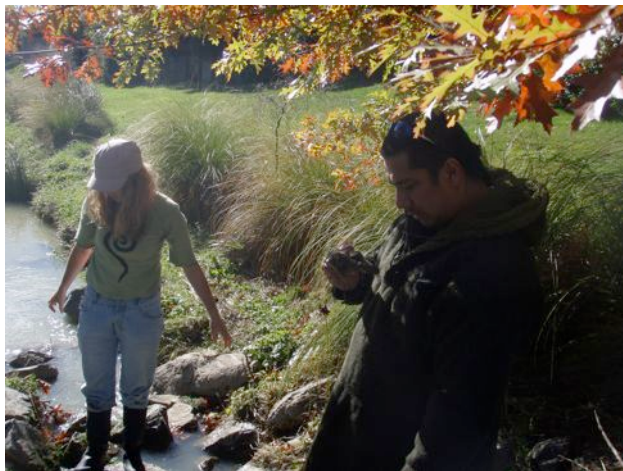
iv. Welsh Place

This reach follows a public walkway, which meanders through an urban, grassy park-like setting.
