Engineering Services Committee

AGENDA

Tasman District Riverbed Level Monitoring Results

December 2018 Tasman District

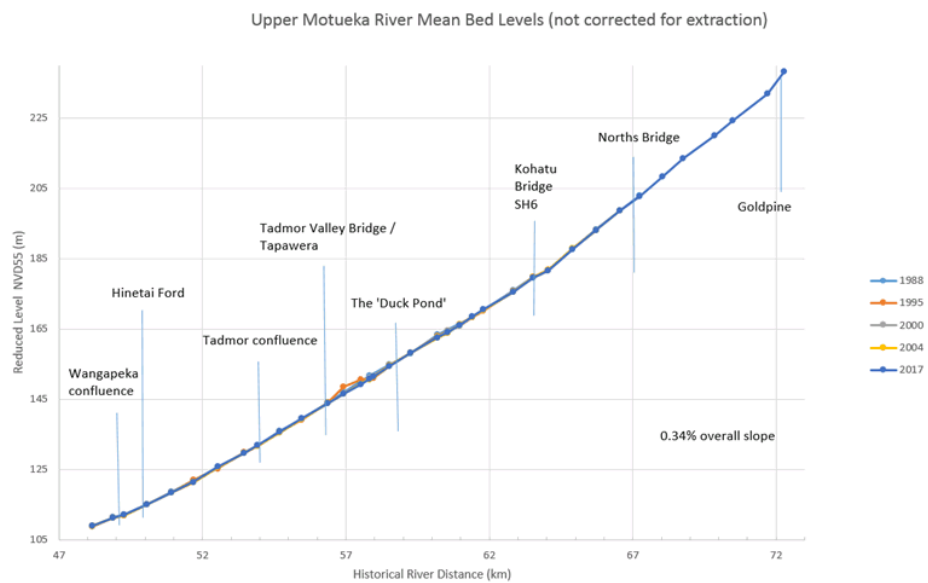
Fig 4 Overall MBL Upper Motueka

Surveys available to compare 2017 against were 1988, 1995, 2000 and 2004. Data was reformatted and imported into Hilltop Manager for plotting of cross sections. All survey years were plotted for each cross section and ‘common offsets’ (i.e. a common horizontal position on left and right banks) carefully chosen for comparison purposes. These points were chosen so that they included the entirety of the main channel for each survey year and where possible were as close to the base of the stopbanks or top edge of the natural bank where no discernible stopbanks are present. Note that there are no official Council maintained stopbanks in this catchment, but informal bunds of material either natural or pushed up by landowners in the past, as well as some Catchment Board built stopbanks that have not been taken on as Council assets.

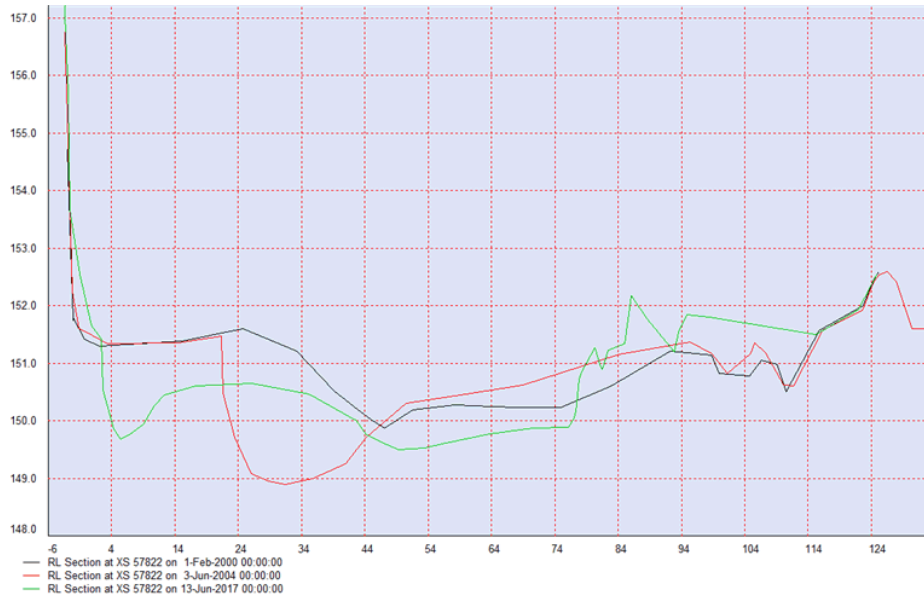
Fig 5 Upper Motueka cross-sections at 57.822km. The red one was in 2004. Black year 2000, Green is 2017.

There was also significant bank erosion between 2000 and 2004 at the next cross section 200m downstream of the Duck Pond (see Fig 2.), possibly as a result of high bed levels here forming a 'plug' and a flood event subsequently 'blowing this out' during that period.

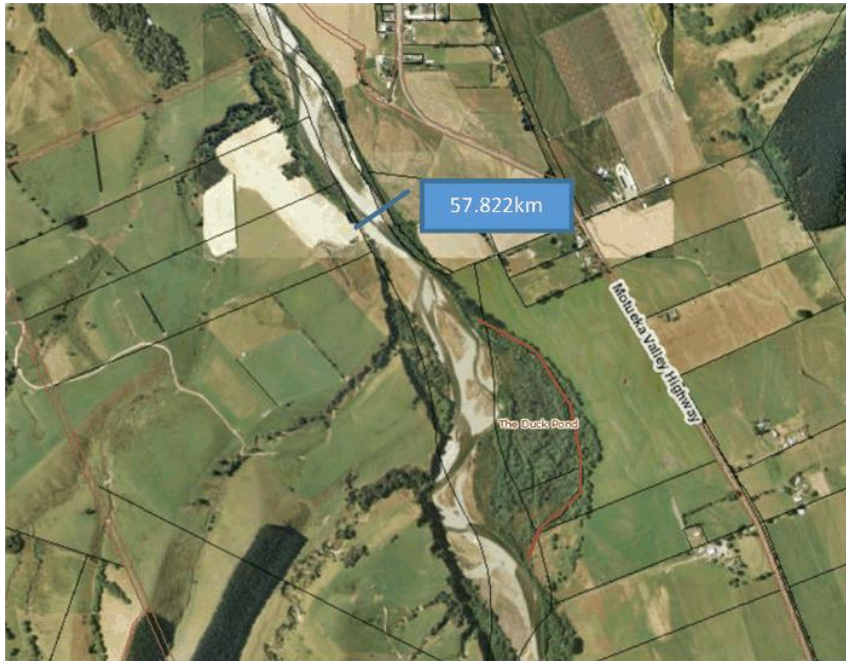
Fig 6. Duck Pond and downstream cross section 57.822km location
 Figures above show the MBLs for the mid and lower reaches from Norths Bridge down to the confluence with the Wangapeka River at a finer scale. The reach above Norths Bridge is not shown as there are only two surveys for this section with little variation in bed level.

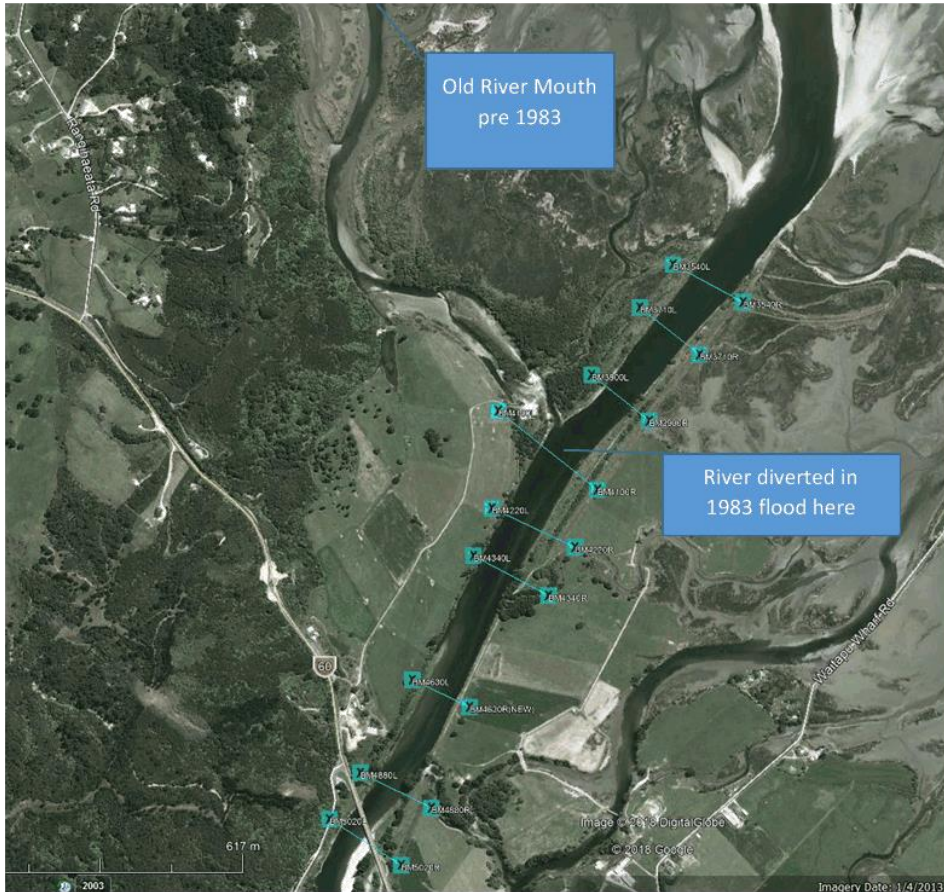
Fig. 13 Takaka Rivermouths

Bed levels in this part of the river varied greatly as the river adjusted over the next couple of decades due to the straighter and steeper nature of the new alignment.

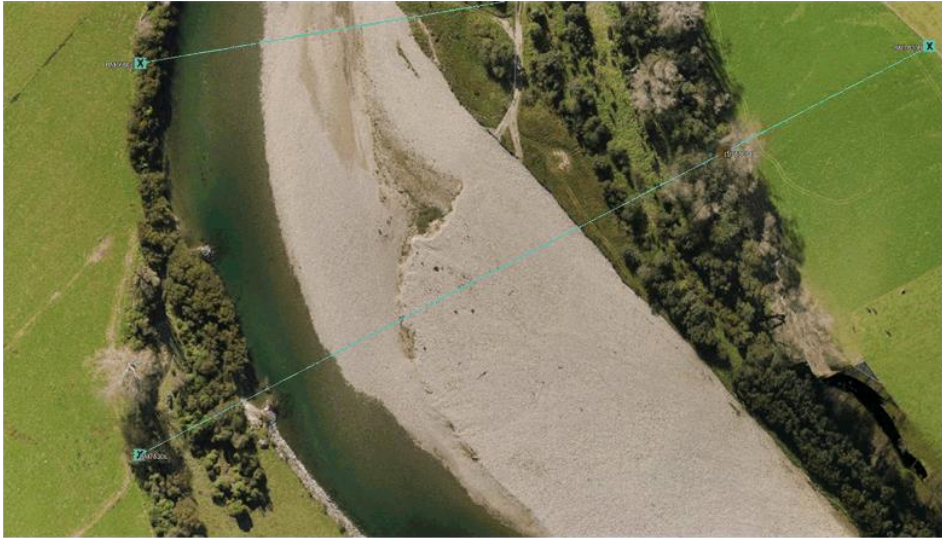
Fig 15. Roses Beach with CS 07830 relating to Fig.2 shown at bottom

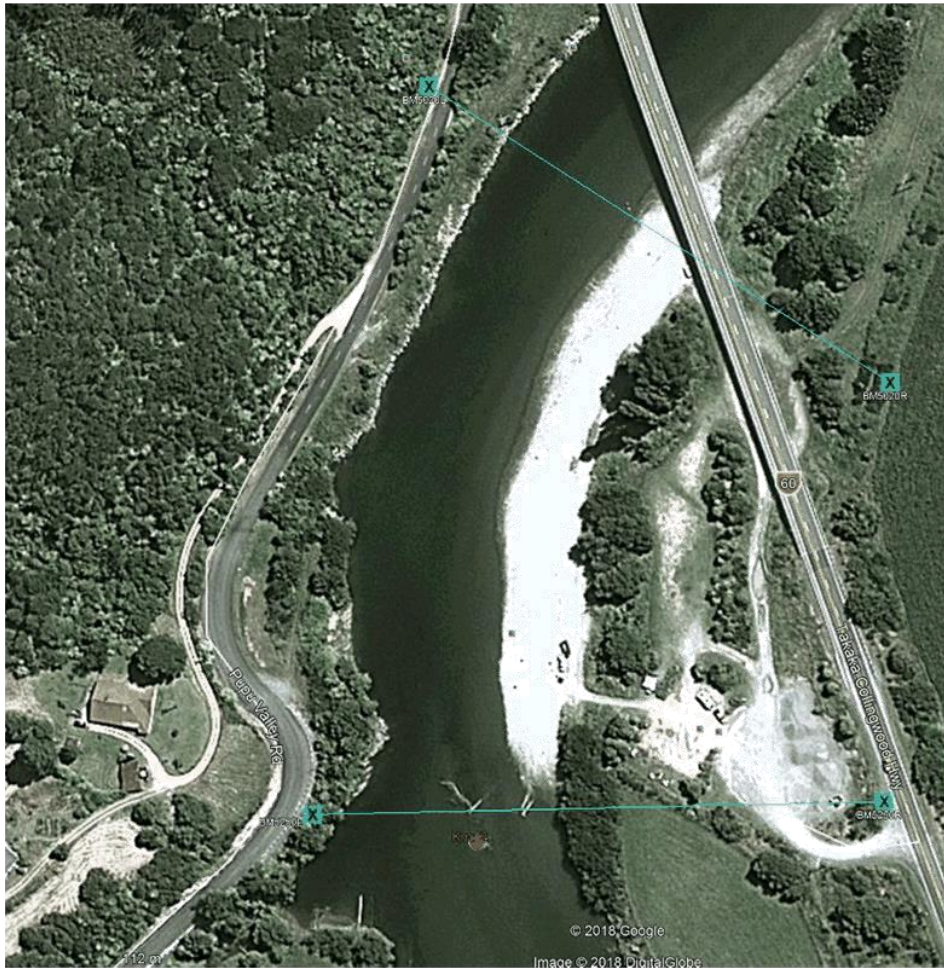
See Fig.18 below which shows the location of these two cross sections.

Fig. 18 Waitapu Bridge bed level anomaly

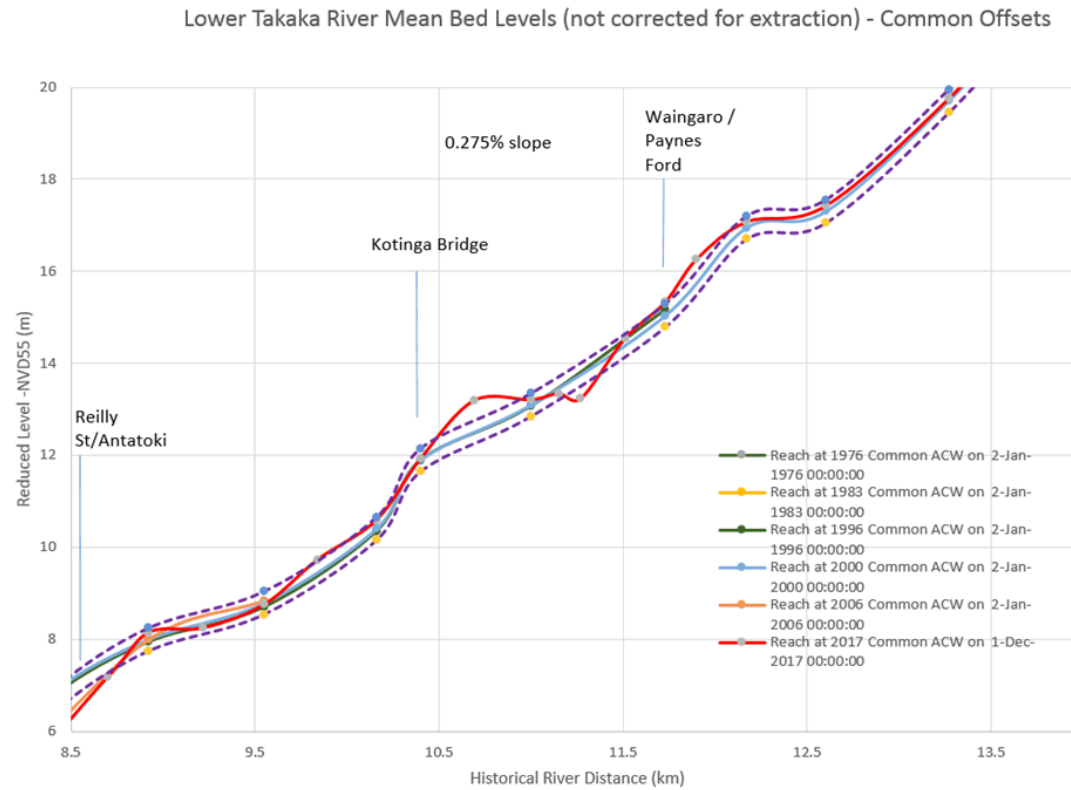
Fig 19. Lower Takaka MBLs 1

It is important to note that the graphs represent actual mean bed levels and that any gravel extraction has not been taken into account. Hence under a natural regime with no extraction, some of the earlier profiles (given that last century extraction levels were typically much higher) could well in fact have been higher, meaning the setting of the envelope could be conservatively low.

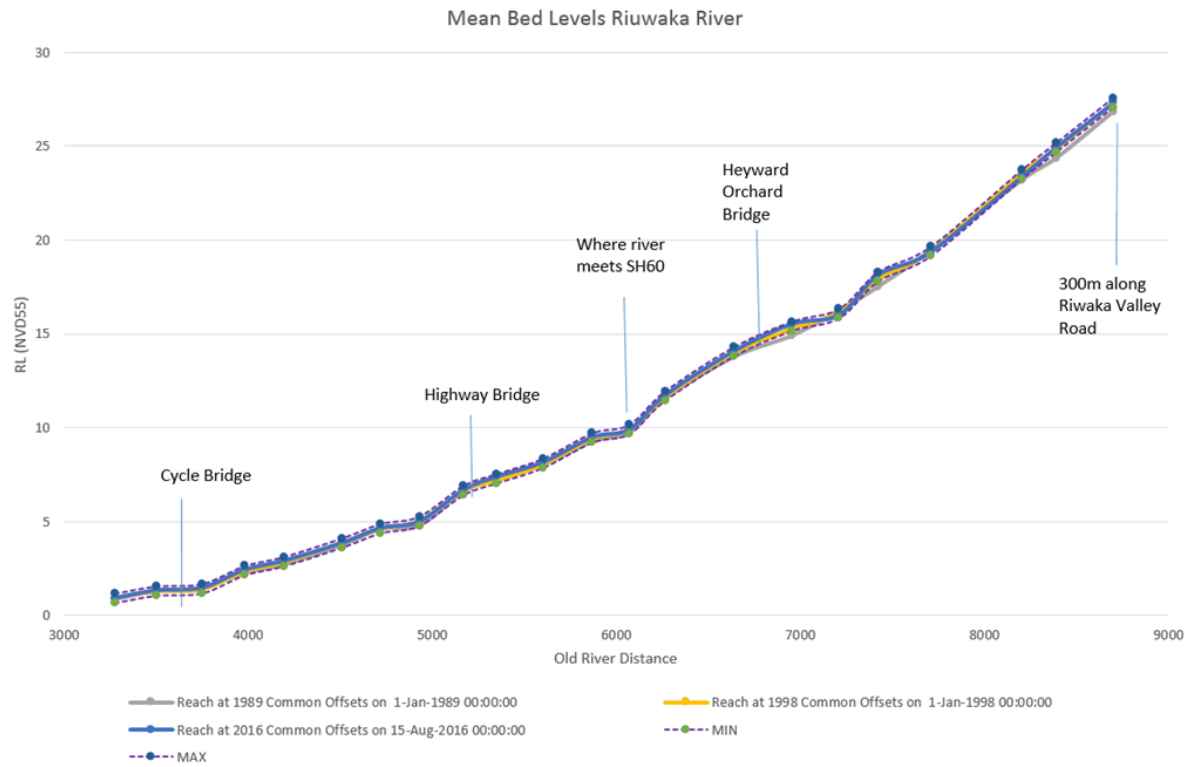
Fig 25. Riuwaka River MBLs

The floodplain outside the banks was not surveyed, with also only the main channel being picked up at the mouth where the river merges with the estuary.

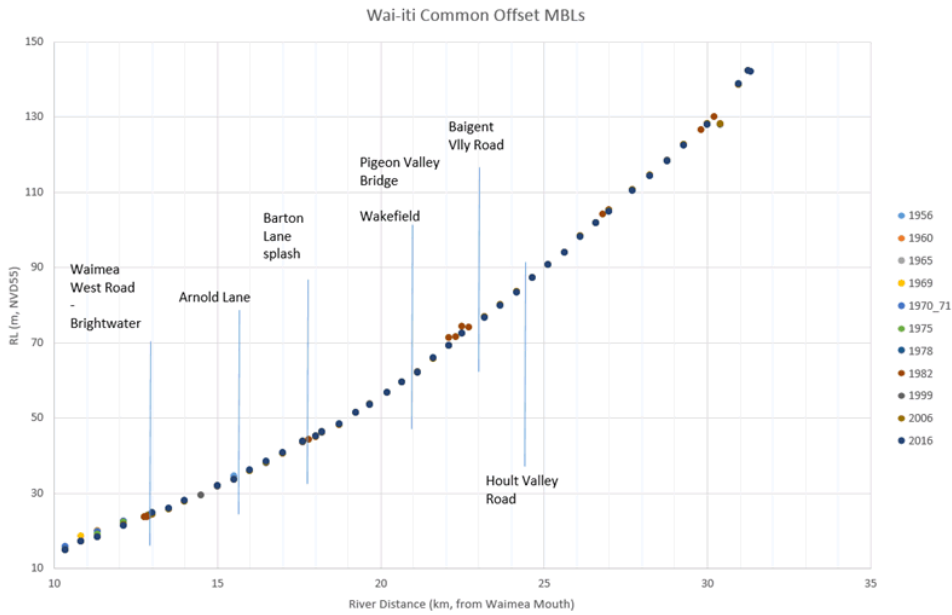
Fig 41 Overall Wai-iti riverbed Common Offset MBLs downstream of Belgrove

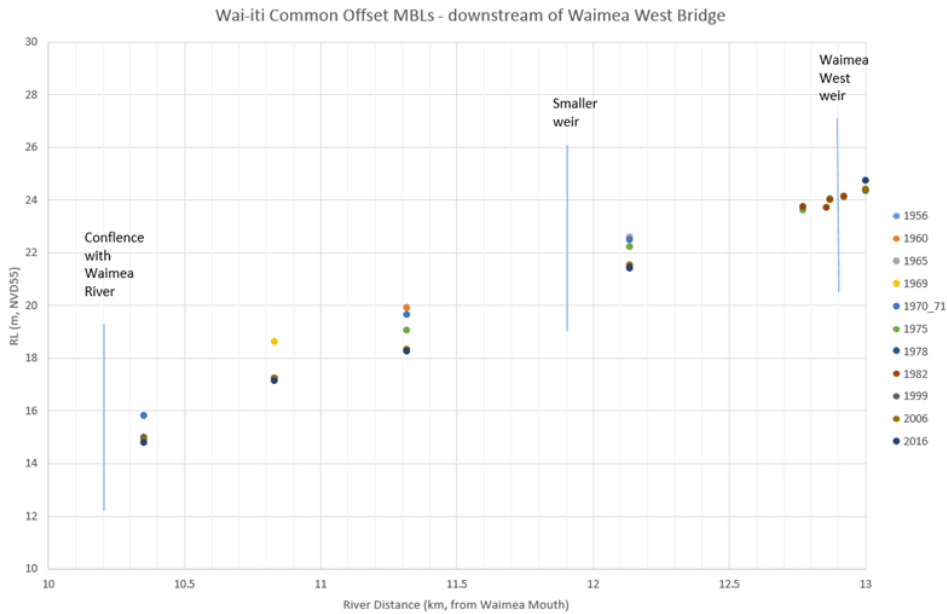
Fig 42 MBLs below Waimea West Road Bridge – Lower Wai-iti River

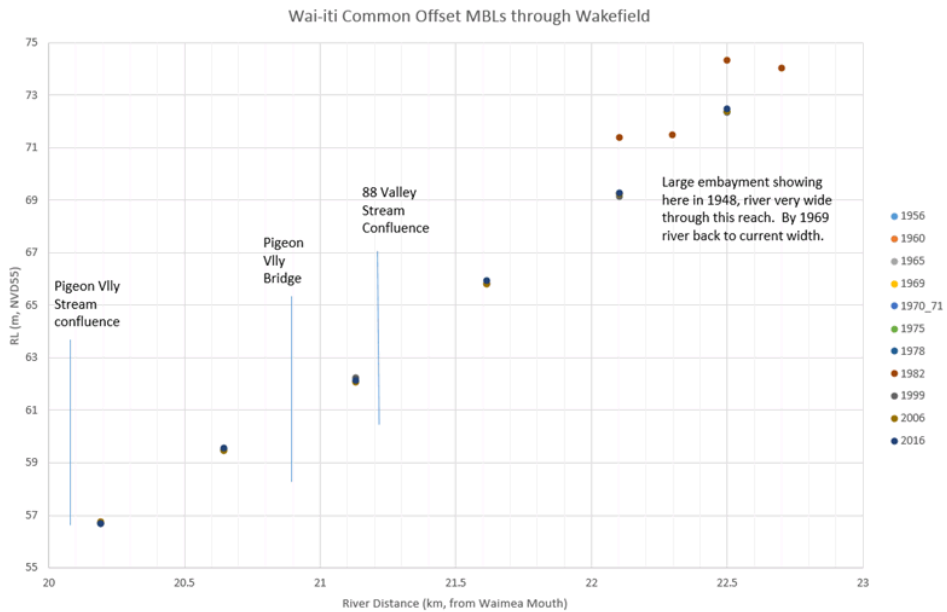
Fig 43 Wai-iti River MBLs through Wakefield township

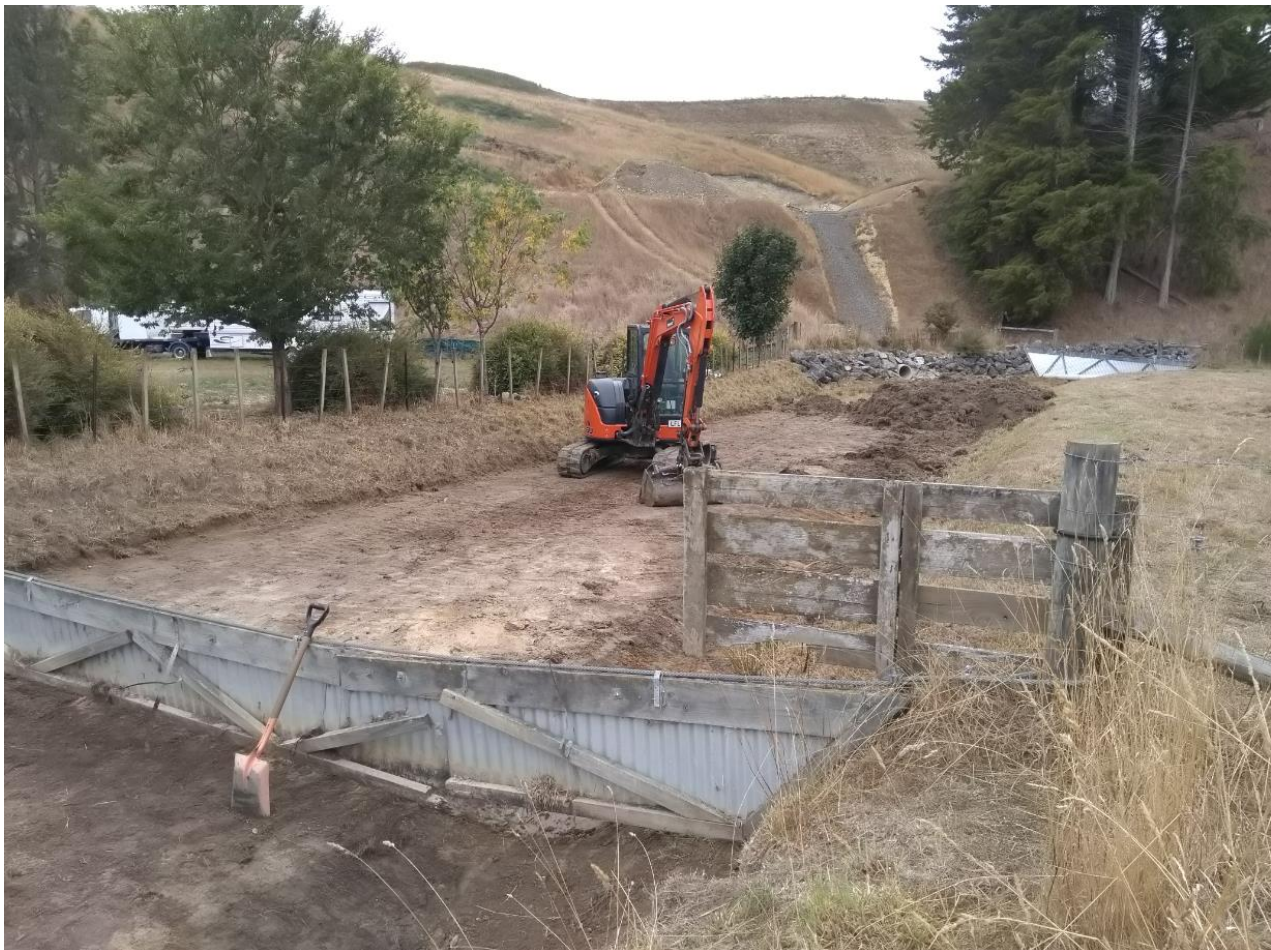
- 6.31 Silt removal from Jeffries Creek in Brightwater has been completed while there was no flow in the channel.

Removal of silt from Jeffries Creek, Lord Rutherford Road South, Brightwater

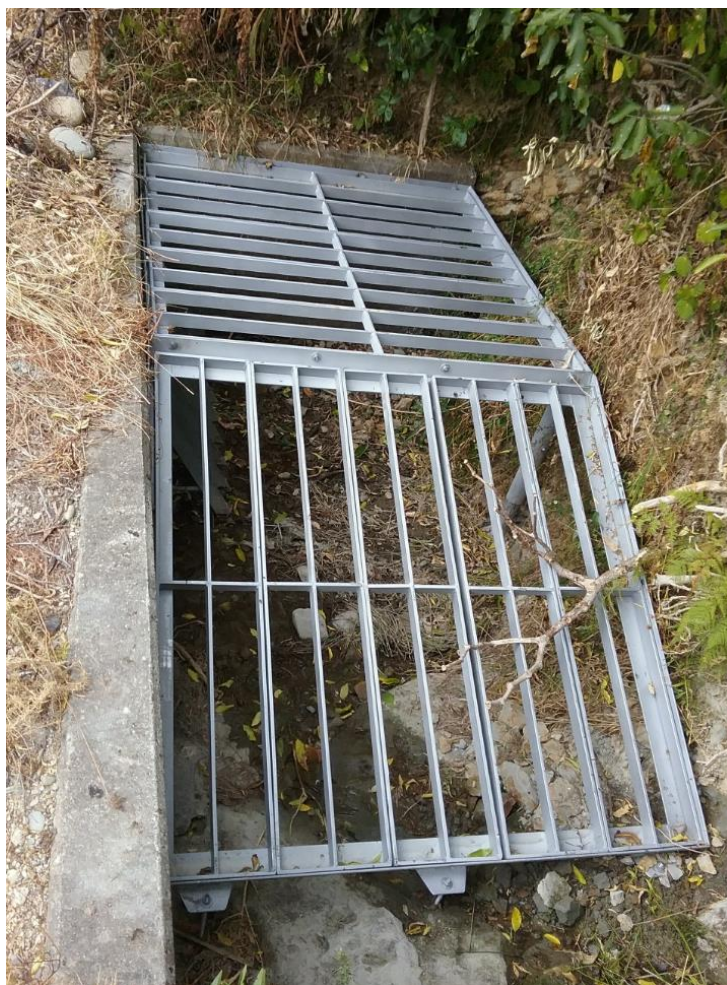
Culvert inlet grill – Gibbs Road, Collingwood

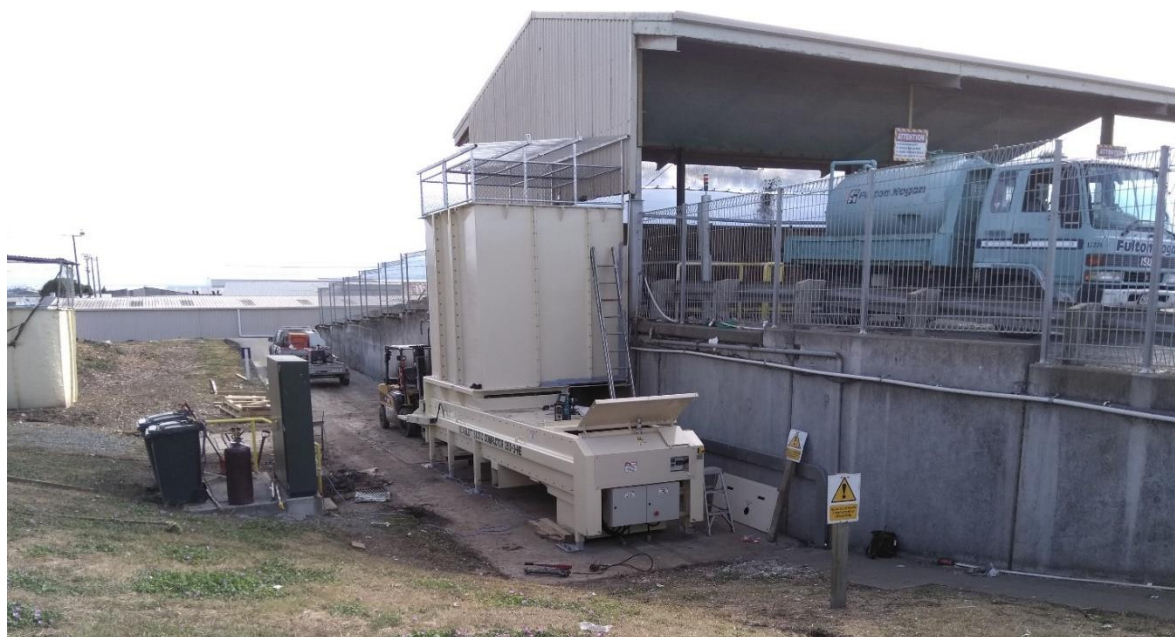
6.43 A new higher capacity compactor was installed at the Richmond Resource Recovery Centre in early March. The existing compactor has been transported to the manufacturer in Timaru for a full refurbishment before installation in Takaka later in the year.

New waste compactor at Richmond Resource Recovery Centre
