Former Fruitgrowers Chemical Company Site (FCC), Mapua - Ammonia Gas Survey Investigation

18 FEBRUARY 2010

Prepared for
Tasman District Council
189 Queen Street
Richmond
42173607

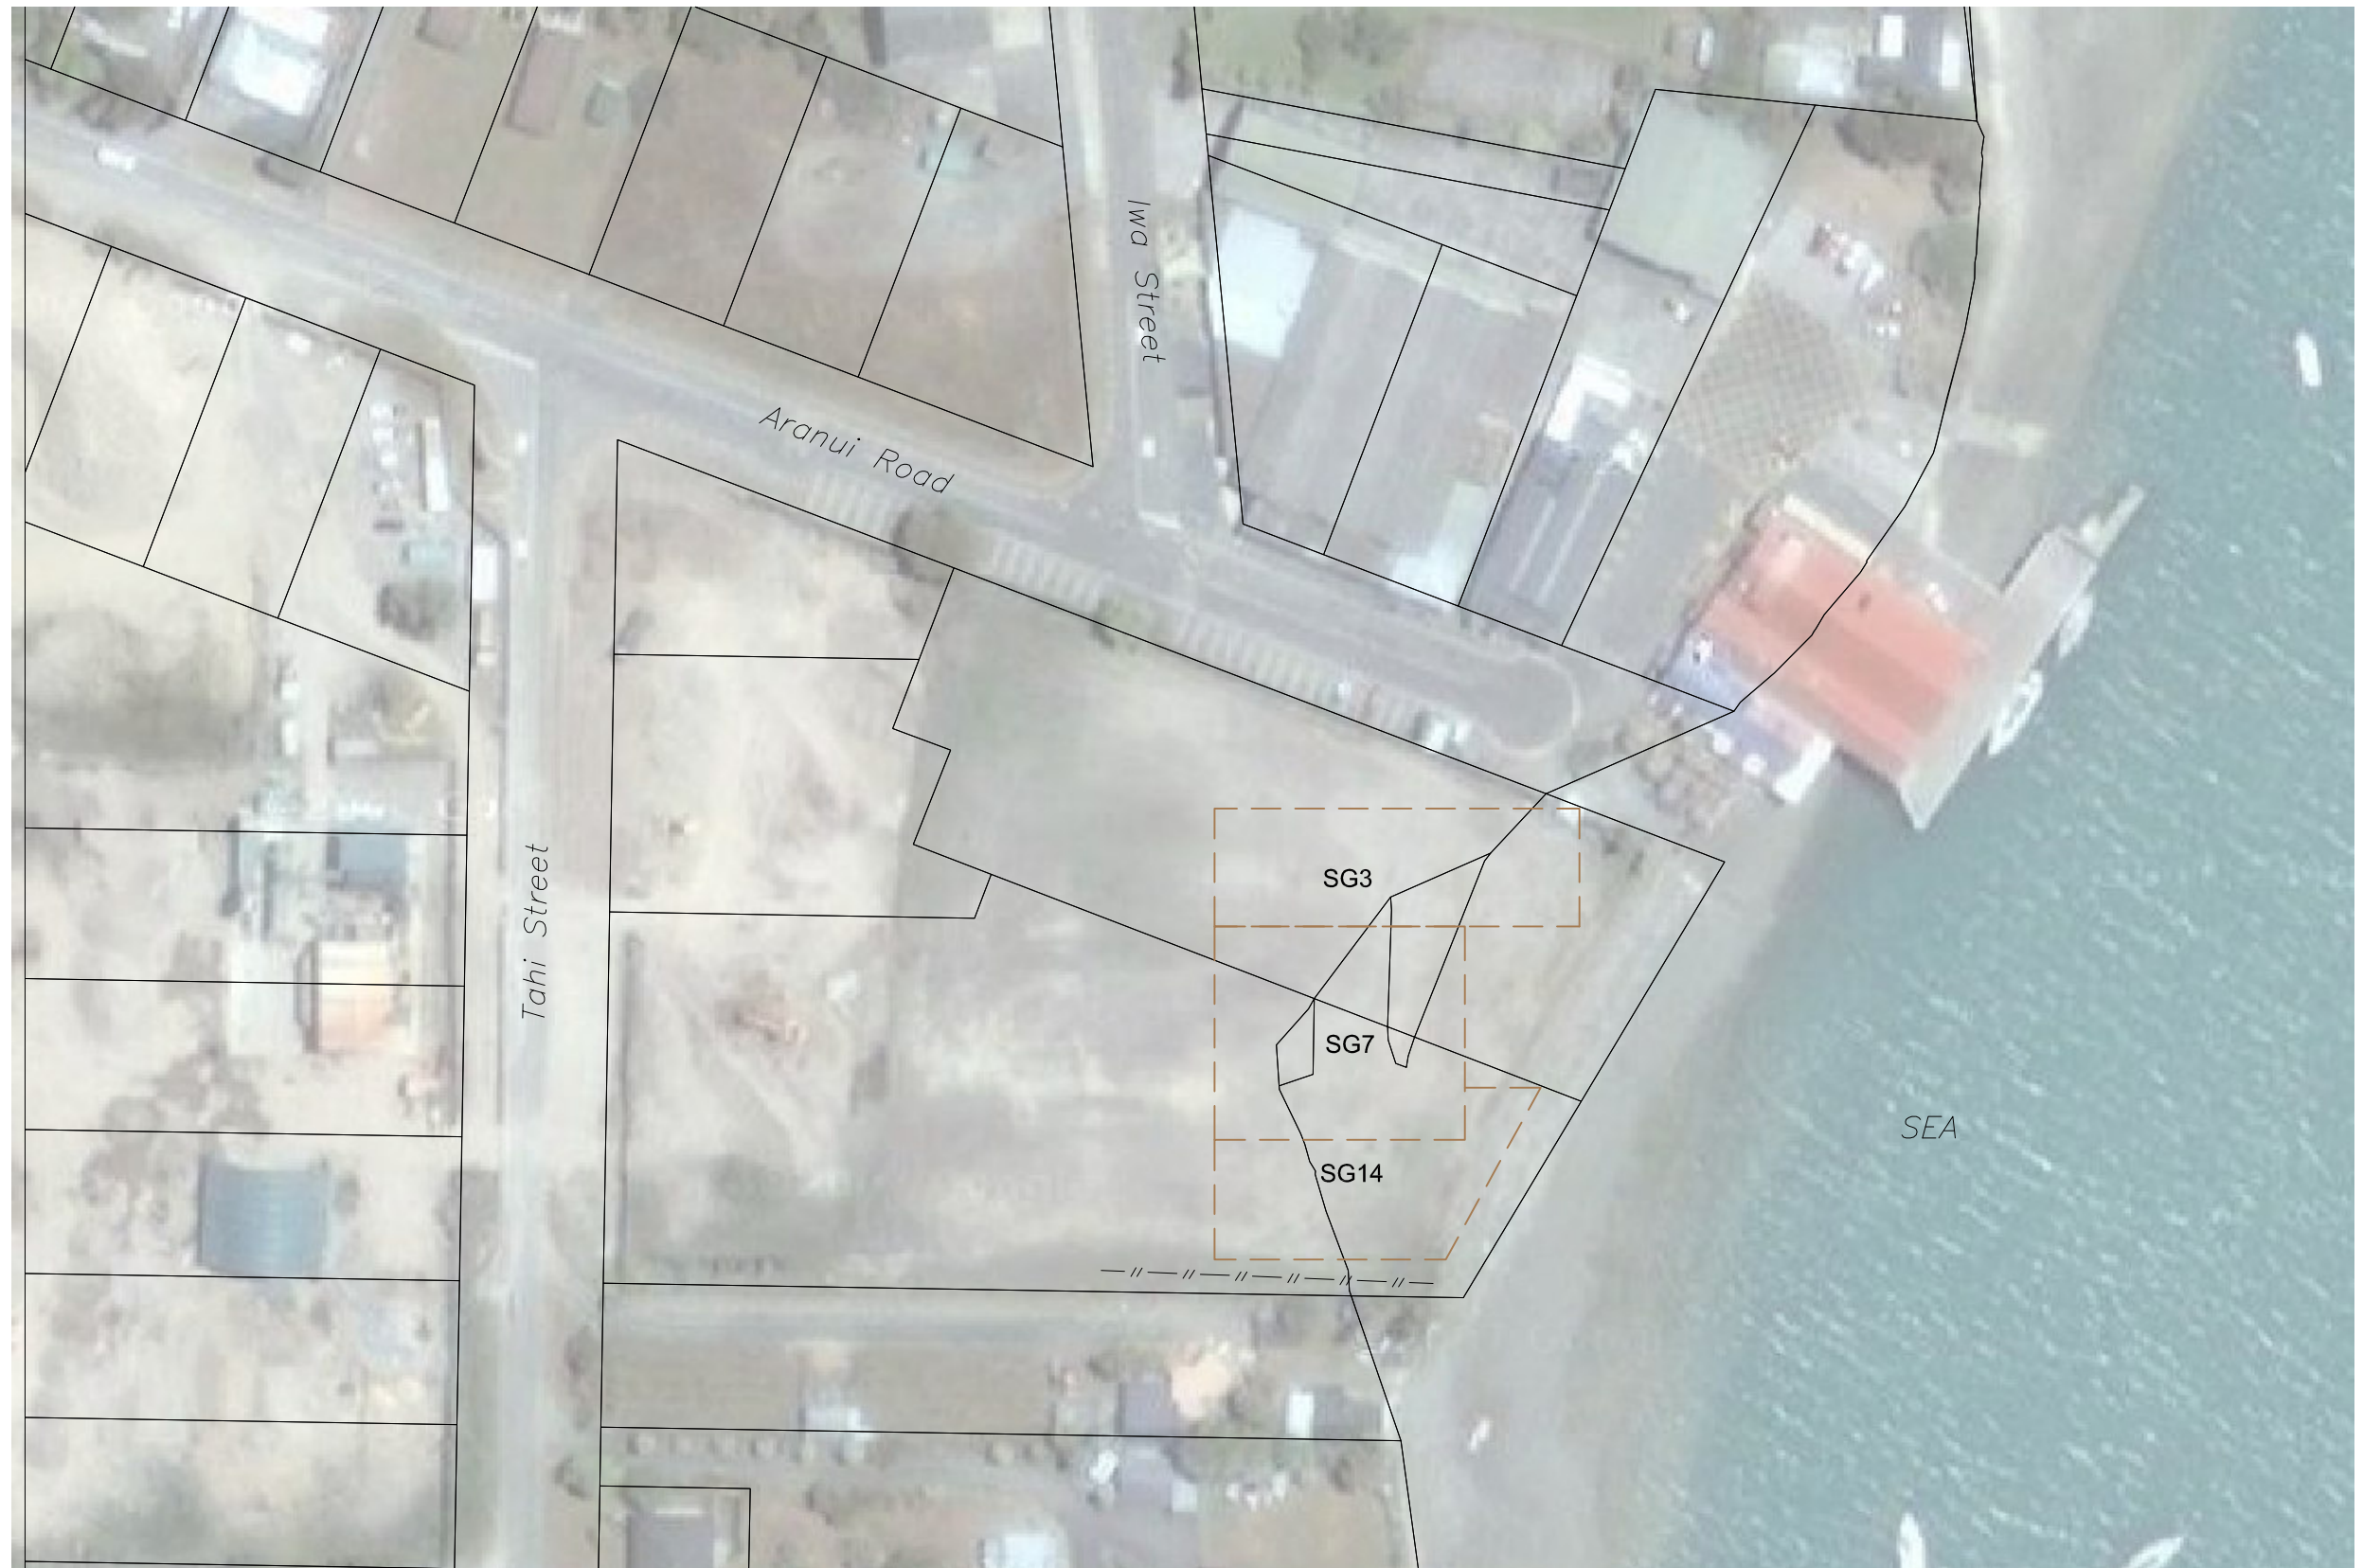
FIGURE 2-2

SG3, SG7, SG14 - SUBGRADES ON FCC EAST

**TASMAN DISTRICT COUNCIL
FCC MAPUA AMMONIA GAS SURVEY
SITE LAYOUT PLAN**

The site is located at 11 Tahi Street, Mapua and is surrounded by commercial businesses to the north, residents to the west and south and Tasman Bay Harbour to the east. The geographical location of the site is shown in Figure 2-1, and site layout provided in Figure 2-2. The site is predominately grassed and currently not used for any specific purpose other than an undesignated parking lot for retail customers of the area.
