Tasman District Council

Jackett Island Long Term Erosion
Management
Preliminary Practicable Options
Report

Tonkin & Taylor

T&T Ref: 27882-PPO-R2

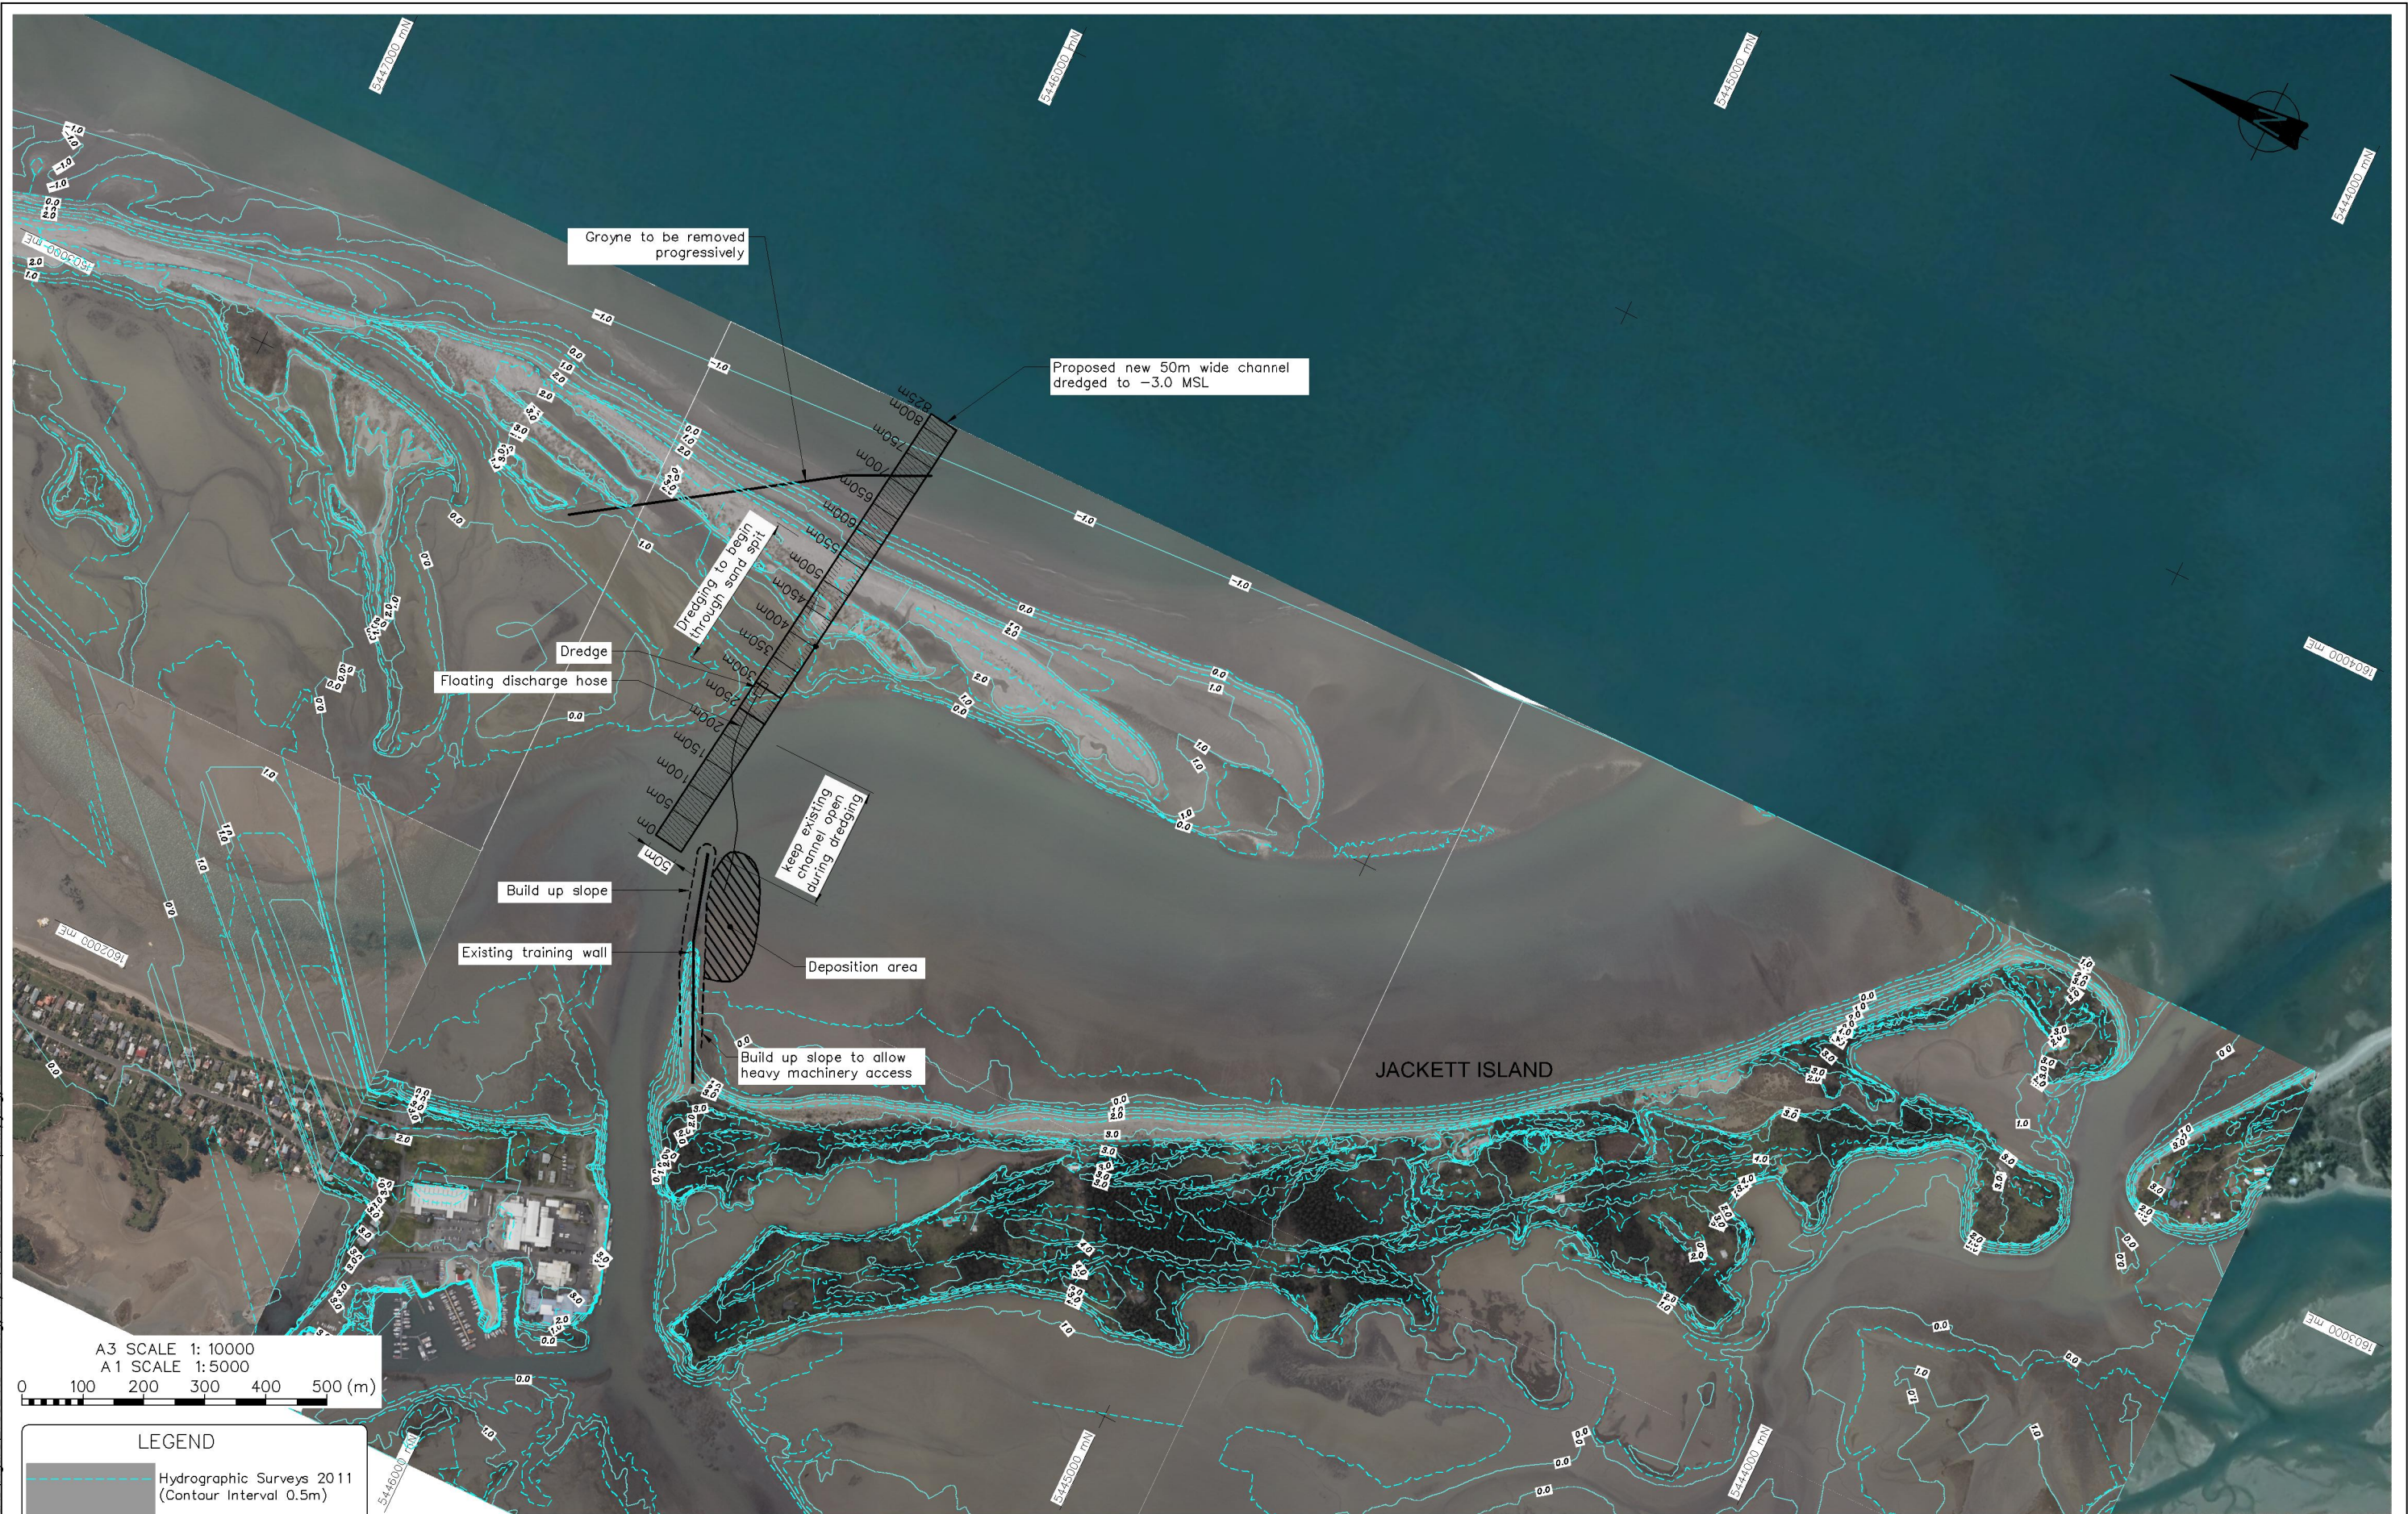
L:\27882\WorkingMaterial\CAD\Figure\27882-HS-F7.dwg, F7, 24/11/2011 2:23:15 p.m., iatg, 1:2

This option is discussed in the draft report prepared by OCEL for the Port Motueka User Group (PMUG). The objective is to dredge a channel across the spit, based on the recommendation by Kirk (1991) to provide improved access to the port. The proposal as illustrated in Figure 7 and involves a channel 50 m wide set at 3 m below Nelson Vertical Datum (or approximately Mean Sea Level). They estimated some 132,500 m³ of sand would need to be moved to form this channel and they identified that the existing channel would need to be closed off. OCEL proposed an extension of the gravel berm to the end of the existing training wall would be sufficient in combination with the flows from the inlet through the new opening being sufficient to reinforce the new channel position and that full closure of the existing channel would not be required. Sedimentation rates of between 14,250 and 23,750 m³/yr were estimated by OCEL based on work done by Kirk (1991).

While not identified in the OCEL plan, their draft report identified that the material dredged for formation of the channel and ongoing maintenance could be used to replenish the foreshore of Jackett Island. This would be done by a cutter suction dredge with a slurry pump discharging to an area in the lee of the existing training groyne and then the sand transferred by truck to place along the Jackett Island shoreline.

We note the proposal does not cut off the existing channel and there is a risk that flows both from the inlet and the area to the north between the mainland and the spit may divert back into the existing channel should the new channel block or be less hydraulically efficient than the existing channel. The likelihood of this occurring would require additional assessment and modelling.
