Notice is given that an ordinary meeting of the Engineering Services Committee will be held on:

Date: Thursday 28 March 2013

Engineering Services Committee AGENDA

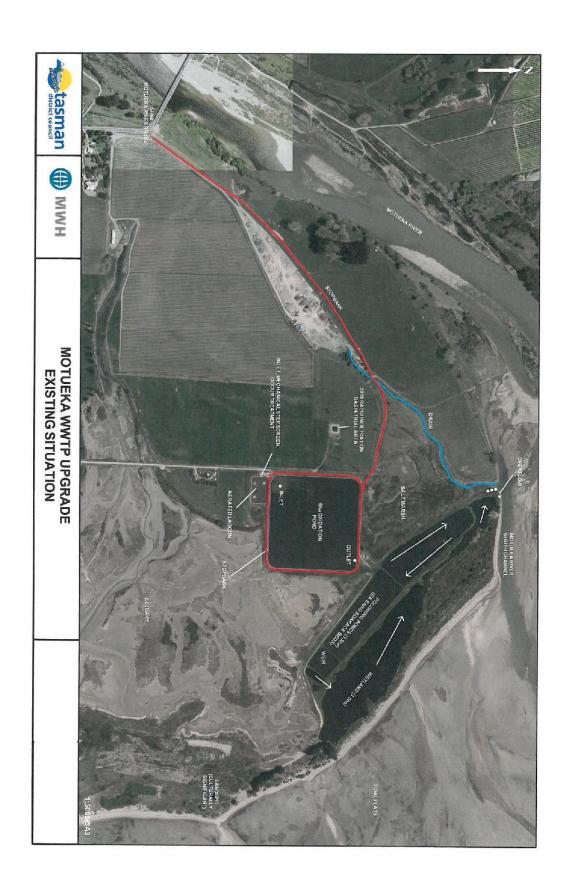
13	Appendices	
1. 2. 3.	Appendix 1 - Motueka WWTP Existing Situation Appendix 2 - Motueka WWTP Upgrade option Appendix 3-Motueka WWTP Upgrade-Project Decision Tree	23 25 27

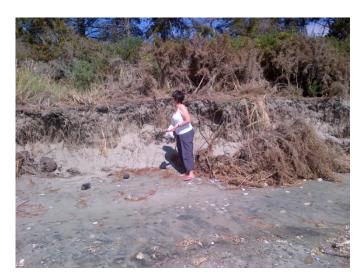
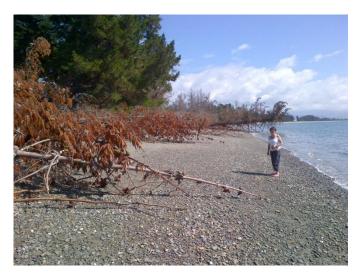
Appendix 3

Erosion on the Rhoades property at the southern end of Jackett Island (photographs supplied by Brian Rhoades)

- 3.8 However, the rate of erosion is high at the southern end of the island. Appendix 2 shows photographs taken by Mr Rhoades of the erosion on his property since early January. It should be noted that this erosion is not due to a storm event. It is apparent from the work investigating a long term solution there is very little sediment that can be transferred to the Jackett Island foreshore under the present conditions. Accordingly erosion at the southern end of Jackett Island is expected to get worse.

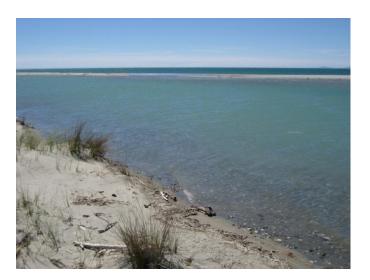
6.2 Further to this monitoring, staff have also been monitoring the northern end of the spit close to Motueka golf course. The spit is narrow and lower in this area and there have been occasions where it has been overtopped at high tide (see photo below).

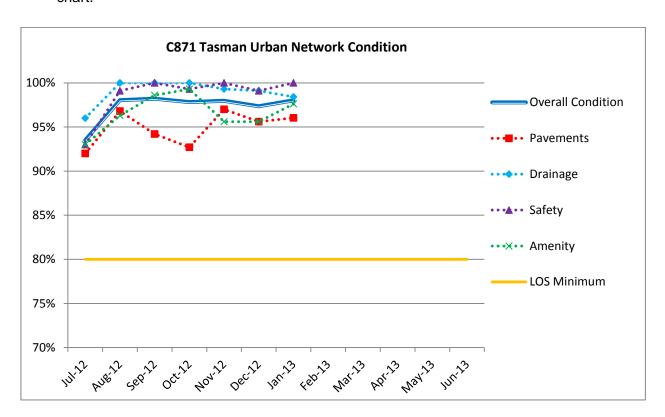
- Pre-reseal repairs for 2013/14 reseal sites.
- District-wide footpath inspection and prioritisation of repairs.
- 3.2 The results of recent MWH inspections of the network condition are shown in the following chart.

3.3 All inspection items are fairly steady and are consistently above the minimum target.

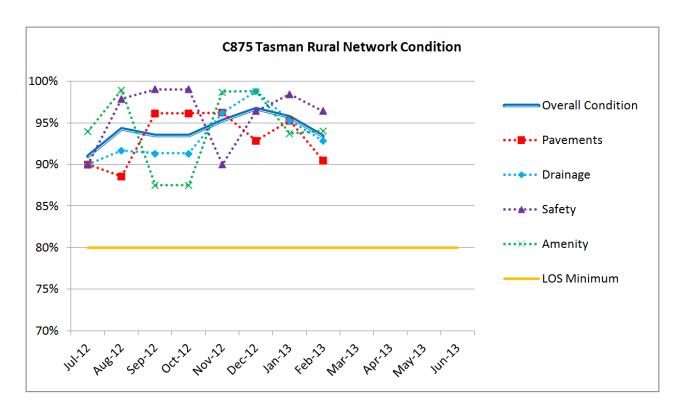
- One hundred and thirty sealed pothole repairs.
- Grading for 54 km.
- Water table cleaning for 1.8 km.
- Replaced culverts for 28 metres.
- One thousand, three hundred and sixty nine cleaned and straightened signs.
- 3.5 Programmed work for February and March:
- Pre-reseal repairs for 2013/14 reseal sites.
- Completion of network drainage inspection and delivery of report.
- 3.6 The results of recent MWH inspections of the network condition are shown in the following chart.

3.7 All inspection items are fairly steady and are consistently above the minimum target. Some unsealed pavements are becoming corrugated with the prolonged dry weather.

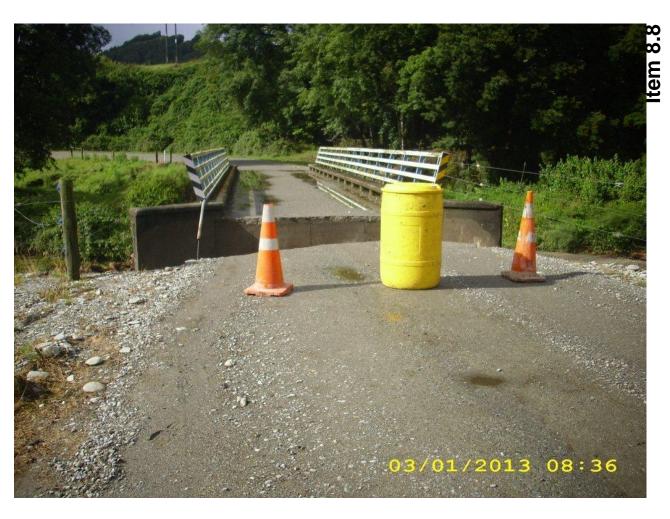
3.14 A significant amount of the January works resulted from the rain event on 3 January 2013. Flood repair work across the network included blocked culverts, slips, rock work, pavement repairs, flooding, tree felling and general tidy up. There were also a number of bridge repairs including Glenroy Bridge, Rifleman Bridge and Pyrites Bridge. In some instances the entire bridge approach was washed out exposing the bridge abutment.

Glenroy Road – Riflemans Bridge approach washed out 3 January 2013

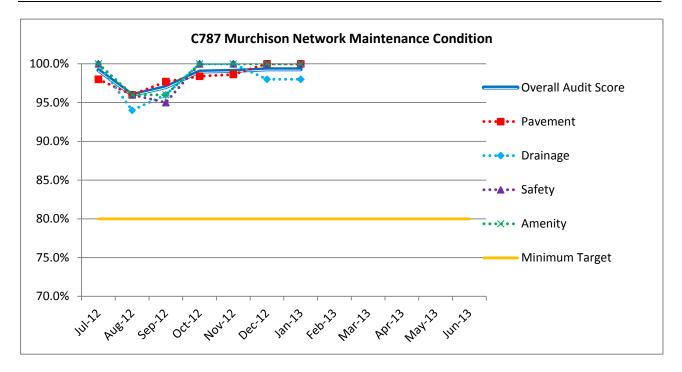
- 3.15 Work Summary for January to early February:
- Sixty three km of grading.
- Watertable cleaning for 1.2 km
- Mowing for 289 km.
- January weather event emergency works.
- 3.16 Programmed Work for February and March:
- Maruia Saddle Road slip repair works.
- Matiri Valley Road pavement rehabilitation.
- Rock repairs at flood damaged sites in Glenroy Road and Rappahannock Road.
- 3.17 The results of recent MWH inspections of the network condition are shown in the following chart.

- 3.18 All audited items are consistently well above the minimum target requirements.
- 3.19 Customer Service Requests (CSRs)

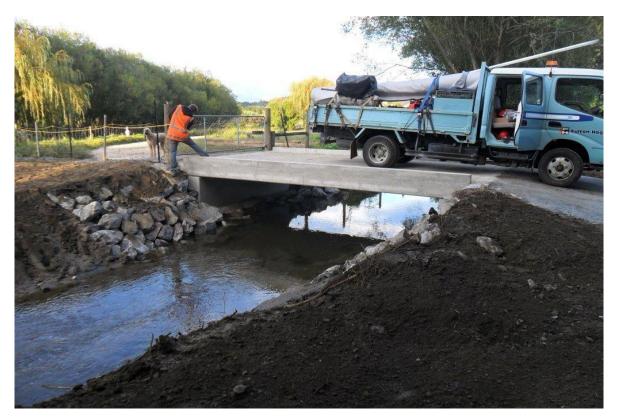
Staff are continuing to work on prioritising remaining flood repair works from the December 2011 event, while continuing with essential works. A contract to replace culverts on Ellis Creek was awarded in mid-January 2013 and the work completed in February 2013.

Figure 8.1 - New bridge on Ellis Creek

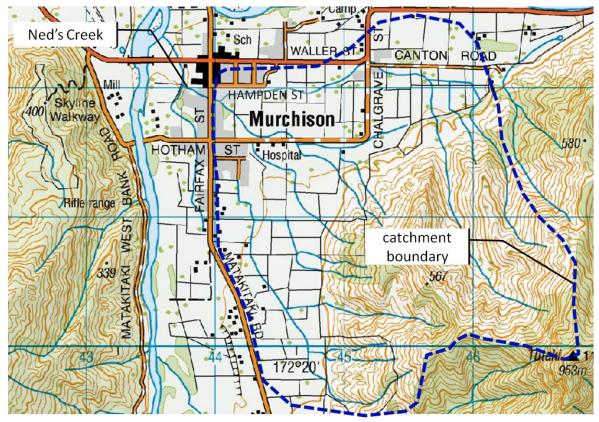
3.1 Neds Creek is a stream that flows east to west through Murchison into the Matakitaki River and is fed from the hills south-east of the town. The northern branch of the stream flows from south of Canton Road, parallel with Waller Street (SH6), through the Murchison Recreation Reserve and several private properties to Fairfax Street. The southern branches of the creek flow from hills in the south through private properties in Hotham, George and Hotham Streets.

Figure 3.1 - Neds Creek: Location

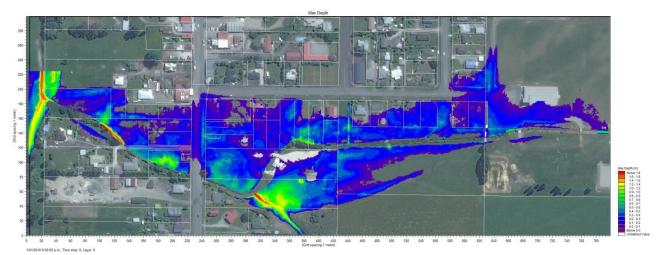
- 5.1 Following the flooding events of last year, Council staff commissioned a computer modelling study of Neds Creek. The purpose of the work is to better understand the relative effect of the causes of flooding in the area and to identify the properties likely to benefit from a given engineering solution. The work has been assisted by a recent LIDAR survey of the catchment and has been supplemented by a ground survey of the stream channel and of property floor levels.
- 5.2 Initial modelling of the existing creek has now been completed, and a preliminary assessment of options is in progress. The following figure gives a snapshot of results from the model for the April 2012 event. The following figure shows peak flood levels and depth of water in the floodplain.

Figure 5.1 - Output of initial modelling work

5.3 The initial results of the modelling have given good information on the causes of flooding and have indicated that there is no one simple solution to flooding issues in the area. Staff will be meeting with local residents in coming weeks to discuss the results of the modelling to check that our results agree with on-the-ground observations from locals.
