Recognising an Historic Sheep Dip

A Photographic Guide to Recognising and Identifying Historic and Abandoned Sheep Dips

Current: June 2012

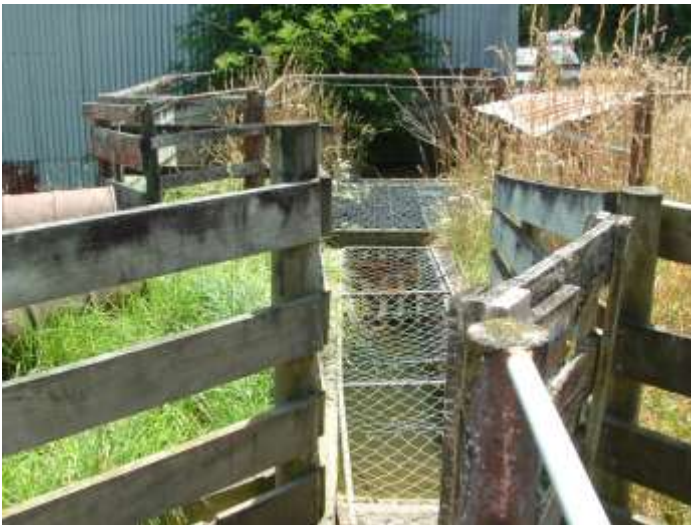
Classic round plunge dip covered over with old gates

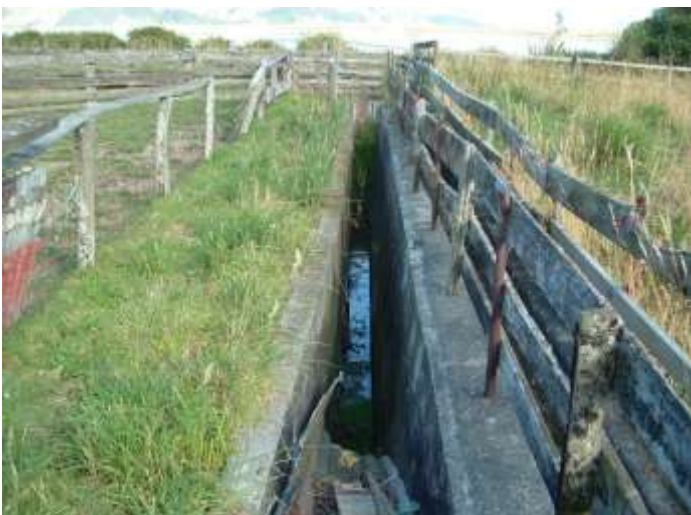
Classic narrow swim through dip, with a parallel foot bath.

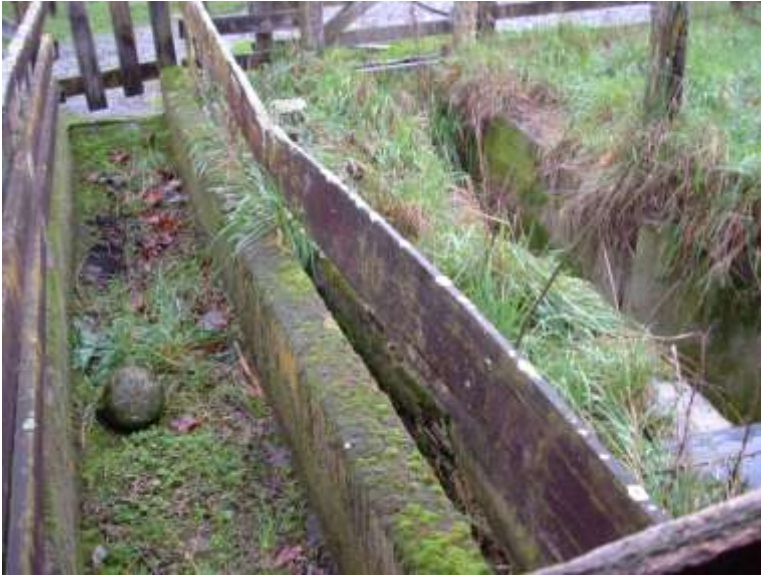
Foot bath beside old swim through dip.

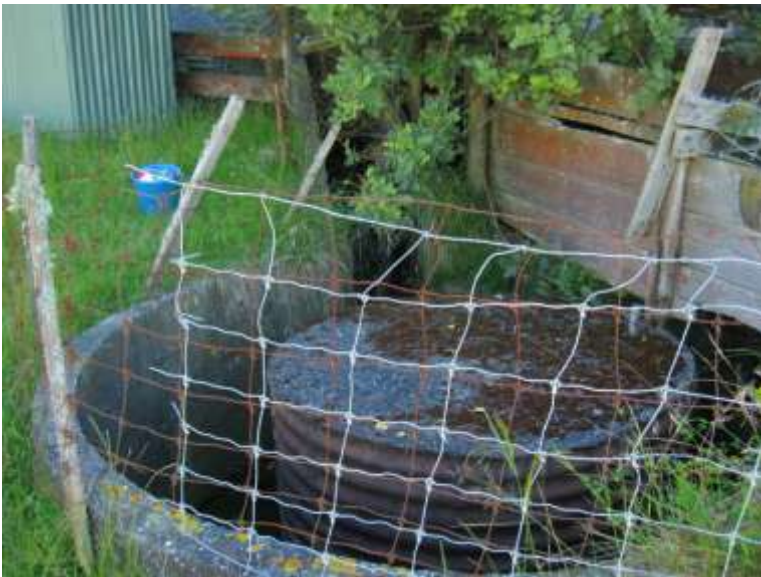
Close up of an island dip. The sheep swam around the central island to scramble out up the concrete ramp.

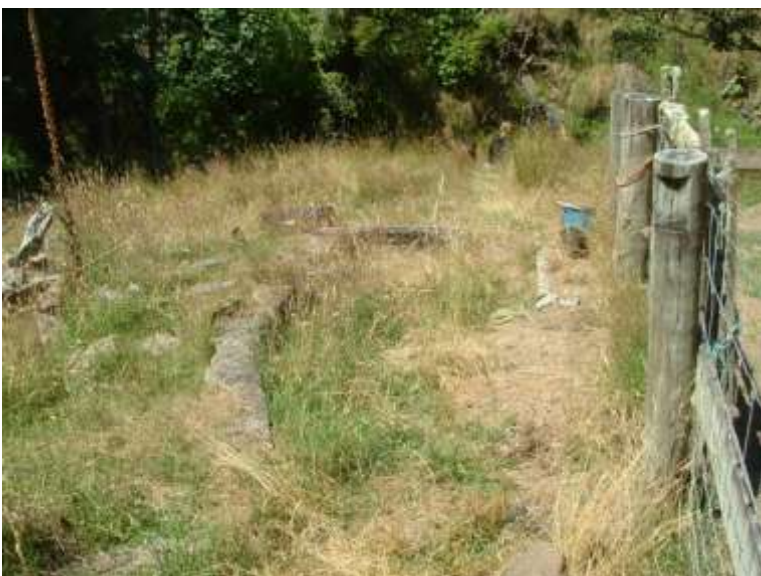
Visible edges of a wide concrete dip in a grassy paddock, with a stream bank in the background.

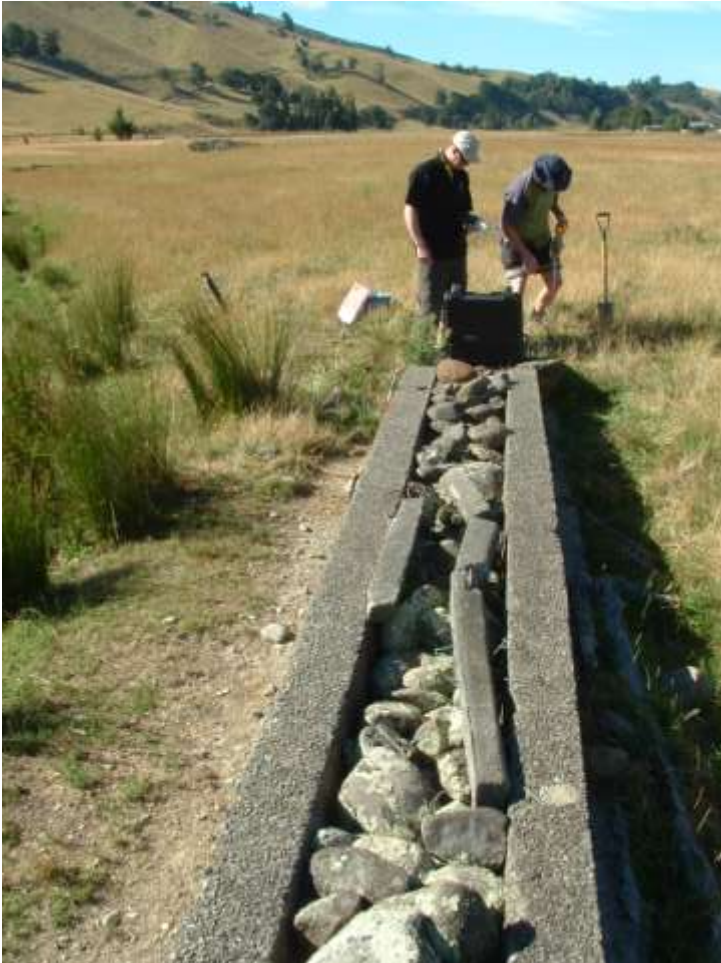
The swim through dip is fill with boulders, and the land around it has been eroded away by a stream.

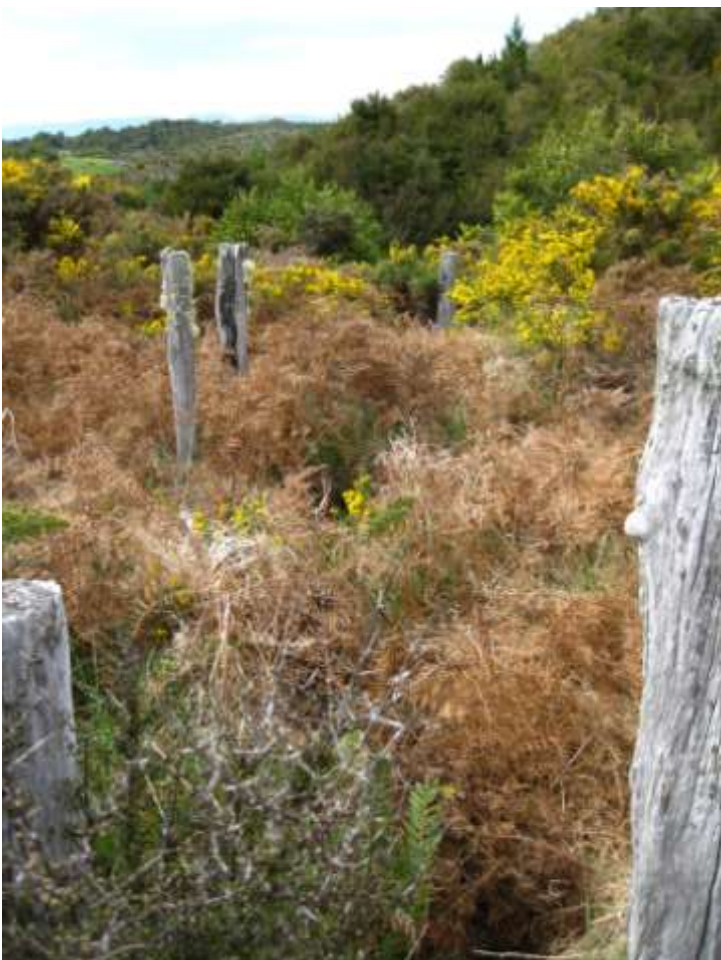
The clues here are sturdy posts in a rectangle around the old holding pen, and a gorse covered swim through dip.

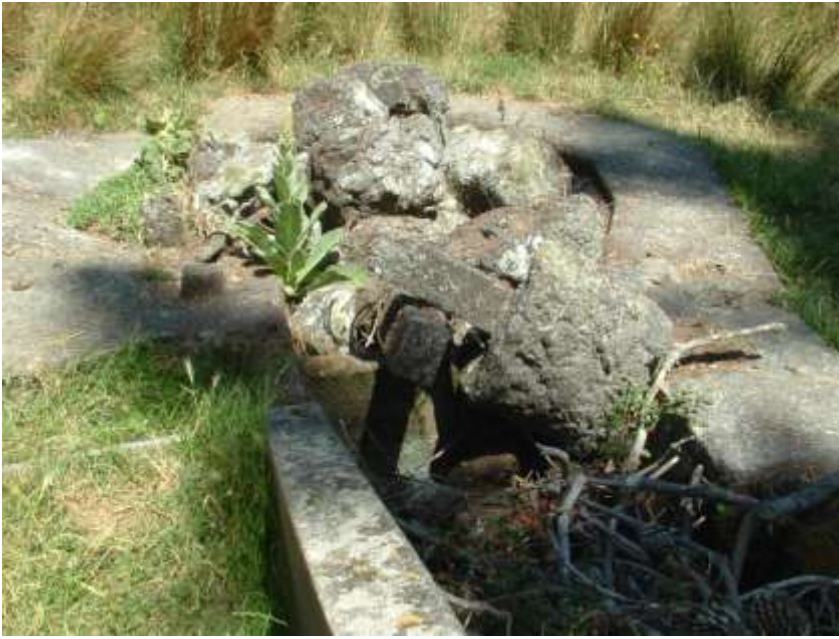
A key hole shaped plunge dip, filled with rubble.

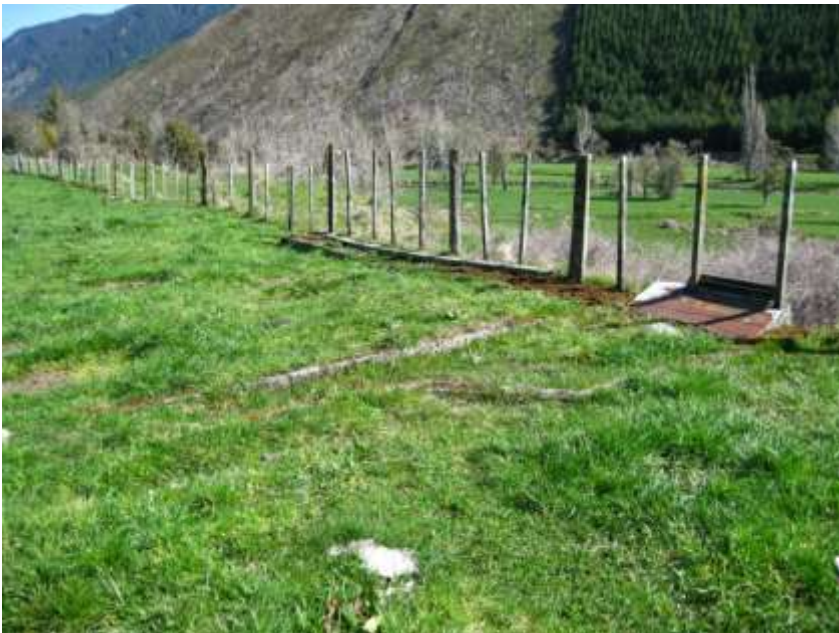
The sheep went into the dip from the metal slope. The concrete rim is visible and the drainage pad is present under the grass.

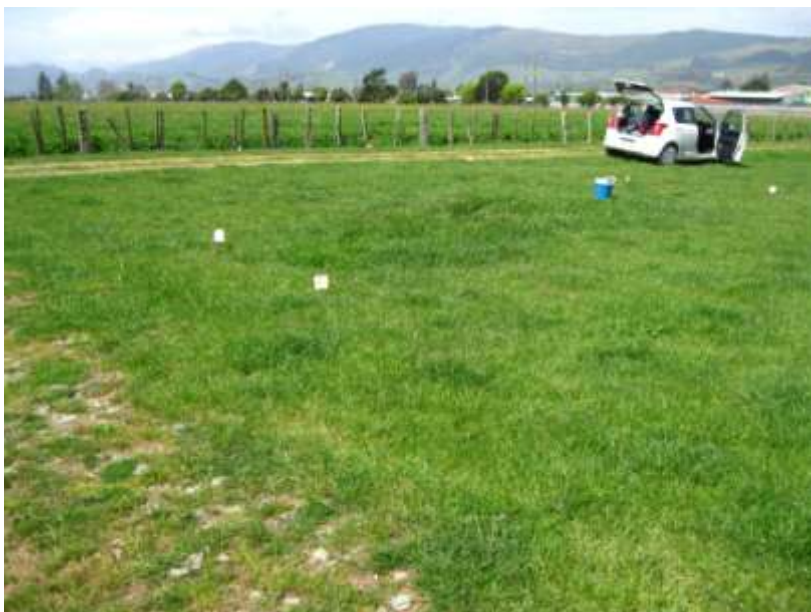
The damp depression is where the dip was, and the piped water still leaks there. Sheep yards long gone. The current landowner didn't know this was dip site, and information was provided by an employee of the original owner.

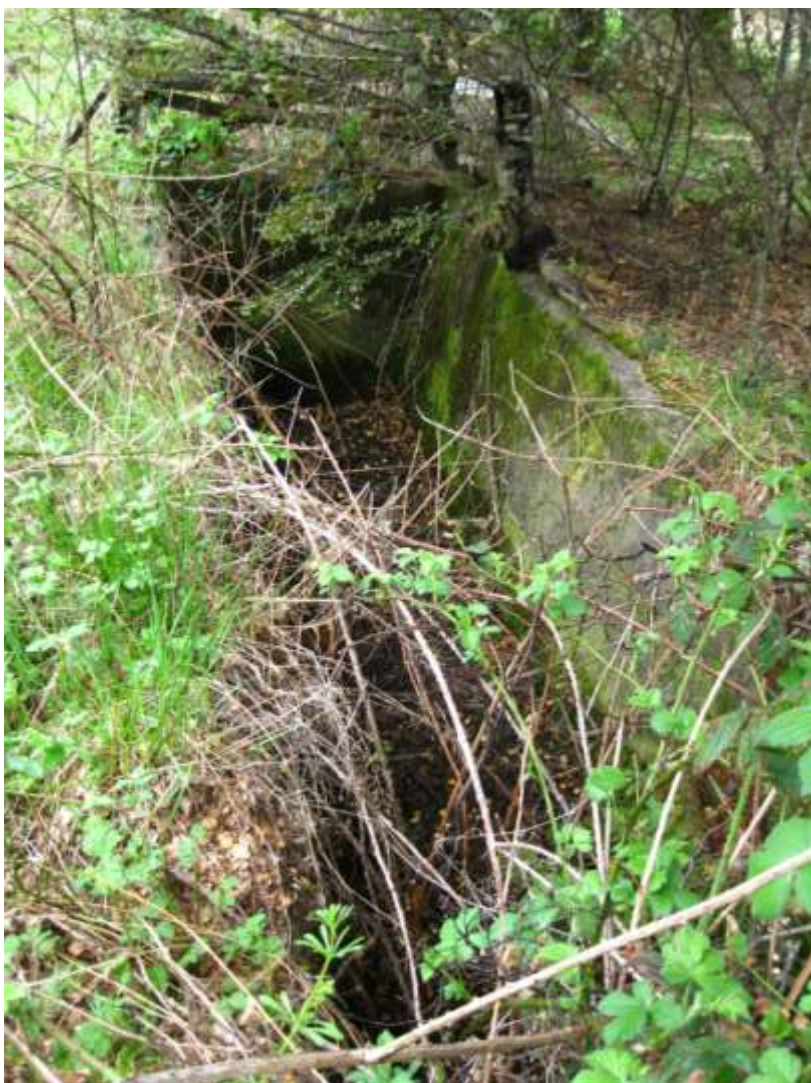
Swim through dip, overgrown with blackberries, and not filled in, or covered over.

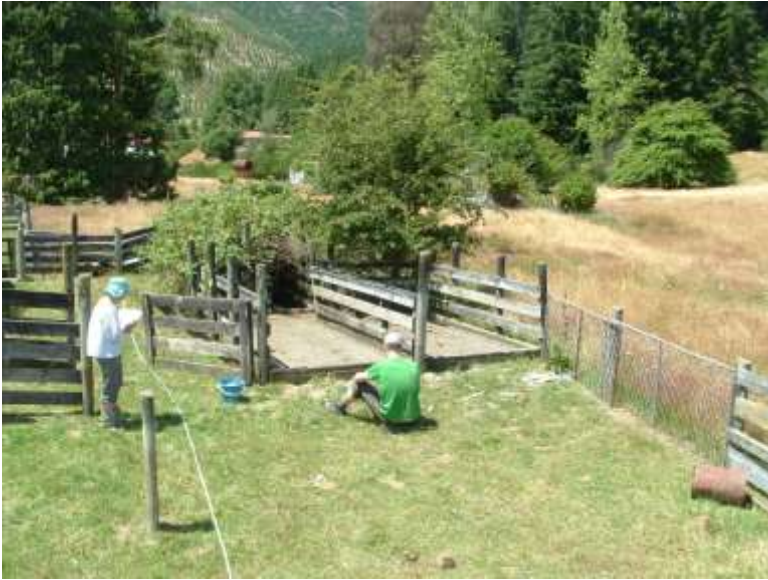
The dip is under the blackberry, and the drainage pad is divided in two. Release paddock in foreground.

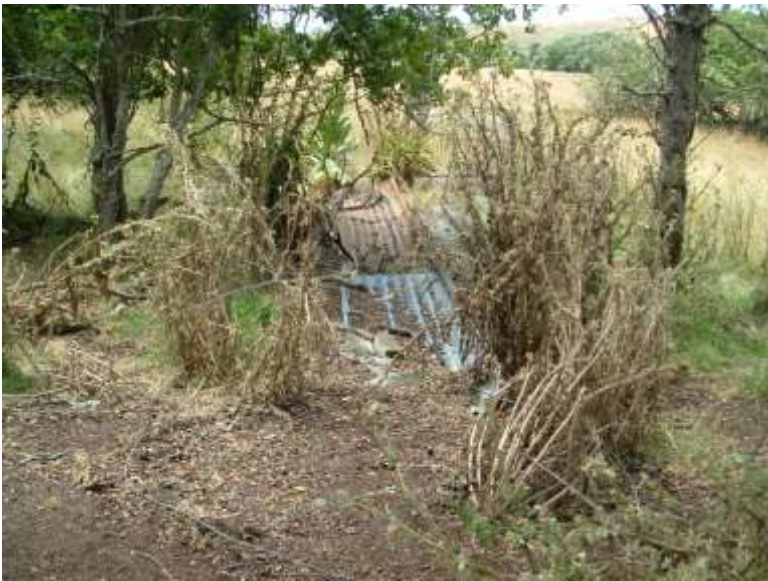
Old swim through dip covered with corrugated iron. Close to a stream.

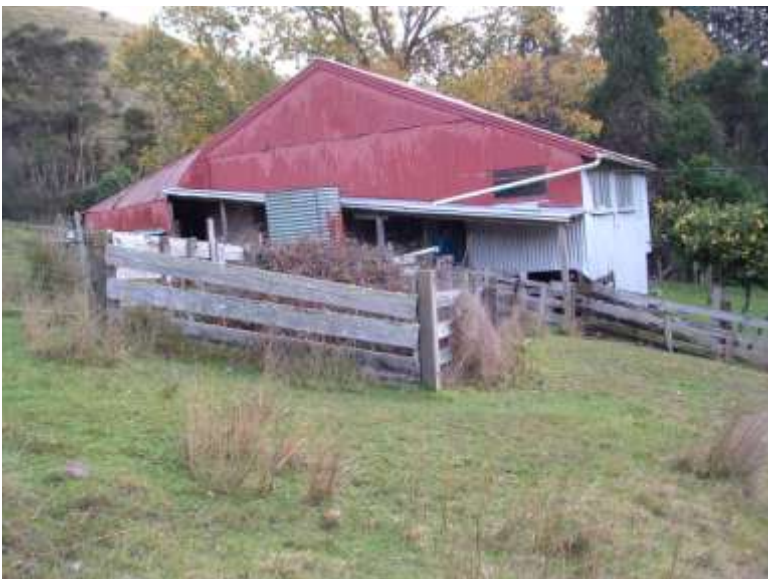
The clues here are fenced off area that is overgrown, adjacent water tank, and shearing shed.
