STAFF REPORT

SUBJECT: **FISH PASSAGE IN THE TASMAN DISTRICT - REPORT EP05/06/09** - Report Prepared for 1 June 2005 Meeting

INVENTORY OF POTENTIAL FISH PASSAGE BARRIERS

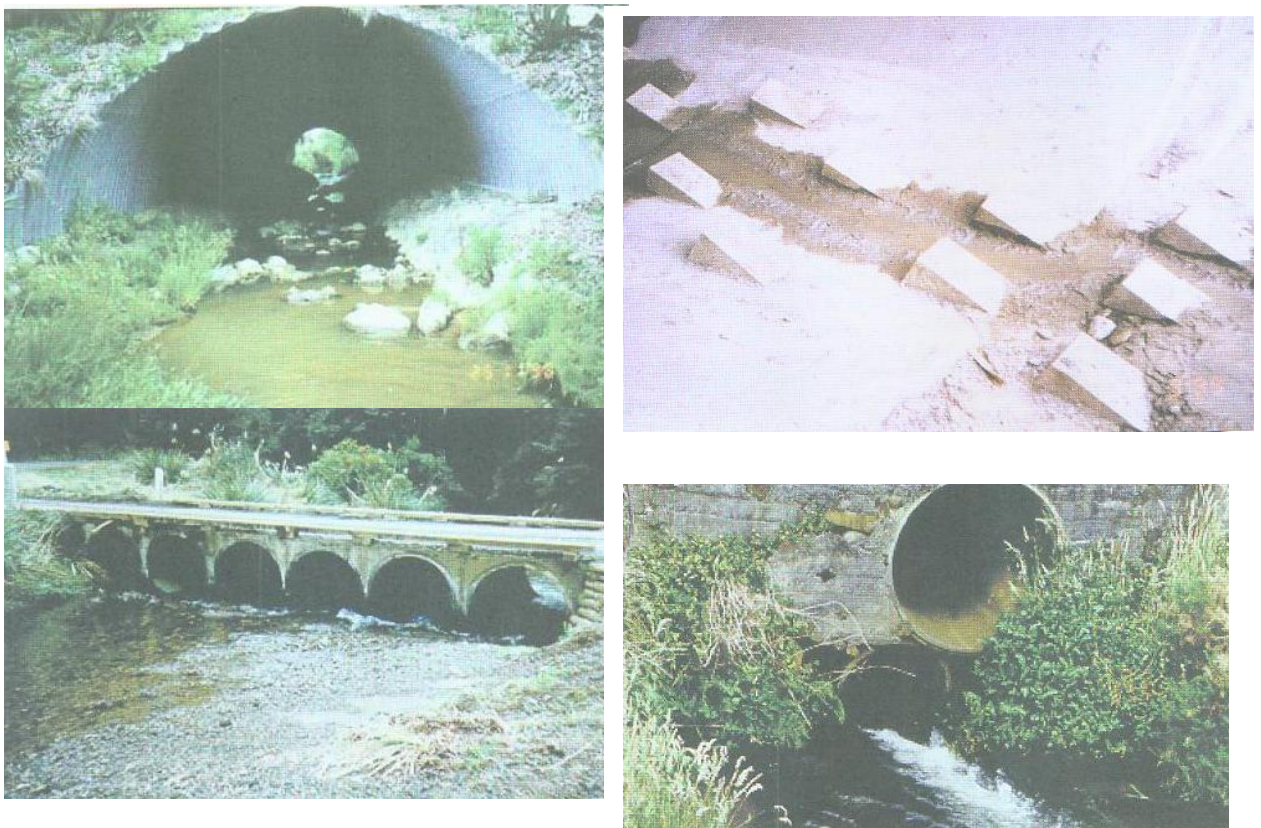
Figure 1; A: Top left: A fish-friendly culvert showing the natural stream bed filling the base.

Figure B: Top right: The use of spoilers can be used to create resting places for fish that can only sustain short bursts of swimming in high velocity water.

Figure C & D: With multiple barrels some can be set deeper to ensure passage at low flows.

To design a new culvert or structure that allows for regular fish passage is straight forward and no more expensive than those that act as barriers. Some examples of well-designed culverts are shown in Figure 1 A, 1C & 1D below. Modification of existing structures can be achieved. For example spoilers can be bolted on to the base of the culvert (see Figure 1B).

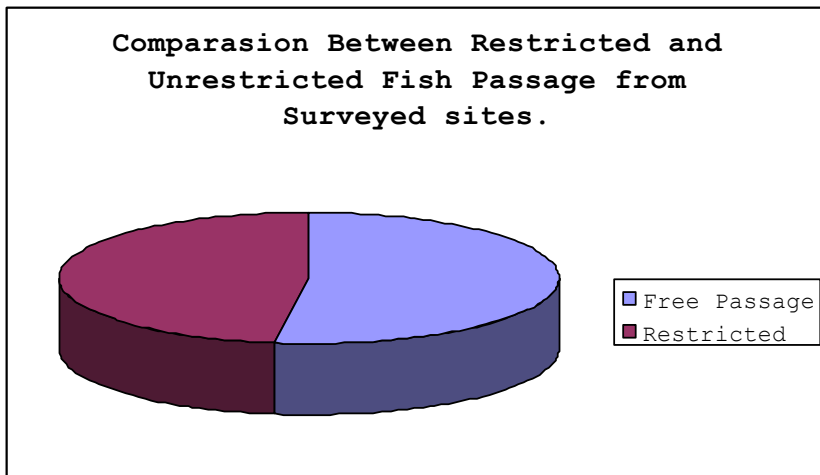
Graph 1: Comparison between Restricted and Unrestricted Fish Passage (Jan 2005).

A total number of 92 sites were surveyed, of these 47.8 percent (n = 44) were considered to restrict fish passage to some degree. 6.5 percent (n = 6) were identified as low flow restrictions, 2.2 percent (n = 2) high flow restrictions to fish passage, while 39 percent (n = 36) restricted fish passage during most flows. In contrast 52.2 percent (n = 48) allowed unrestricted fish passage (Graph 1).

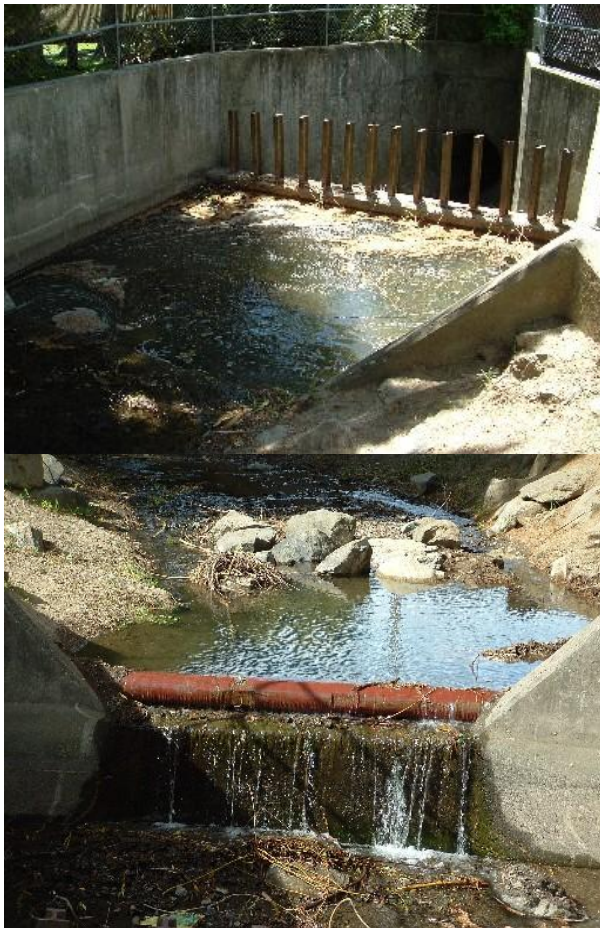
Figure 2: Reservoir Creek, Marlborough Terrace Easby Park.

Figure 2 and Figure 3 are examples of concrete structures which are acting as fish passage barriers due to a number of factors, but in particular the limitation of flow and vertical height differential.

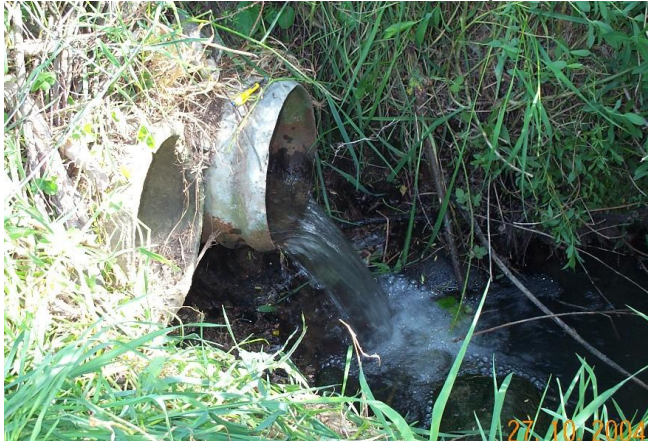
Figure 5: Reservior Creek Culvert, tributary Kareti Drive (now removed).

Figure 5 is an example of a culvert which is a fish passage barrier due to its vertical height above the creek and its overhanging nature. This particular structure has since been removed in a redevelopment.

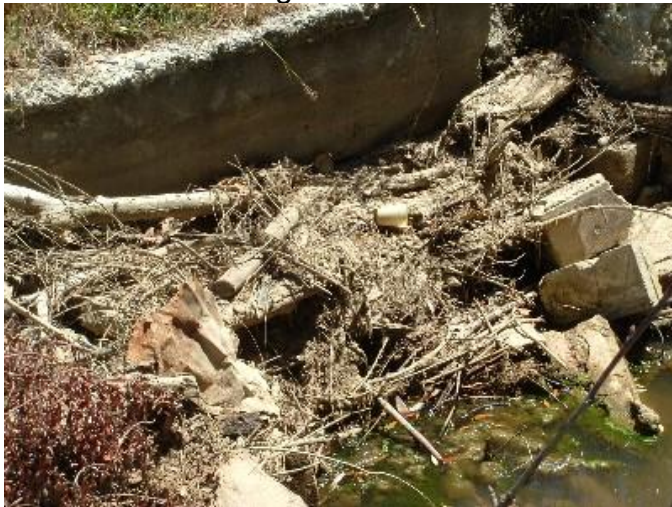
Figure 6:Kaiteriteri inlet, wetland outflow.

Figure 6 is an example of a culvert which is poorly maintained and is dilapidated to a state that it has become a fish passage impedence. This particular culvert also inhibits flow limiting the wetland behind it from being flushed.

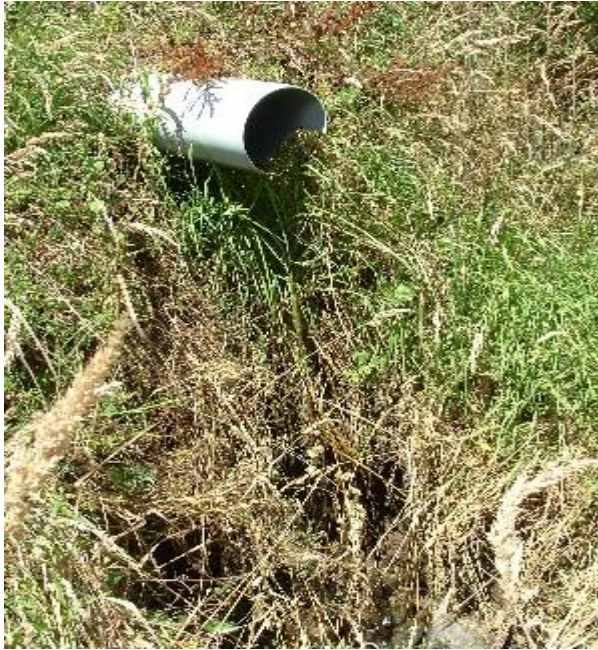
Figure 7: Reservoir Creek, Walkway

Figure 7 and Figure 8 are examples of culvert pipes which have a large vertical drop creating a fish passage barrier, due to the distance from the creek bed. These particular examples have a low flow during dry periods; the upstream habitat is an important feature to take into account when considering improving fish passage.

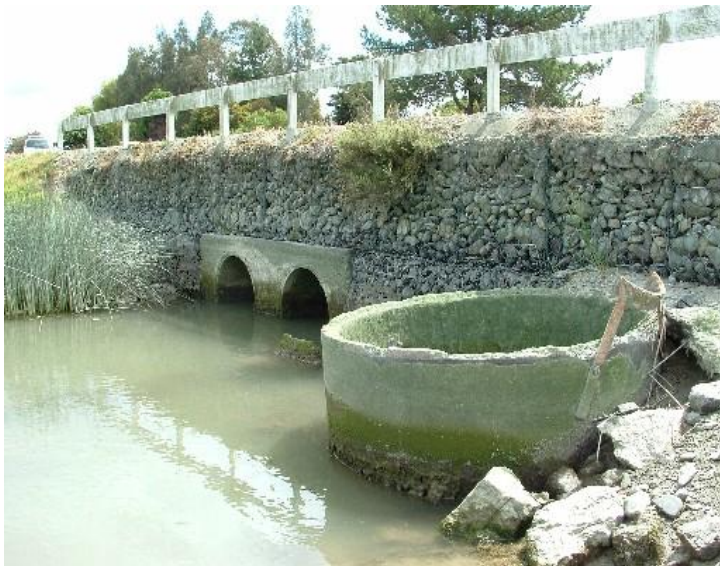
Figure 9: Nieman Ck, Queens St

Figure 9 is an example of a culvert system which is a fish passage impendence due to flow velocity in the culvert pipes. If flow velocity exceeds 3.5 ms^{-1} it is considered a potential barrier for fish passage. In this example the culverts are considerably narrower than the creek width creating the problem associated with flow velocity. This is only a barrier for 2- 4 hours at near-low tide. Fish gather below the culvert trying to move upstream and are then vulnerable to predation.

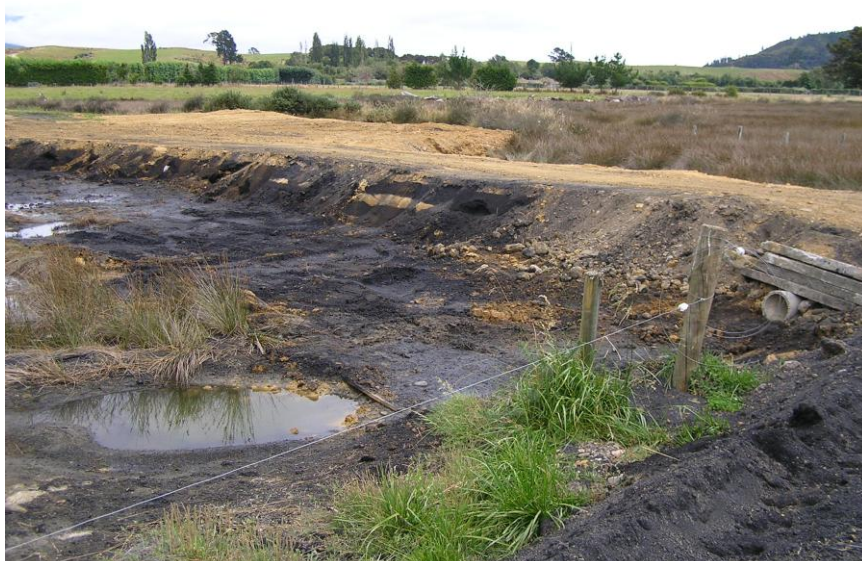
Figure 10: Farm crossing near the Motupipi Inlet, Golden Bay.

Rural road crossings have been identified as a potential source of fish passage barriers (Figure 10). Adequate culvert size, placement, as well as maintenance can provide problems for both water flow and fish passage. The Ministry for the Environment has produced a document with guidelines for appropriate farm culvert and bridge structures which allow for fish passage (Ministry for the Environment. Culvert and Bridge Construction: Guidelines for Farmers, 2004). There are a number of other suitable guidelines for design of culverts such as "Fish Passage at Culverts – A Review, with Possible Solutions for New Zealand indigenous species" (Boubee et al 1999) and Fish Passage Guidelines for the Auckland Region, Auckland Regional Council Technical publication 131

Single barrel culverts, such as shown in Figure 5 and 10 are the most common type of fish barrier, typically due to the overhang at the downstream end but also from high water velocity.

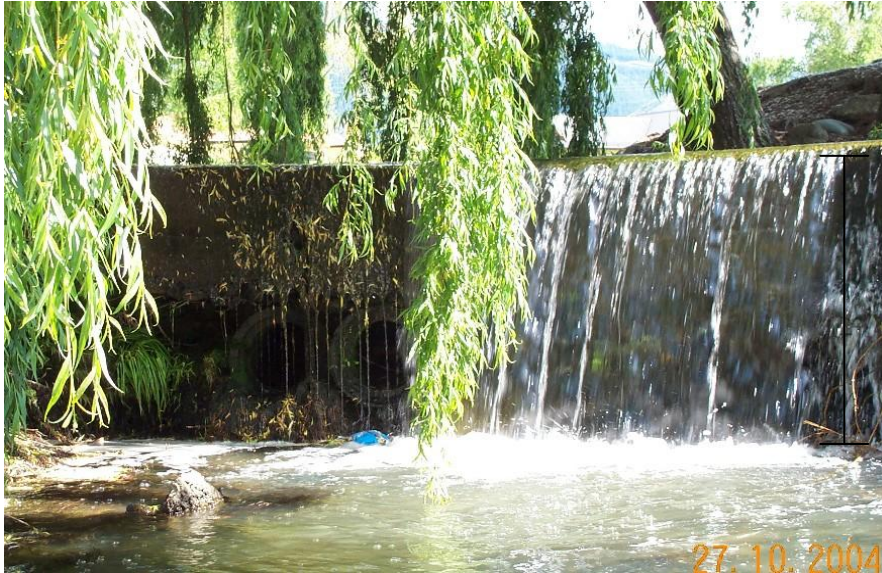
Figure 11: Reservoir Creek Concrete Ford downstream Templemore Pond (Scale 1.0 m).

Fords can create large restrictions on water flow and fish passage (Figure 11), these can occur in both urban and rural environments. Forestry fords have been identified as a potential fish passage barrier problem (Figure 12).

This structure is due for removal in mid 2005.

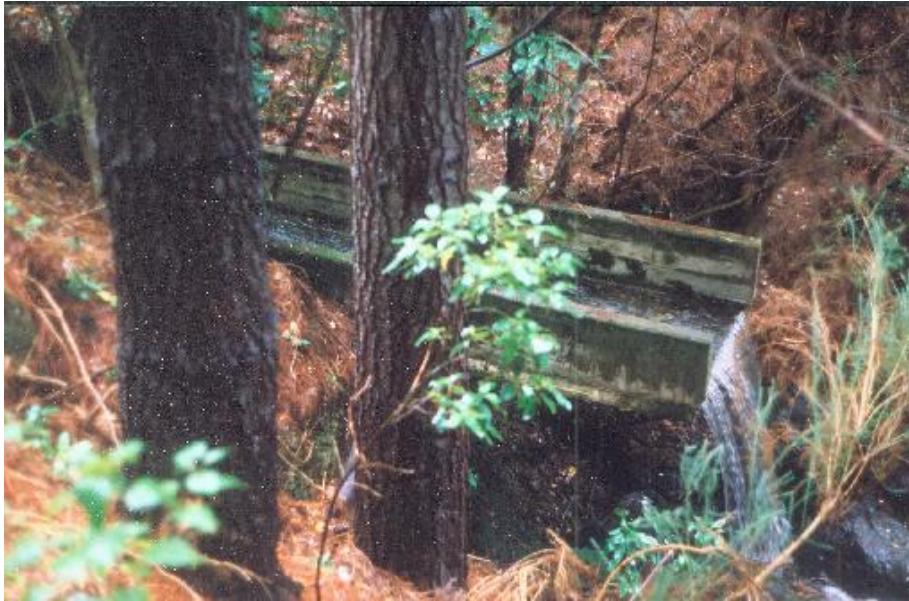
Exotic Forests have many roads; many of these have structures which restrict fish passage due to poor design. Culverts and Drains can provide restricted fish passage access to waterways and creeks. Figure 13 is an example of a forestry culvert which is restricting fish passage.

Figure 13: Example of a forestry culvert acting as a barrier to fish passage.

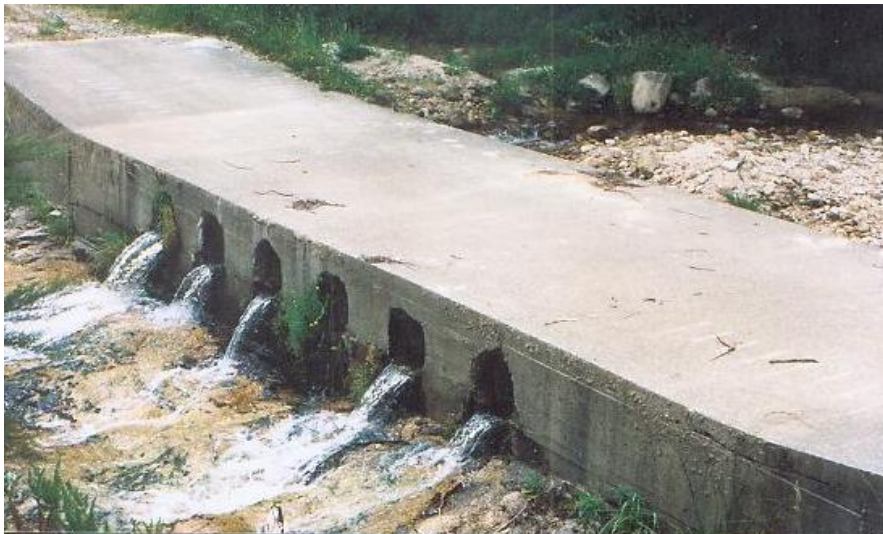
Figure 14: Ford at Dart River, Wangapeka

Multi barrelled culvert bridges (Figure 14 and 15) can pose a potential Fish passage barrier for different reasons; flow velocity, blockage, Perched and overhanging heights. Also having a concrete apron attached makes a shallow wide shelf which can inhibit passage by jumping fish which need to obtain thrust from deeper water. New designs are available which try to limit these factors e.g. Baigent Bridge.

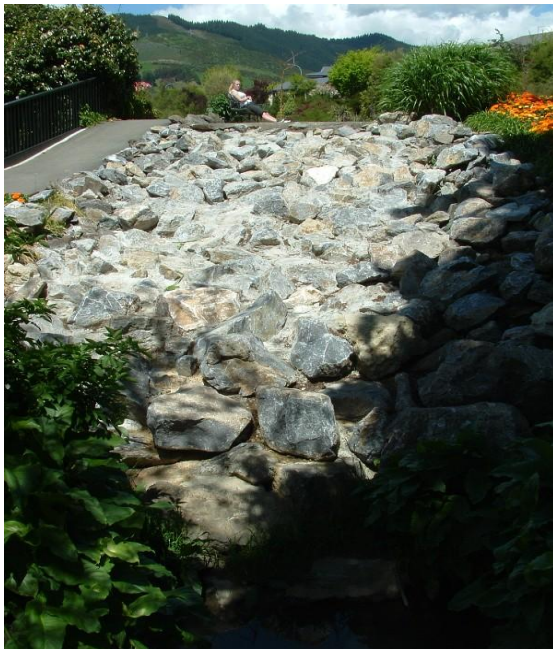
Dams can be potential fish passage barriers due to the nature of the structure and design. There are approximately 260 dams in the Tasman District, the majority of which are within the Moutere. Although dams are usually a physical barrier to most fish species, with provision for reasonable residual flow, good habitat and good management they can have a positive effect on fauna. Currently a dam can be constructed as a Permitted Activity if the catchment is under 20ha in size in the Tasman District. Most waterways with catchments of this size are ephemeral in nature and contain few natural pools and so are more likely to have limited habitat value for fish.

Figure 16: Emergency overflow spillway on Jimmy-Lee Creek at Retention Dam in Washbourne Gardens

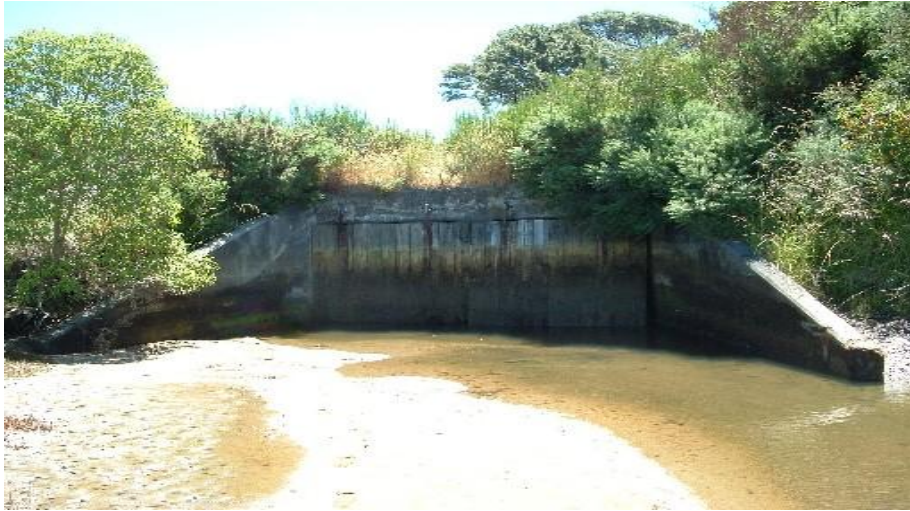
Figure 17: Wai Atua Stream Tidal Flap gate.

Coastal structures such as tidal flap gates are potential fish passage barriers (Figure 17). The Engineering department has provided an inventory of known coastal tidal flap gates which will be surveyed as part of this ongoing project. There are 28 known and maintained tidal flap gates owned by the TDC, the majority of these structures are in the Waimea, Motueka and Riwaka coastal areas.

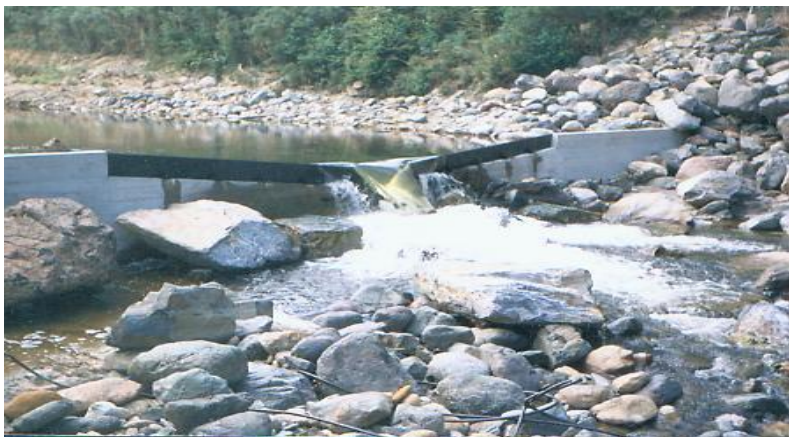
Within the region a number of river flow measuring sites utilise weirs that are potential fish passage barriers or impedances (Table 2), these structures can be easily retro fitted to minimize the impact that they have on fish passage. Figures 18 and 19 are typical flow measuring weirs which can impede fish passage due to flow velocity and vertical drop. There are 14 of these structures known to the TDC in this region.

Figure 18: Example of Hydrology Weir at the Maitai River (not in Tasman).

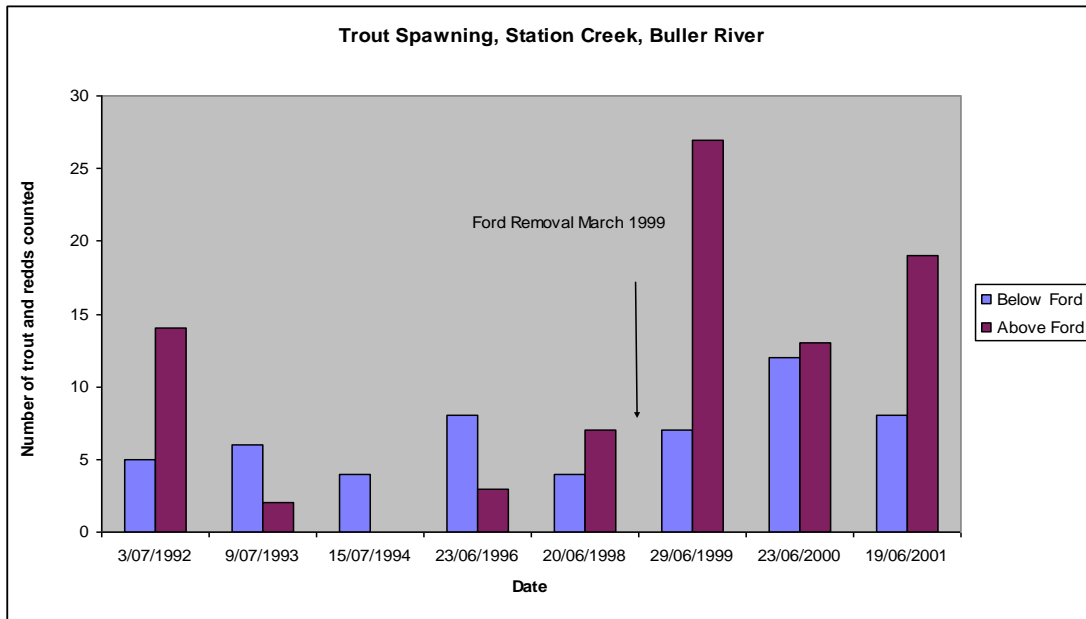
Graph 4: Fish and Game Example of fish abundance pre and post Fish Passage barrier removal (Fish & Game).

This graph displays the positive affect that removal of a fish passage barrier can have on the population of fish in a River system. The exact date of construction of the ford is unknown.
