Report No:	REP12-05-06
File No:	W416
Date:	8 May 2012
Information Only - no decision required

Report to: Environment & Planning Committee
Meeting Date: Thursday, 17 May 2012
Report Author: Trevor James, Resource Scientist - Environmental
Subject: **CONTACT RECREATION WATER QUALITY ANNUAL REPORT: 2011-2012**

1. Introduction

This report outlines results of bathing water quality monitoring at 22 of Tasman's most popular beaches over the 2011/2012 summer.

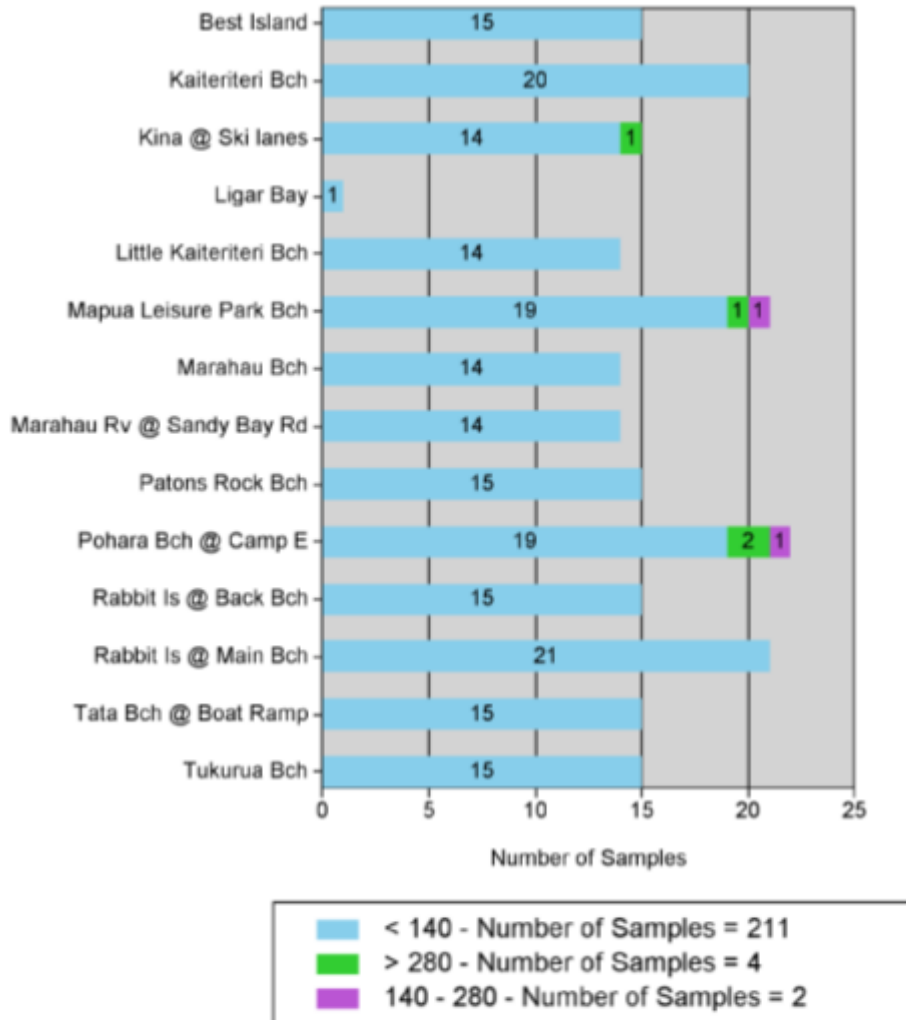
Figure 1: Number of samples exceeding national guidelines for contact recreation water quality at marine beaches for the 2011-2012 season. Green shows results over alarm levels (>280 *Enterococci*/100ml) and purple shows results over alert levels (140-280 *Enterococci*/100ml).

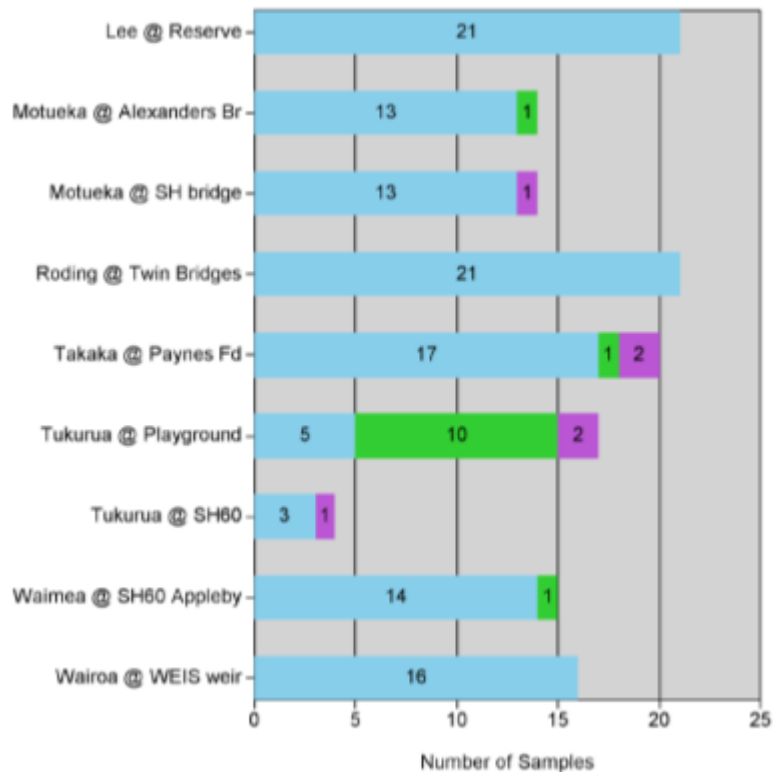
Figure 2: Number of samples exceeding national guidelines for contact recreation water quality at freshwater swimming holes for the 2011-2012 season. Green shows results over alarm levels (>550 *E. coli*/100ml) and purple shows results over alert levels (260 *E. coli*/100ml). Note: Tukurua River at SH60 is not a swimming site and is included as a reference for the Tukurua @ Playground.

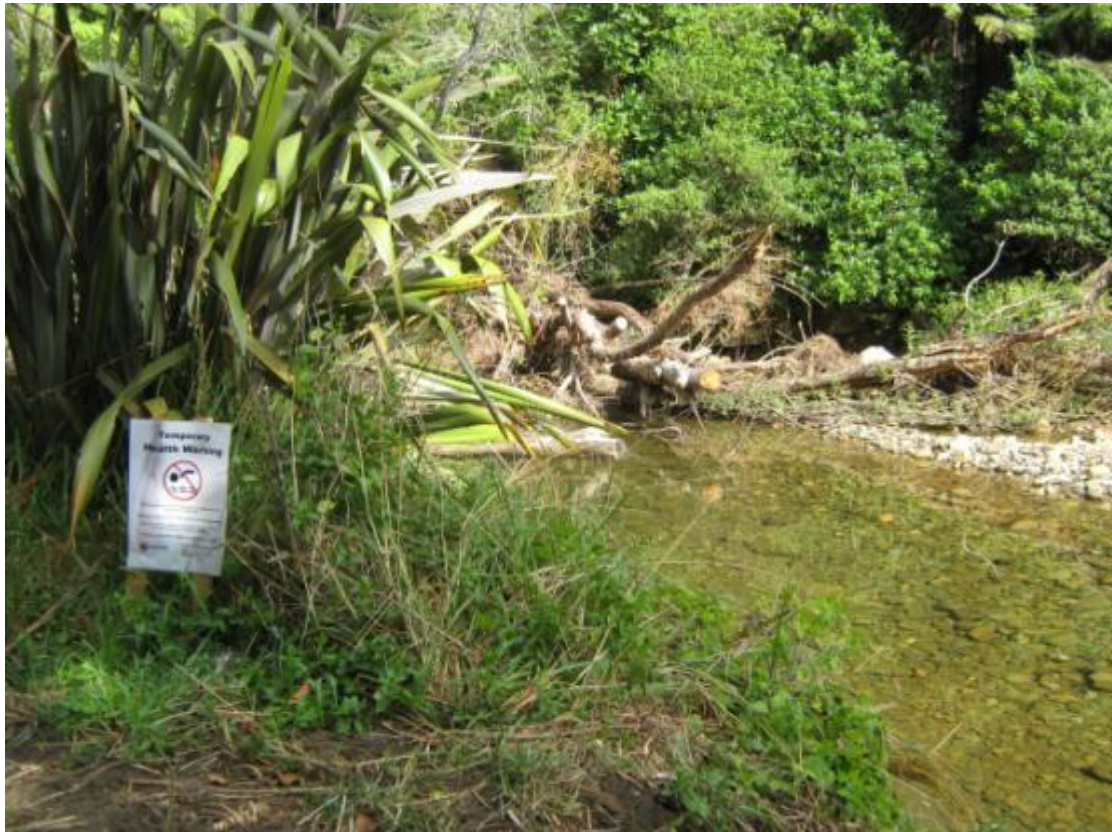
Over the past two years results show that ongoing faecal contamination issues in Tukurua Stream with 50% of (11 of 22) samples being above recreation water quality guidelines (70% for this season). Microbial source tracking results taken in January showed both ruminant and human bacterial markers. All samples taken show there is no source of contamination upstream of farmland so this excludes the possibility of feral animals in the native bush as contributing to the source.

Figure 3: Photo of the lower end of the Tukurua swimming hole showing the warning sign.

For streams running through farmland, Tukurua is fairly typical. However, given that the swimming hole is used by many people during the peak summer and the number of results above guidelines, it suggests that we should further investigate the source of this contamination. Compliance staff have walked the creek this time last year and did not find an obvious source (one discharge point found). There are plans to investigate septage systems above the SH60 bridge this summer.

- Sign warning against swimming has been maintained at the lower site (by the stream adjacent to the camp playground). It seems to have been well headed (talking to child campers).
- Compliance staff isolated one failing septic tank downstream of SH60 - so that should start to improve the situation.
- The on-going contamination issues upstream of SH60 remain unsolved despite thorough searches of the stream upstream of SH60. The environmental performance of Steve Barnett's farming operation in the Tukurua catchment appears to be up to standard. An inspection of septic tanks in this area will be carried out by Jim Trembath in the 2012-2013 peak season.
- We have suspended sampling until next bathing season (20 November 2012).

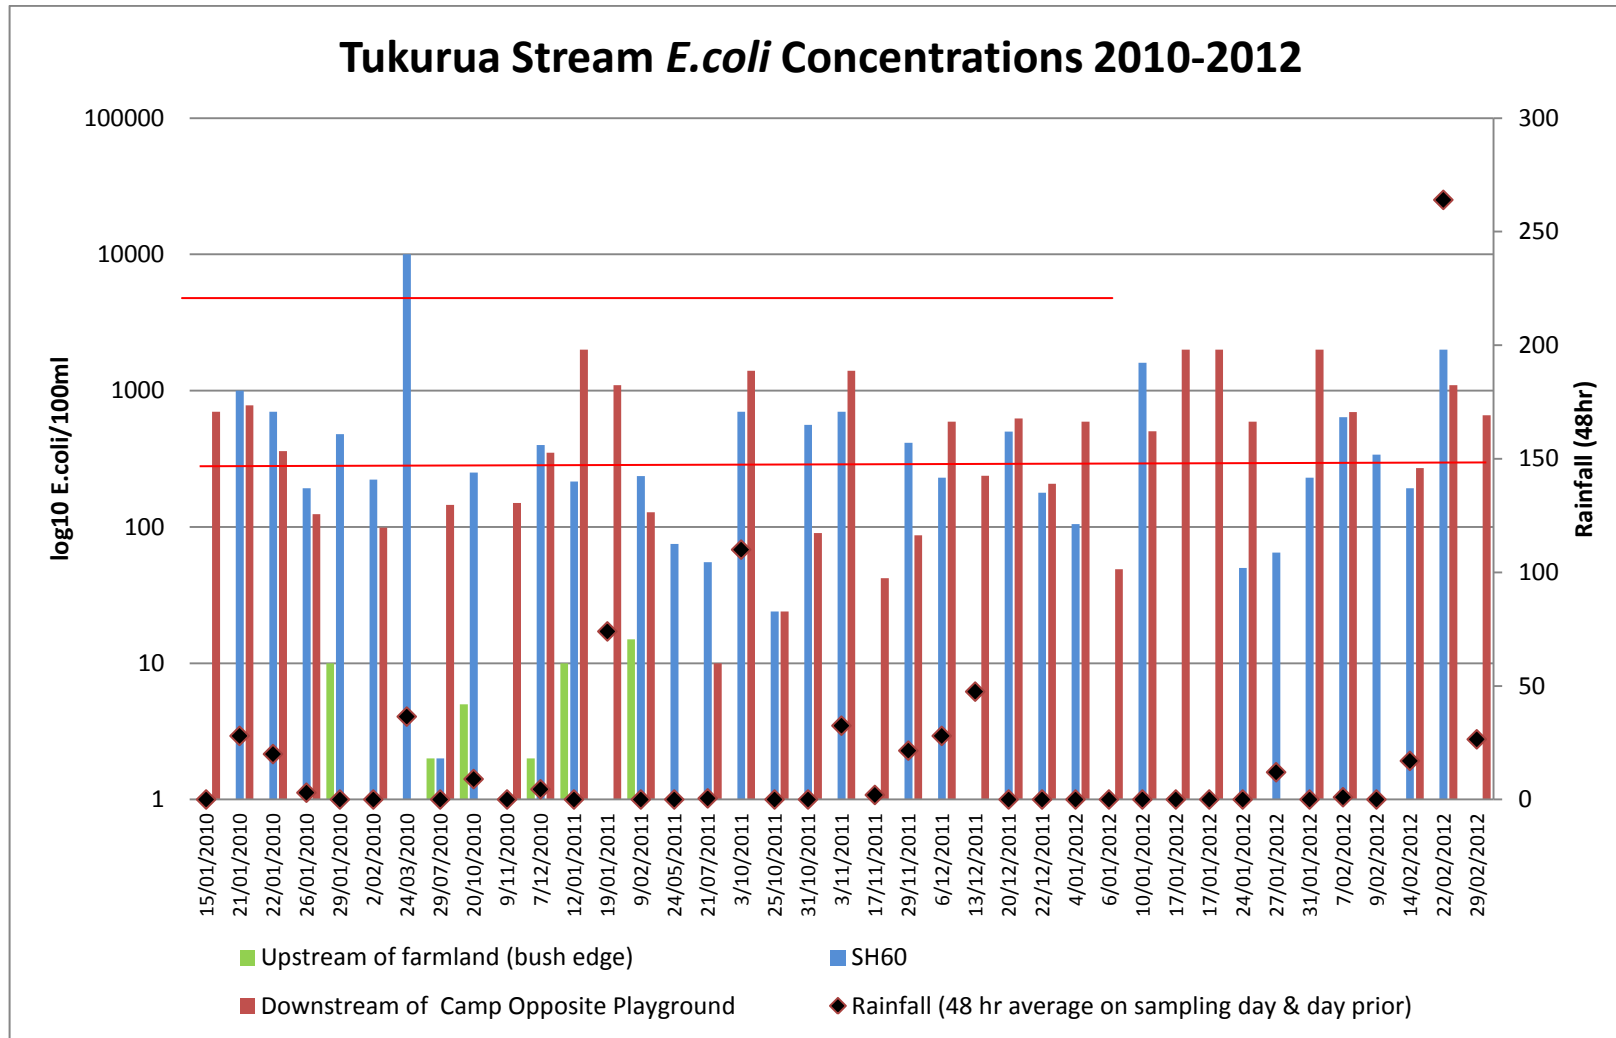
- Much more likely to have an exceedence in the peak season (25/12 - 29/2) (~80%, compared to ~50% in the off-peak times).
- Majority (2/3^{rds}) of exceedences in peak season were NOT rainfall related
- When there was an exceedence the site near the mouth of the stream was ~60% more likely to be higher than at SH60 (comparing each sample date where there were samples taken at each site).
- The magnitude of exceedences were much greater at the lower site (mean of 3x the concentration of the upper site)

Figure 4: Bathing water quality (*E. coli*) results for Tukurua Stream sampled in 2010-2012 plotted against rainfall. The alert level indicated by the horizontal red line.

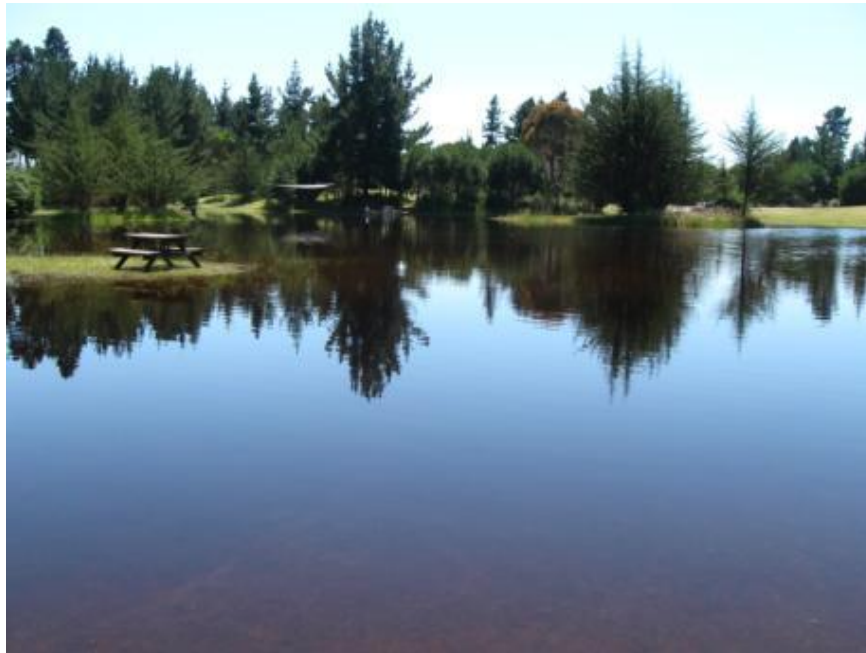
For the first time in 30+ years² significant areas of overland flooding was present in three of the four main recreation areas just inland from the main beach on Rabbit Island. This ponding was due to the record heavy rainfall on December 14-15 and associated elevated groundwater levels. Ponding was present at many sites over the coastal plains near the Waimea estuary. Groundwater level sampling at several regularly-monitored bores on Rabbit Island showed a rise in level of about 300mm after this rainfall event.

Figure 5: Photo of Rabbit Island pond C taken on 21 December 2011.

Because the ponds were deep enough for contact recreation (500-600mm deep), relatively warm and inviting and located in a very popular area it was decided to take water samples for faecal indicator bacteria (FIB). Samples taken revealed elevated *E.coli* concentrations, with several samples exceeding guidelines for contact recreation (see Table 1). Concentrations generally decreased over time.

The cause of this contamination is not clear. Potential causes include past or present toilet blocks at the reserve, wildfowl, feral animals and the biosolids discharge.

The risk of sickness to recreationists visiting the Rabbit Island reserve was managed by closing the reserve from 14th December due to the overland flooding. Temporary fencing was erected around these areas which allowed the front beach picnic areas to be opened again on December 23rd. Ponding in these areas dried out in early-mid February but remained closed until 19/3/2012. The exclusion fence remained for so long due to staff concern about soil compaction or turf damage from vehicles on these soft areas until they were fully recovered.

It is recommended that if these ponds form again in any of the Rabbit Island reserves or at McKee Domain, in the future, the water be tested as soon as possible, not only for FIB, but also for MST if the *E. coli* concentrations were over 240/100ml (samples for MST analysis can be stored frozen for months pending a decision on whether to analyse).
