# OUR FRESHWATERS

River Water Quality 2010

Summary Report

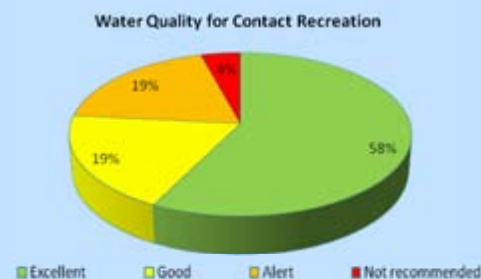
\* For interpretation of box plots see glossary on Page 12

Of all the sites tested for suitability for contact recreation, swimming is not recommended at Kaituna @ Sollis Rd, due to **excessive algal (periphyton) growth** and Onahau, due to **high levels of potentially disease causing organisms**.

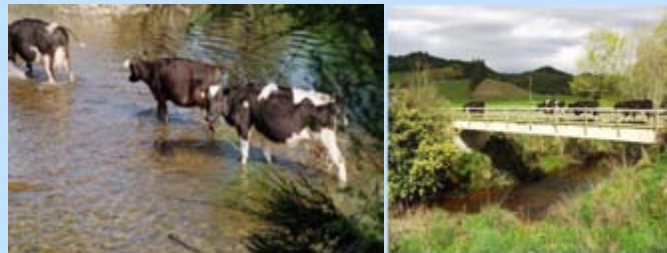
Cows on their way to the milking shed before and after the construction of one of the bridges in the Sherry Valley.

Research suggested that **bridging of raceways** to keep cows out of the stream water should have major water quality benefits. All four dairy farms in the Sherry Valley have subsequently constructed bridges so cows are no longer regularly crossing the river.

**Water quality has been markedly improved** as a result of these efforts, with faecal contamination at the Matariki monitoring site less than half of the levels seen previously. However, the lower reaches of the Sherry River are still not safe for contact recreation for much of the time and the local community is still working towards better water quality in the affected reaches. Landowners in this catchment, like many landowners in the Aorere catchment, are busy implementing actions recommended in their farm environmental plans.

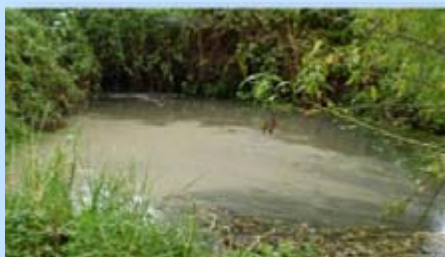
The greatest potential effect from forestry is **fine sediment discharges** (see Graph A) to streams and the coast between two to three years after harvesting. **Reduced water yield** (reduced flow in streams) due to the high rate of evaporation and transpiration from pine trees is another typical forestry effect on waterways. Harvesting large catchments within a short duration can also lead to **increased nitrate concentrations** (see Graph B) extensive **bank erosion** and stream habitat disturbance due to flooding.

Fine sediment discharge - Murchison Creek

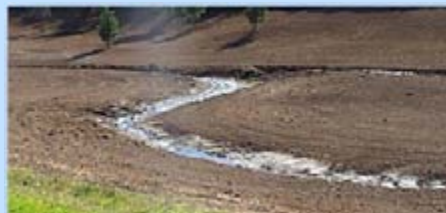
Fine sediment runoff can be caused by intensive farming

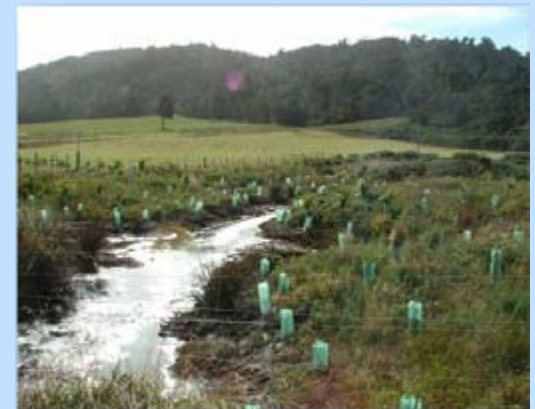
Riparian restoration through riparian replanting north Pakawau

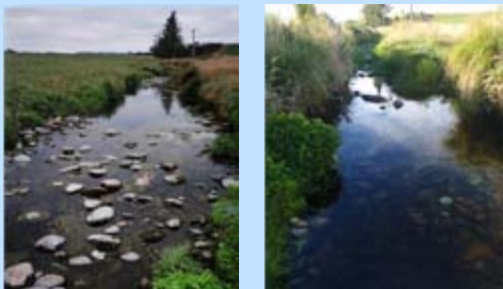
James Cutting Creek before and after fencing and planting of the riparian zone 2005 & 2009 respectively
