State of the Environment Report

River Water Quality in Tasman District 2015

A technical report presenting results of the Tasman District Council's 'State of the Environment' River Water Quality Monitoring Programme and additional data from the National River Water Quality Network. Indicators measured include: physical, chemical, and bacteriological characteristics of the water, macroinvertebrate indices and periphyton cover. The report highlights water quality condition and trends, from the Waimea, Motueka, Takaka, Aorere and Buller water management areas.

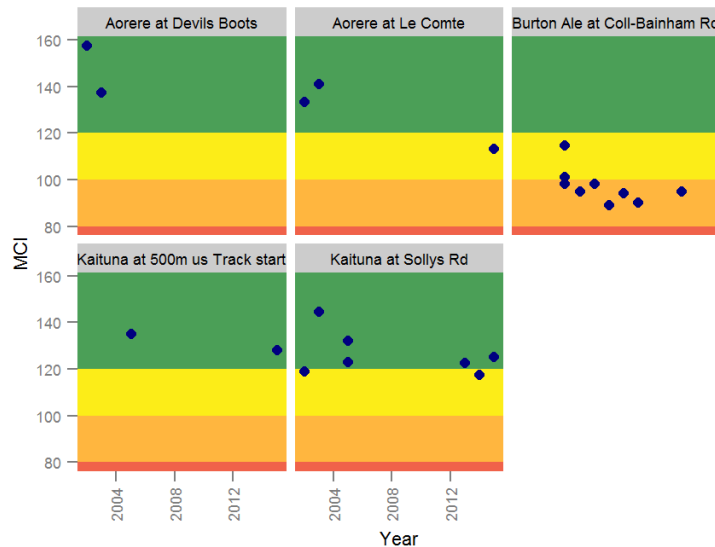
Figure 8. Macroinvertebrate community index (MCI) scores between 2001 and March 2015 for sites in the Aorere Water Management Area (blue dots). The background colours indicate these quality classes: excellent (green), good (yellow), fair (orange) and poor (red).

Based on MCI scores, the **invertebrate community was ‘excellent’ at Aorere at Le Comte and Kaituna at Solllys** (MCI greater than 119); Note: these are the only two sites in the Aorere Water Management Area with at least three recorded macroinvertebrate samples; Figure 8). The SQMCI scores, however, shifted from ‘excellent’ to ‘poor’ for Aorere at Le Comte and ‘excellent’ toward ‘fair’ for Kaituna at Solllys Rd in recent years. After 2005 at the Kaituna site there were notable reductions in sensitive macroinvertebrate taxa (particularly *Deliatidium* and *Helicopsyche*) while there were marked increases in pollution-tolerant taxa (snails (*Potamopyrgus*), true flies (*Orthoclad* and *Aphrophila*), axe-head caddisflies (*Oxythira*)).

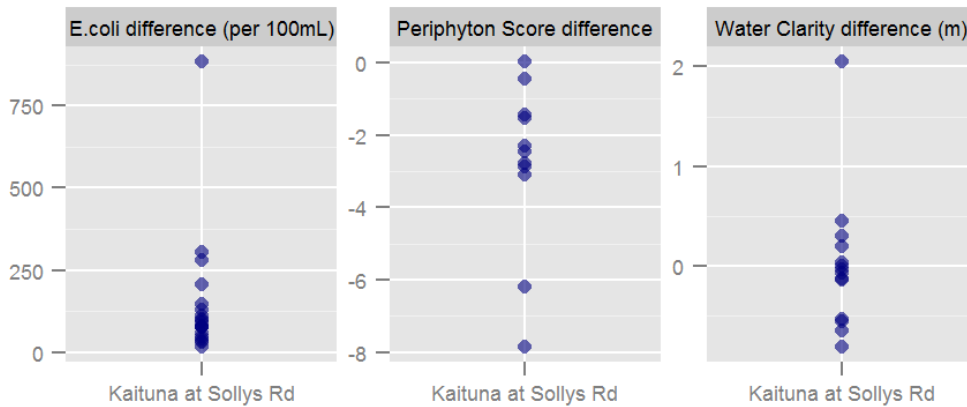
Figure 9. Difference between Kaituna at 500 m u-s Track start (upstream) and Kaituna at Sollys Rd (downstream) for water quality data collected at both sites on the same day. A positive difference means the downstream site had a higher value than the upstream site.

Kaituna at Sollys Rd was paired with Kaituna at 500 m u-s Track start (reference site). Comparisons between these sites revealed two main differences (Figure 9). First, *E. coli* concentrations at Sollys Rd were higher than the reference site (mean increase = 148 *E. coli*/100 ml, SD = 195, n = 19, comparing each site on each sampling event). This difference would be expected even with best practice followed on each farm. The concentration of *E. coli* was more than 50 times higher on three sampling occasions. Second, the resuspendable solids scores were higher at Sollys Rd compared to the reference site (mean increase = 0.7, SD = 0.6, n = 10). A higher resuspendable solids score indicates higher fine sediment deposition.

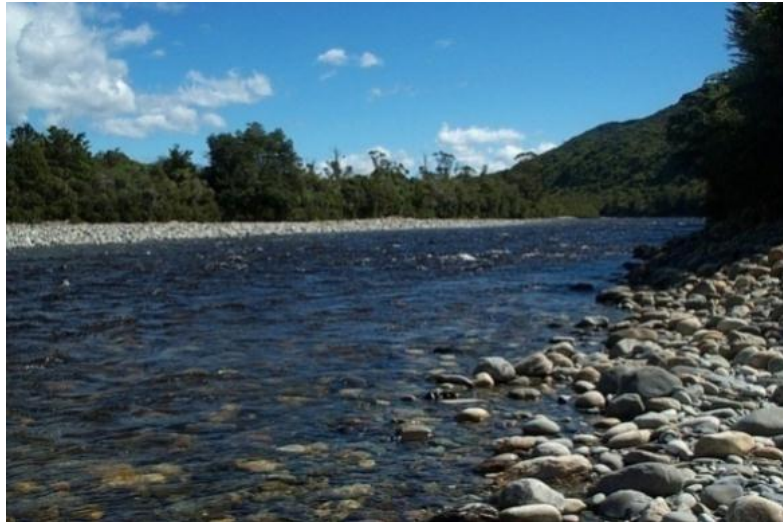
Aorere Rv at Devils Boots (February 2005)

Devils Boots	Le Comte
River Environment Class	Cool Extremely Wet Hard sedimentary Indigenous forest Low gradient	Cool Extremely Wet Hard sedimentary Indigenous forest Low gradient
Catchment area (km²)*	561	681
Predominant land use upstream		80% native forest 16 % agriculture (11,000-13,500 dairy cows in the catchment) 3 % scrub 1 % exotic forestry
Mean annual rainfall (mm)	2490	
Mean flow (l/sec)	69,274	
Median flow (l/sec)	31,816	NA
7-day Mean Annual Low Flow (l/sec)	11,300	NA
Lowest recorded flow (l/sec)	5,969	NA
Highest recorded flow (l/sec)	3,560,550 (one of the highest specific discharges in NZ)	NA
Water quality record	2000-present	Quarterly: 2000-present Monthly: 2011 - present

The Aorere River currently has moderately low levels of nutrients. However, nitrate concentrations are increasing (Figure 15). With dissolved reactive phosphorus at Le Comte decreasing (Figure 14), it

Sampling by Nottage in 2000 showed **very good macroinvertebrate condition** at Le Comte (MCI 140, QMCI 7.8, # taxa 9; mean of 3 samples) and 11 other sites around the catchment (MCI range: 158-139, QMCI range: 8.3-6.8, # taxa range: 8.7-15.6). This compared well to the reference site on the Aorere at 900 m downstream Brown River (MCI 158, QMCI 8.0, # taxa 9.6; mean of 3 samples). The limited macroinvertebrate sampling in the Aorere River at Le Comte as part of the RWQMP also shows good water quality (the most recent sample is an exception and further sampling is required to confirm if this is a downward trend. The sampling frequency has been lower at this site because it was felt that land uses in the catchment are less likely to adversely affect the river given the high dilution, allowing resources to be diverted to other sites.

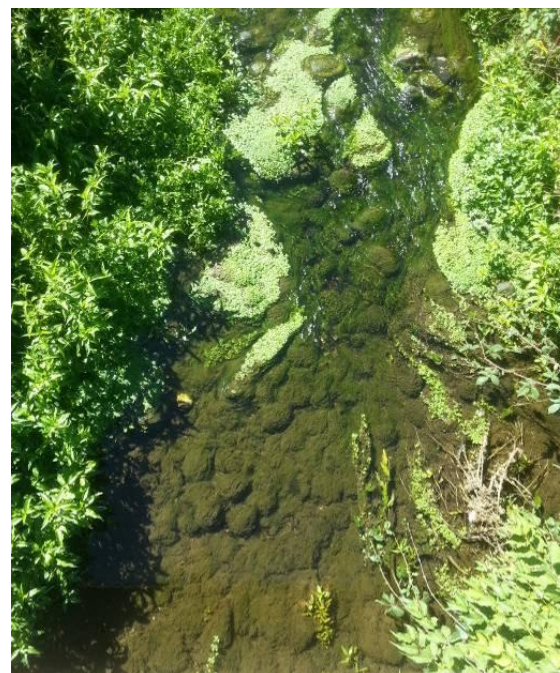
Above: Clay Ck 30 m upstream Aorere Rv. Below: Clay Ck 550 m upstream Aorere Rv. Both photos taken in February 2015.

Daily **dissolved oxygen** minima were **below standard** for ecosystem health at around 53-55% (continuous sampling March 2015) (Figure 16). However, it is likely that it won't take much effort to improve this (to bring it up to over 60%) by further removing dairy effluent discharges from raceways to the stream and more riparian planting. The relatively flat bottom to the daily dissolved oxygen curves shows that there is reasonable re-aeration – in this case from turbulent flow over riffles in the lower reaches. The low daily maxima are consistent with this creek having reasonable shading and therefore less extensive aquatic plant coverage. Water temperatures were very suitable for aquatic ecosystem protection (daily maxima: 18°C).

Macroinvertebrate metrics indicate this creek is in relatively poor condition (MCI 93, SQMCI 3.88, snails very abundant; based on one sample in February 2014). However, there was relatively high number of taxa (20) and a 'satisfactory' proportion of sensitive taxa in the sample (%EPT: 55%), mostly cased caddisflies.

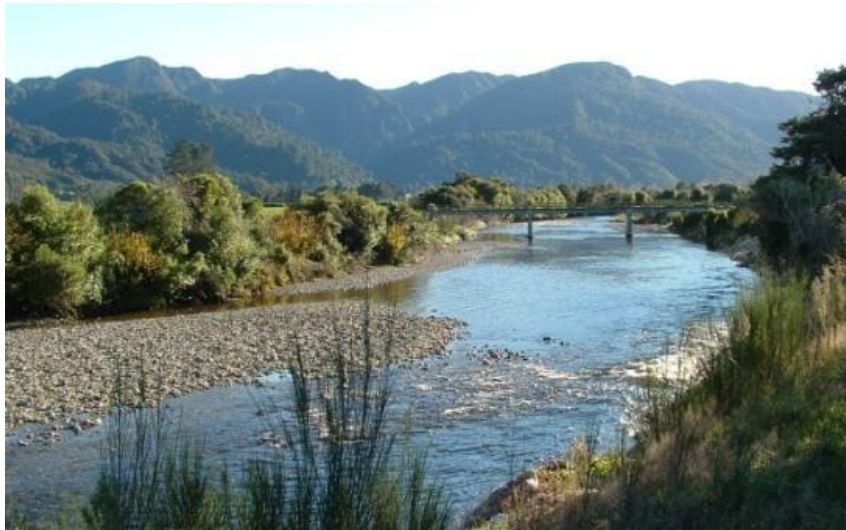
Kaituna Rv at Sollys Rd (June 2010)

Kaituna u-s track start	Kaituna at Sollys Rd
River Environment Class	Cool Extremely Wet Soft sedimentary Indigenous forest Lowland-fed Low gradient	Cool Extremely Wet Soft sedimentary Indigenous forest Lowland-fed Low gradient
Catchment area (km ²) ⁺	44.6	79
Predominant land use upstream	100% native forest	73% native forest
Mean annual rainfall (mm)	3621*	NA
Mean annual flow (l/sec)	2,274*	4,277
Lowest recorded flow	NA	519 (Mar 2003)
Water quality record	Monthly: 2000-01 and 2013-present Quarterly: 2005-present	2000-present

Water clarity is often naturally low in this stream (median: 3.5 m, 25th percentile 2.2 m) due to dissolved colour from water percolating through the leaf and bark litter on the podocarp forest floor. At the Solly's Rd site water clarity is similar to the upstream site (median: 3.3 m, 25th percentile 2.1 m).

Good or excellent macroinvertebrate condition was found in the **lower Kaituna River** (MCI generally greater than 119). The SQMCI scores, however, shifted from excellent toward fair for Kaituna at Sollys Rd in recent years. Sampling by Nottage in 2000 showed at Solly Rd (MCI 141, QMCI 6.9, # taxa 14.3; mean of 3 samples). This was not much less than the reference site on at Kaituna at Track Start (MCI 149, QMCI 8.3, # taxa 15.6; mean of 3 samples).

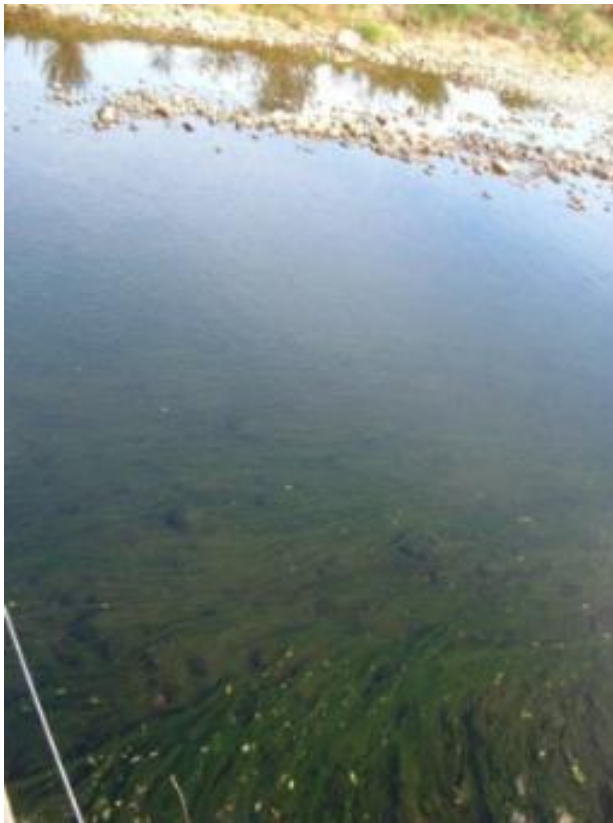
From 2007 until present the percent cover of **filamentous green algae** on the bed of the river at the Solly Rd site each summer has been well above nuisance levels (75% cover in each of 2007 and 2010). It is obvious that Mackay Creek is the cause of this, as there are very low (<10% cover) levels upstream of this stream confluence. The mixing profile is also very visually apparent from the presence of bright green algae (i.e. the algae spreads across the streambed as the waters of the two streams progressively mix downstream of the confluence), with almost complete mixing downstream of the stock bridge and complete mixing downstream of the next riffle. The original source of the problem was traced to **dairy effluent** treatment pond sludge that was placed near the stream and ran off into MacKay Creek. This issue has been resolved by removing the sludge as it is

Kaituna Rv at Sollys Rd taken from stock bridge. Left: Filamentous green algae cover at 75% cover (April 2007) Right: View upstream with filamentous green algae cover at 50% (February 2013). Note there are very little filamentous algae on the true left side of the river (right side of the photo).

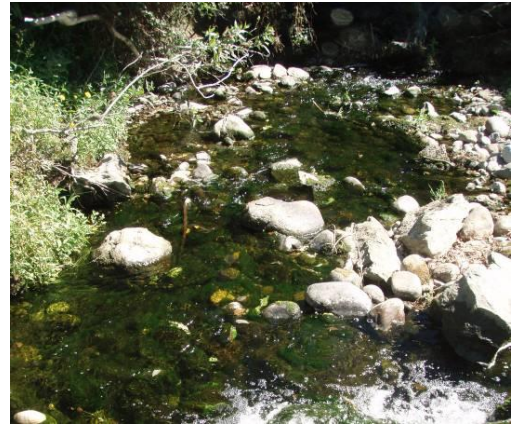
Filamentous green algae at the site 30 m upstream of the Kaituna River is high at times (40 and 50% cover have been recorded; see photo at top of previous page) but due to shading by tree cover at this site is on average is likely to be lower than other sites.

The **level of disease-causing organisms is moderately high** at base flows at the 50 m upstream Kaituna site (median 280 *E. coli*/100 ml (2010-2015), and exceed the guideline for contact recreation more than half the time. Stock drinking water and secondary contact guidelines are exceeded just over 20% of the time. Compared to a site in the upper catchment on mostly sheep and beef farmland (1 km upstream Collingwood-Bainham Rd) the *E. coli* concentration at Collingwood-Bainham Rd was on average 1.8 times greater (comparing samples collected from the sites within hours of each other). Only 15% of samples were lower at the downstream site. Two results in 2014 were particularly concerning (13,000 *E. coli*/100 ml on 14 April and 20,000 *E. coli*/100 ml on 21 October with results 2.2x and 75x less upstream). In late 2014 another site on Mackay Creek downstream of a tributary above Gillies Rd was sampled and found to have levels on average 1.5x lower than the Collingwood-Bainham Rd site (average difference of each sampling event over 8 events).

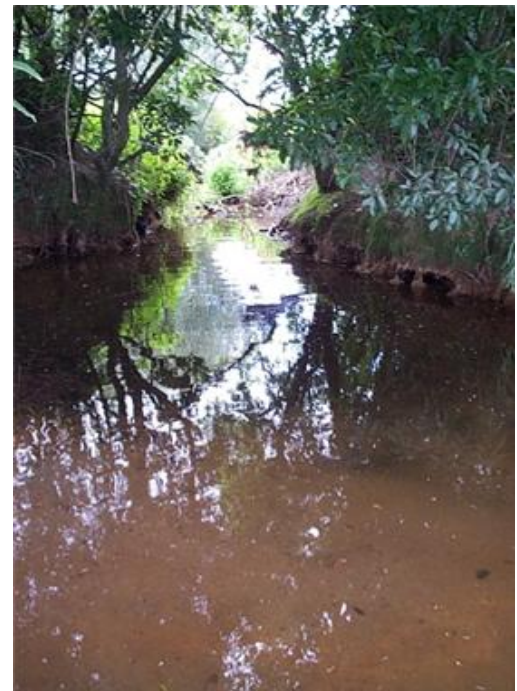
Above: Mackay Creek 30 m upstream Kaituna Rv showing high filamentous green algae coverage (January 2009). Below: 50 m upstream Kaituna Rv (February 2007).

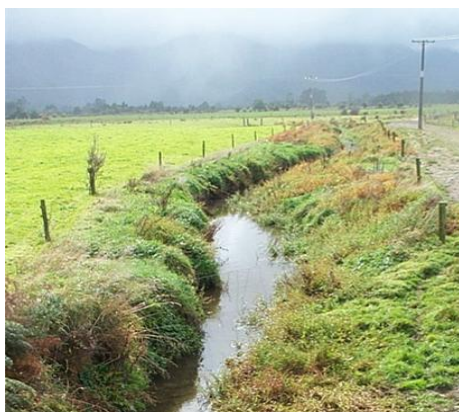
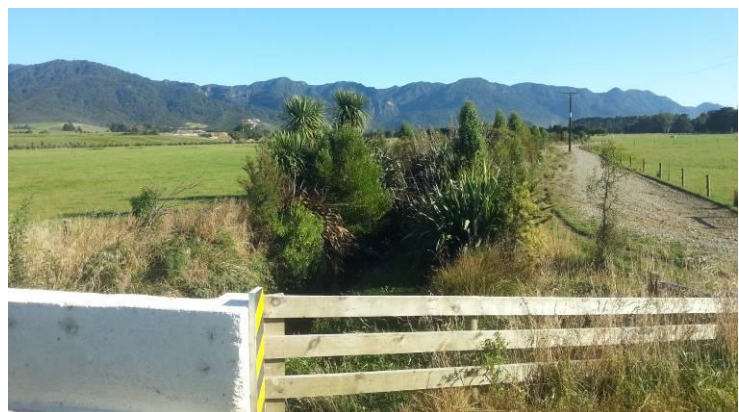
Above: Mackay Ck at Collingwood-Bainham Rd, looking downstream (Left: April 2005, Right: February 2015)

In 2015 a source of high nitrate was found coming from a drain from the true right about 920 m downstream of Collingwood-Bainham Rd. The origin for this has not been found but may be due to something buried within the paddock.

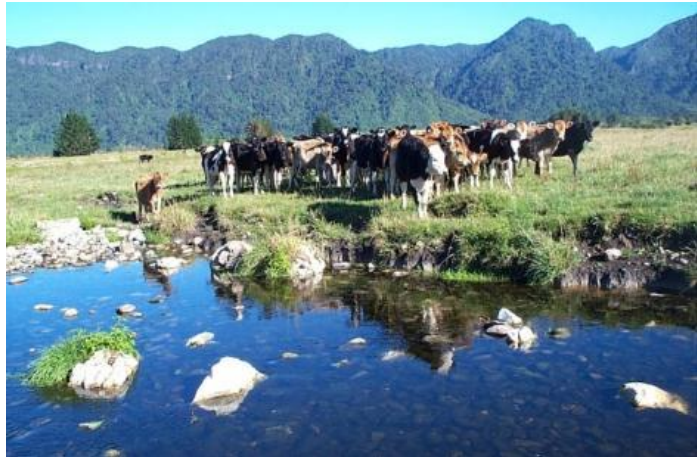
Burton Ale Ck 60 m downstream Collingwood-Bainham Rd, looking downstream (Left: February 2005)

Stream habitat is generally good i.e. natural meander, water depth variety, cobbly/bouldery bed and regenerating riparian scrub overhanging the stream. Reasonable numbers of native fish reside in this stream where the habitat is good, including short-jaw kokopu and red-fin bully. Because of the limited mixing of water from this creek with the Aorere River at the mouth, and that swimming and other contact recreation occurs in the area near the mouth, this creek has been assessed against the contact recreation guidelines. The total area of this catchment is 802 ha with 247 ha in sheep and beef, 450 ha in dairy farming and about 65 ha in scrub and forest. The flow in this creek can be as little as 5 L/sec in the driest summers.

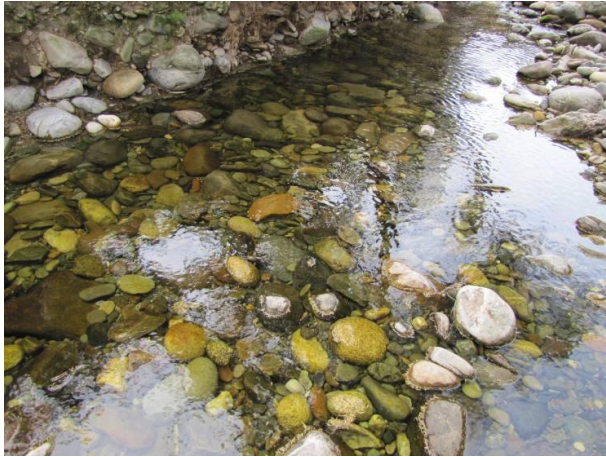
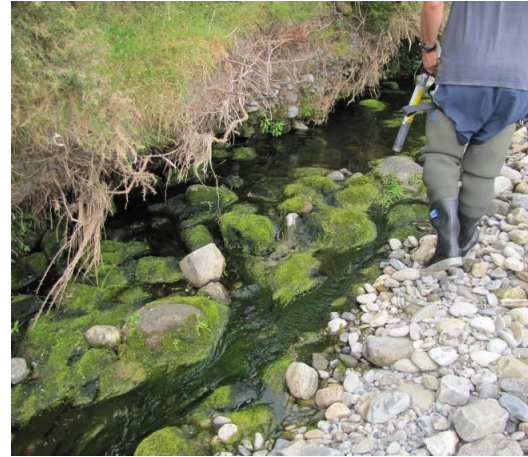
Filamentous green algae cover is high at times during summer (median summer: 25% cover, 5 of 15 samples over 30% cover and 2 of 15 samples over 90% cover at Collingwood-Bainham Rd). There was often a marked difference between filamentous green algae cover in tributaries dominated by dairy (e.g. Southern tributary) versus those dominated by sheep farming (Northern tributary) (see photos below).

Above left: Northern tributary Burton Ale Ck (9 February 2012). Above right: Southern tributary Burton Ale Ck (9 February 2012)

Dissolved reactive phosphorus concentrations were very high in this stream (in dry weather typically 0.1-0.2g/m³; 10-20 times guidelines) even during dry periods as a result of farming on pakihi soils with very low phosphorus retention. The ANZECC guidelines are 0.01 g/m³ and excessive algal growth usually occurs when dissolved reactive phosphorus concentrations are over 0.015-0.03g/m³ in the presence of sufficient nitrogen. Wet weather phosphorus concentrations were 2-3 times higher than dry weather. A tributary of Burton Ale Creek that is dominated by sheep farming has dissolved reactive phosphorus concentrations less than half that of tributaries dominated by dairy farming. At lower catchment sites increases in phosphorus concentrations were often matched by increases in dissolved nitrogen (r²=0.47). **Nitrate-N concentrations are relatively low** (typically around 0.1-0.3g/m³ except for two sites on two southern tributaries where they cross Plain Rd where they were 0.4-0.6 g/m³).

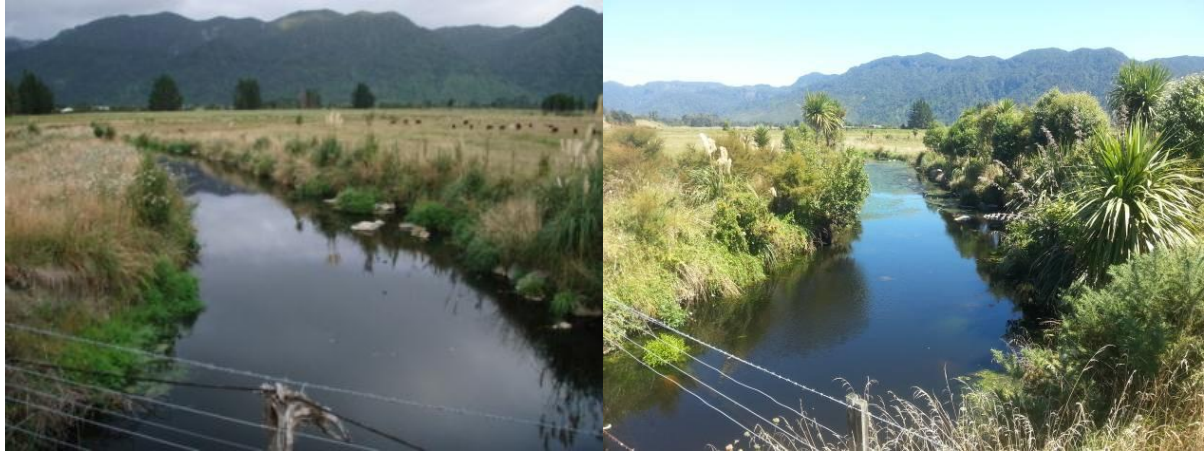
Burton Ale Ck at Collingwood-Bainham Rd, looking downstream (Left: January 2009, Right: February 2015).

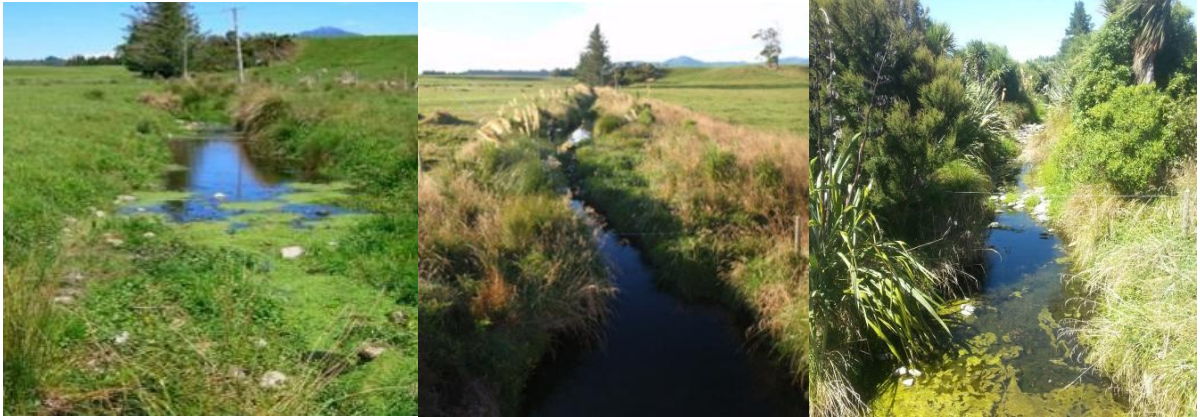
Riparian planting began in 2007 and by 2015 the shading and habitat in the stream was greatly improved and is a credit to those involved in restoring in stream habitat and overland flow interception (see photo sequence below).

James Cutting Ck viewing upstream of Collingwood-Bainham Rd (from left October 2005, January 2009, and February 2015 right).

This creek has **extensive cover of filamentous green algae**, indicating high nutrient concentrations. Like Burton Ale Creek, dissolved reactive phosphorus concentrations are high in this creek. In 2008 the riparian zone upstream of Collingwood-Bainham Rd was fenced and planted, which has improved habitat greatly. However, water quality would particularly benefit from the installation of wetlands in key parts of the catchment, to act as filter strips. In 2014-15 further planting was carried out after the diversion of the creek for the 800 m reach downstream of Collingwood-Bainham Rd.

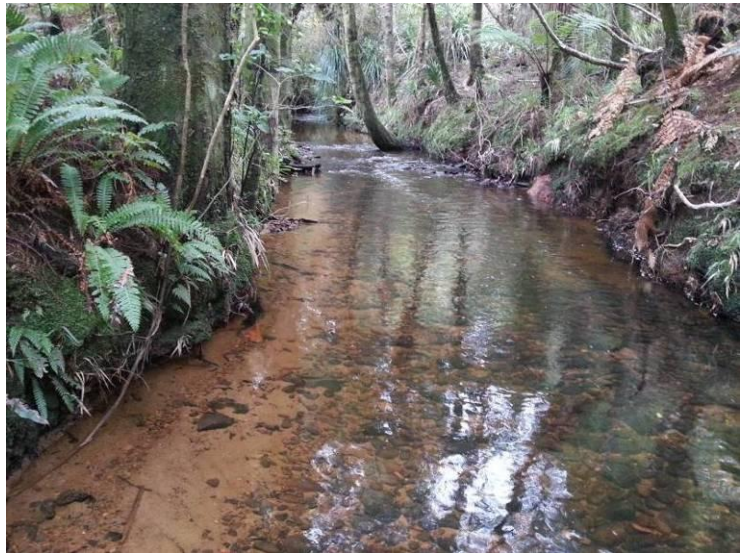
Yellow Pine Creek ~1.2 km upstream estuary (Sept 2013)

A heavy discharge of fine sediment (estimated at least 50 m³) to Yellow-Pine Creek occurred in 2012 as a result of logging and tracking operations causing slips and erosion into 'Culvert 15 Creek' (James, Sept 2013). Sampling the effects of this discharge took place in February 2013. Fine sediment volumes in Yellow Pine Creek were much higher downstream of Culvert 15 Creek (7.5 m³/100 m reach), compared to upstream (0.2 m³/100 m reach). This activity resulted in a prosecution for the company involved.

It would appear from the results of macroinvertebrate samples that the effects of mining masked that of any affect of the forestry operation. No mayfly, stonefly or caddisfly taxa were found in the sample downstream of mining but were found upstream of the mining and forestry. The acid mine drainage index showed a marked difference between the upstream reference site (above known mining discharges) and downstream of the mining discharges. The macroinvertebrate community index (MCI) also showed this trend but not to a degree considered significant. Four koura were caught upstream of forestry and mining but not in any of the downstream samples.

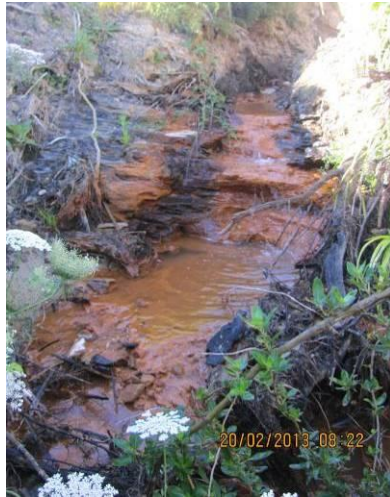
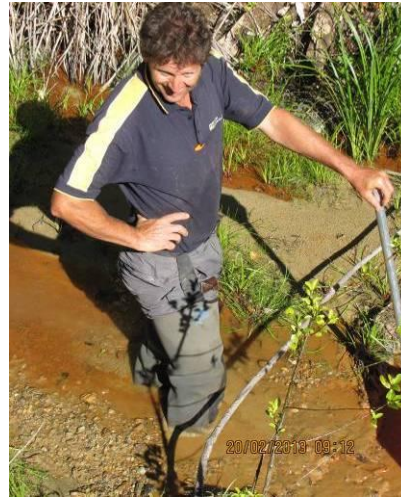
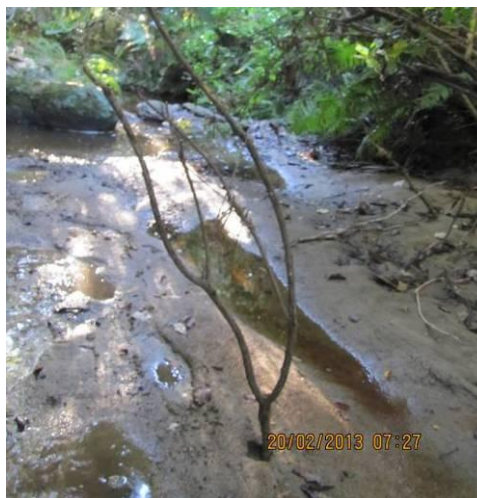
Above left: Yellow Pine Creek tributary ('Culvert 15 Ck') showing the effect of mine drainage. Above right: 'Culvert 15 Ck' showing a sediment depth of about 300 mm. Middle: Yellow Pine Ck downstream of Culvert 15 Ck sediment depths 100-200 mm.

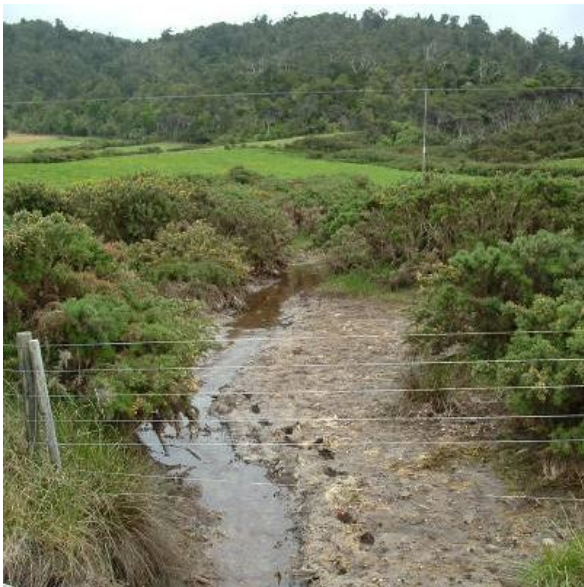
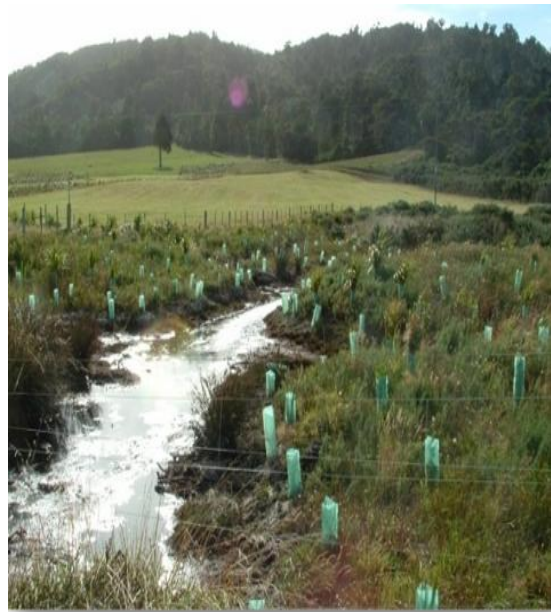
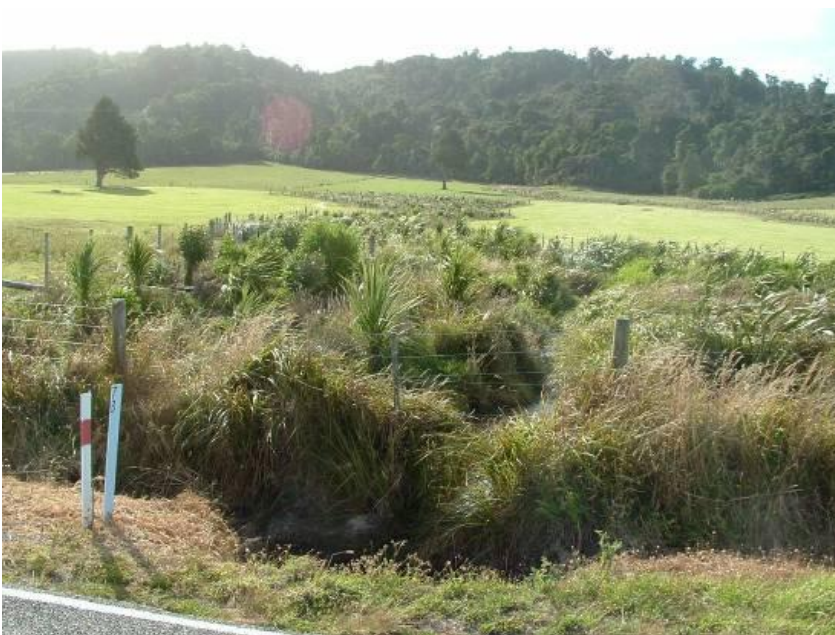
The streams are fully fenced and the stream's headwaters are in native bush. A large-scale riparian planting programme was initiated in 2009 (see photos below).

Unnamed stream north of Pakawau, Culvert 78 (Top left: October 2006, Top right: February 2010, Left: February 2011).

Extremely **low dissolved oxygen** was found in several streams (flowing out of culverts 74-80) on the Pakawau-Puponga Road (about half way between these settlements; 3.5-4 km north-west of Pakawau Hall) in summer. Anoxic or near anoxic conditions were found at some of these sites. Bubbles of **Methane** were observed in the area and a white precipitate was noticed on the cobbles and sand at the mouth which is likely to be caused by a natural methane discharge related to coal deposits in the area. These bubbles may be a symptom of anoxia (i.e. produced by methanogenic bacteria living under anoxic conditions). Summer flows in most of these streams are low but not stagnant (0.5-2 L/sec).
