# River Water Quality in Tasman District

# State of the Environment Report

## River Water Quality in Tasman District 2015

A technical report presenting results of the Tasman District Council's 'State of the Environment' River Water Quality Monitoring Programme and additional data from the National River Water Quality Network. Indicators measured include: physical, chemical, and bacteriological characteristics of the water, macroinvertebrate indices and periphyton cover. The report highlights water quality condition and trends, from the Waimea, Motueka, Takaka, Aorere and Buller water management areas.

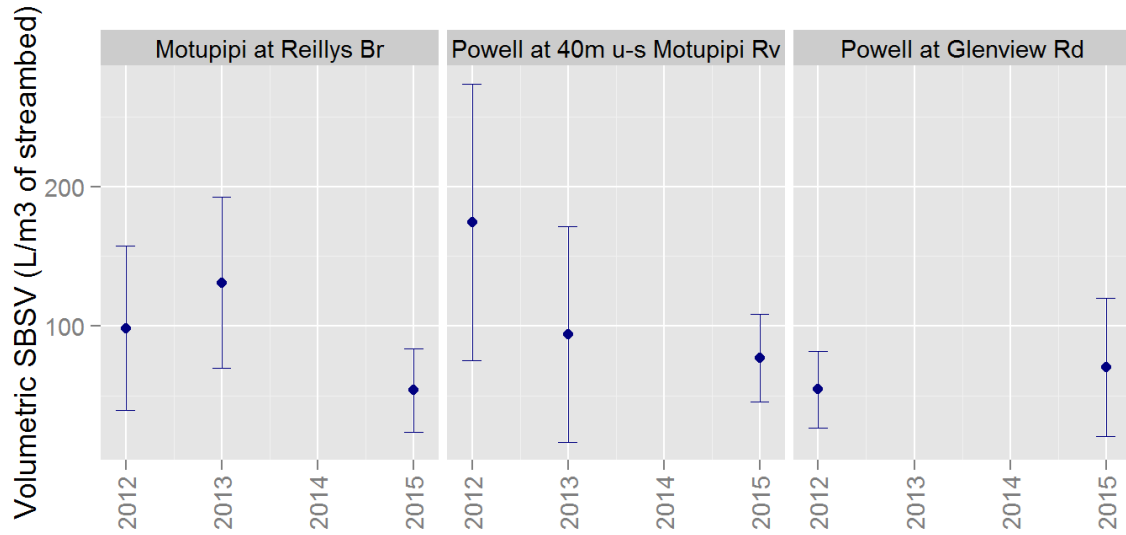
**Figure 7. Mean volumetric suspendable benthic sediment volume (SBSV) from 2012 to 2015 (sampled during Summer). The error bars show 95% confidence intervals.**

Volumetric SBSV were examined for three high risk sites on smaller waterways in the Takaka catchment and found to be relatively high compared to others across the district. There were no differences found between the sampling years (2012 to 2015) at these sites (Figure 7).

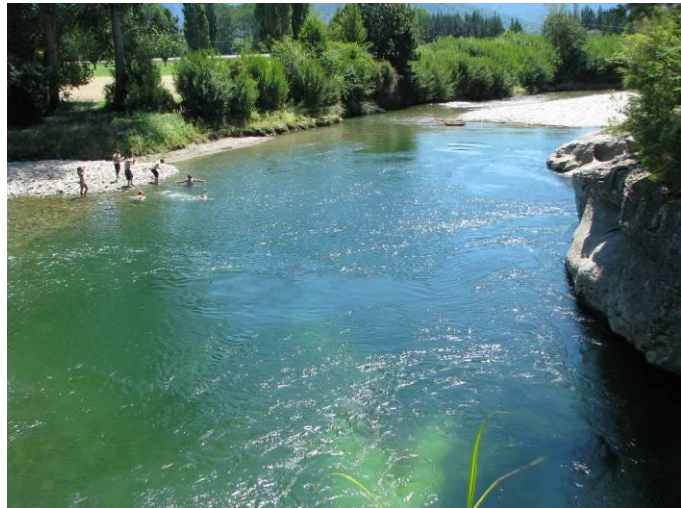
Above: Takaka River at Paynes Ford looking downstream to SH60 (December 2010)

l/sec the Takaka River can be anticipated to dry from 0.5-1km downstream of

Lindsay's Bridge (upper crossing of SH60) for a stretch of several kilometres downstream through to about 1 km upstream of Paynes Ford bridge (SH60).

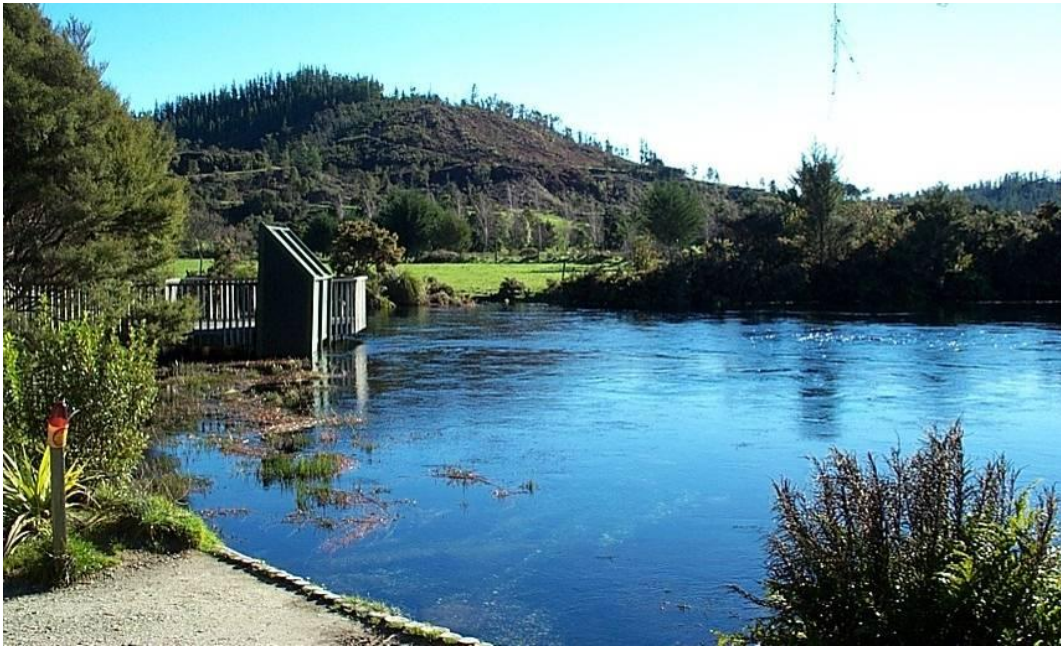
Te Waikoropupū Main Spring (March 2004)

This river is fed by one of the largest springs in the Southern Hemisphere (mean flow in main spring is almost 10 m<sup>3</sup>/sec (8.5-15 m<sup>3</sup>/s range), with Fish Creek Springs contributing 3.3 m<sup>3</sup>/sec (Thomas and Harvey, 2013). The waters emanating from the spring arise from the Arthur Marble Aquifer, karst system that takes leaked water from rivers such as the Takaka (below Lindsay's Bridge) and lower Waingaro and many tributaries in the mid and upper Takaka Valley.

Te Waikoropupū Main Spring has the **second-highest clarity of freshwater in New Zealand** (after Blue Lake and the Sabine River in Nelson Lakes National Park) and amongst the highest in the world at over 60 m. At a monitoring site on Te Waikoropupū River about 600 m downstream of the spring (upstream of a salmon farm discharge) the median is 22 m, but is decreasing (Figure 12). This natural reduction is from a number of sources such as: dissolved organic carbon (colour) from soil leaching (mostly from the Fish Creek catchment) and exudates from the aquatic plants that have extensive coverage of the bed in the spring and river. The higher the clarity the more reduction you get in clarity for a given amount of dissolved or particulate material in the water. The water clarity median downstream of the salmon farm discharge from 2012 to 2015 is 18.5 m.

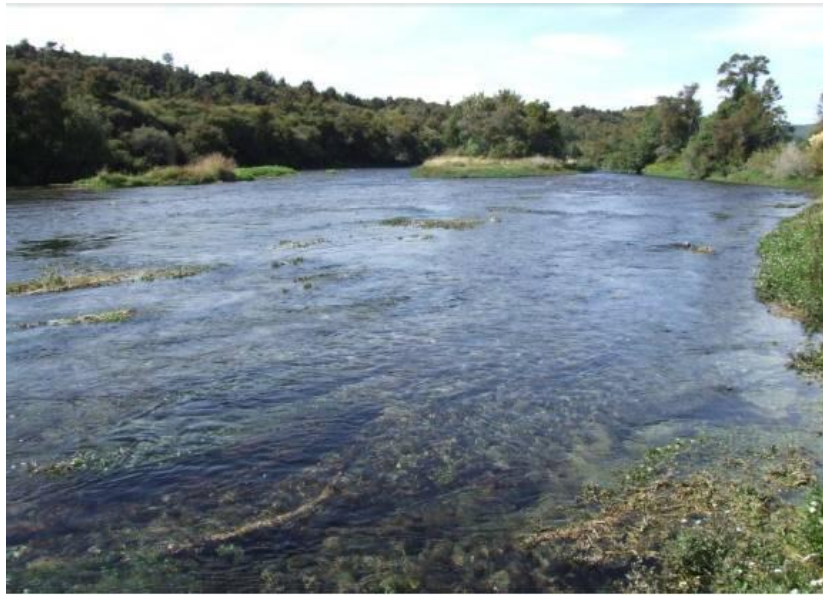
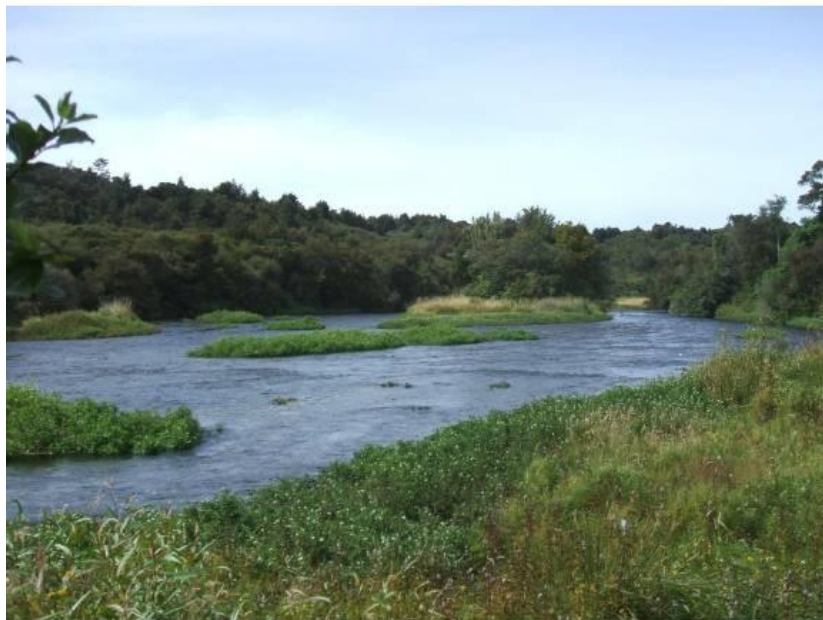
Te Waikoropū River at biomonitoring Site 3a upstream of the NZ King Salmon discharge. Top: January 2009, Bottom: February 2010. Photos: Courtesy John Stark. Note the variability in aquatic plant growth.

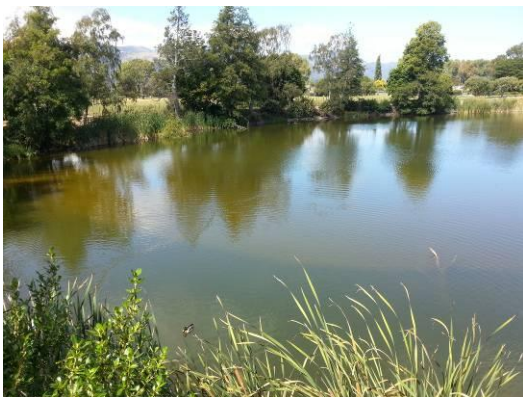
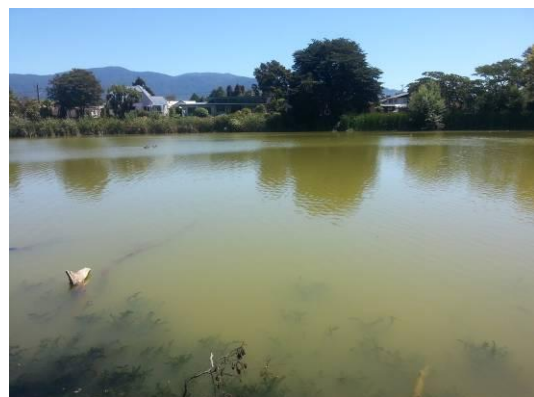
**Left:** Looking south over Lake Kilarney on 10 March, 2014 showing an algal bloom. Note that the bloom is not so prevalent near the shaded edge of the lake. **Right:** Looking west over Lake Kilarney on 19 February, 2015. Whole lake is highly turbid looking due to an algal bloom.

The brown coloured plume observed on Lake Kilarney on 10/3/2014 was due to the microalgae, *Peridinium*. This is a motile algae and so explains why it was found only in part of the lake (the sunniest part). This is not an uncommon occurrence, but there are no previous records of this microalgae for this lake. *Microcystis* was also found in the sample at lower concentrations. *Microcystis* can be a concern due to its ability to produce toxins and so contact recreation and stock drinking is not recommended if this alga were to build up in the lake. The present concentration of this species was probably not high enough to need to warn the public. There is a need to sample nutrient concentrations in the lake and also any input drains.

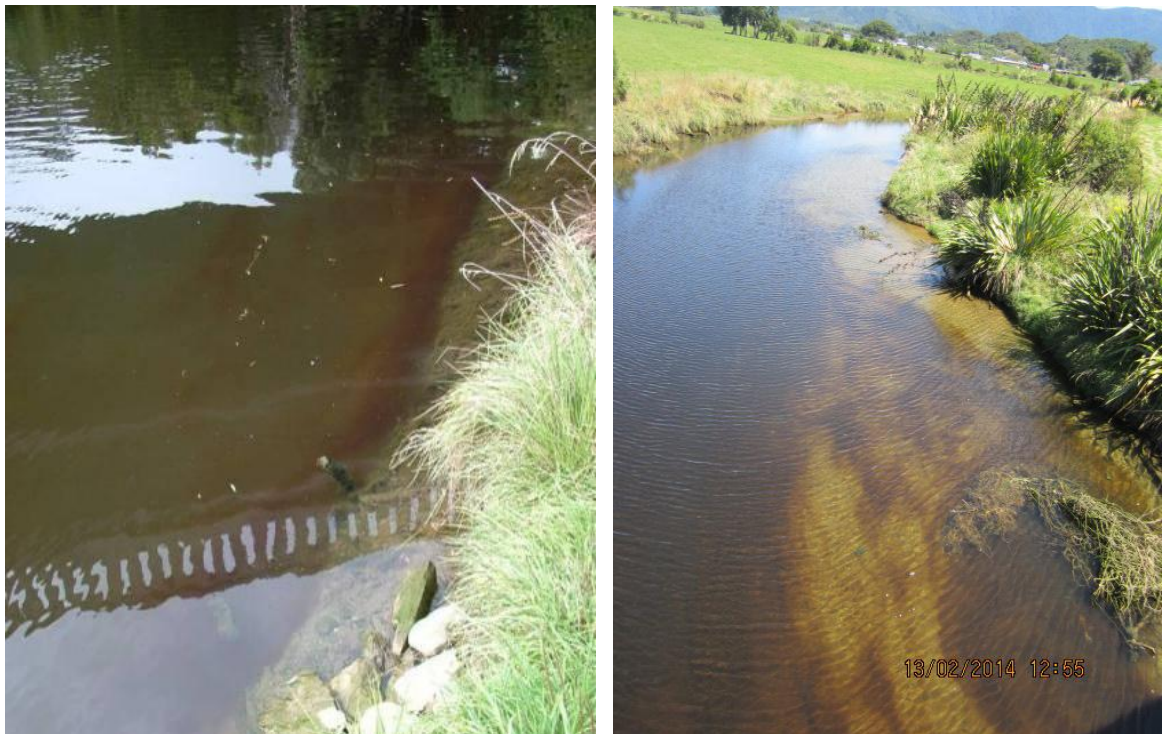
Above: *Cryptomonas* algae bloom in the lower Motupipi. Left: April 2007; Right: February 2014

If there is sufficient light algae can grow to nuisance levels it has sufficient quantities of both nitrogen and phosphorus in soluble form, as well as stable flows and warmer water temperatures. **Filamentous green algae** cover exceeded nuisance levels (30%) for about 20% of the records for Motupipi at Reilly Br and 25% of records for Powell at Reilly Br (spring-autumn records only; no excessive algal growth has been observed in winter). It appears that the level of cover is decreasing, maybe in relation to the decrease in dissolved reactive phosphorus.

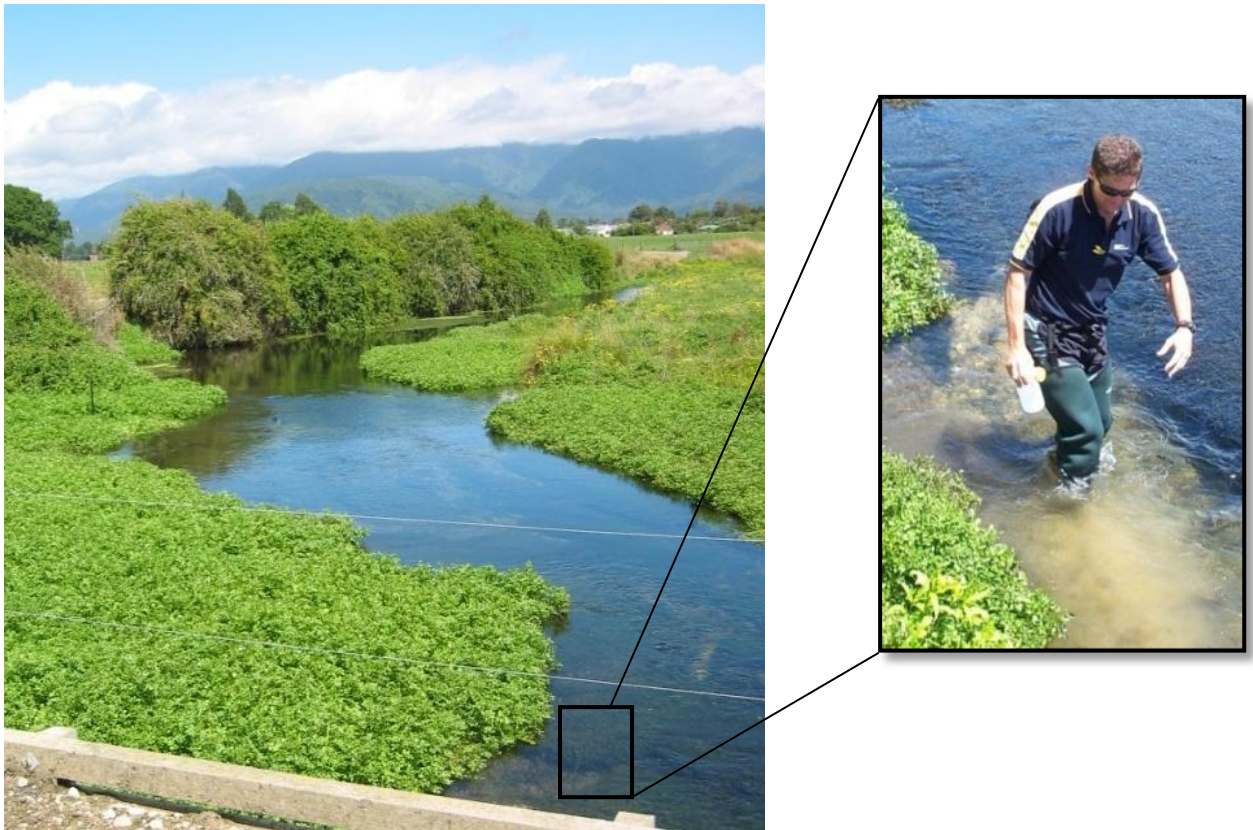
Motupipi Rv at Reilly's Bridge (January 2006, left and November 2004, right).

**Macroinvertebrate condition** was mostly **poor or very poor in the lower parts of this catchment, including lower Powell Creek**, except for upper Powell Creek, which was good in 2004 but has declined since. The excessive levels of fine sediment and elevated nitrate (median 1.5 g/m<sup>3</sup>) are probably the reason for this. Powell Creek at Glenview Rd showed a decline in most macroinvertebrate indices (MCI, % mayflies, stoneflies and caddisflies) which seems to coincide with the removal of a peat bog wetland upstream of this site in September 2008 and a change to cropping maize.

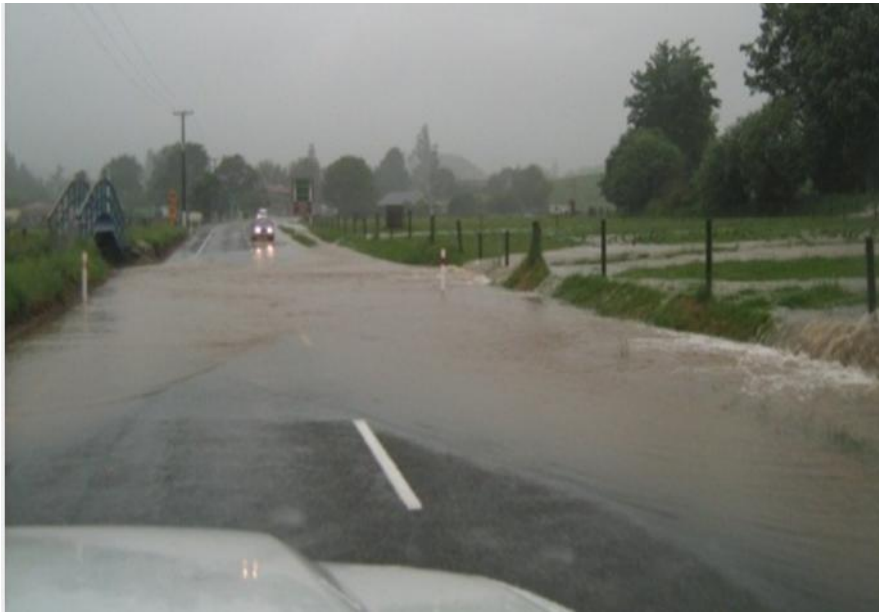
Above: Overflow from the Takaka River to the Motupipi during a flood in November 2008.

Another factor affecting the state of water quality in the Motupipi River is the **lower frequency of overflows of floodwater** from the Takaka River into the Motupipi compared to 10-20 years ago, most probably due to lower bed levels in the Takaka River. Takaka River currently overflows into the Motupipi at about 1400 m<sup>3</sup>/sec, providing flushing of fine sediment deposits and aquatic plants and algae. Anecdotal evidence suggests that the overflow from the Takaka River in 2008 (24 November) resulted in reduced algal blooms for the two years following (reports from whitebaiters). The **lack of flushing flows, over recent years, leads to greater levels of fine sediment** in the bed and more prolific aquatic plant growth. Controlled release of Takaka floodwaters to the Motupipi River

through automatically controlled gates could produce a significant gain for water quality and aquatic ecology.

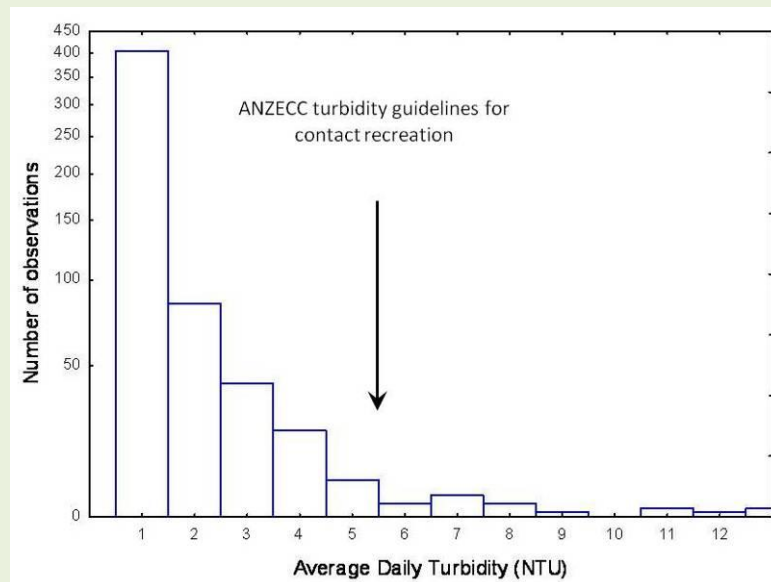
**Figure 18.** Frequency of average daily turbidity recorded between December 2006 and August 2010.  
**Note:** The X-axis is on a log scale.

**Turbidity** analyses showed that recommended guidelines for contact recreation (i.e. 5.6 NTU) were only exceeded for 2.5 % of the time, with the majority of the records (97.5%) being between 1 and 5 NTU (Figure 18). The lowest daily average turbidity recorded was 0.11 NTU (12/08/2010) and the highest 36.5 NTU (23/07/2009). **Time trend analyses** showed a statistically (P=0.02) and ecologically significant (RSKSE = -13.82%) **decrease in turbidity** at the site over the monitoring period (Figure 19B). Average monthly turbidity was highest in July and November 2008, following major floods and lowest in September 2010 (Figure 19B).

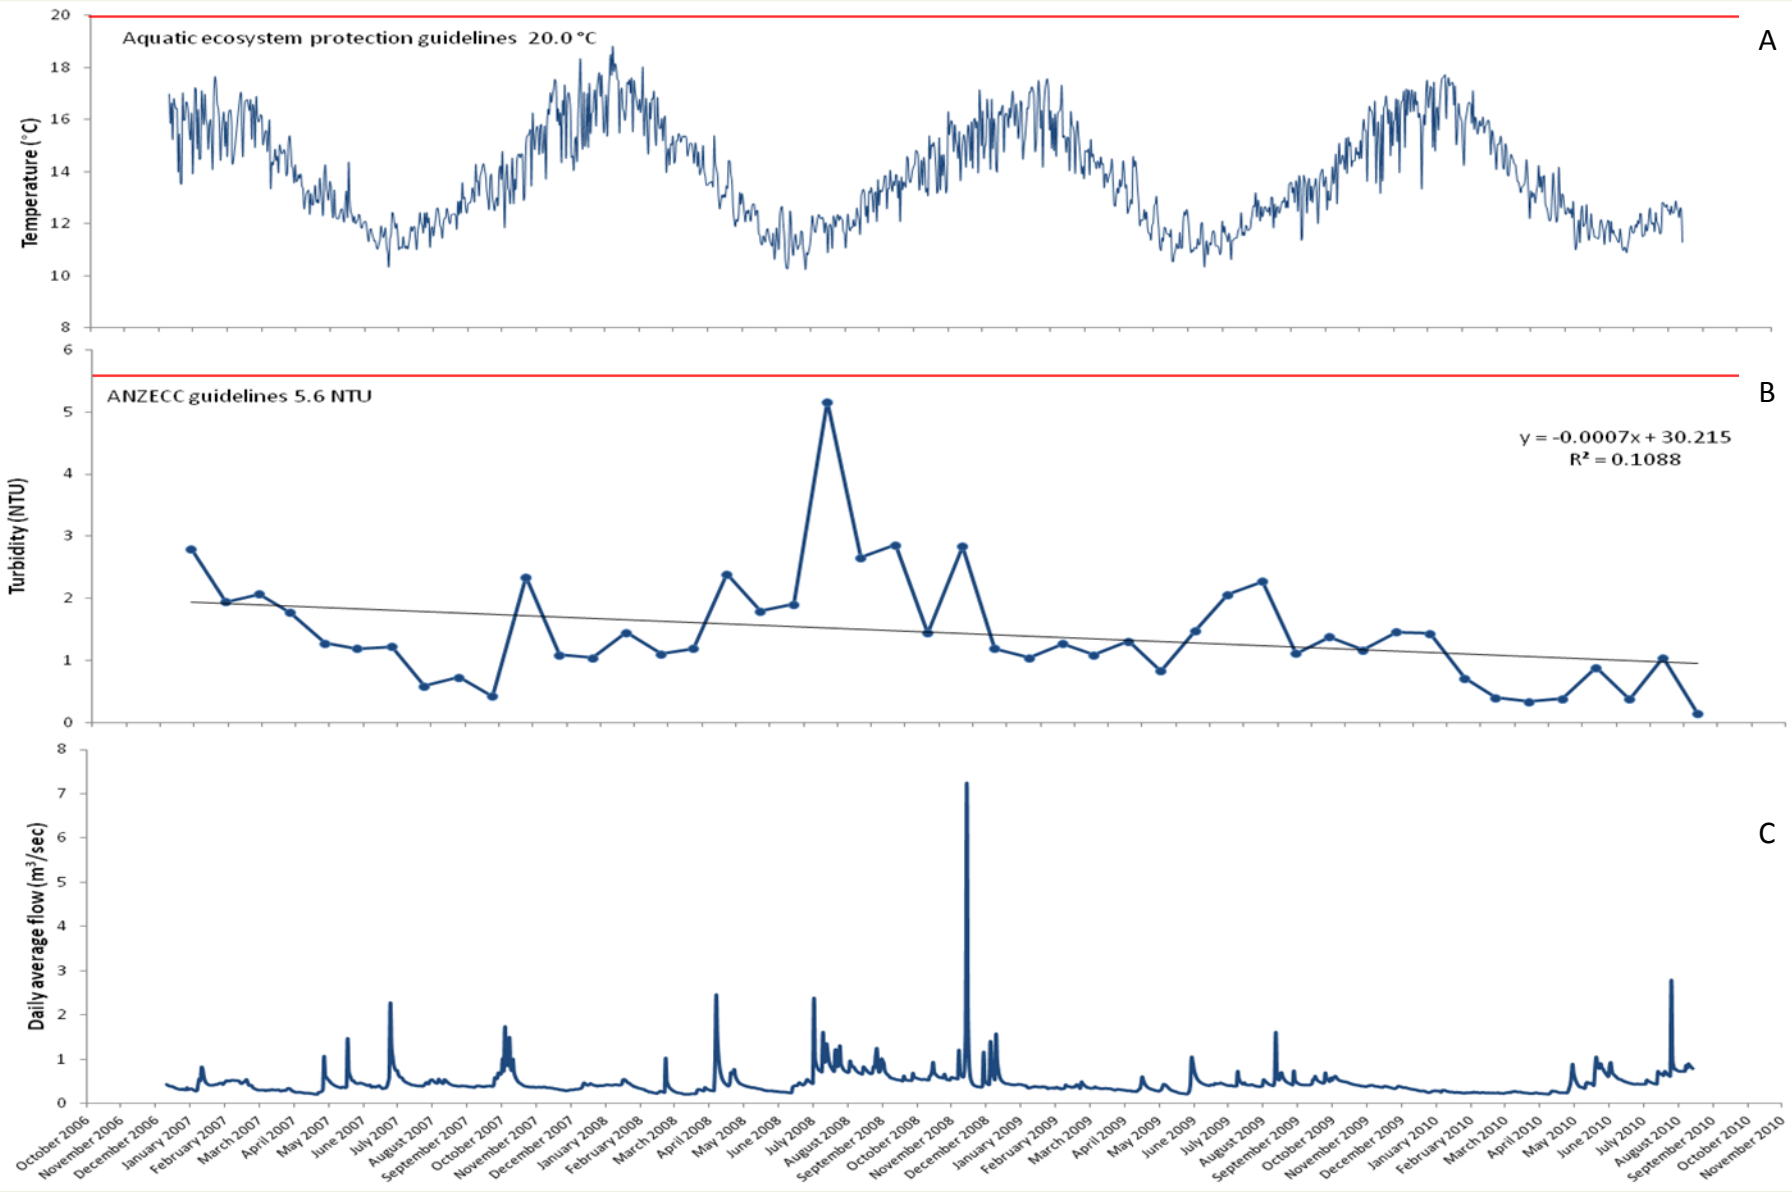
Figure 19. A) Average daily temperature records halfway between the daily mean and daily maximum, B) monthly average turbidity and C) daily average flow recorded between December 2006 and August 2010 at Motupipi at Reilly's Bridge.

Between December 2006 and August 2010, **temperature** records showed clear seasonal patterns, with warmer temperatures in summer and cooler ones in winter (Figure 19A). The highest temperature halfway between the daily mean and maximum recorded was 18.8 °C (15/01/2008) and the lowest 10.25 °C (06/07/08) with an average of 13.85 °C. Therefore, the site never exceeded the recommended guidelines for aquatic ecosystem protection of 20°C.

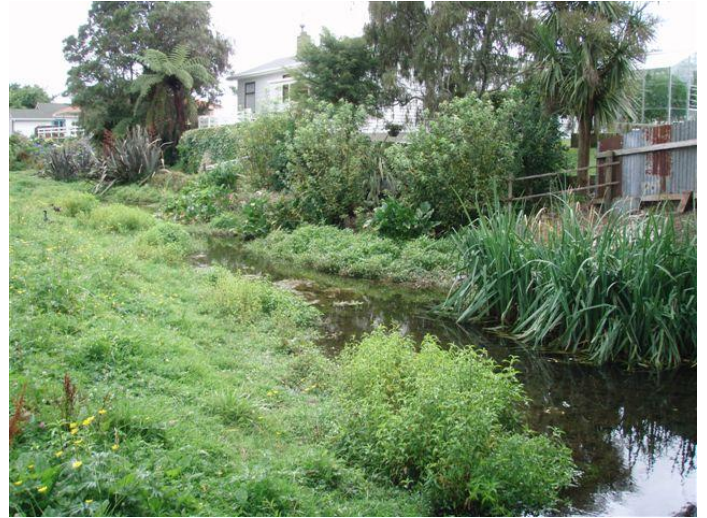
Te Kakau Stm downstream Rose Rd, January 2006

Te Kakau Stream is spring fed and flows along the western edge of Takaka township. The invasive and prolific waterweed *Lagarosiphon major* was accidentally released into the waterway in a flood during the 1960's. To date water quality sampling has only been carried out at this site over the period from 2005-07.

Summer-time minimum **dissolved oxygen levels** were (3-10 February 2006) were found to be **extremely low** (40% saturation for the middle reaches of Te Kakau Stream, as shown in Figure 24, and 0% saturation for the lower reaches of Te Kakau Stream, as shown in Figure 25). Aquatic plant growth rates at the Feary Crescent site are over double the rates for the median for streams draining intensive agriculture in New Zealand and internationally (Young 2006).

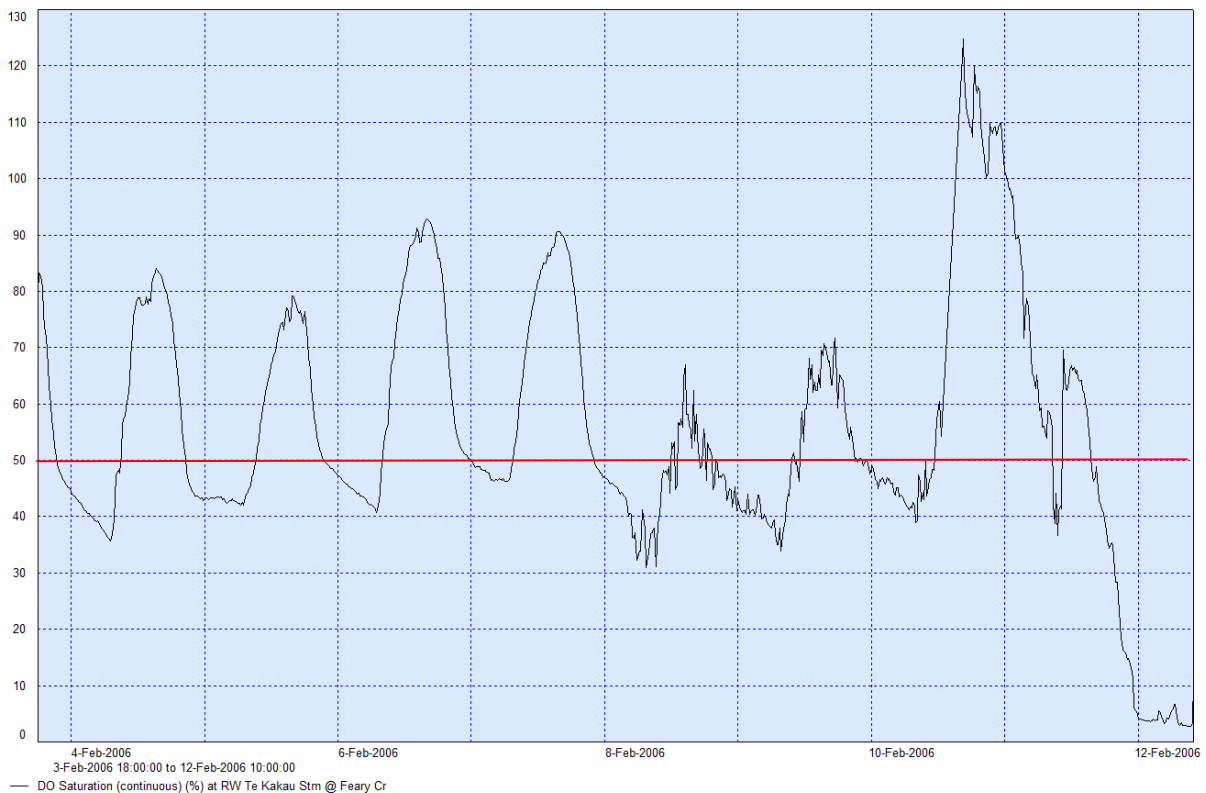
Figure 24 Continuous dissolved oxygen saturation data for Te Kakau Stream at Feary Cres (3-12 February, 2006). The national proposed bottom line for the daily 1-day minimum is shown by the red line.

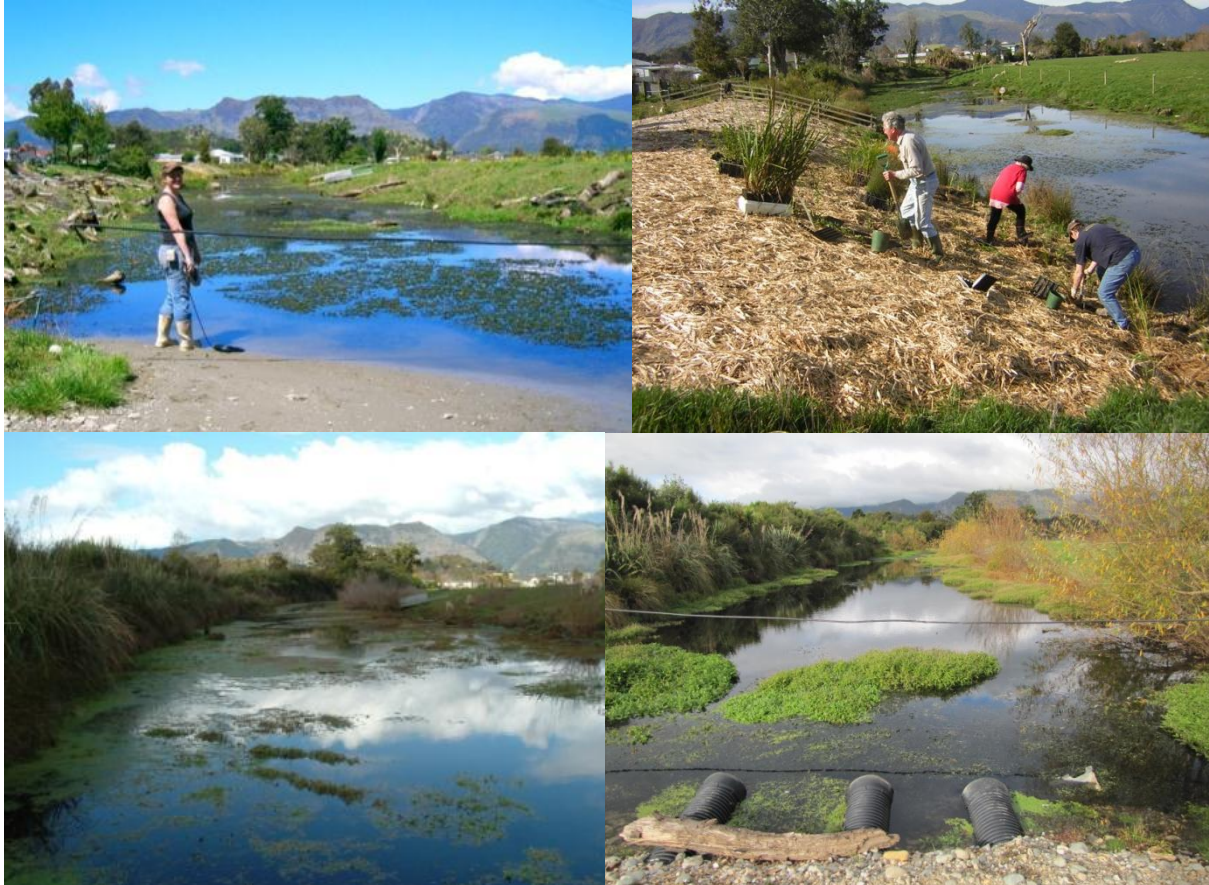
**Te Kakau Stm at Haldane Rd looking upstream (Top left: October 2005, Top right: September 2005, Bottom Left: July 2010, bottom right: May 2012).**

The local community has participated in the management plan process and on-the-ground work. Trials of different methods of aquatic weed control were trialled in 2007-08. While two layers of weed mat was shown to be very effective, the cheapest effective method is shading by streamside plantings. Council reserve land adjacent to the waterway has been largely planted (see photo from 2010 below) as well as several properties. Council has offered native trees for planting along the stream.

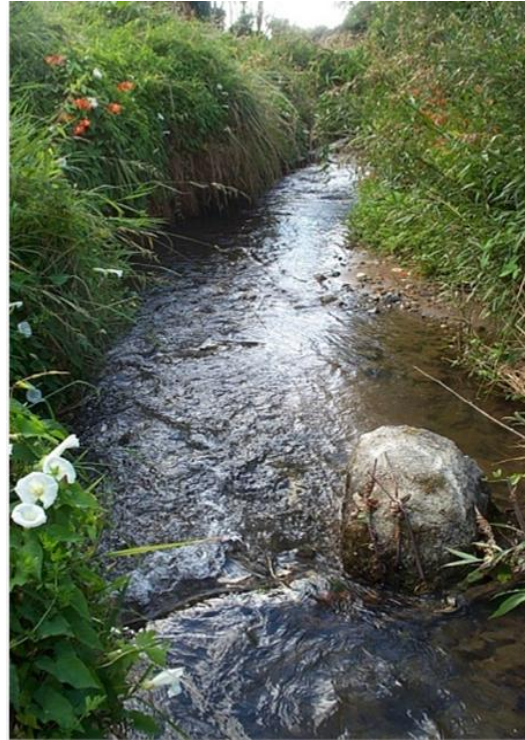
Winter Ck at 500 m upstream Abel Tasman Drive (February 2005).

Conductivity is very high (700-800  $\mu\text{S}/\text{cm}$ ) in a tributary running out of a limestone cave that joins Winter Creek about 220 m upstream of Abel Tasman Drive, potentially explaining the low macroinvertebrate indices scores. Aluminium and iron concentrations in sediment in this tributary are elevated (10,900 and 33,400 mg/kg dry weight respectively). No other heavy metals were detected. Neither were any hydrocarbons (including poly-aromatic hydrocarbons), volatile organic compounds or semi-volatile organic compounds, or phenols, ketones. This sampling was carried out after allegations that there may be leachate from materials on the former Golden Bay Cement Works site causing the high conductivity.

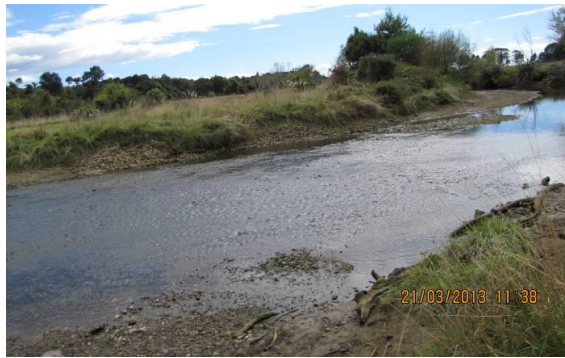
Above left: Onekaka Estuary looking to the catchment upstream (June 2010). Above right: Inanga spawning sites on the lower Onekaka River (March 2013).

This stream has **outstanding native fish values** with the highest species richness for a particular reach known in the district, (one 300 m reach had 12 native fish species plus trout). Most fish species were also abundant. Prolific inanga spawning has been found to occur at a site about 600 m downstream of Shambala Rd. A hydro-electric power scheme operates in the catchment with a 10.7 m high dam (built in 1928) about 4km upstream of the monitoring site at Shambala Road.

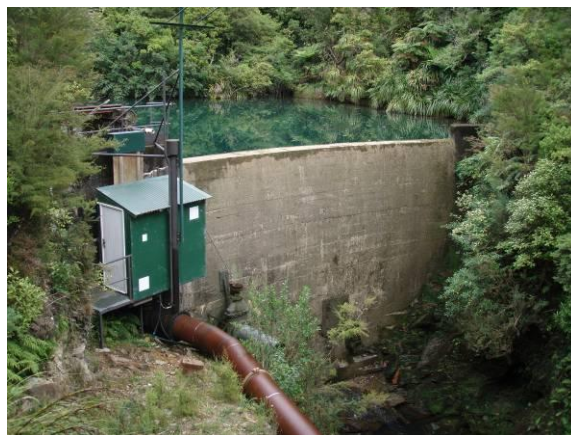
Above: Electric Waters Dam on the Onekaka River (January 2009)

**Moderate levels of fine sediments** deposited in the bed matrix are found in the lower reaches. Prior to 2005 sediment was dug out and discharged downstream of the dam at low flows resulting in heavy load of fine sediment in the stream bed. This practice is now not permitted under condition of resource consent.

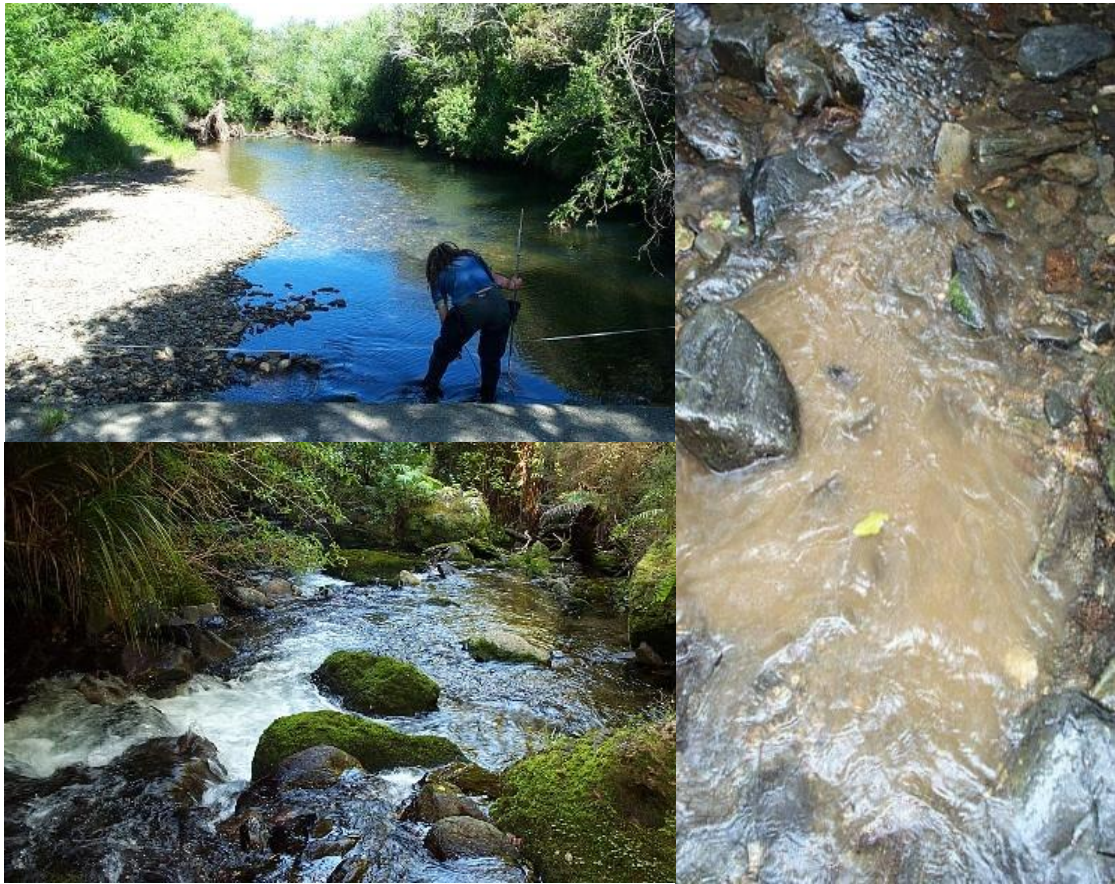
Onekaka River at the lower site at Shambala ford, November, 2004 (top left) and at the upstream site at Ironstone Ck January 2002 (bottom left), typical sediment plume from kicking in the stream bed at Shambala Rd, November, 2004 (right).

On average, **water clarity is halved in the 2km below Ironstone Creek** (median: 10 m to 5 m; u-s Ironstone to Shambala) (Figure 27). The reasons for this are unclear. It may be the geology, inputs from farmland and roads, or tannins from wetlands or particular forest type.
