# River Water Quality in Tasman District

# State of the Environment Report

## River Water Quality in Tasman District 2015

A technical report presenting results of the Tasman District Council's 'State of the Environment' River Water Quality Monitoring Programme and additional data from the National River Water Quality Network. Indicators measured include: physical, chemical, and bacteriological characteristics of the water, macroinvertebrate indices and periphyton cover. The report highlights water quality condition and trends, from the Waimea, Motueka, Takaka, Aorere and Buller water management areas.

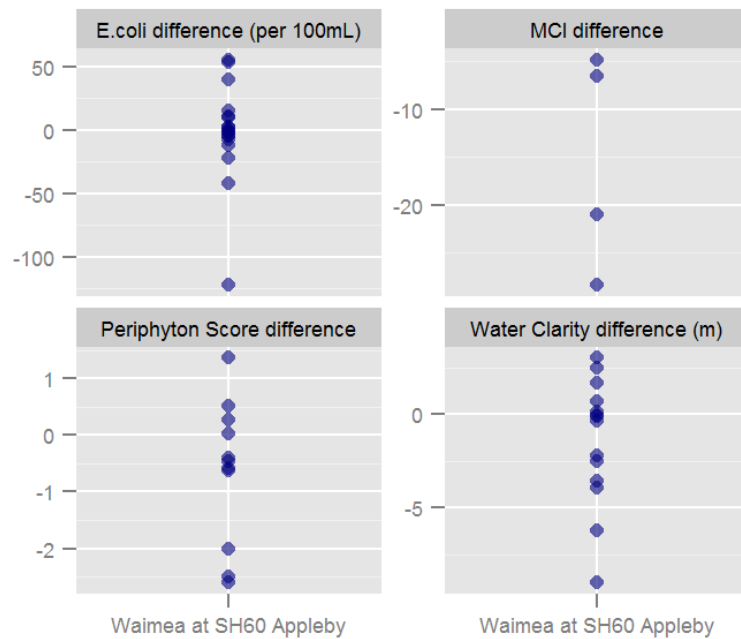
Wairoa at Irvines (upstream) was paired with Waimea at SH60 Appleby (downstream). The *E. coli* results, over the five-year reporting period, were similar (mean difference = -1.7 *E.coli*/100 mL, Figure 10). The macroinvertebrate community was in a slightly poorer condition at the downstream site (mean difference = -15 MCI units).

**Figure 10. Difference between Wairoa at Irvines (upstream) and Waimea at SH60 Appleby (downstream) for water quality data collected at both sites on the same day. A positive difference means the downstream site had a higher value than the upstream site.**

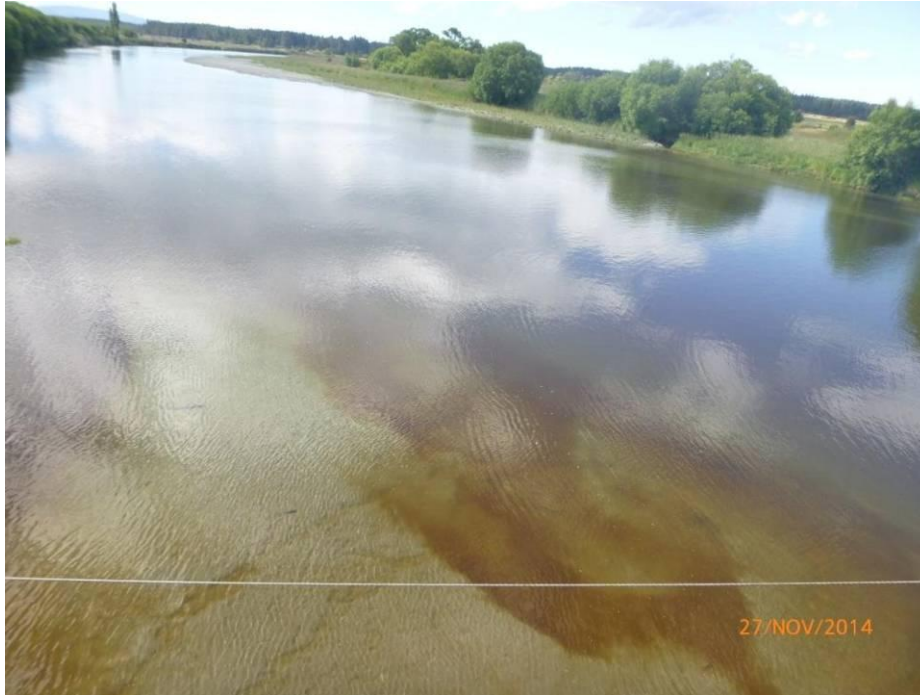
**A Cryptomonad algal bloom in the lower Waimea River (November, 2014).**

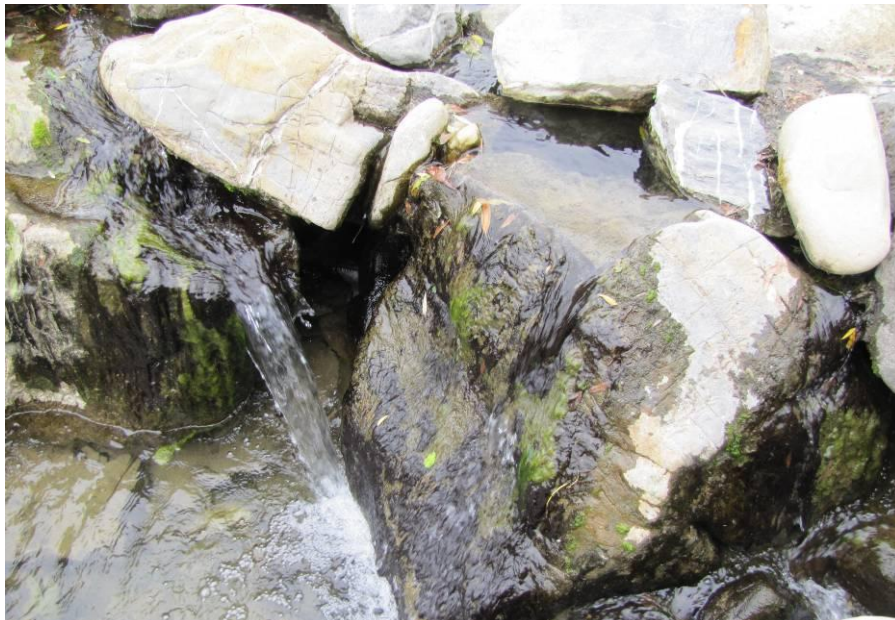
Like the lower Waimea River, the lower Wai-iti has relatively high coverage of the toxic algae *Phormidium* during stable base flows in late spring to early autumn. This toxic algae is implicated in the deaths of two young dogs on this river in November 2012 and December 2014. No dog deaths were reported for this catchment prior to that period. There is also the possibility of other factors to do with the nutrients from the Wai-iti River (may be related to the release of water from the Wai-iti dam) that might favour *Phormidium* growth. Another possibility would be the reduction in shear stress as the area coincides with the zone where river water is lost to ground (i.e. the river leaks to the groundwater below).

***Phormidium* (the black growth) on the Wai-iti River weir downstream Waimea West Rd.**

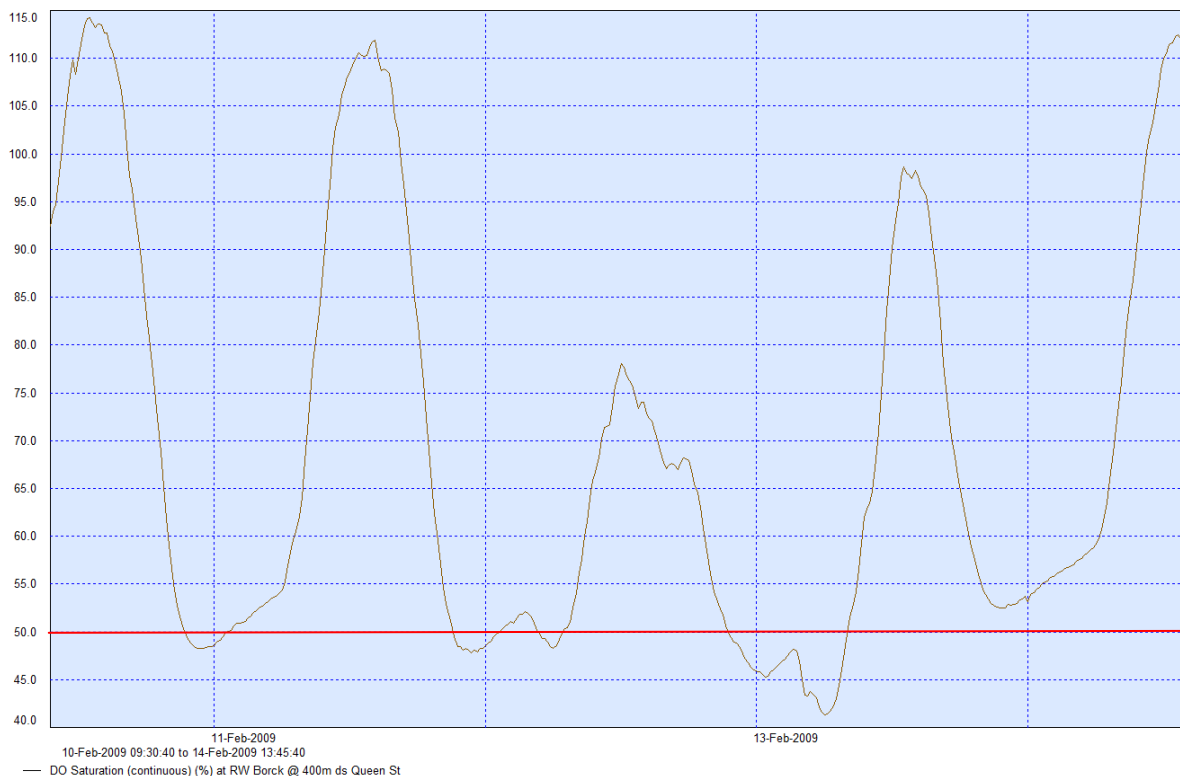
**Dissolved oxygen** daily minima in lower Borck Creek were found to be regularly around 50% saturation (10-14 Feb, 2009). The bottom of the curves are reasonably flat indicating that there is reasonable aeration and limited reservoirs of organic matter with high biological oxygen demand.

**Figure 14. Dissolved oxygen percent saturation at Borck Creek at 400 m downstream Lower Queen St (10-4 February, 2009). The national proposed bottom line for the daily 1-day minimum is shown by the red line.**

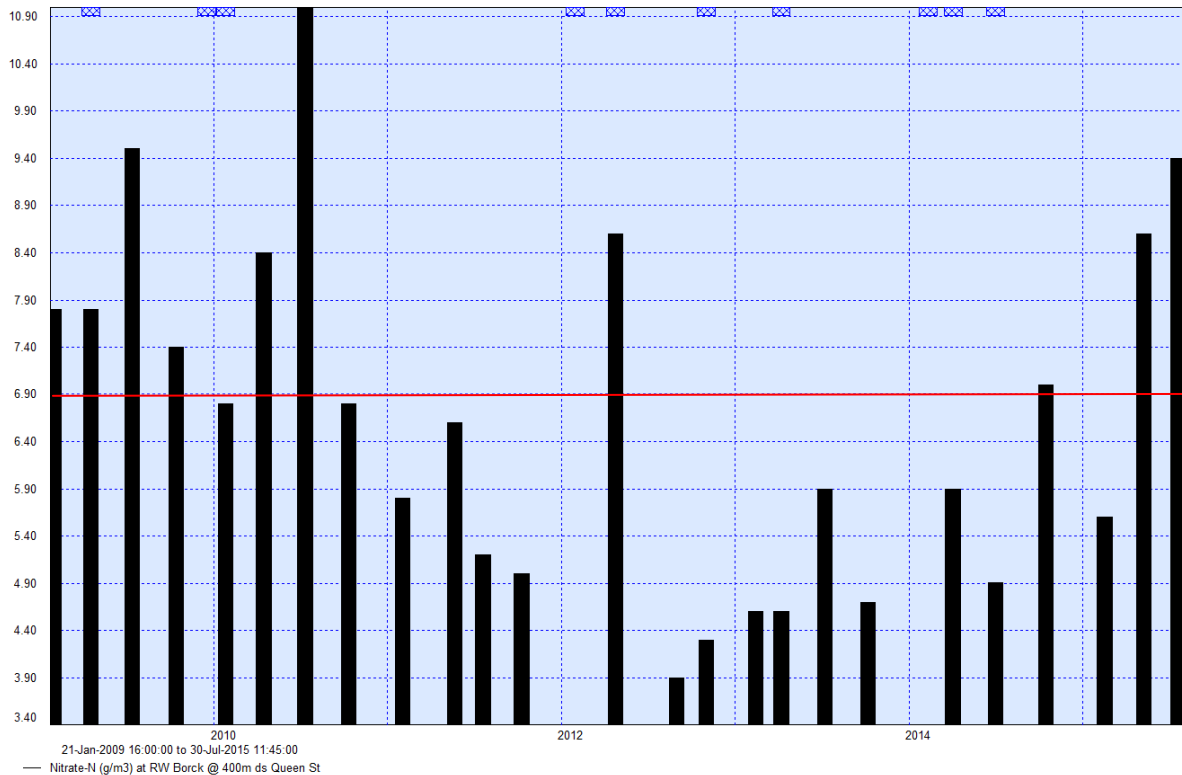
monitoring of water quality only began in this creek in 2009, the creek water consistently shows very **high concentrations of nitrate** (median nitrate-N: 5.8 g/m<sup>3</sup> from 2009-2015, moderately high concentrations of disease-causing organisms (median 2009-2015: 380 *E.coli*/100 ml) and poor macroinvertebrate condition (MCI score 76).

Figure 15 Nitrate-N concentrations in Borck Creek 400 m downstream Lower Queen St (2009-2015). The national bottom line is shown by the red line.

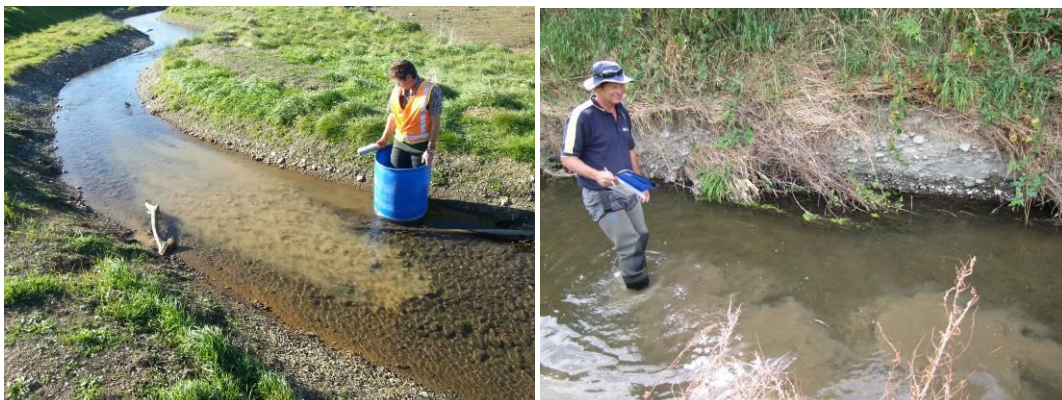
Fine sediment almost completely fills the spaces between the cobbles of the bed in Borck Creek. **Suspendable Bed Sediment Volume (SBSV) in lower Borck Creek is very high** (mean of 6 replicates range 23-57 l/m<sup>3</sup> (2013 and 2015); see photos below). Following the new channel commissioning an even greater proportion of fine sediment was found (69 and 124 l/m<sup>3</sup>) even though 100 mm of clean gravel was added to the new stream bed. This seems to be because the fine sediment composition of the base layer is very high and the depth that this procedure stirred to was 150-180 mm (below the layer of clean gravels).

Resuspending the fine sediment in Borck Ck 400 m downstream Queen St. Left: May 2015 following diversion into a new channel, Right: Old straight channel January 2012.

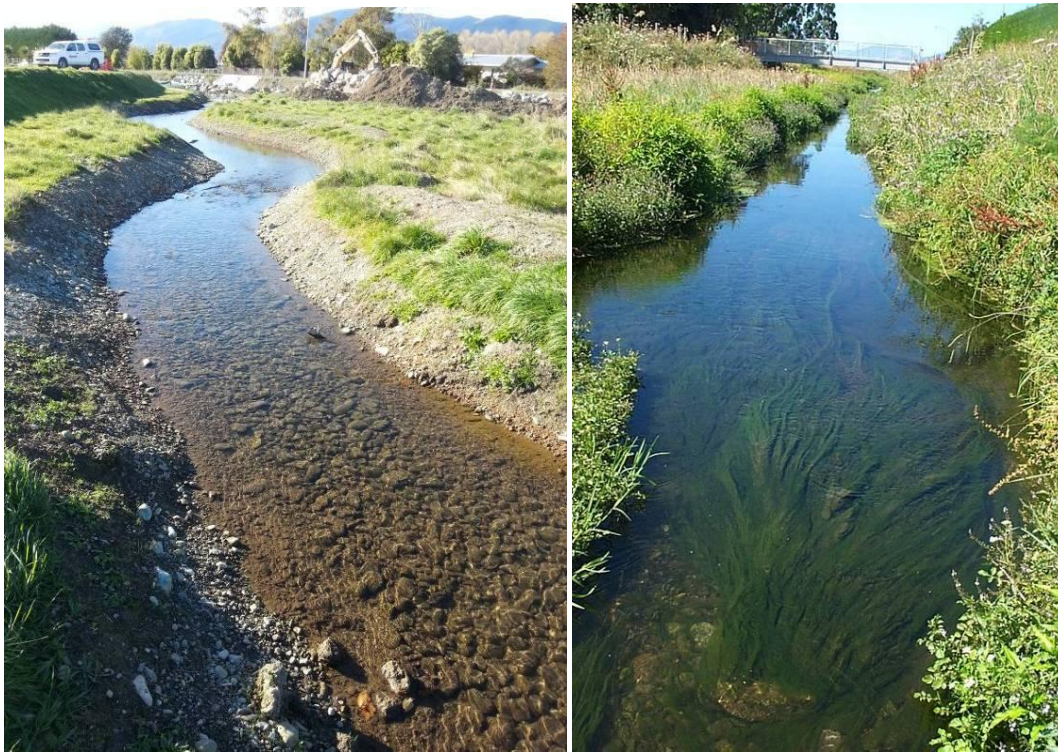
**Borck Ck 400 m downstream Queen St Left: May 2015 two months after the diversion into the meandering channel, Right: January 2009 showing extensive filamentous green algae cover.**

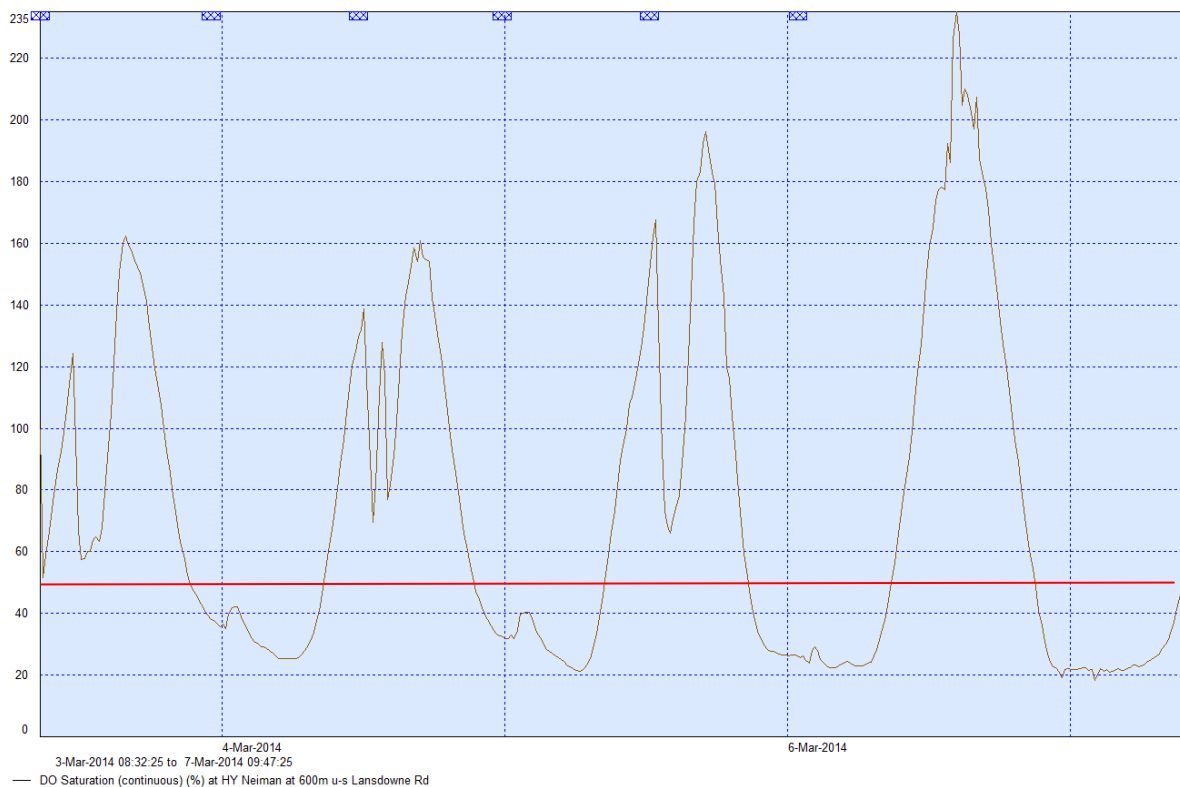
**Figure 16 Dissolved oxygen percent saturation at Neimann Creek at 400 m upstream Landsdowne Rd (3-7 March, 2014). The national proposed bottom line for the daily 1-day minimum is shown by the red line.**

Tidewater was found to influence the creek at the site 600 m upstream of Landsdowne Rd, as shown by the peaks in the conductivity plot (Figure 17). This tidewater temporarily lowered dissolved oxygen levels, hence the double peaks on 3, 4 and 5 March 2014. Without tidal influence this effect was not apparent i.e. on 6 March, 2014.

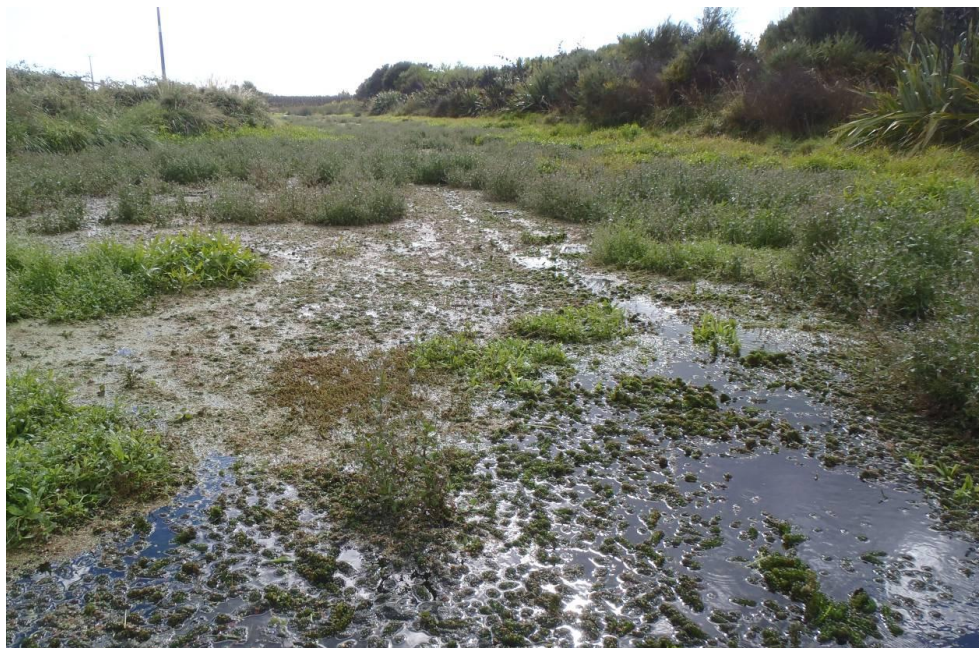
**Pearl Creek 200 m upstream tidegate, view downstream (March 2014). Note extensive aquatic plant growth including *Lagarosiphon major*.**

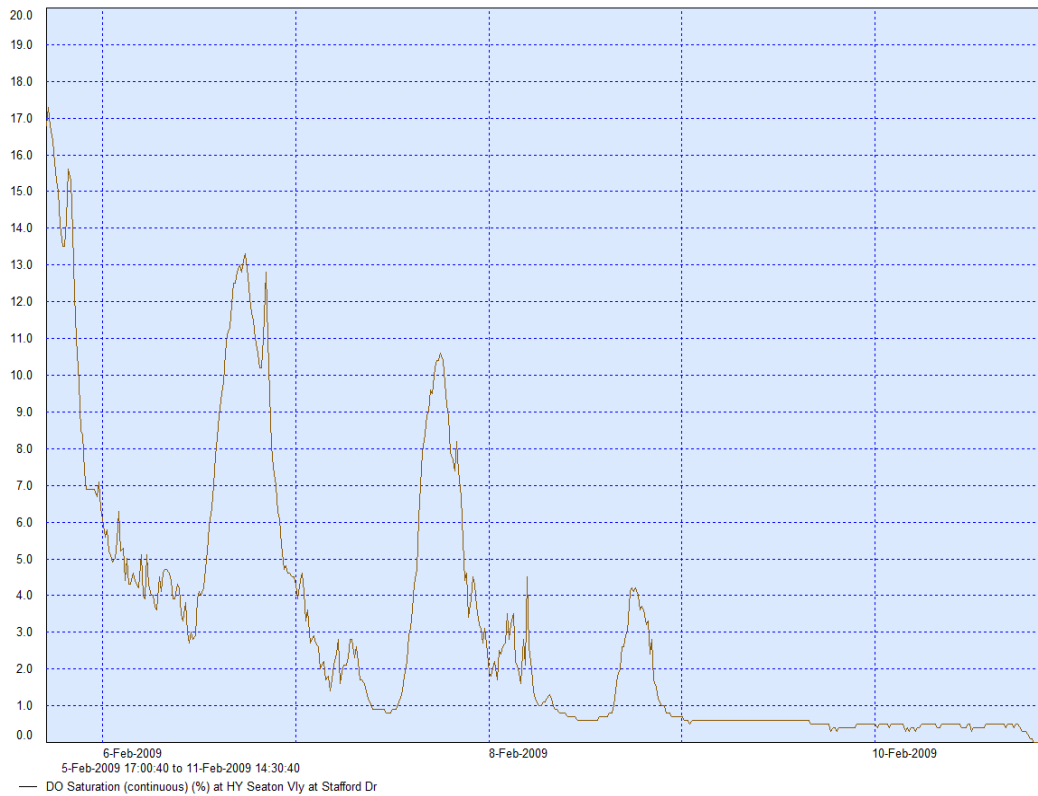
**Figure 21. Dissolved oxygen saturation (%) at Seaton Valley Stream at Stafford Dr, February 2009. The proposed national bottom line is 5g/m<sup>3</sup> (which usually equates to about 50% saturation).**
