## STAFF REPORT

**SUBJECT:** **IMPACT OF DISCHARGES FROM STORMWATER SYSTEMS ON STREAMS AND ESTUARY MARGINS IN RICHMOND: 2010 REPORT - REPORT REP10-07-07** - Report prepared for meeting of 1 July 2010

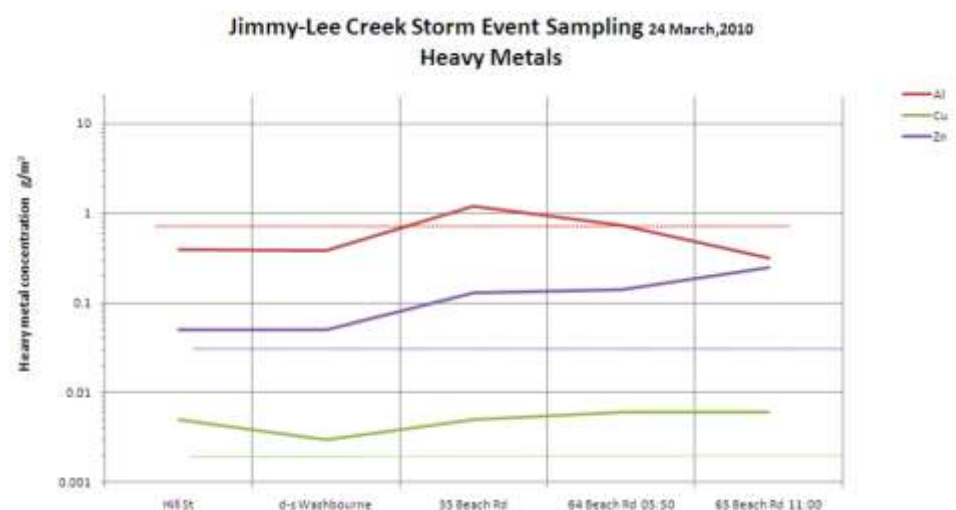
**Figure 3** Selected heavy metal concentrations (total, not soluble) from water samples from Jimmy-Lee Creek on 24 March, 2010. Dashed lines are the ANZECC guideline value for 90% level of protection; the colour of the dashed line relating to the specific metal identified by colour in the legend. Note: the scale is logarithmic (Base 10) and the lines appear flatter than for a normal scale.

Water samples from Jimmy-Lee Creek were slightly above ANZECC guidelines (90% level of ecosystem protection) for the heavy metals aluminium, copper and zinc at all sites, including the upstream reference site (see Figure 3). These metals are also the most soluble of the metals tested. However, when compared to guidelines for 80% level of ecosystem protection all these metals were at acceptable concentrations. Aluminium and zinc increased 2-3 times between the residential area (Washbourne Gardens) and industrial area (top end of Beach Road Drain). The concentrations of all other heavy metals were below detection levels and guidelines (for 90% protection) in the stream samples. Lead and nickel were above the guidelines in the road run-off sample.

Copper and chromium concentrations in Borck Creek at the Railway Reserve are almost 10x and 14x higher than Jimmy-Lee Creek respectively (and ~23x and 7.3x the guidelines for 90% protection respectively) downstream of a yard storing timber treated with copper-chrome-arsenic. It is likely that this yard is a significant contributor to this situation. Aluminium, cadmium and lead were also above this guideline with only aluminium being significantly above. This site on Borck Creek is also the only site sampled where arsenic and cadmium was above detection.

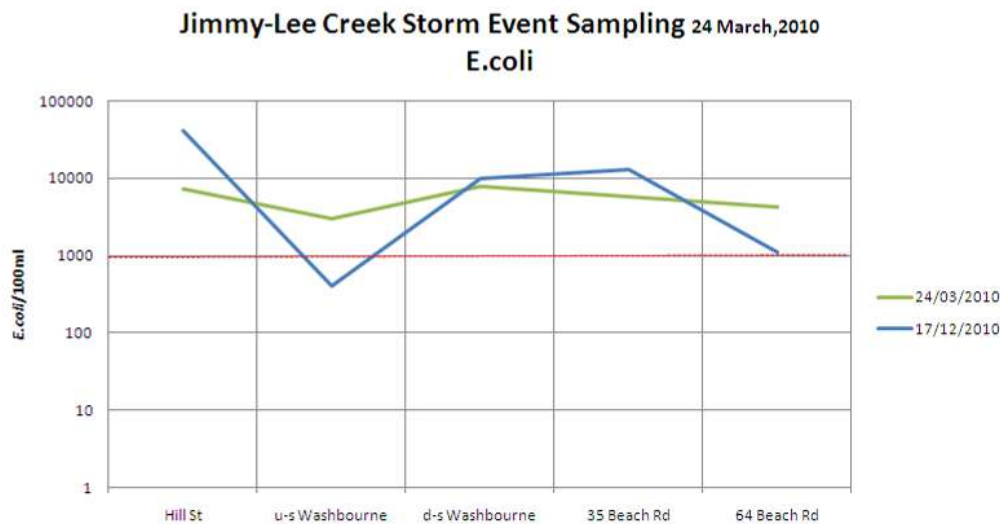
**Figure 4a:** *E.coli* concentrations on a longitudinal transect on Jimmy-Lee Creek during two separate stormwater events. The dashed red line is the stock drinking water guidelines (ANZECC 2000). Note: the scale is logarithmic (base 10) and the lines appear flatter than for a normal scale.

Faecal bacteria in Jimmy-Lee Creek were elevated at the upstream reference site (upstream Hill Street) and generally decreased downstream with the exception of a spike from a source in Washbourne Gardens where *E.coli* concentrations more than doubled (see Figure 4a).

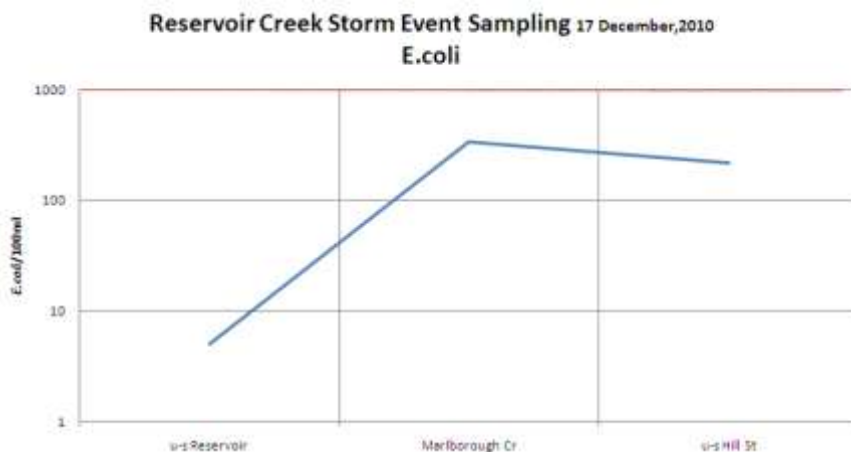
**Figure 4b:** *E.coli* concentrations on a longitudinal transect on Reservoir Creek during a stormwater event on 17 December, 2009. The dashed red line is the stock drinking water guidelines (ANZECC 2000). Note: the scale is logarithmic (base 10)

*E.coli* concentrations in Reservoir Creek at Easby Park (upstream Marlborough Cres) were similar to that in Jimmy-Lee Creek on 24/03/2010. A sample taken upstream of the Reservoir on 17/12/09 showed much lower concentrations (at detection).

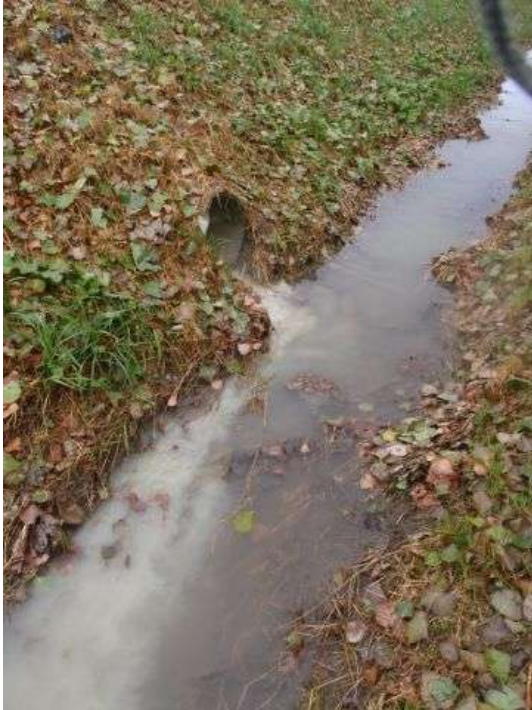
Figure 5a Discharge to Borck Creek downstream Gladstone Road on the Railway Reserve

While sampling during the March storm event two particularly conspicuous discharges from industrial areas were evident. One discharge was moderately alkaline bright, white-coloured appeared to originate from a cement fabricator on Gladstone Road discharging to Borck Creek (see Figure 5a). The other discharge was a petroleum slick from a coolstore on Beach Road to Jimmy-Lee Creek. Both these discharges were followed up by Council's compliance team (see Figure 5b).

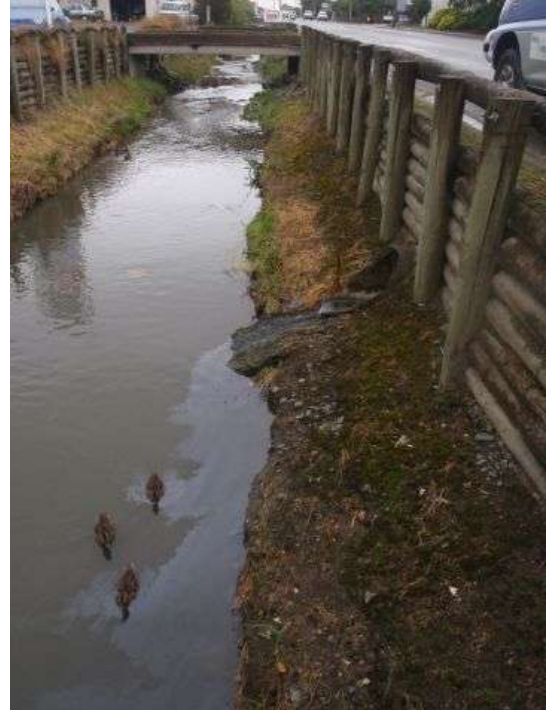
Figure 5b Petroleum sheen from a discharge near 64 Beach Road

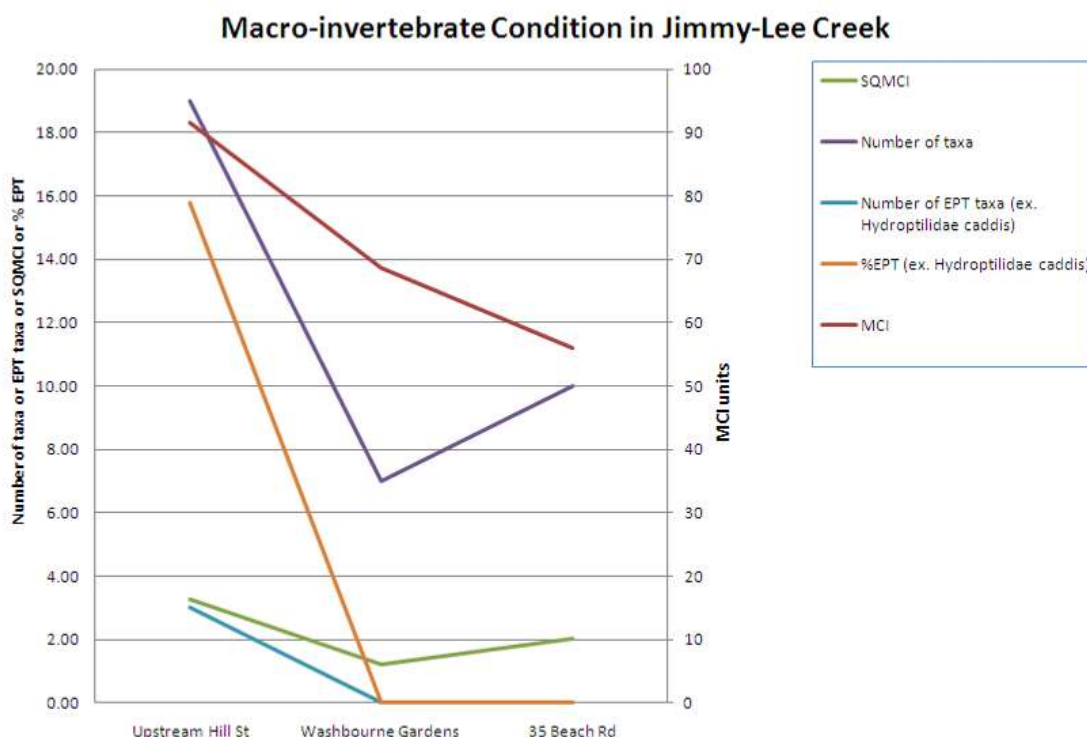
**Figure 6** Five metrics of macro-invertebrate condition along a longitudinal transect of Jimmy-Lee Creek.

The middle and lower part (downstream Washbourne Drive and along Beach Road respectively) of Jimmy-Lee Creek had very poor macro-invertebrate condition compared to the upper part (upstream Hill Street)(see Figure 6). The habitat at the Washbourne Gardens was characterised by a high fine-sediment load and high turbidity.

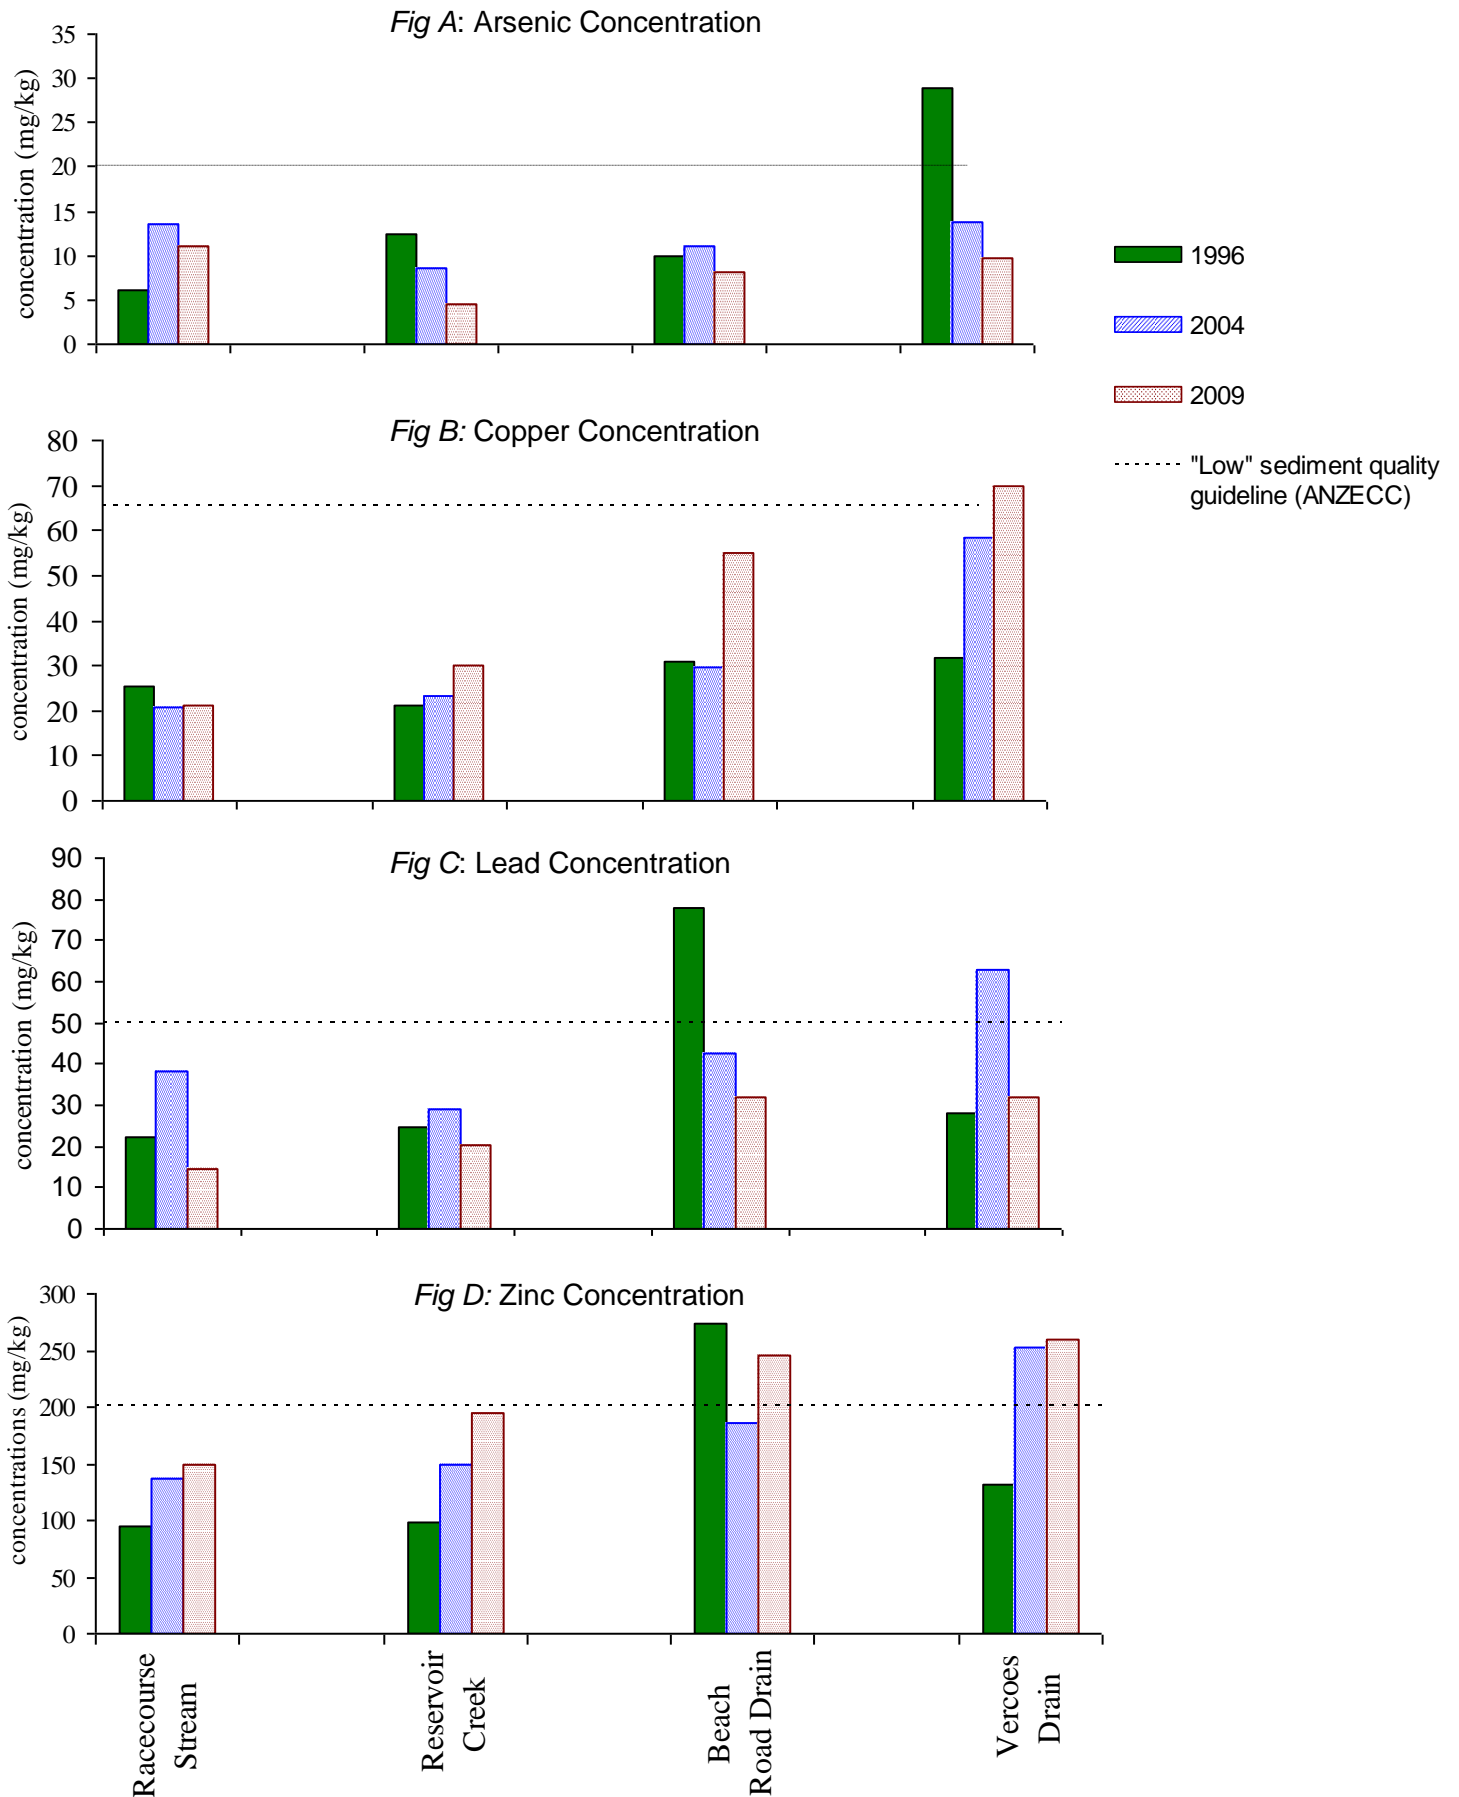
Fig7: Selected heavy metal concentrations in sediments at four locations  
1996-2009

There are only four sites that have been sampled in 1996, 2004 and 2009, and the results for four heavy metals are plotted in Figure 7. This provides a graphic comparison between the residential stream Reservoir Creek, and the commercial and industrial Beach Road and Vercoe Drains.

It can be seen in Figure 7(A) there is a marked decline in Vercoes Drain where the closure of a tanalising timber treatment facility has removed that source of arsenic. There is a slight reduction in the residential Reservoir creek, and the reason is not known.

Since 1996 copper has increased in the two industrial catchments, but the sources are not known. Figure 7(B). The timber treatment plant would have been contributing less over time (as for arsenic) but another industry may be discharging more.

Figure 7(C) shows a marked reduction in lead from the two industrial Drains.

There is an increasing trend for zinc concentrations since 1996 (see Figure 7(D) in urban catchments, presumably from vehicle brake linings and emissions, and this reflects the increase in traffic density in Richmond. The pattern with Beach Road may reflect the higher usage of a transport yard and vehicle washes going to stormwater in 1996. The sediments from mainly rural catchments Racecourse stream, Borck creek, and NPI culvert had complying concentrations of zinc, see Appendix A3.

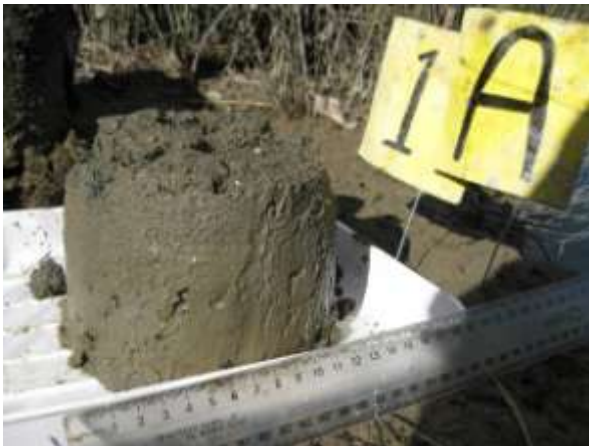
Sediment core from urban stream (Reservoir Creek)

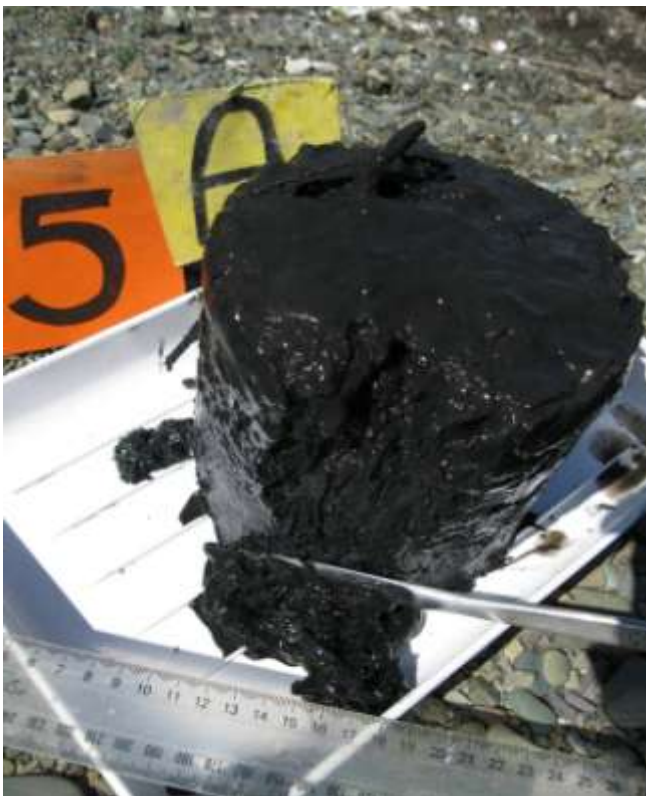
Anoxic sediment core from Nth RTS

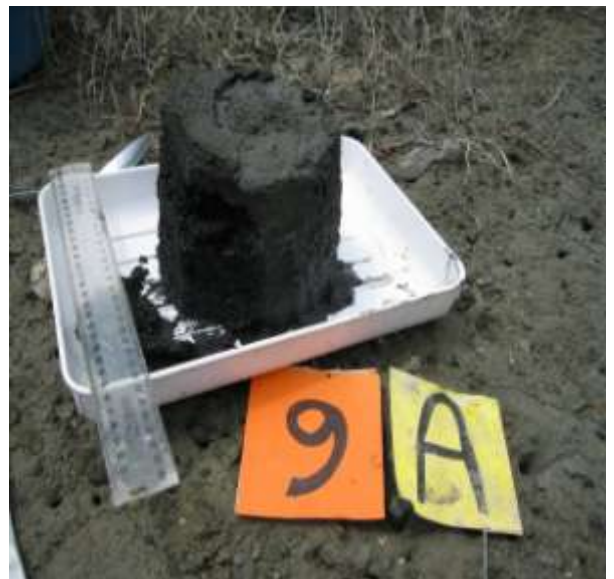
Anoxic core from Dynea culvert

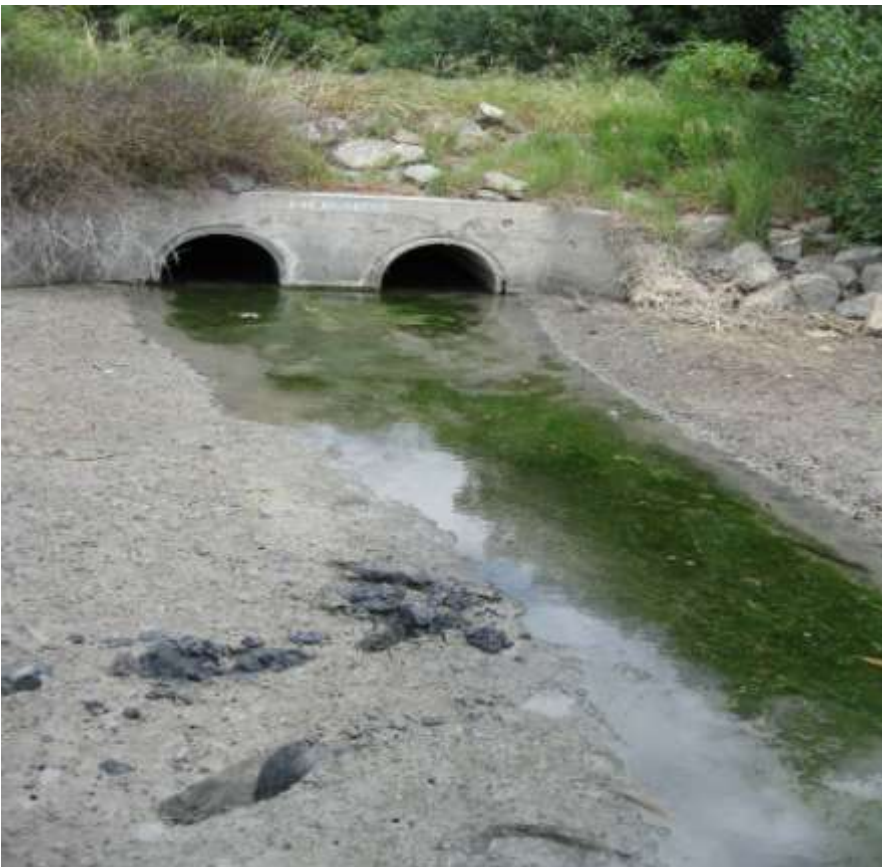
Soft mud at Dynea culvert sample site
