State of the Environment Monitoring of Waimea Estuary: Broad Scale Habitat Mapping 2007

Prepared for
Tasman District Council and Nelson City Council

Clark K, Gillespie P, Forrest R, Asher R 2008. State of the Environment Monitoring of Waimea Estuary: Broad Scale Habitat Mapping 2007. Prepared for Tasman District Council and Nelson City Council. Cawthron Report No. 1473. 24 p

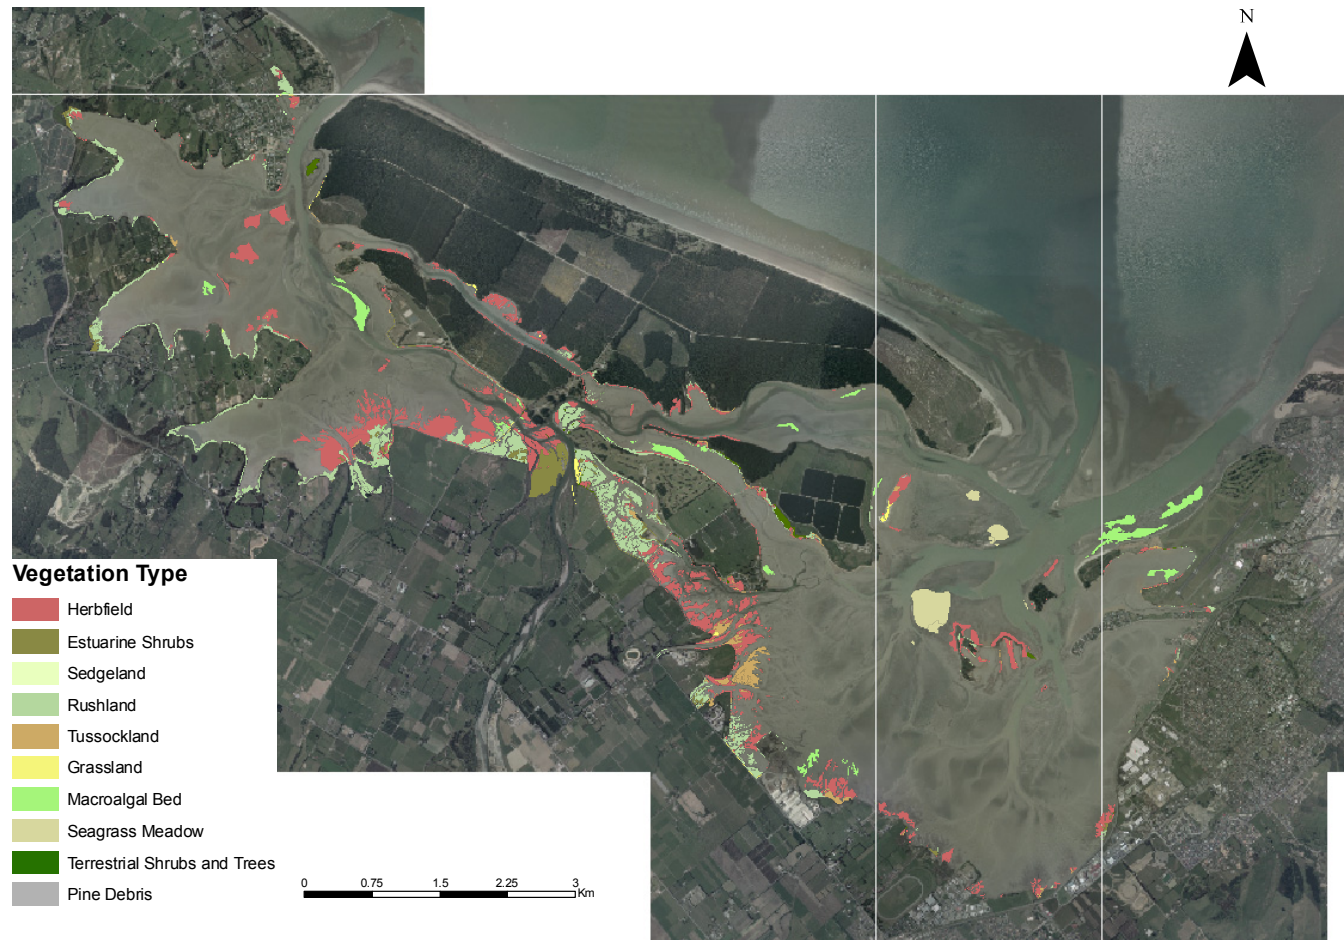
Vegetated habitats within and surrounding the estuary showed considerable complexity with most classification categories present; including Grassland, Shrubland, Tussockland, Rushland, Herbfield, Eelgrass meadows, Sedgeland, Estuarine Shrubs and Terrestrial Shrubs and Trees. Within the vegetated habitats, the most common classification was Herbfield (154 ha, 43%), with the dominant species being *Sarcocornia quinqueflora* (glasswort) found mainly along the estuary margins. Also very common was Rushland (101 ha, 28%), dominated by *Juncus kraussii* (searush) and *Leptocarpus similis* (jointed wirerush). Macroalgal beds, dominated by *Enteromorpha* sp and/or *Ulva* sp. and *Gracilaria chilensis*, covered a moderate area at the time of the survey (33 ha, 9%), however it must be recognised that coverage of these species can fluctuate considerably over the short term (*i.e.* weeks to months). Eelgrass meadows (*Zostera* sp.), although relatively less abundant, covered an ecologically significant area of 21 ha or 5.8% of the vegetated substrata.

Figure 4. Aerial photograph of Waimea Inlet showing vegetation present in November 2006.

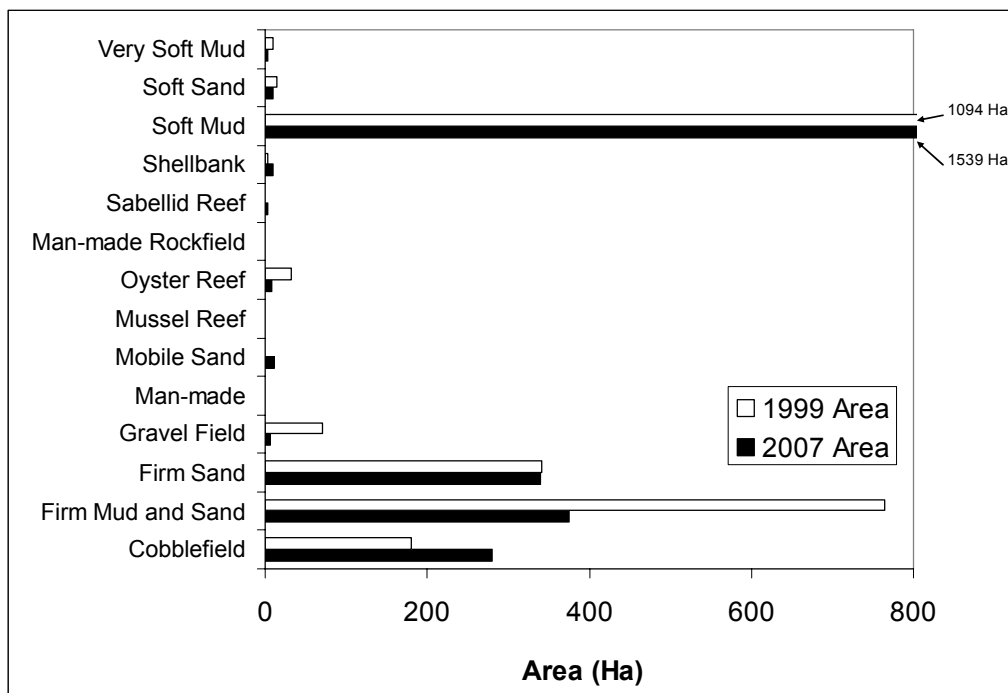
The area of soft mud was significantly increased from 1999 to 2006 (Figure 5), however, during the same period, the area recorded as firm mud/sand decreased significantly. Similarly gravel field areas decreased while cobble fields increased. Although these changes may be at least partly due to slight differences in methodology between years, it is likely that the Inlet has become muddier over time.

Figure 5. The area of unvegetated class habitats (based on dominant substrate type) in the Waimea Inlet in 1999 and 2006.

al. (2002) and it represents an expansion of 12% compared to that observed in 1999. These results suggest that sediment depositional rates may be increasing, resulting in adverse ecological effects to some estuary habitats. Alternatively, historical accretion of fine sediments within areas of invasive *Spartina* marsh (and subsequent remobilisation after eradication during the mid 1980s) may also have contributed to the increased “muddiness”.

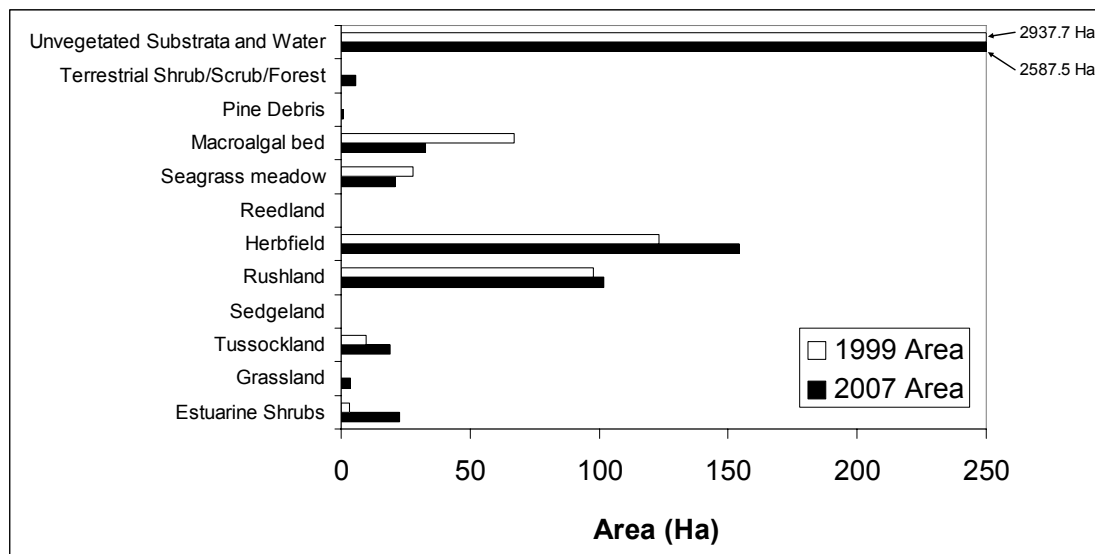
Herbfield areas dominated by *Sarcocornia quinqueflora* (glasswort) were significantly greater in 2006 than the previous survey (Figure 6). This change was at least partially the result of a “softening” of the upper intertidal boundary in some regions (e.g. the Traverse) due to tidal erosion of supra-tidal shore gradients.

Figure 6. The area of structural class habitats (based on dominant vegetative cover) in the Waimea Inlet in 1999 and November 2006.

Rushland (primarily *Juncus* marsh), Tussockland, Grassland and Estuarine shrub-covered areas also increased 1999 to 2006 but to a lesser extent. Although these increases may have been partly due to personnel changes between the two surveys, they are likely also partly related to the same erosional mechanism.

Macroalgal beds were reduced from the 1999 survey as was the total area of unvegetated substrate. Since macroalgal beds can vary considerably both seasonally and between years their reduction is not surprising. Of more concern would be a major increase in macroalgal coverage that could be indicative of over enrichment. Although this was not observed, interpretation of such changes would require a targeted, more detailed monitoring approach.

A small reduction in the areal coverage of eelgrass meadows was also observed. This is probably explainable by natural variation, however long-term continuation of this trend in conjunction with later surveys could be indicative of a negative impact. A more focused assessment of changes in eelgrass habitat in the Bell Island region, using the maps produced
