Synoptic assessment of ecological status of the southwest embayment of Kaiteriteri Estuary

Prepared for
Tasman District Council
March 2023

Salt Ecology
Report 109

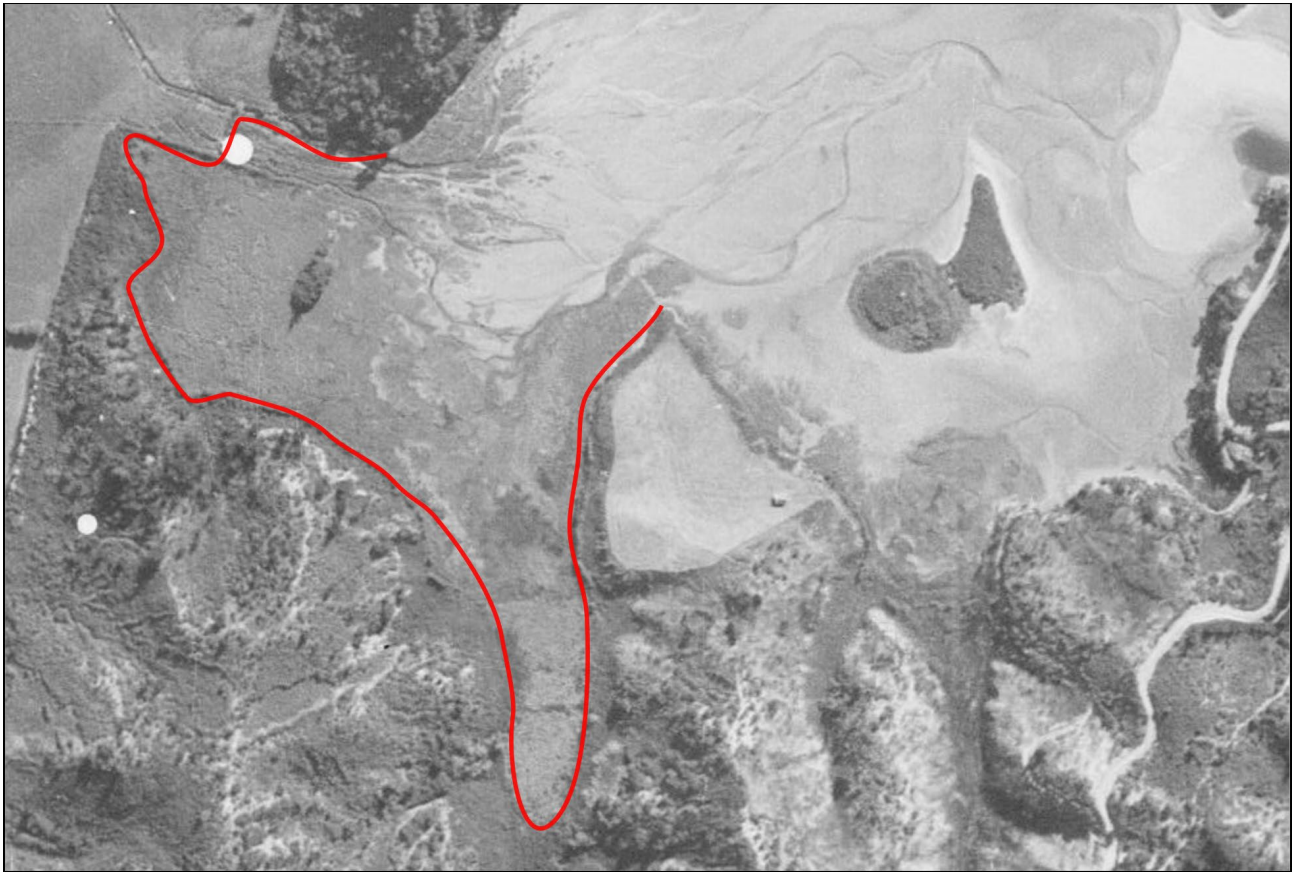
Figs 2 and 3 indicate that the Martin Farm Road causeway was constructed between 1944 and 1947, at a time when the present-day embayment and reclaimed land to the west appears to have been dominated by salt marsh and was part of the main tidal estuary.

Fig. 2. Kaiteriteri Estuary in 1944 (source: <http://retrolens.nz>), before construction of the Martin Farm Road causeway. The wider embayment (approximated by red line) comprised mainly intertidal salt marsh.

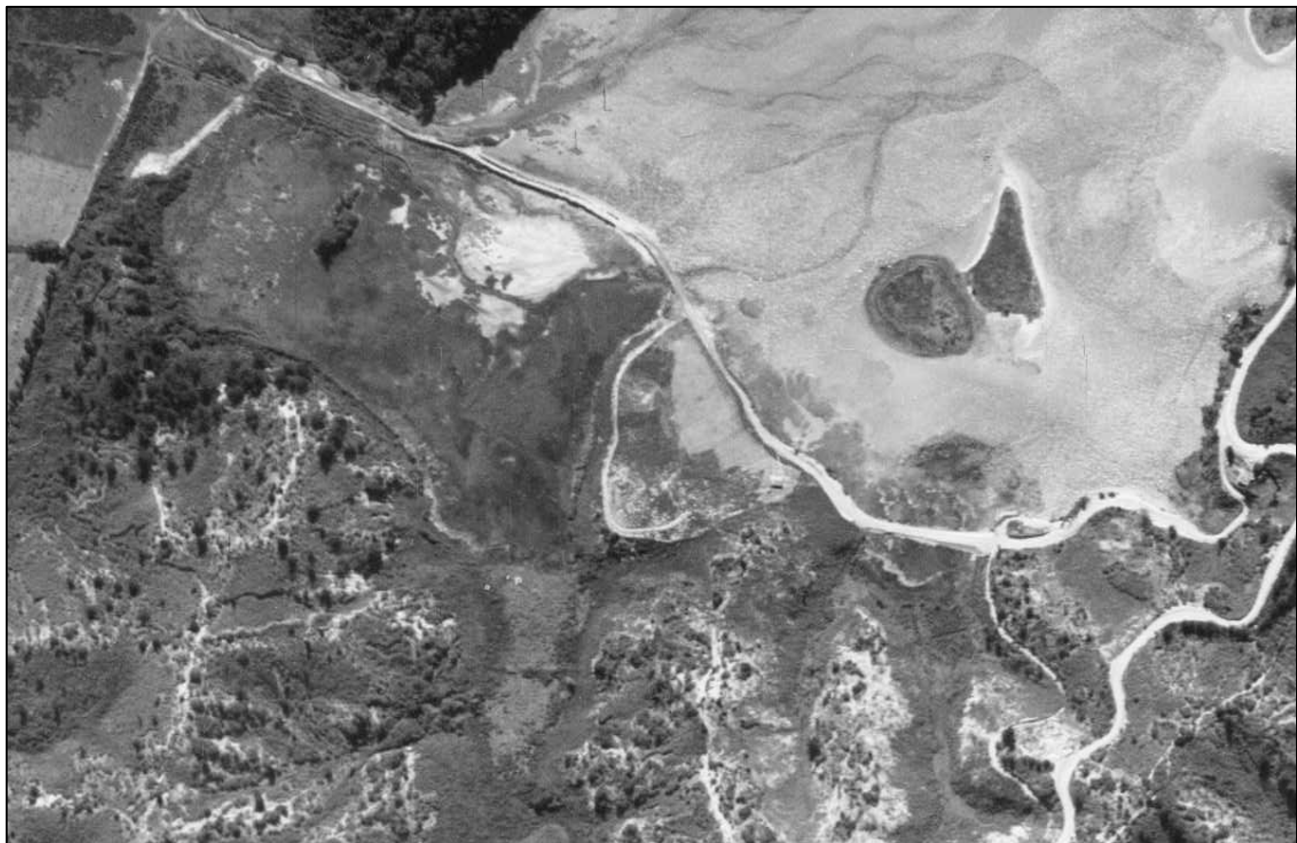
Fig. 3. Kaiteriteri Estuary in 1947 (source: <http://retrolens.nz>). The Martin Farm Road causeway separates the southwest embayment from the main estuary.

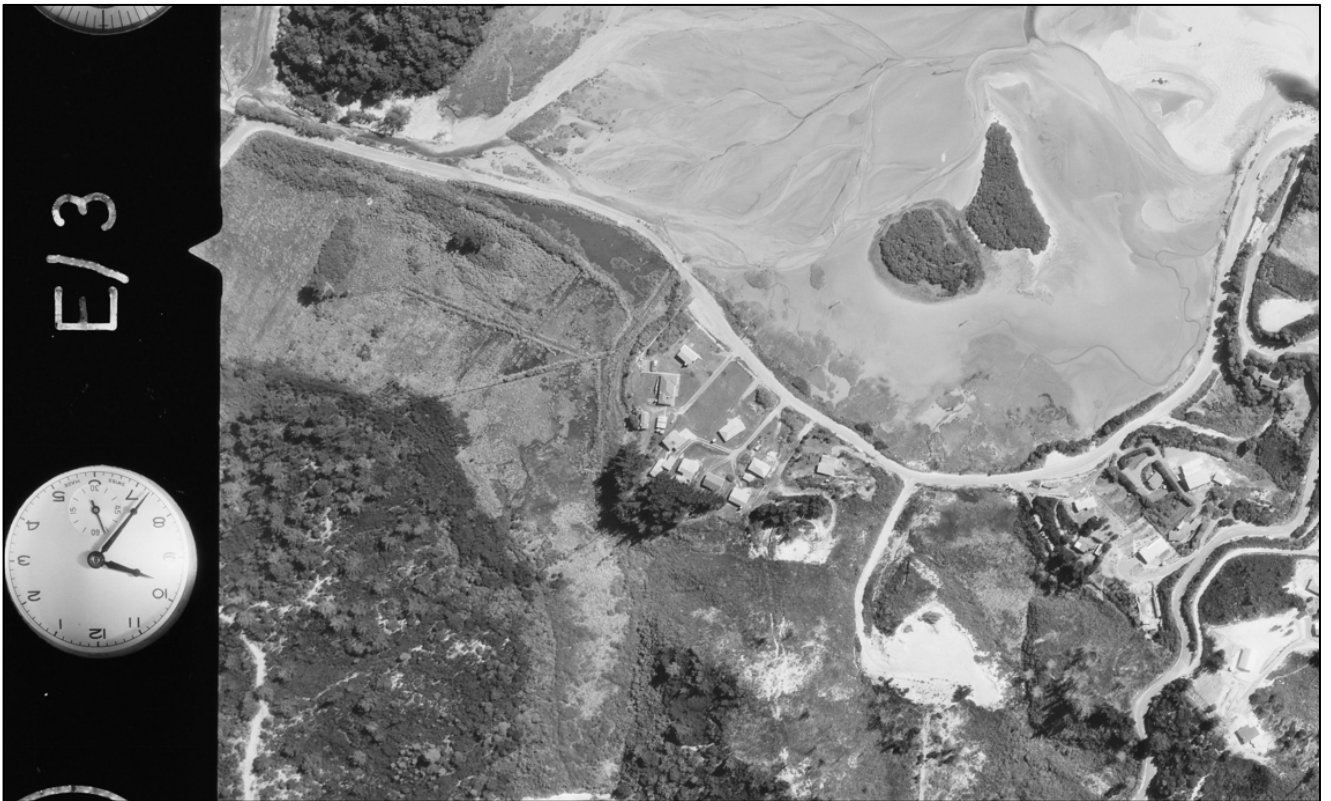
Images from about 1958 show the appearance of channels, presumably used to drain water from the embayment in order to convert it to farmland. The 1969 image shows multiple channels among what appears to be rough pasture and remnant salt marsh (Fig. 4).

Fig. 4. Kaiteriteri Estuary in 1969 (source: <http://retrolens.nz>). Embayment centre-left comprising rough pasture and remnant salt marsh. Drainage channels evident here appear in imagery as early as 1958. Rough pasture still evident through to 1980.

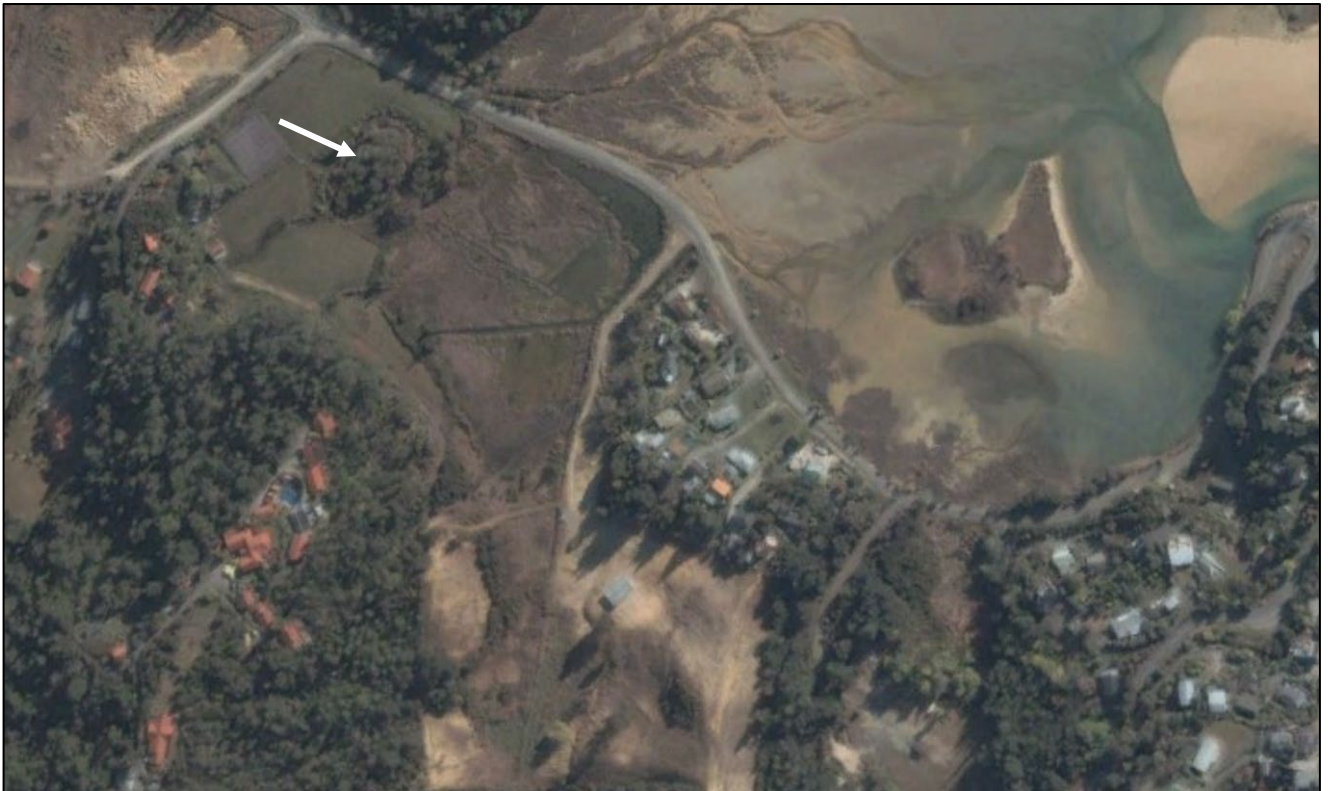
Photos taken over 2002-2006 indicate that there had been considerable re-establishment of previously lost salt marsh along the eastern side of the embayment, although salt marsh subsequently decreased between 2003 (Fig. 5) and 2011 (Fig. 6), with ponded water apparent in some areas. This decrease in salt marsh extent appears to be associated with the installation of five culverts beneath Martin Farm Rd in 2007, which was undertaken to "improve stormwater drainage from the catchments on the south side of Kaiteriteri Inlet and improve tidal flow through to the lagoon..." (TDC 2007).

Fig. 5. Kaiteriteri Estuary in 2003 (source: Google Earth Historic Imagery). Half of the embayment (western side) remains in pasture, with much of the eastern half having reverted to salt marsh. A constructed channel (oval shape indicated by arrow) is evident.

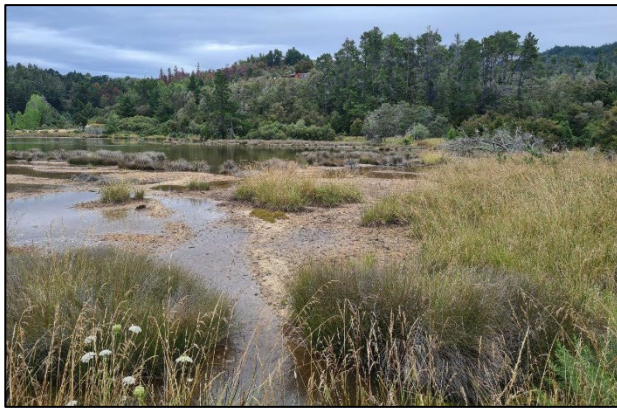
Superficially, the area of interest has a degraded appearance due to terrestrial weeds around the margin of the estuary, a fallen pine tree, and a constructed channel that was likely originally intended as an artificial wetland. Except for sand-dominated sediments in tidally-elevated areas in the northwest corner of the embayment, the sediment in the western side of the embayment consists of soft mud in a layer 50-250mm deep that overlies a firm base. The base material comprises soil with an entrained root mass, and is probably a remnant of the pasture and salt marsh habitats that have come and gone over time (Figs 2-7).

View of southwest embayment from Martin Farm Rd with rushland and sand-dominated sediments in northwest corner.

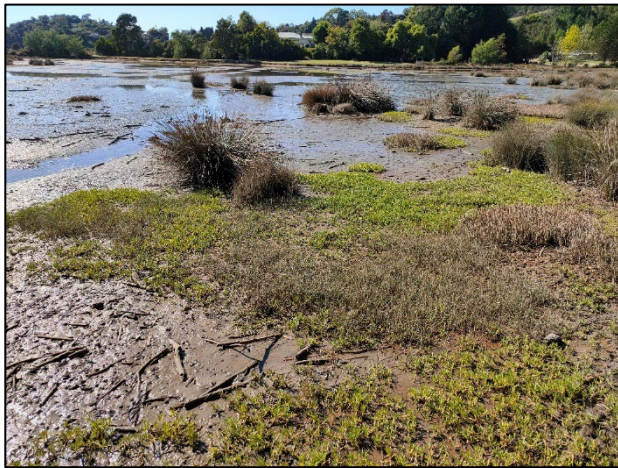
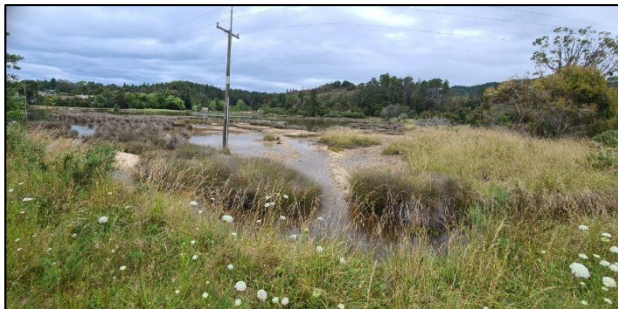
Outside of the degraded areas of muddy sediment, the western side of the embayment has a margin of salt marsh vegetation comprising mainly rushland (searush *Juncus kraussii* and jointed wirerush *Apodasmia similis*) but also including small areas of herbfield, in particular bachelor's button (*Cotula coronopifolia*), glasswort (*Sarcocornia quinqueflora*), and slender clubrush (*Isolepis cernua*).

Bachelors button and glasswort on the front edge of rushland along the western margin (top) and rushland with a terrestrial border of weeds and tall fescue (*Festuca arundinacea*; bottom)

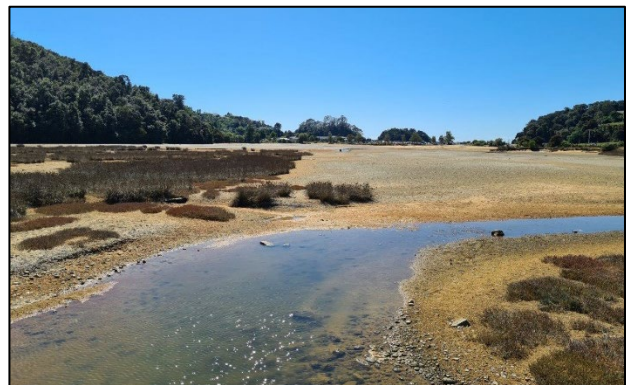
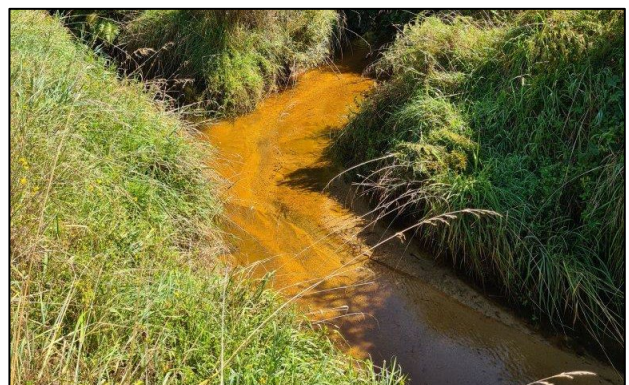
Salt marsh, and coarse granite sand habitats of the main Kaiteriteri Estuary and stream that runs parallel to the western end of Martin Farm Road
