23 March 2012

Ms Jenny Easton  
Tasman District Council  
Private Bag 4  
**RICHMOND 7050**

### **GROUNDWATER MONITORING AT FORMER FCC SITE, MAPUA – FEBRUARY 2012 SAMPLING UPDATE**

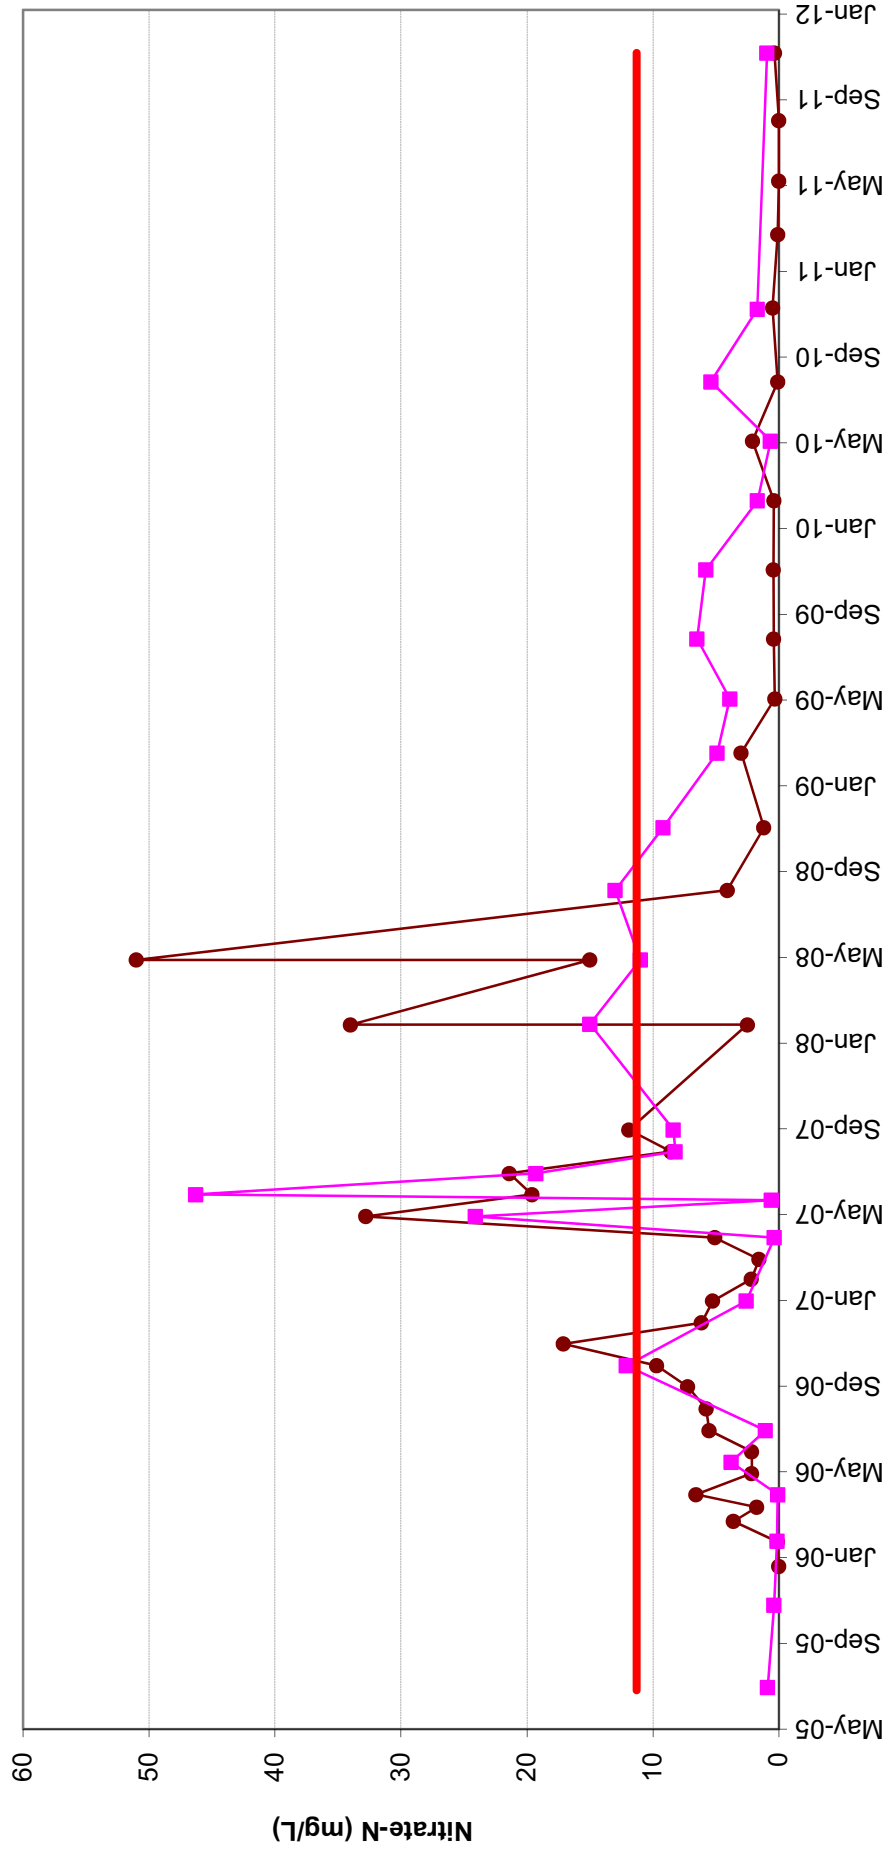
**Figure 2a. Nitrate-N**  
**MAV DWSNZ 11.3 mg/L**

- ∴ Figure 2 shows nitrate-nitrogen concentrations. Three boreholes have historically shown elevated concentrations: BH2, BH5 and BH9. Since late 2007, concentrations have decreased substantially, which coincides with the cessation of the MCD reactor in mid-2007. Despite this general decline, BH5 continues to show significantly elevated concentrations. During the last year, only BH5 and BH9 have had measured nitrate-N concentrations above the Maximum Acceptable Value in the Drinking Water Standards for New Zealand 2005 (Revised 2008), which is 11.3 mg/L. BH9 has one exceedance of the MAV in February 2011 (25 mg/L), with the remaining concentrations between 0.004 and 1.49 mg/L. BH5 recorded concentrations between 62 and 189 mg/L. Figure 2a shows the boreholes that have typically displayed lower nitrate-N concentrations. Both BH1 and 13 Tahī Street remain at stable, low concentrations;

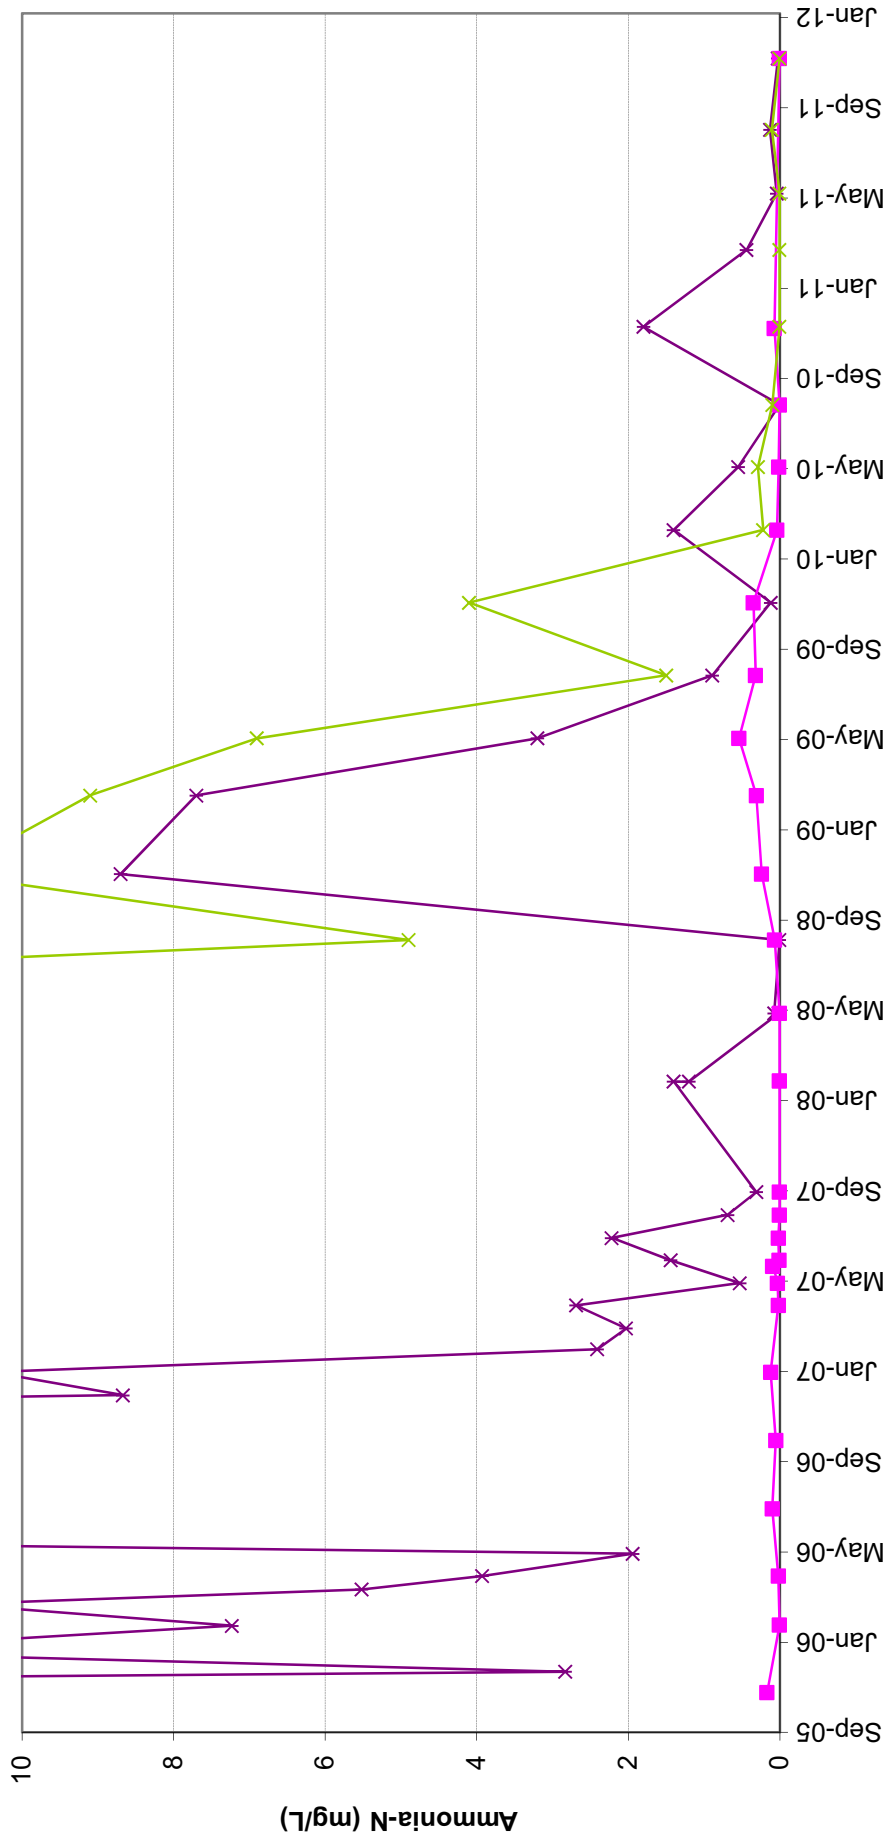
**Figure 3a. Ammonia-N  
GV Aesthetic DWSNZ 1.2 mg/L**

- ∴ Figure 3 shows ammonia-nitrogen concentrations. The bores with elevated concentrations (BH1 and BH2) have shown a small decrease over the last year. Those bores with lower ammonia-N concentrations (Figure 3a) show stable concentrations in BH5, BH9 and 13 Tahī Street.

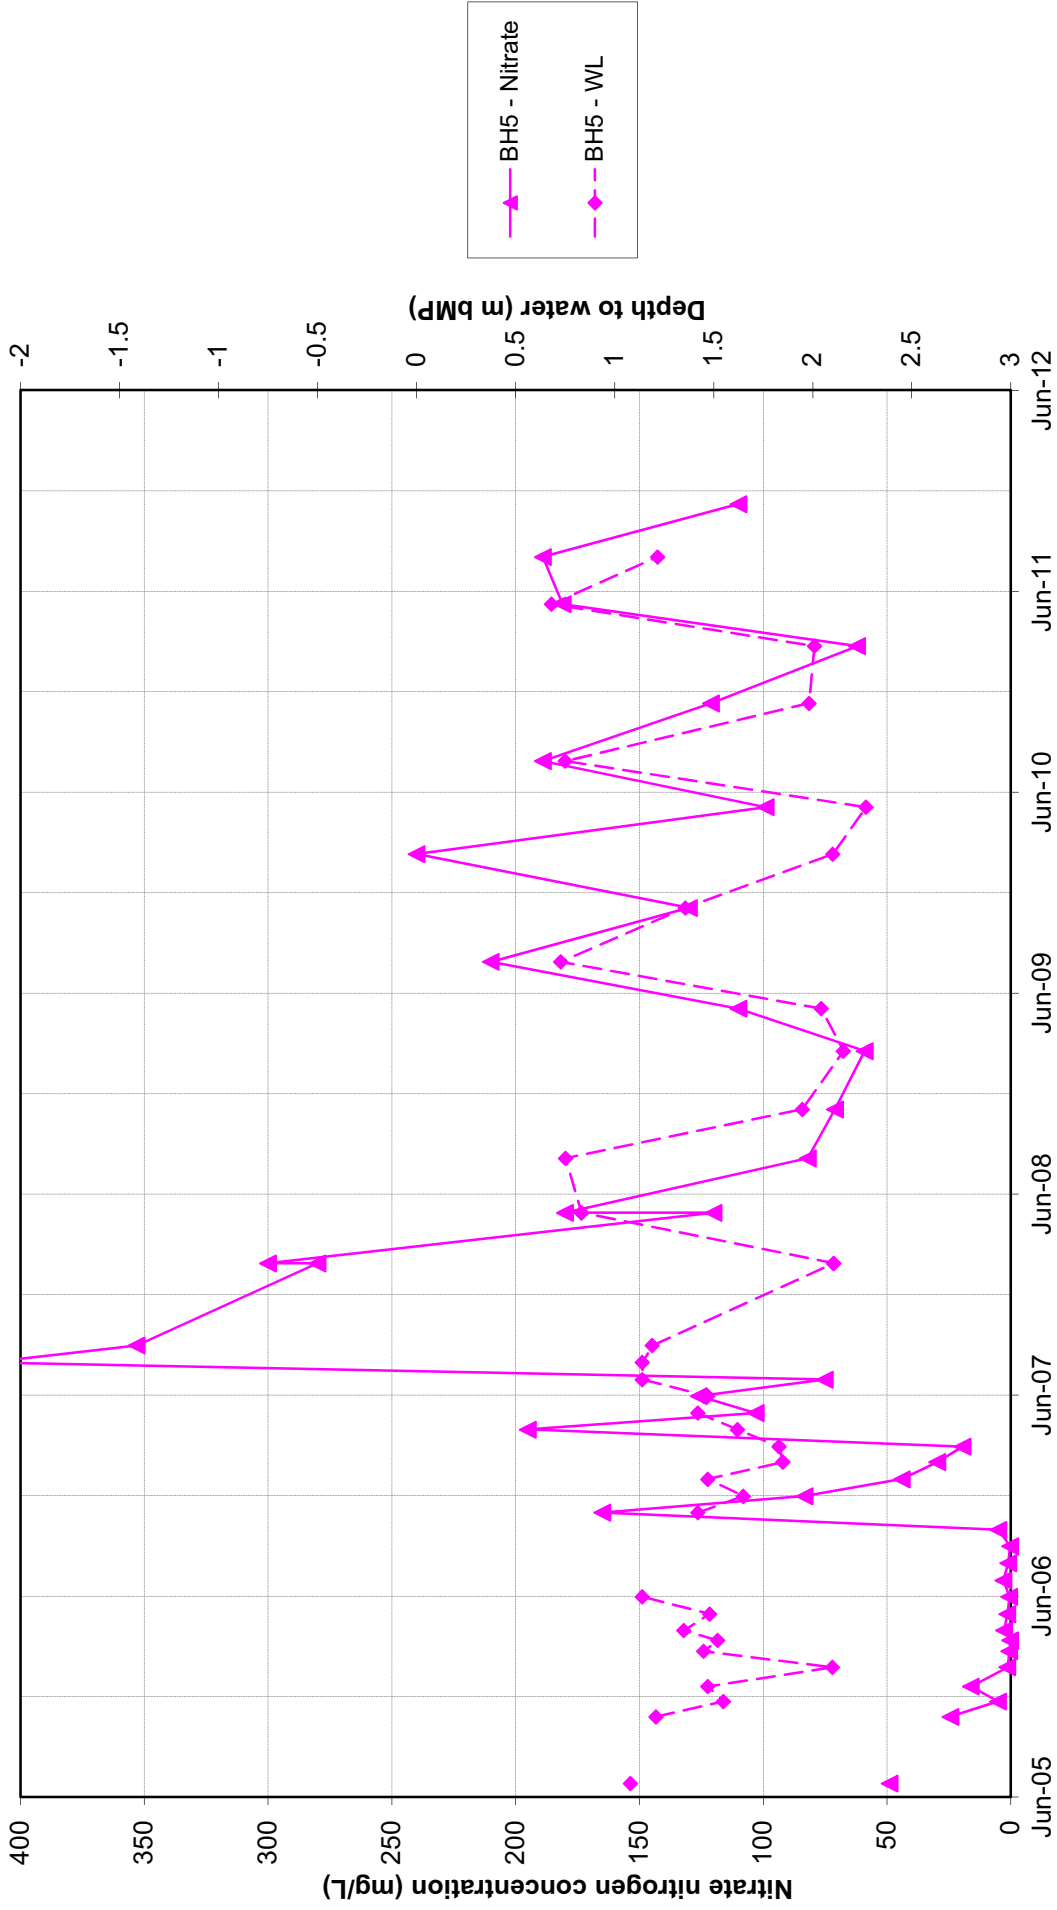
Figure 12. Nitrate vs Water Levels in BH5

Figure 11 shows a plot of depth to water in bores BH1 and BH5. During the last year water levels have fluctuated within their typical range in BH5, but have tended to be higher than average in BH1. Most chemical concentrations have been generally stable or shown a slight improving trend over the last year, with the exception of nitrate-N in BH5, DDX in BH1 and BH5 and aldrin + dieldrin in BH2 and BH5. It is expected that the more significant fluctuations in these bores are related to groundwater level fluctuations causing two contrasting mechanisms to operate. At times of low groundwater level, there is less groundwater throughflow to dilute the on-site concentrations. At times of high groundwater levels there will be some areas of the site where groundwater inundates the treated fines, or where there has been a time of increased infiltration, resulting in increased leaching of chemicals. Figure 12 shows the groundwater level and nitrate-N concentration in the bore showing the most significant fluctuations (BH5). Whilst water level fluctuations in this bore may be partly affected by the artificially placed bund and backfill material it does give an indication of the times of high and low groundwater levels. The resulting pattern in Figure 12 indicates a general pattern of increased nitrate at higher groundwater levels. Figures 13 and 14 show a more variable pattern for DDX and aldrin + dieldrin, with the peak concentrations tending to lag behind the groundwater level peaks.
