WAIMEA WATER AUGMENTATION
COMMITTEE

Lee Valley Dam Feasibility
Investigations
Geotechnical Investigation Report

December 2009

T&T Ref: 24727.204

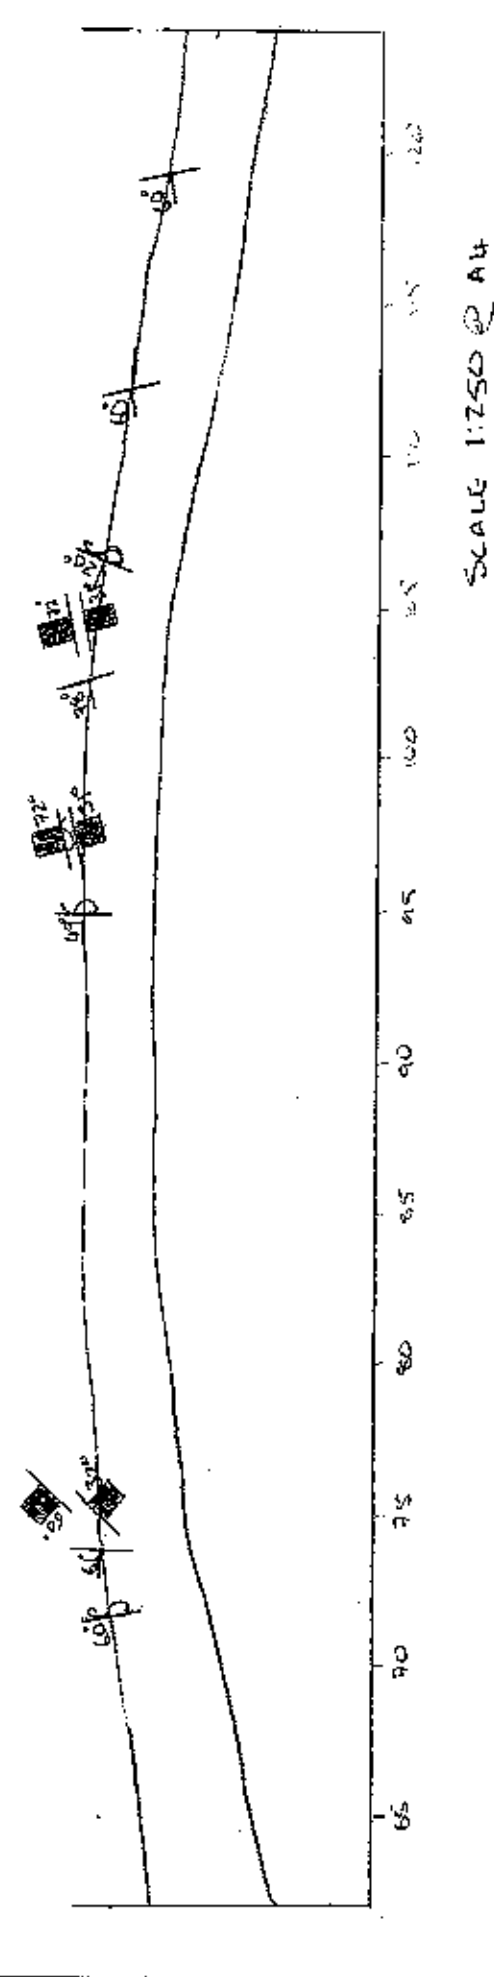
RIGHT ABUTMENT
UPPER FORESTERY ROAD MASS TYPICAL PLAN VIEW
CH 62m to CH 124m

- Rock is steeply dipping SW-SE to the maximum with an opposing northeast dipping sand slab. Blocky, B2 to B3.
- Rock mass is consist of fragments with improving spacing towards the centre of the section.
- No distinctive shear zones observed in trench.
