11 March 2013

Mr Glenn Stevens  
Tasman District Council  
Private Bag 4  
**RICHMOND 7050**

### **GROUNDWATER MONITORING AT FORMER FCC SITE, MAPUA – MARCH 2013 SAMPLING UPDATE**

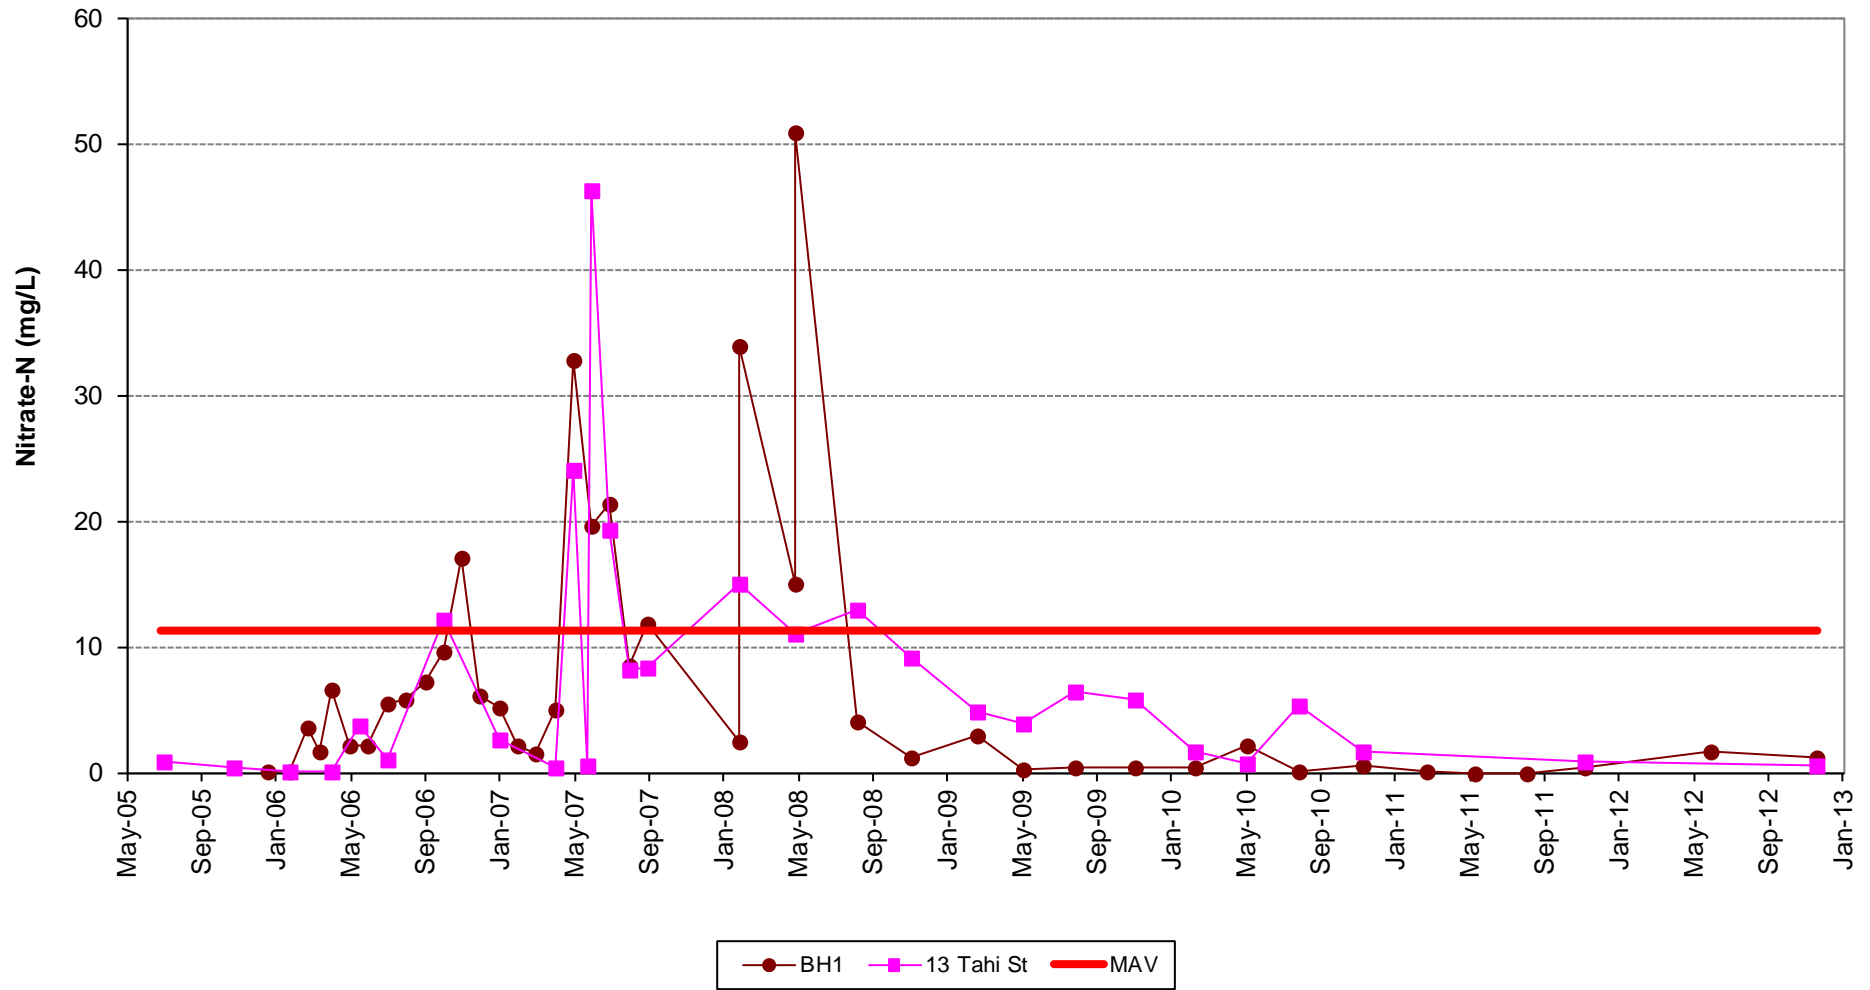
**Figure 2a. Nitrate-N**  
MAV DWSNZ 11.3 mg/L

Figure 2 shows nitrate-nitrogen concentrations. Three boreholes have historically shown elevated concentrations: BH2, BH5 and BH9. Since late 2007, concentrations have decreased substantially, which coincides with the cessation of the MCD reactor in mid-2007. Despite this general decline, BH5 continues to show significantly elevated concentrations. During the last year, only BH5 and BH9 have had measured nitrate-N concentrations above the Maximum Acceptable Value in the Drinking Water Standards for New Zealand 2005 (Revised 2008), which is 11.3 mg/L. BH9 had one exceedence of the MAV in November 2012 (19.9 mg/L), while the concentration in May 2012 was approximately half the MAV (6.4 mg/L). BH5 recorded concentrations of 74 mg/L in May 2012 and 47 mg/L in November 2012. Figure 2a shows the boreholes that have typically displayed lower nitrate-N concentrations. Both BH1 and 13 Tahi Street remain at stable, low concentrations significantly below the MAV.

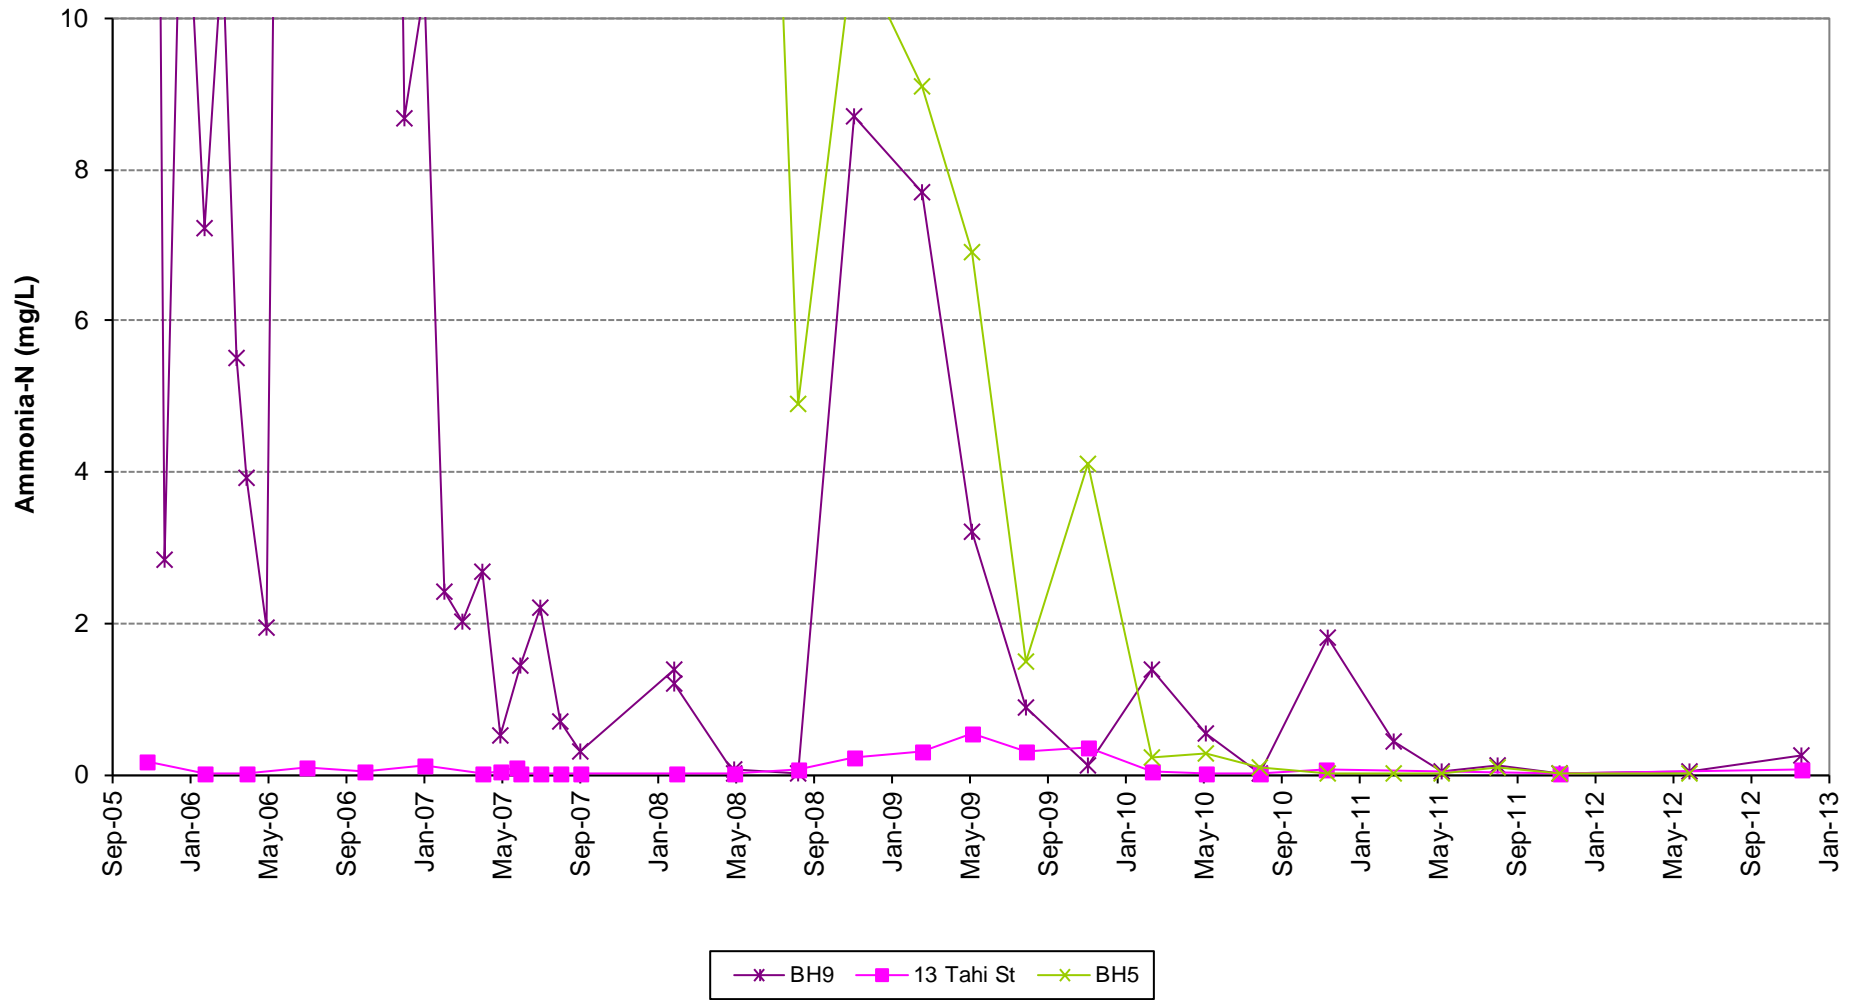
**Figure 3a. Ammonia-N**  
**GV Aesthetic DWSNZ 1.2 mg/L**

Figure 3 shows ammonia-nitrogen concentrations. The bores with elevated concentrations (BH1A and BH2A) have maintained stable levels and are very similar to the previous year. Those bores with lower ammonia-N concentrations (BH5, BH9 and 13 Tahi Street, see Figure 3a) maintain stable concentrations. The slight rise observed in BH9 in November 2012 to 0.25 mg/L is still significantly below the ANZECC Aquatic Ecosystem Guideline of 0.71 mg/L.
