## Engineering Services Committee ATTACHMENTS

SUBJECT: Fatal Crash 29/05/11 Moutere Highway/Golden Hills Road

### TRAFFIC CRASH REPORT

Moutere Highway/Waimca West Road, (Rust Corner) Proposed Roundabout Safety Audit Report  
 11802 Concept Safety Audit Report.docx

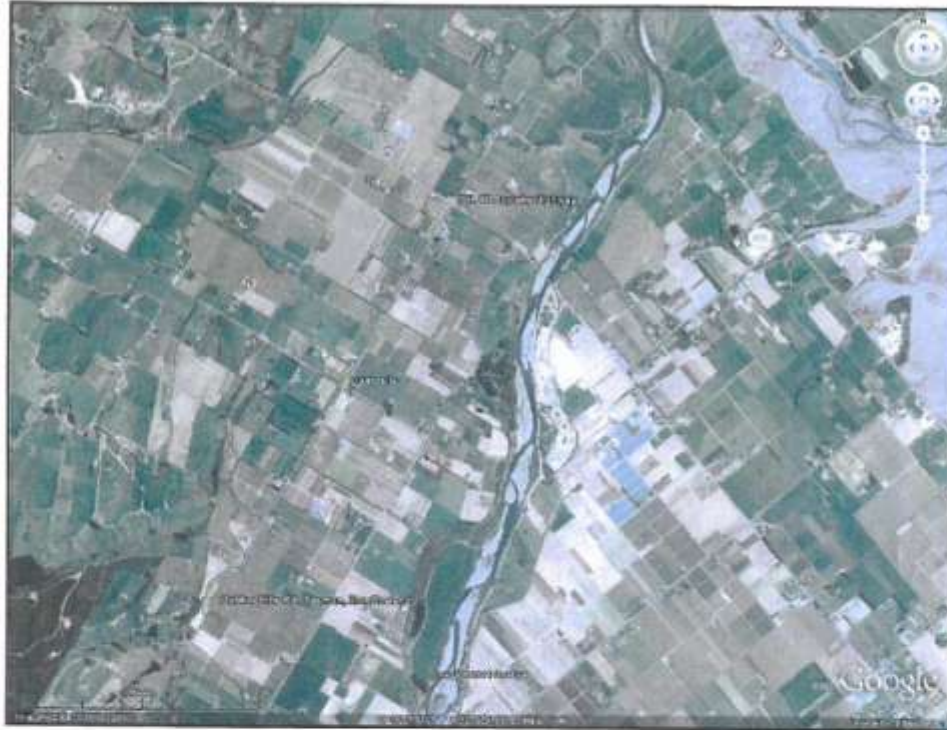
**THE CRASH SITE:**

The intersection where the crash occurred is known locally as RUSS Corner. The intersection has an unusual lay-out as it is situated on a corner where the Moutere Highway turns through ninety-degrees, making up two legs of a cross-intersection with Waimea West Road and Golden Hills Road.

The Moutere Highway carries a high volume of traffic servicing the Waimea basin and is considered a main road. As such it carries a right of way through the ninety-degree corner at this intersection and the other two intersecting roads are controlled by Stop signs.

Inspection of the crash site found that the sealed road was in good condition and free from any substance or objects likely to have caused a loss of driver control.

The road markings and signage were in good repair and clearly visible to traffic approaching the intersection from all directions.

Measurements found that when approaching the intersection, eastbound drivers could not view southbound traffic until within 22 metres of the corner and the southbound drivers could not view eastbound vehicles until approximately 26 metres from the corner.

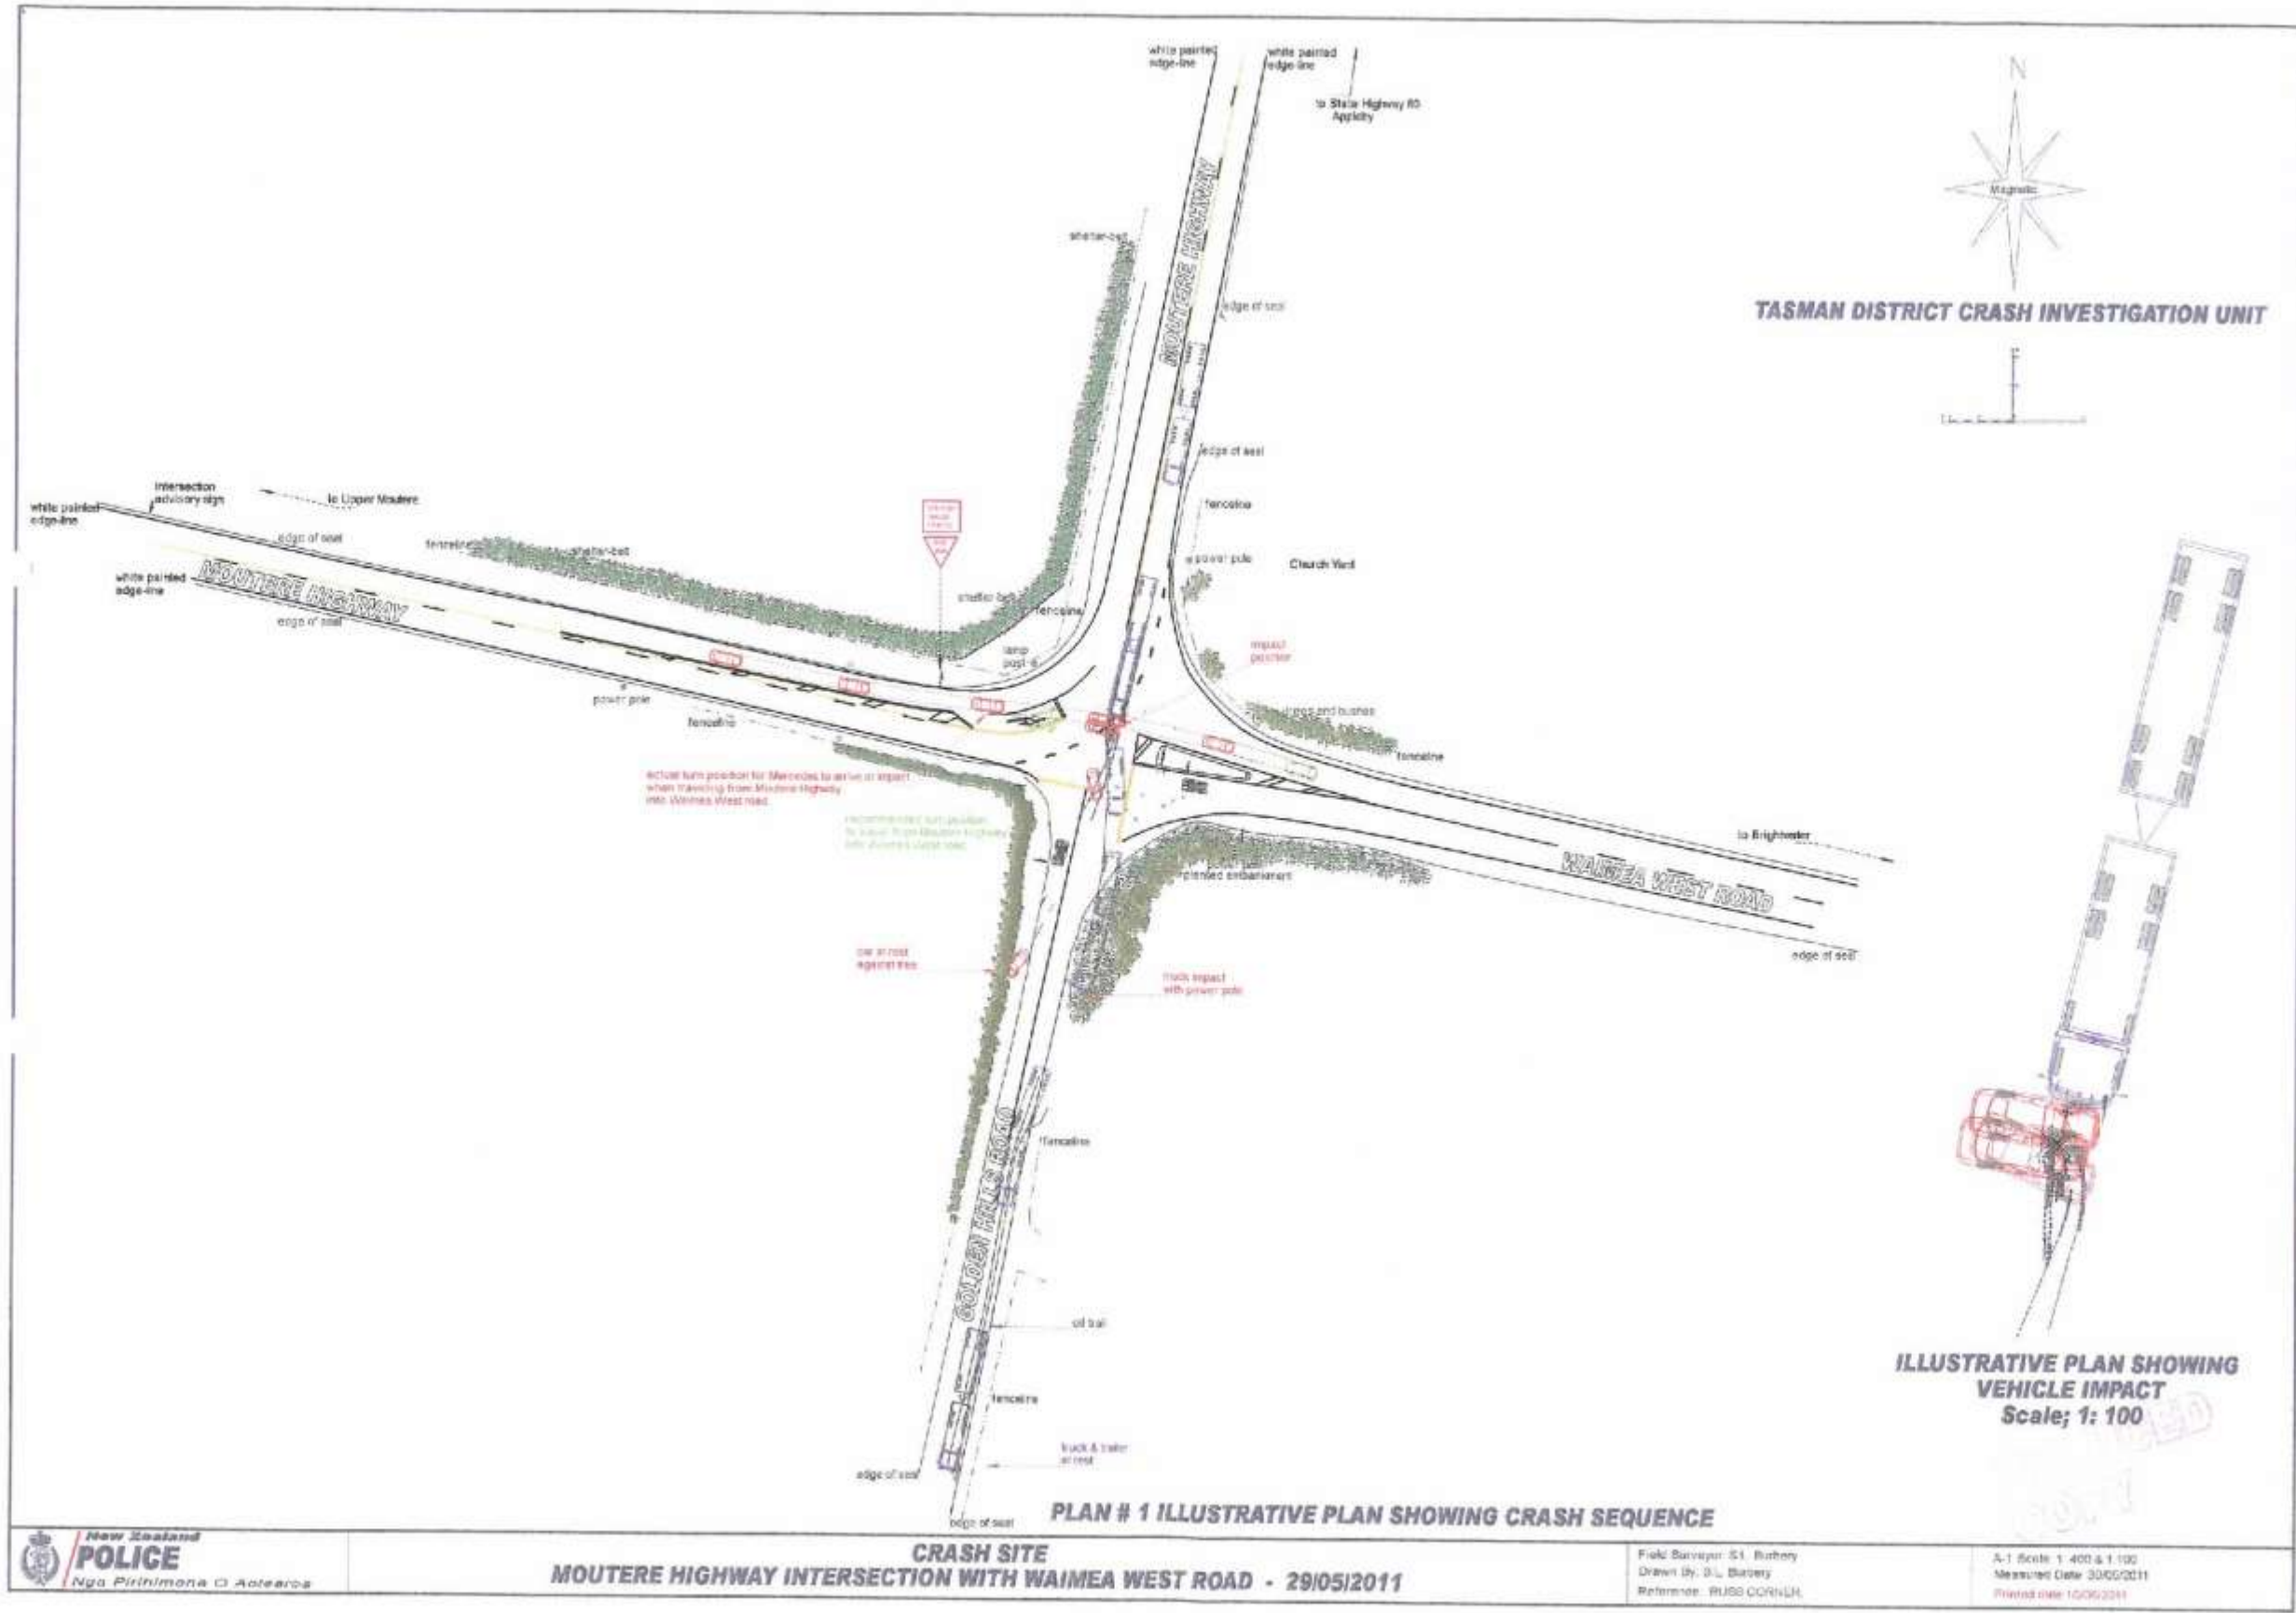
Car 7

Observations done at the crash site show some southbound road users travelling through at speeds close to the 100km/h speed limit into Golden Hills Road. Those drivers were completely reliant of the compliance of other road users, whom they could not even see.

While at the crash site several local drivers independently approached Police to complain at the speed of traffic crossing the intersection, many of whom are local lifestyle block residents who appear to have developed a complacency regarding the busy rural cross-road.
