**Tasman District Council**

**Site Investigation of Sheep Dips and Slipways using a Portable X-ray Fluorescence Meter (XRF)**

**Contaminated Site Remediation Fund Contract Number 20369**

**October 2013**

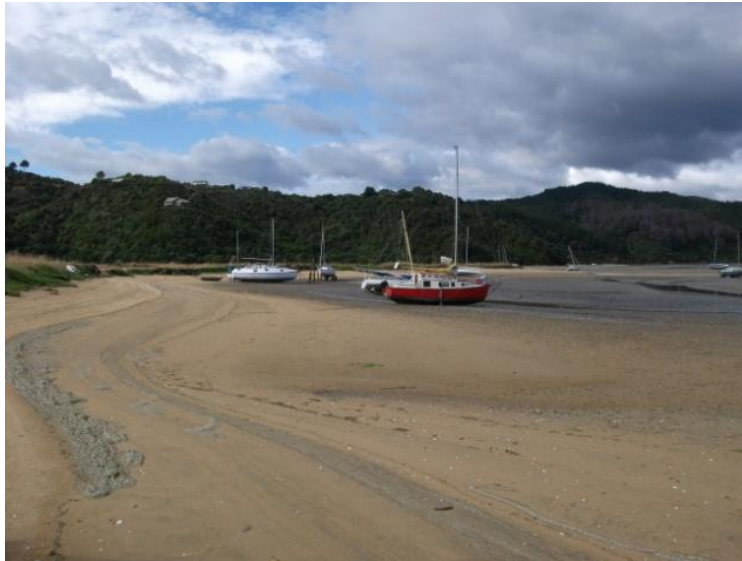
The sites varied in both nature and the intensity of use. They ranged from formal slipways with extensive associated hard stand areas which were regularly used for the maintenance of a significant number of vessels (such as at Port Motueka and Waitapu Bay slipways, Photo 4) to very low density swing mooring sites in isolated bays, for example in the Otuwhero Inlet area near Marahau (See Photo 3|).

Photo 3: Swing Moorings Otuwhero Inlet

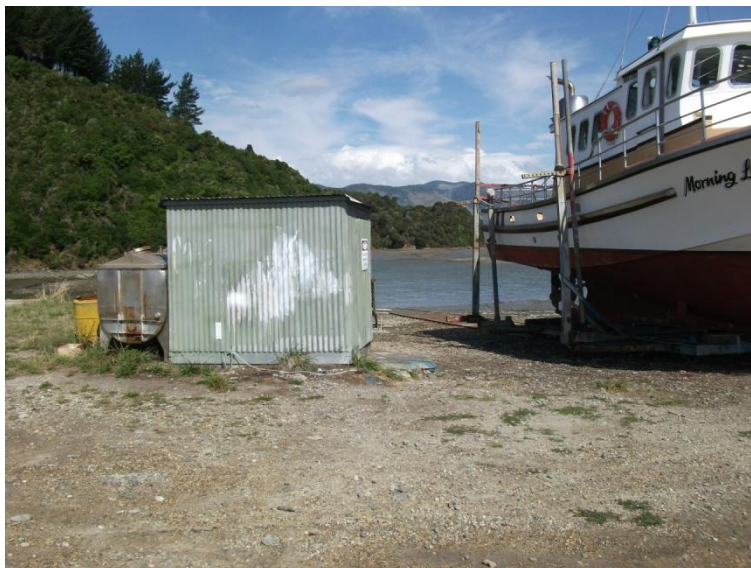
Photo 4: Waitapu Slipway
