PROJECT TECHNICAL MEMORANDUM FOR TASMAN DISTRICT COUNCIL

Project: Fault Rupture Risk Area Review

Subject: Review of Waimea Fault Location, Cushendall Rise to Champion Road, Richmond

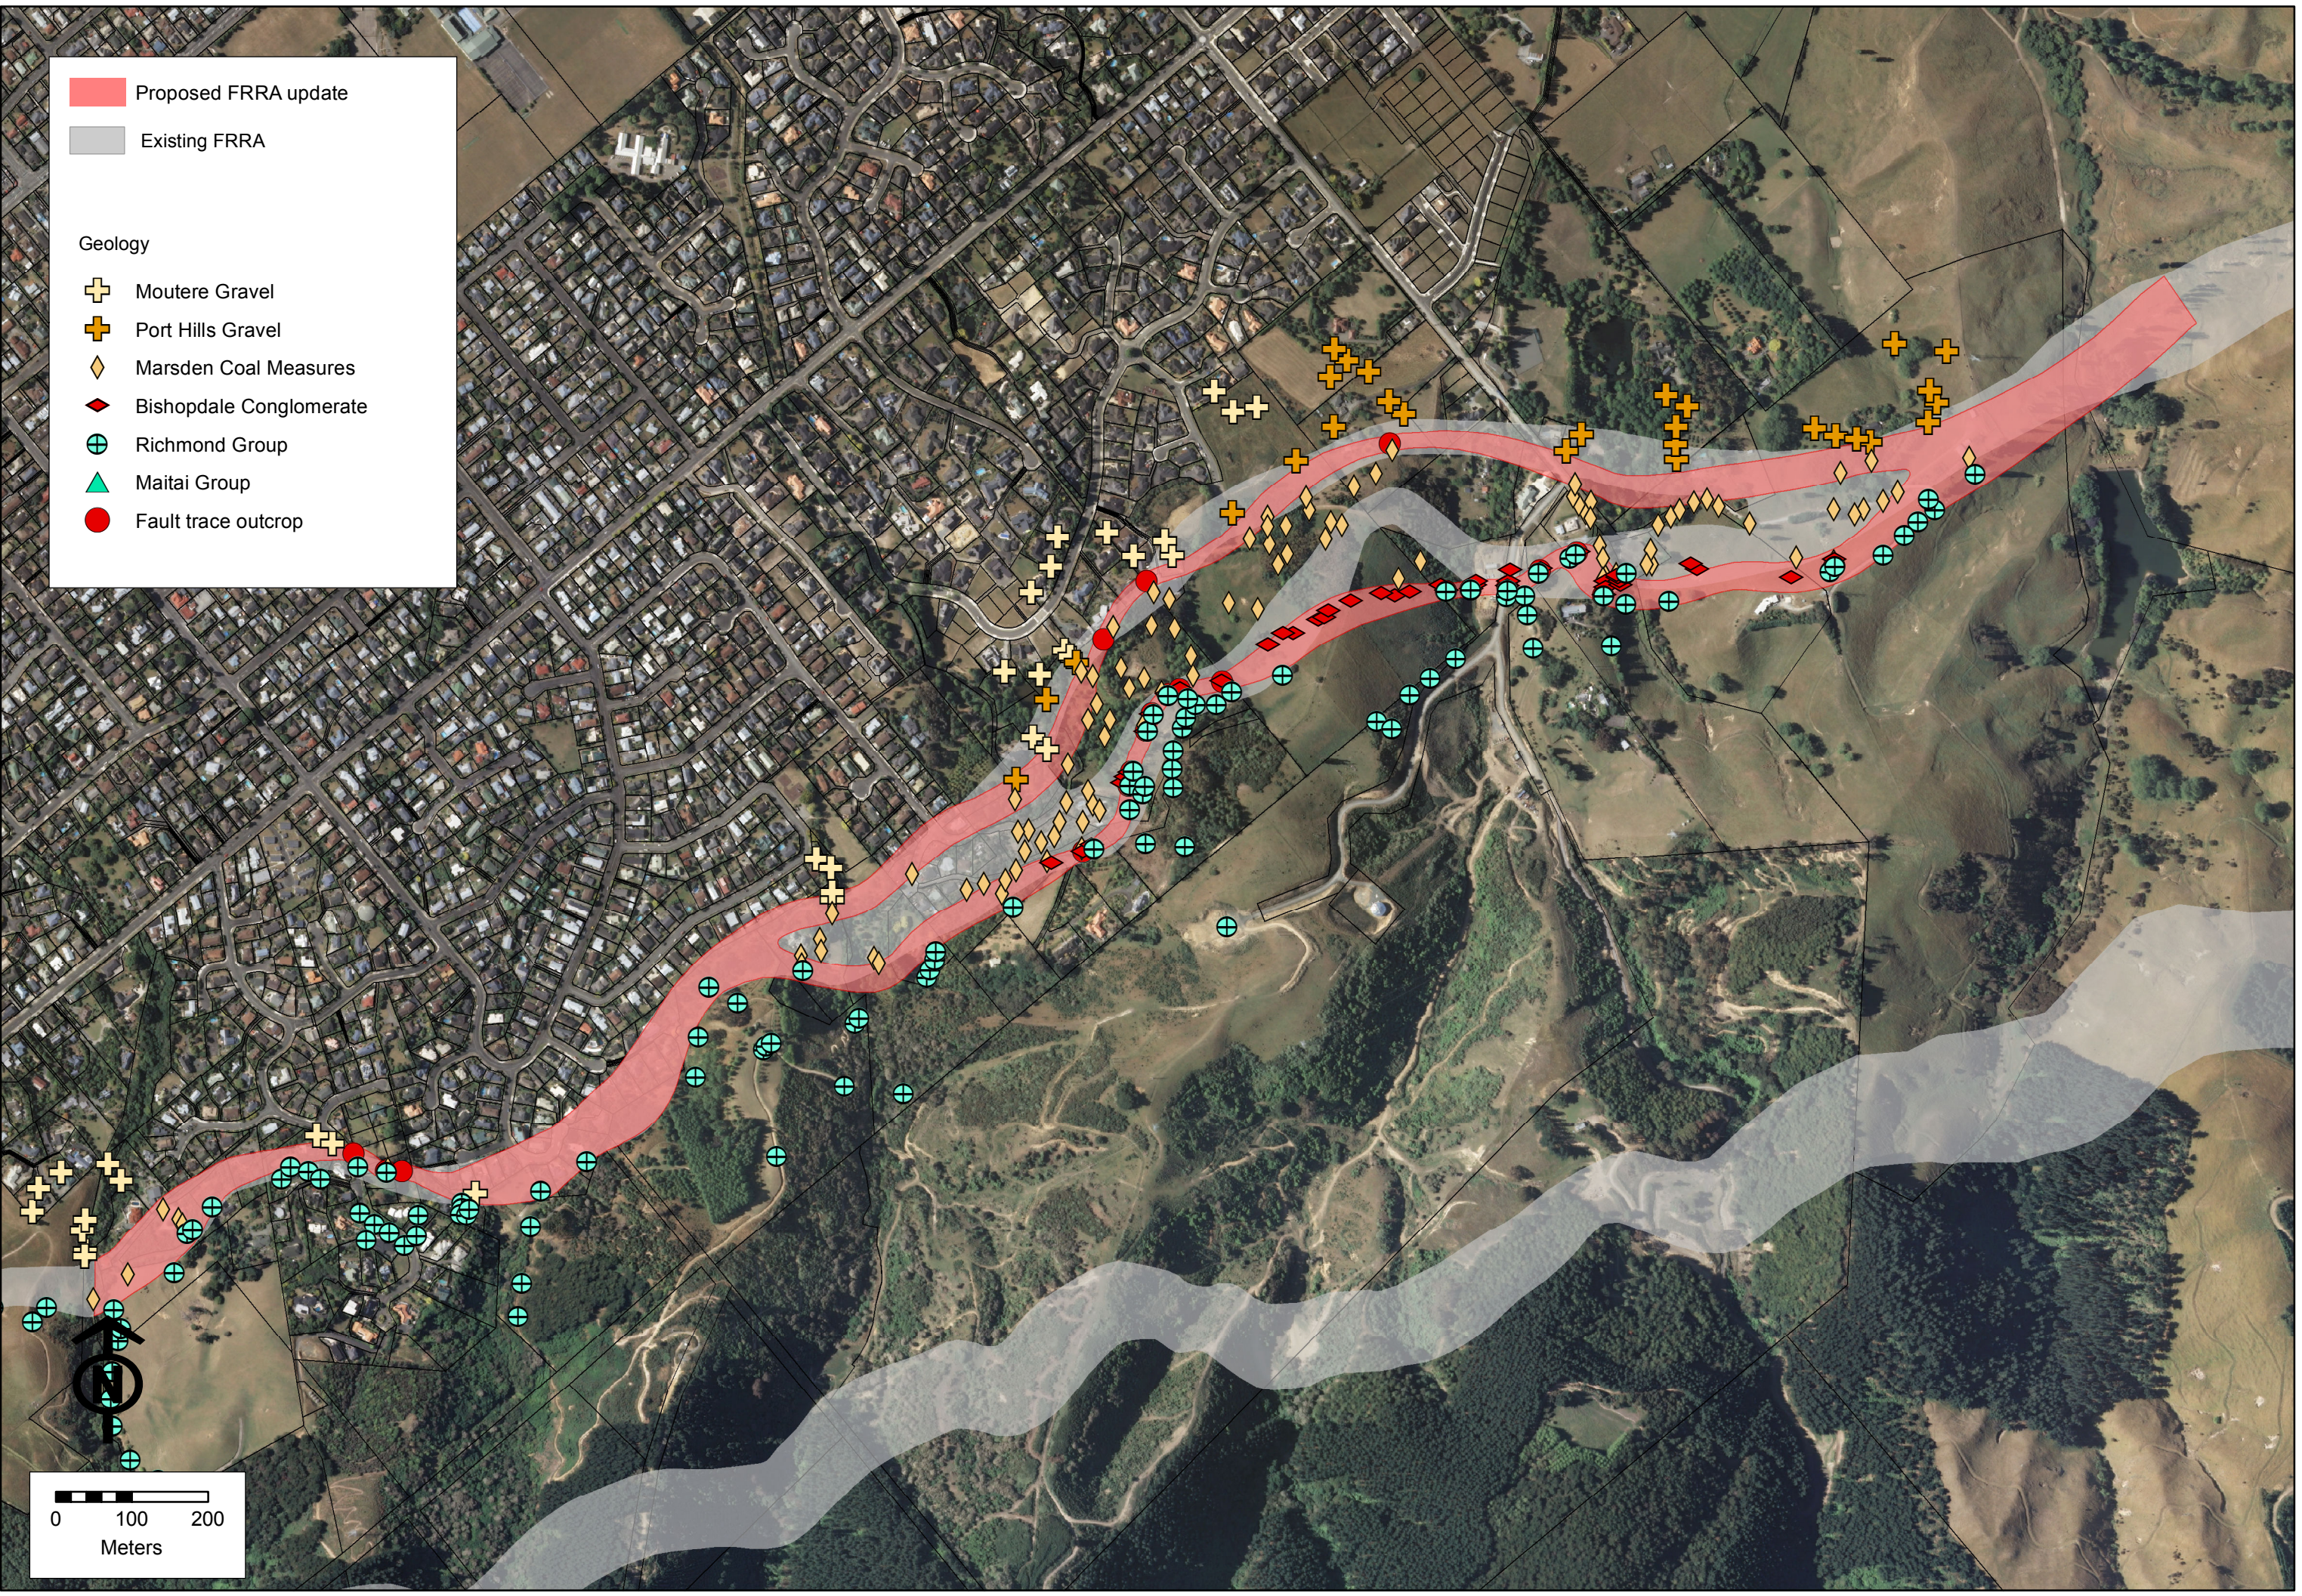
Geology

- Moutere Gravel
- Port Hills Gravel
- Marsden Coal Measures
- Bishopdale Conglomerate
- Richmond Group
- Maitai Group
- Fault trace outcrop

Based on our desktop study of available geotechnical information and observed geology we have produced a series of five plans of a geological envelope which contains the fault zone. The plotted fault zone envelope on each sheet encompasses the fault zone plus the required 10m habitable building setback on each side of the fault zone. In areas of greater geological confidence (i.e. a greater density of data) a 5m habitable building setback on each side of the fault is encompassed within the plotted fault zone and in these cases the total width is narrower.

The fault zone envelope is shown as a single zone due to the fact the Marsden Coal Measures are very narrow as indicated by outcrops and test pit logs in the vicinity of Valhalla Drive. The fault zone envelope is shown as a narrow zone where it has been identified by GEOadvice Ltd in two fault trenches at 45 Kihilla Road and in a cut batter opposite 10 Valhalla Drive. Further west the fault position is constrained by test pit data and outcrop mapping carried out by Soils and Foundations Limited at 4 Valhalla Drive and at lots on Cushendall Rise.
