Information Only - no decision required	
Date:	10 August 2012
File No:	
Report No:	RESC12-08-07

Report to: Engineering Services Committee

Report Author: Sarah Downs – Transportation Planning Officer
Subject: Port Motueka – Jackett Island Erosion Project

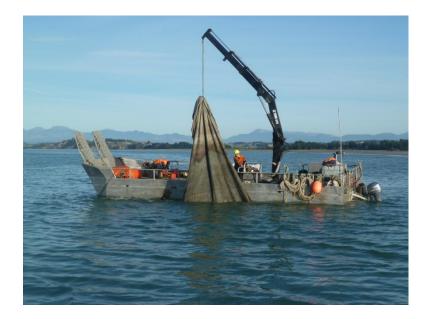
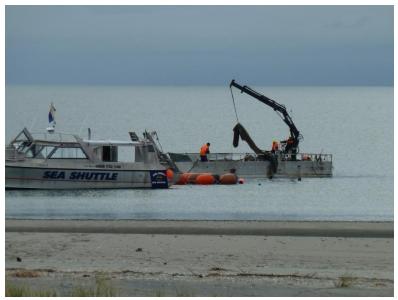
- 4.5 To date, the exposed parts of the groyne have been successfully removed.
- 4.6 As of 10 August 2012, the only remaining section of groyne to be removed is a short 90 metre section which is underwater and sand. The weather at the end of July and the beginning of August have made it very difficult for any further progress to remove the remaining section. The presence of oil drums and old fertiliser sacks, plus another ground cloth have been discovered by the contractors in the process of removing the groyne. This has added further complications to the removal of the remaining groyne under the water. The contractors believe that these articles were used for weighting down the groyne when it was installed. They have also found little evidence of the side sausages which were meant to be part of the original design.

The photographs above show the groyne removal process for the remaining sections under water
