Tonkin & Taylor
Environmental & Engineering Consultants
D Auckland D Nelson D Christchurch D Hamilton D Wellington D Whangarei

TASMAN DISTRICT COUNCIL
GEOTECHNICAL PRE-FEASIBILITY ASSESSMENT
Lee River Valley, Tasman
Investigation Location Plan – Dam Sites

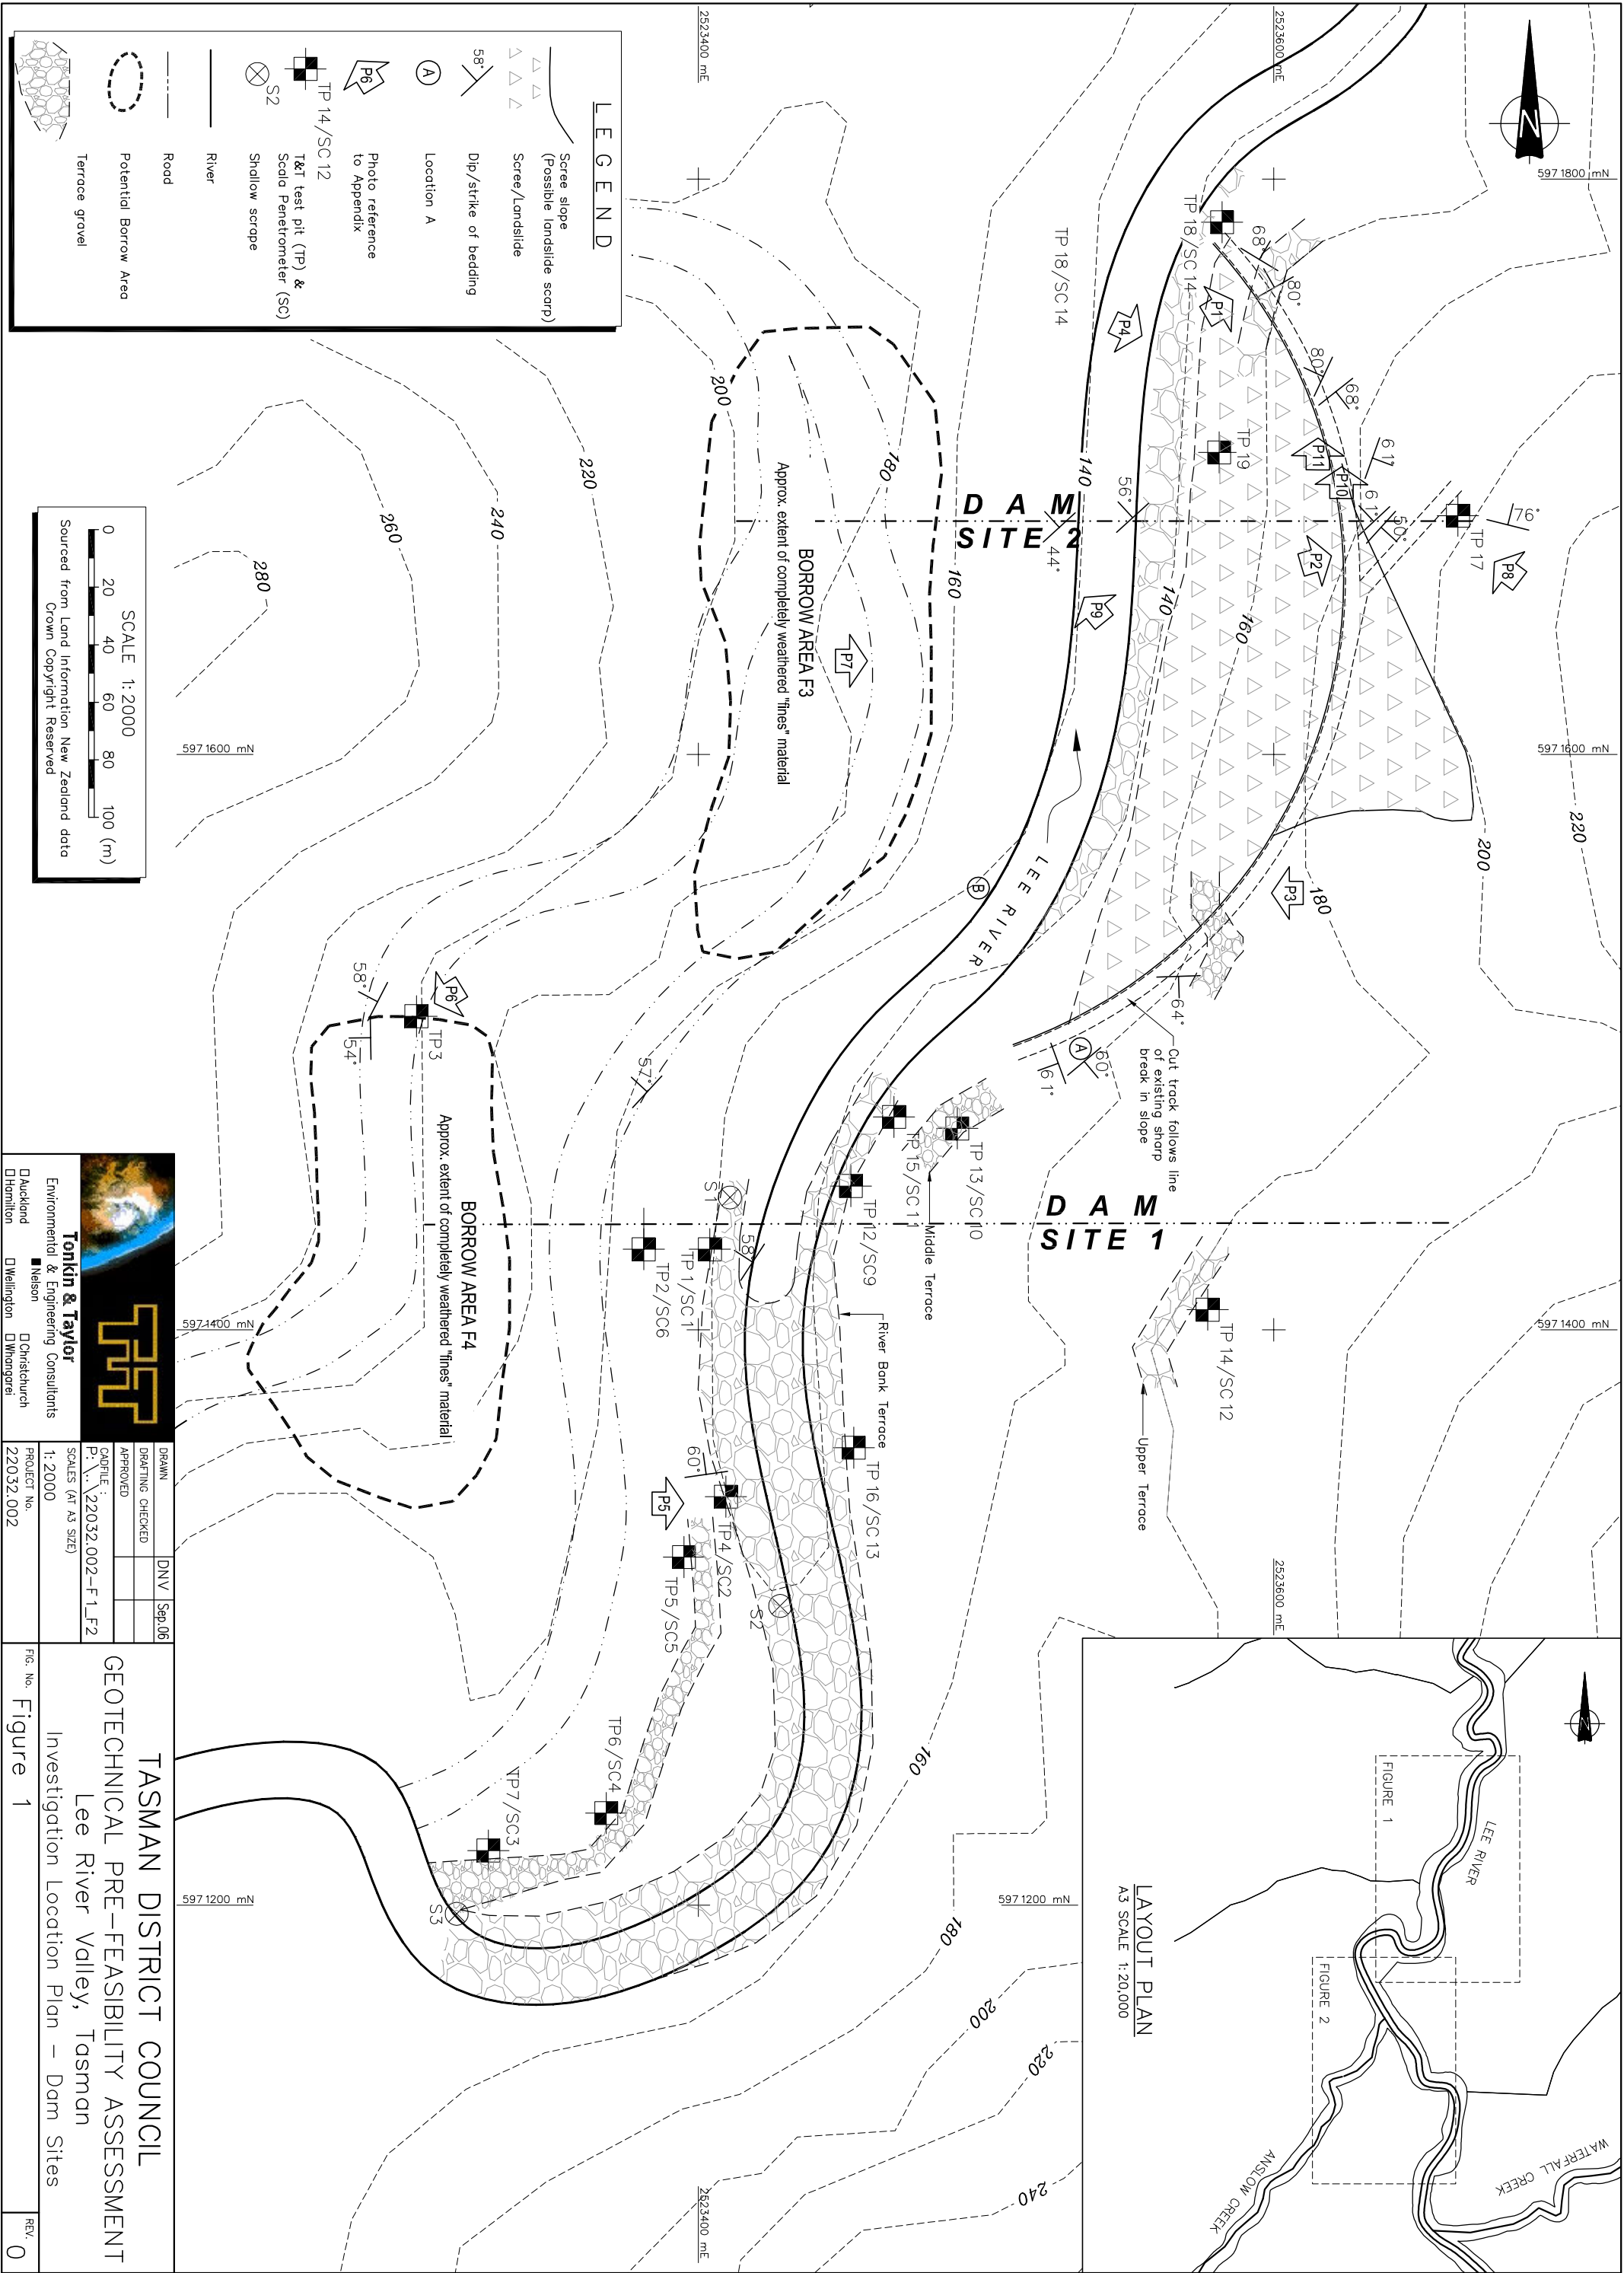
FIG. No. **Figure 1**

- Scree slope (Possible landslide scarp)
- Scree/Landslide
- Dip/strike of bedding
- Location A
- Photo reference to Appendix
- TP 14/SC 12
- T&T test pit (TP) & Scota Penetrometer (SC)
- Shallow scrape
- River
- Road
- Potential Borrow Area
- Terrace gravel
